**FOUNDATION INVESTIGATION REPORT
HIGHWAY 11 AT PAN LAKE, 10.6 km NORTH OF HIGHWAY 64
STATION 14+750 TO 14+950, IN OLIVE TOWNSHIP.
WP 5578-04-00, NORTH BAY AREA
GEOCRES No. 31L-123**

**MTO NE REGION CONTRACT #5006-E-0070
ASSIGNMENT #7**

3 September 2008
TB7206007-I

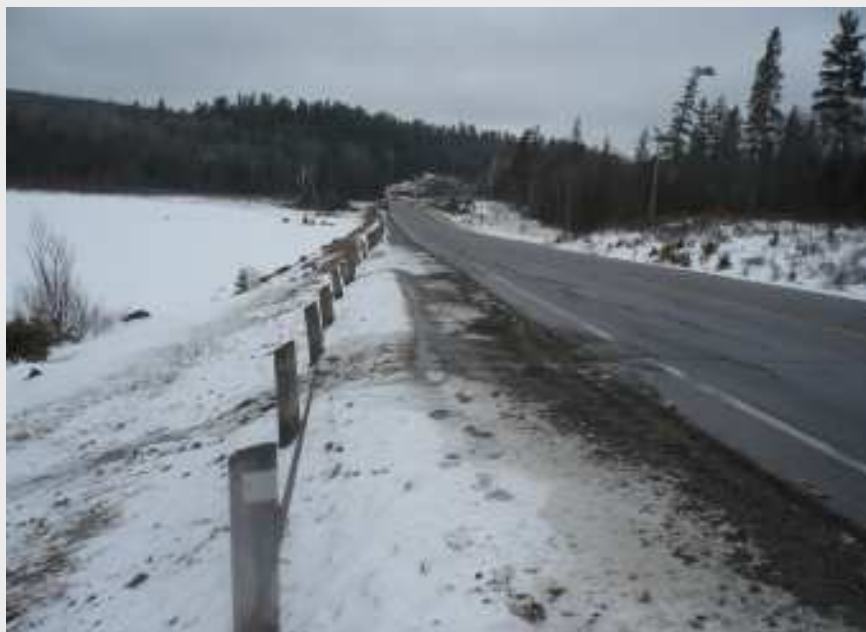
3

Guiderail

Hwy 11 Pan Lake Looking North. Existing guiderail and embankment on Highway 11 at Pan Lake

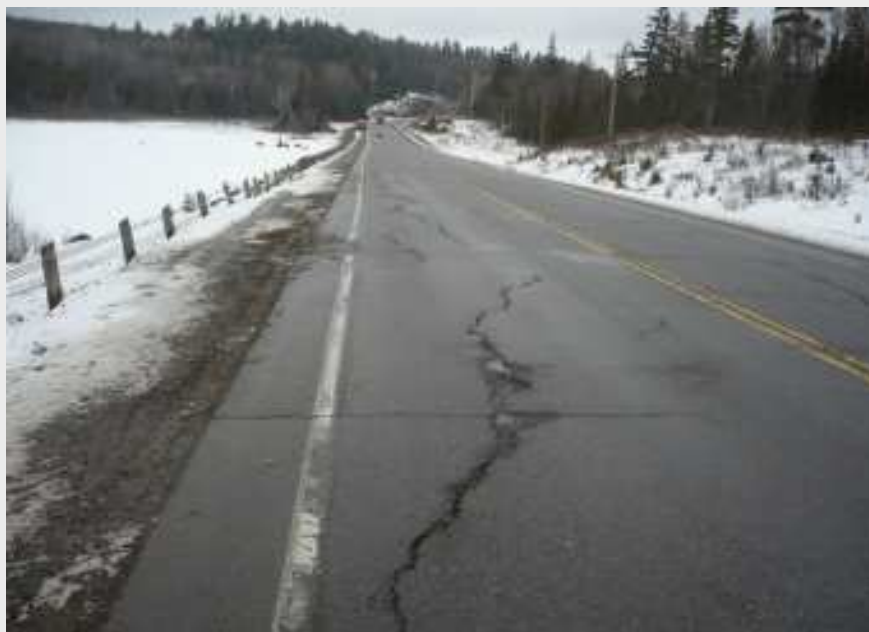
7

Pavement Condition

Hwy 11 Pan Lake Looking North

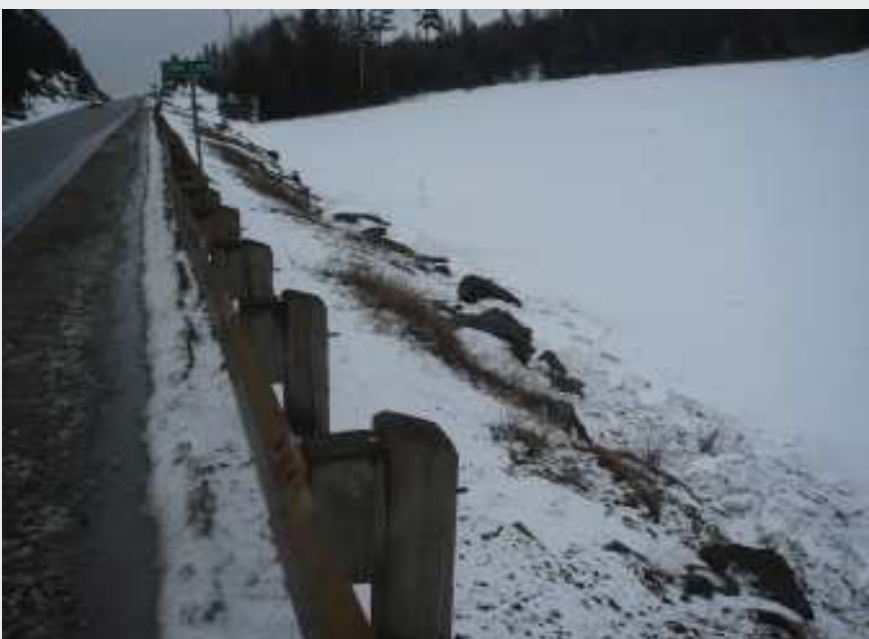
8

Site Condition
