**FOUNDATION INVESTIGATION AND DESIGN REPORT
HIGHWAY 11 AT PAN LAKE, 10.6 km NORTH OF HIGHWAY 64
STATION 14+750 TO 14+950, IN OLIVE TOWNSHIP.
WP 5578-04-00, NORTH BAY AREA
GEOCRES No. 31L-123**

**MTO NE REGION CONTRACT #5006-E-0070
ASSIGNMENT #7**

3 September 2008
TB7206007-II

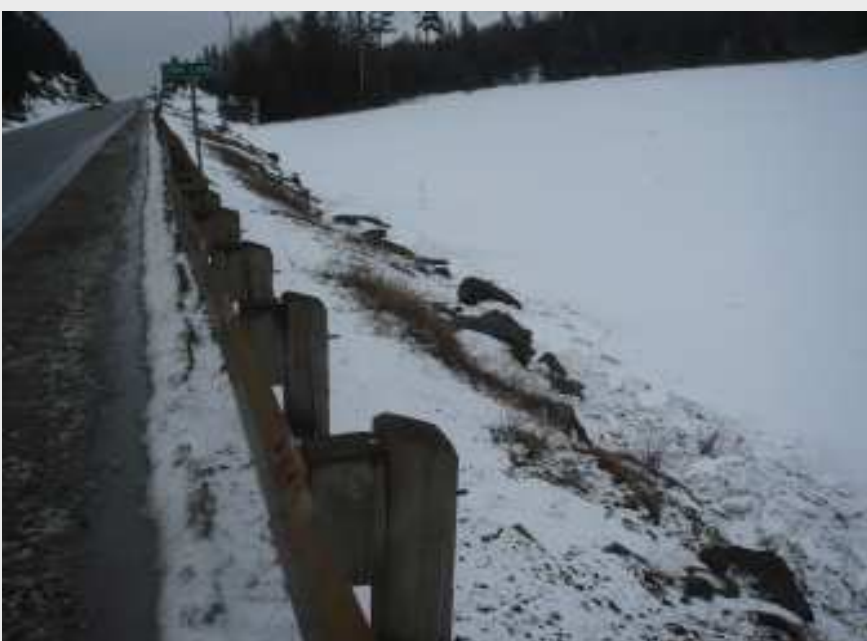
8

Hwy 11 Pan Lake Looking North

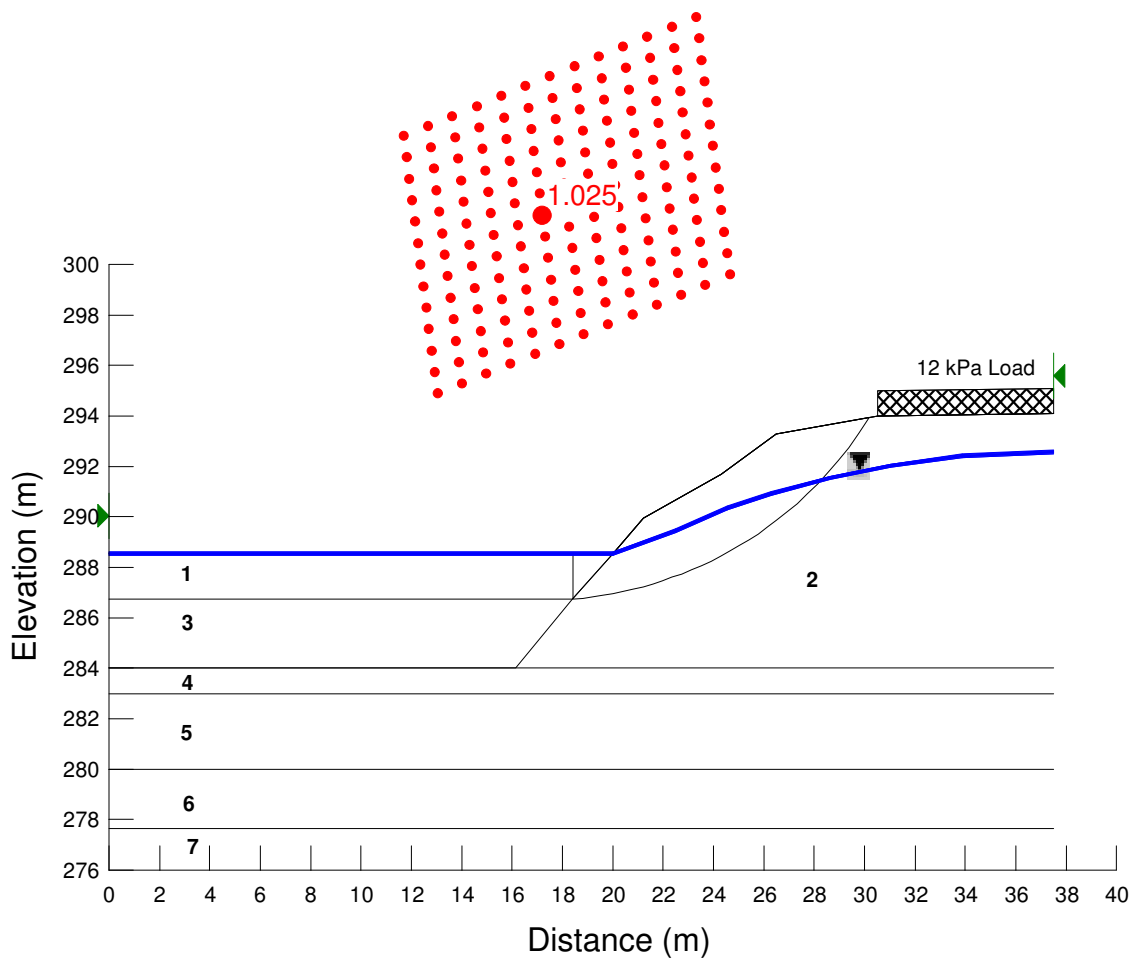
Figure D1.1 Stability of HWY11 Road Section at Sta. 14+800
 (Slip Surface within Rockfill)

Figure No.	Conditions of Road Embankment	Considerations for Analysis	Minimum Calculated Factor of Safety (FOS)	Remarks
Station 14 +800				
D1.1	Existing slope (~1V:1.2H)	Slip surface within rock fill	1.02	Slip surface within rock fill is possible.
D1.2	Existing slope (~1V:1.2H)	Deep seated slip surface with assumed weak layer	1.02	Deep seated slip surface is possible.
D1.3	Existing slope (~1V:1.2H)	Deep seated slip surface without assumed weak layer	1.29	Assumed weak layer in D1.2 is possible.
D2.1	Existing slope (~1V:1.2H)	Slip surface within rock fill with assumed weak layer and additional rock fill (1V:1.5H)	1.06	Slightly increase FOS in D1.1.
D2.2	Existing slope (~1V:1.2H)	Deep seated slip surface with assumed weak layer and additional rock fill (1V:1.5H)	1.13	Increase FOS in D1.2.
D2.3	Existing slope (~1V:1.2H)	Slip surface within rock fill with assumed weak layer and additional rock fill (1V:2H)	1.25	Increase FOS in D1.1 and D2.1.

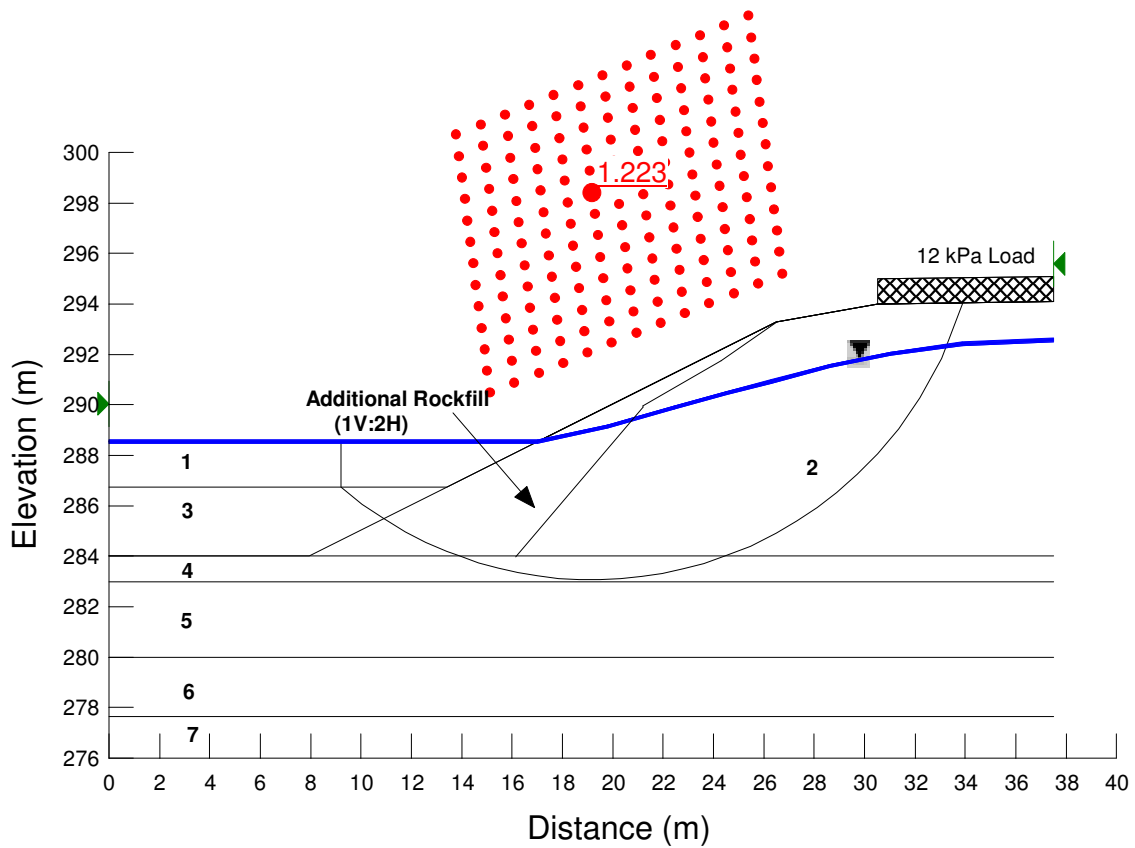
Figure D2.4 Stability of HWY11 Road Section at Sta. 14+800
 (Deep Seated Slip Surface with additional Rockfill in Lake)

Figure No.	Conditions of Road Embankment	Considerations for Analysis	Minimum Calculated Factor of Safety (FOS)	Remarks
D2.4	Existing slope (~1V:1.2H)	Deep seated slip surface with assumed weak layer and additional rock fill (1V:2H)	1.22	Increase FOS in D1.2 and D2.2.
D3.1	2m grade raise and 2.5m horizontal alignment shift	Slip surface within rock fill with assumed weak layer and additional rock fill (1V:1.5H)	1.02	Slip surface within rock fill is possible.
D3.2	2m grade raise and 2.5m horizontal alignment shift	Deep seated slip surface with assumed weak layer and additional rock fill (1V:1.5H)	1.05	Deep seated slip surface is possible.
D3.3	2m grade raise and 2.5m horizontal alignment shift	Slip surface within rock fill with assumed weak layer and additional rock fill (1V:2H)	1.28	Increase FOS in D3.1.
D3.4	2m grade raise and 2.5m horizontal alignment shift	Deep seated slip surface with assumed weak layer and additional rock fill (1V:2H)	1.15	Increase FOS in D3.2.
