FINAL REPORT

**Foundation Investigation and Design Report
Englehart Project
HWY 11, Township of Pacaud
Culvert # 60 Extension Replacement and Slope Failure
Station 11+684
Englehart, Ontario
WO 2009-11030
MTO GEOCRES No. 31M-81**

August 05, 2009

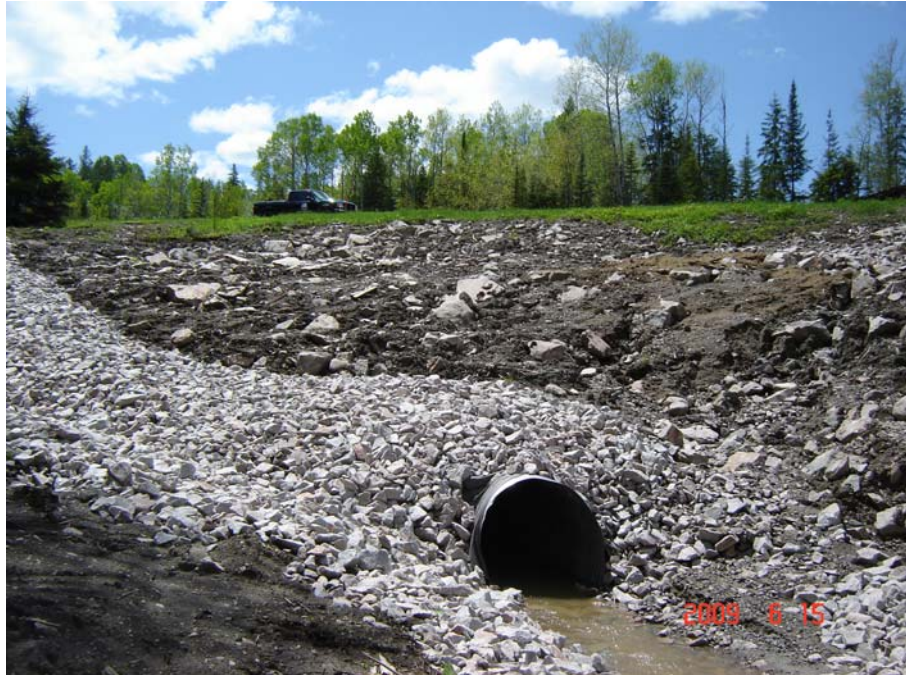
Photograph 1: Culvert # 60 at Station 11+684 (Pacaud Township).
On east side of Highway 11, looking west. Culvert outlet and failed CSP pipe.

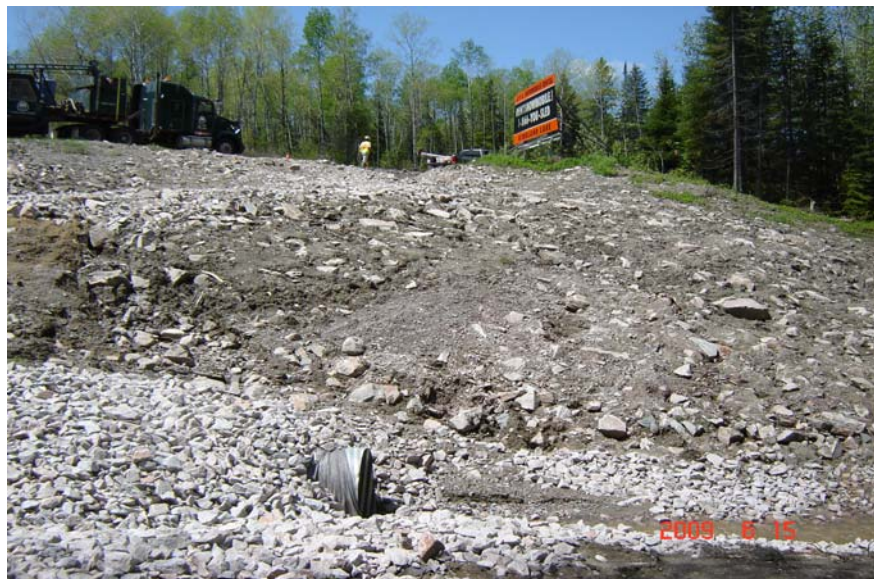
Photograph 2: Culvert # 60 at Station 11+684 (Pacaud Township).
On east side of Highway 11, looking north-west. Failed slope.

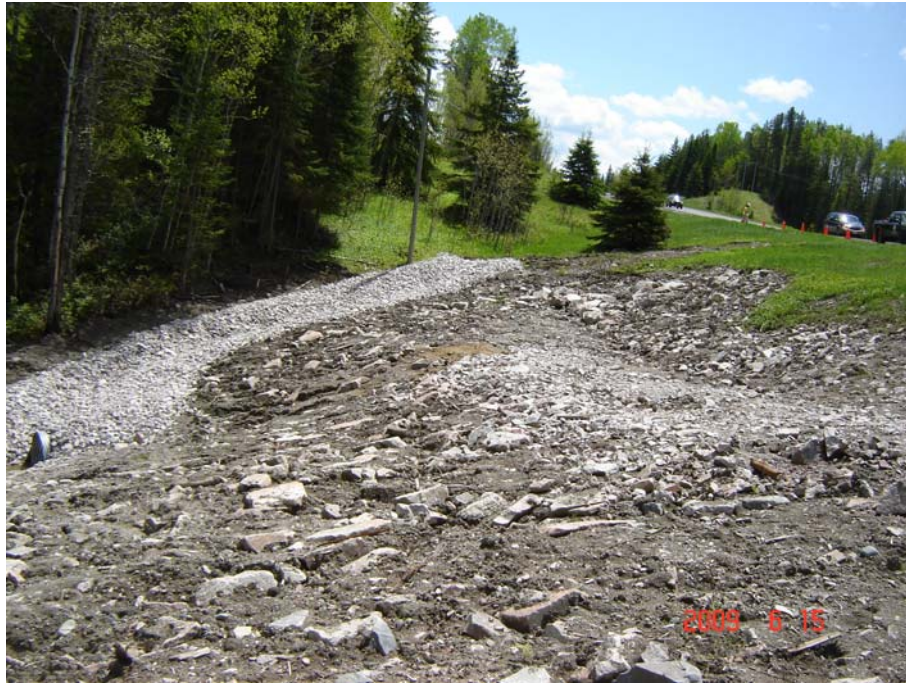
Photograph 3: Culvert # 60 at Station 11+684 (Pacaud Township).
On east side of Highway 11, looking south. Culvert outlet and gravel lined ditch.

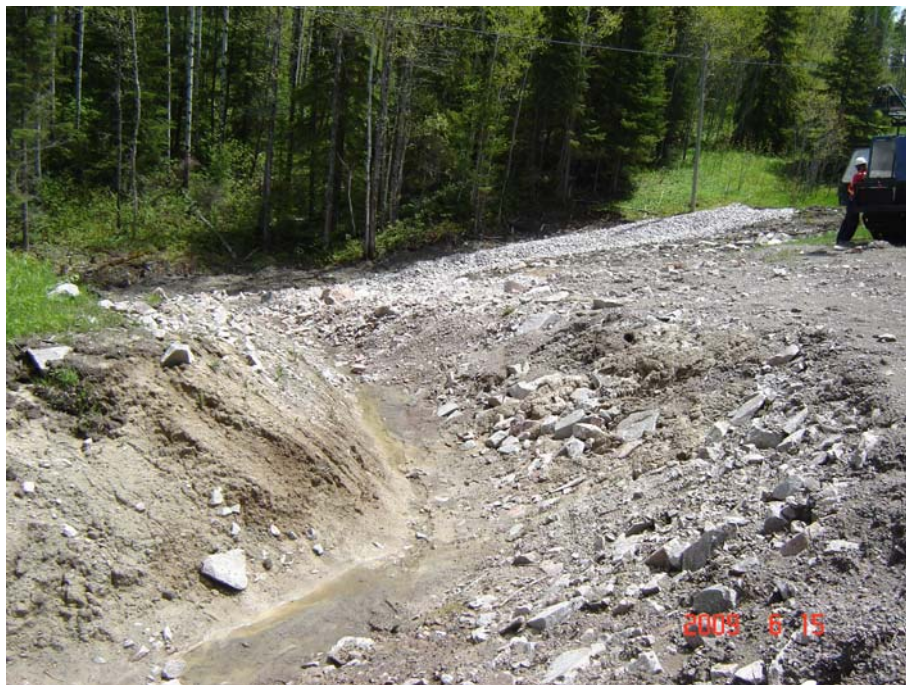
During the site visit and the field investigation it was observed that the failed CSP culvert area had been backfilled/graded with final slopes from the highway embankment and with gentler north and south slopes to the outlet ravine. Some rock fill was apparent on the slope, and in the outlet area, as can be seen on the photographs in Appendix A. Sections of the slope had been filled/excavated to current conditions. A gravel/cobble lined ditch was placed south of the outlet CSP extension to convey drainage from the roadside ditch to the south down to the area of the culvert, as shown on Photographs 3 and 5 in Appendix A. A small gully partway up the south slope also drained into the area, but it was not connected to the gravel-lined downslope ditch. The roadside ditch to the north drained, unchannelized, into and through the north slope material, as shown on Photographs 4 and 6 in Appendix A.

Photograph 4: Culvert # 60 at Station 11+684 (Pacaud Township).
On east side of Highway 11, looking south-east. Failed slope and north roadside ditch.

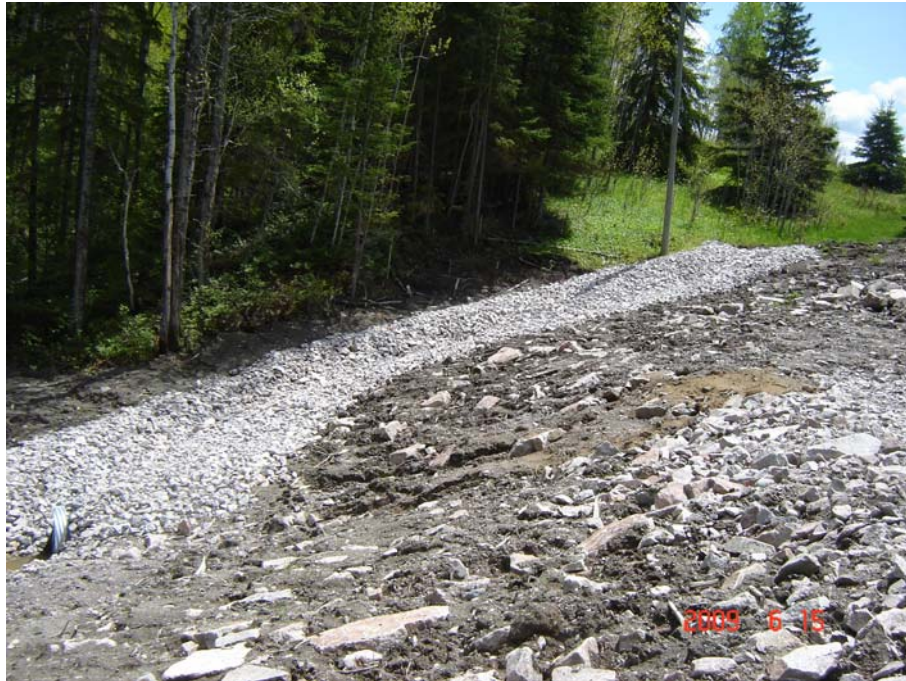
Photograph 5: Culvert # 60 at Station 11+684 (Pacaud Township).
On east side of Highway 11, looking south. Culvert outlet and gravel lined ditch.

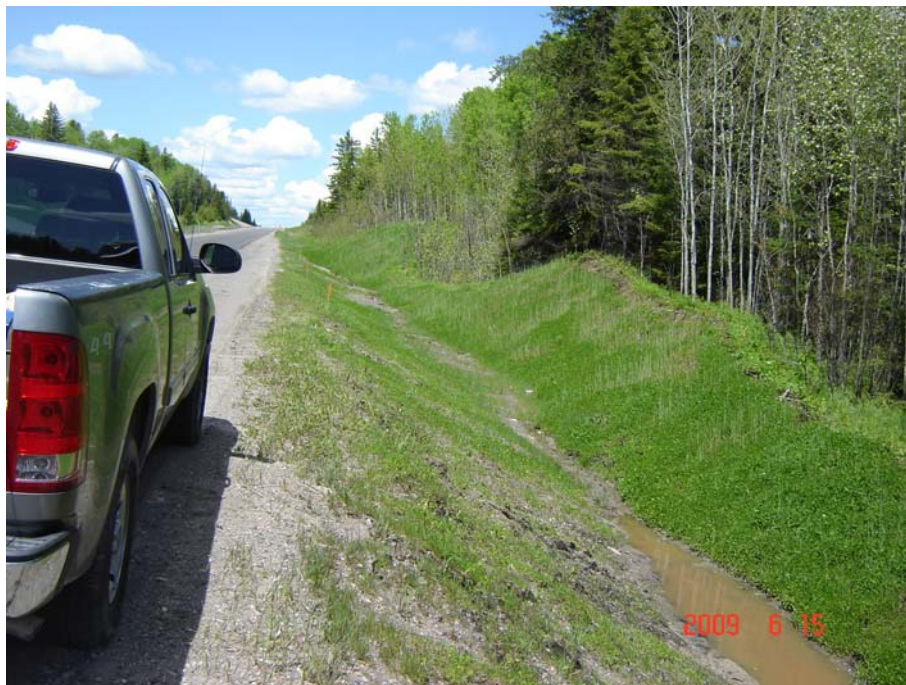
Photograph 6: Culvert # 60 at Station 11+684 (Pacaud Township).
On east side of Highway 11, looking north. Roadside ditch.

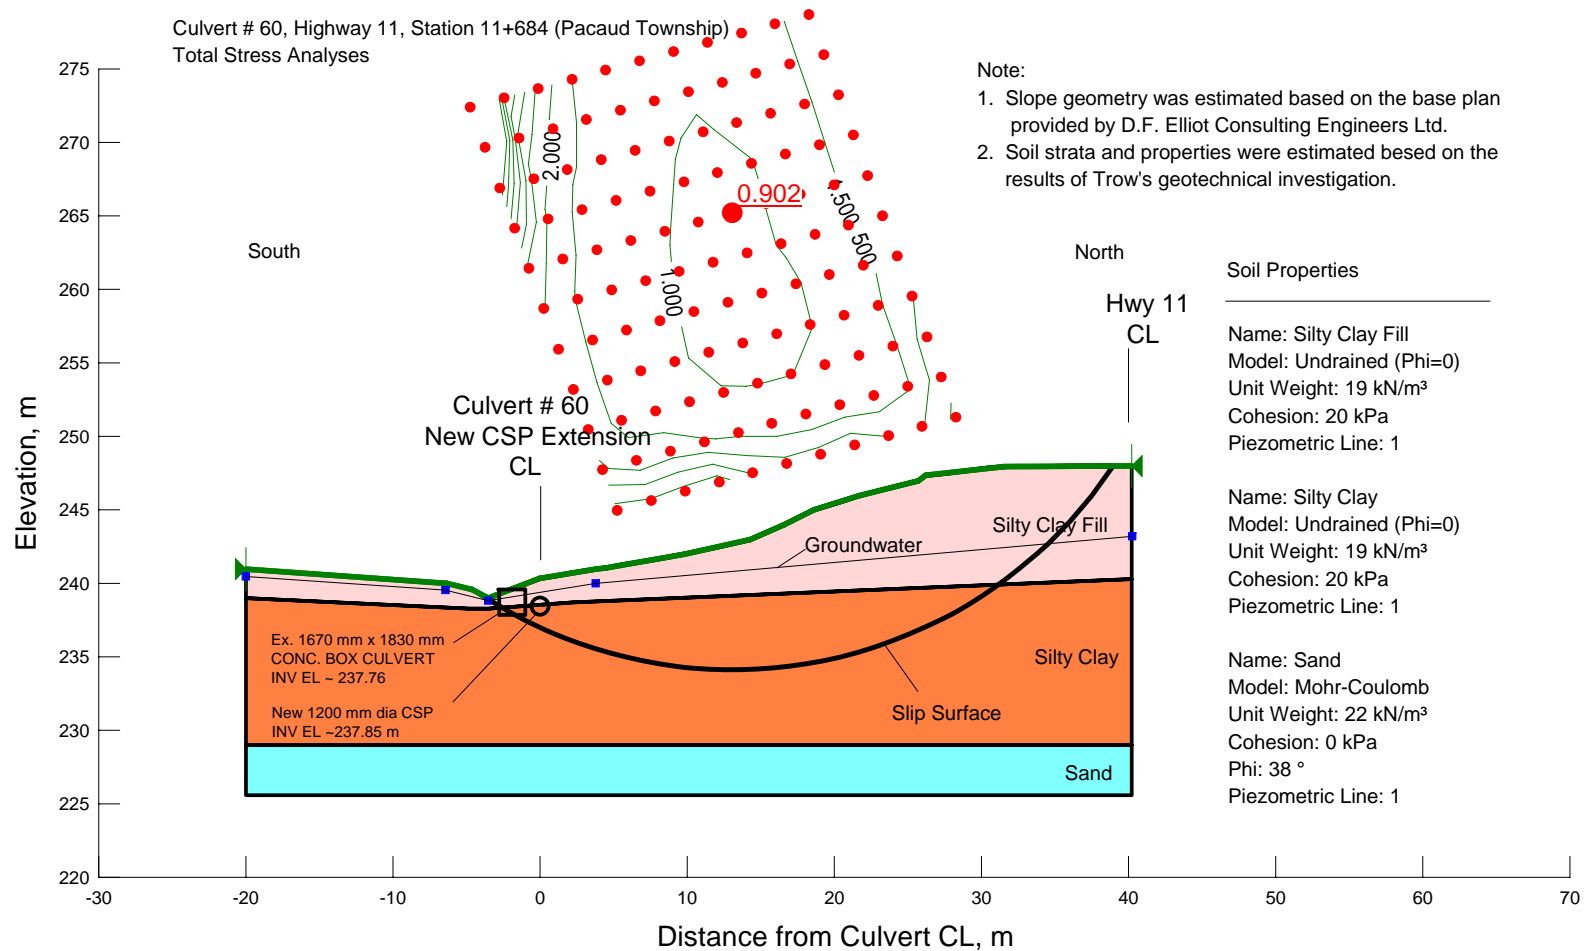
Figure 1 (a). Slope stability analyses before failure (November, 2008) assuming total stress parameters: silty clay fill $C_u=20 \text{ kPa}$ and silty clay $C_u=20 \text{ kPa}$.

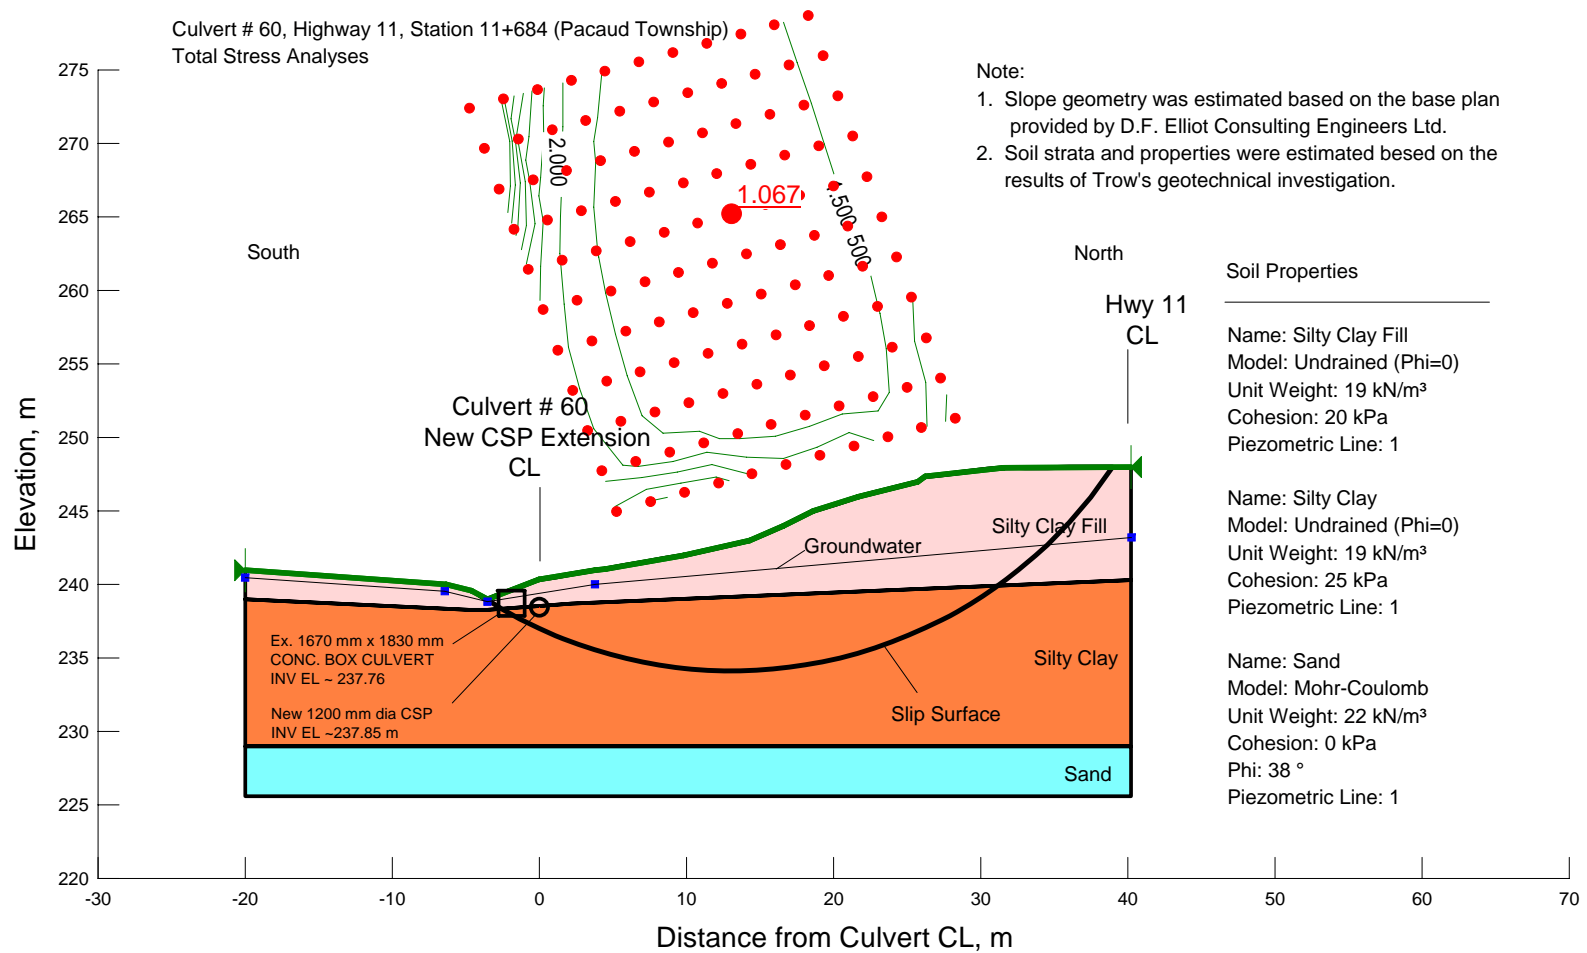
Figure 1 (b). Slope stability analyses before failure (November, 2008) assuming total stress parameters: silty clay fill $C_u=20$ kPa and silty clay $C_u=25$ kPa.

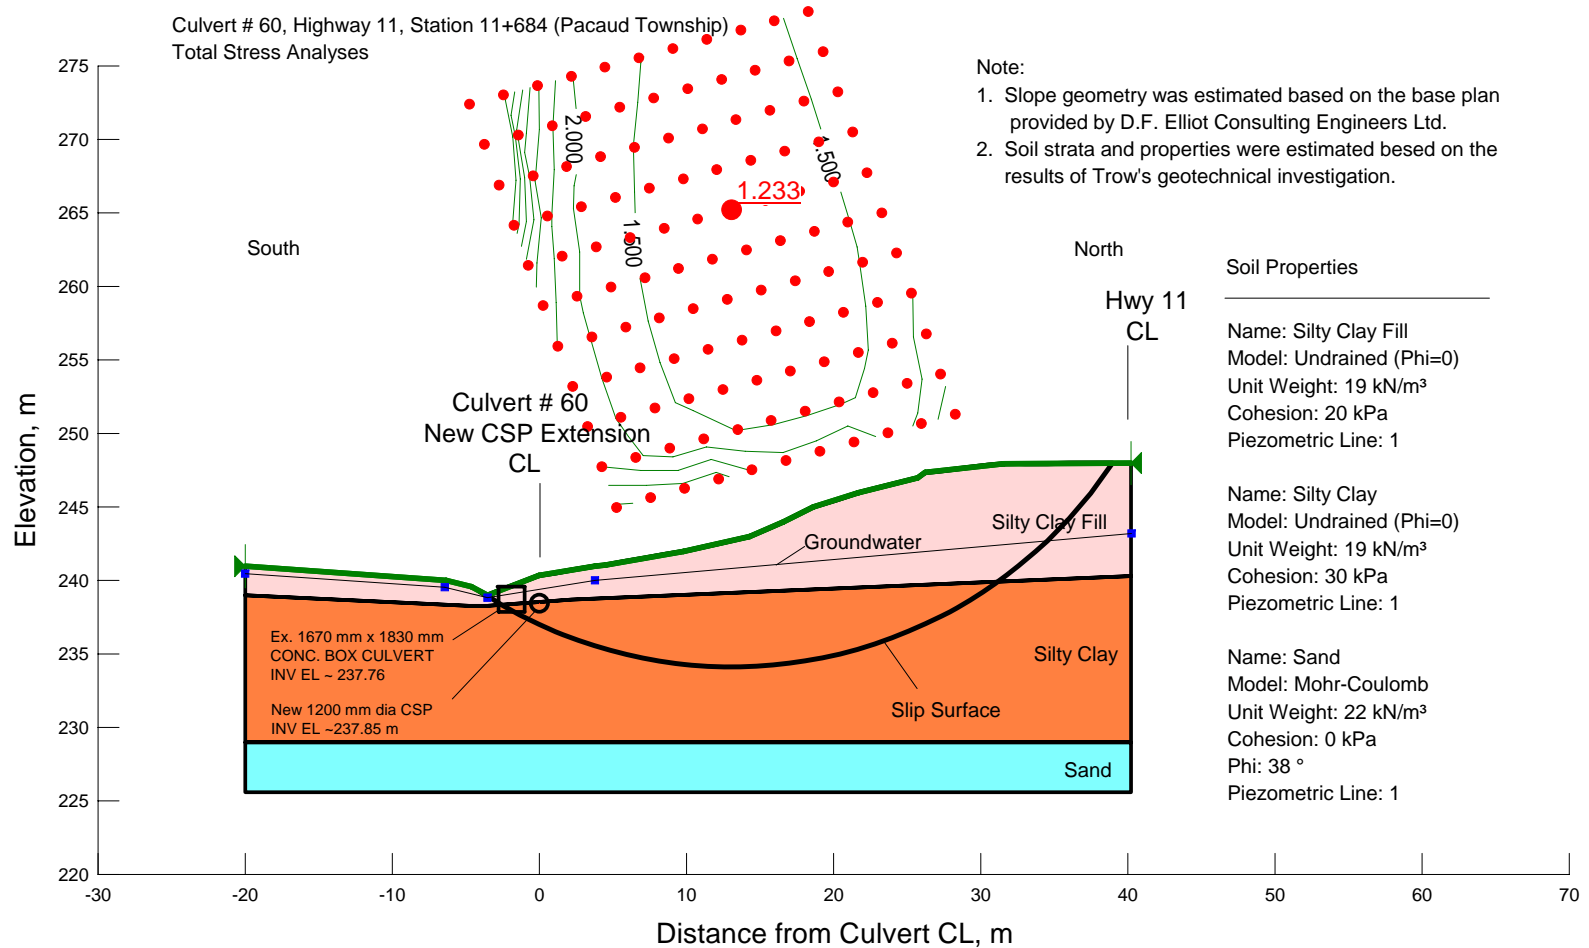
Figure 1 (c). Slope stability analyses before failure (November, 2008) assuming total stress parameters: silty clay fill $C_u=20$ kPa and silty clay $C_u=30$ kPa.

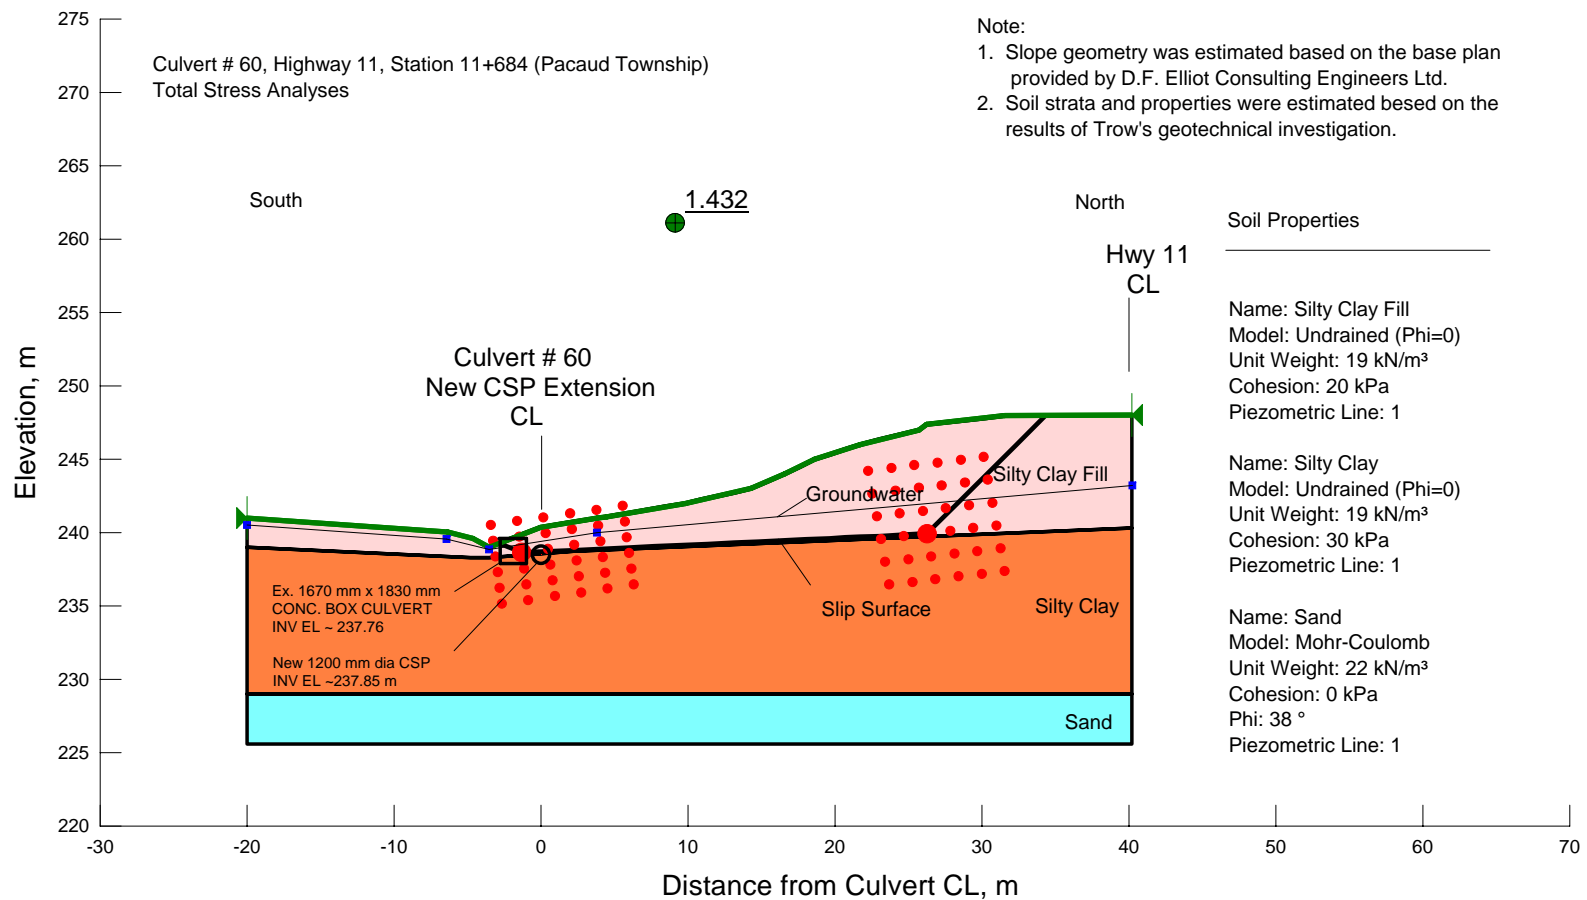
Figure 2. Slope stability analyses before failure (November, 2008) assuming total stress parameters: silty clay fill $C_u=20$ kPa and silty clay $C_u=30$ kPa; and using non-circular slip surface

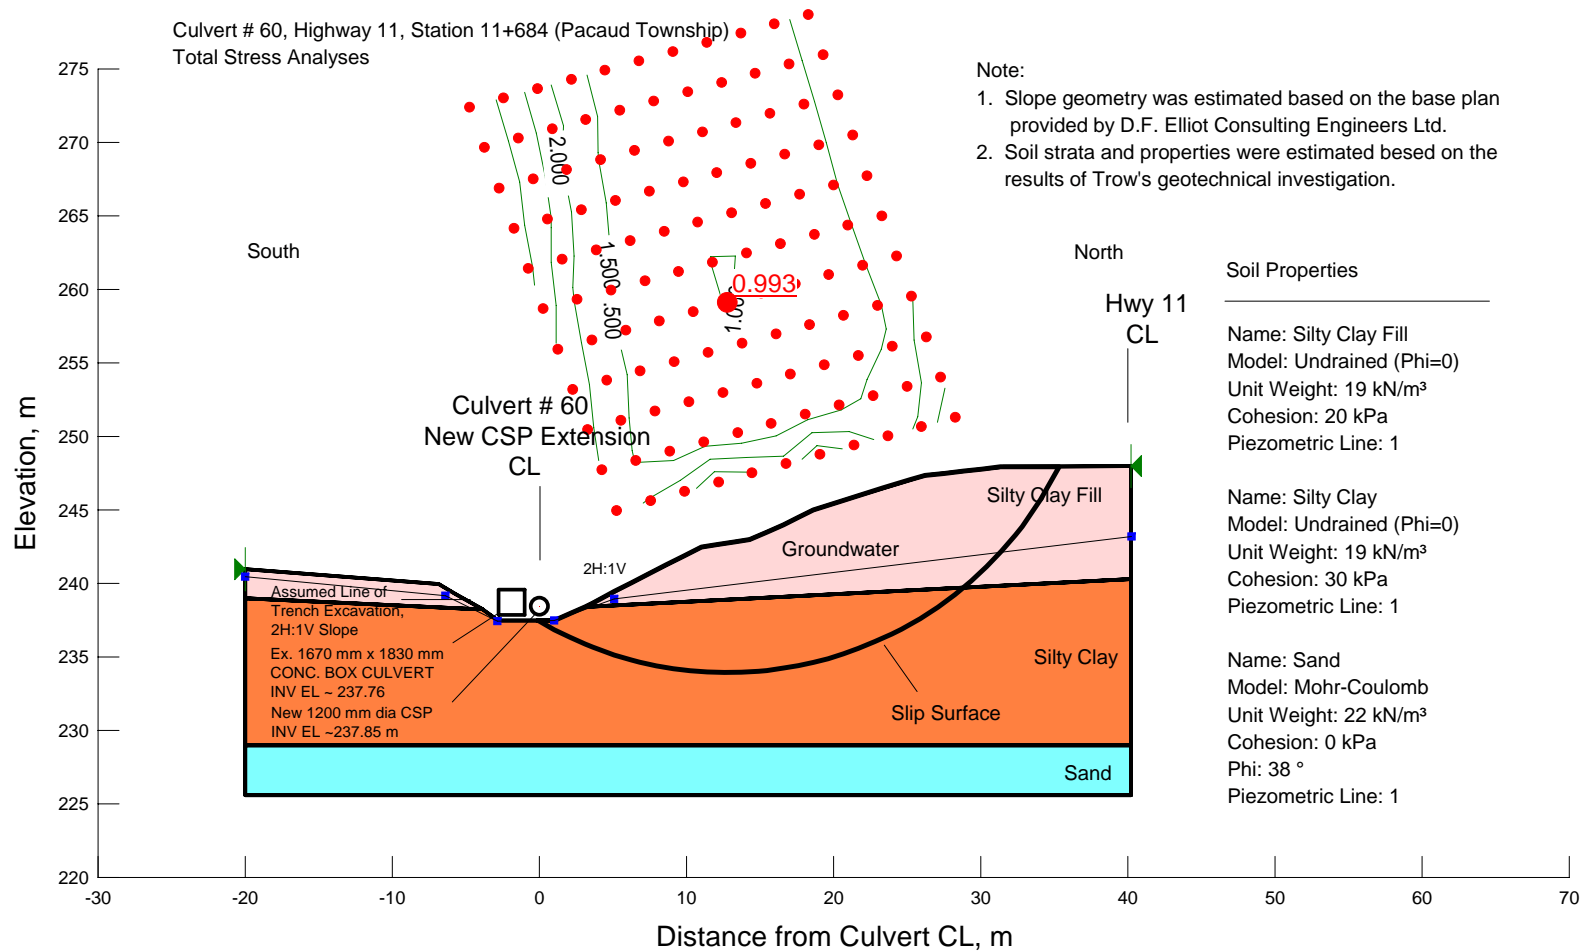
Figure 3. Slope stability analyses assuming trench excavation 2H:1V and total stress parameters: silty clay fill $C_u=20$ kPa and silty clay $C_u=30$ kPa.

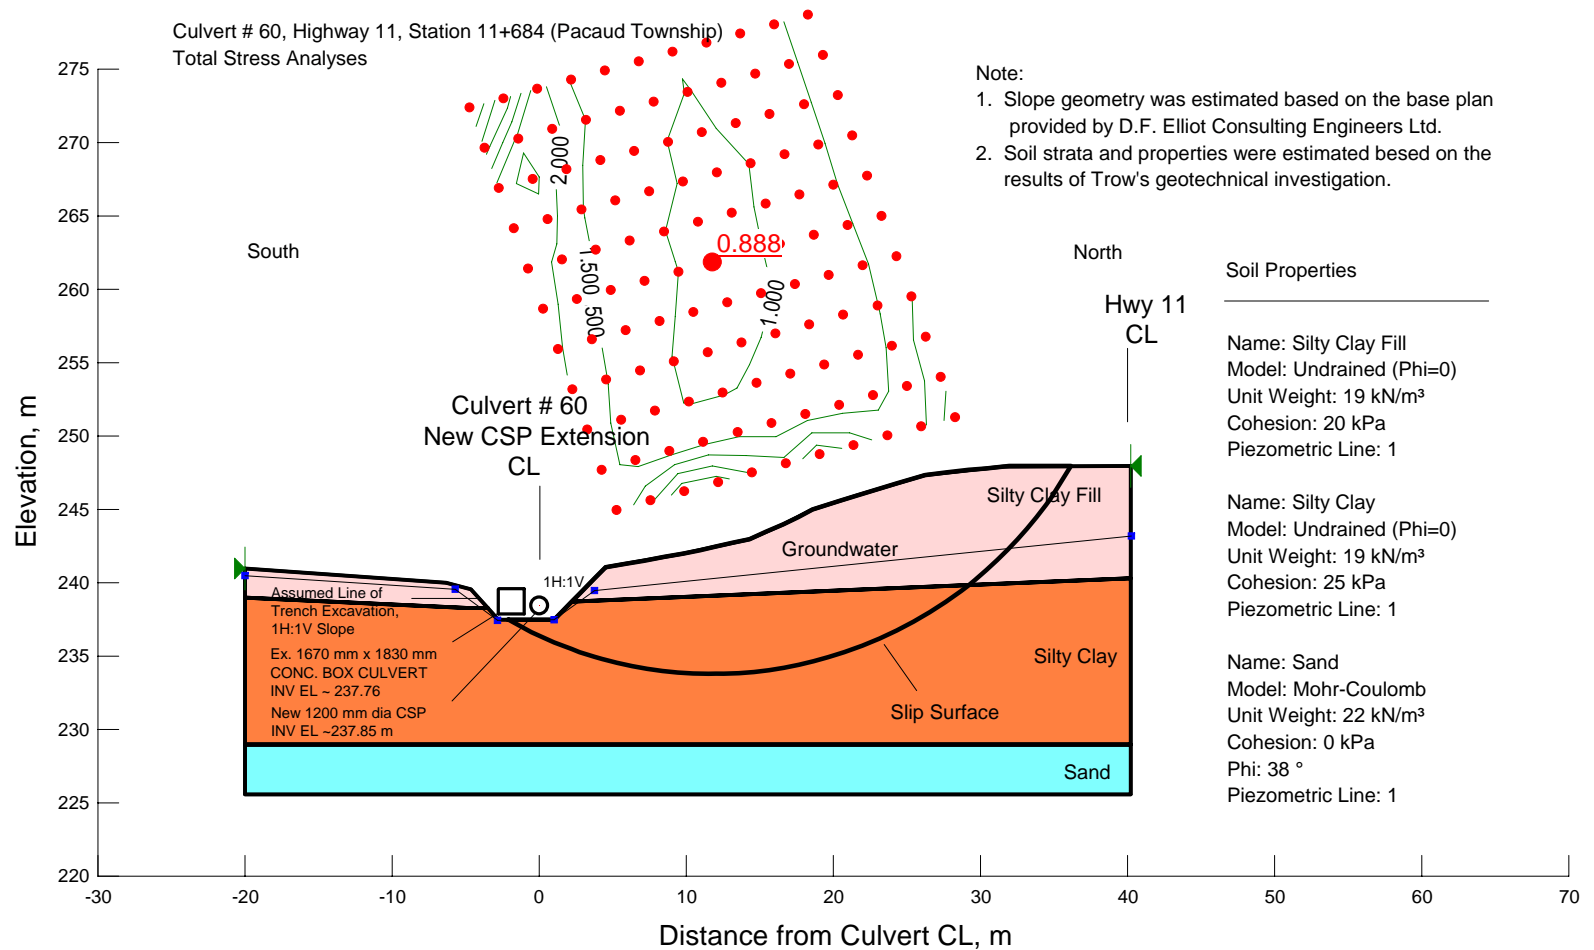
Figure 4(a). Slope stability analyses assuming trench excavation 1H:1V and total stress parameters: silty clay fill $C_u=20$ kPa and silty clay $C_u=25$ kPa.

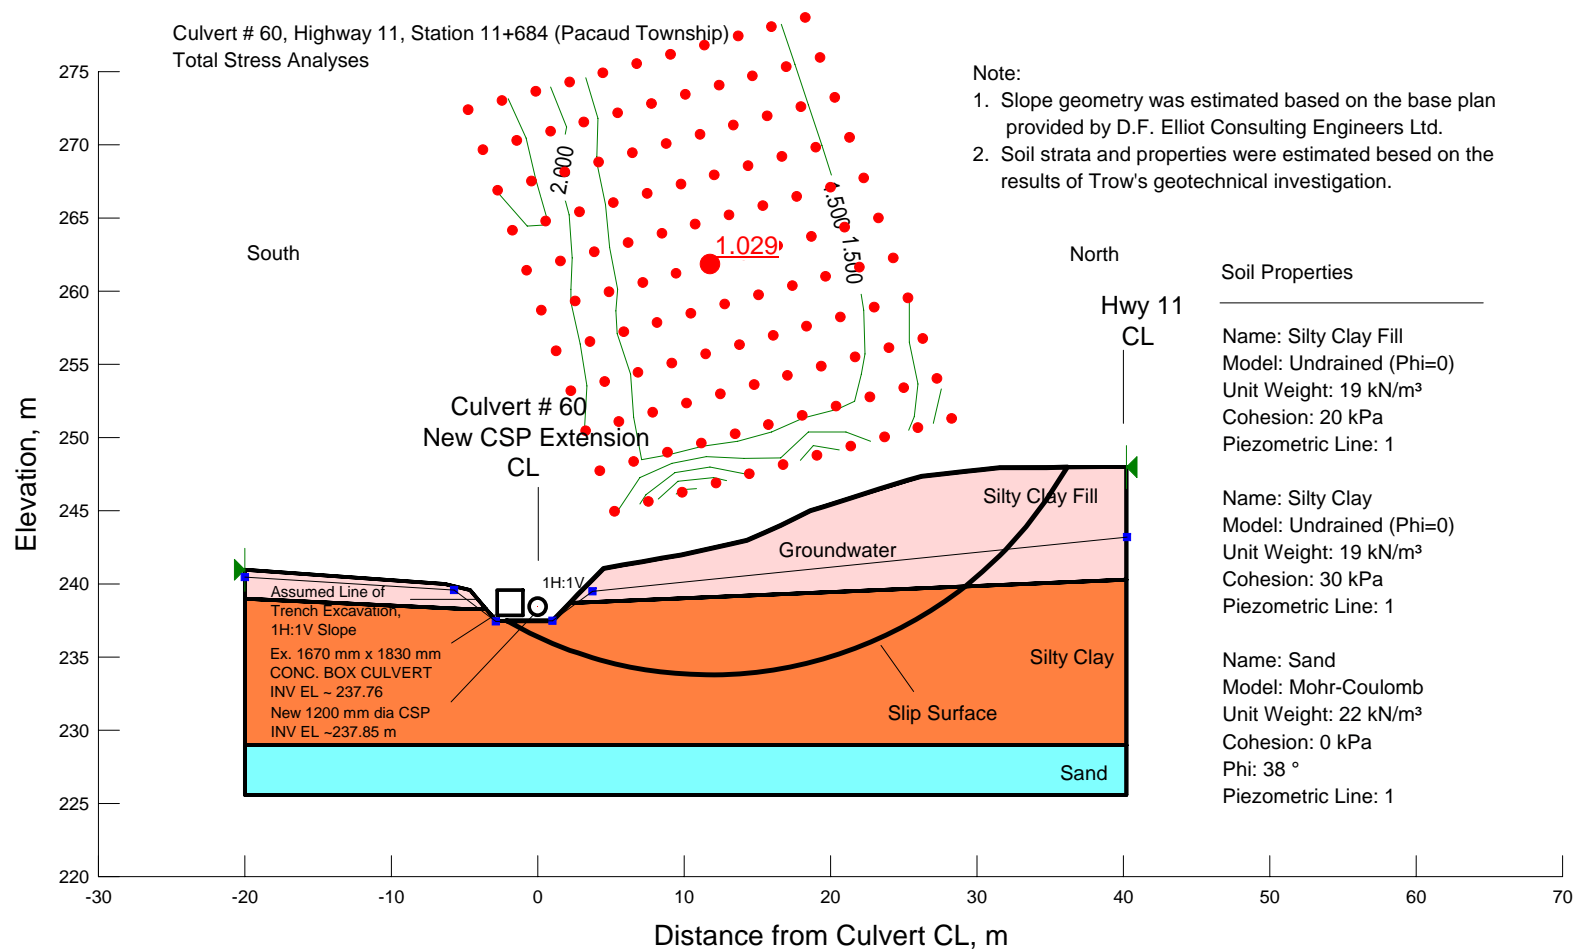
Figure 4(b). Slope stability analyses assuming trench excavation 1H:1V and total stress parameters: silty clay fill $C_u=20$ kPa and silty clay $C_u=30$ kPa.

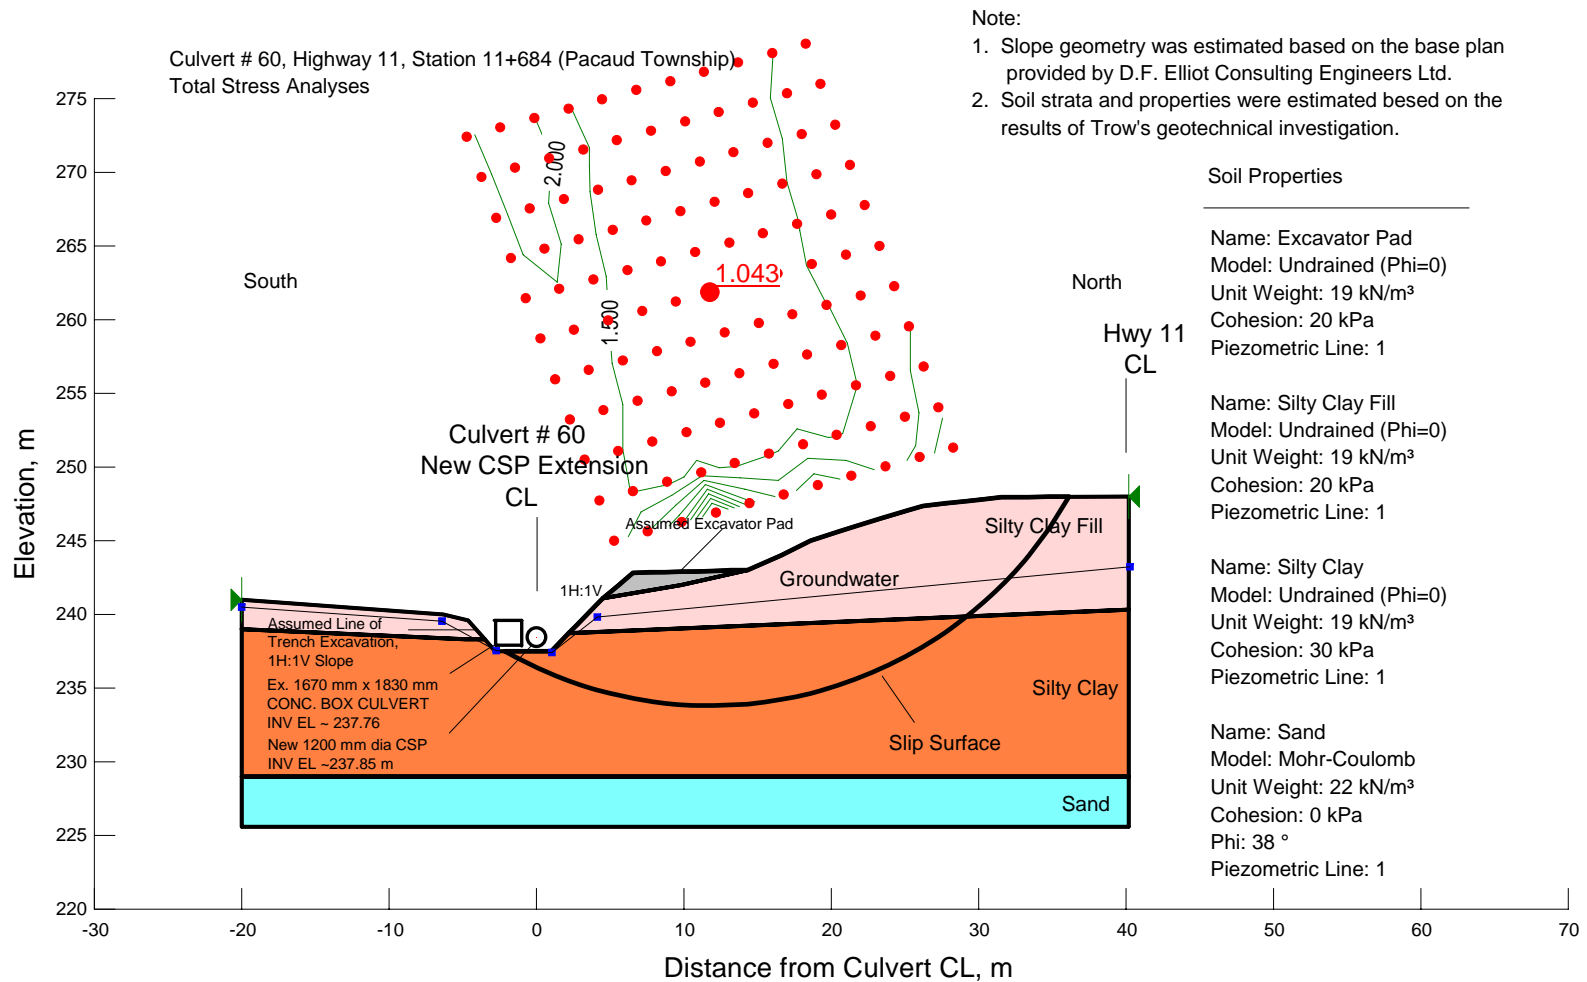
Figure 5. Slope stability analyses assuming trench excavation 1H:1V, excavator pad as surcharge on the slope and total stress parameters: silty clay fill $C_u=20$ kPa and silty clay $C_u=30$ kPa.

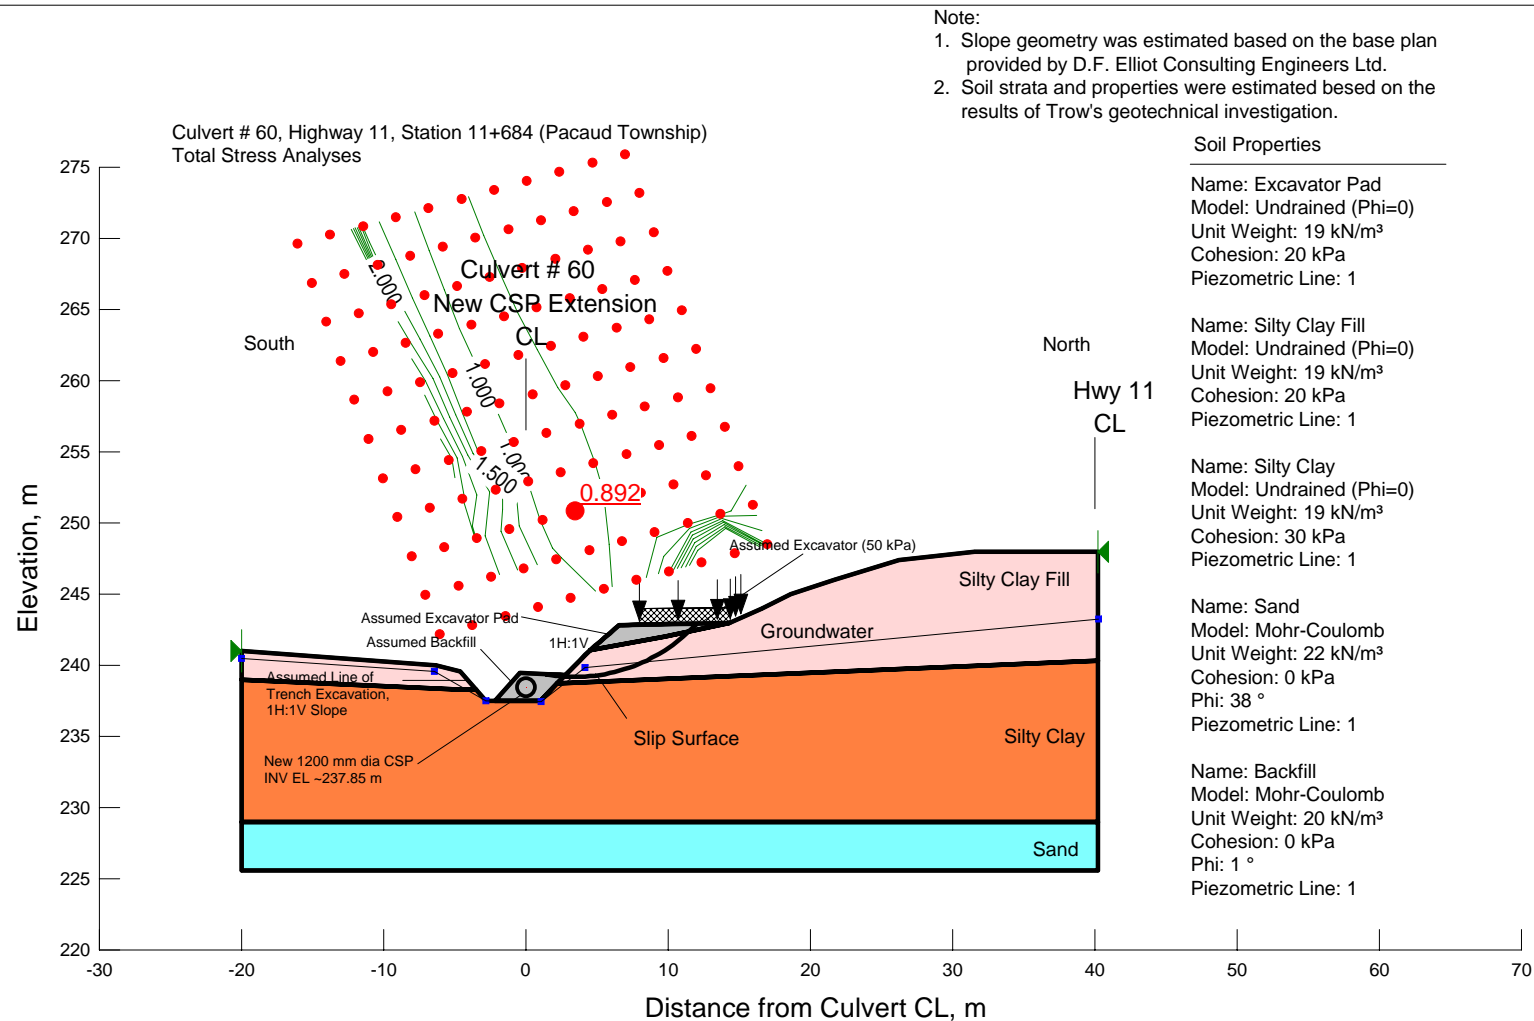
Figure 6(b). Slope stability analyses assuming trench excavation 1H:1V, excavator pad and excavator as surcharge on the slope, culvert backfill and total stress parameters: silty clay fill $C_u=20$ kPa and silty clay $C_u=30$ kPa.

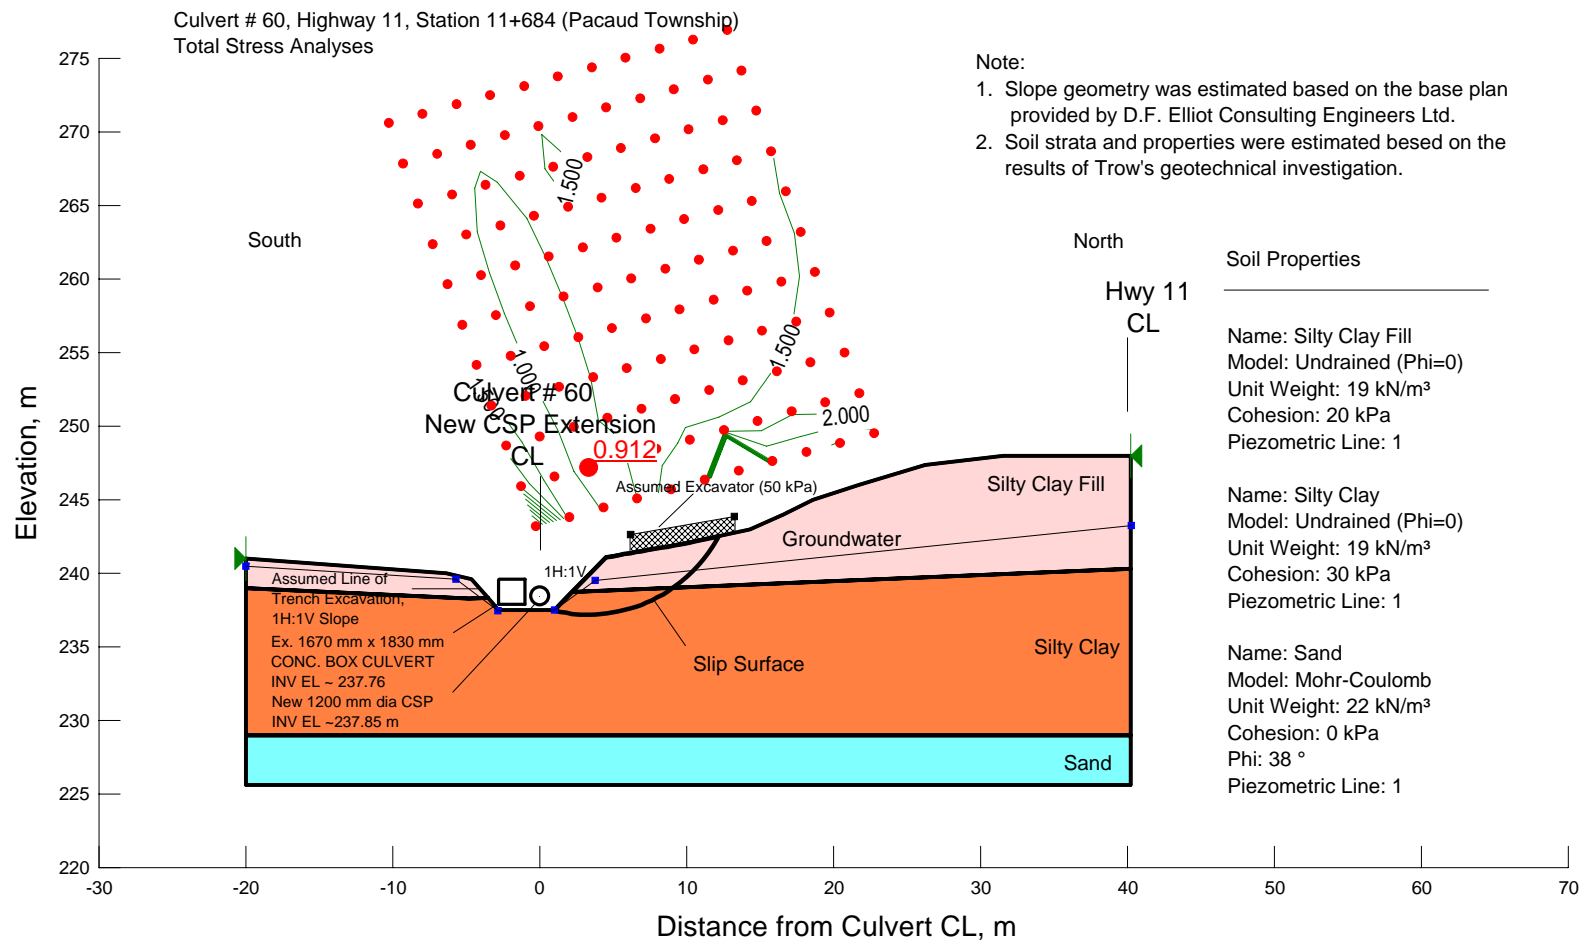
Figure 7(a). Slope stability analyses assuming trench excavation 1H:1V, excavator as surcharge on the slope and total stress parameters: silty clay fill $C_u=20$ kPa and silty clay $C_u=30$ kPa. Critical slip surface for trench slope.
