FINAL REPORT

**Foundation Investigation Report
Englehart Project
HWY 11, Township of Pacaud
Culvert # 60 Extension Replacement and Slope Failure
Station 11+684
Englehart, Ontario
WO 2009-11030
MTO GEOCRES No. 31M-81**

Trow Associates Inc.

August 05, 2009

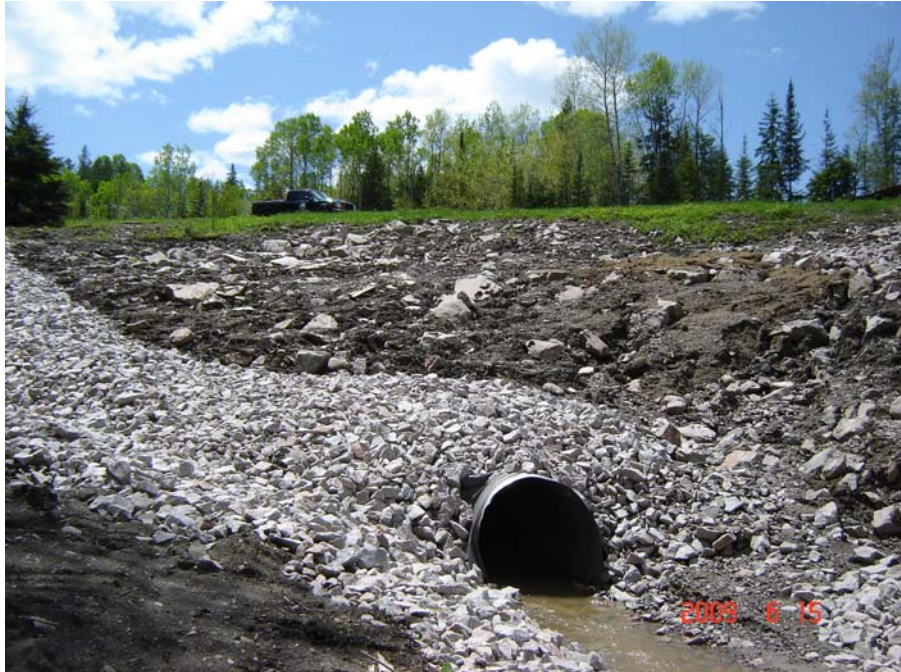
Photograph 1: Culvert # 60 at Station 11+684 (Pacaud Township).
On east side of Highway 11, looking west. Culvert outlet and failed CSP pipe.

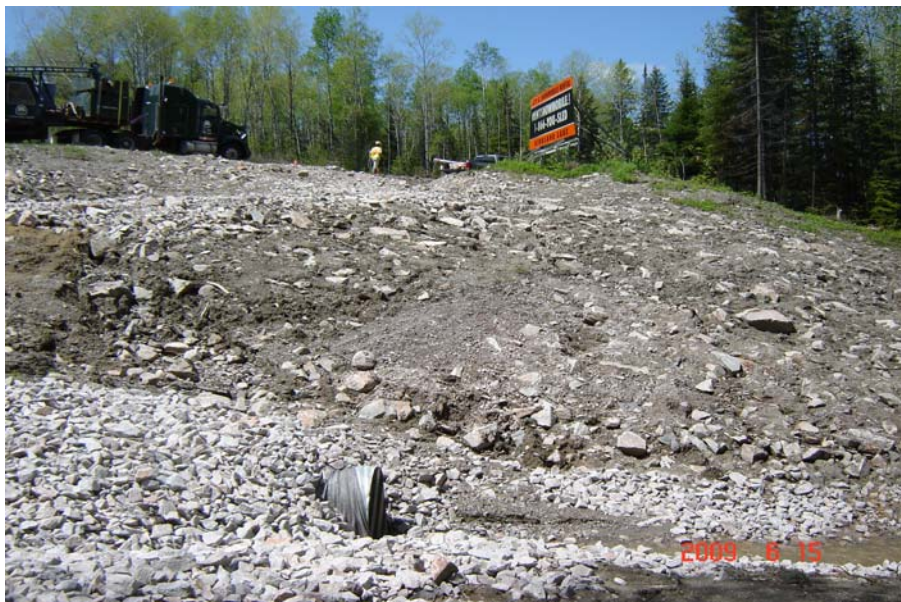
Photograph 2: Culvert # 60 at Station 11+684 (Pacaud Township).
On east side of Highway 11, looking north-west. Failed slope.

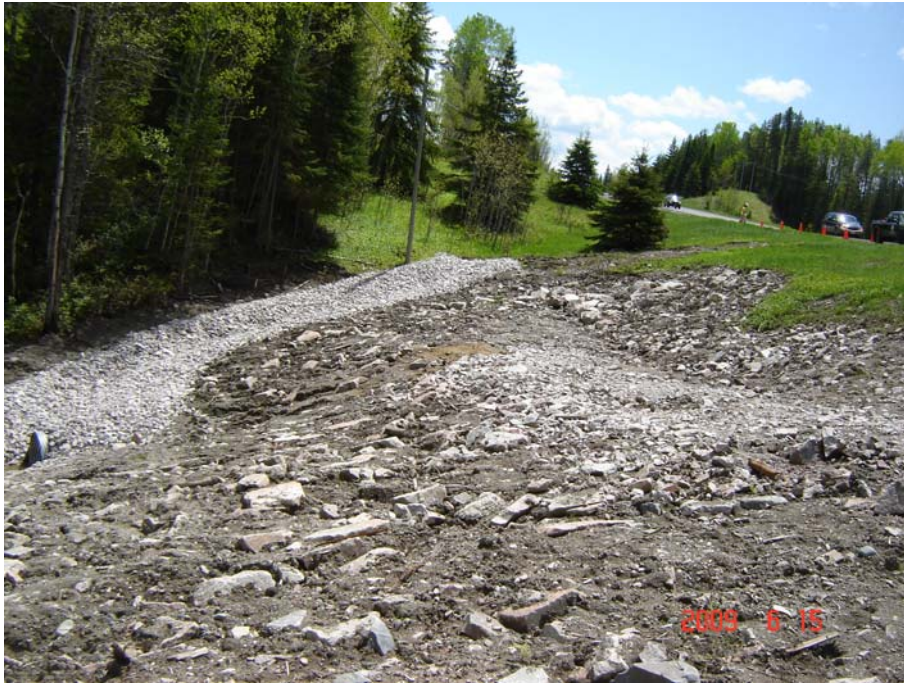
Photograph 3: Culvert # 60 at Station 11+684 (Pacaud Township).
On east side of Highway 11, looking south. Culvert outlet and gravel lined ditch.

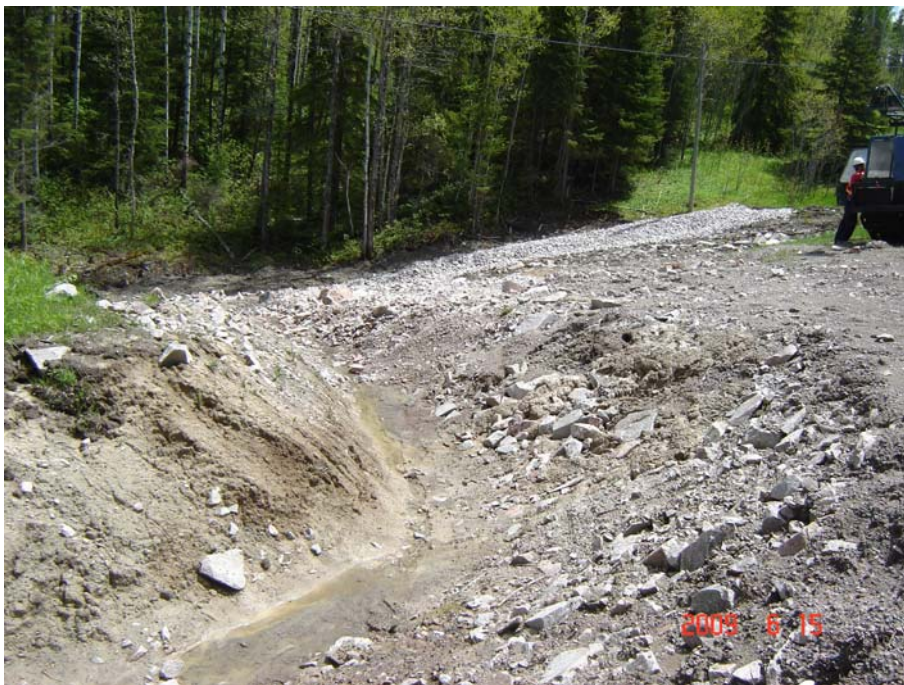
The drainage in the area generally consists of roadside ditches which drain into nearby streams. The drainage from the roadside ditch located south of the outlet CSP extension is conveyed from the ditch to the south down to the area of the culvert by a gravel/cobble lined ditch, as shown on Photographs 3 and 5 in Appendix A. A small gully partway up the south slope also drained into the area, but it was not connected to the gravel-lined downslope ditch. The roadside ditch to the north drained, unchannelized, into and through the north slope material, as shown on Photographs 4 and 6 in Appendix A.

Photograph 4: Culvert # 60 at Station 11+684 (Pacaud Township).
On east side of Highway 11, looking south-east. Failed slope and north roadside ditch.

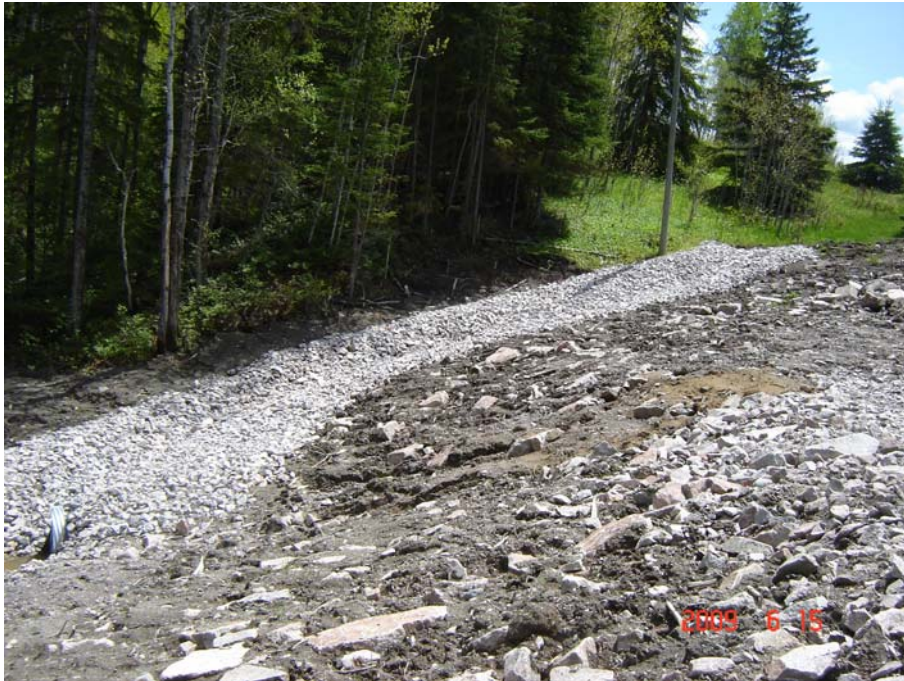
Photograph 5: Culvert # 60 at Station 11+684 (Pacaud Township).
On east side of Highway 11, looking south. Culvert outlet and gravel lined ditch.

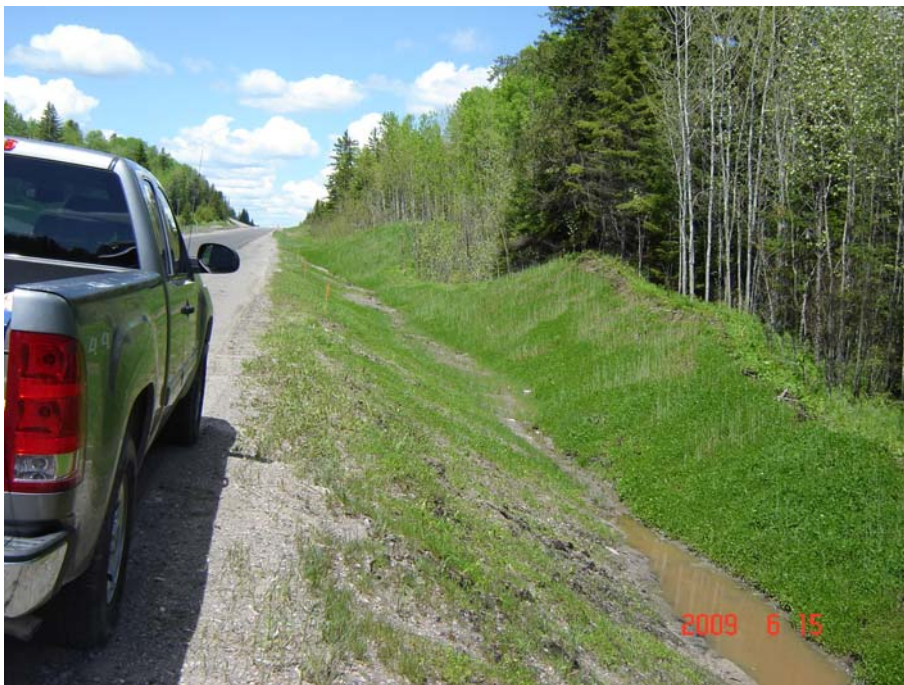
Photograph 6: Culvert # 60 at Station 11+684 (Pacaud Township).
On east side of Highway 11, looking north. Roadside ditch.

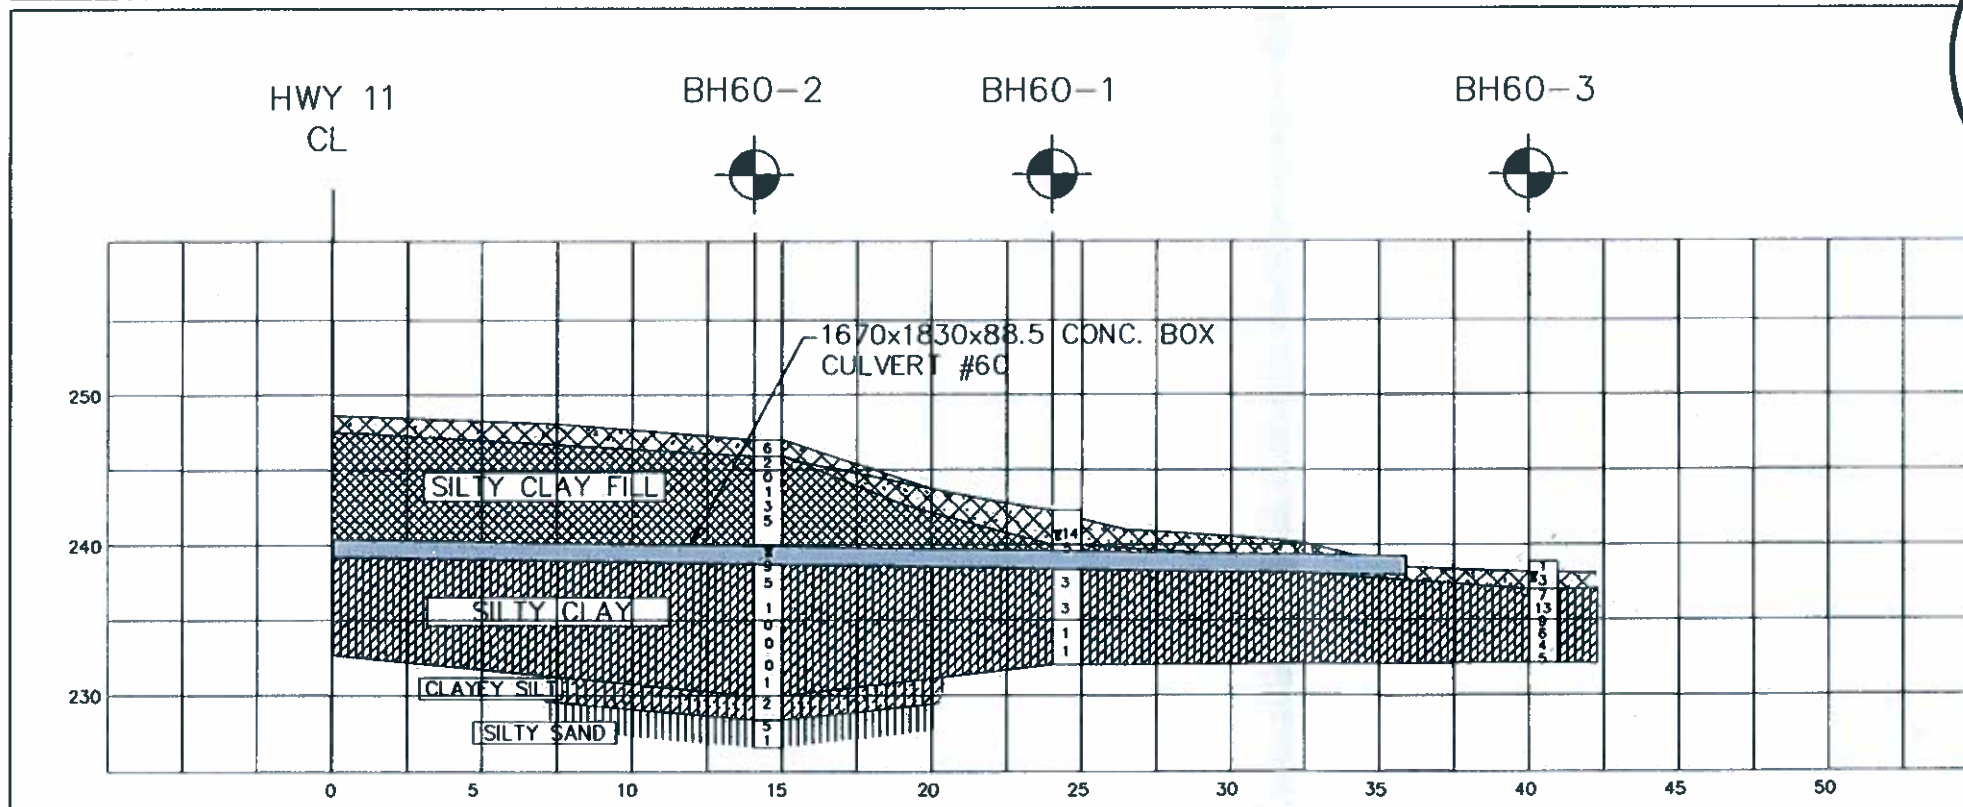
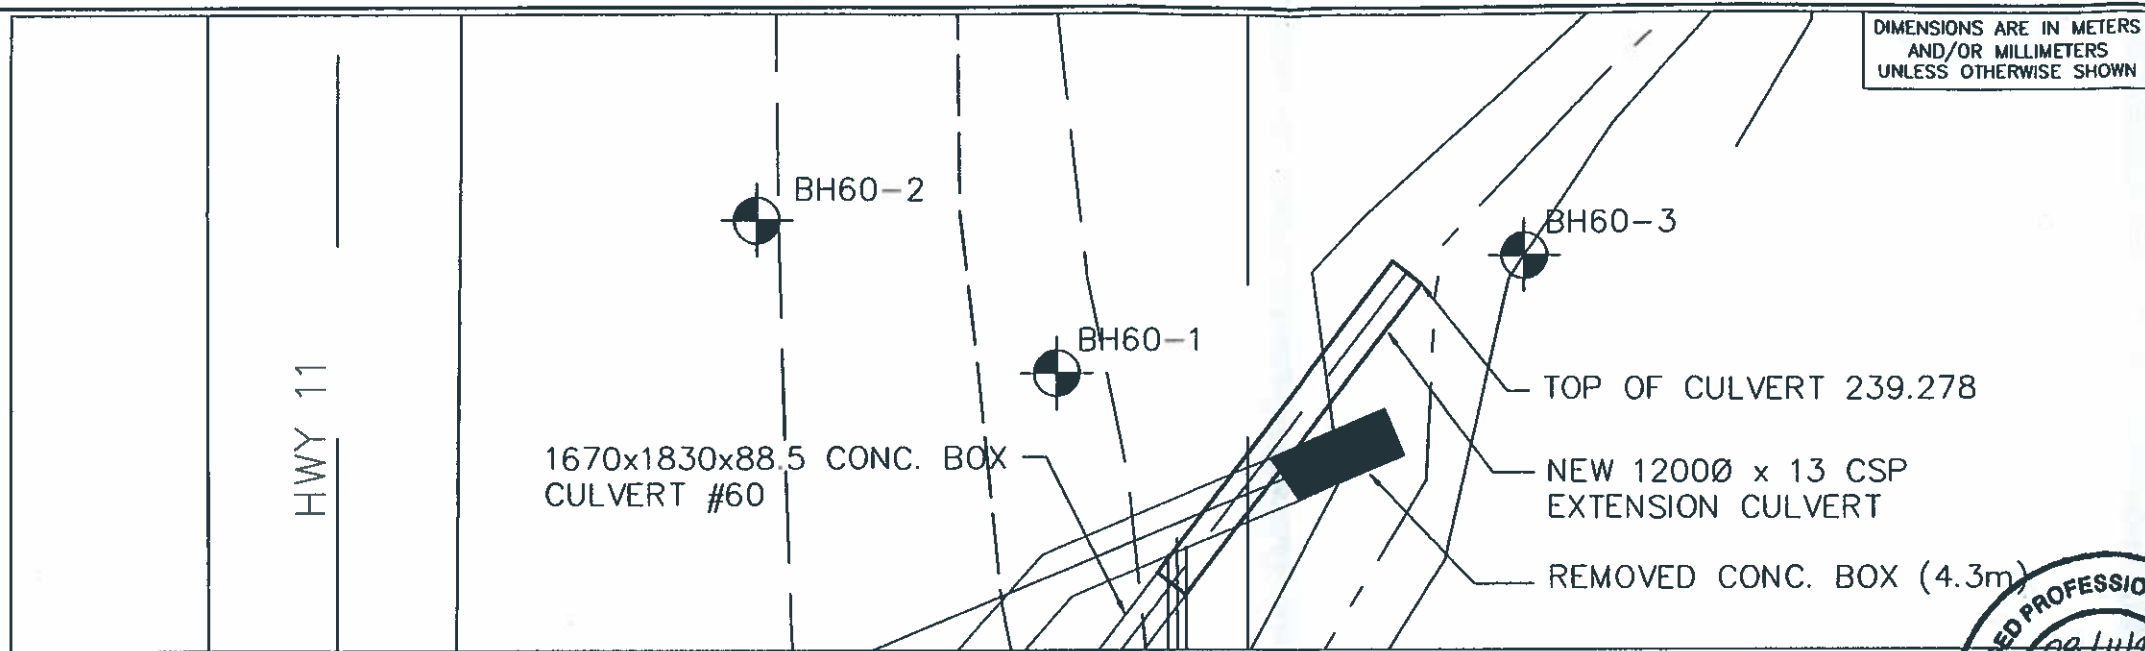
BOREHOLE LOCATIONS
AND
SOIL STRATA

A borehole location plan and a strata plot of the soils encountered in the boreholes are provided on Drawing No.1 in Appendix B. In general, the stratigraphy along the centerline of the slope failure between Boreholes BH60-1 and BH60-2 consisted of sand and gravel fill, silty clay fill, silty clay, clayey silt and silty sand.

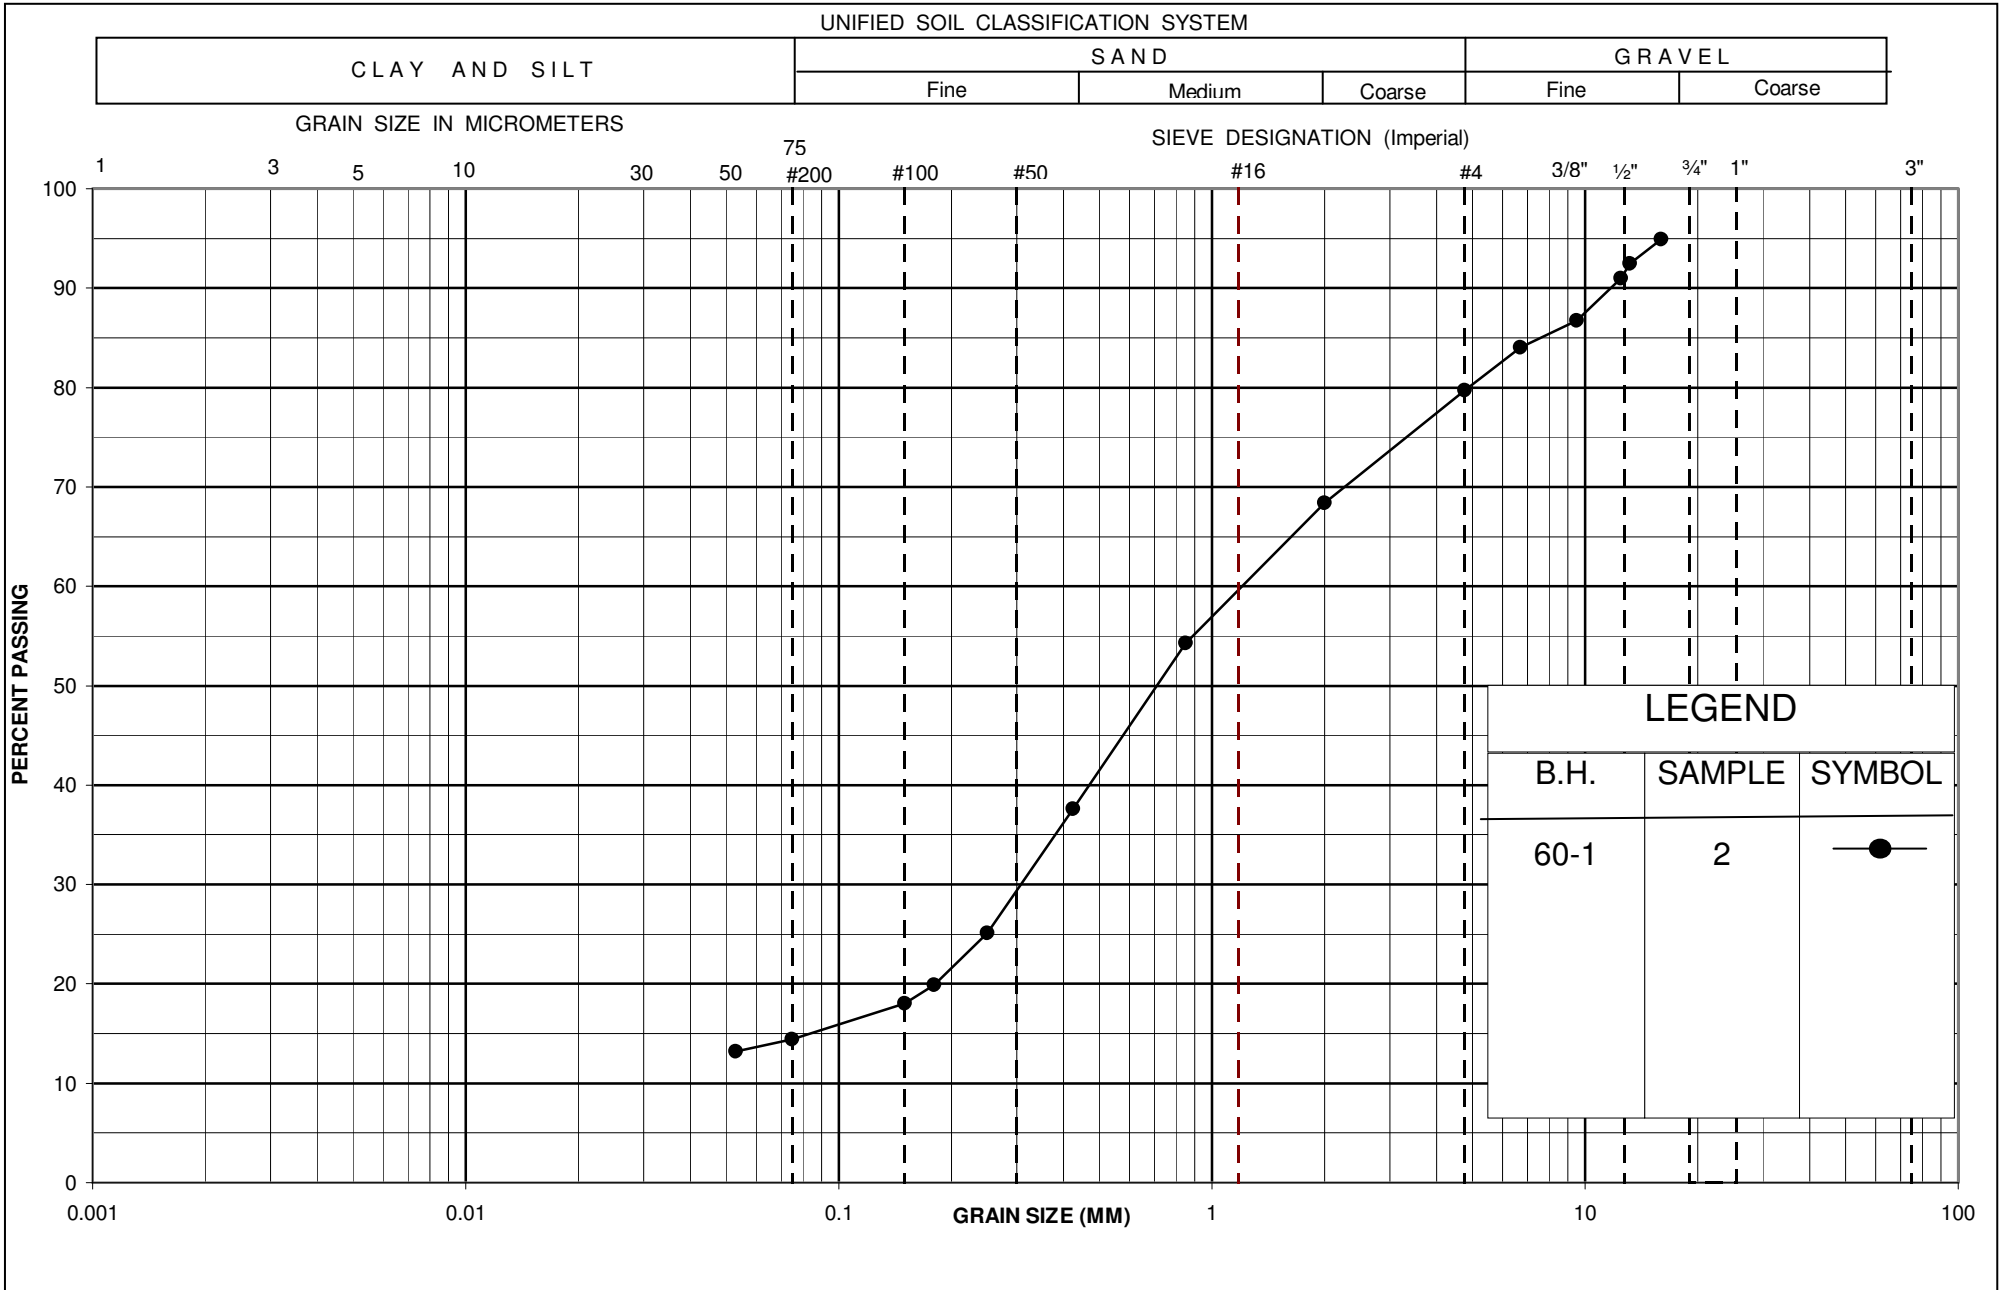
FIGURE No. 1
WO: 2009-11030
Hwy 11 - Culvert # 60 Extension Replacement and Slope Failure

- 20% gravel;
- 66% sand;
- 14% silt and clay

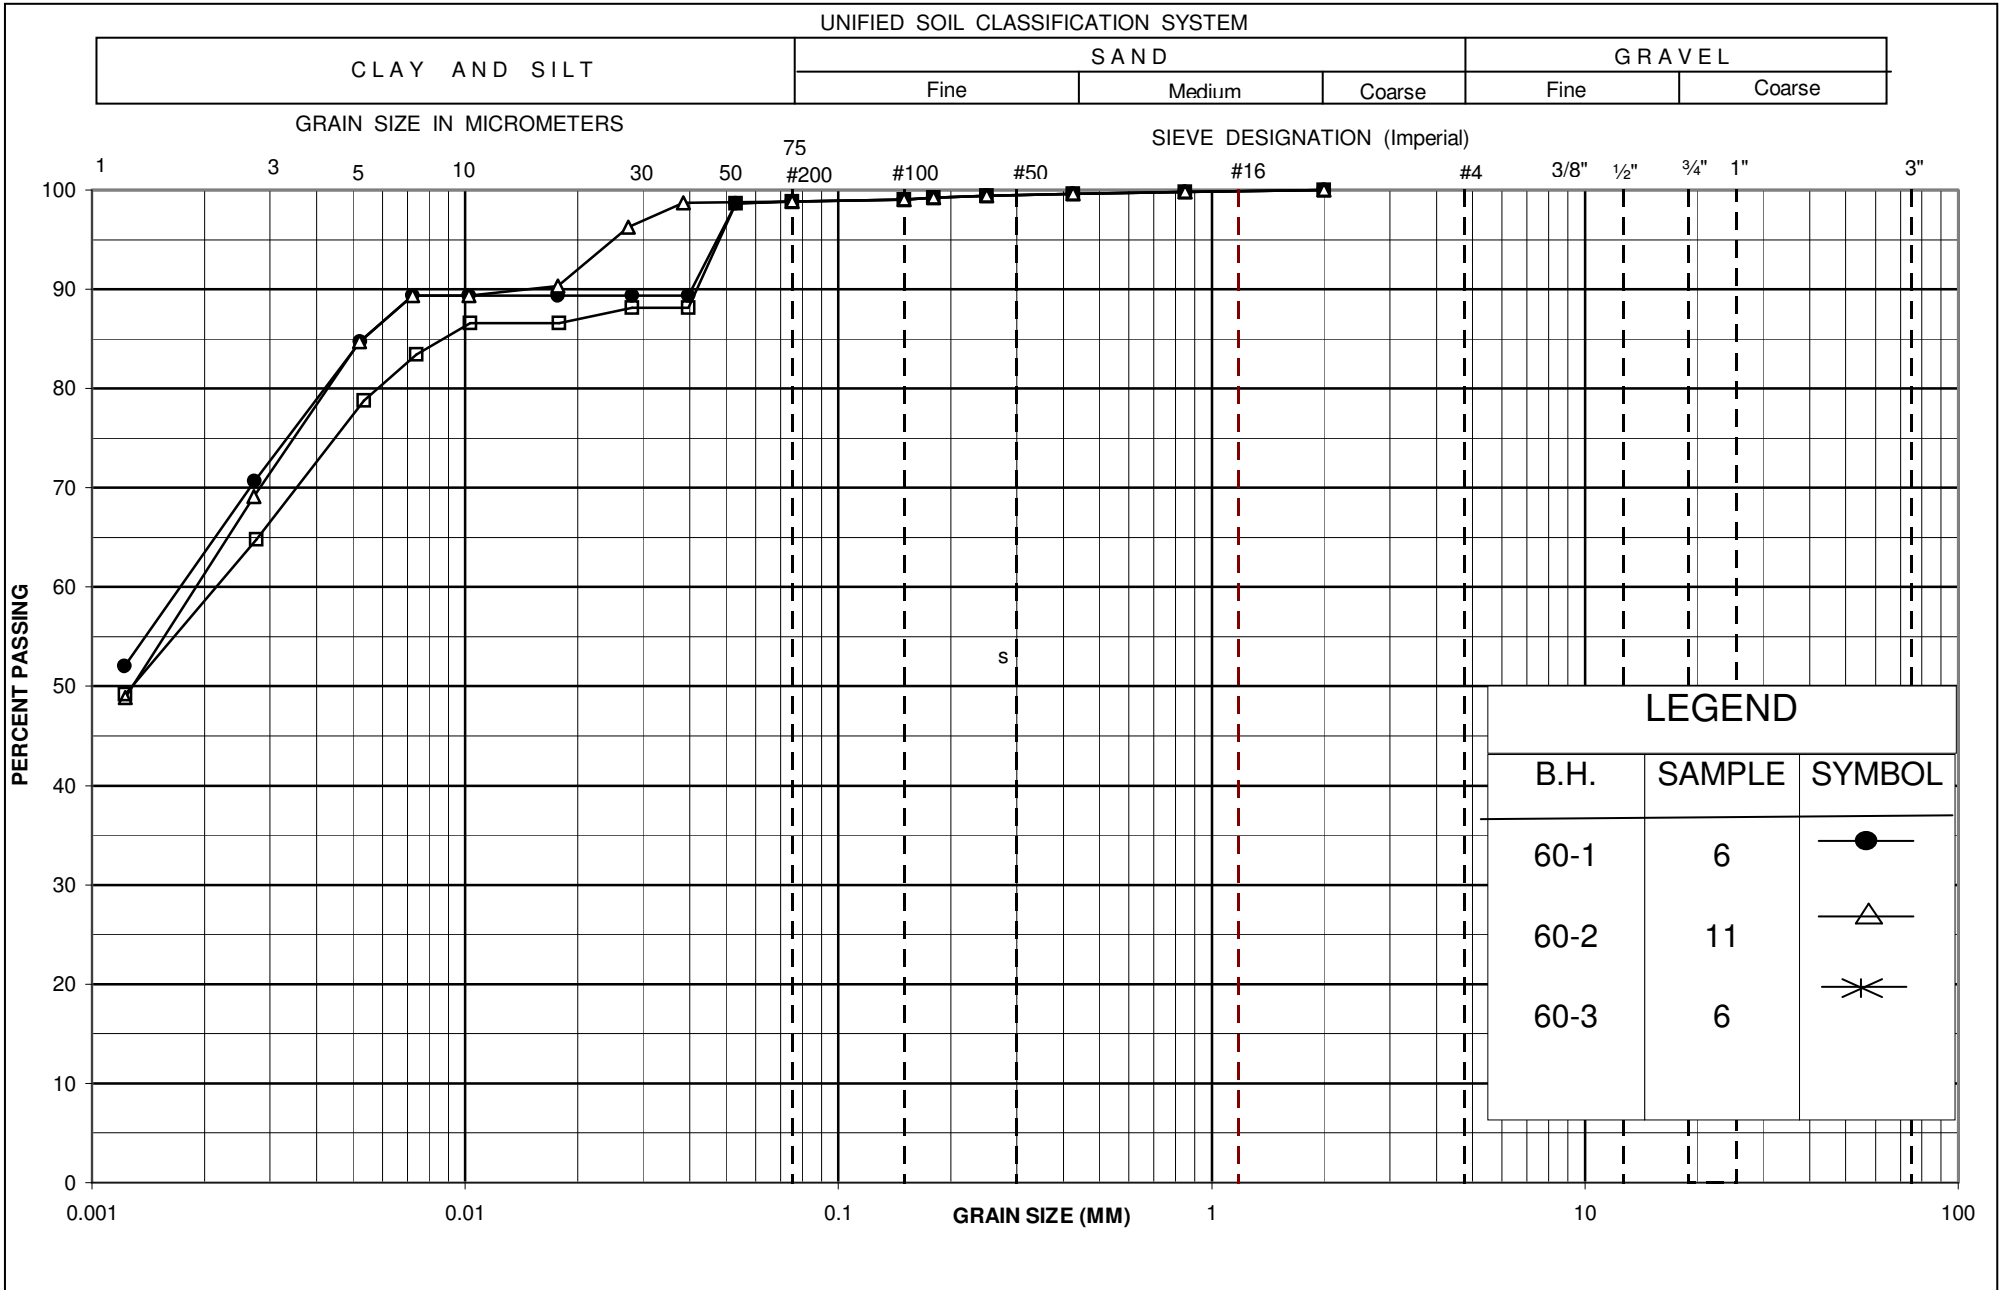
FIGURE No. 2
WO: 2009-11030
Hwy 11 - Culvert # 60 Extension Replacement and Slope Failure

- 0% gravel;
- 1% to 2% sand;
- 37% to 42% silt; and
- 57% to 62% clay.

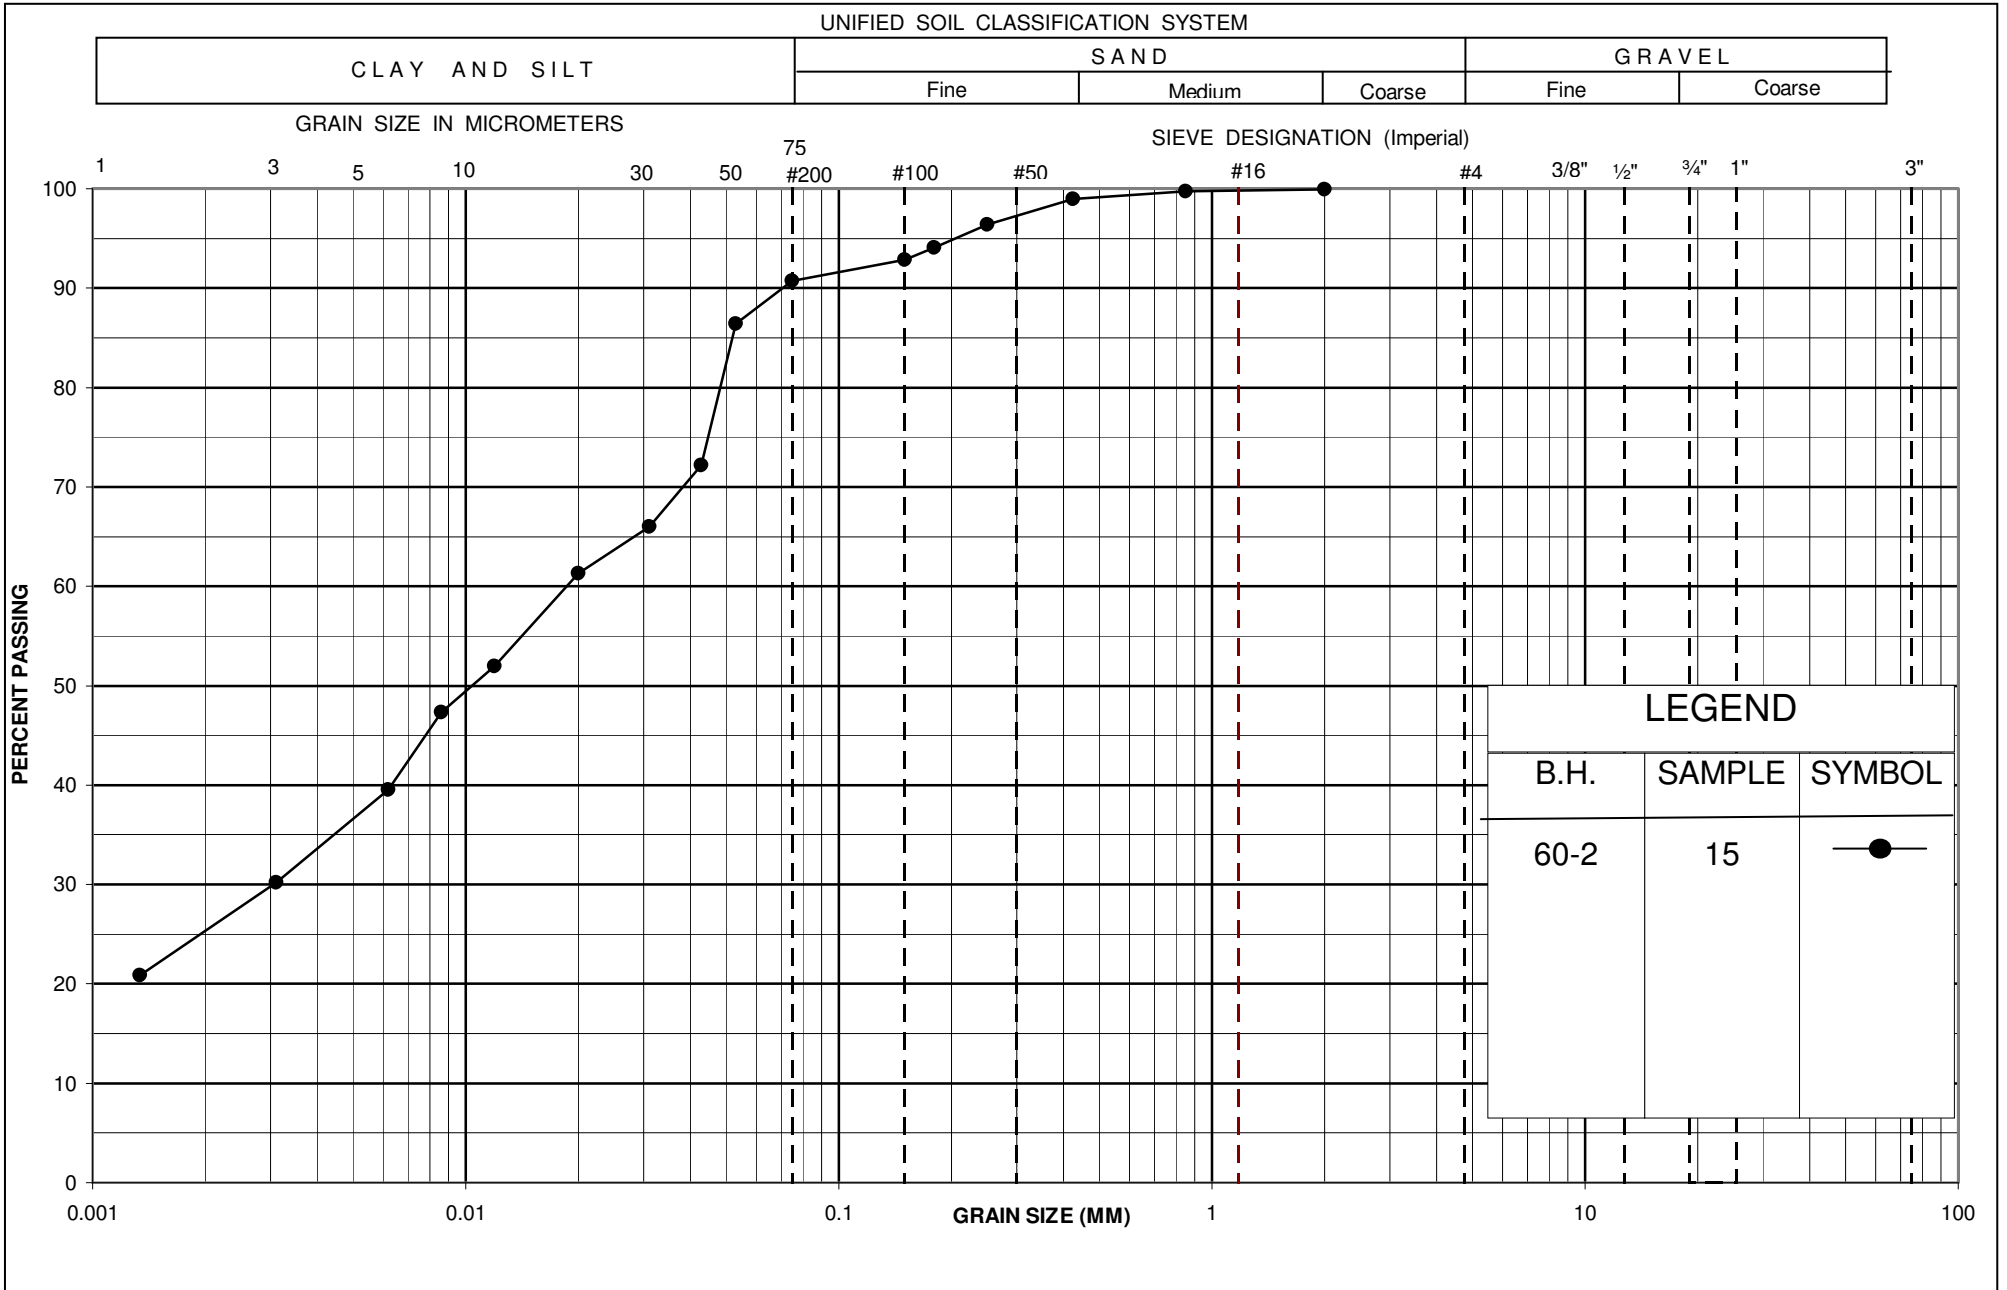
FIGURE No. 3
WO: 2009-11030
Hwy 11 - Culvert # 60 Extension Replacement and Slope Failure

- 0% gravel;
- 9% sand;
- 66% silt; and
- 25% clay.

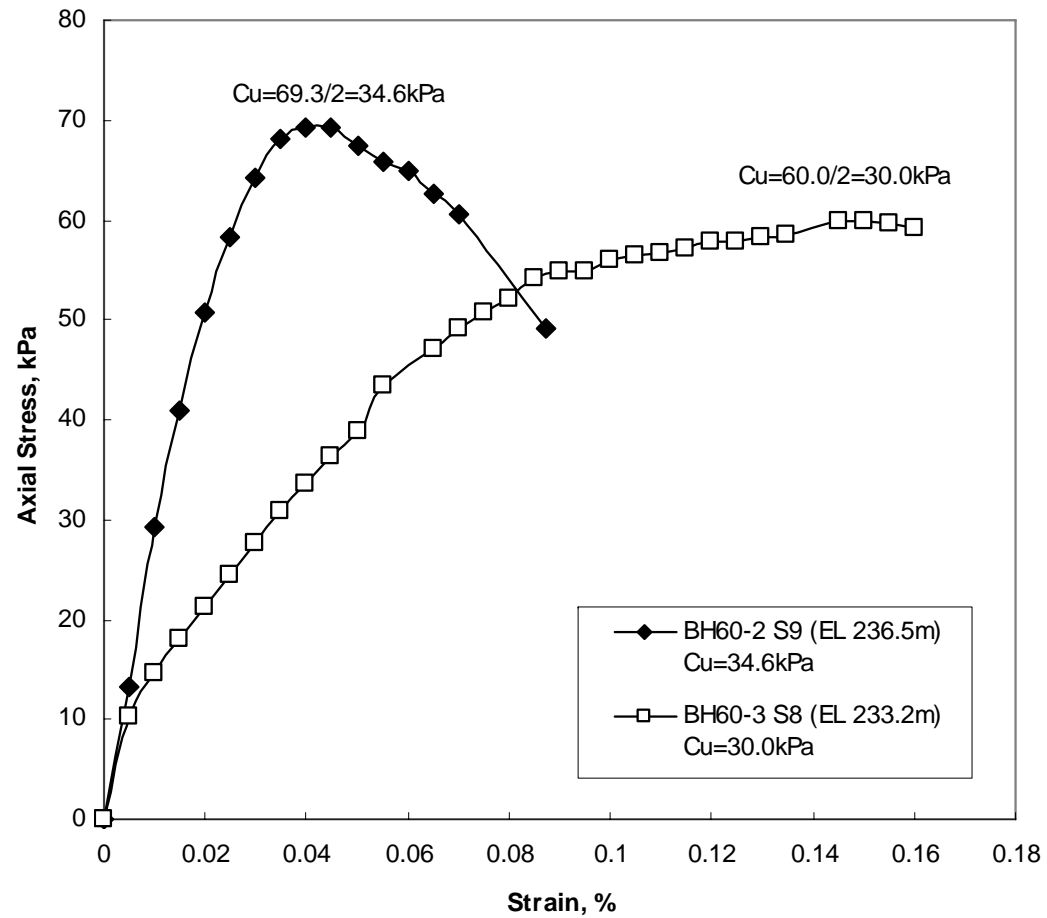
Unconfined Compression Test Silty Clay

- Undrained Shear Strength 30 kPa and 34.6 kPa
