# Memorandum Report

**Subject:** Remedial Measures for Embankment Instabilities  
Hwy 406 Northbound Approaching Westchester Avenue  
W.O. 2012-11003  
GWP 2364-09-00  
GEOCREs No. 30M3-274

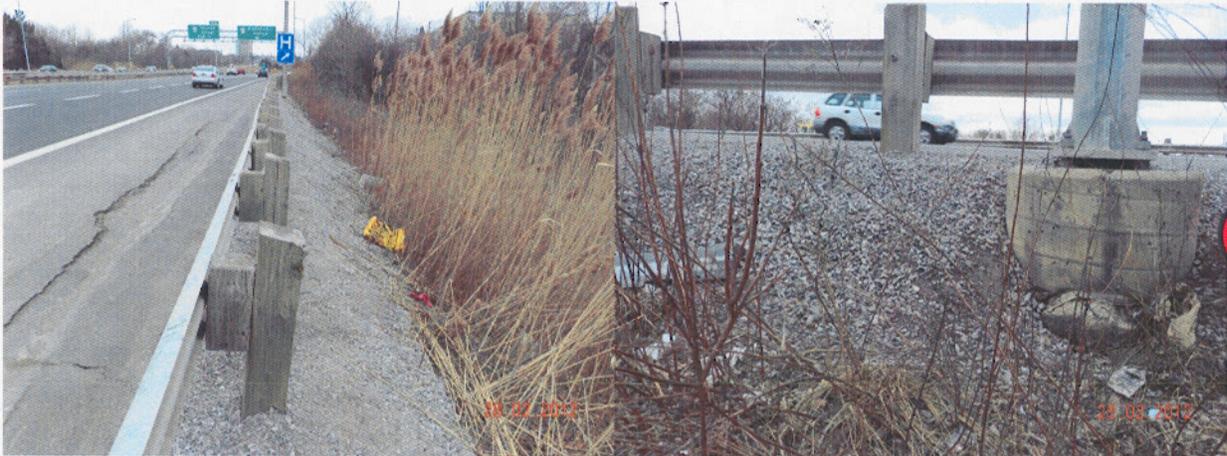
**Figure 2: Sample of the Problem Areas**

Figure 2 illustrates the typical slope problems in these areas.

According to the base plan drawings provided by CR, the problem areas of Hwy 406 are near side slopes that are approximately 5m to 10m high with a design slope geometry of approximately 2H:1V to 2.5H:1V. The crown of the road is located at the centreline or just east of the centreline. Crossfall from the crown is approximately 5% to the east edge of pavement. From the edge of pavement to edge of paved shoulder, the crossfall is approximately 7%. From the edge of paved shoulder to edge of granular rounding, the crossfall is steeper and up to an estimated 10% to 15%. The granular upper portion of the slope including the rounding is approximately 1.2m to 1.5m deep by 1m to 1.8m wide from the edge of shoulder depending on the location. The existing distressed side slopes are approximately 1.2H:1V (estimated by visual inspection), which is much steeper than the 2H:1V to 2.5H:1V indicated on the base plan in the problem areas. The side slopes below the upper granular portion and rounding as well as the bottom of the embankment are covered by vegetation (including swale vegetation and grass).

There are no catch basins nor curbs and gutters, but there are drainage ditches along the median and at the toe of slope at the problem areas. Partial surface runoff flows to the median ditch and partial surface runoff flows over the side embankment and then to the bottom drainage channel. It is noted that all three problem areas are located at low points of the highway grade and that some of the surface runoff follows the natural drainage path to flow over these embankment slopes to the bottom ditch. This is partly caused by the drop off at the rounding increasing the amount of flow overtopping the edge of the embankment. At the time of the site visit, the top layer of soil along the side slopes in these areas was noticeably moister than at other areas.

Steel beam guide rails (SBGR) are installed between station 28+150 and station 28+850 along Hwy 406. According to the OPSD 912.140 SBGR wood post assembly installation, the minimum buried depth of the SBGR wood pole is 1.2m. By observation, the width of the SBGR is approximately 0.3m wide and the width of the rounding from the edge of shoulder is approximately 1m wide. In some areas, the SBGR are tilted away from the road. This indicates that at least the top 1.2m of the embankment material is disturbed and causing the SBGR to tilt.

From the conversation with Tymen, he indicated that the distresses at the top 1.5m of the slope areas (granular material) have been an issue for at least five years. The sides of the granular rounding have been eroded and the erosion has undermined the SBGR and exposed the top portion of concrete bases of light poles. In response to this distress, the CR maintenance contractor placed 'Granular A' around these areas in order to stabilize them and to prevent further undermining of the SBGR and lighting concrete bases. Those 'Granular A' materials were first placed five years ago and again recently in the week of February 8, 2012. However, by observation, there are no visible slope failures apparent within the vegetated areas below the granular zone.

- the current instabilities of the embankment are surficial failures, as opposed to deep-seated failures through the natural subsoil below the base of the embankment
- the surficial failures are triggered by loss of confinement of the upper road bed material aggravated by uncontrolled surface runoff over the slope and to a lesser extent by the development of excess pore water pressures causing loss of soil strength due to the slope material being saturated with water
- the failure zones are isolated in the upper 1.5m of granular rounding/embankment
- erosion by surface runoff caused loss of lateral support of the top layer of the embankment and consequently pavement cracking and undermining and tilting of the SBGR

Based on the conditions at the problems sites, remedial solutions include increasing the lateral support at the upper embankment slope and controlling surface runoff. All pavement cracks shall be repaired to prevent water seepage and development of excess pore water pressures at the problem areas. The following remedial measures to increase the lateral support at the embankment are proposed for consideration:
