FOUNDATION INVESTIGATION AND DESIGN REPORT

**Deformation of Gabion Wall
Structure Site No. 21-647/W
Highway 401 and Graham Creek
Clarington, Ontario
W.O. 2016-11028**

Report Number: 1413191-09

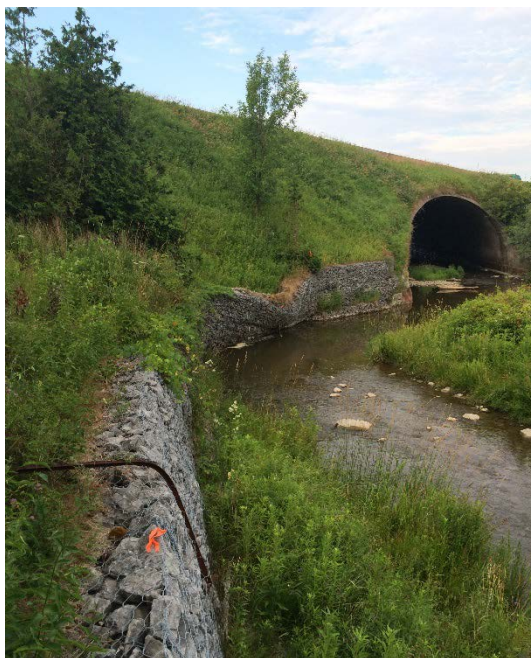
Photograph A1: Looking west along gabion wall, along north toe of Highway 401 embankment.

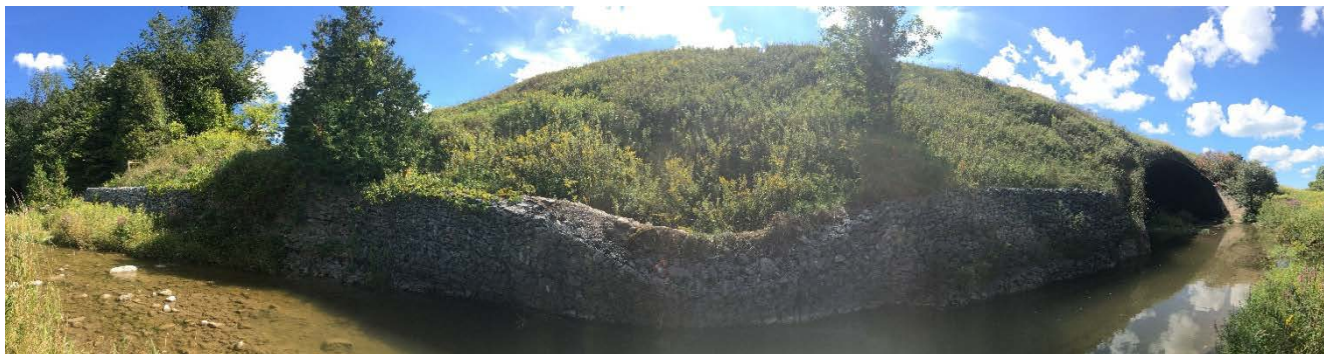
The existing gabion basket retaining wall extends from the east side of the arch culvert footing to approximately 35 m northeast of the footing. During the site inspections, it was noted that the deformed area of the wall extends from approximately 5 m to 22 m east of the arch culvert footing as shown in the photograph below.

Photograph B1: Deformed Area of Gabion Basket Retaining Wall – Looking South (Note image distortion due to panoramic view)

The wall deformation has manifested along the section of wall where Graham Creek turns from a north-south to a northeast-southwest flow direction, where the creek water flow is directed against and along the base of the gabion basket wall. The cause of deformation appears to be from ground loss under the wall (reference the voids below the wall noted during Golder's inspection) due to erosion of the immediately underlying clayey silt to silty sand till and/or sand and gravel deposits. It is assumed that when the wall was constructed, the water depth was similar along the full length of the wall to that noted at the west and east ends of the wall (approximately 0.1 m to 0.3 m as it approaches the wall and as it flows into the arch culvert). It is our opinion that after the gabion basket wall was constructed, the water flow began eroding the soil under the wall, resulting in the creek progressively becoming deeper locally in (approximately 0.6 m deep at the time of inspection).

The erosion of soil from below the base of the wall has caused the wall to sink toward the increasingly lower creek bed in this local area. The sinking of the base of the wall has caused the top of the wall to translate forward (north), toward the creek. It is expected that erosion activities increase at times of higher water flows through the creek such as during spring snow melts and following periods of significant rainfall. As shown in Photograph B3, while an approximately 1.3 m long gap was observed in the presence of the filter fabric behind the wall, there does not appear to be ground loss from behind the wall in this area. Therefore, the gap in the filter fabric does not appear to have contributed to any ground loss that could result in the deformation of the wall.

- **For a short-term repair scenario:** Repair the affected section with armour stone, or alternatively repair the affected section with a gabion basket wall.
- **For a long-term replacement option, should the timing for the repair be compatible with the timing for future highway widening in this area:** Replace the existing wall with a new, "top-down" wall such as an anchored soldier pile and concrete panel wall, which can also be designed to support a widened highway platform at that time.

Repair of the gabion basket retaining wall must include toe protection across the entire retaining wall to prevent further scour and undermining of the structure foundation. Toe protection alternatives are discussed in Section 7.4.

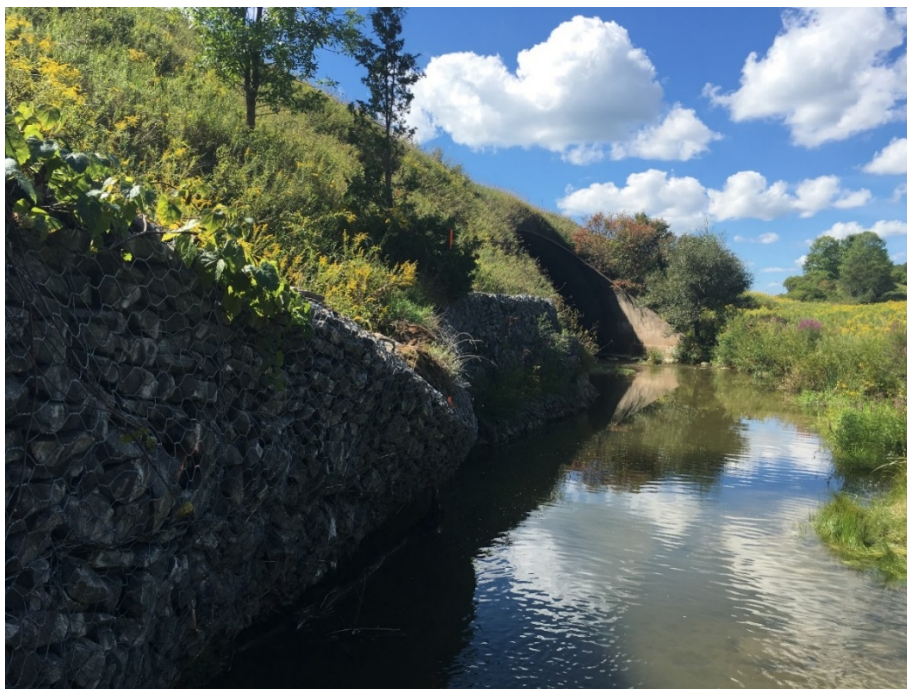
The height of the gabion basket retaining wall to the west of the deformed area is about 3.0 m above the creek bed, with the water being about 0.6 m deep at the time of inspection. The height of the wall to the east of the deformed area is about 2.5 m above the creek bed with the water being about 0.3 m deep at the time of inspection. The height of the wall midway along the slumping/overturned area of the wall is approximately 2.3 m above the creek bed with the water being about 0.7 m deep. Midway along the deformed area where the maximum translation has occurred, the wall has moved laterally approximately 1.4 m to the north of its original location as shown in the photograph below.

Photograph B2: Translation/Toppling of Gabion Basket Retaining Wall – Looking West

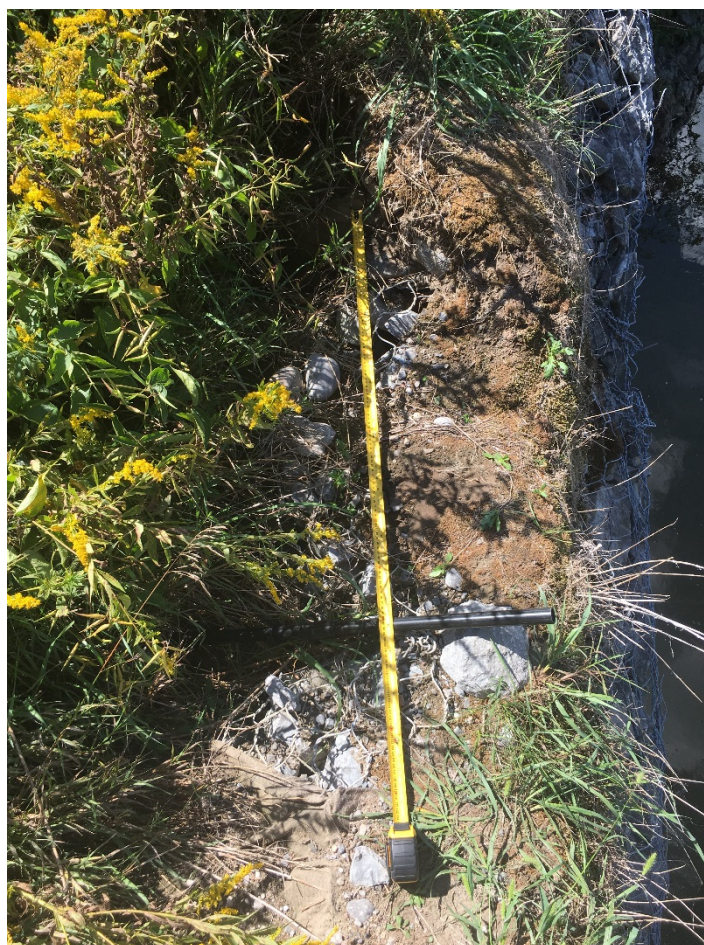
At the base of the retaining wall, a 0.6 m wide “bench” was observed in the “intact” sections of the wall, and this may have been incorporated for global stability and/or to provide for erosion protection. However, the bench was not observed to be present (or it has been eroded/deformed such that it is no longer visible) over the extent of the deformed area of the wall at the time of Golder’s 2016 inspection, or in the photographs provided by MTO taken in 2014 and 2015. A geotextile (non-woven) fabric was visible behind the wall as observed during the inspection from the toe of the embankment/top of the wall, except for an approximately 1.3 m long section near the middle of the deformed area. The area in which the geotextile fabric is missing is shown in the photograph below.

Photograph B3: No Geotextile Fabric Visible Behind Wall – Looking West Along Top of Wall

Where an armour stone repair is adopted, the structural designer must incorporate appropriate transition details between the ends of the existing adjacent sections of gabion wall, and the new armour stone segment. This should also include placement of a geotextile fabric behind the gabion and armour stone sections, to ensure that no loss of backfill material through the face of the wall.

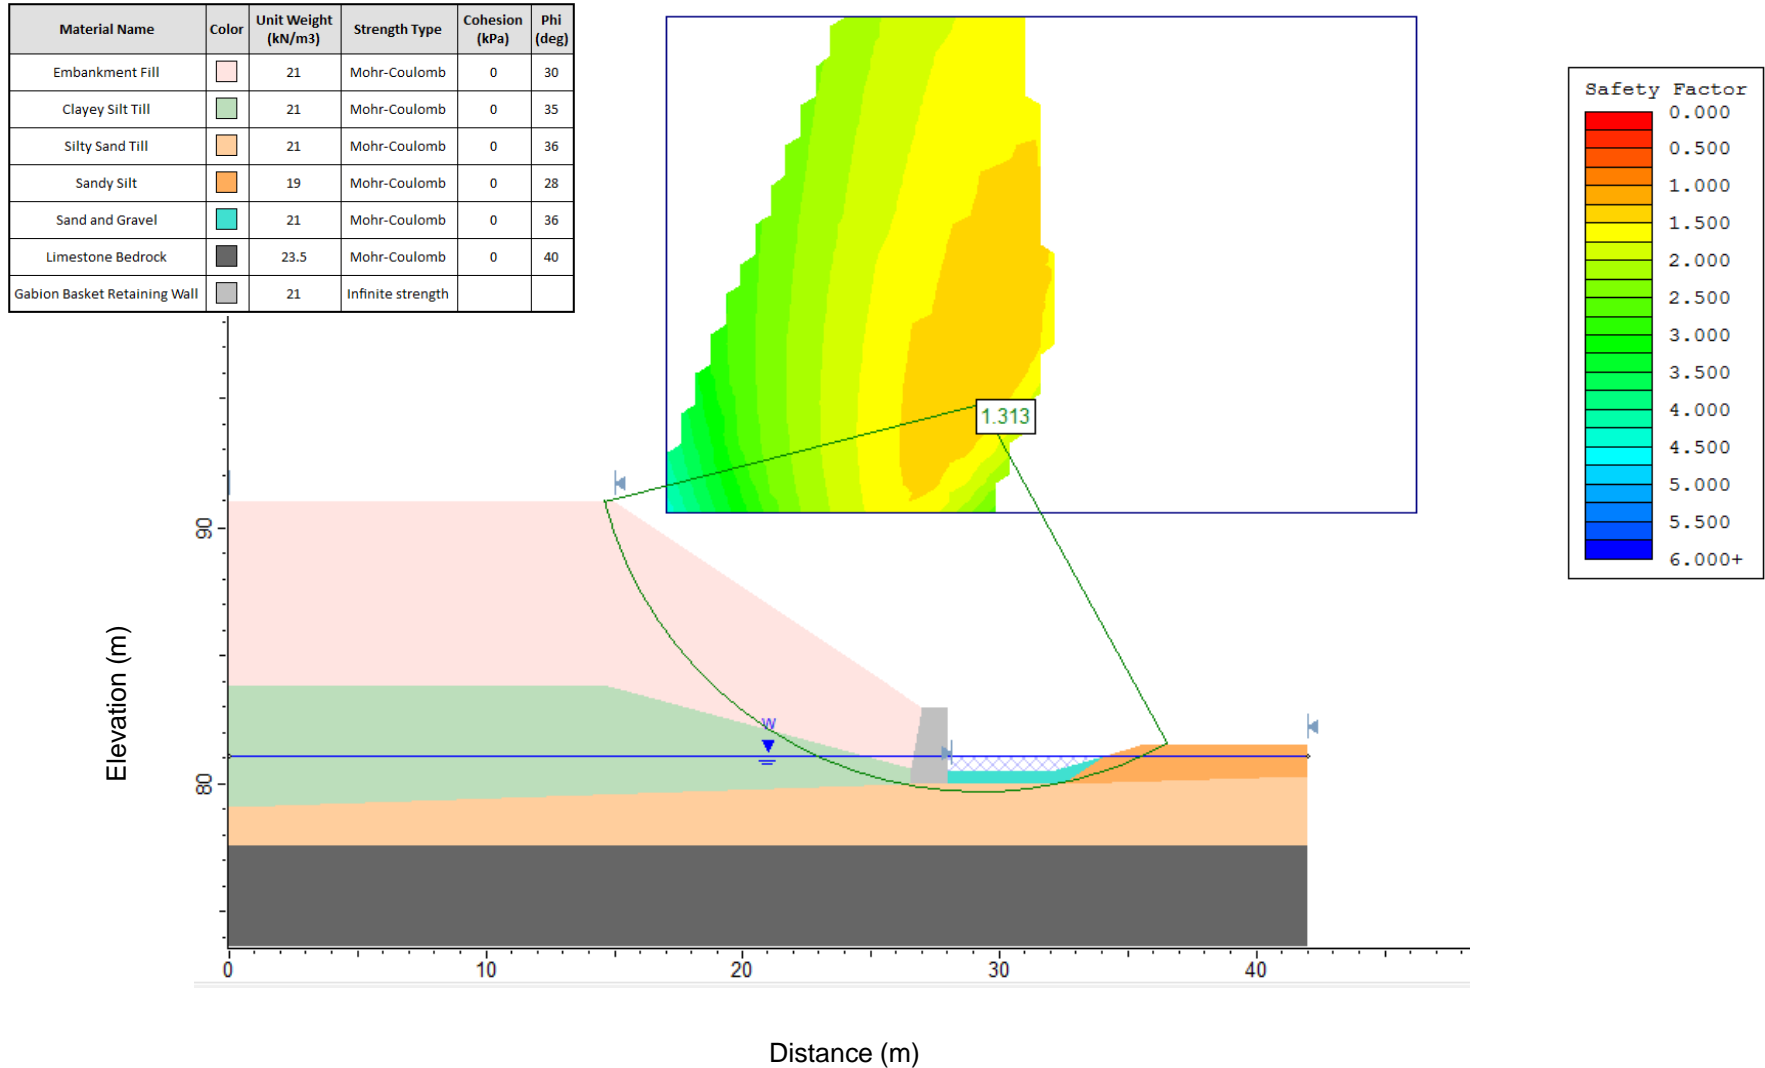
Figure 1

The global stability analysis for the 10 m high embankment was completed for the steepest configuration, 1.5H:1V, measured above the wall. The global stability analysis completed for the condition with the gabion basket retaining wall in place (i.e., original construction or pre-deformation) has a factor of safety of 1.3 against global instability, as shown on Figure 1. This calculated factor of safety for the embankment and retaining wall configuration meets the 2006 CHBDC standards, which would have applied at the time of design and construction of this embankment and wall section. This configuration would not meet the higher factor of safety of 1.54 required for the permanent condition under CHBDC 2014.

Given that two sections of the gabion basket retaining wall are performing adequately (that is, they satisfy the original global stability design requirement of a factor of safety greater than 1.3 – see Figure 1), the approximately 17 m long section of deformed wall could be repaired with new gabion baskets, or with armour stone. If this option is adopted, it will be necessary to remove the existing gabion baskets and found the base of the new gabion baskets or armour stone for the replacement section on a granular fill pad or on unshrinkable fill placed after removal of any loose/softened material from the footprint of the new wall section. Cofferdams and creek water/groundwater control are likely to be required, although the work could be completed in “wet” conditions with the placement of unshrinkable fill or tremie concrete within a flooded cofferdam area. In addition, a temporary protection system would be required behind the area to be removed and replaced, to maintain the stability of the embankment and protect the workers during construction.

Static Global Stability Initial Construction (Pre-Deformation) Long-Term (Drained) Conditions

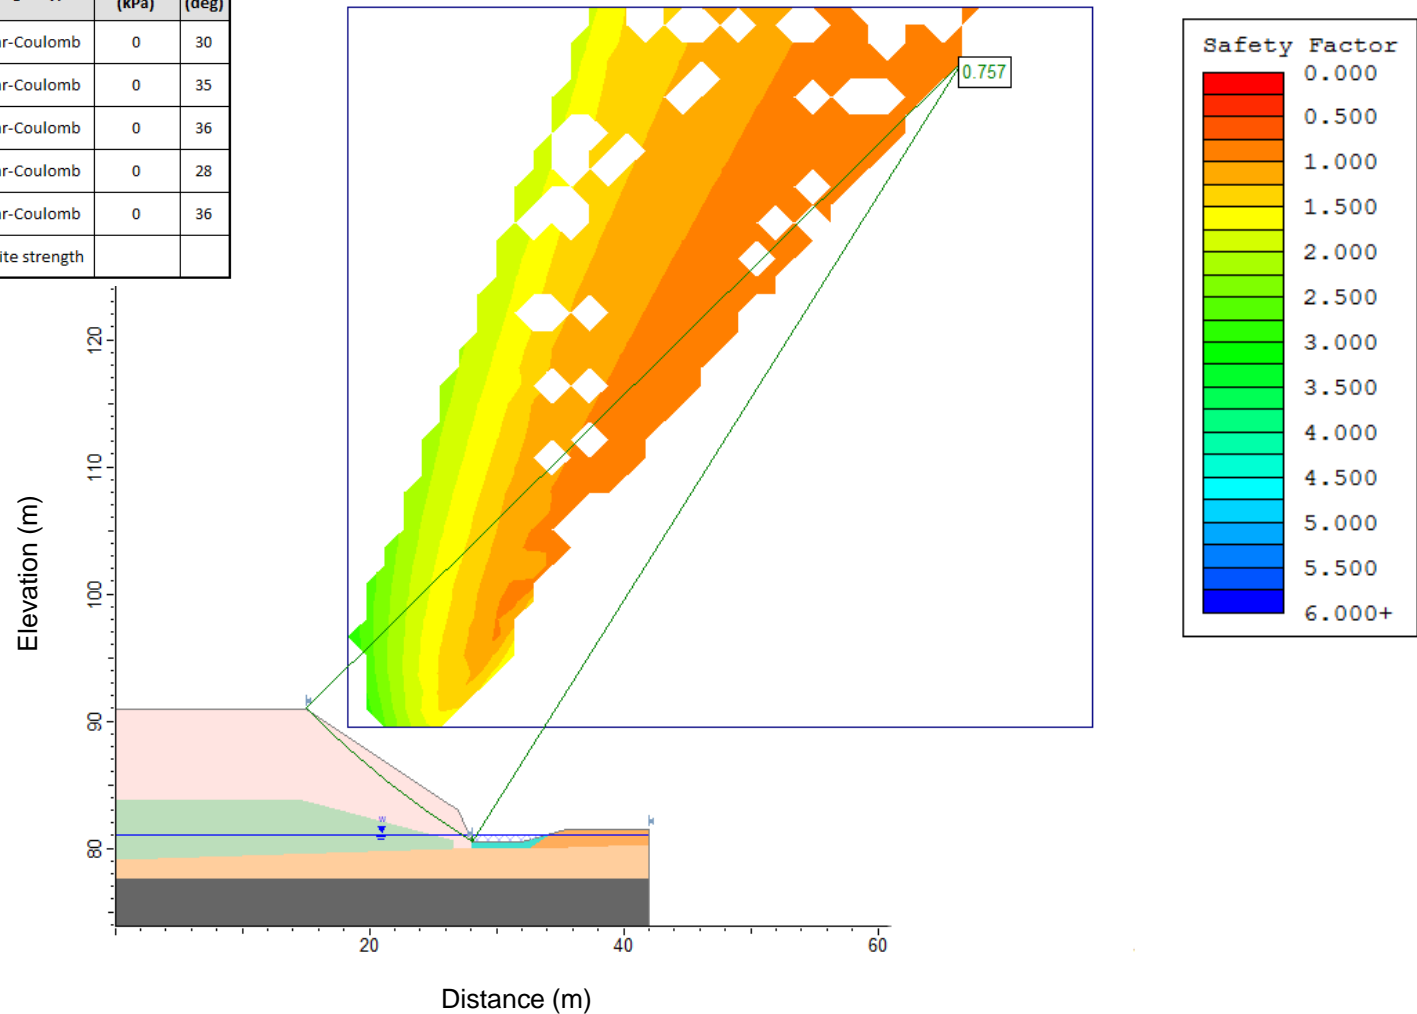
Figure 2

The global stability analysis completed for a section of the slope where the wall has failed (i.e. the wall has toppled or has been removed) yields a factor of safety of less than 1.0, as shown on Figure 2. These results indicate that if the deformed segment of the gabion basket retaining wall is not repaired or replaced, the Highway 401 embankment could become unstable in the future. It is noted that we consider that the current configuration of the slope remains stable due to soil arching within the embankment slope, relative to the intact sections of the wall, although this effect is difficult to model in a two-dimensional slope stability analysis.

Static Global Stability Gabion Wall Toppled/Removed Long-Term (Drained) Conditions

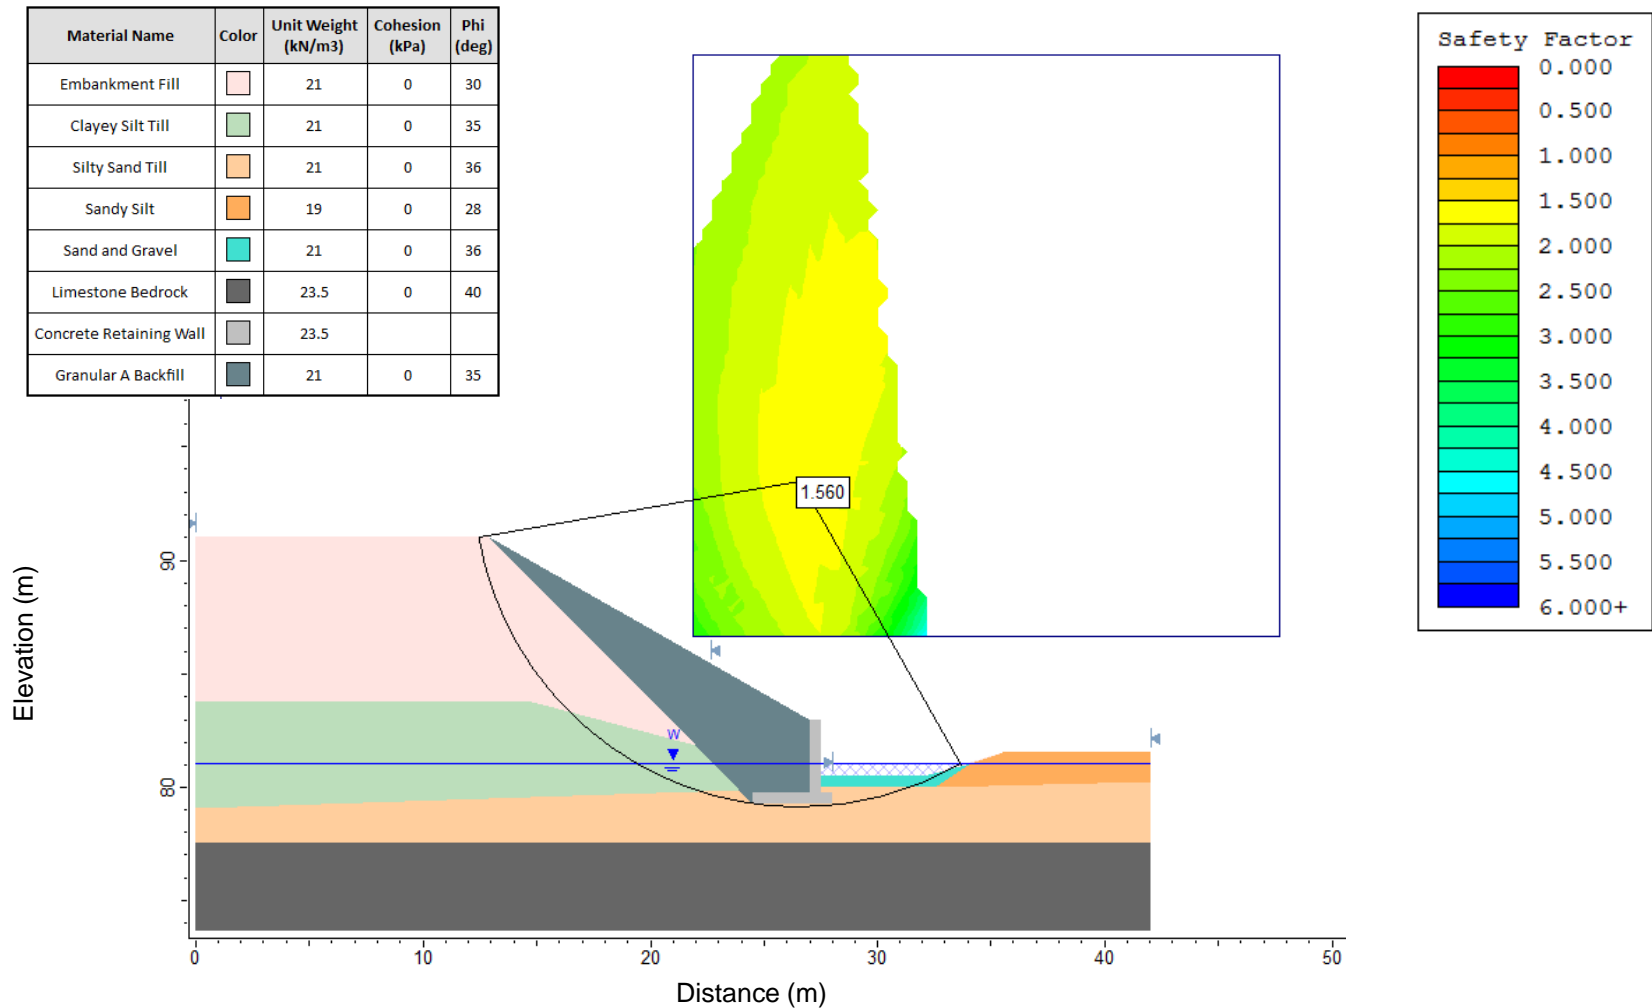
Figure 3

The embankment fill is comprised of clayey silt and the native overburden at this site is generally comprised of a hard cohesive till deposit and compact to very dense non-cohesive soils. The factor of safety against global instability of a concrete retaining wall is 1.55, as shown on Figure 3; this is based on a footing founded at a minimum depth of 1.2 m below the ground surface in front of the wall, and assuming that has an overall width of at least 3.5 m (extending at least 2.5 m behind the back of the wall). This analysis has been completed based on the steepest observed slope configuration (1.5H:1V) observed above the wall, although it is noted that the slope varies from about 1.5H:1V to 1.75H:1V. This assessment of the global stability of the retaining wall should be reviewed and confirmed if this option is adopted by the detail designers.

Static Global Stability Concrete Retaining Wall Long-Term (Drained) Conditions
