**Foundation Investigation and  
Design Report**

Mariposa Brook Culvert Replacement  
Site No. 32-161/C  
Highway 7  
Station 13+322 Township of Mariposa

G.W.P. 4066-10-00

March 2012

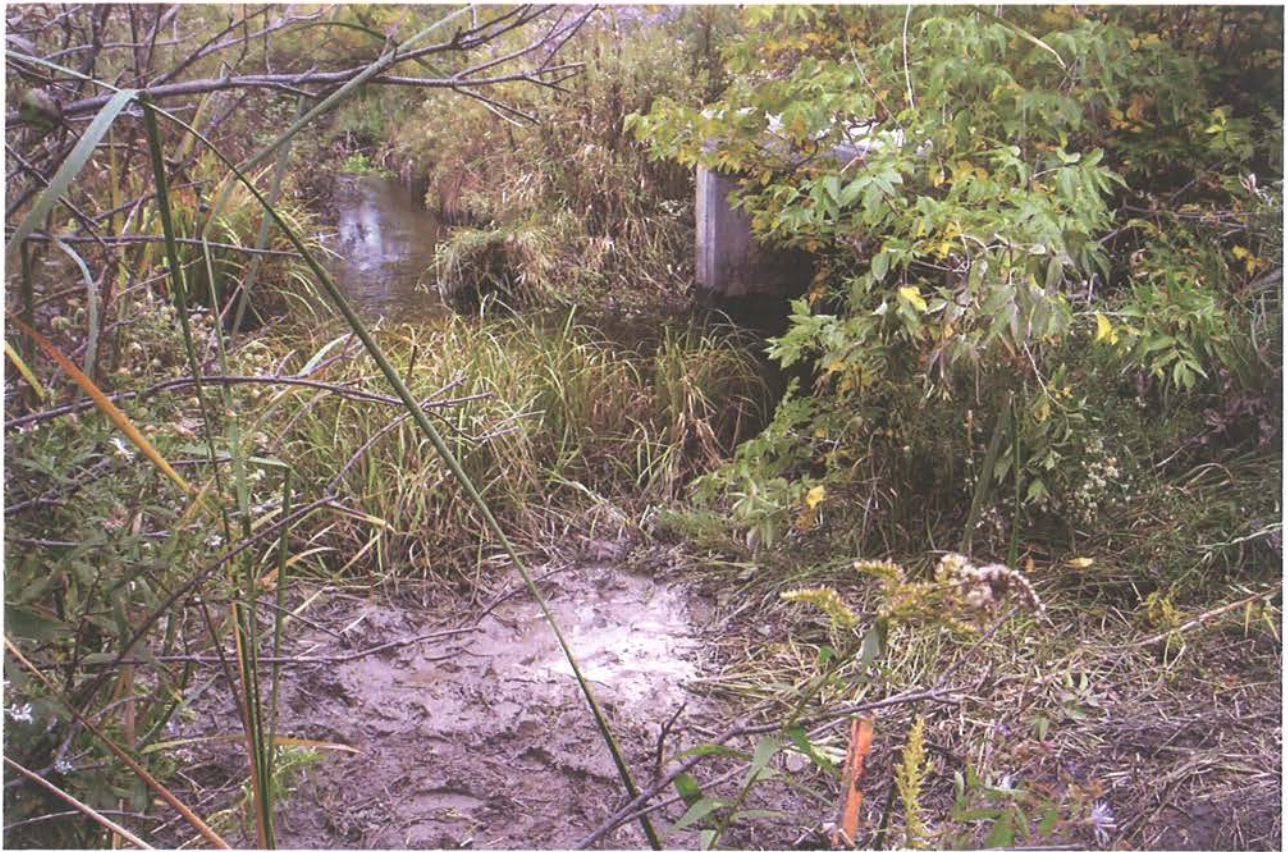
**Photo No. 1: Looking west at culvert inlet near BH11-4**

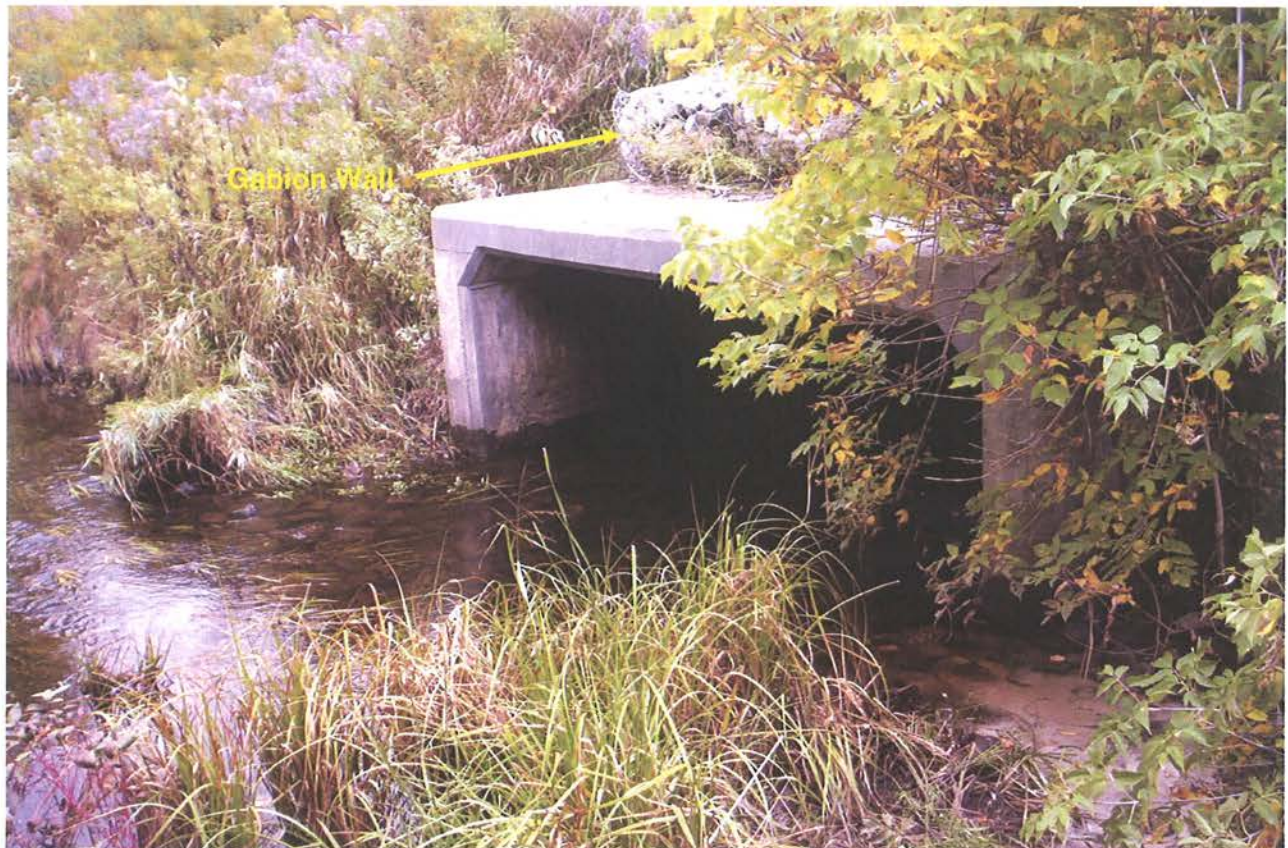
**Photo No. 2: Close-up view of culvert at the inlet**

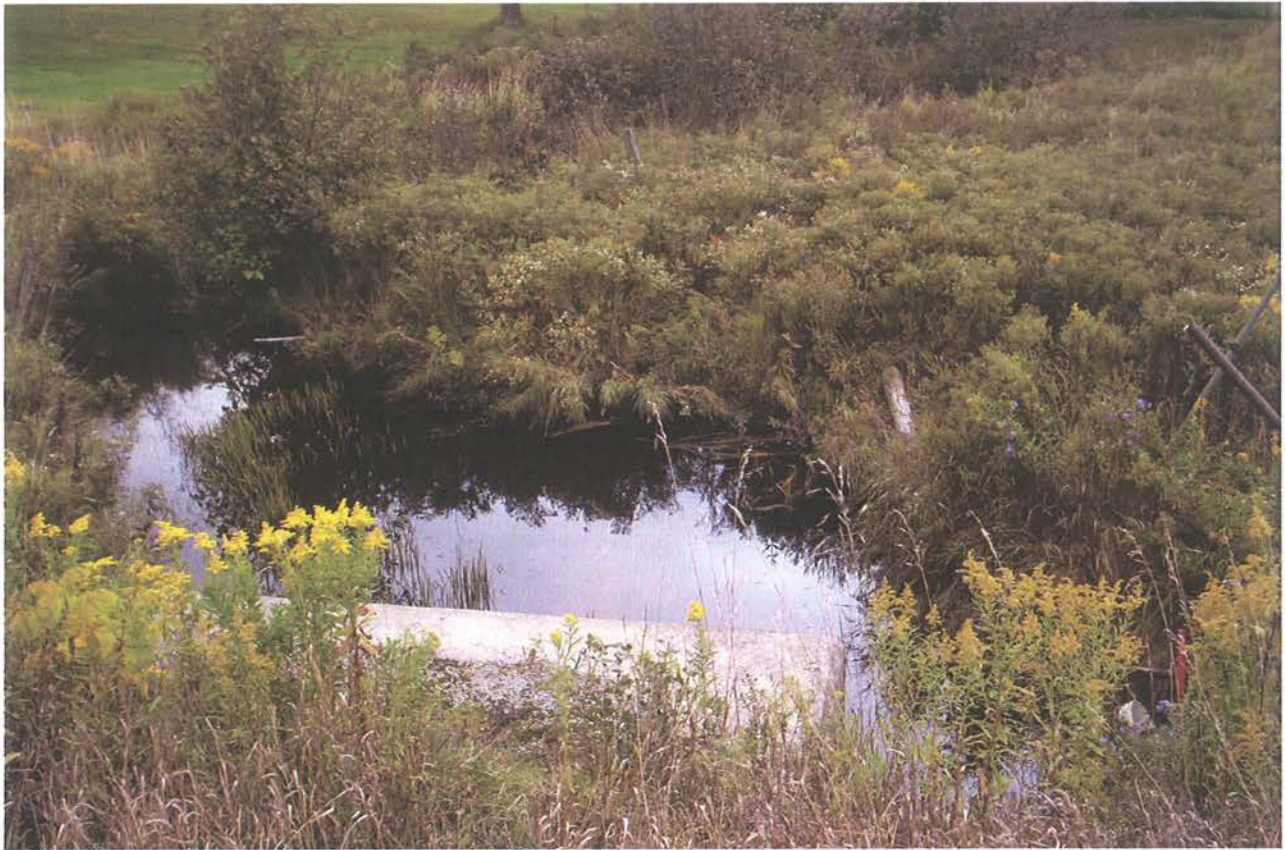
**Photo No. 3: Looking north at culvert outlet near BH11-1**

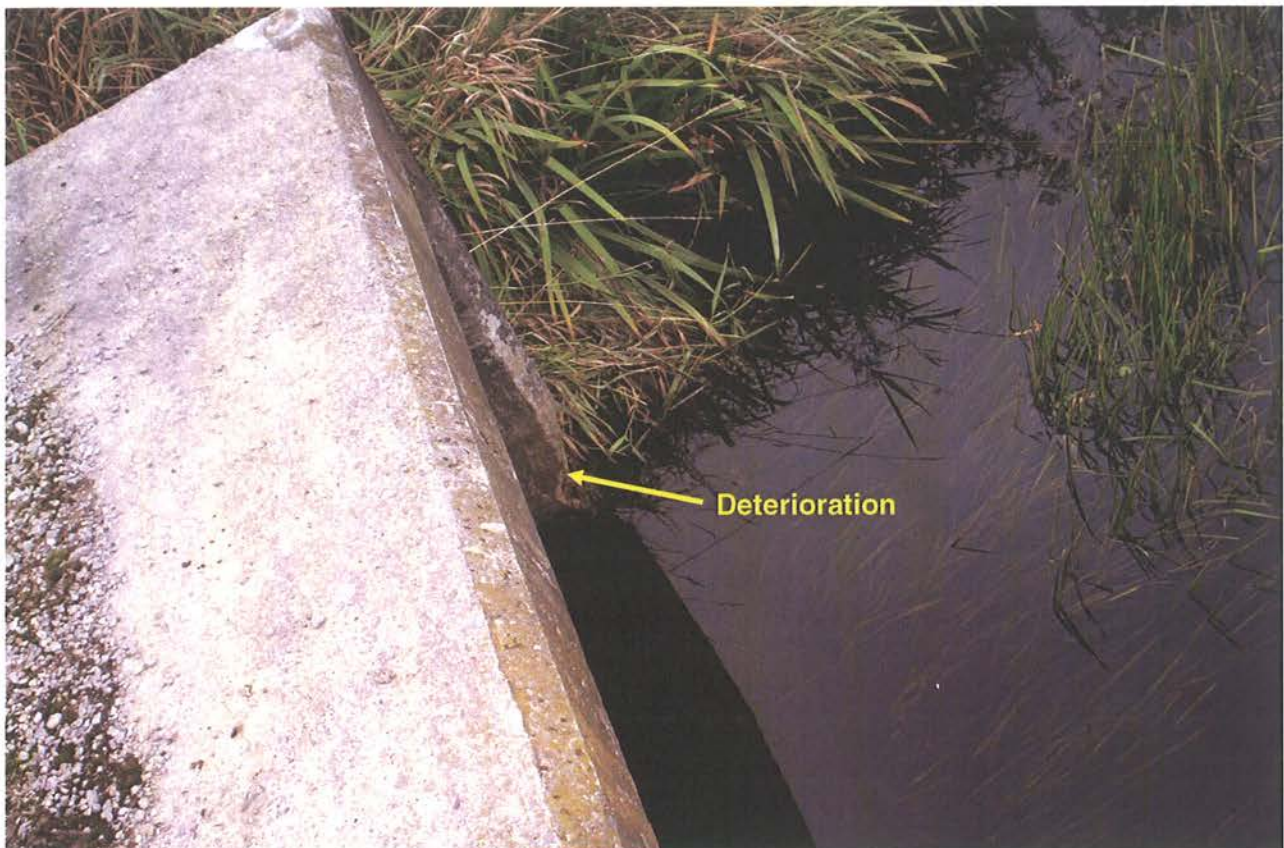
This culvert consists of four sections with the top slab of the original sections supported by steel beams that are braced with timber beams and supports. The inlet and outlet sections are also showing signs of deterioration and weathering (see Photo 4). This culvert has been identified as requiring replacement.

The outside sections of the culvert were observed to be generally in a fair condition. Spalling of the concrete was noted at the culvert outlet and is shown on Photo No. 4 in Appendix A. The water level in culvert was noted at approximately 50% of the culvert height, the water level is shown in Photos 1 through 4. The gabion wall located on the top of the inlet was observed to be in a fair condition; slight bulging of the gabion was noted.

**Photo No. 4: Culvert at outlet showing signs of deterioration**

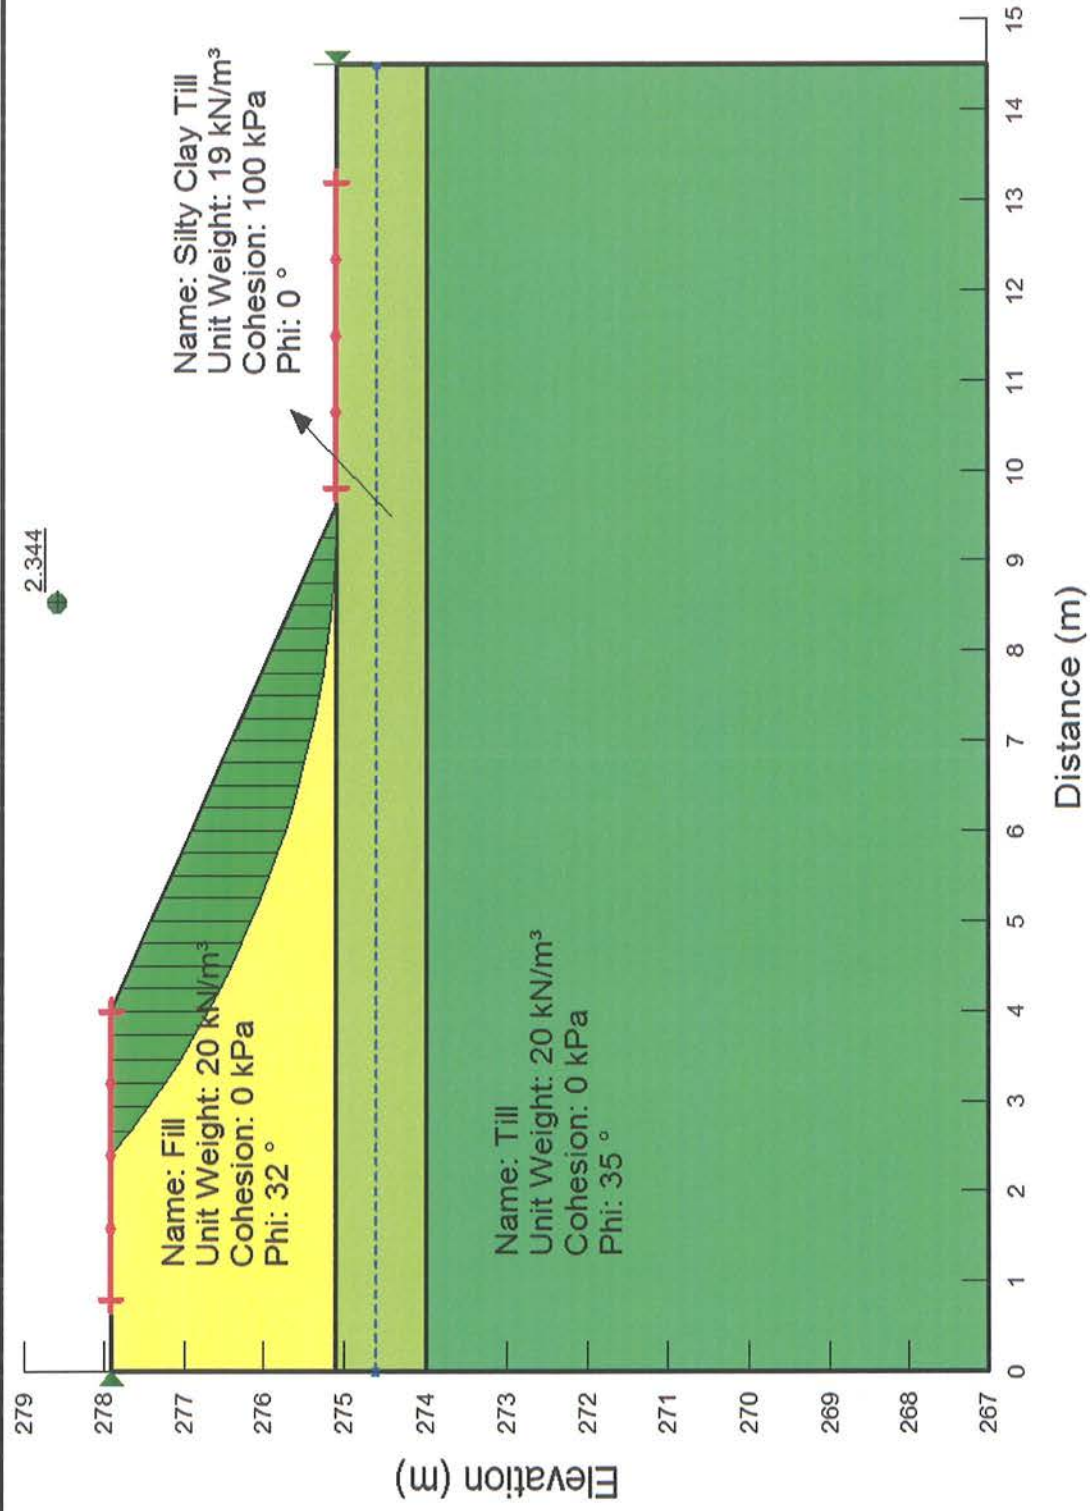
Figure 5

A 2H:1V permanent embankment slope was considered. The slope stability analysis results are presented in Figures 5 to 7 in Appendix D. The slope stability evaluation results indicate that the failure planes generally tend to be relatively shallow. Based on this preliminary slope stability analysis, the factor of safety against the shallow critical failure plane meets the required target value of 1.3 for highway embankments.
