Wildlife Underpass  
Highway 69 Four-Laning, Phase 2, Site No. 46-515  
W.P. 5262-07-01, Index No.: 734FDR  
PML Ref.: 06TF052F, May 5, 2009

## SITE INSPECTION REPORT

Comments by D. Wood Associates Ltd. Regarding Structure Foundations

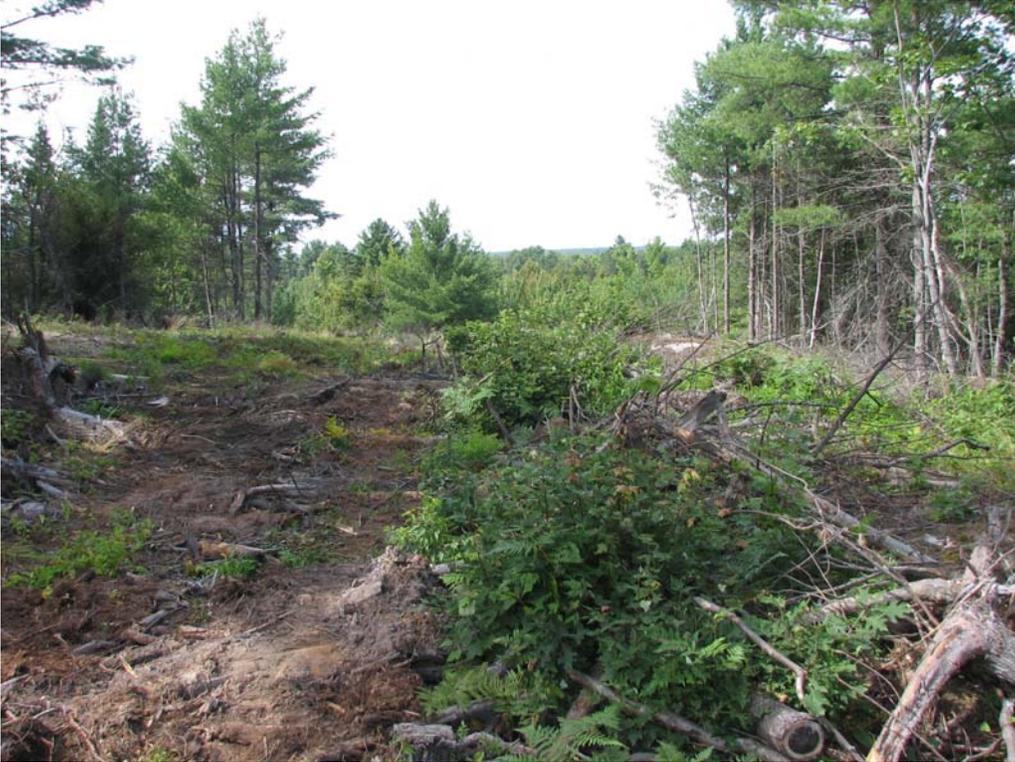
The area abounds with glacially eroded, bedrock outcrop (Images 1 and 2) and within 40 or 50 metres of the site there are also steep drop-offs up to 4 or 5 metres high. A general inspection of these outcrops was made, and a number of rock mass measurements were taken to establish the character of the exposed bedrock, so that this could be compared to the drill core information. The rock mass may be described as: “*Fresh (with local iron stained joints), massive, pale grey with darker flecks, coarse to very coarse grained, very strong, Granitic Gneiss, with dominant high grade metamorphic structure presented as aligned minerals of different colours without rock material segregation into gneissic banding or foliation.*” The metamorphic structure is locally consistent in orientation at 24-35 degrees dip to 172 to 194 degrees dip direction (measured relative to magnetic north). It was observed that the features measured were more consistent than those recorded in the Golder study. A few joints were also measured and they fit in perfectly with the Golder joint set 2m (peak orientation 59/354). From this perspective it could be seen that there were no significant discrepancies between the rock mass data observed by Wood and Golder.

Image 1. Looking north along the proposed Hwy 69 alignment. Note topographic high in this area and abundant outcrop.

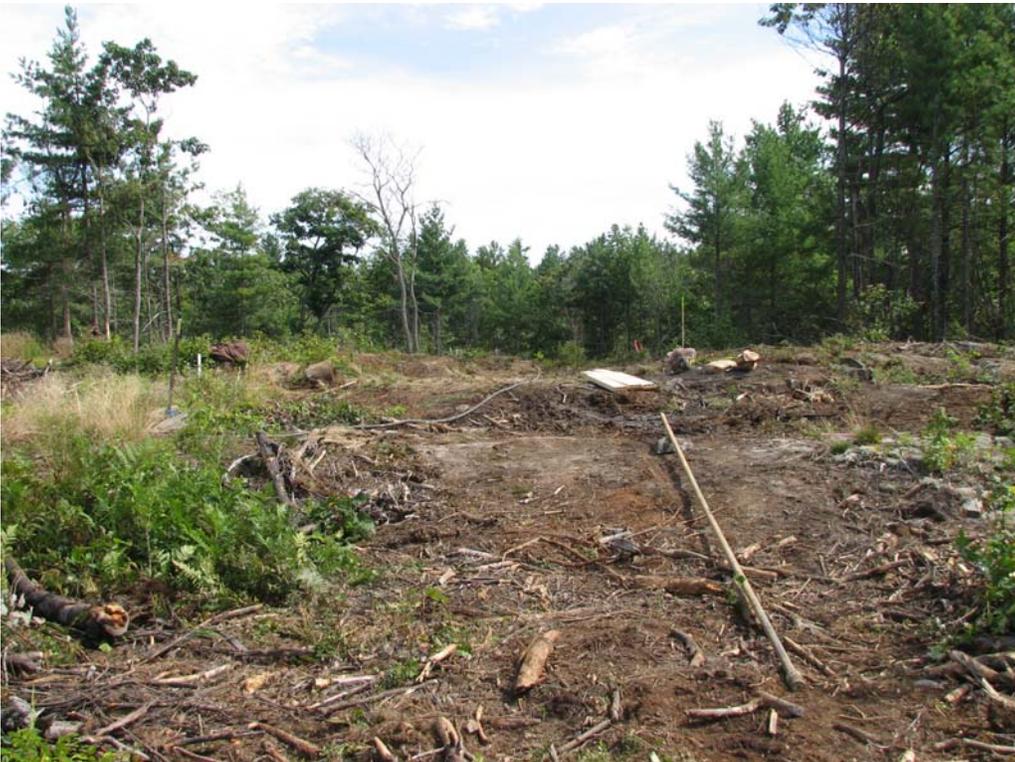
Image 2. Looking south along the proposed Hwy 69 alignment. Note drill rods with clay core orientation device affixed to end.

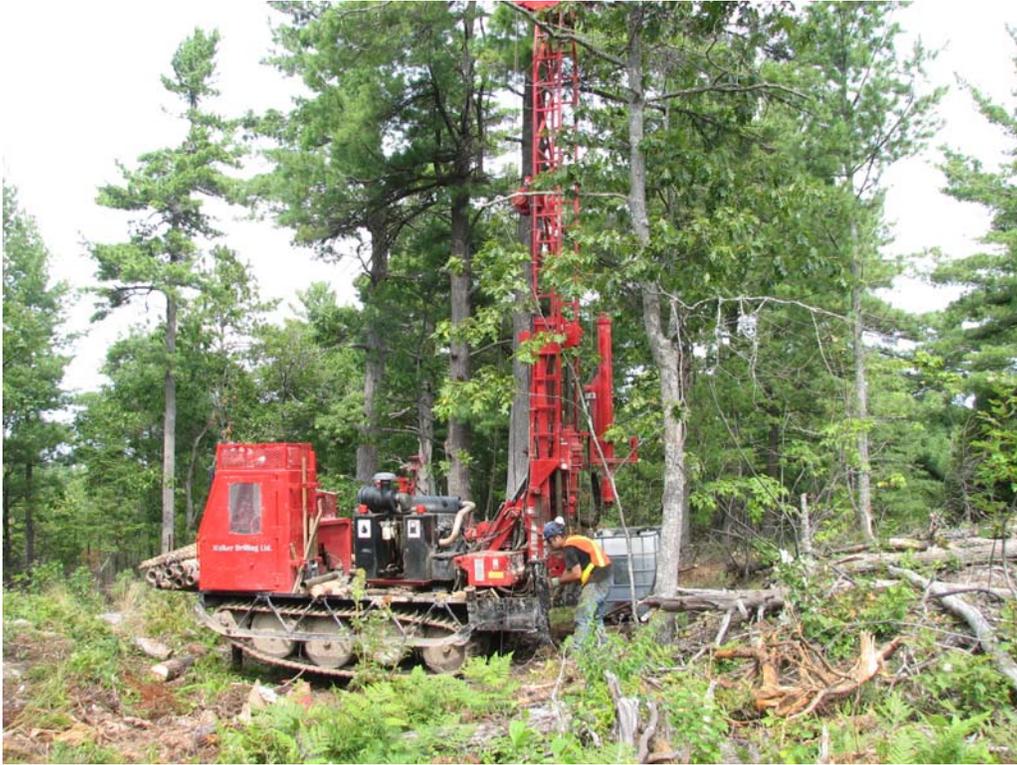
Image 3. Walker's Dietrich D 50 Turbo preparing to set up on hole F8.

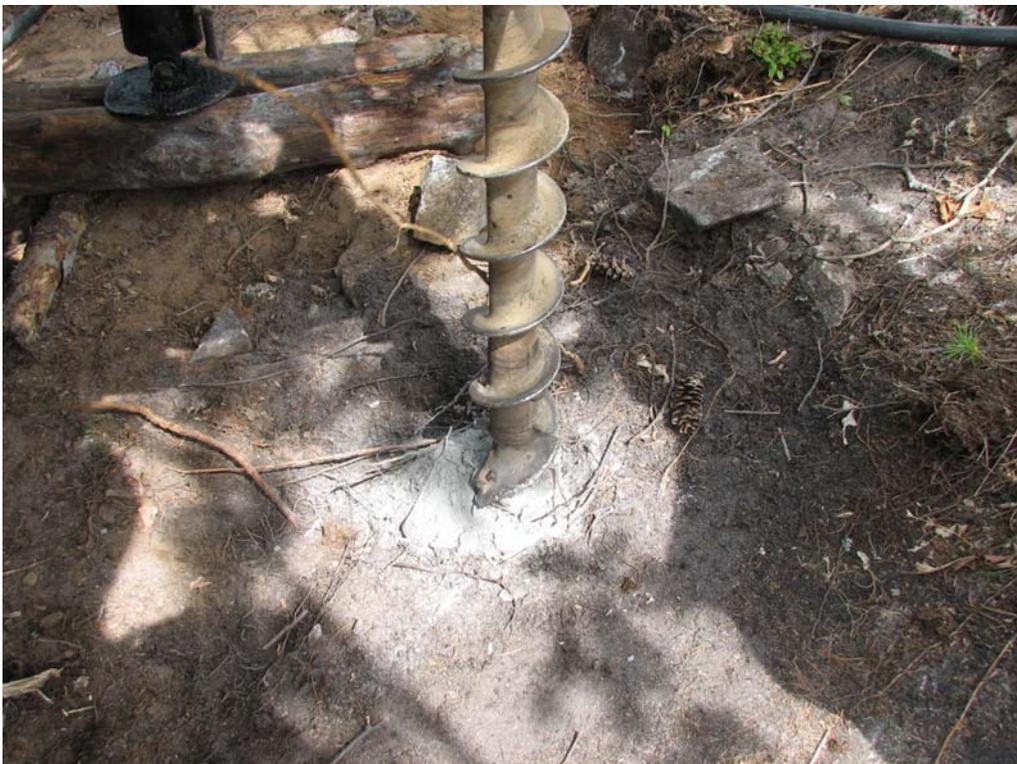
Image 4. Collaring the core hole using a corundum-tipped auger bit.

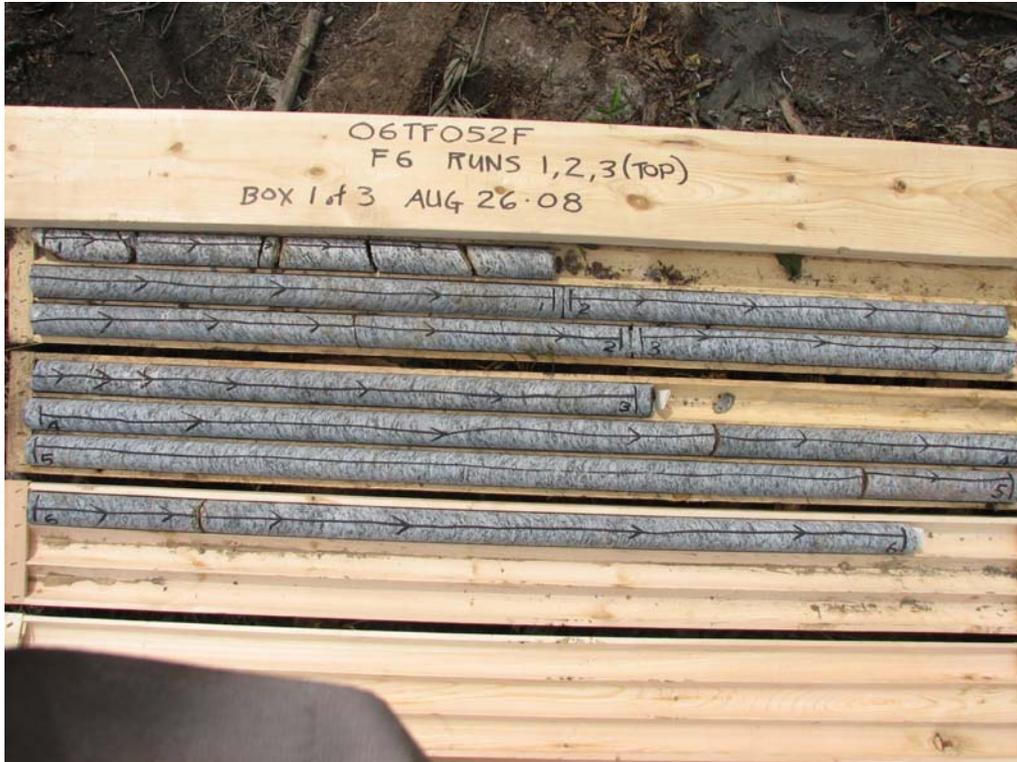
The rock mass at the site, on a topographic high, is of very high quality (Image 5). There are only a few natural joints visible in the abundant outcrops and the capacity of the bedrock to carry foundation loads is high. There may be the odd joint that intersects one or more of the excavation walls for the foundation elements, but these will be relatively unimportant from a design viewpoint and can be handled at the time of excavation. It would be virtually impossible to predict the location and orientation of any specific joint that may be encountered, and designing site specific rock mass reinforcement is not warranted until the excavation is well underway.

Image 5. Typical rock mass conditions encountered during drilling with very high quality rock mass with very few natural discontinuities, and very strongly developed metamorphic fabric.

It is recommended that once a final crossing design is confirmed and the exact locations of the foundation elements are established and drill and blast activities are proceeding, then another brief site visit could be scheduled to confirm that the currently anticipated rock conditions do indeed exist at depth.
