FOUNDATION INVESTIGATION  
AND DESIGN REPORT

PROPOSED REHABILITATION OF  
STRUCTURAL CULVERT SITE NO. 30-676/C  
TOWNSHIP OF RAMA  
HIGHWAY 12 FROM GAMEBRIDGE TO RAMA ROAD 25

W.P. 365-98-00  
Agreement # 2004-E-0070

08-1-IEG6-30-676/C

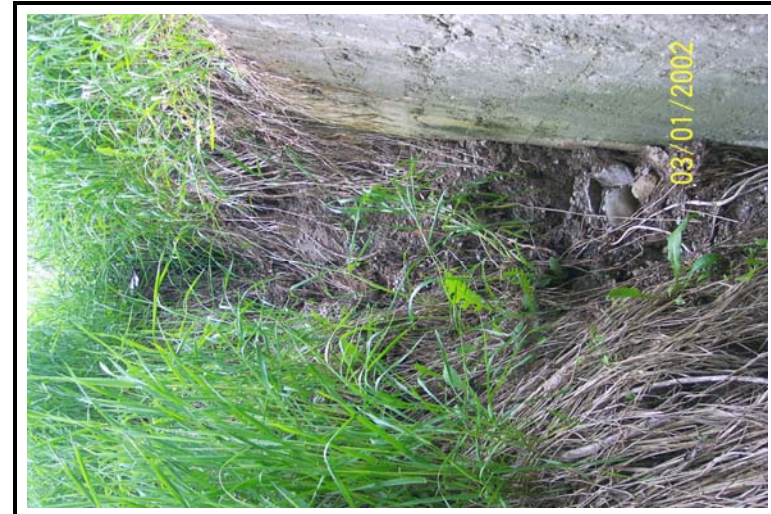
C28 Photo 4 Embankment Erosion at Northwest Corner
