MEMORANDUM

FOUNDATION INVESTIGATION REPORT

Wainfleet Patrol Yard
Lot 15, Con. I, Twp. of Wainfleet,
Hwy. #3, District #4.
W.J. 64-F-6 -- W.P. (Nil)

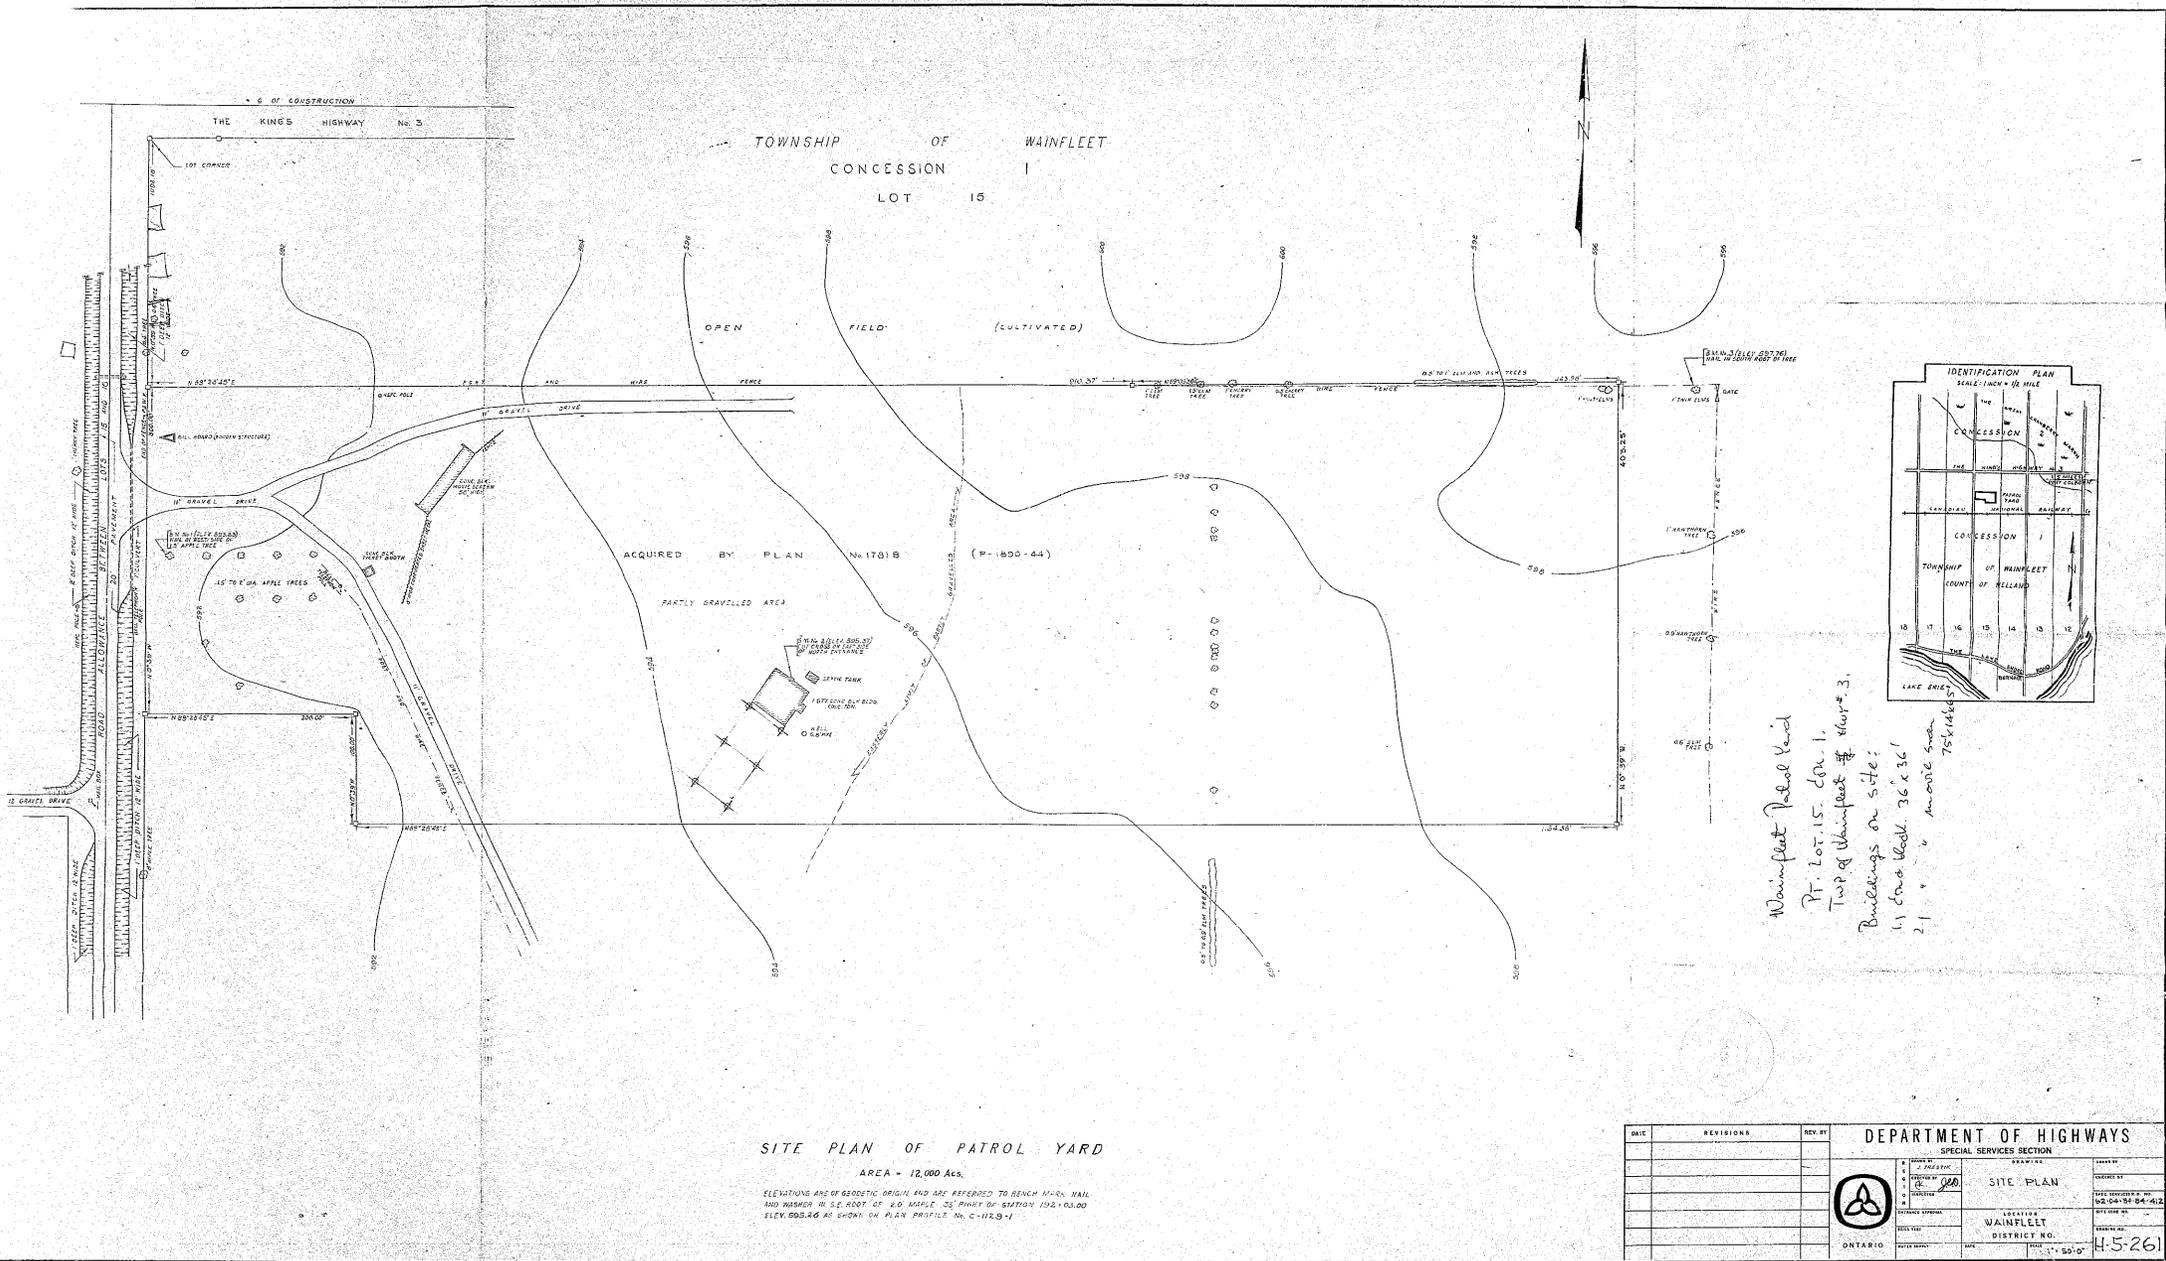
SITE PLAN OF PATROL YARD

The field investigation consisted of 4 sampled boreholes and 6 dynamic cone penetration tests. The locations and elevations of these boreholes are shown on Dwg. 64-F-6A.

The subsoil at the site was found to consist of loose to very dense silt at boreholes No. 5 and No. 6 to the depths of 1 to 9 feet.
