WP #174-61

OVERPASS

W.A. TROW & ASSOC. LTD.			
FOUNDATION INVESTIGATION			
PROPOSED CROSSING AT HIGHWAY NO 401 E.B.L. LINE 'G' AND ROCKPORT RD. LINE 'A'			
PROJECT NO 1967	W.P. NO 174-61	DATE NOV. 1962.	DWG. 1.

Re: Foundation Conditions - Rockport Road Overpass  
Hwy. 401, W.P. 174-61 - 1

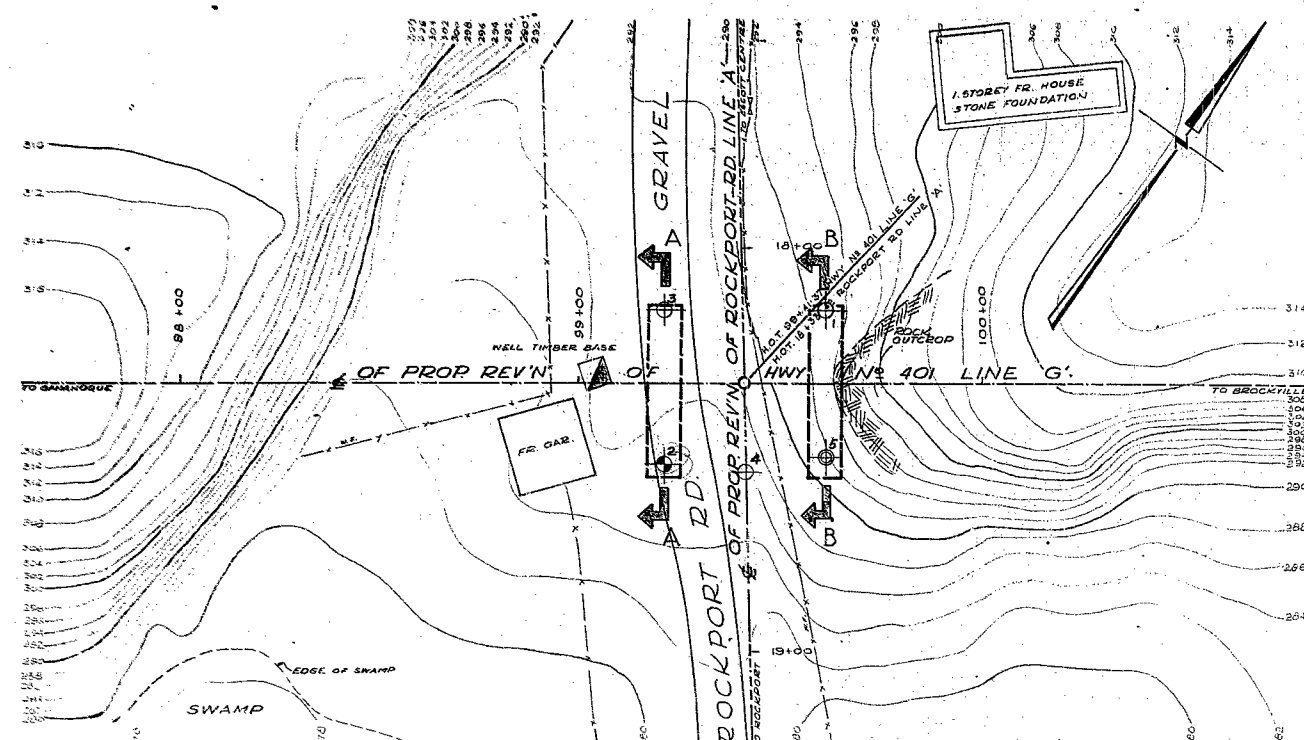
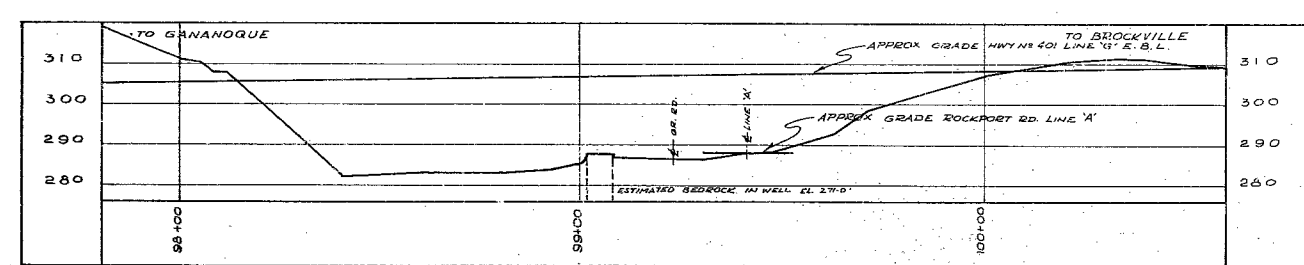
1) Bedrock lies at very shallow depth under this bridge site. The maximum depth to rock, as determined at the south end of the west abutment, is 14.9 feet, or 17.0 feet. The rock is overlain by stiff to hard marine clay.

3) It is probable that bedrock falls off to greater depths under the clay plain to the southwest of this bridge. However, the thickness of clay under the west embankment approach probably is not much greater than the depth indicated for hole 2 at the southwest corner of the bridge. The strength of this clay is more than sufficient to support the weight of 22 feet of approach fill, particularly since the length of this fill is limited by the rock outcrop 60 feet to the west of the bridge.

2) It is recommended that the abutment footings of this structure be carried down to bedrock. No excavation problem is envisaged. The clay walls should stand unsupported.

Although very stiff competent clay occurs under the west abutment, it is recommended that the bridge abutment on this side also be taken to rock. In this way there will be no possibility of undesirable differential settlement. The excavation work through the clay should be accomplished without difficulty. The walls of the clay should stand unsupported, although light strutting may be required to hold the top of the cut, or, alternatively the banks should be cut back slightly. No excavation difficulty is envisaged when digging to bedrock through the clay.

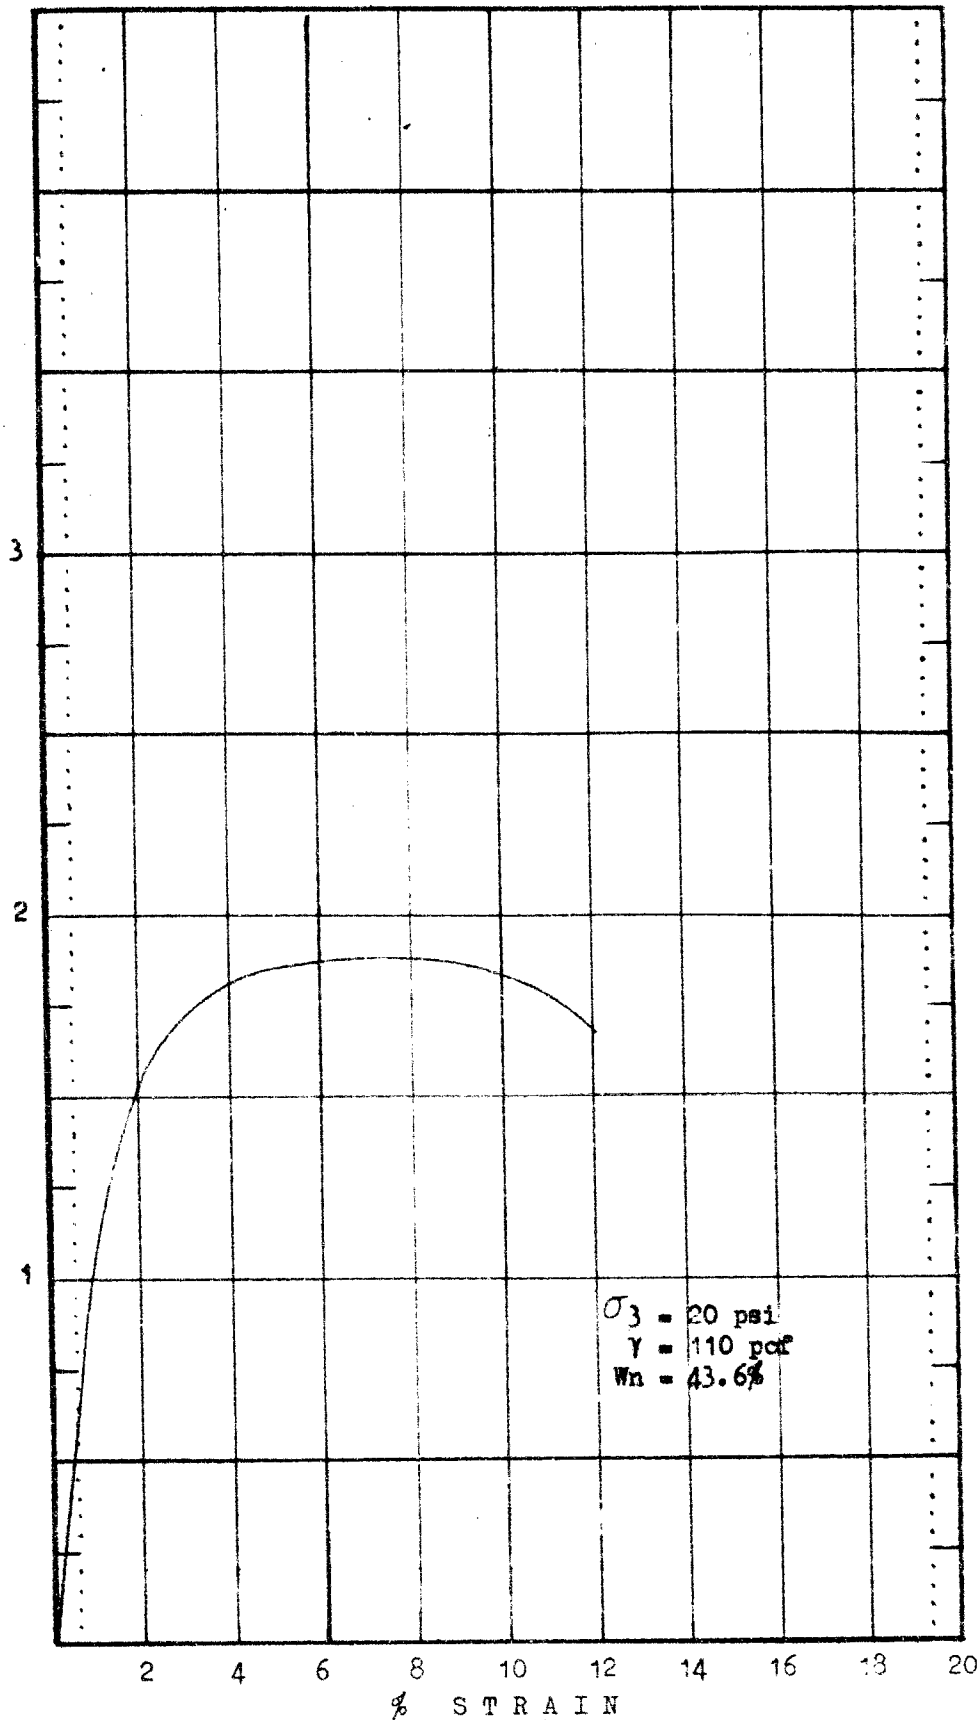
HOLE 2 - 9 FEET

In hole 2 at the southwest corner, very stiff dark brownish grey marine clay was encountered. This soil becomes less stiff with depth, relatively speaking, although the laboratory undrained strength on a sample from 9 feet still indicated a strength of about 1900 psf. No other laboratory testing was performed on this clay, since it is obviously strong enough to support the weight of the approach fill. In view of the close proximity of rock at all other locations, it would be unwise to support a portion of the west abutment on this clay and, consequently, the bearing capacity of the clay is not of concern. Just above bedrock, the clay contains pockets and seams of wet sand, and consequently it is somewhat weaker.

UNDRAINED TRIAXIAL TEST RESULT
