DEPARTMENT OF HIGHWAYS - ONTARIO			
MATERIALS & RESEARCH SECTION			
GANANOQUE RIVER			
HWY. 401 EMBANKMENTS			
SHOWING POSITIONS & ELEVATIONS OF HOLES			
HWY. 401	DISTRICT 8	COUNTY LEEDS	
TOWNSHIP LAUSDONNE	LOT 18E	CON 1	
LOCATION APP. 1 MI. N. OF GANANOQUE			
DRAWN BY T. MELLORS	CHECKED BY W.K.	W.P.	
DATE JULY 1959	APPROVED BY		DRAWING NO.
SCALE AS SHOWN			F59-80A

**GANANOQUE RIVER
HWY. 401 EMBANKMENTS**

Re: Highway No. 401 Crossing
at Gananoque River -
District #8 - W.J. P-59-80.

REPORT ON
EMBANKMENT STABILITY INVESTIGATION
HIGHWAY 401 at GANANOQUE RIVER
DISTRICT NO. 8, KINGSTON.

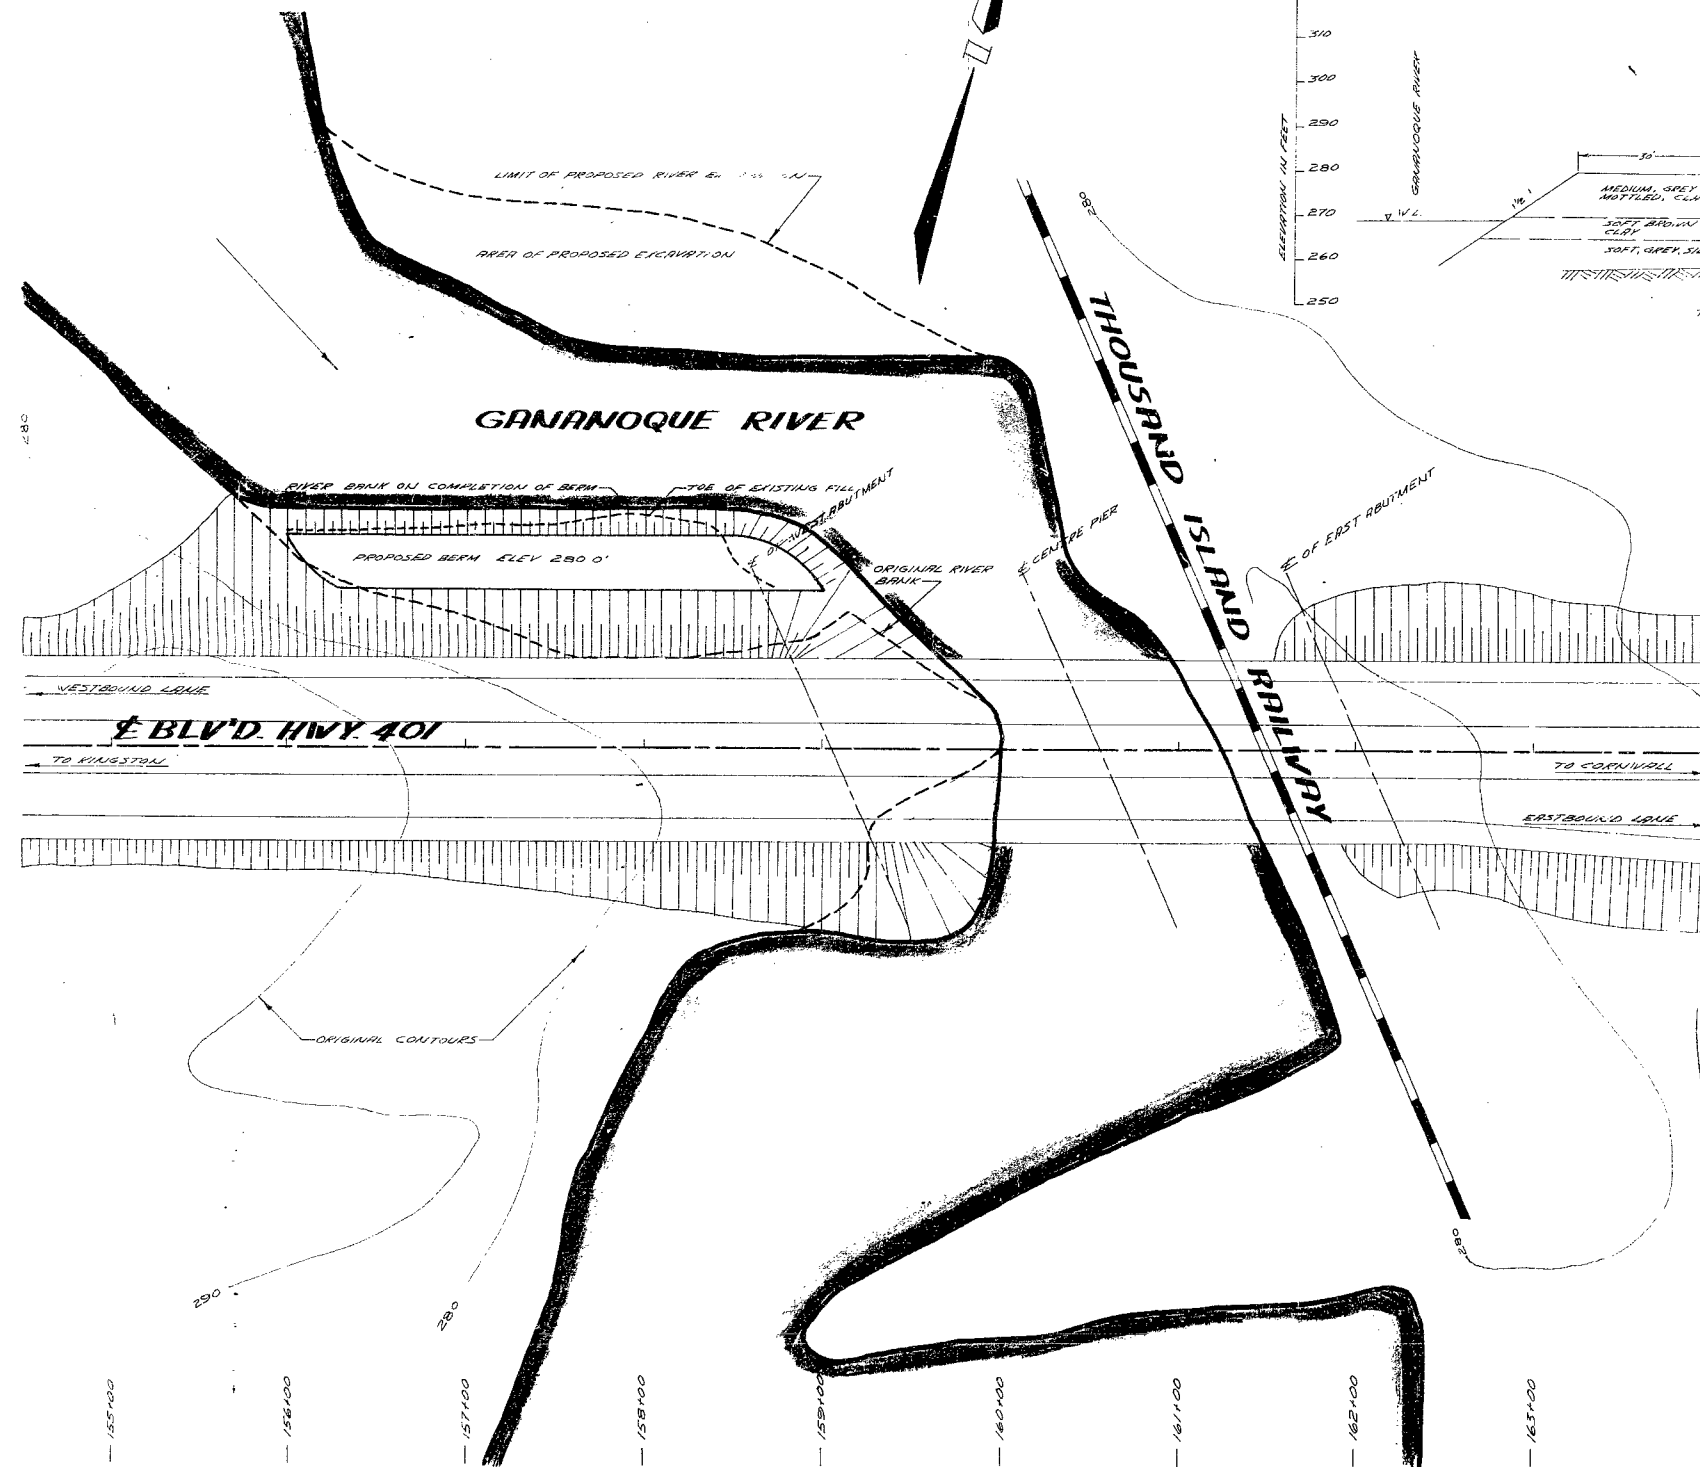
1. Unless remedial measures are taken, further embankment failures are probable at the West approach on the North side of the river between Stations 156+00 and 159+00. These probable failures, as in previous failures, are due to a layer of soft clay found near the bottom of the embankment. This soft clay is believed to be fill material; however, some may be river deposits.

- (1) Unless remedial measures are taken, further embankment failures are probable at the West approach on the North side of the river between Stations 156+00 and 159+00. These probable failures, as in previous failures, are due to a layer of soft clay found near the bottom of the embankment. This soft clay is believed to be fill material; however, some may be river deposits.

2. To prevent further failures, the embankment between Stations - 156+00 to 158+50 should be trimmed and a berm constructed as shown on Drawing P 59-80A (enclosed). This berm has been designed so that it extends a minimum distance into the existing river. Material trimmed from the top of the slope should be used in the construction of the berm.

- (2) To prevent further failures, the embankment between Stations - 156+00 to 158+50 should be trimmed and a berm constructed as shown on Drawing F 59-80A. This berm has been designed so that it extends a minimum distance into the existing river. Material trimmed from the top of the slope should be used in the construction of the berm.

It was found that in order to obtain a factor of safety of 1.3, it will be necessary to construct a berm at elevation 280, 30 feet wide. The slopes from the edge of the shoulder to the berm and from the edge of the berm to the river should be constructed at 1 1/2:1. Drawing F-59-80 A shows the proposed typical section. This operation would involve moving material from the upper part of the embankment to the toe. Superposition of the proposed section on the cross-sections of the existing embankment indicates that there is probably sufficient material presently in the embankment to construct the berm without having to dispose of excess material. Furthermore, the proposed section does not at any point, encroach more than an additional 10 feet into the river except at Sta. 158+50 where the present slope is dangerously steep.

It is recommended that the berm should extend from Sta. 156+00 to Sta. 158+50 and then taper in to the present slope at about Sta. 159+00.

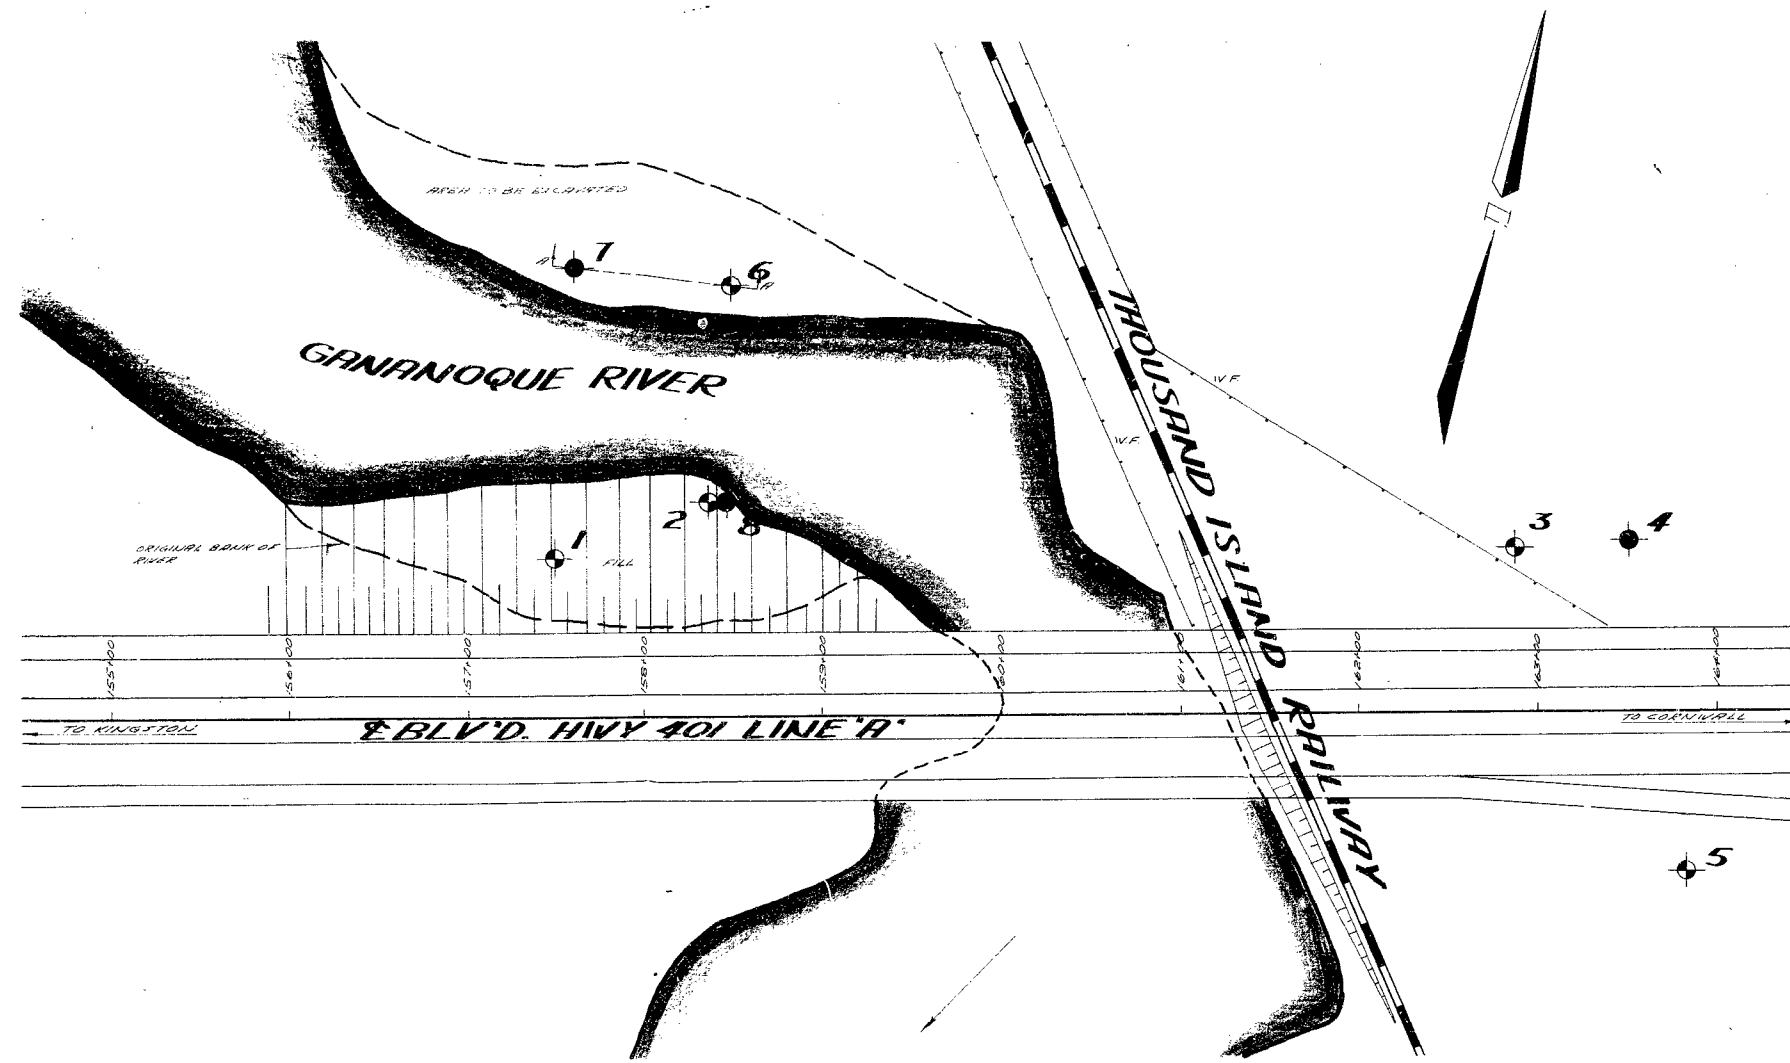
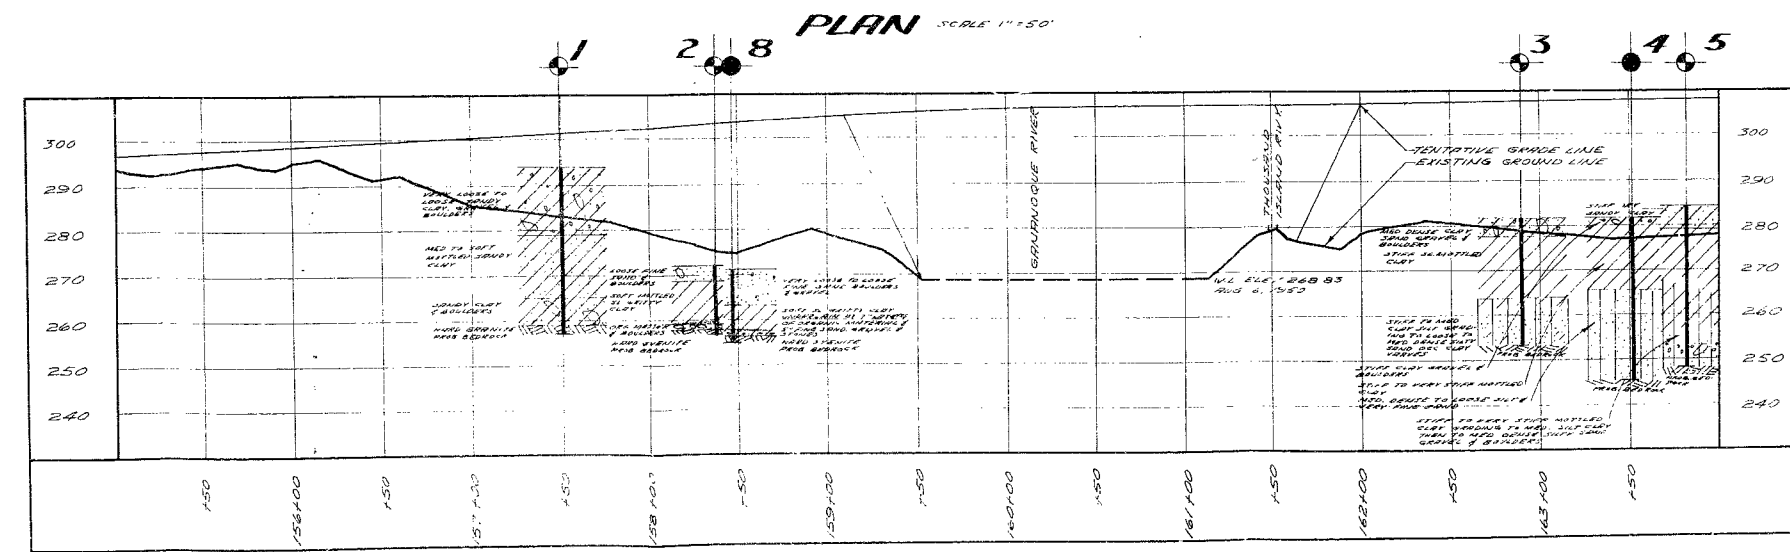
Drawing No. F-59-80 B shows the borehole locations and the subsoil profile.

Samples obtained from the boreholes in the "failure zone" of the West embankment indicate that the embankment consists basically of a varying depth of rock fill and sand and sandy clay overlying a layer of soft clay or sandy clay up to nearly 20 feet in depth. The shear strength of the clay layer ranges from 700 p.s.f. at the bottom, to about 1400 p.s.f. at the top. This material is believed to be mostly the initial earth fill as it is underlain in Boreholes No. 2 and 8 by a thin layer of slightly decomposed organic material which is possibly the original river bottom. Beneath this decomposed organic material, is a thin layer of fine sand and boulders underlain by very hard pink granite and grey syenite bedrock. It must be realized, however, that the numerous failures which have occurred make it practically impossible to define accurately the limits of the various strata.

Failure to find any evidence of a layer of soft clay at any location other than in the West embankment indicates that past and present failures at the West embankment are due to failure of the fill material.
