REPORT NO. S-500-501/55/T-129 AND FINAL

RE: SOILS INVESTIGATION FOR PROPOSED BRIDGE  
CROSSING THE MOON RIVER WNW OF BALA,  
MUSKOKA (TRANS-CANADA HIGHWAY)

RE: SOIL CONDITIONS AT PROPOSED BRIDGE  
CROSSING THE MOON RIVER NEAR BALA

RE: FOUNDATION INVESTIGATION - PROPOSED  
BRIDGE SITE FOR TRANS-CANADA HIGHWAY  
CROSSING THE MOON RIVER (MUSKOKA)

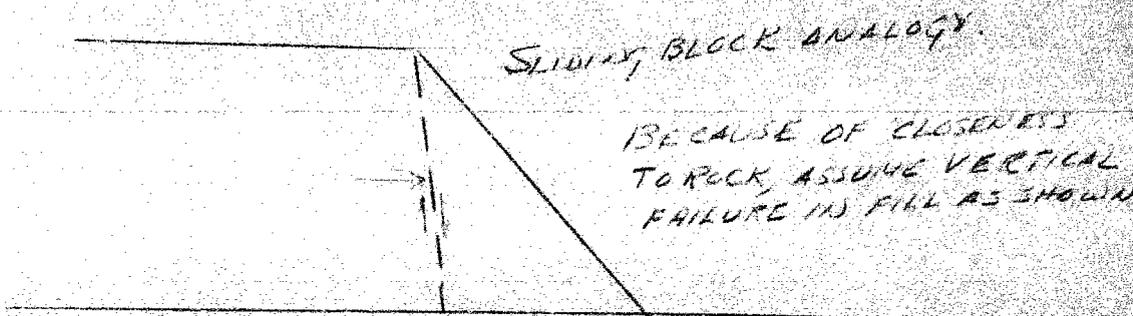
COULOMB - RANKINE PRESSURE

THE CLAY BEING CAPABLE OF APPROX 200 PSF  
THE DESIGN IS UNSAFE.

ASSUME PIERS OF INFINITE RIGIDITY AS COMPARED  
TO CLAY, DESIGN FOR  $5000 \text{ \#/LIN. FT.}$  E.G. CAISSONS  
@ 4'4" 20 K/CAISSON.
