Just an update regarding our piling issue at Reg. Rd 29 Contract 2001-0002.

**RE:** Replacement of Piles  
South Abutment  
R.R. #29 Bridge  
Auriprior, Ontario

Re: Draft Foundation Investigation and Design Report  
Hwy 417 Underpass Bridge at Regional Rd 29  
WP 128-92-00 & 452-90-00

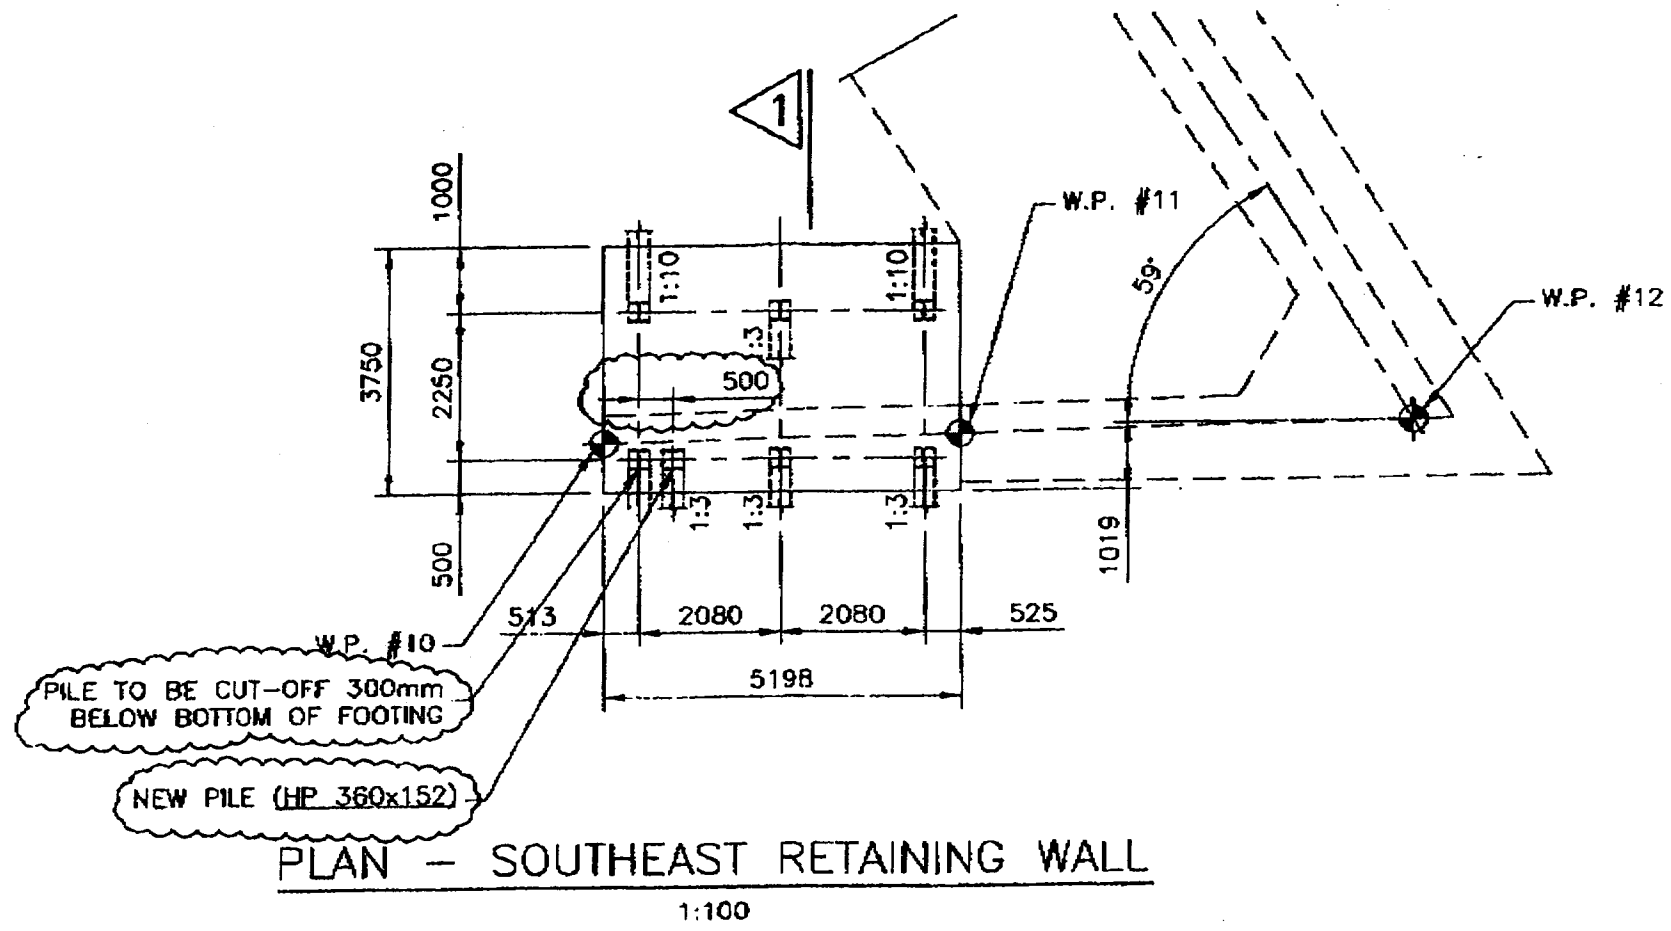
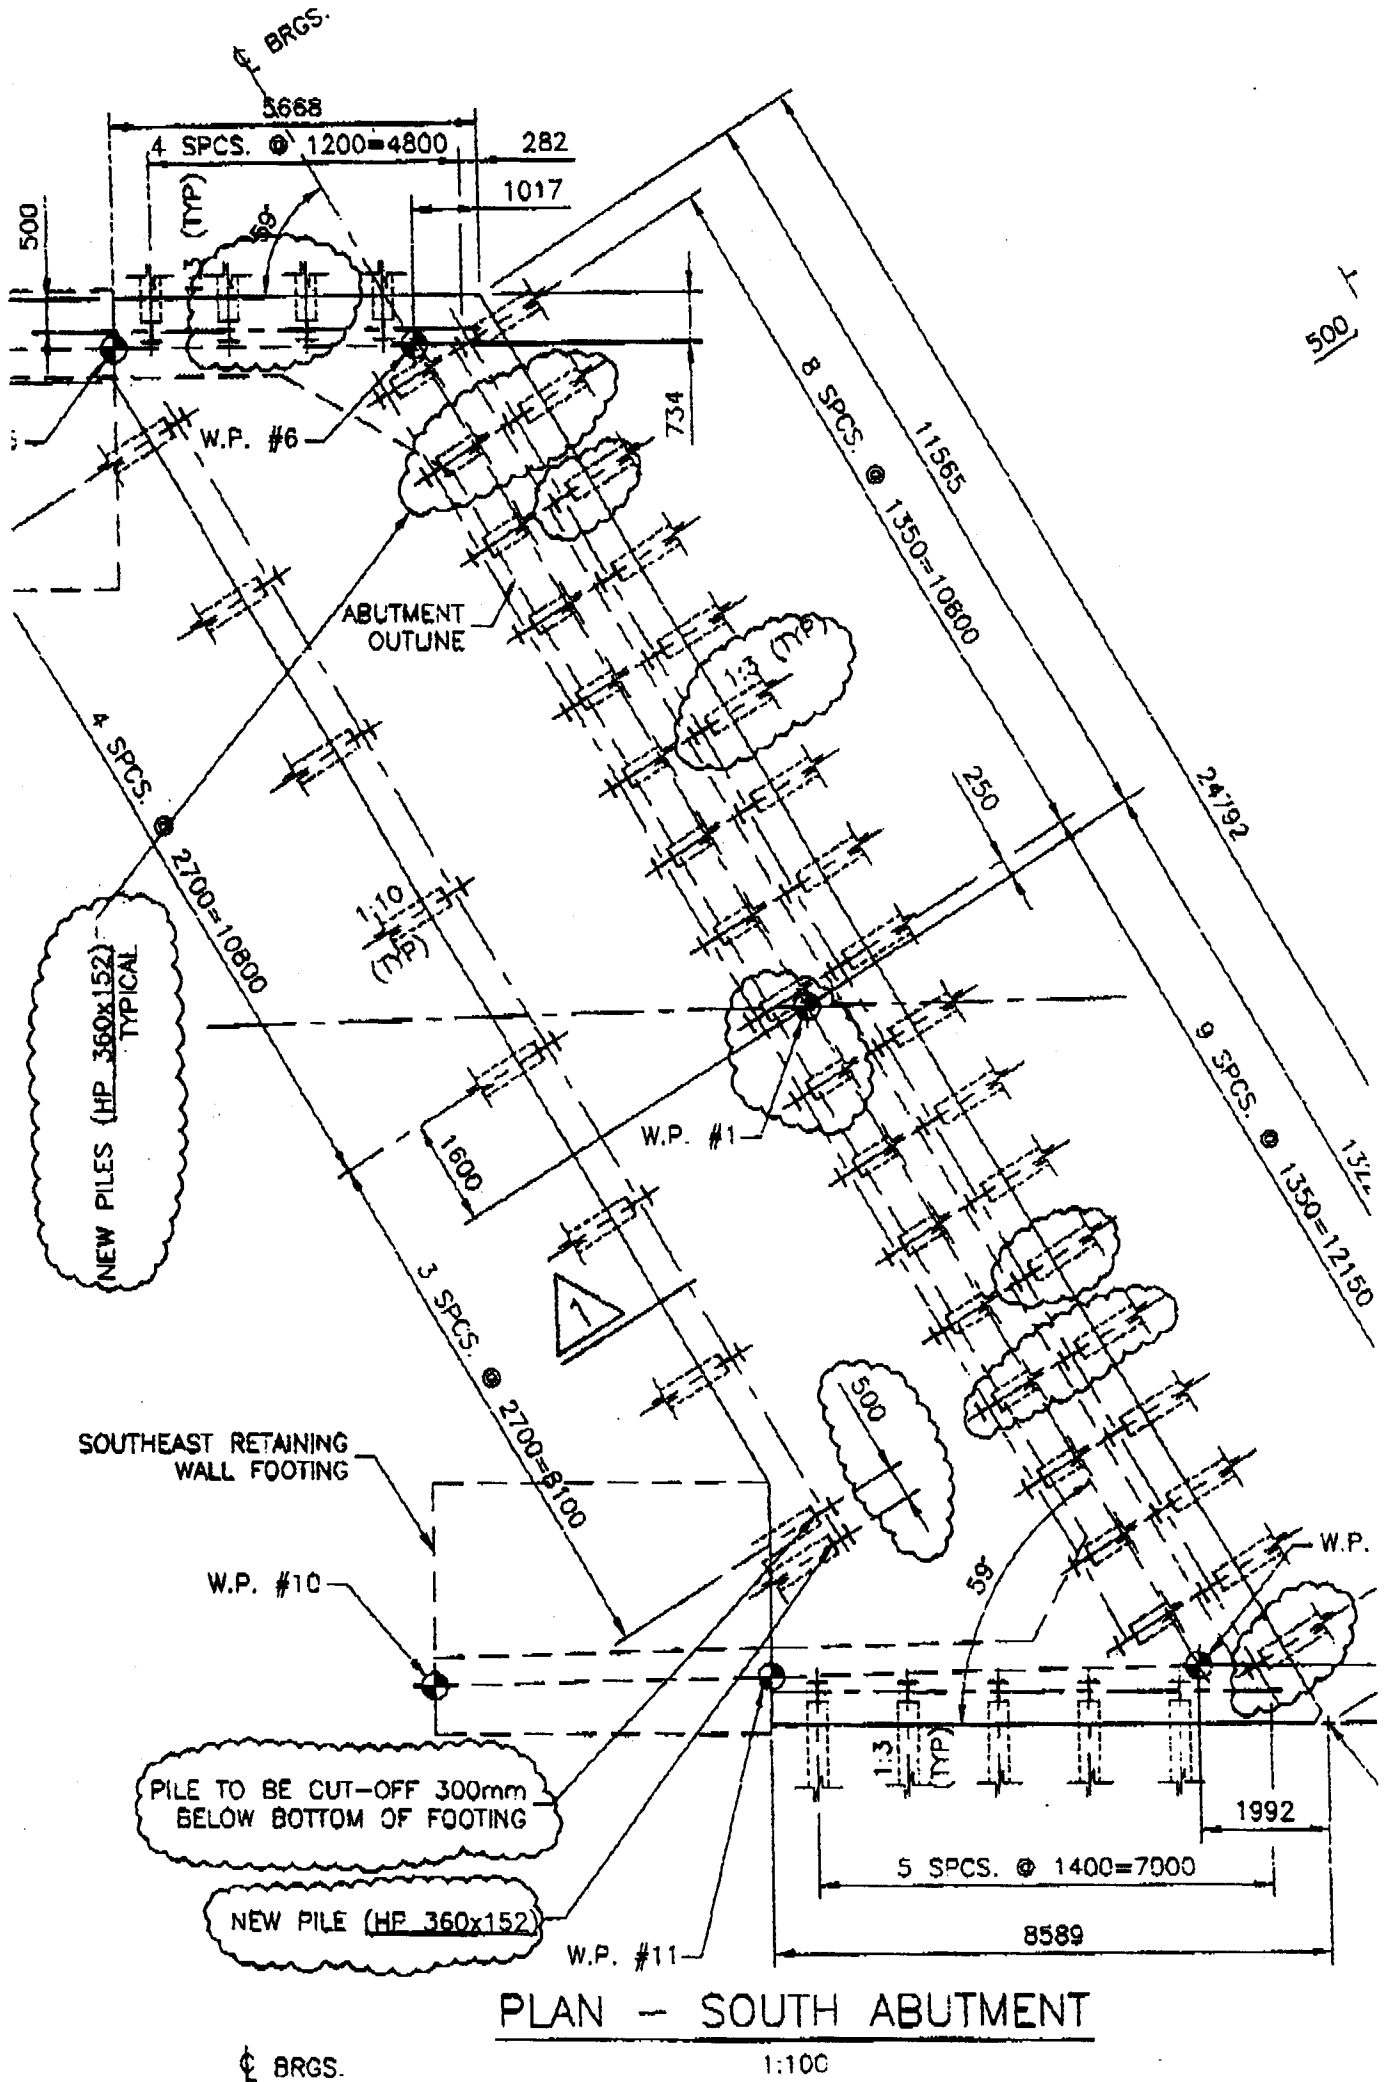
\\msd-fj\cadd\2003\01-2026\3001\3001.dwg Jun 17, 2003 2:59 PM MSD/FJH/mmh - 3001.dwg - 3001.dwg

On completing the piling work at the above site, some 13 piles at the south abutment were labelled as "non-set". Some of these piles were driven hard onto the bedrock and the movement was probably the result of some damage of the pile tip. Other piles did not meet significant resistance and it was believed that these battered piles were sliding on the bedrock. This latter group is of concern and remedial action is proposed. New piles could be driven adjacent to these piles if sufficient space is available or the piles could be extracted and new piles driven in their place. If the piles are extracted the tip should be examined to see what damage has taken place and to determine whether the pile is re-usable.

OPTION	ADVANTAGES	DISADVANTAGES
<i>Option 1</i> Extract the non-set piles and cut-off the damaged portion of the tip. Attach a rock point and redrive.	Pile spacing will be maintained as per the original structural design as per OHBDC design comments.  Rock point may prevent possible sliding along the rock surface. Extracting the pile provides an opportunity to assess the condition of the non-set pile.	Additional costs for extracting piles. Extra cost for rock points and possible supply delays. Cost of possible splicing extra pile length to be added for the damaged portion of the pile. If the pile is bent in the original driving the cut-off portion may be of significant length.
<i>Option 2</i> Extract the non-set piles and replace with a heavier section pile i.e. 360 x 152 fitted with standard driving shoes similar to the one used for 310 x 110 steel H piles.	Pile spacing will be similar to the present design satisfying the OHBDC requirements. Heavier pile section minimizes the damage to the pile tip and less chances of sliding on the level bedrock surface. Extracting the pile provides an opportunity to assess the condition of the non-set pile. No supply delays of rock points.	Cost for extracting the non-set pile. Additional cost for supply and drive heavier pile section (360 x 152) with driving shoes.

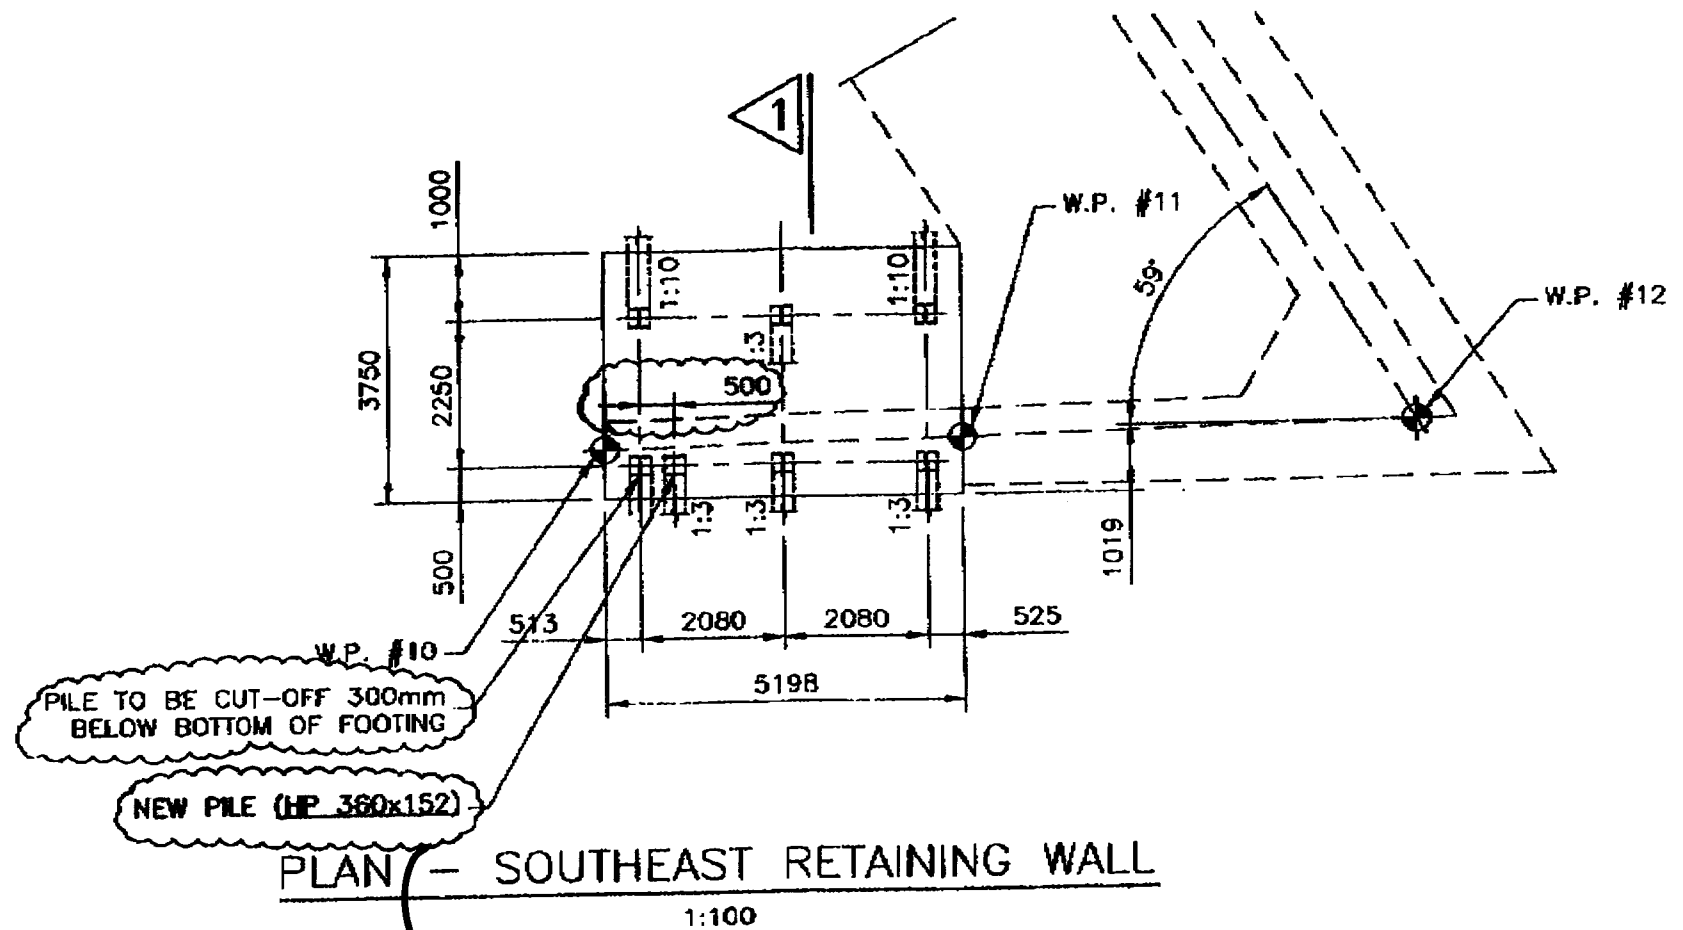
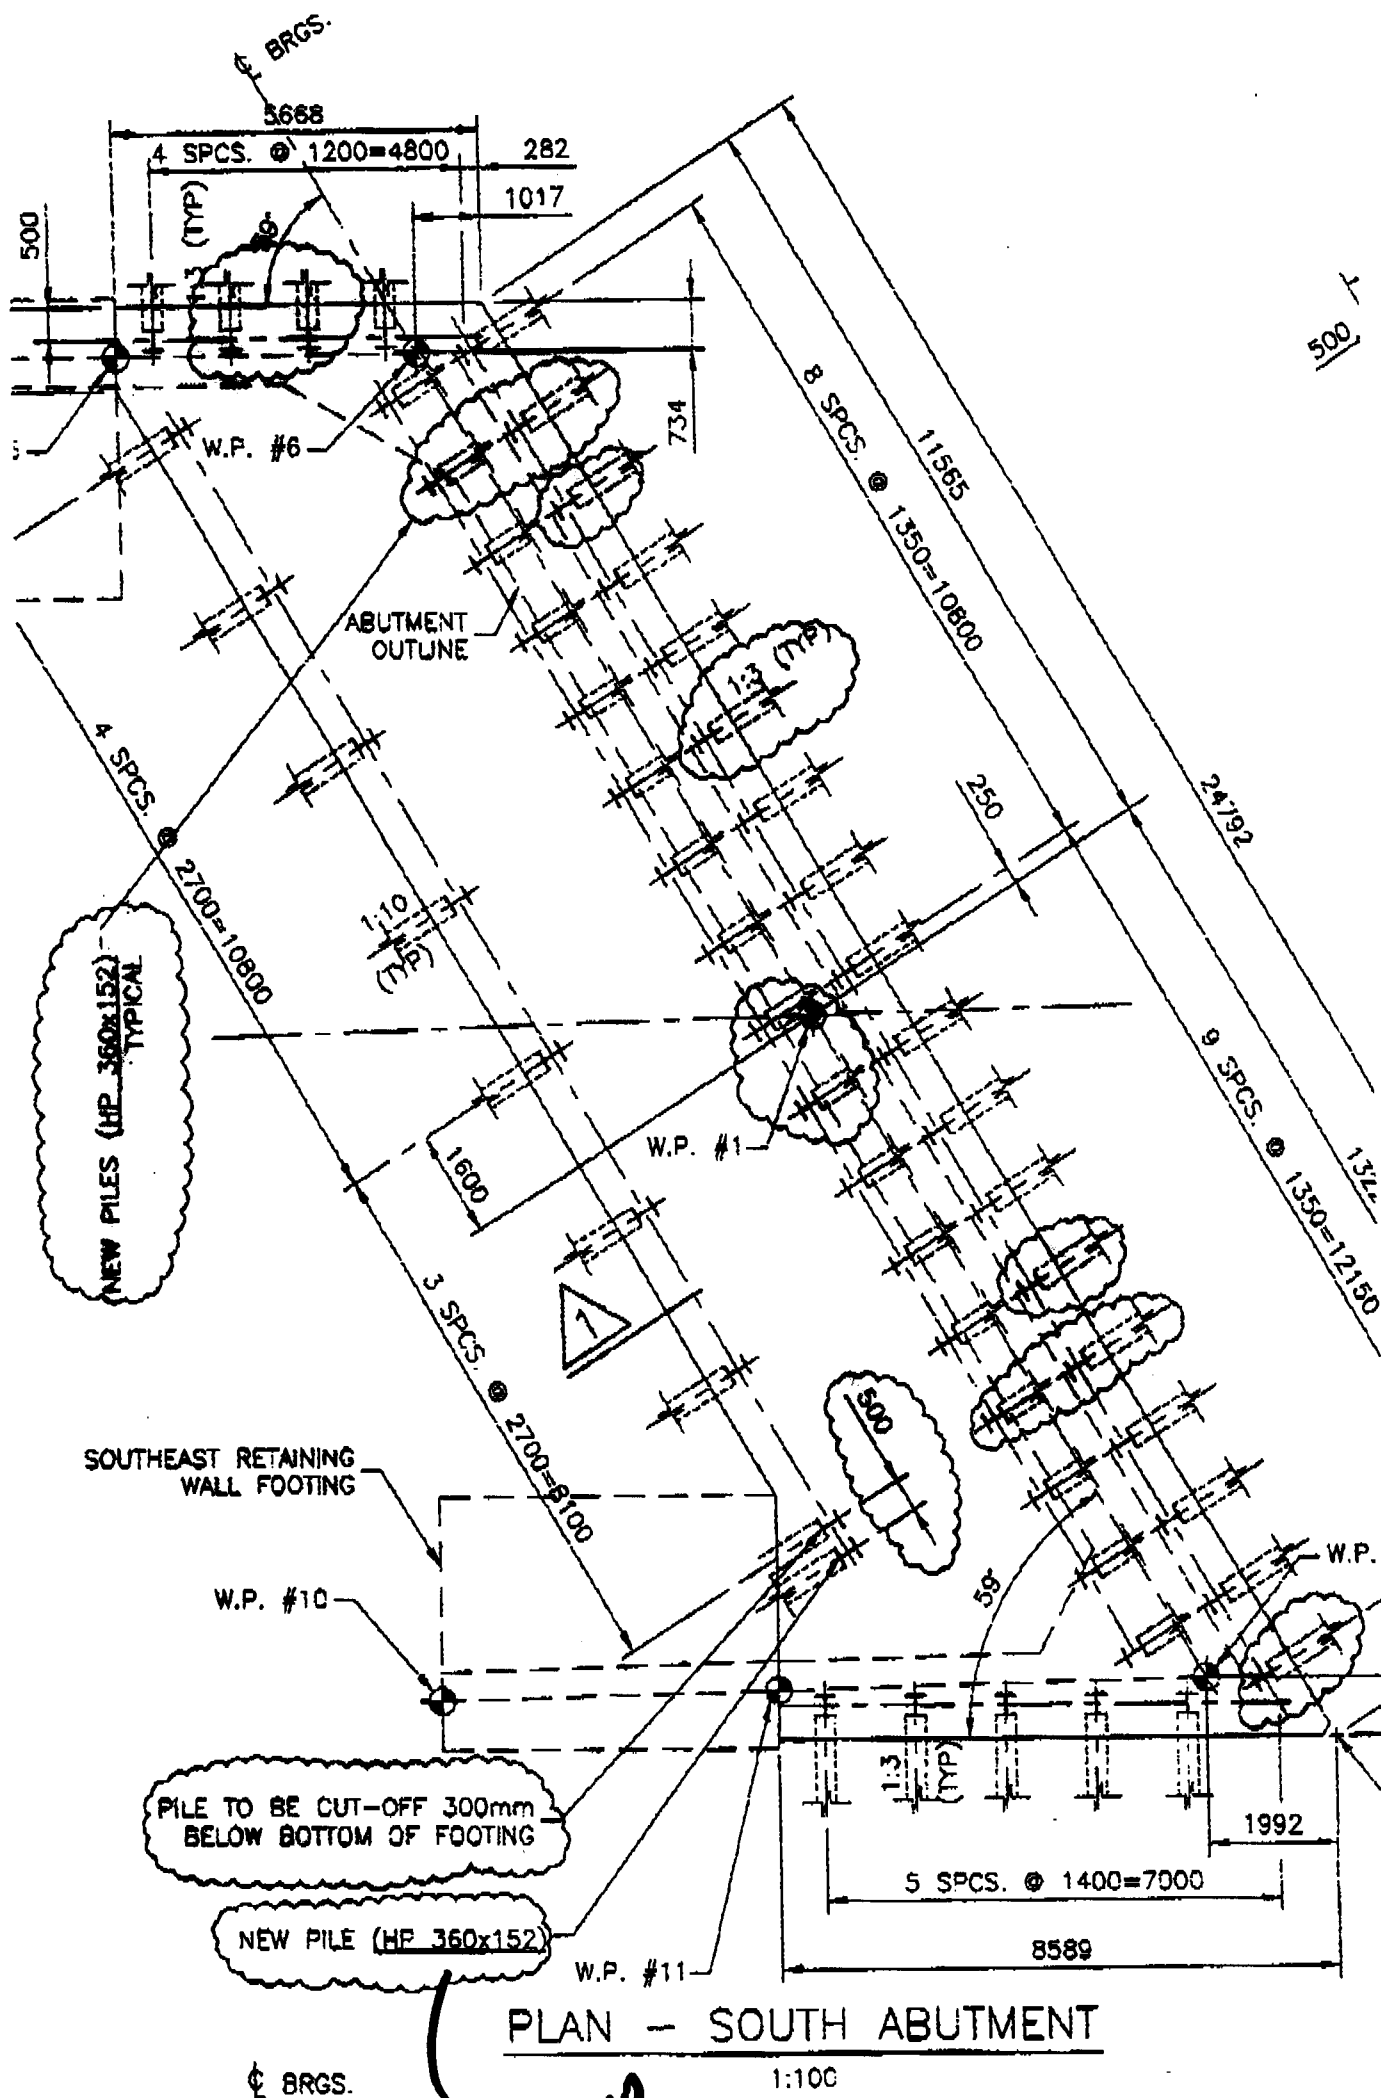
HP 310x110 with Rock Point

x - does not conform with Code  
spacing

Option 1a - Extract the non-set piles  
and replace with HP 310x110  
Fitted with rock points and redrive
