Waba Creek Bridge,
Lot 2, Con. IV/V,
Twp. of McNab, County of Renfrew.
(Bridge Office Ref. BA 1651)

REPORT OF SOIL INVESTIGATION

PROPOSED CULVERT

REPORT NO. S 311 - 63

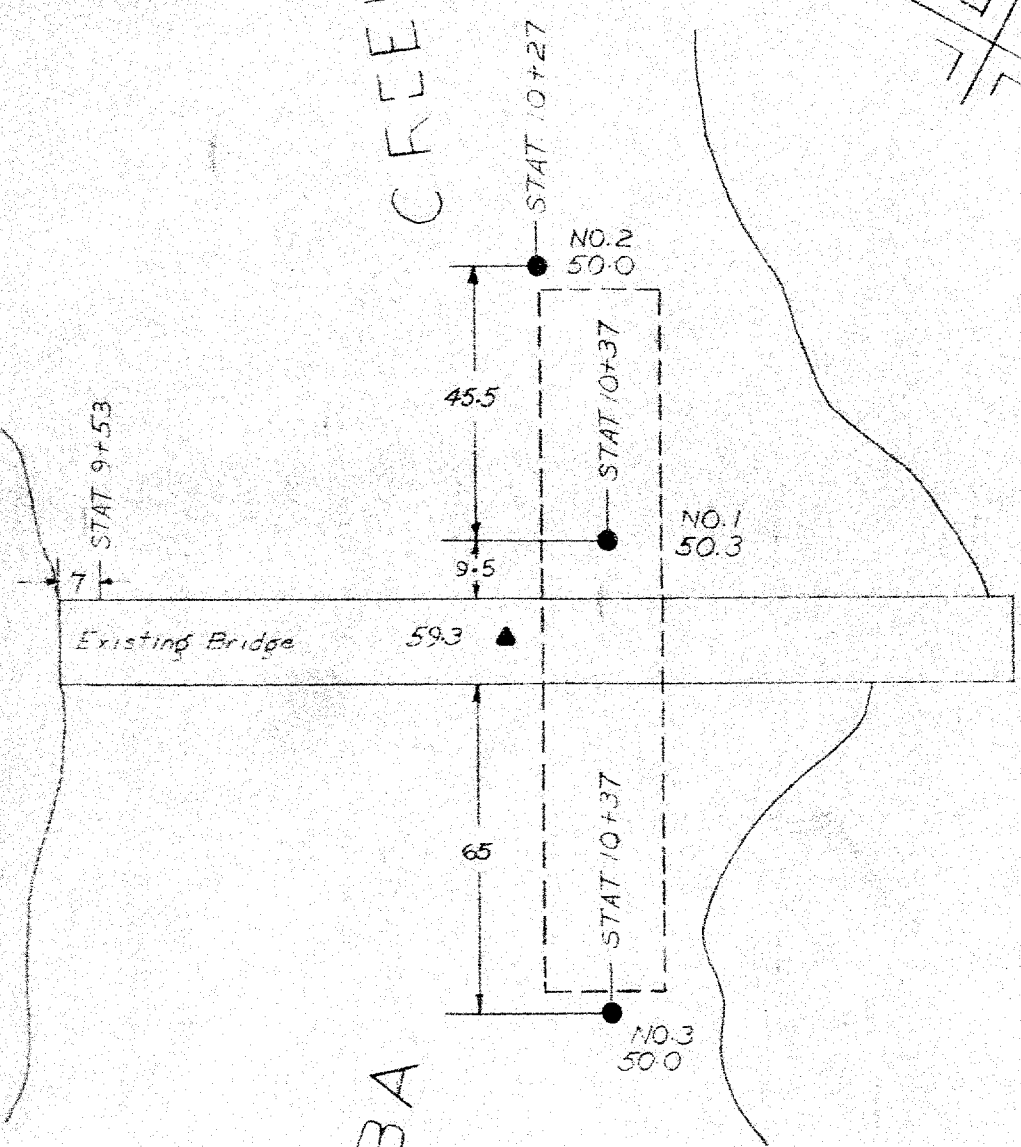
TEST BORING PLAN
PROPOSED CULVERT
LOT 2 CON 4 & 5
MCNAB TOWNSHIP

Three test holes were put down at the locations shown on the Test Boring Plan. At Holes 1 and 2 cone probes were driven to 23 and 24 feet, respectively, and at Hole 1 the soils were sampled to 24 feet. At Hole 3 a cone probe was driven by hand to refusal.
