W.P. # 103-59

BRIDGE NO. <sup>#</sup>10

Re: Intersection of Hwy. No. 401 and  
Brookdale Ave., Cornwall, Ontario.  
W.P. 103-59 -- District 9.

RE: SOIL INVESTIGATION AT INTERSECTION  
OF HWY # 401 AND BROOKDALE AVENUE,  
CORNWALL, ONTARIO.

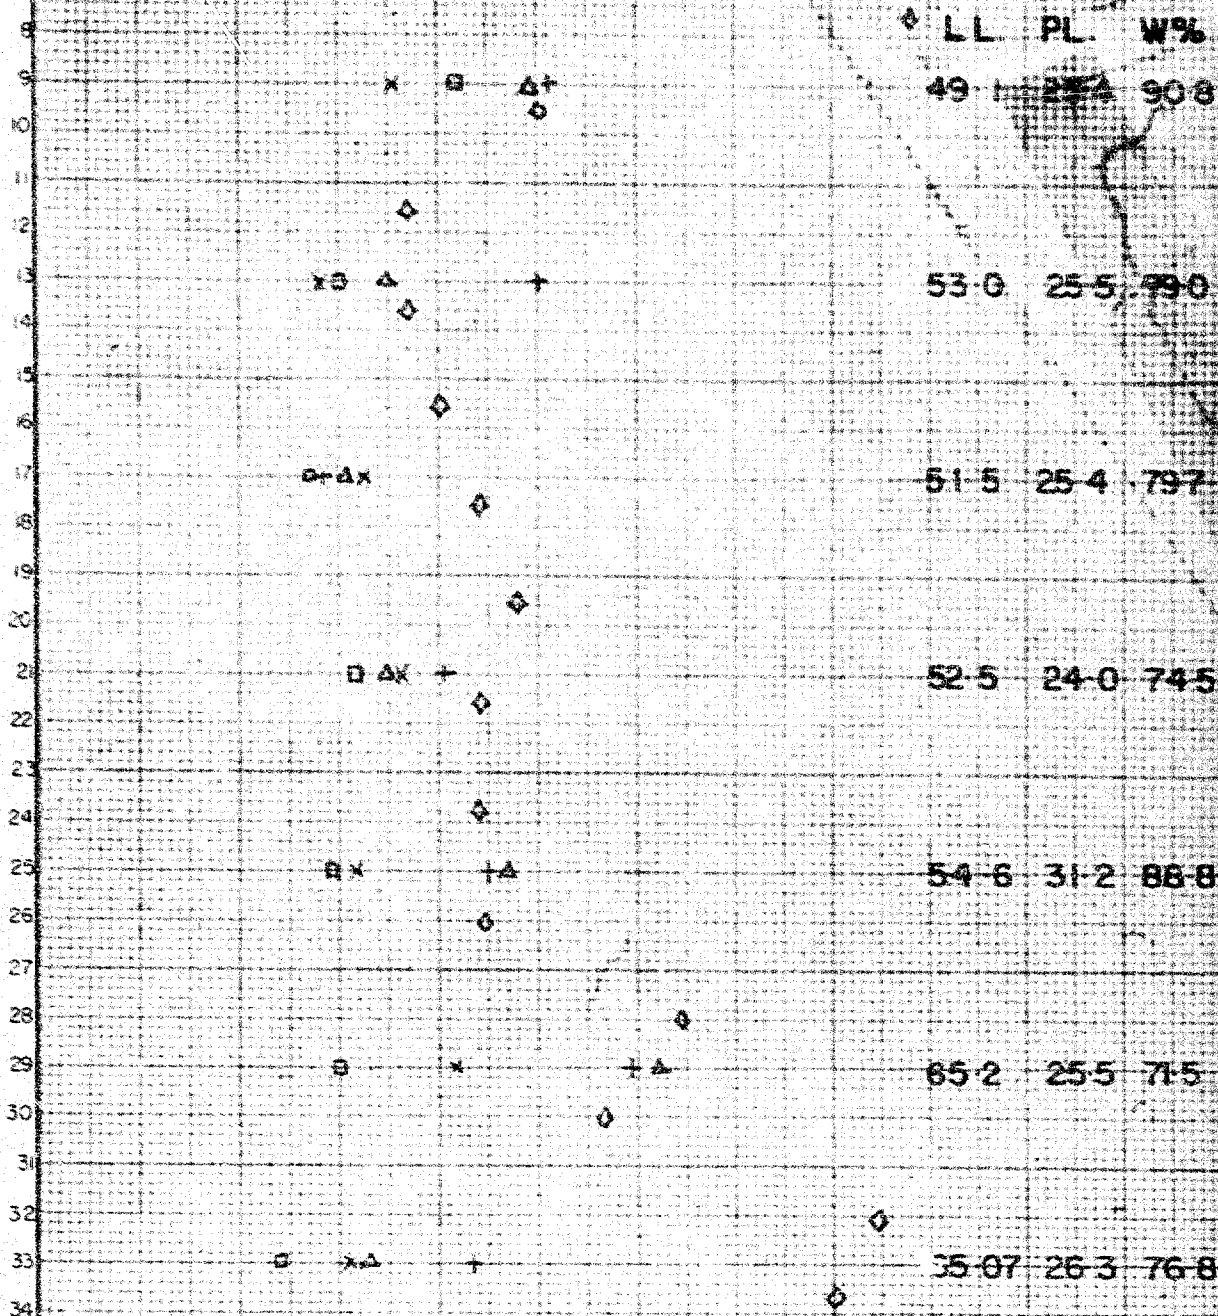
## SHEAR STRENGTH p.s.f.

Height of fill equals 22 ft.; shear strength of the clay subsoil  $c = 350$  p.s.f. Because of the very limited depth of the upper stiff layer (approx. 7 ft.) the increase of shear strength has been neglected. The embankment slope was taken as 2:1.

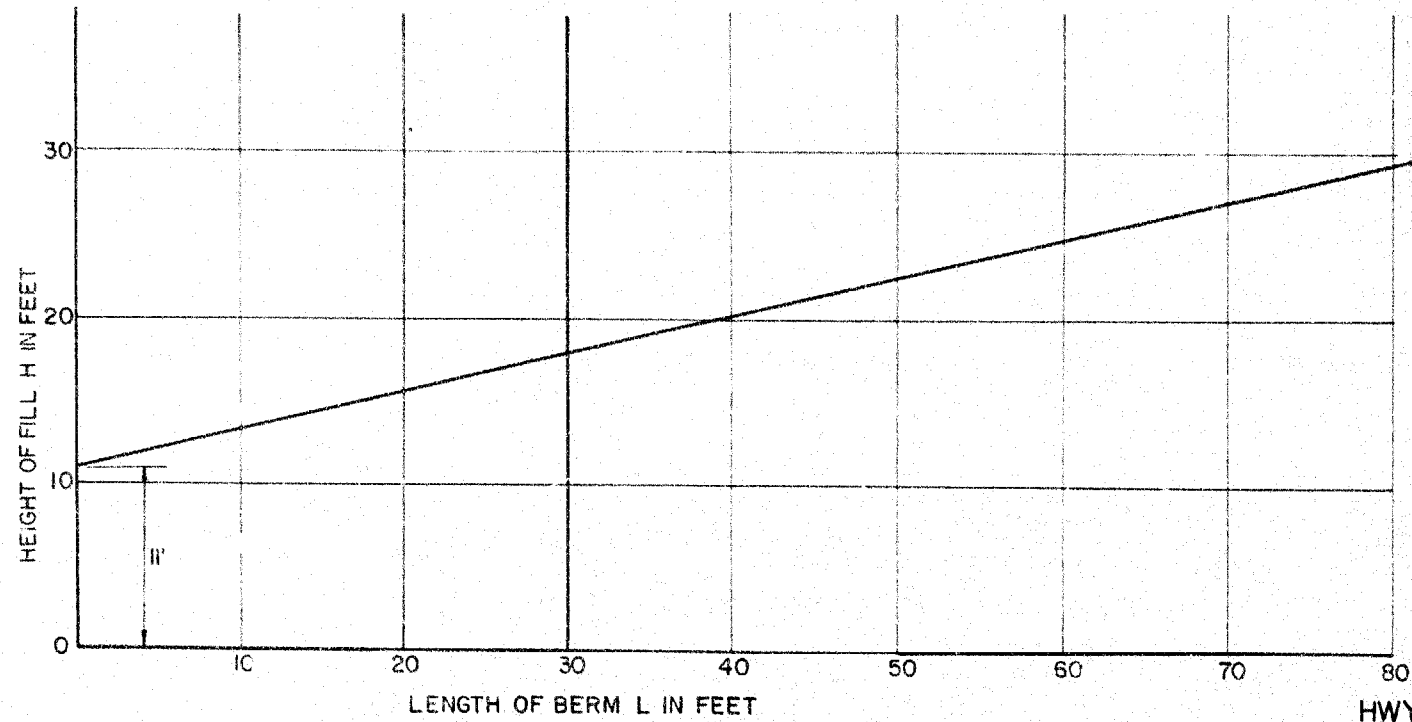
RECOMMENDED BERM SECTION

Stability calculations have shown that counterbalancing berms are required for the fill height of 22 ft., proposed. The maximum safe height of the fill that can be built without a berm, is 11 ft. The required length of berm is given on the attached graph giving the relationship between the height of fill to the length of berm. The berm slope is also 2:1. The berm will have to be built in a direction parallel to road centre line, as well as at rightangle to centre line. The structure will have to be founded on end-bearing, small displacement type piles, driven to the contact of the limestone bedrock formation.

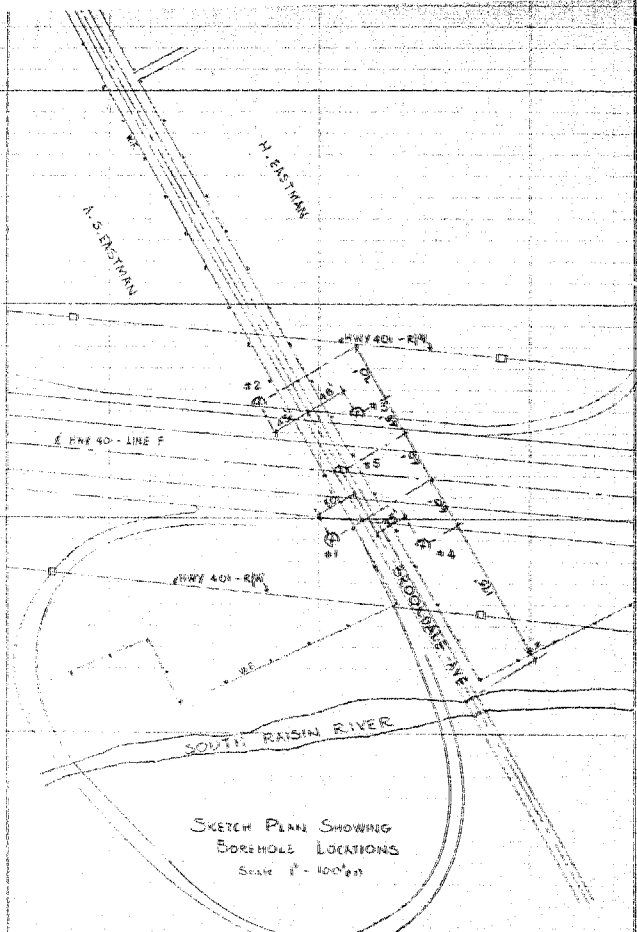
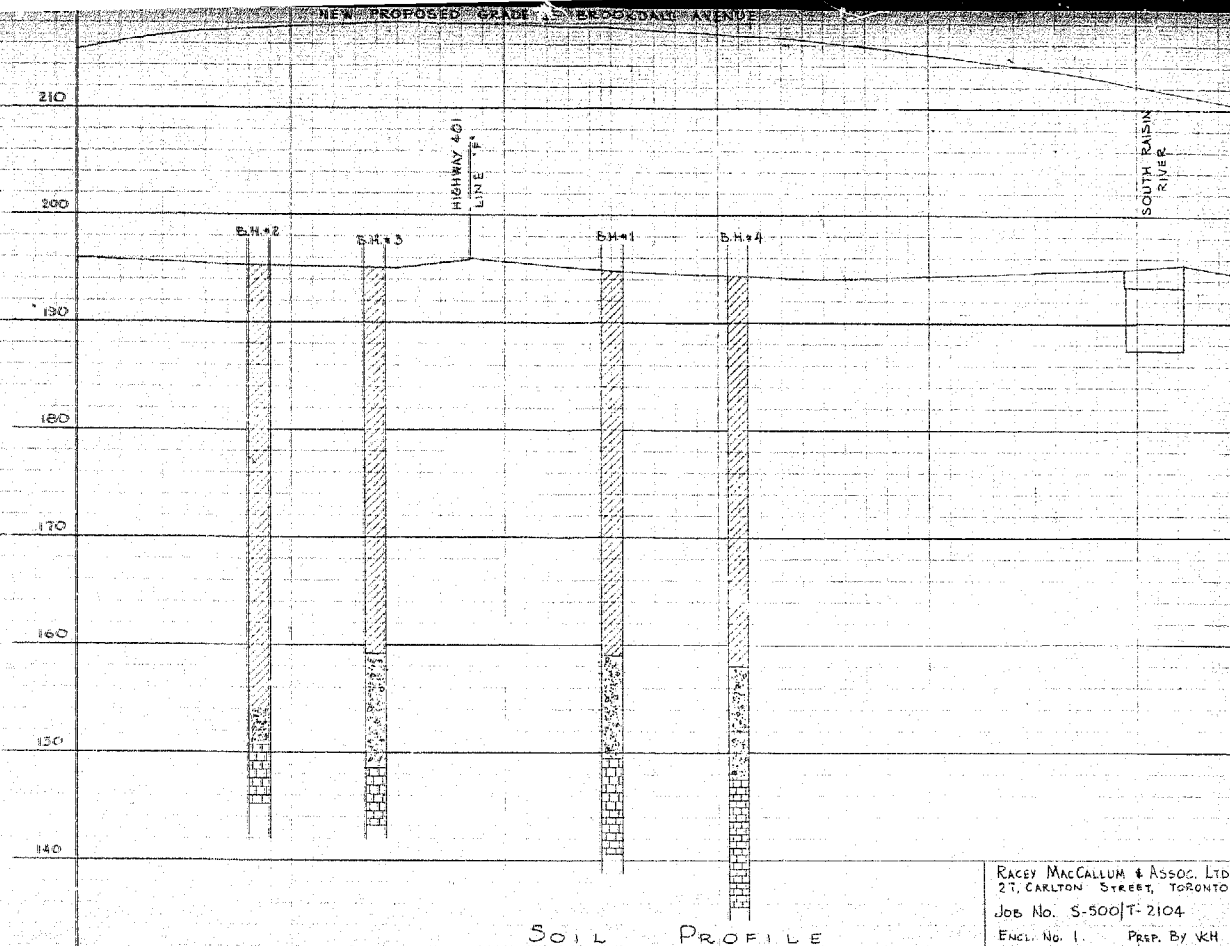
RACEY MACCALLUM & ASSOC. LTD.  
27, CARLTON STREET, TORONTO  
JOB No. S-500/T-2104  
ENCL. No. 1 PREP. BY K.H.

The soil profile along the proposed centre-line of the overpass - shown on Enclosure No 1 - indicates generally uniform sub-soil conditions over the site. It consists of approximately 36 to 40 feet of soft to very soft, silty clay (for grain size analysis see Enclosure No 11), overlying approximately 10 feet of dense to very dense clayey sandy till interspersed with gravel and some boulders. Limestone bedrock underlies all this.

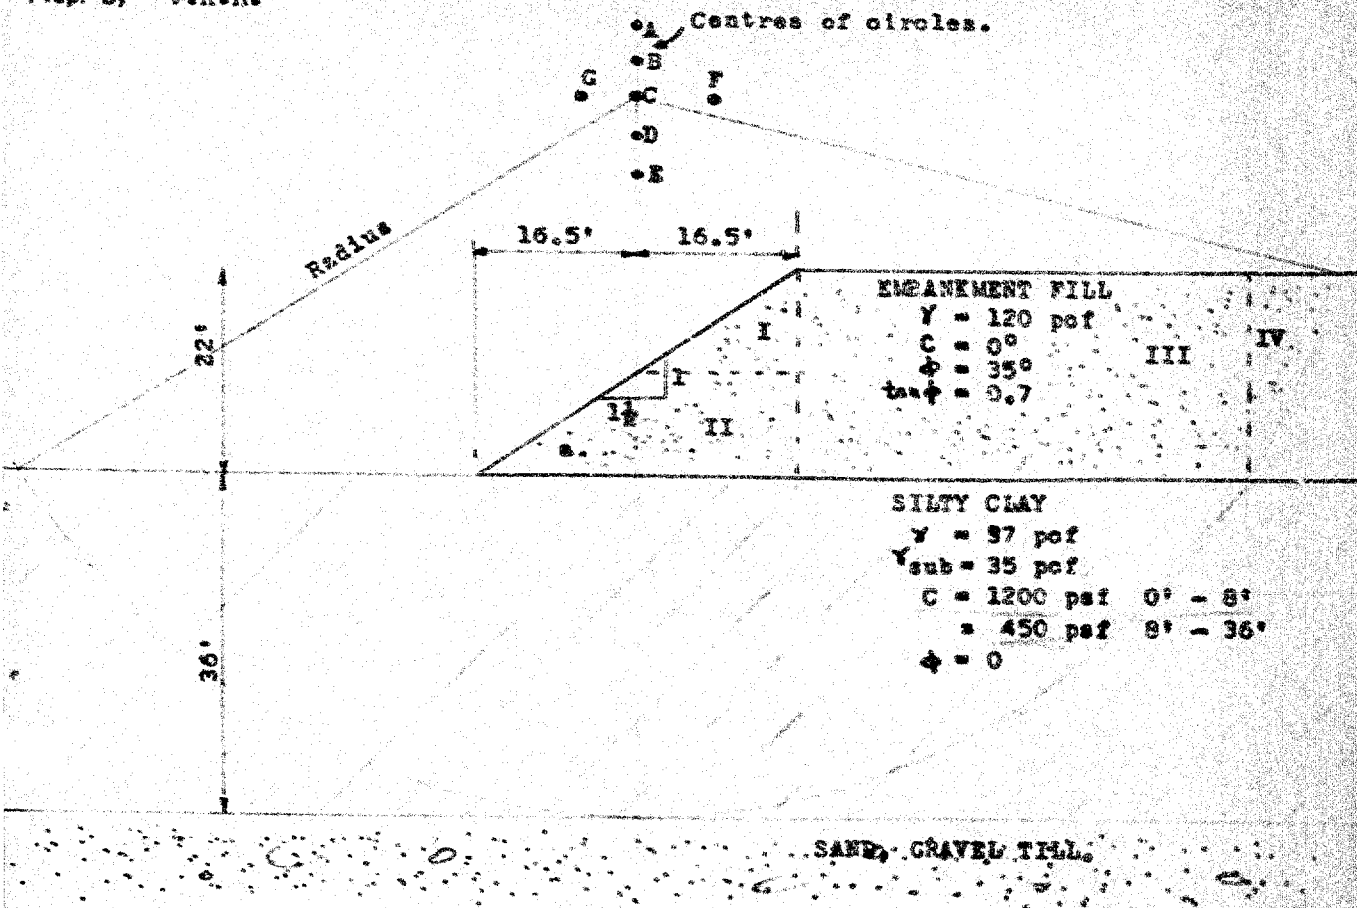
The results of the analyses are shown on Enclosure No 13 and No 14. The factor of safety for the embankment fill was found to be 1.06, and for the abutment fill to be 1.02. Greater stability could be obtained by increasing the side slopes from 1 to  $1\frac{1}{2}$  to 1 to 2 or better.

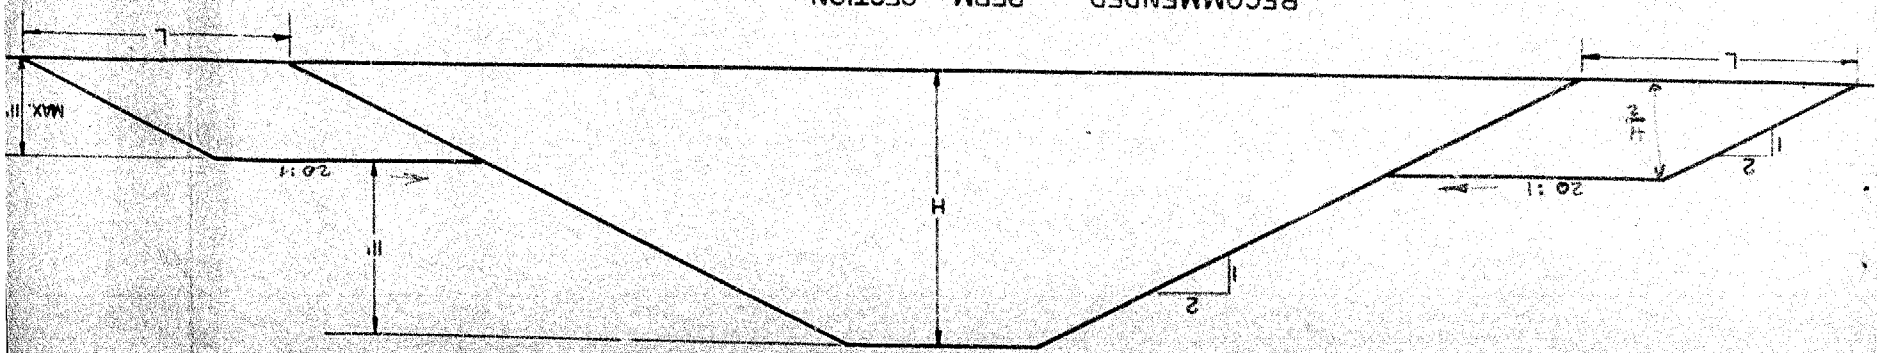
RECOMMENDED BERM SECTION

Stability calculations have shown that counterbalancing berms are required for the fill height of 22 ft., proposed. The maximum safe height of the fill that can be built without a berm, is 11 ft. The required length of berm is given on the attached graph giving the relationship between the height of fill to the length of berm. The berm slope is also 2:1. The berm will have to be built in a direction parallel to road centre line, as well as at rightangle to centre line. The structure will have to be founded on end-bearing, small displacement type piles, driven to the contact of the limestone bedrock formation.
