#61-F-13
W.P. #924-61
Hwy. #17
CROSSING
PANCAKE RIVER
56 MILES N.W. OF
SAULT STE.
MARIE

DEPARTMENT OF HIGHWAYS - ONTARIO		
MATERIALS & RESEARCH SECTION		
PANCAKE RIVER AND HIGHWAY NO. 17		
ORIGINATED BY KULMATICAS	DISTRICT NO. 18	DATE 10 APR 1961
DRAWN BY [Signature]	W.P. NO. 924-61	JOB NO. 61-F-13
CHECKED BY [Signature]	SCALE 1 in. = 20 feet	DRAWING NO.
APPROVED BY [Signature]		61-F-13A

D.H.O. FOUNDATION INVESTIGATION
REPORT -
W.J. 61-F-13 --(W.F. 924-61.)

For: Panceake River and the King's Hwy. No. 17 Crossing
(Approx. 56 miles North-West of Sault Ste. Marie)
Twp. of Herrick and Ryan, District of Algoma.
District No. 18.

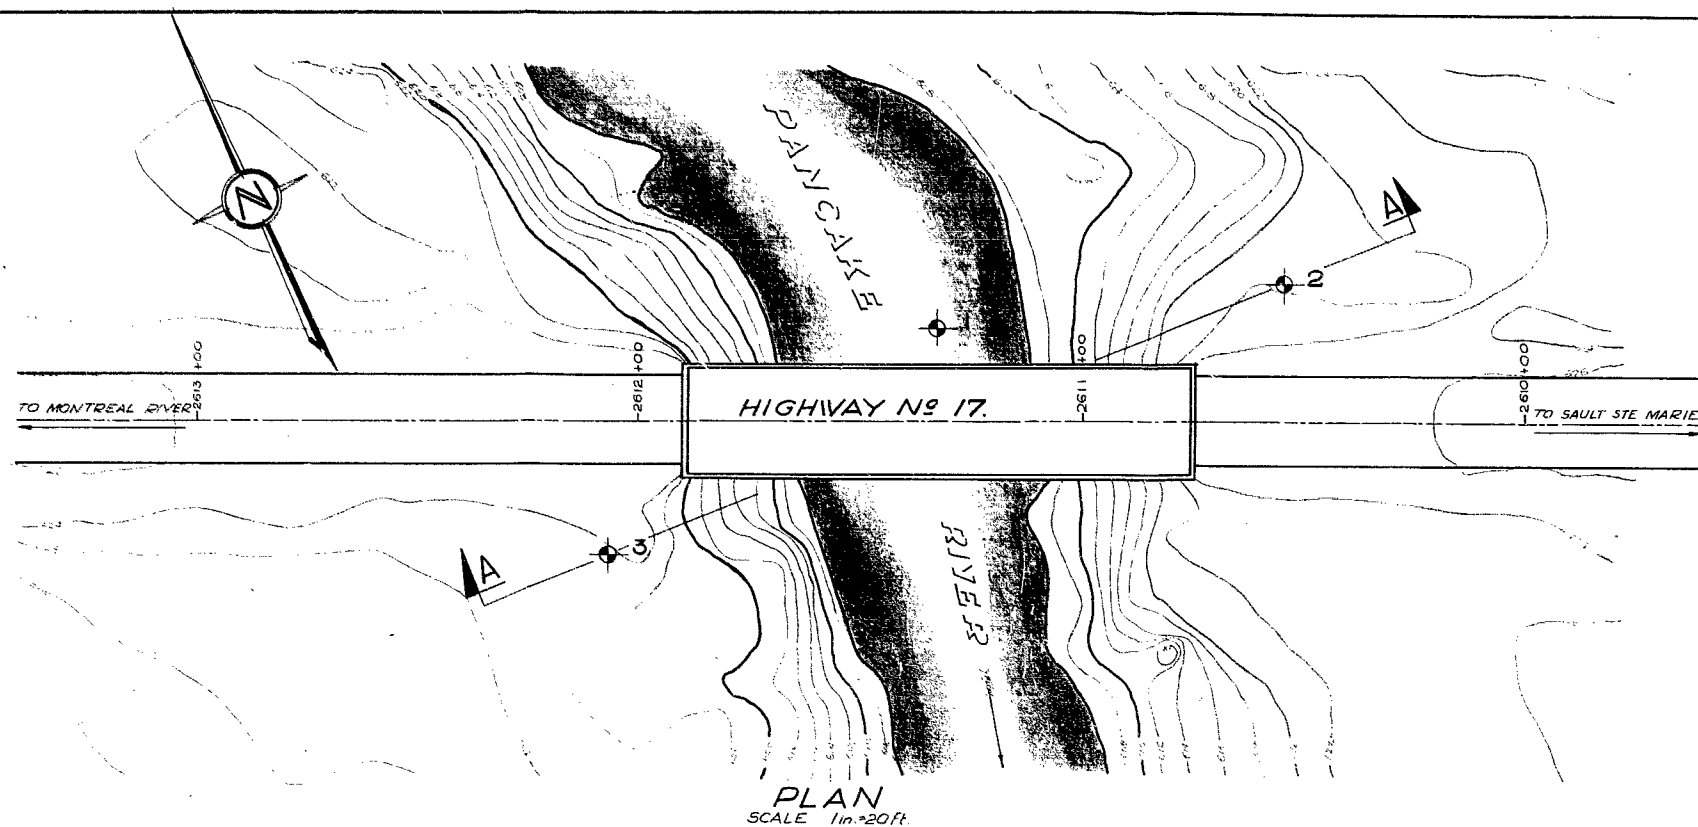
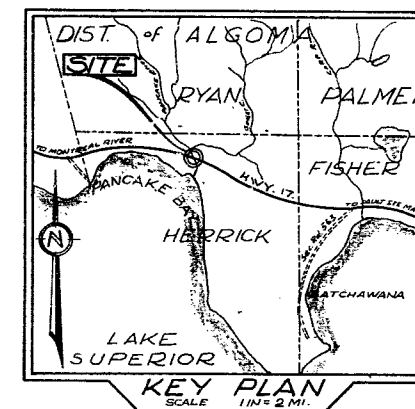
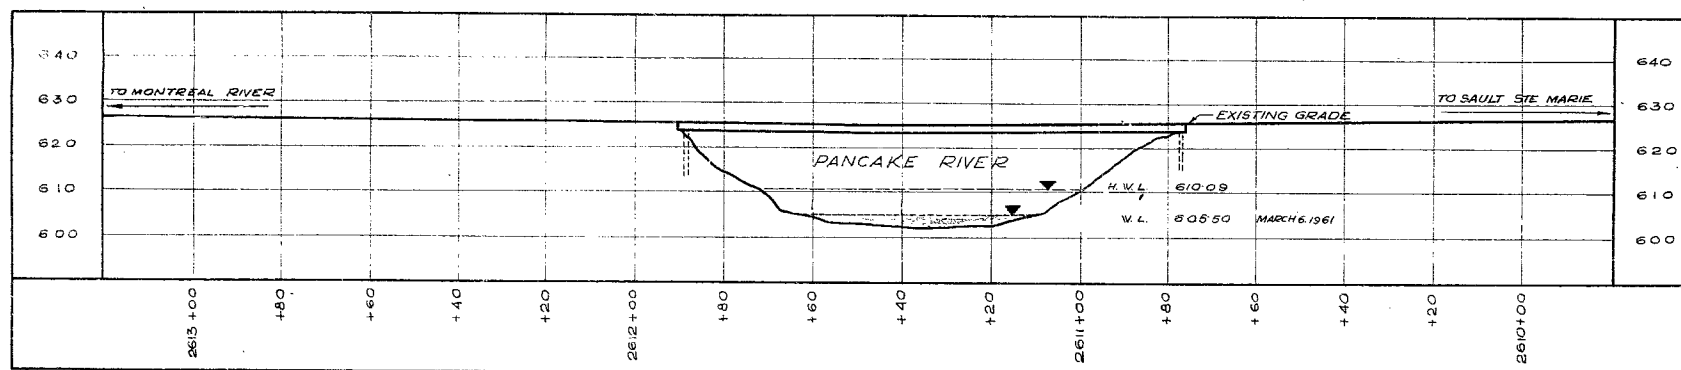
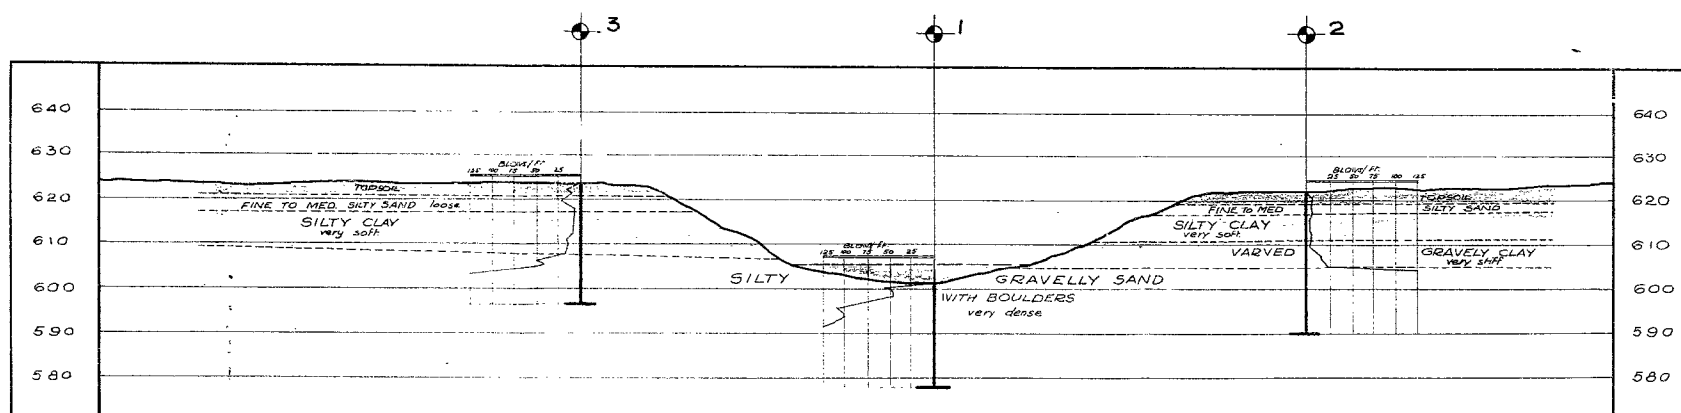
Boreholes No. 1, 2 & 3 were terminated in the underlying very dense, gravelly, silty sand with boulders stratum at a depth of 22.5 ft., 31.5 ft., and 26.5 ft., respectively, below the existing ground level.

The elevations as well as the locations (chainages) of the boreholes, are given on Drawing No. 61-F-13A, attached to this report (Appendix I).

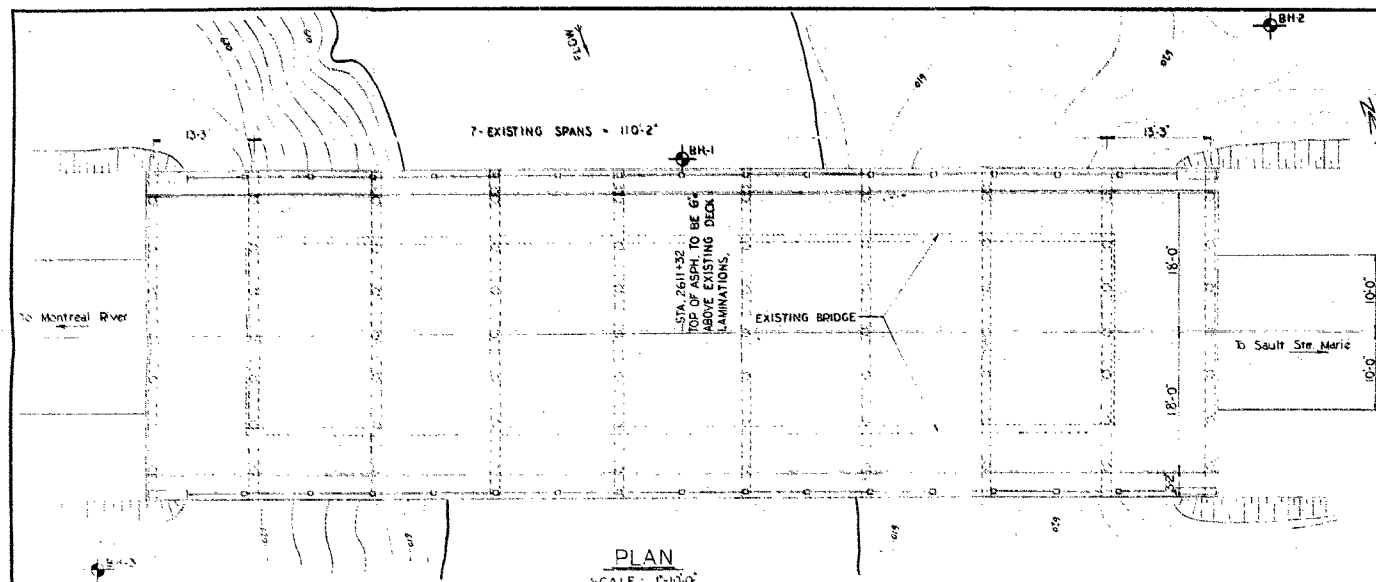
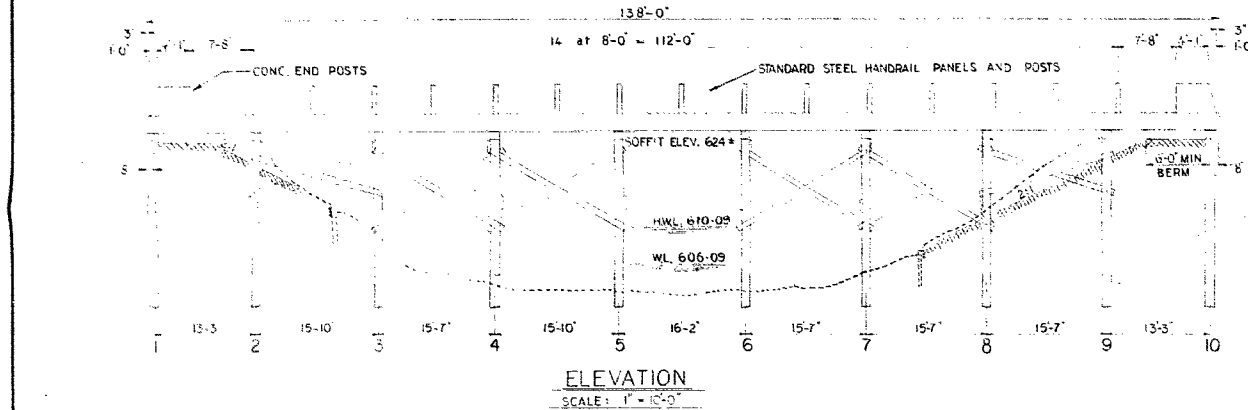
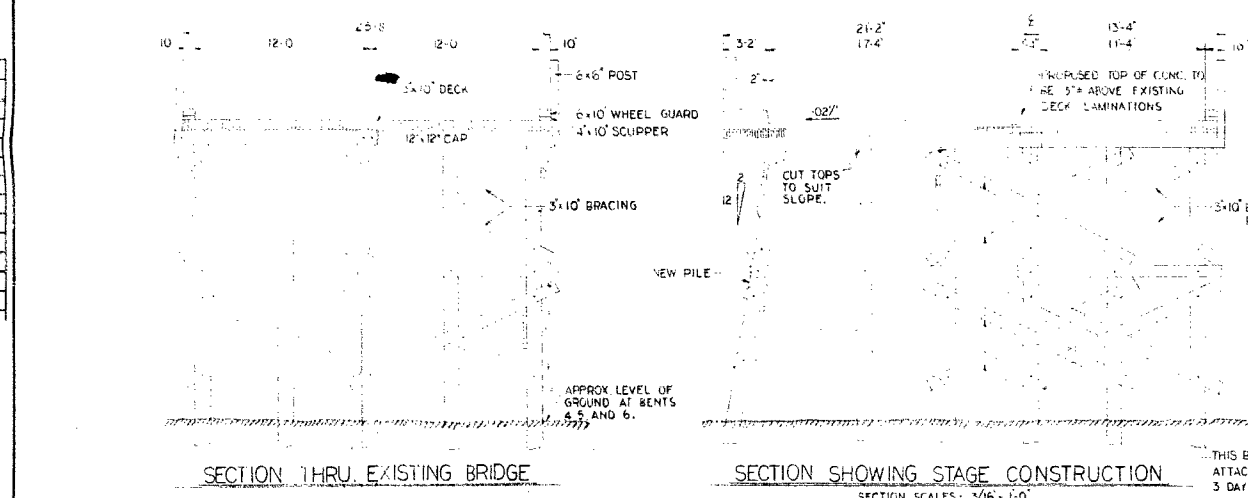
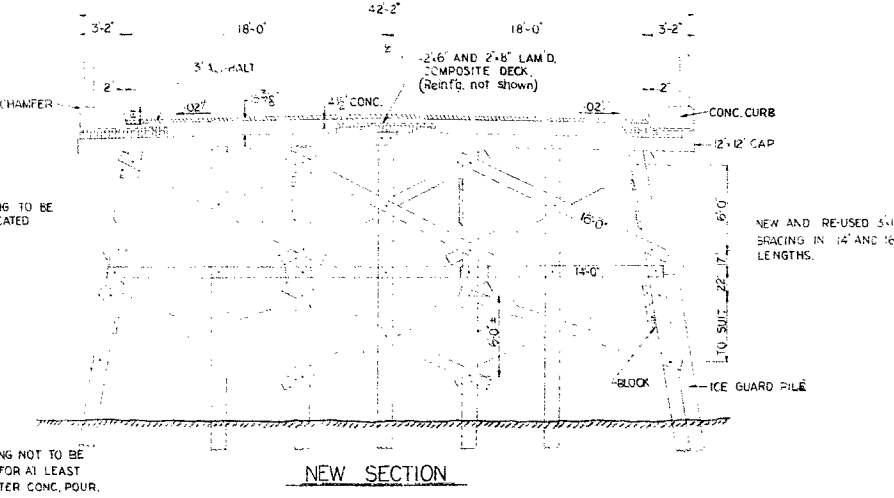
It is the opinion of the Bridge Office that
the existing structure is in good condition and it has been
decided to widen and lengthen the structure as shown.

1. DRIVE NEW OUTSIDE PILES - BENTS 2 TO 9.
2. DRIVE NEW ABUTMENT PILES - DOWNSTREAM SIDE ONLY.
3. REMOVE DOWNSTREAM HALF OF EXISTING SUPERSTRUCTURE, INCLUDING PILE CAP, AND PROVIDE TEMP'Y BARRIERS.
4. CONSTRUCT DOWNSTREAM HALF OF NEW SUPERSTRUCTURE, PLACE NEW BRACING, POUR CONC. DECK AND CURB.
NOTE: AT THIS STAGE, TRAVELLED PART OF STRUCTURE IS NOT TO BE CONNECTED BY BRACING TO NEW PORTION FOR AT LEAST 3 DAYS AFTER DECK CONC. HAS BEEN POURED.
5. DRIVE REMAINDER OF ABUTMENT PILES.
6. REMOVE UPSTREAM HALF OF EXISTING SUPERSTRUCTURE.
7. COMPLETE NEW BRACING.
8. CONSTRUCT UPSTREAM HALF OF NEW SUPERSTRUCTURE.

In case that only the existing bridge will be repaired and enlarged, it is recommended that the additional piles be driven into the underlying dense gravelly sand stratum as recommended for the new structure, and that additional bracing be provided to stiffen the whole structure.

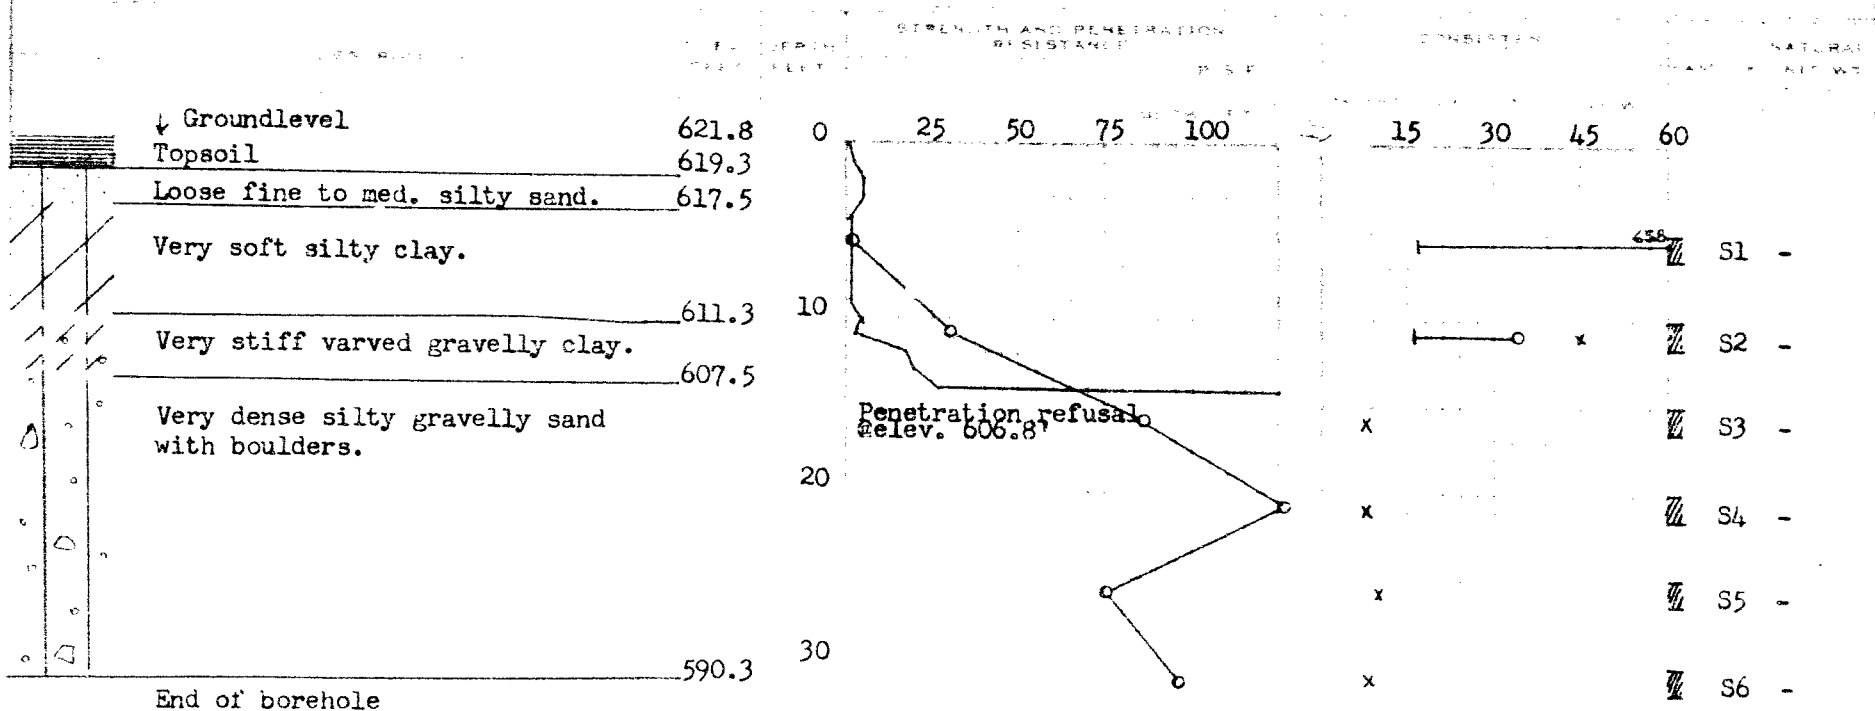
BORE HOLE NO. 2

Penetration resistance profile shown; obtained by driving a 2" dia. cone from groundlevel to depth noted with an energy of 350 ft. lb. per blow.

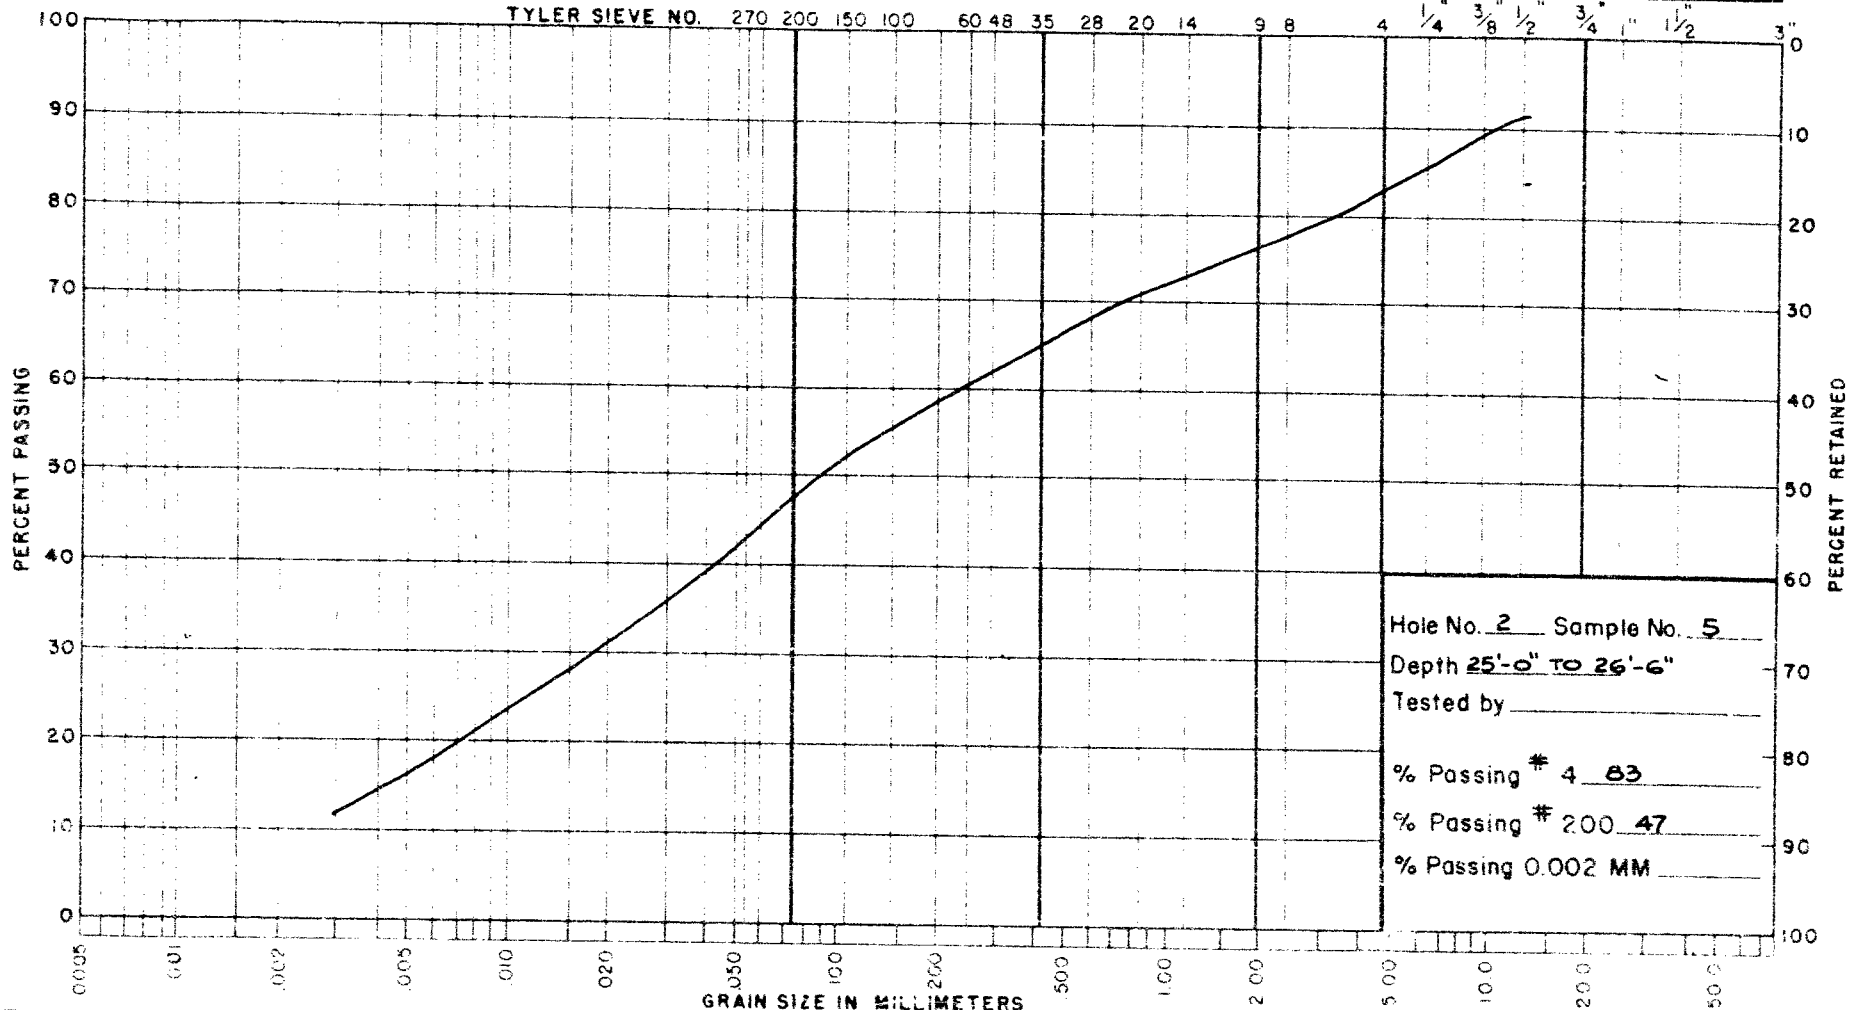
Hole No. 2 Sample No. 5

% Passing # 4 83

% Passing # 200 47

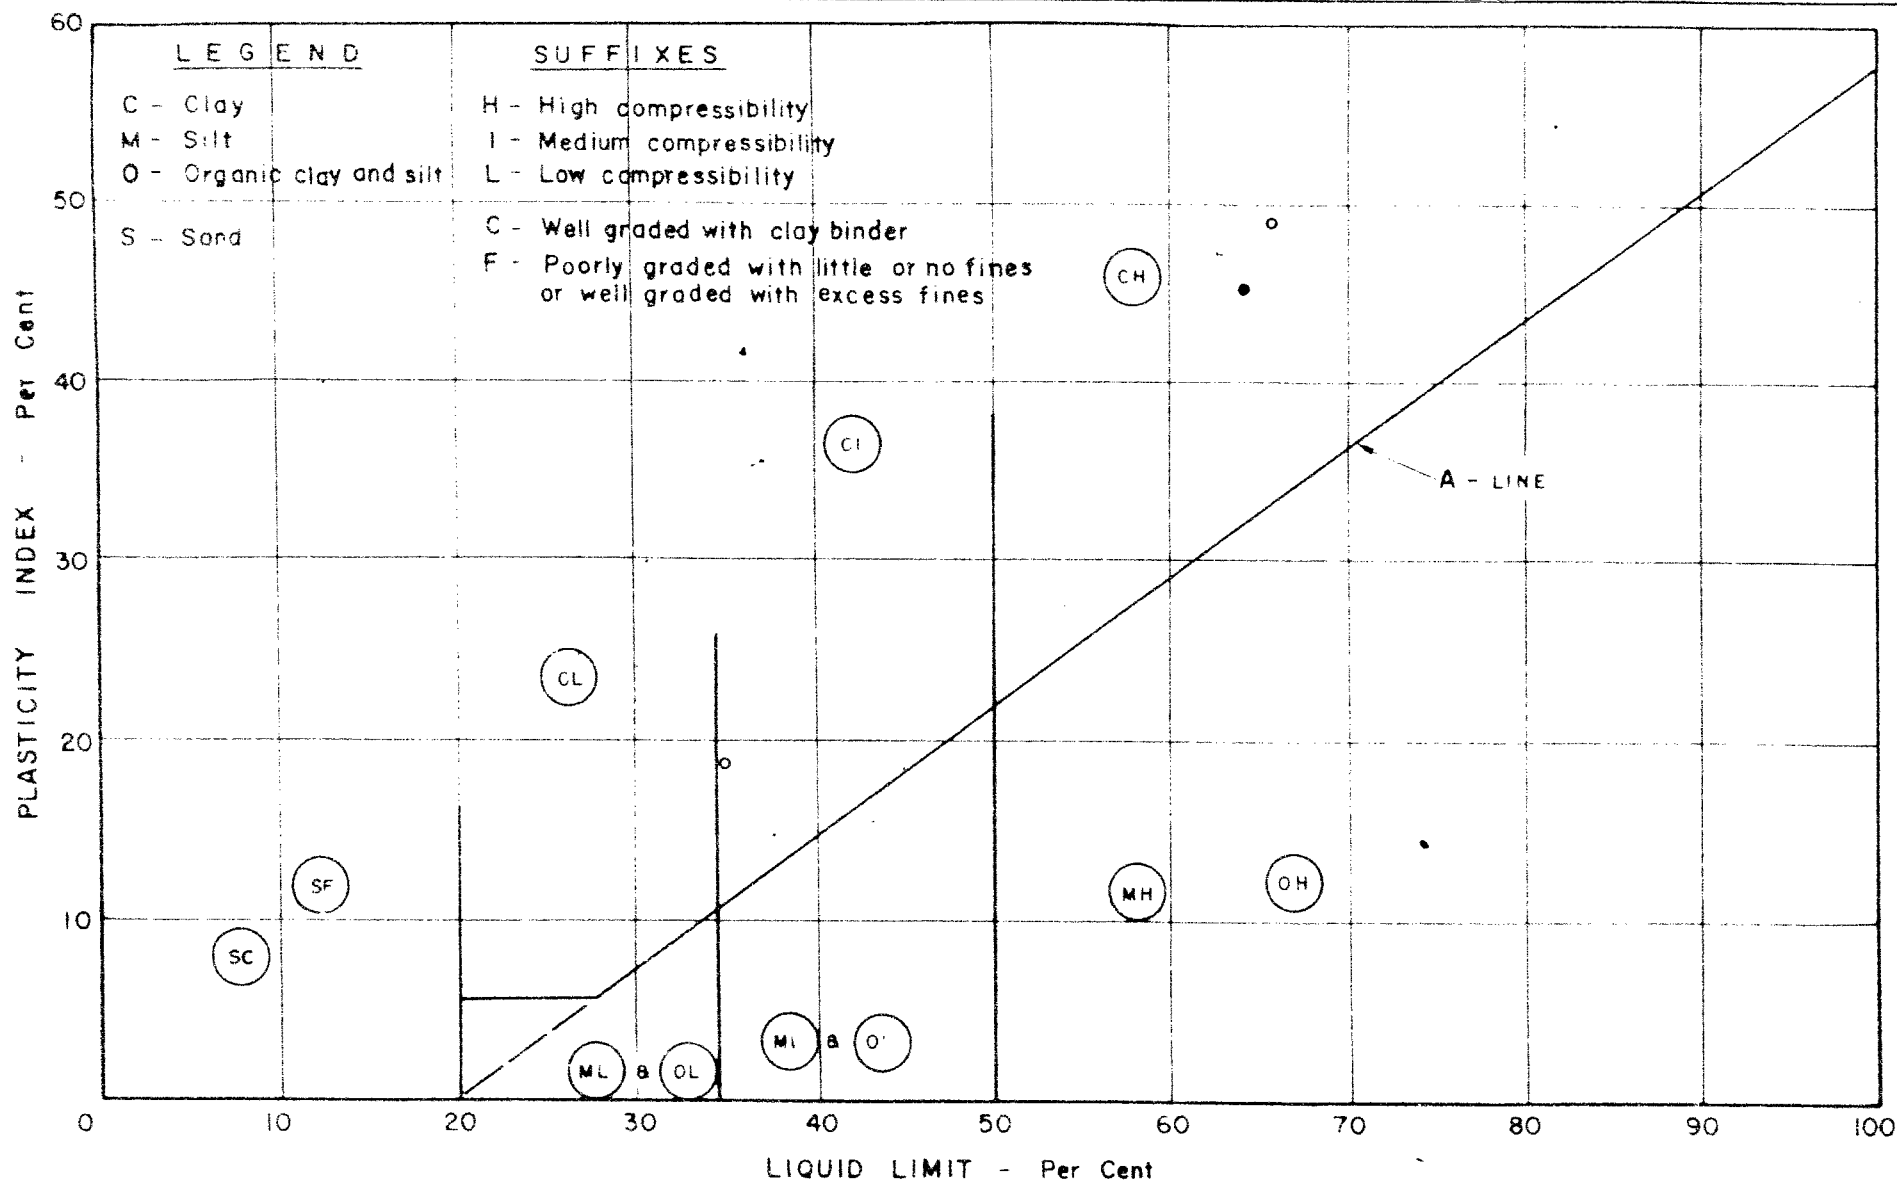
DEPARTMENT OF HIGHWAYS - ONTARIO
MATERIALS & RESEARCH SECTION
PLASTICITY CHART

- - BOREHOLE #2
- - BOREHOLE #3
