FOUNDATION INVESTIGATION AND DESIGN REPORT

Trenchless Installation of Three Pipe Culverts, Highway 11

New Liskeard Area, Ontario

September 17, 2018

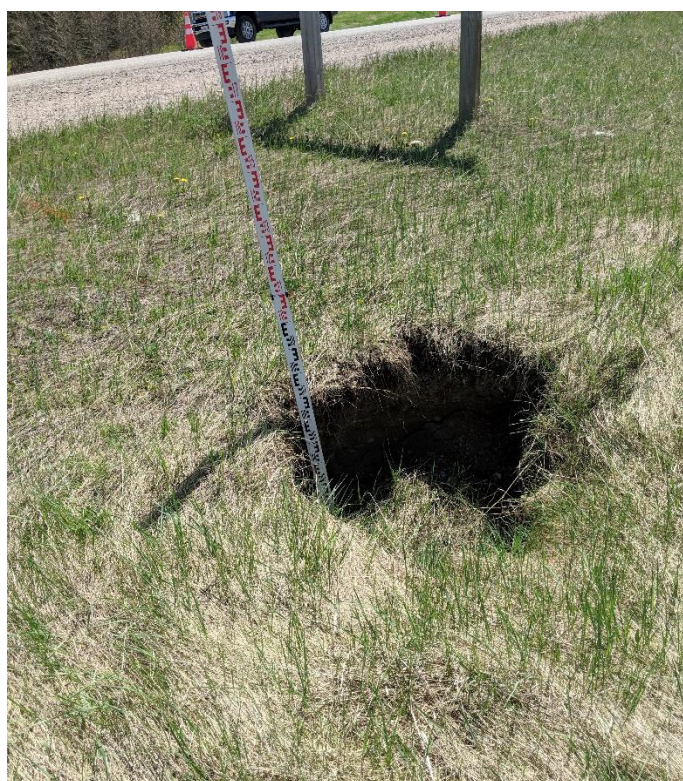
The creek flows from the west to east direction at this culvert location. During the site visit, a sink hole of approximately 1.2 m diameter and 0.7 m deep was observed on the west side slope at the existing culvert location (see Photo 4 in Appendix A).

Photo 4. Sinkhole on west side slope at Culvert #1

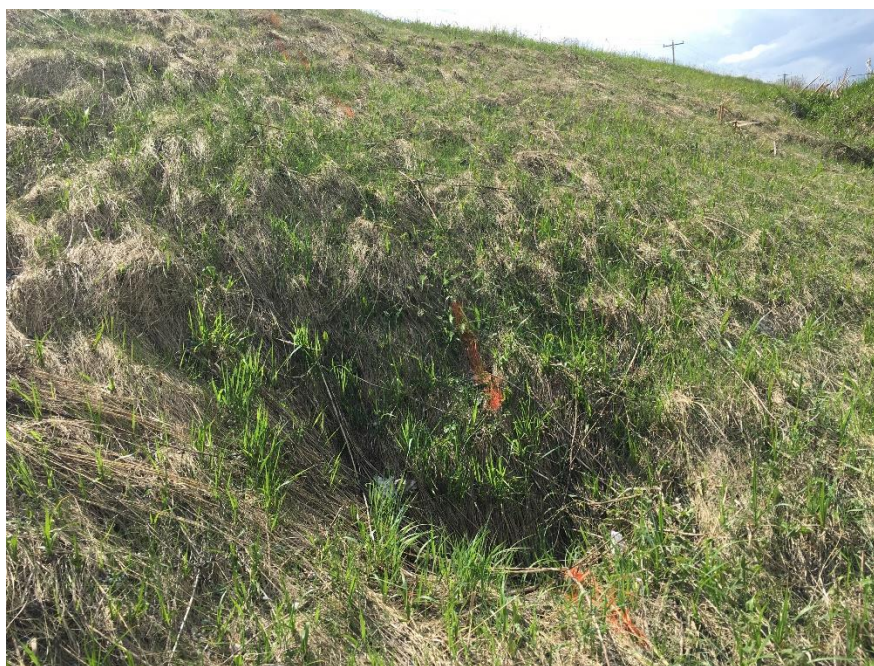
The creek flows from the west to east direction at this culvert location. During the site visit, sink hole of approximately 0.8 m diameter was observed on the west side slope at the existing culvert location (see Photo 8 in Appendix A).

Photo 8. Sinkhole on west side slope at Culvert #2

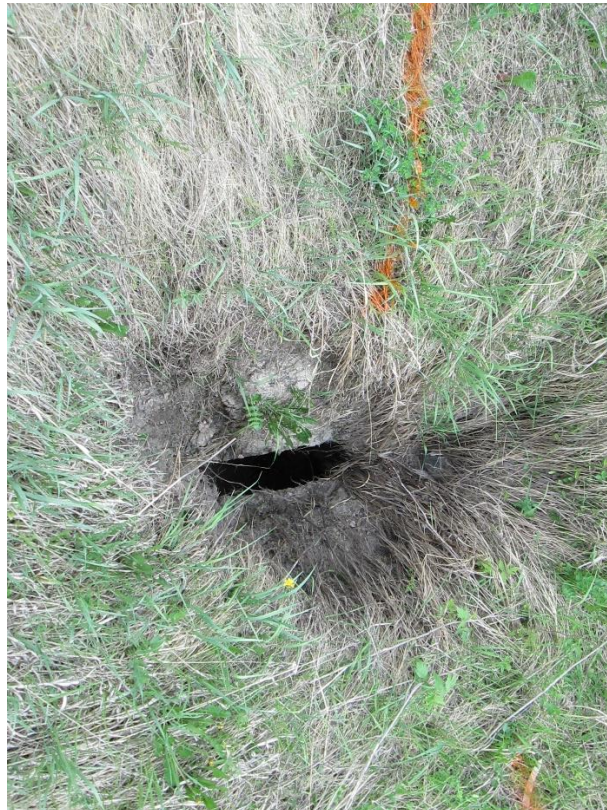
The creek flows from the east to west direction at this culvert location. During the site visit, a sink hole of approximately 0.8 m diameter was observed on the west side slope at the existing culvert location. It is also observed that, the existing culvert at the sink hole location is disjointed forming a hole (see Photo 16 in Appendix A).

Photo 16. Sinkhole with separated culvert at west side slope at Culvert #3
