# 55-F-37  
Hwy. # 120  
SWAMP RIVER  
WEST OF  
SHEBANDOWAN

REPORT OF FOUNDATION INVESTIGATION

BRIDGE AT SWAMP RIVER ON

HIGHWAY # 120

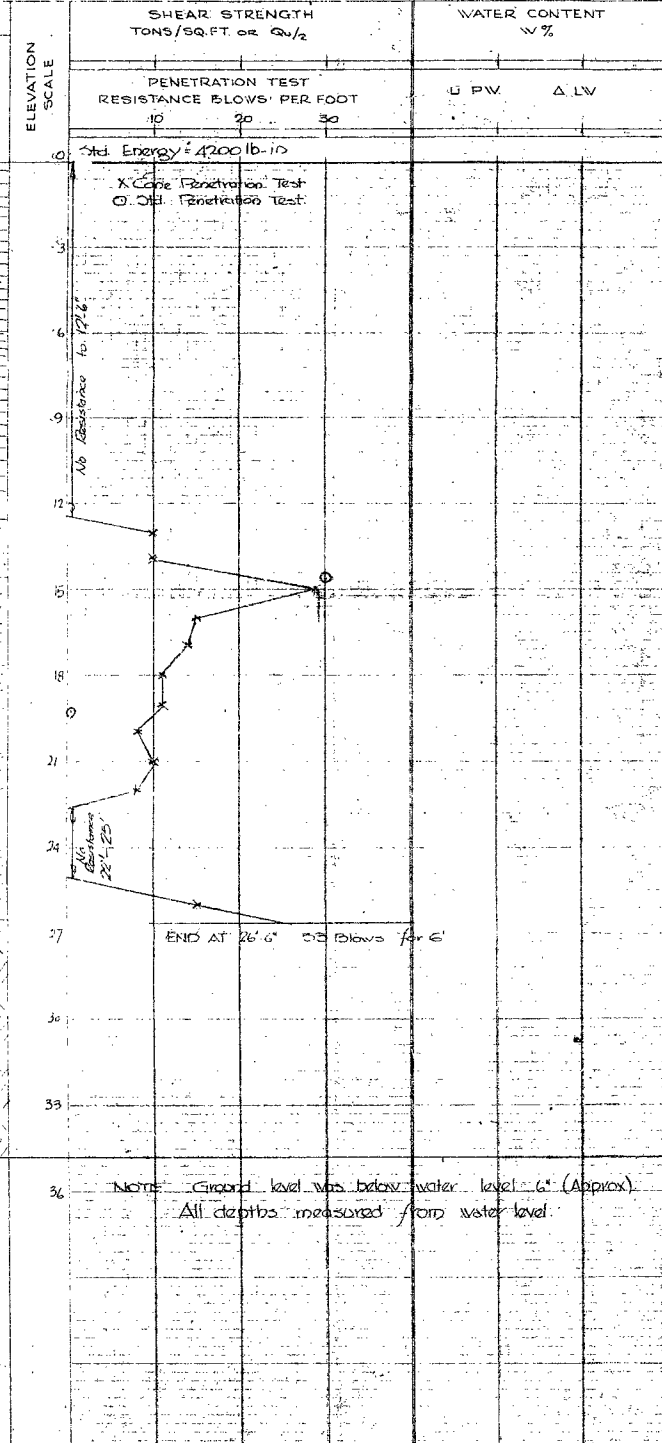
DRILL RIG CORE DRILL #1 JOB 55-F-37 HWY #120 AT SWAMP RIVER BORING NO. 1  
CASING BY (STANDARD SAMPLERS TO FIT UNLESS NOTED) DATUM STA 515+78.23 LT DATE REPORT  
SAMPLER HAMMER WT 250 # DROP INCHES COMPILED BY B.H. CHECKED BY BORING DATE Oct 20 & 21 1955

ELEV. DEPTH	WATER CONDITIONS	DESCRIPTION	STRAT. PLOT
1473.9		Swamp Surface	
1463.4		Very soft saturated brown silty clay muck with decayed organic material	
1461.4		Dark gray medium sand	
1441.4		Red Lira

OTHER TESTS	CONDITION	TYPE	NO.	PENETRATION RESISTANCE	ELEV. RECOV.
	CS	1		4200 lb-in	1467.9
	DO	2	39 ft	100	1462.1
	DO	3	18 blows 30"	76	1457.9
	DO	4	28 blows 18"	100	1453.9
	RC	6	Run #1	3' 6" broken rock core recovered	1443.9
	RC	6	Run #2	1 ft broken core recovered

NOTE: Ground level was below water level 6" (Approx).  
All depths measured from water level.

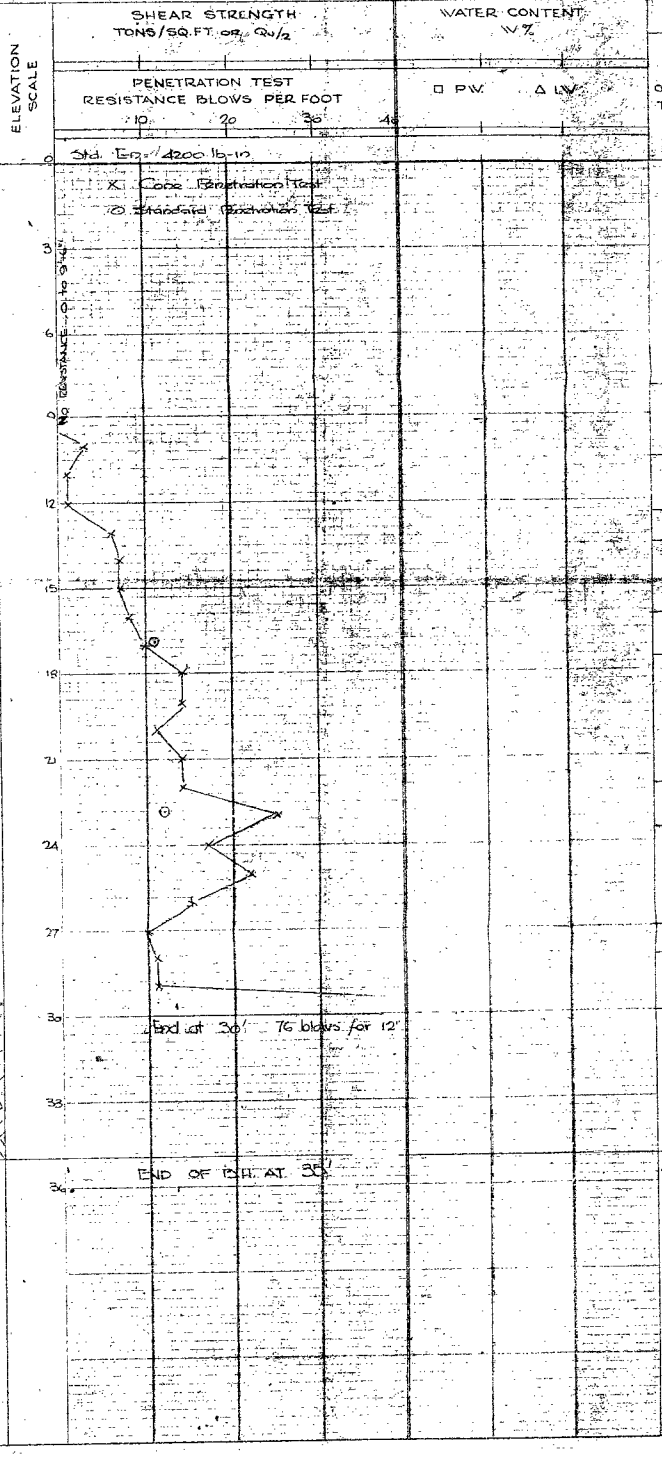
DRILL RIG CORE DRILL #1 JOB 55-F-37 HWY #120 AT SWAMP RIVER BORING NO. 2  
CASING BY (STANDARD SAMPLERS TO FIT UNLESS NOTED) DATUM STA 515+78.23 LT DATE REPORT  
SAMPLER HAMMER WT 250 # DROP INCHES COMPILED BY B.H. CHECKED BY BORING DATE Oct 21 & 22 1955

ELEV. DEPTH	WATER CONDITIONS	DESCRIPTION	STRAT. PLOT
1473.9		Swamp Surface	
1463.9		VERY SOFT SATURATED BROWN SILTY CLAY MUCK WITH DECAYED ORGANIC MATERIAL	
1463.9		DARK GRAY MEDIUM SAND	
1446.4		RED ROCK

OTHER TESTS	CONDITION	TYPE	NO.	PENETRATION RESISTANCE	ELEV. RECOV.
	CS	1		4200 lb-in	1467.9
	DO	2	39 ft	100	1463.4
	DO	3	18 blows 30"	76	1457.9
	DO	4	28 blows 18"	100	1453.9
	VS	5			1448.9
	RC	6	Run #1	3' 6" broken rock core recovered	1443.9

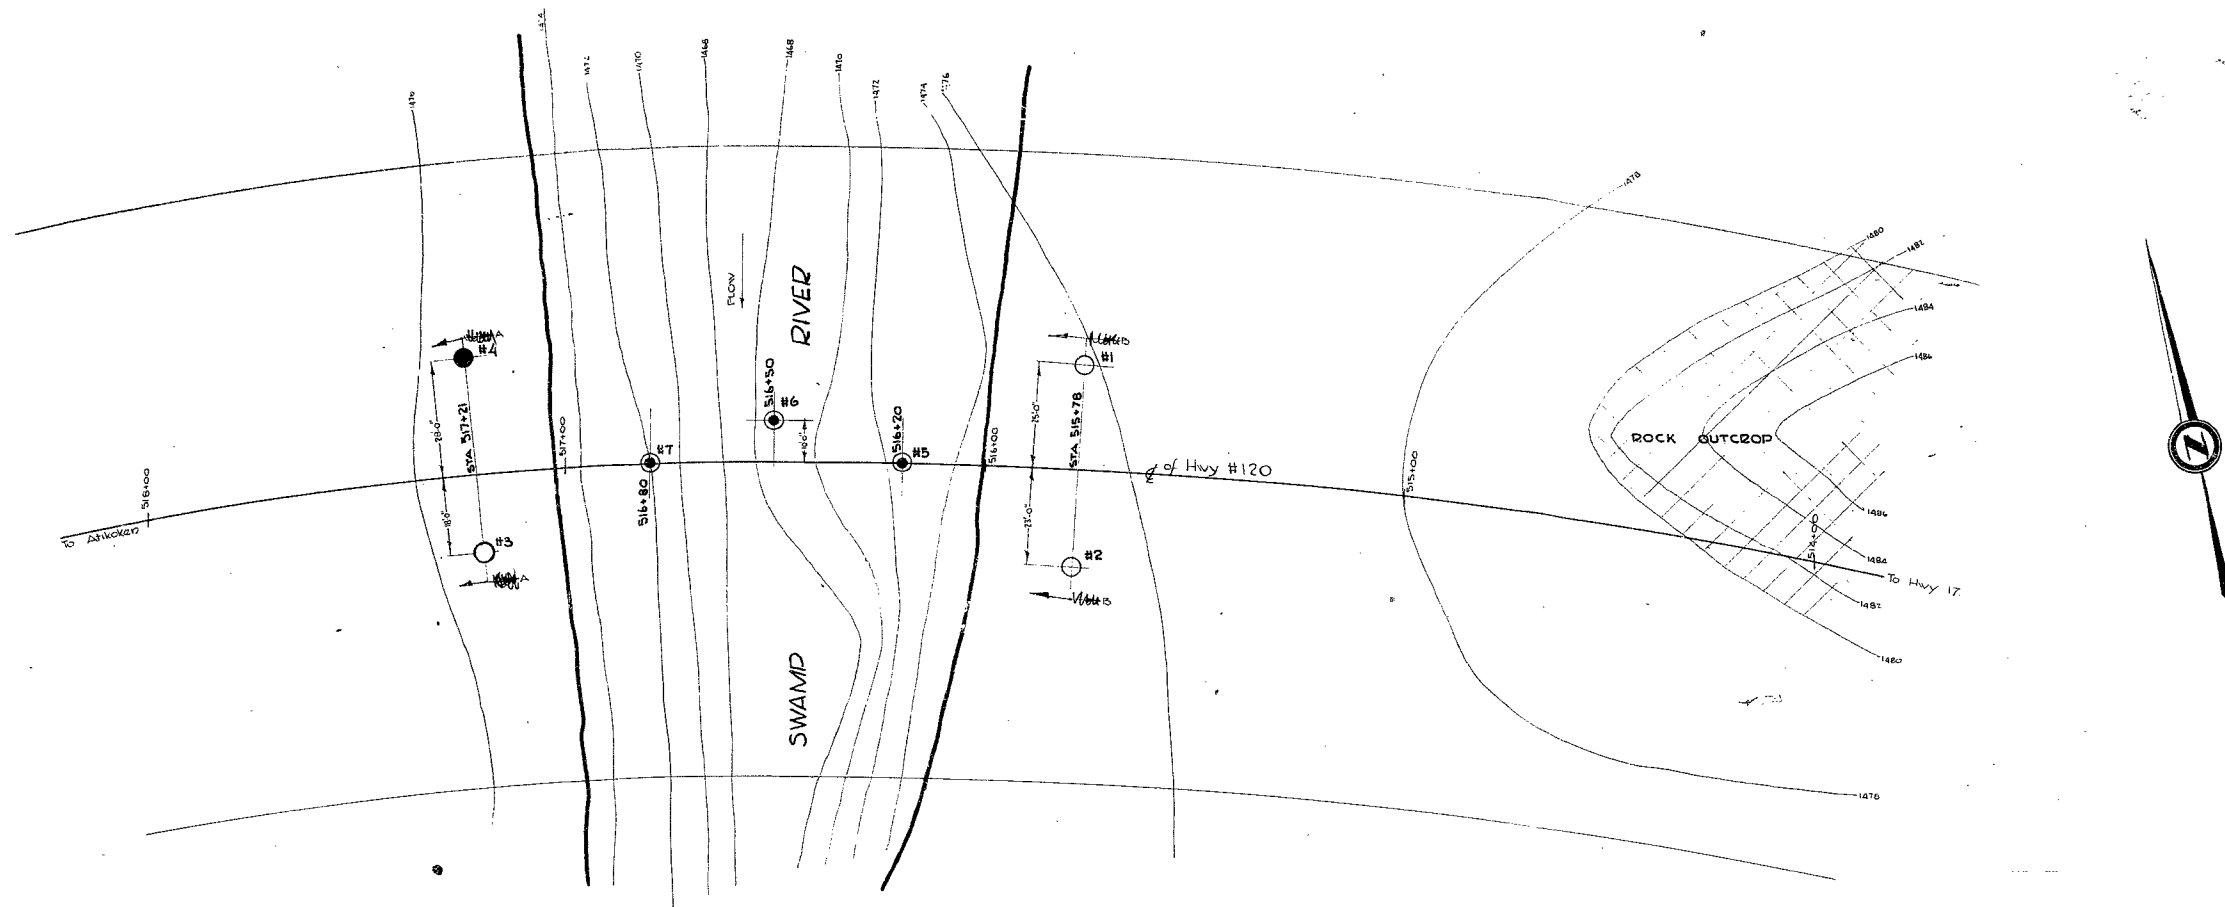
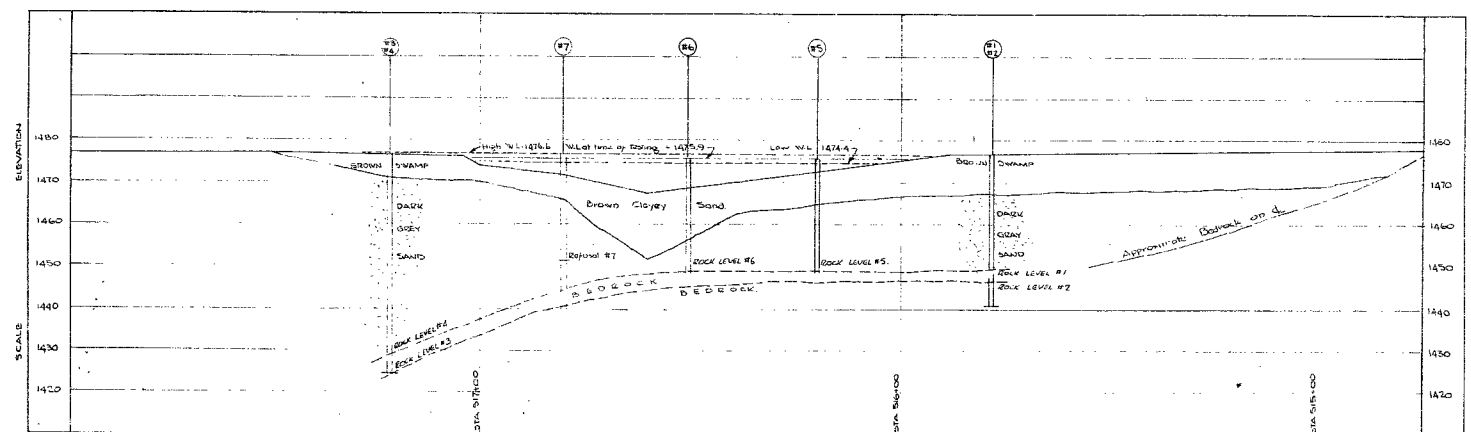
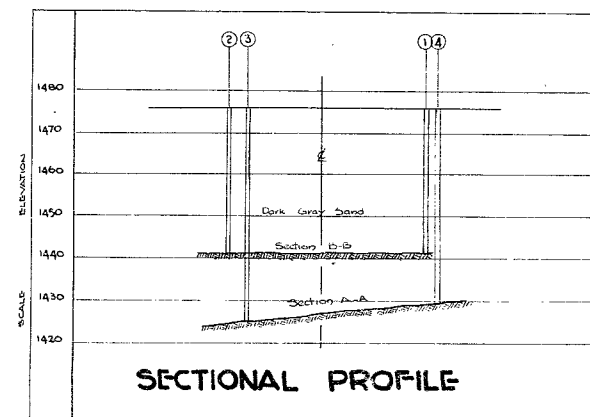
Piles should be driven to bedrock. The bedrock profile is indicated on drawing F55-37A. It's elevation varies from 1446 to 1449 on the east bank to 1426 to 1429 on the west bank with a general dip to the south east.

Piles should be driven to bedrock for end bearing and little difficulty should be experienced in driving them to this level.

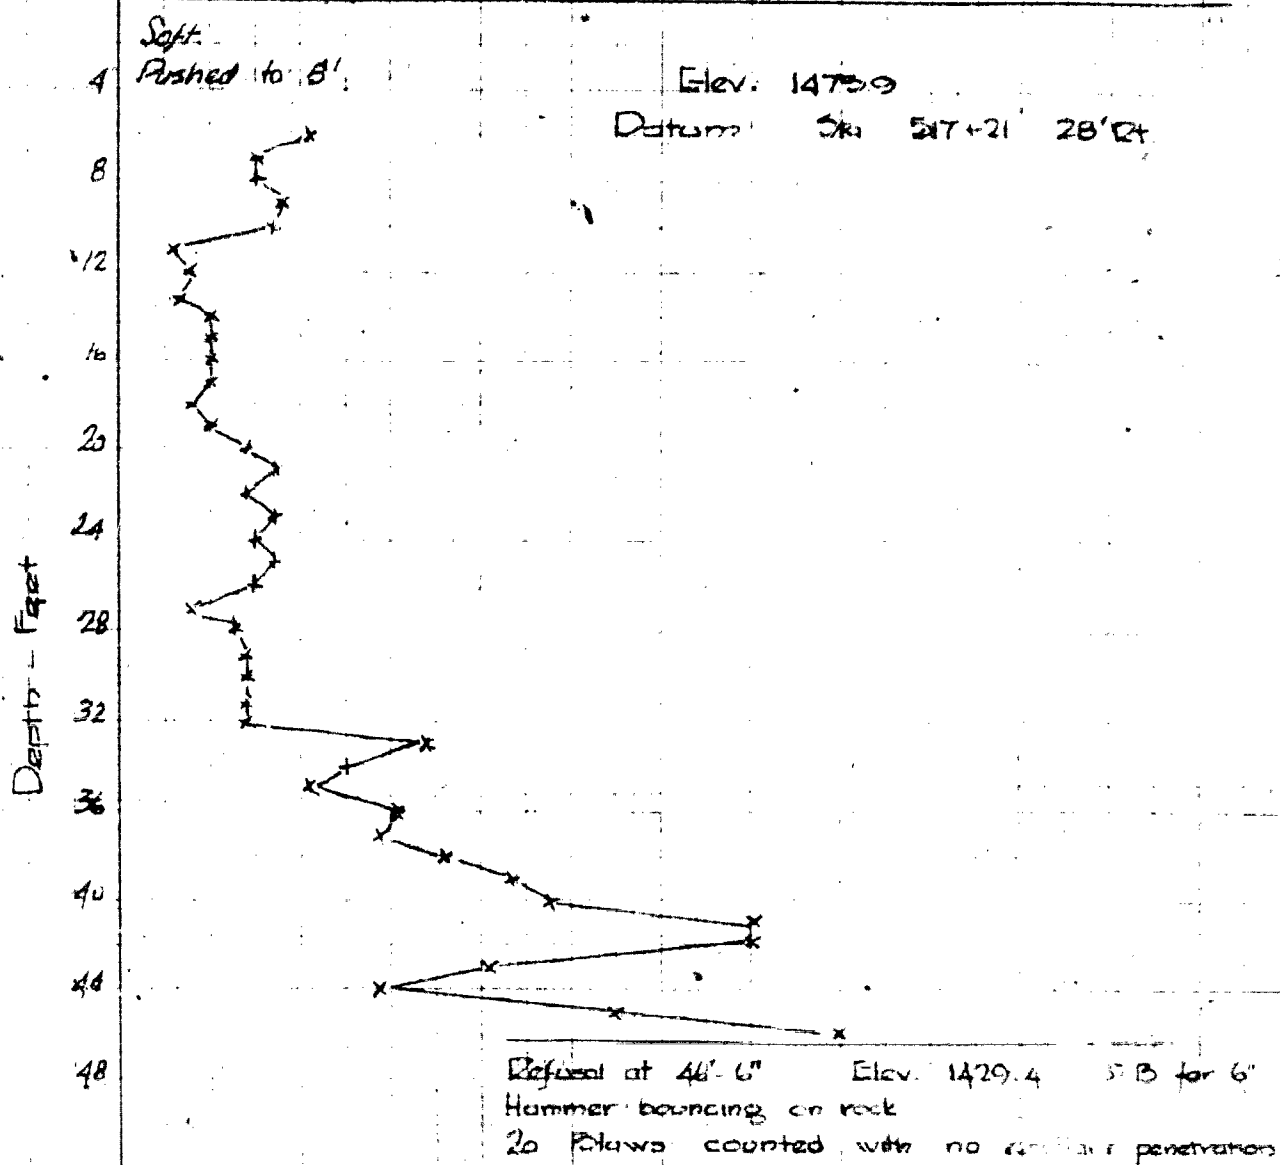
## GRAPH OF CONE PENETRATION TEST

Except for a layer immediately below the swampy material the gray medium sand is very loose with a standard penetration resistance of less than 1 blow per foot at a standard energy of 4200 lb. in. Its bearing capacity is therefore negligible and a piled foundation would be necessary.
