52F-19

**ENGINEERING GEOLOGICAL INVESTIGATION
MTC TURTLE RIVER BRIDGE CROSSING
DISTRICT OF KENORA, ONTARIO, CANADA**

**Our Reference Number R81136
MTC Reference No. WP 18.77.09
August, 1981**

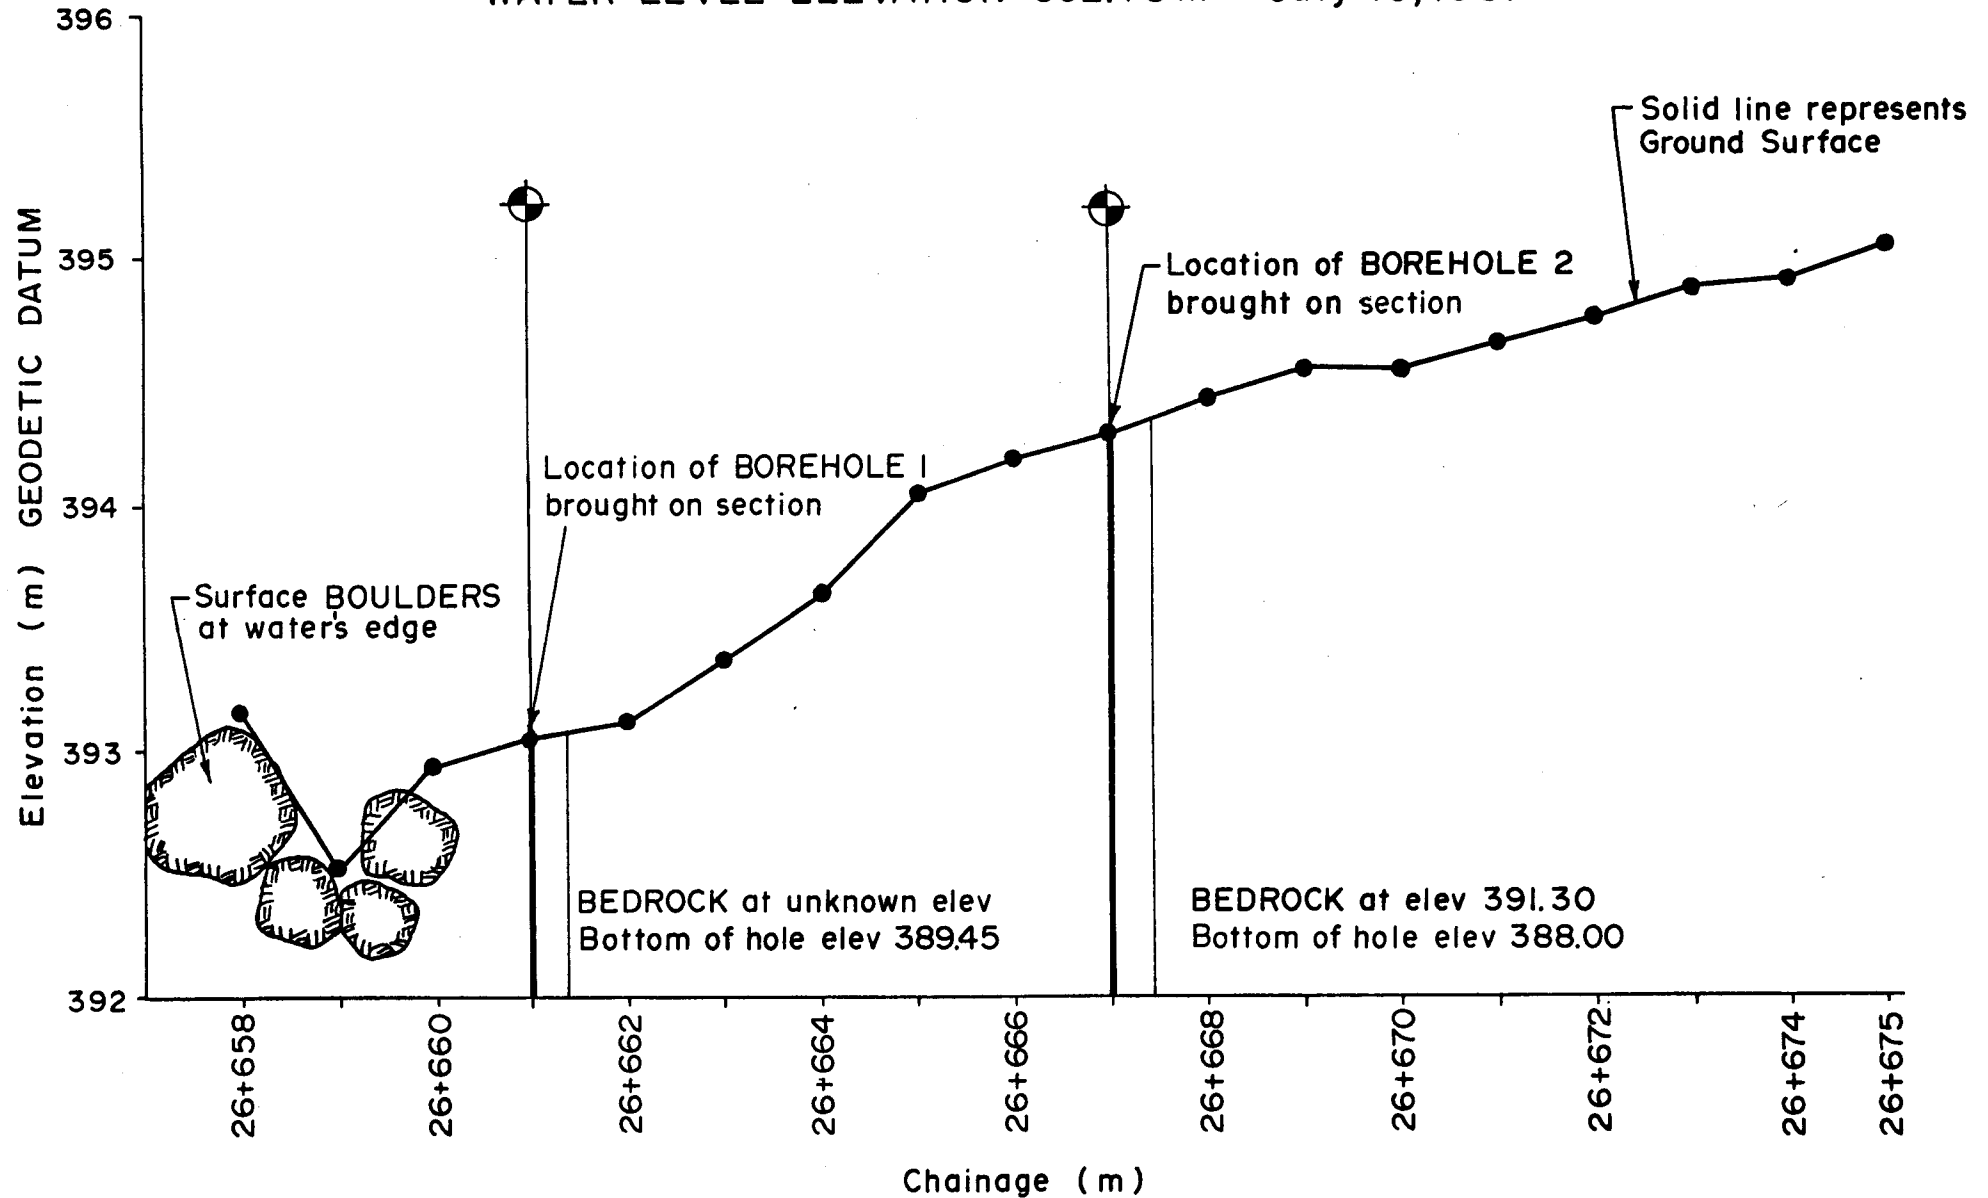
SECTION ALONG BRIDGE ALIGNMENT: CHAINAGE 26+658 - 26+675

The field investigation of the proposed location of the Turtle River crossing has indicated that sound bedrock exists to support foundation footings on the western abutment. It also indicates, however, that overburden coverage at the eastern abutment location is more extensive than was originally anticipated. Examination of eastern bedrock exposure suggests that the bedrock below the proposed footing is steeply dipping and on the leeward edge of a bedrock embankment.

It is suggested that this bedrock feature is a possible result of graben faulting which would also explain the configuration of the river course and the steeply dipping exposed bedrock interfaces surrounding the abutment locations. It is, therefore, recommended that in light of these considerations, the span of the bridge be increased slightly to place the foundation of the eastern leading edge of the proposed structure on more competent subsurface bedrock.

1. It is recommended that the span of the bridge be increased to ensure that adequate bedrock support is provided for the eastern abutment footings.
2. It is recommended that rock anchors be installed at the abutment locations to provide resistance to horizontal movement.
3. Design of the location of the rock anchor should allow for field alterations based on the following criteria:
 - a) Anchors should not be drilled along fractures or joints,
 - b) The anchors ideally should be drilled into the granite or syeno granite units.
4. Stripping of the overburden cover at the eastern abutment locations should provide for removal of large boulders to expose the bedrock surface.
5. Bedrock surface and/or joints should be cleared of all debris. The final cleaning of the surface can be carried out by either brooming or by compressed air.

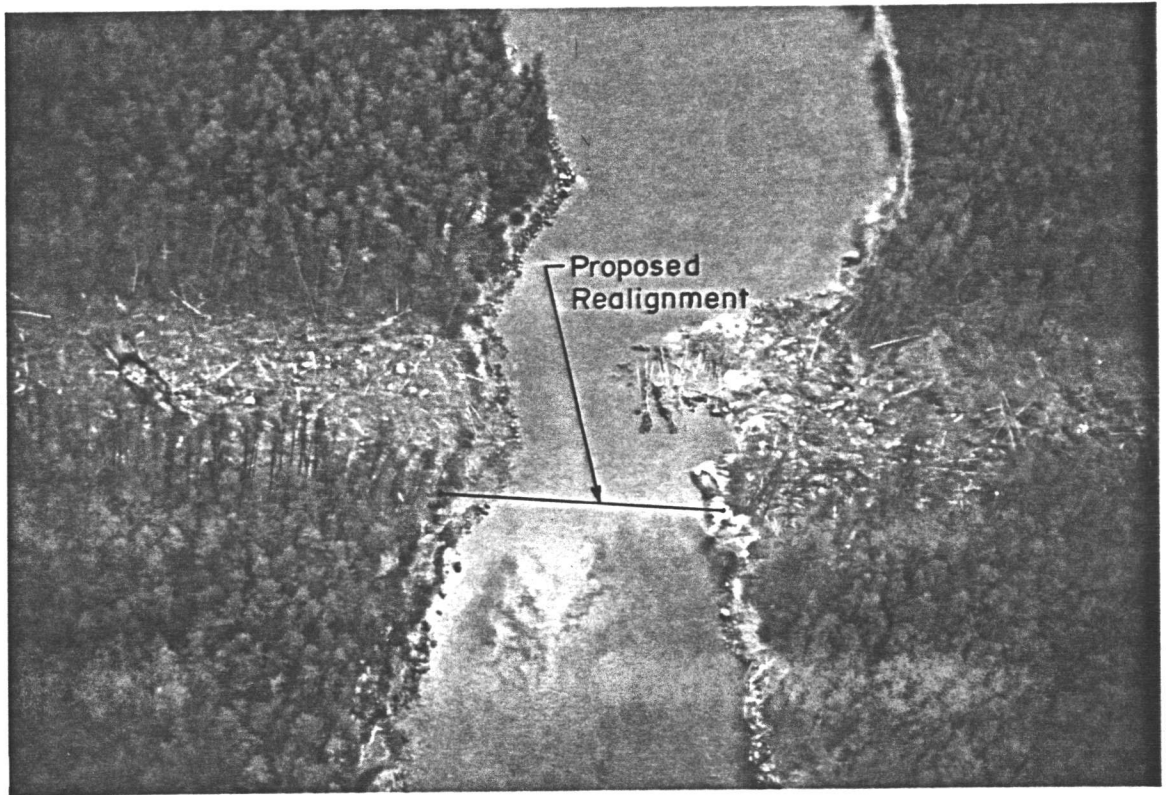
PHOTO NO. 1

Proposed Realignment of the Turtle River Crossing

5. Alternative design should be considered such as founding the east abutment in the overburden soils or shifting the bridge location slightly to the north to allow both abutments to be founded directly on bedrock.
