HYDROGEOLOGICAL SCREENING REPORT

**HIGHWAY 62 REALIGNMENT AND ROAD IMPROVEMENTS
1.0 kilometre South of Quin Mo Lac Road to the South Limit of the Village of Madoc**

GWP 4506-02-00

AUGUST 2008

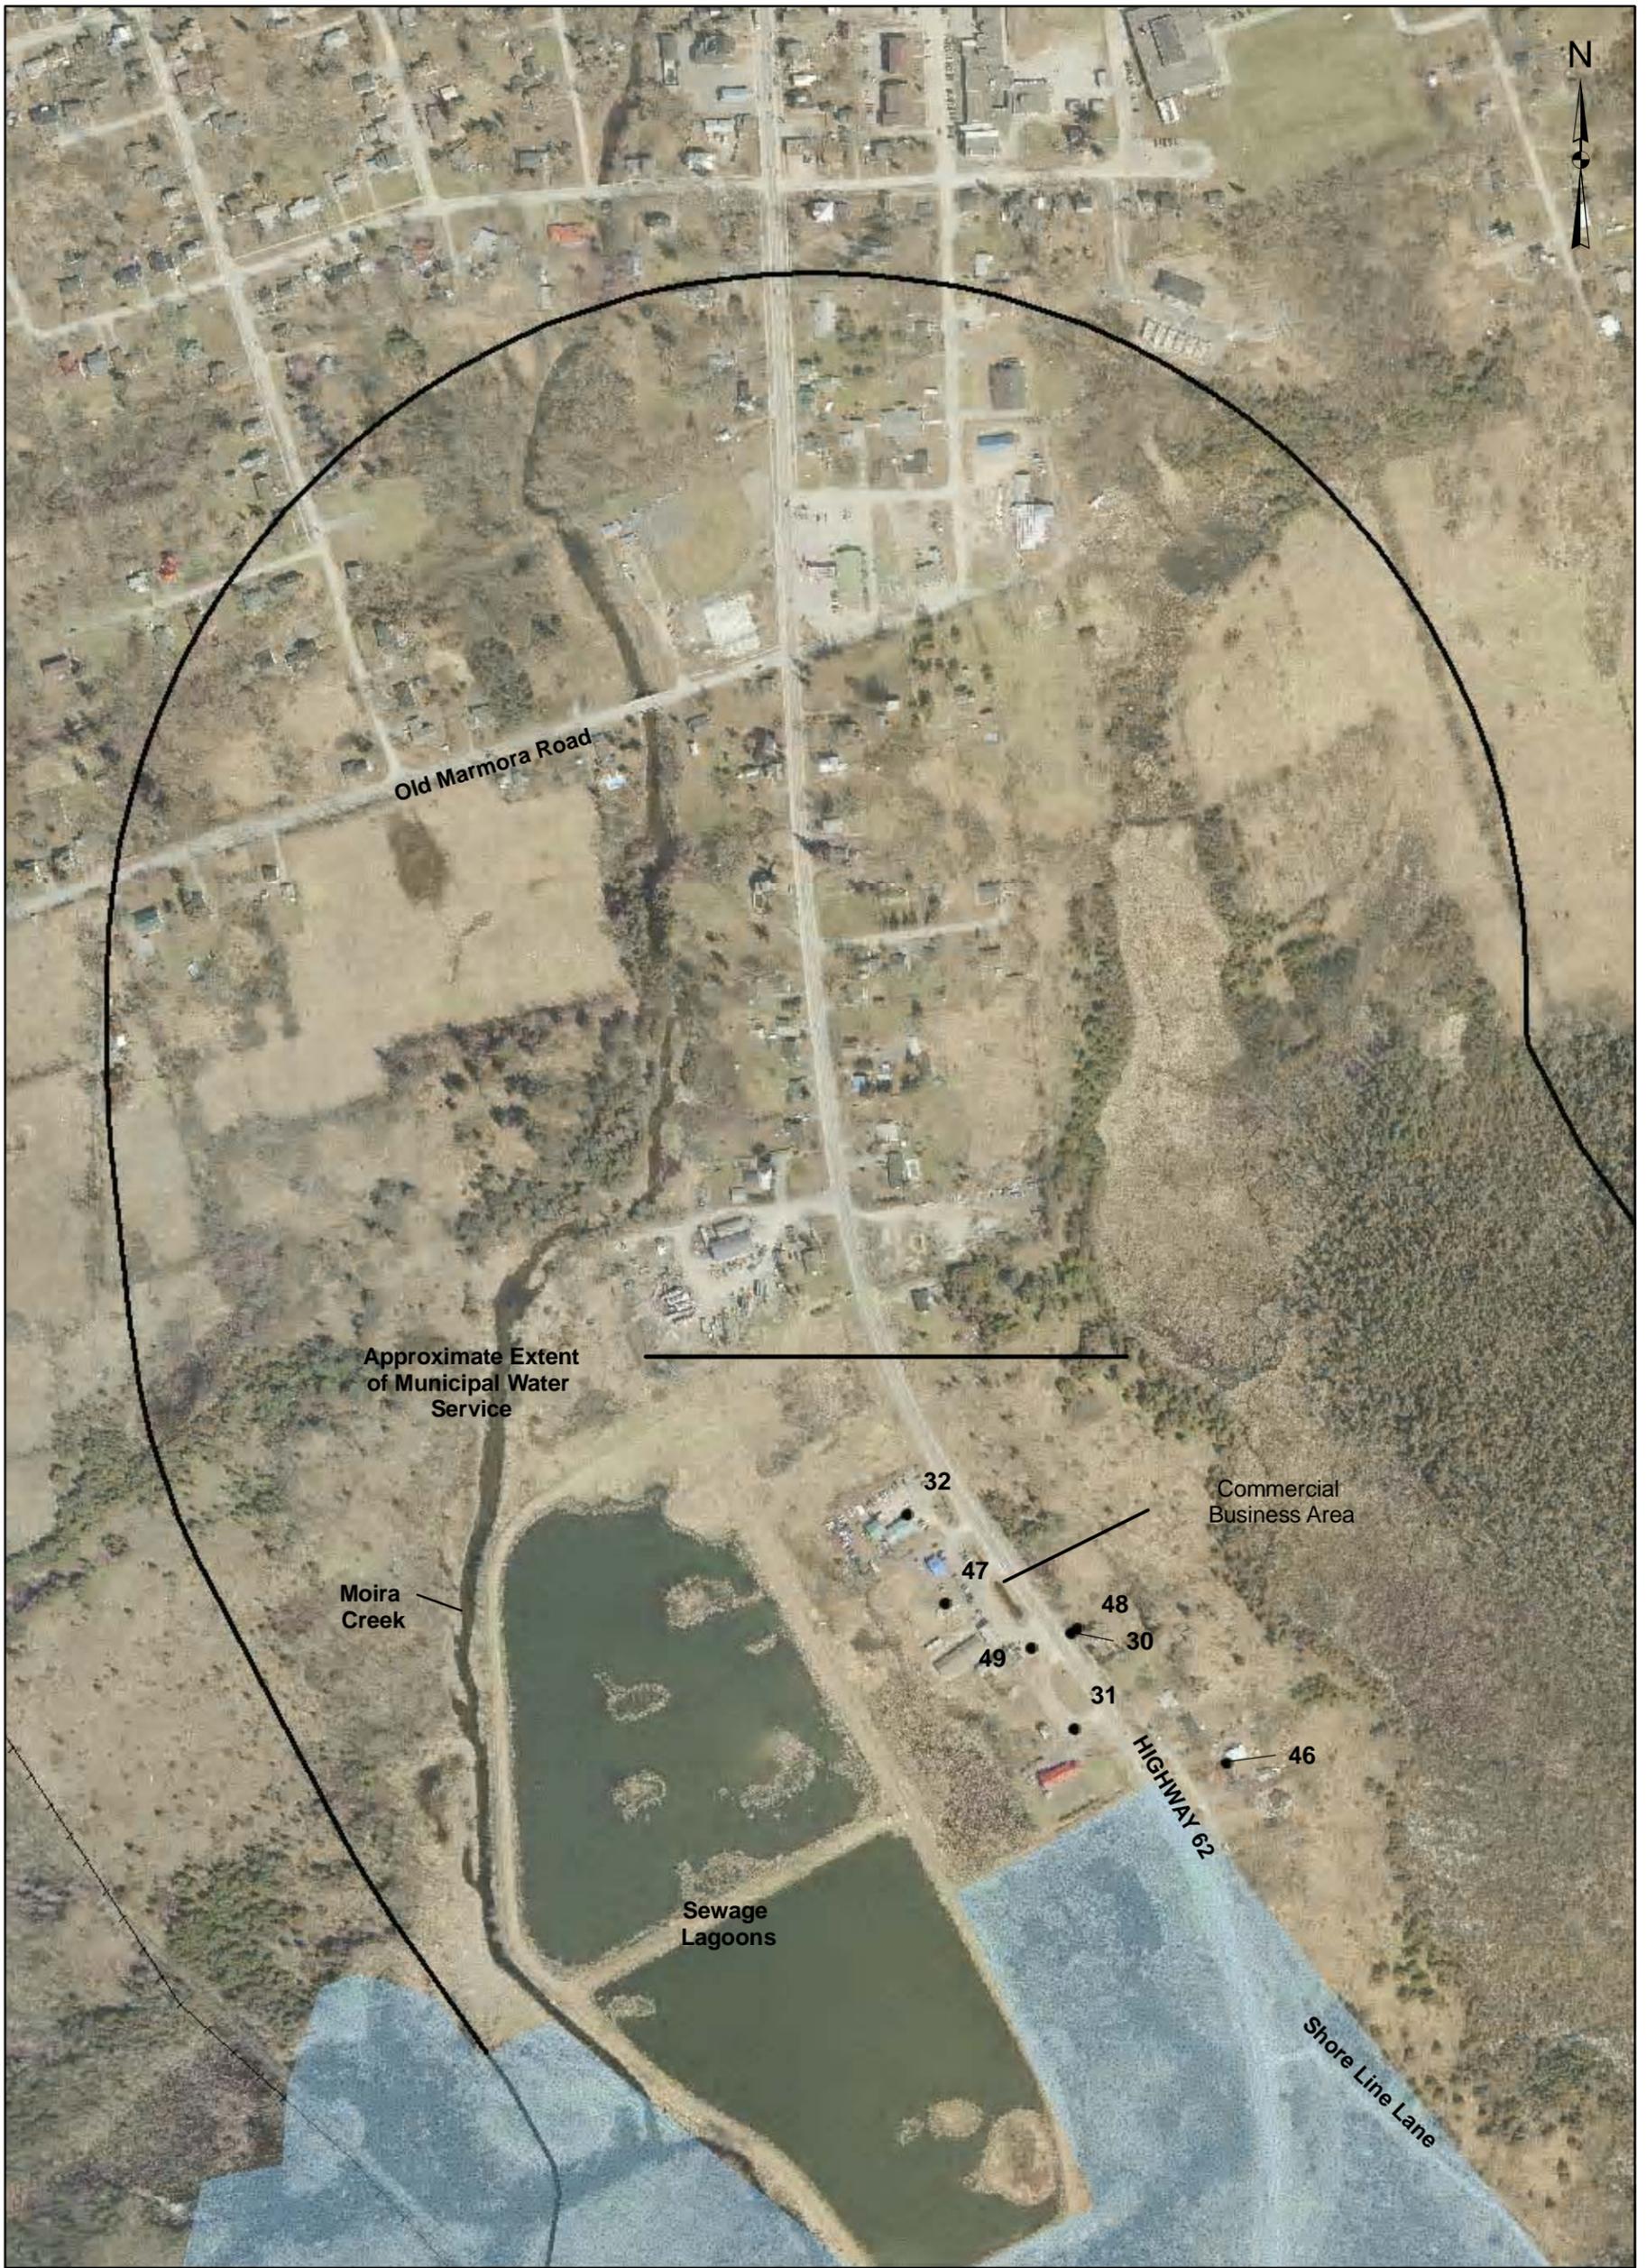
FIGURE
5A

- Municipally supplied water was observed (i.e. fire hydrants) throughout the Town of Madoc. The approximate limit of supplied water is outlined in Figure 5A (i.e. last observed hydrant);

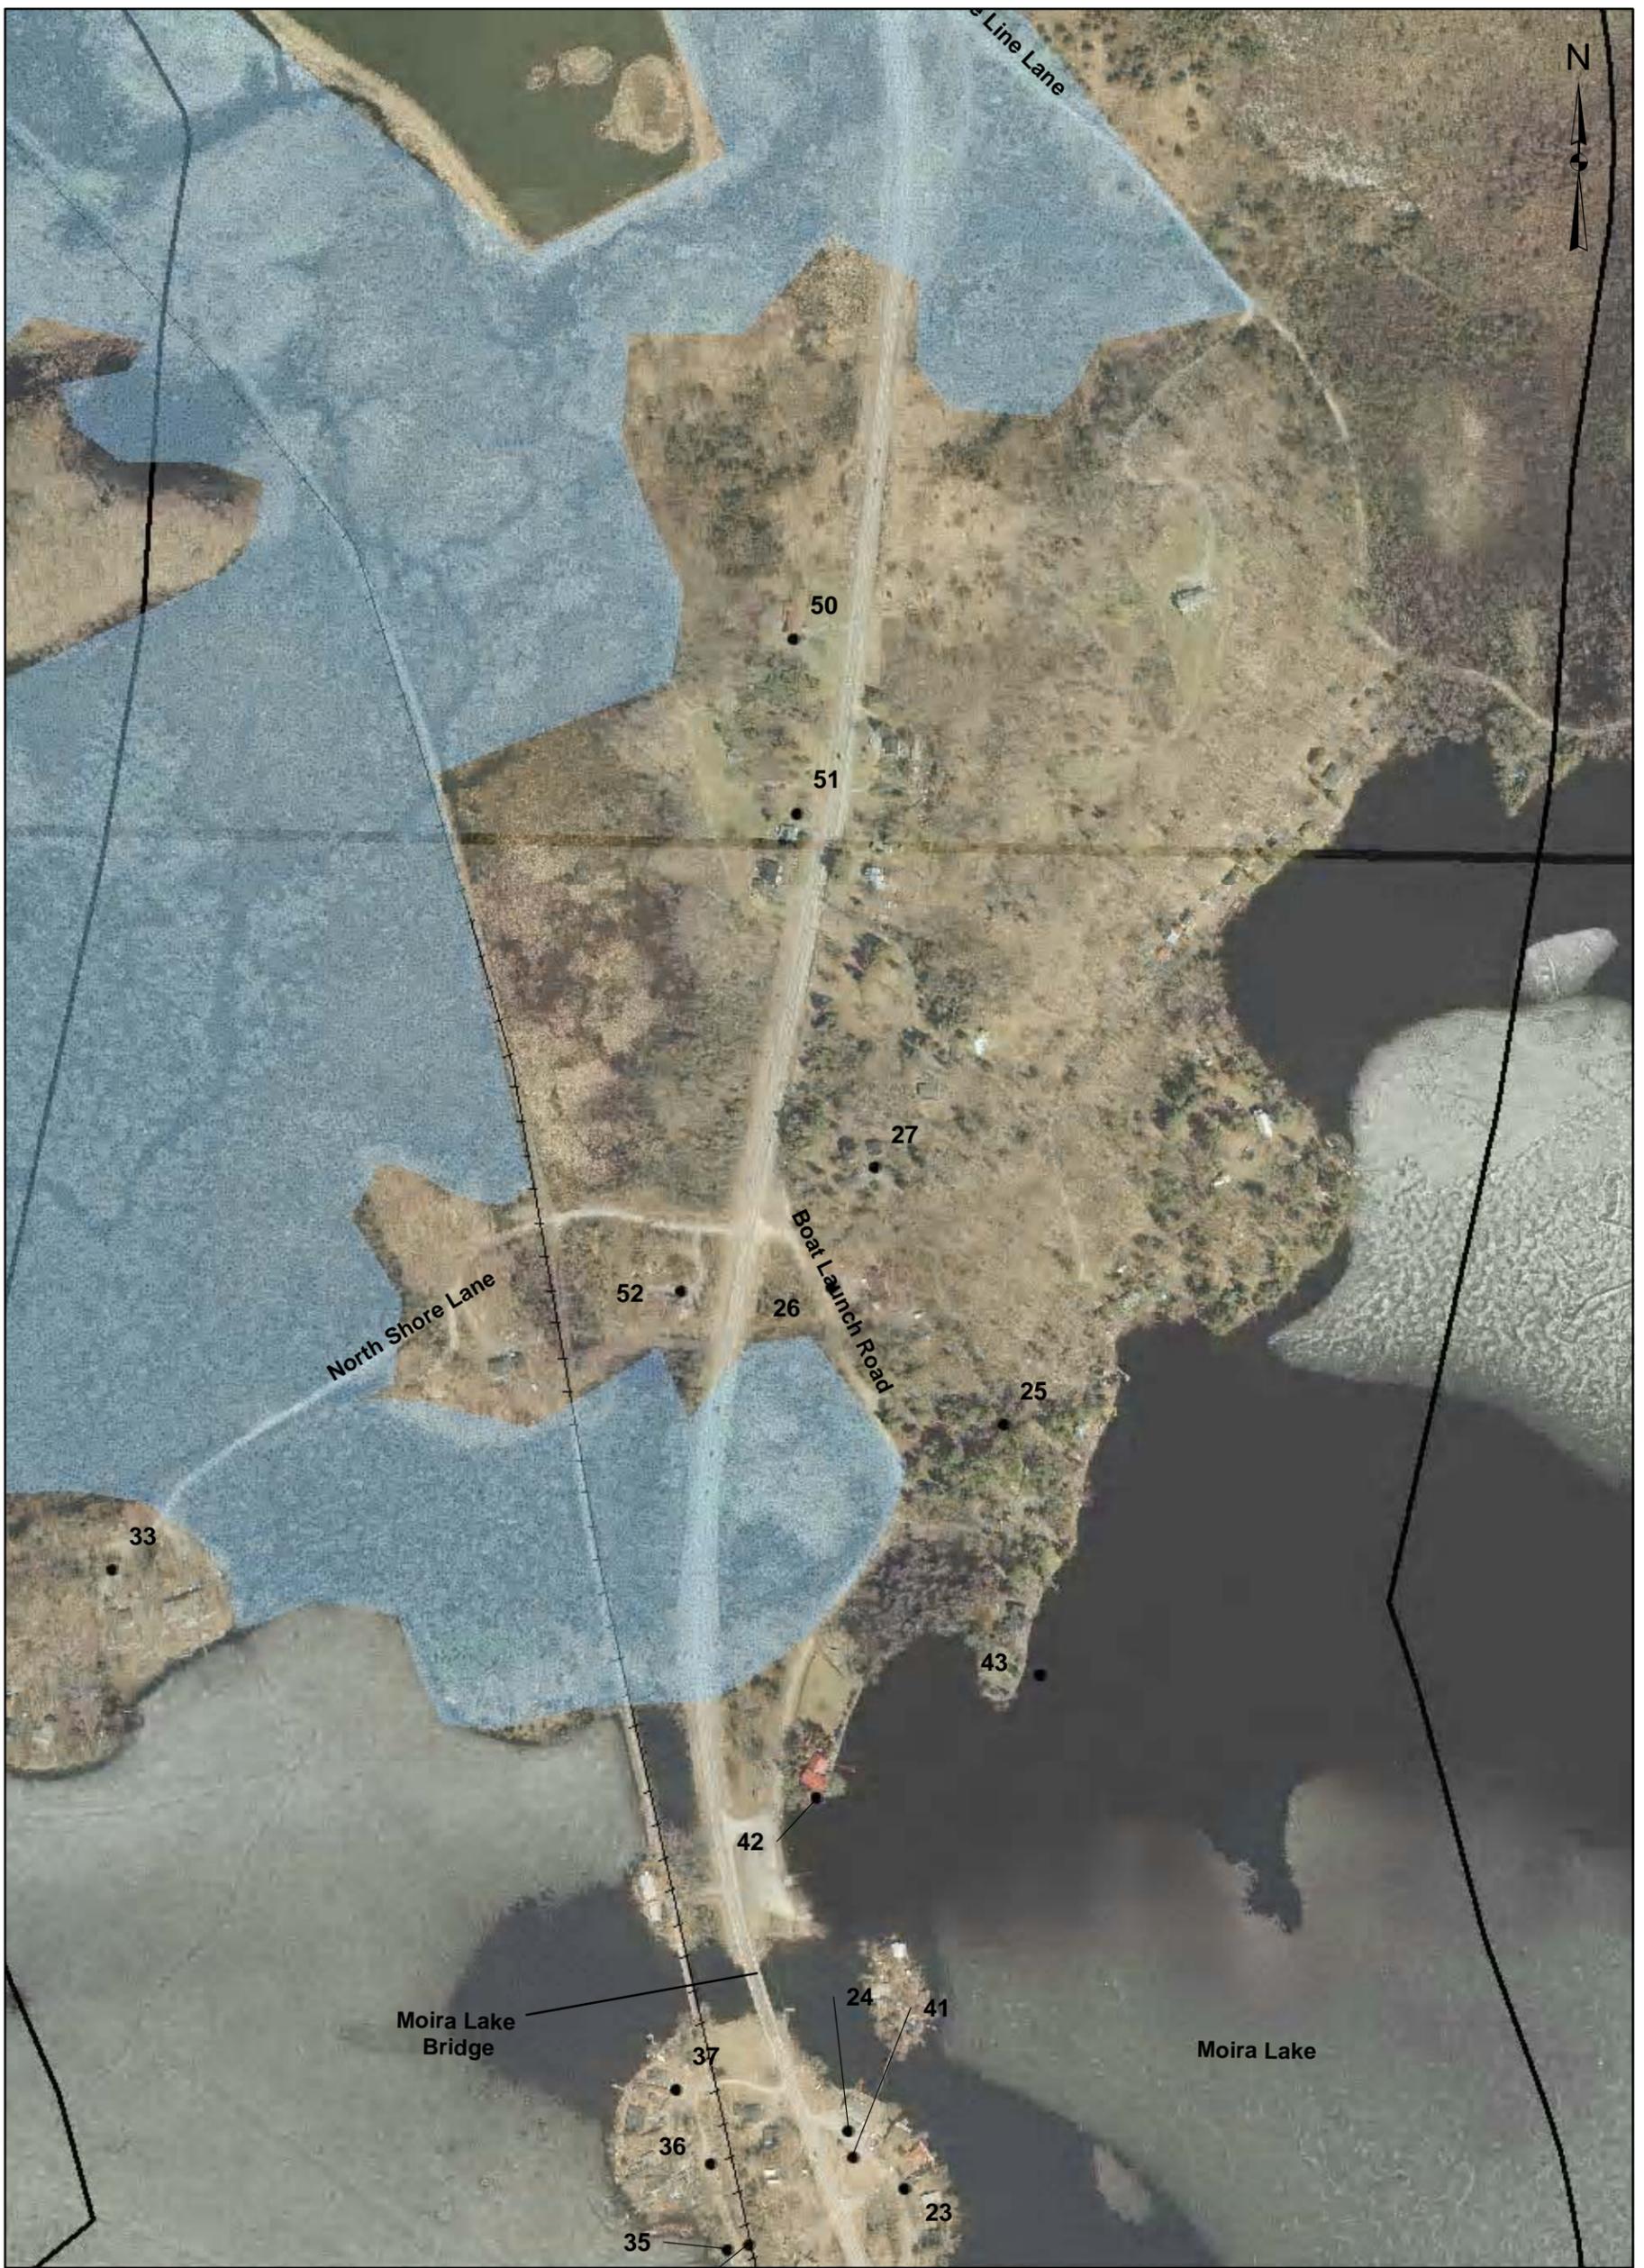
FIGURE
5B

- A former rail bed was observed running northwest from the Highway 62 and Watson Lane intersection northwest towards the village of Madoc (as labeled on Figures 5B and 5C);

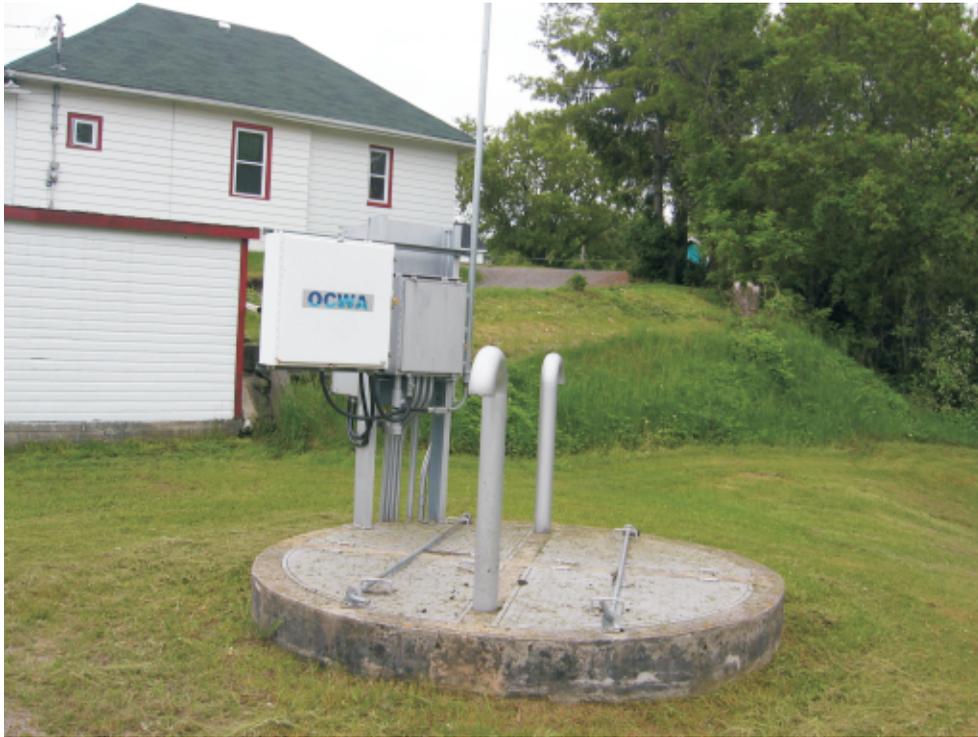
A1 - Madoc municipal well

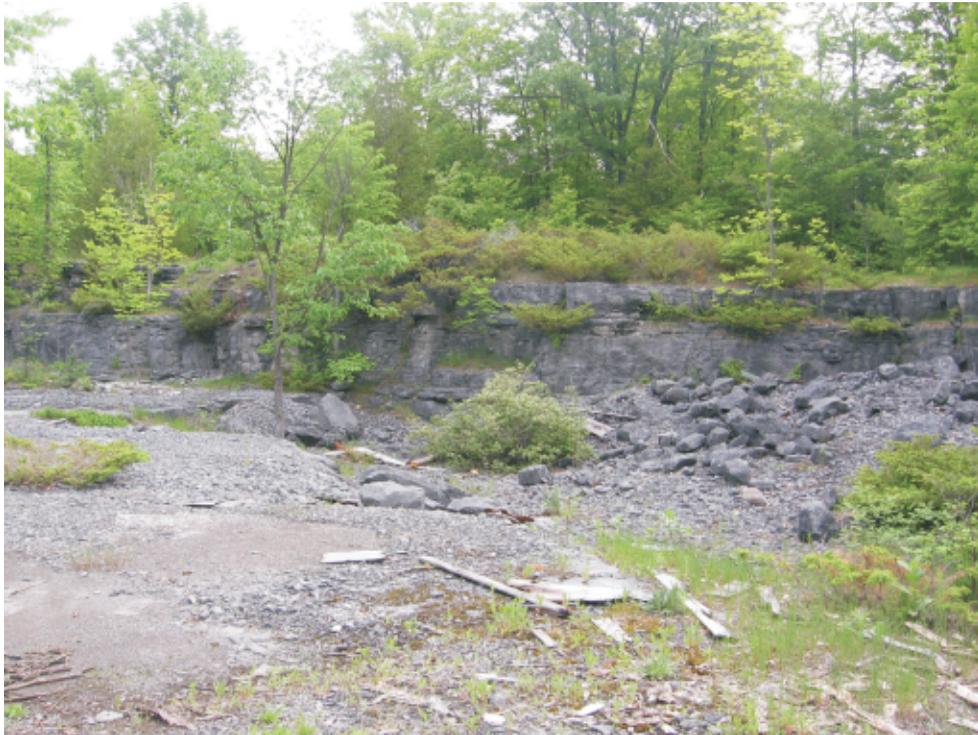
- A former limestone quarry is located at the northeastern corner of highway 62 and Quin-Mo-Lac Road. The quarry is approximately 0.18 ha in size and has an approximate maximum depth of 5 m. The former quarry is located directly within the proposed new re-alignment of Highway 62;

A2 - Looking northeast into Abandoned Quarry - Quin-Mo-Lac Road

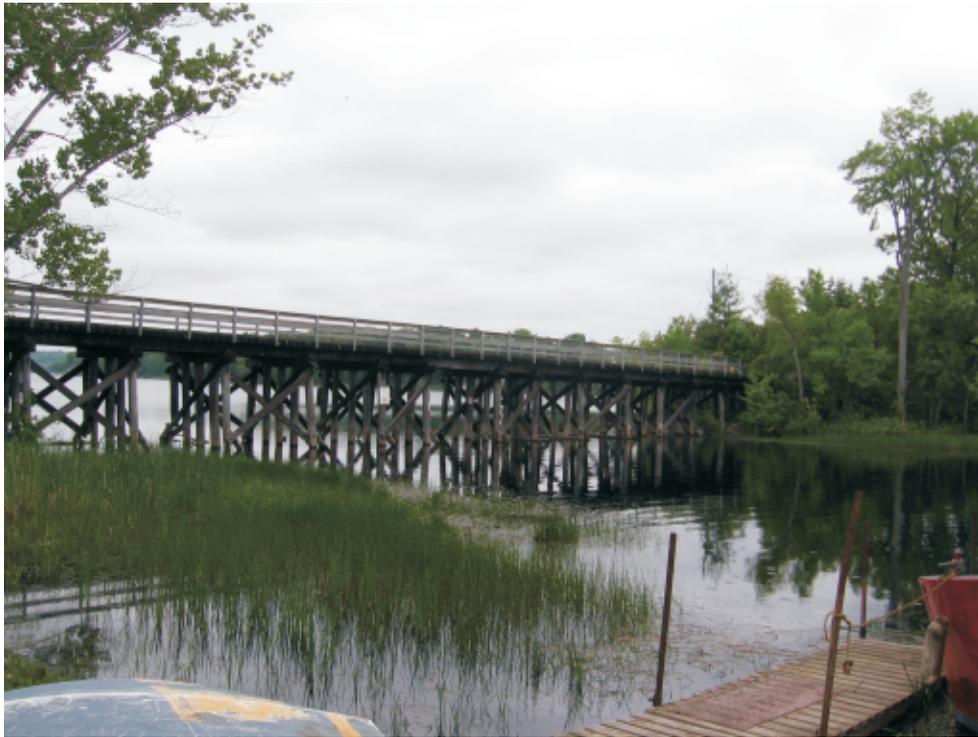
A3 - Looking northwest at former CN rail bridge

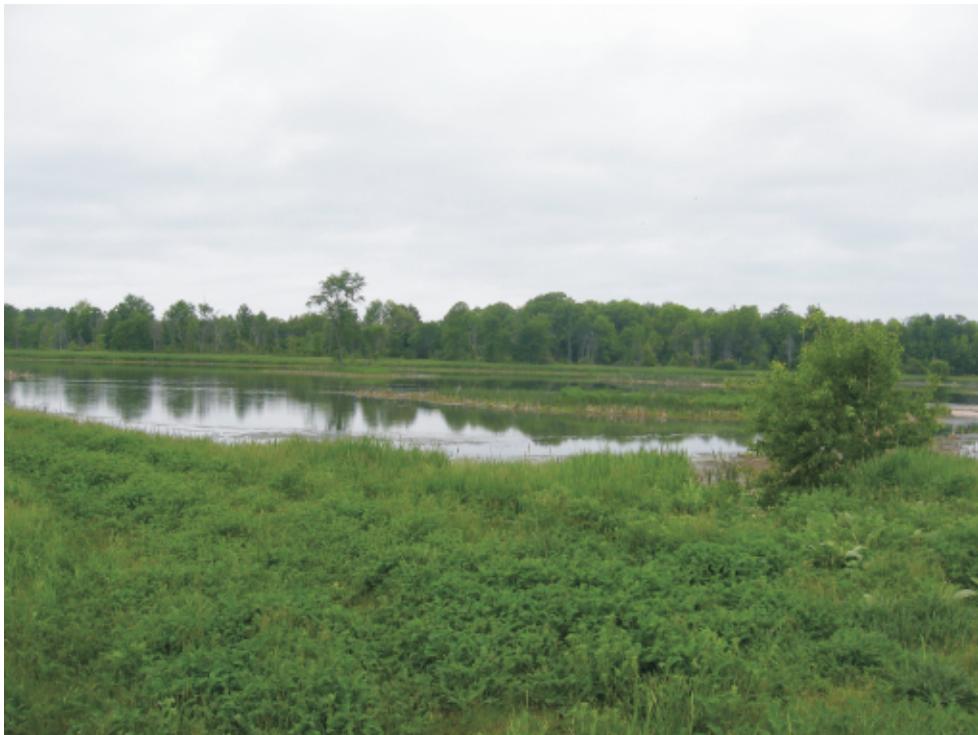
A4 - Looking northwest at northern sewage lagoon

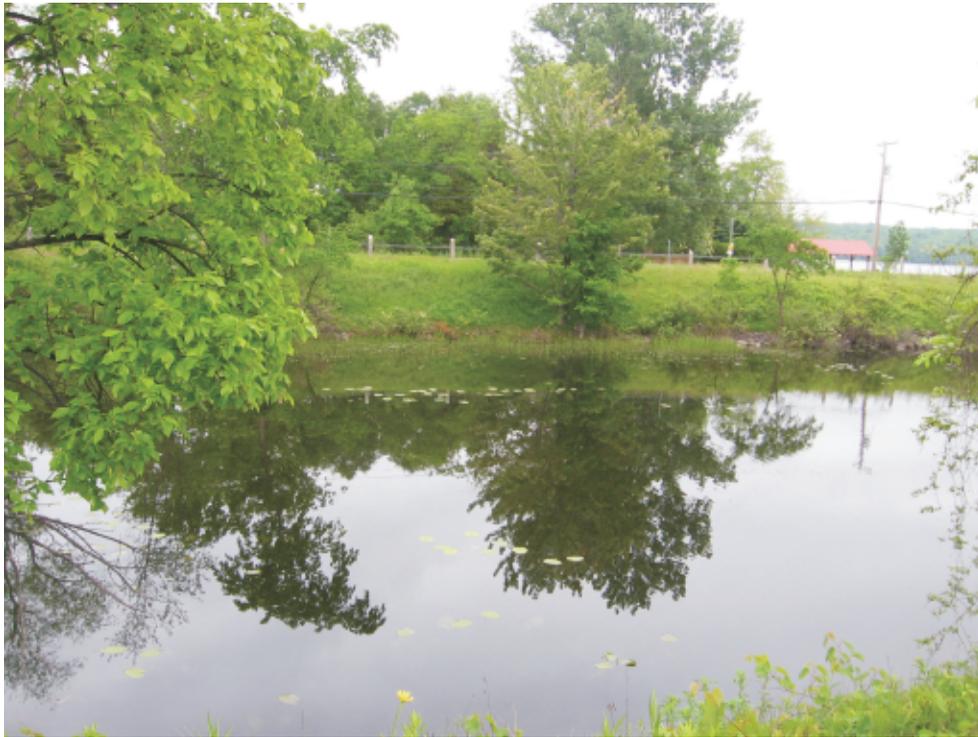
A5 - Looking southeast at pond from former rail yard towards Highway 62

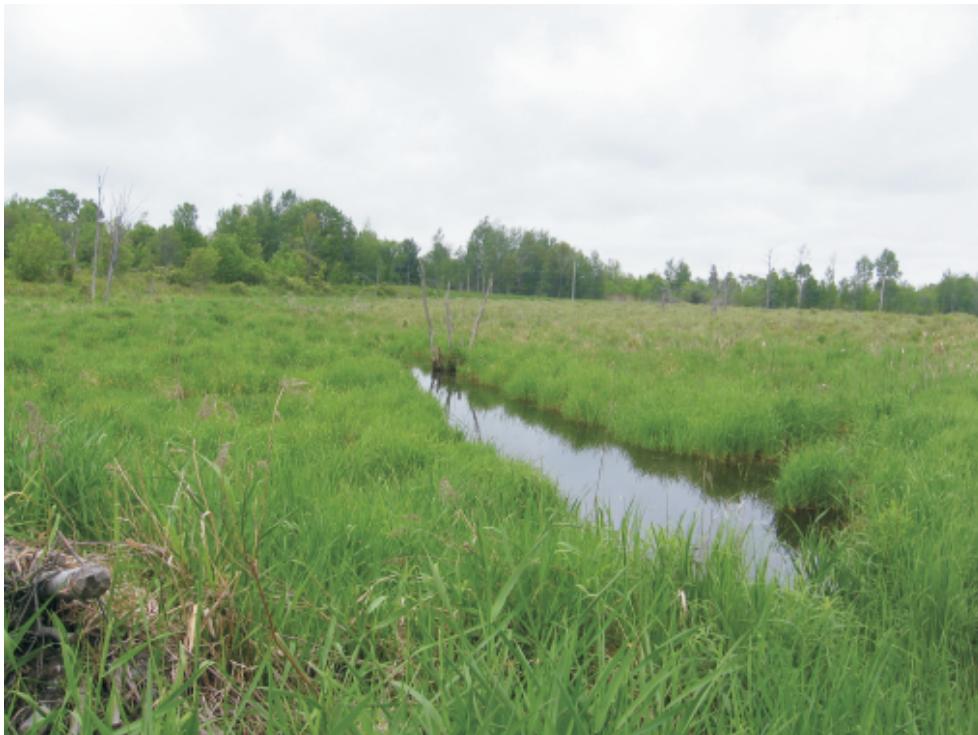
A6 - Wetland located 900m east of Quin-Mo-Lac road and Highway 62

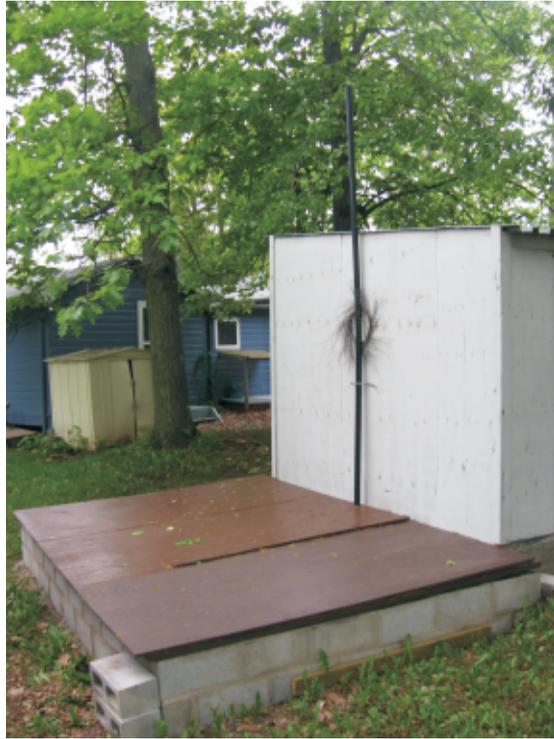
A7 - Former mine shaft currently used for deep sewage disposal on cottage island

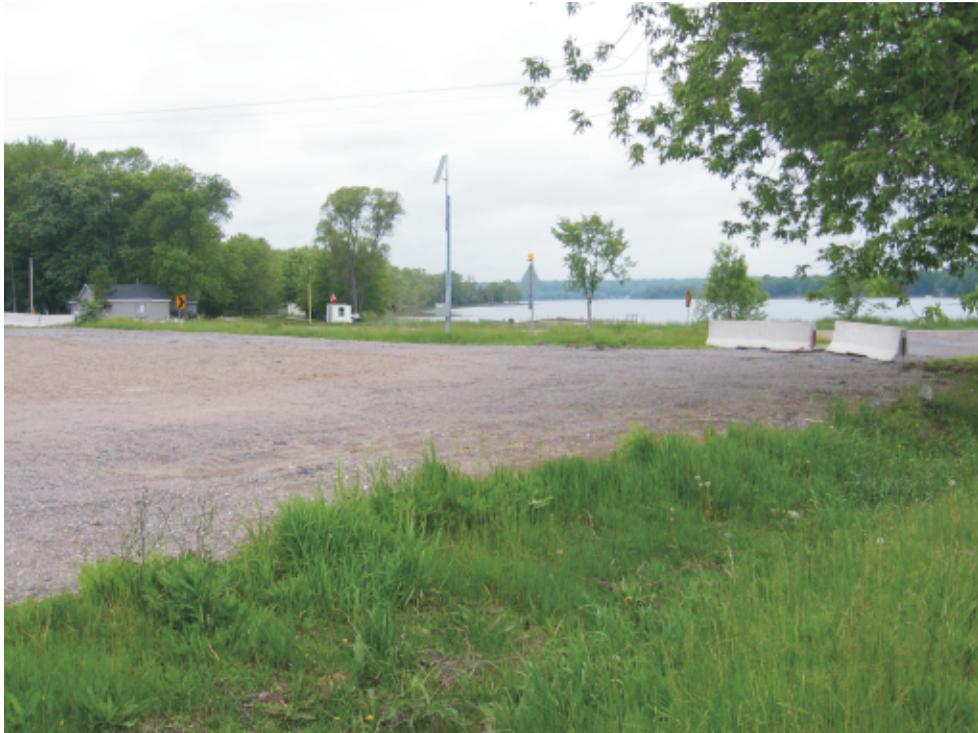
A8 - Looking northeast at former two loons restaurant
