HYDROGEOLOGICAL SCREENING

FINAL REPORT

**Highway 17 Twinning Campbell Drive to Scheel Drive
GWP 4067-03-00**

August 2007

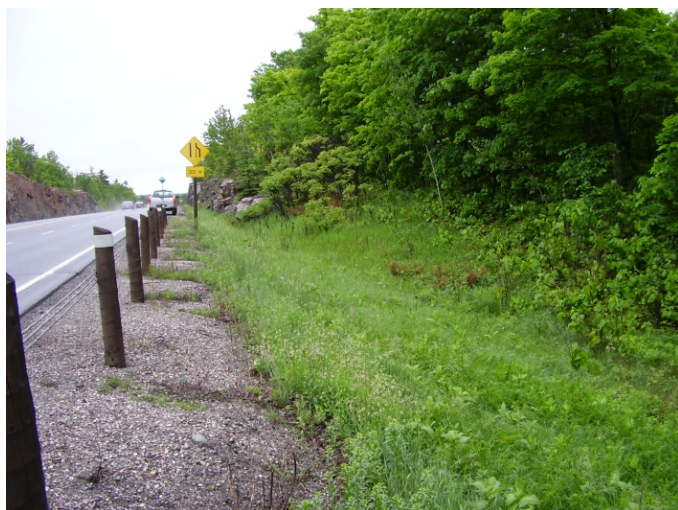
← Photo 1
Photo showing Highway 17 and general location of Site 2 (bottom of embankment at right side of photo). Photo taken facing east.

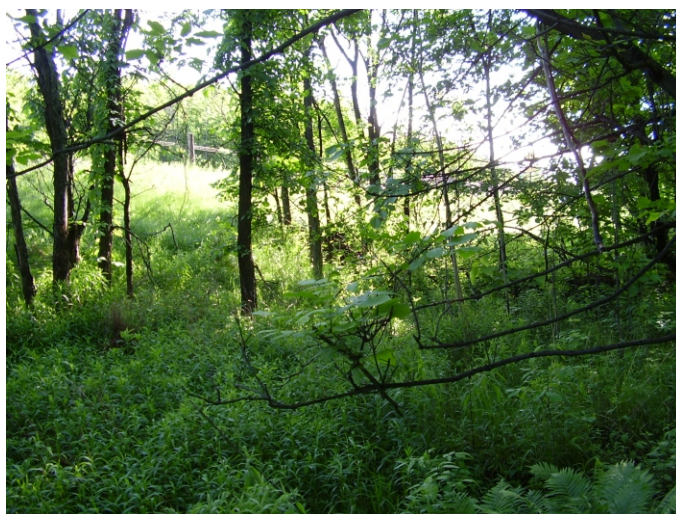
Photo 2 →
Photo showing Highway 17 forested embankment from Site 2. Photo taken facing northeast.

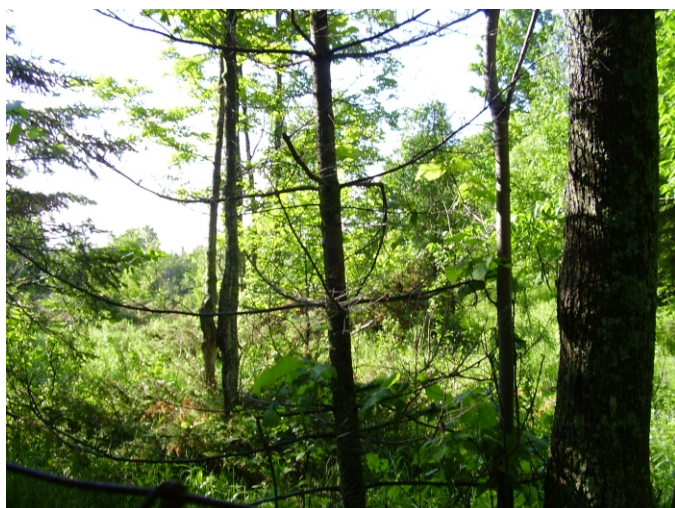
← Photo 3
Wetland on south side of highway located immediately south of Site 2. Photo taken facing southwest.

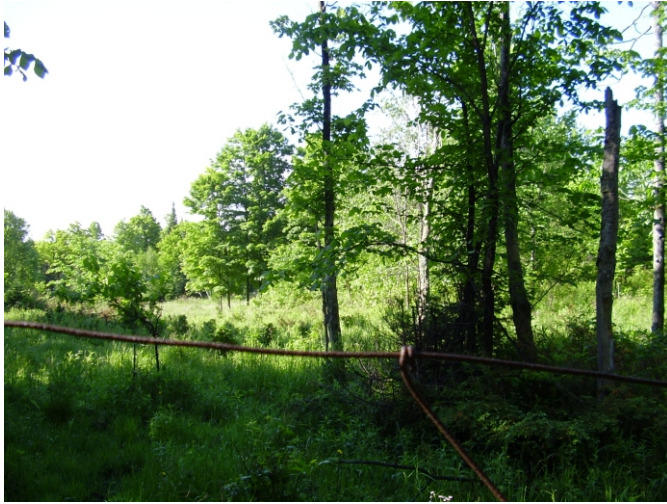
← Photo 4
Wetland on south side of Highway 17.
Photo taken facing south.

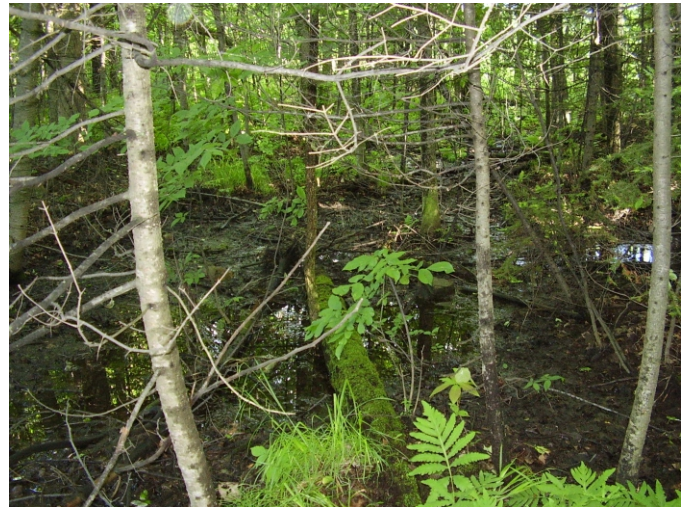
Photo 5 →
Wet area located north of Highway 17
flowing south into culvert and discharging
into wetland south of the highway (Site 2).
Photo taken facing northwest.

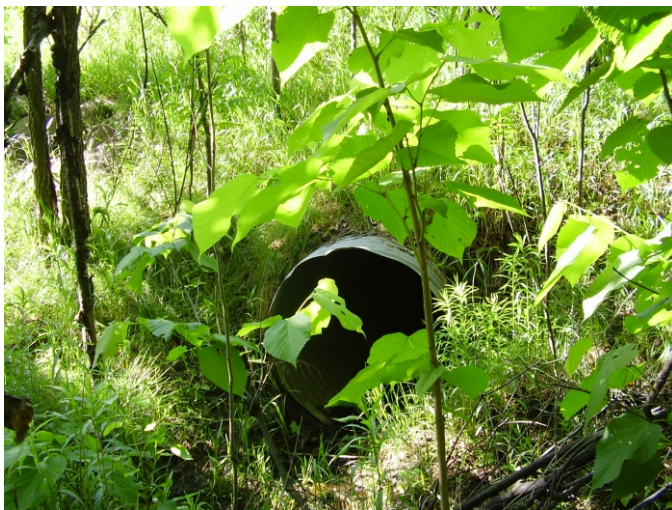
The site inspection identified the presence of a culvert running beneath Highway 17. Upstream of the culvert is a small wetland with observable standing water. The wetland appears to drain through the culvert and discharges into the larger wetland located south of the highway. The area around the culvert discharge was noted to be saturated with small pools of standing water. This predominantly surface water system drains into Locha Creek (located approximately 1.6 km southeast of the site) through a series of wetlands and connecting creeks oriented in a northwest-southeast direction. There likely is groundwater contribution (baseflow) to the system.

← Photo 6
Close up of culvert located on the north
side of Highway 17 which drains under
the highway and into the wetland on the
south side of the highway. Photo taken
facing north.

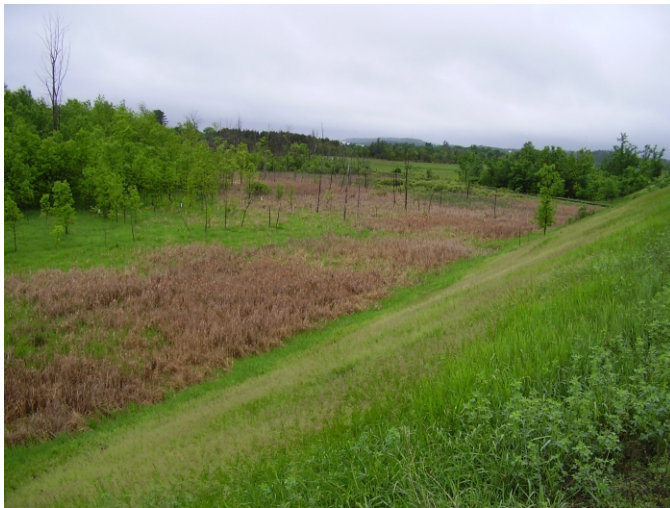
← Photo 1
Wetland between Highway 17 (right side of photo) and gravel pits (beyond left side of photo). Photo taken facing west.

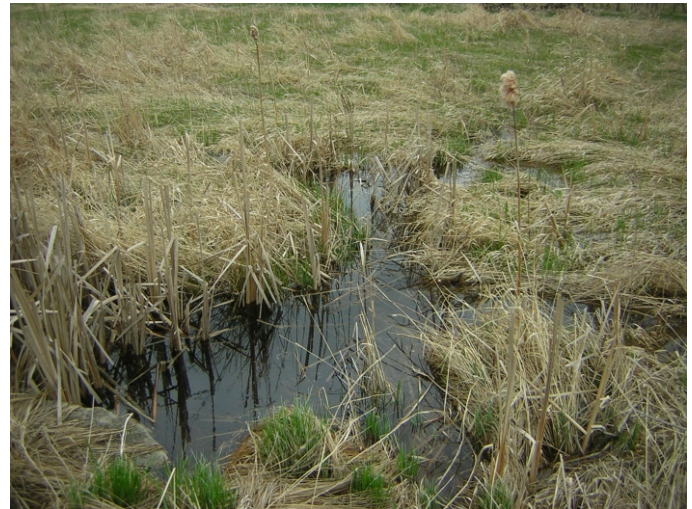
- The discrete groundwater seep observed during the site inspection appears to emerge from the base of a shallow exposed bedrock terrace next to a wetland.

Photo 2 →
Groundwater seep discharging groundwater from bedrock face (bottom right corner of photo) and into wetland.
Photo taken facing south.

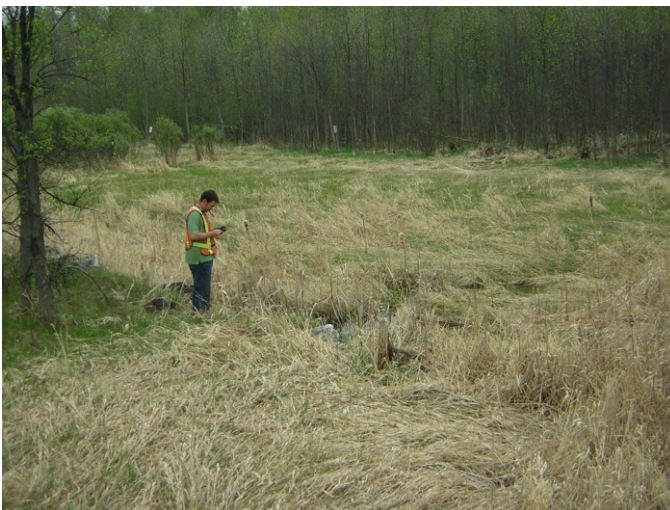
← Photo 3
Location of groundwater seep at base of bedrock terrace (in front of person). Photo taken facing east.

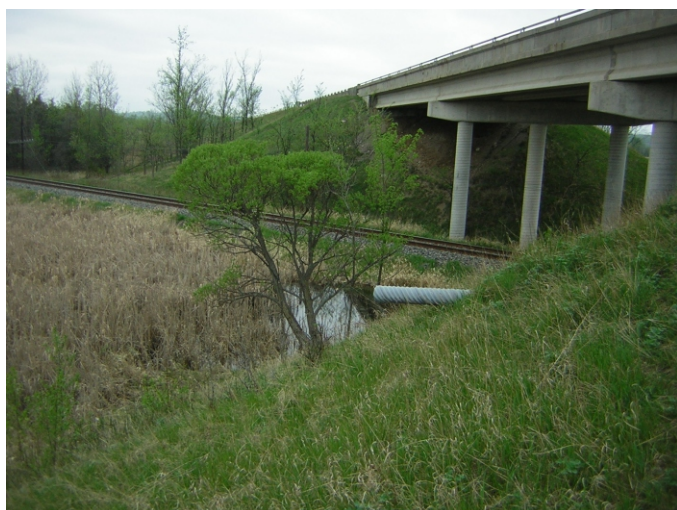
← Photo 4
West end of wetland showing drainage culvert and CPR Overpass. Photo taken facing west.

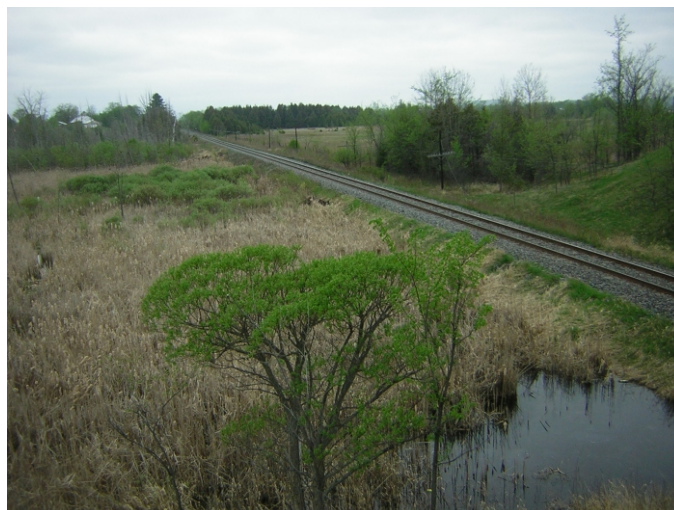
Photo 5 →
West end of wetlands showing standing water and CPR tracks. Photo taken facing southwest.

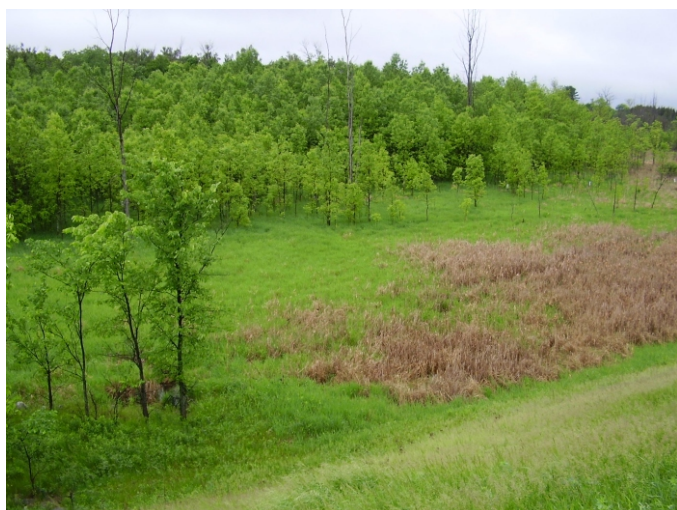
← Photo 6
East end of wetland showing small stream (in the few trees at the left side of the photo) flowing to the east towards Deil's Creek. Photo taken facing west.

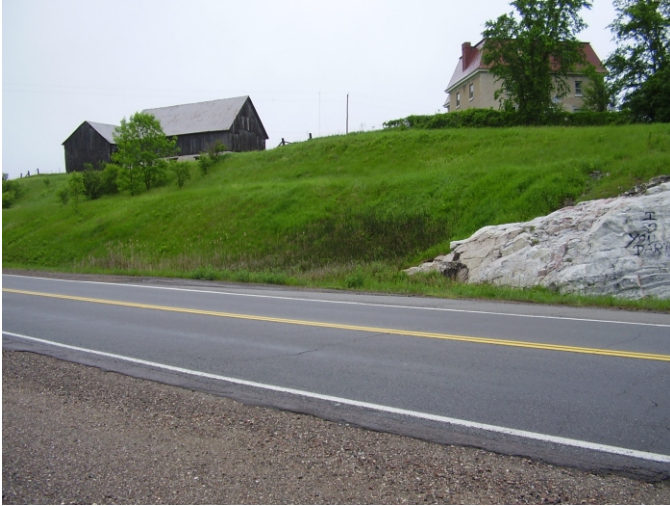
- On the east side of the highway at Station 19+000 (immediately upgradient of a bedrock cut), a passive groundwater discharge zone (seep) exists on the side of the steep slope rising up to the surrounding bedrock tableland (Seep 2). The soil covering the localized seep area which measures approximately 10 metres in length by 5 metres high was noted to be wet and vegetated with grasses and horsetails (indicative of wet conditions). At the base of the seep, groundwater pools and then flows along the drainage ditch flanking the east side of the highway and downslope into the culvert (Culvert 2) running beneath the highway and into the pool located on the west side of the highway as noted above.

← Photo 1
Photo showing groundwater seep (Seep 2). The seep area is the patch of brown vegetation (horsetail) to the left of the bedrock outcrop. Photo taken facing northeast.

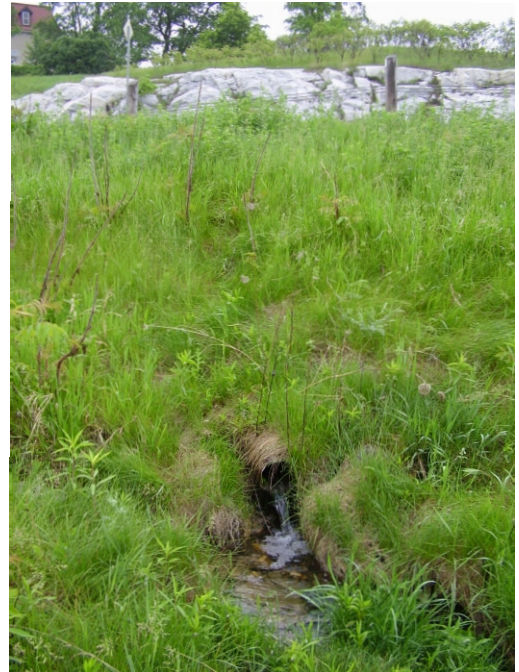
The site inspection identified a discrete groundwater discharge zone (Seep 1) discharging from a culvert (Culvert 1) located on the west side of Highway 17. The discharge water flows along the ditch flanking the west side of the highway and collects and pools approximately 120 metres south of the site on relatively flat terrain. At this pool location, another culvert (Culvert 2) running beneath the highway conveys drainage water from the east side of the highway. The pool likely collects both storm water and groundwater from both sides of the highway and slowly infiltrates into the shallow aquifer system. On the east side of the highway (approximately 80 metres to the northeast of Seep 1), immediately upgradient of a bedrock cut, a passive groundwater discharge zone (Seep 2) exists on the side of the steep slope rising up to the surrounding bedrock tableland (Seep 2). At the base of the seep, groundwater pools and then flows along the drainage ditch flanking the east side of the highway and downslope into Culvert 2 running beneath the highway and into the pool located on the west side of the highway as noted above. Another culvert (Culvert 3) exists on the east side of the highway, approximately 50 metres south of Seep 2. The culvert is on an approximate 45⁰ angle with the ditch and discharges groundwater into the ditch. Both flow from this culvert and Seep 2 contribute to the receiving pool at the Culvert 2 discharge area.

Photo 2 →
Photo showing a close-up of Seep 1 with water flowing from the culvert (Culvert 1), pooling and flowing into a south flowing ditch along the west side of Highway 17. Photo taken facing east.

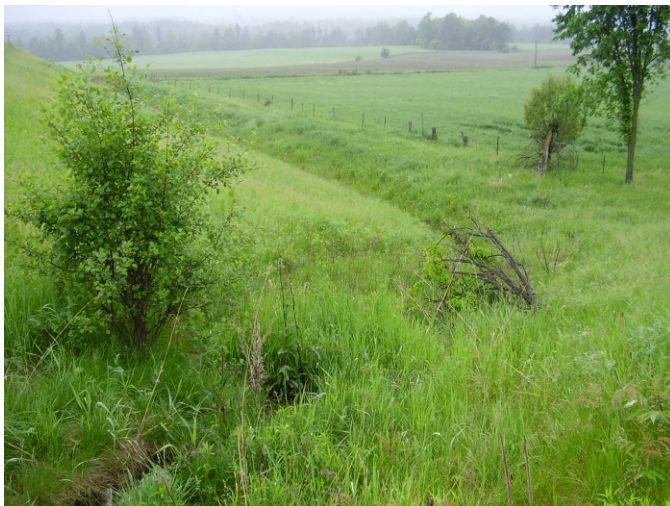
← Photo 3
Seep 1 drainage ditch following the base of the west highway embankment conveying discharge water from Culvert 1 towards a pool of water south of the site. Photo taken facing southwest.

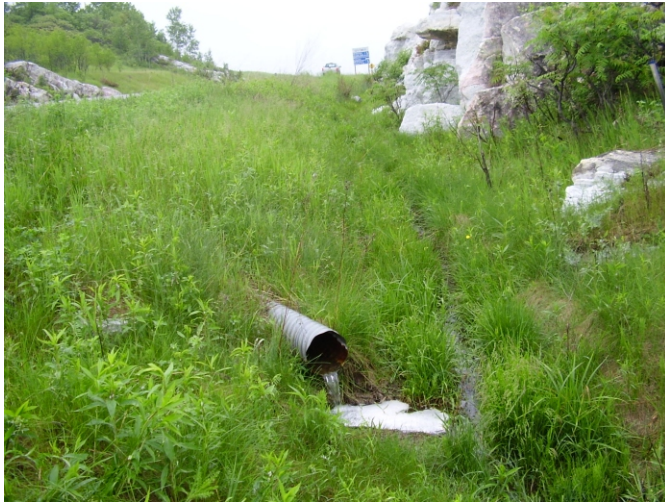
← Photo 4
Photo showing Culvert 3 discharging water into the drainage ditch on the east side of Highway 17 which then flows to the south of the site and into Culvert 2. Photo taken facing north.

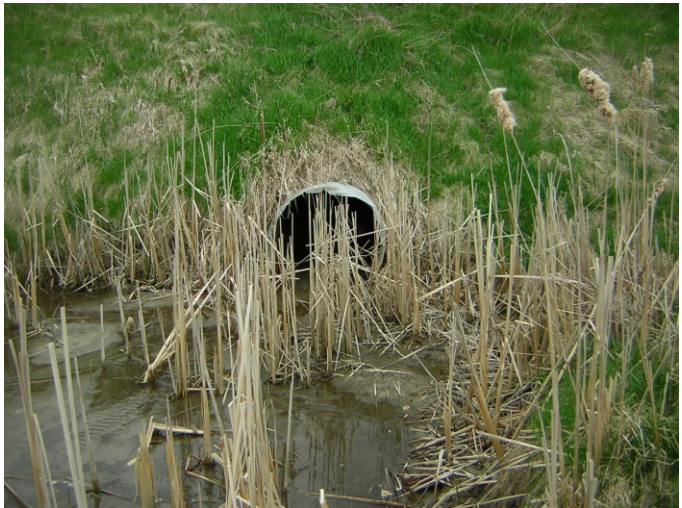
Photo 5 →
Photo showing Culvert 3 located south of the site on the west side of Highway 17. Photo taken facing east.

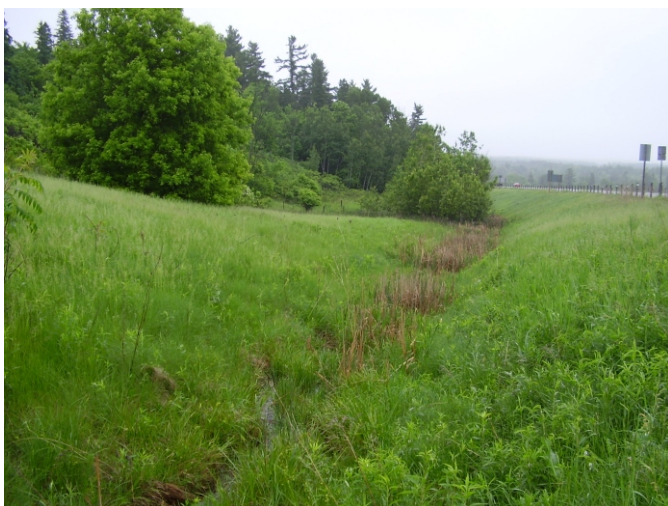
← Photo 6
Drainage ditch flanking the east side of the highway between Culverts 2 and 3. Photo taken facing south.
