FOUNDATION INVESTIGATION REPORT

RETAINING WALLS

HIGHWAY 7A

TASK NO. 2013-E-0039-008

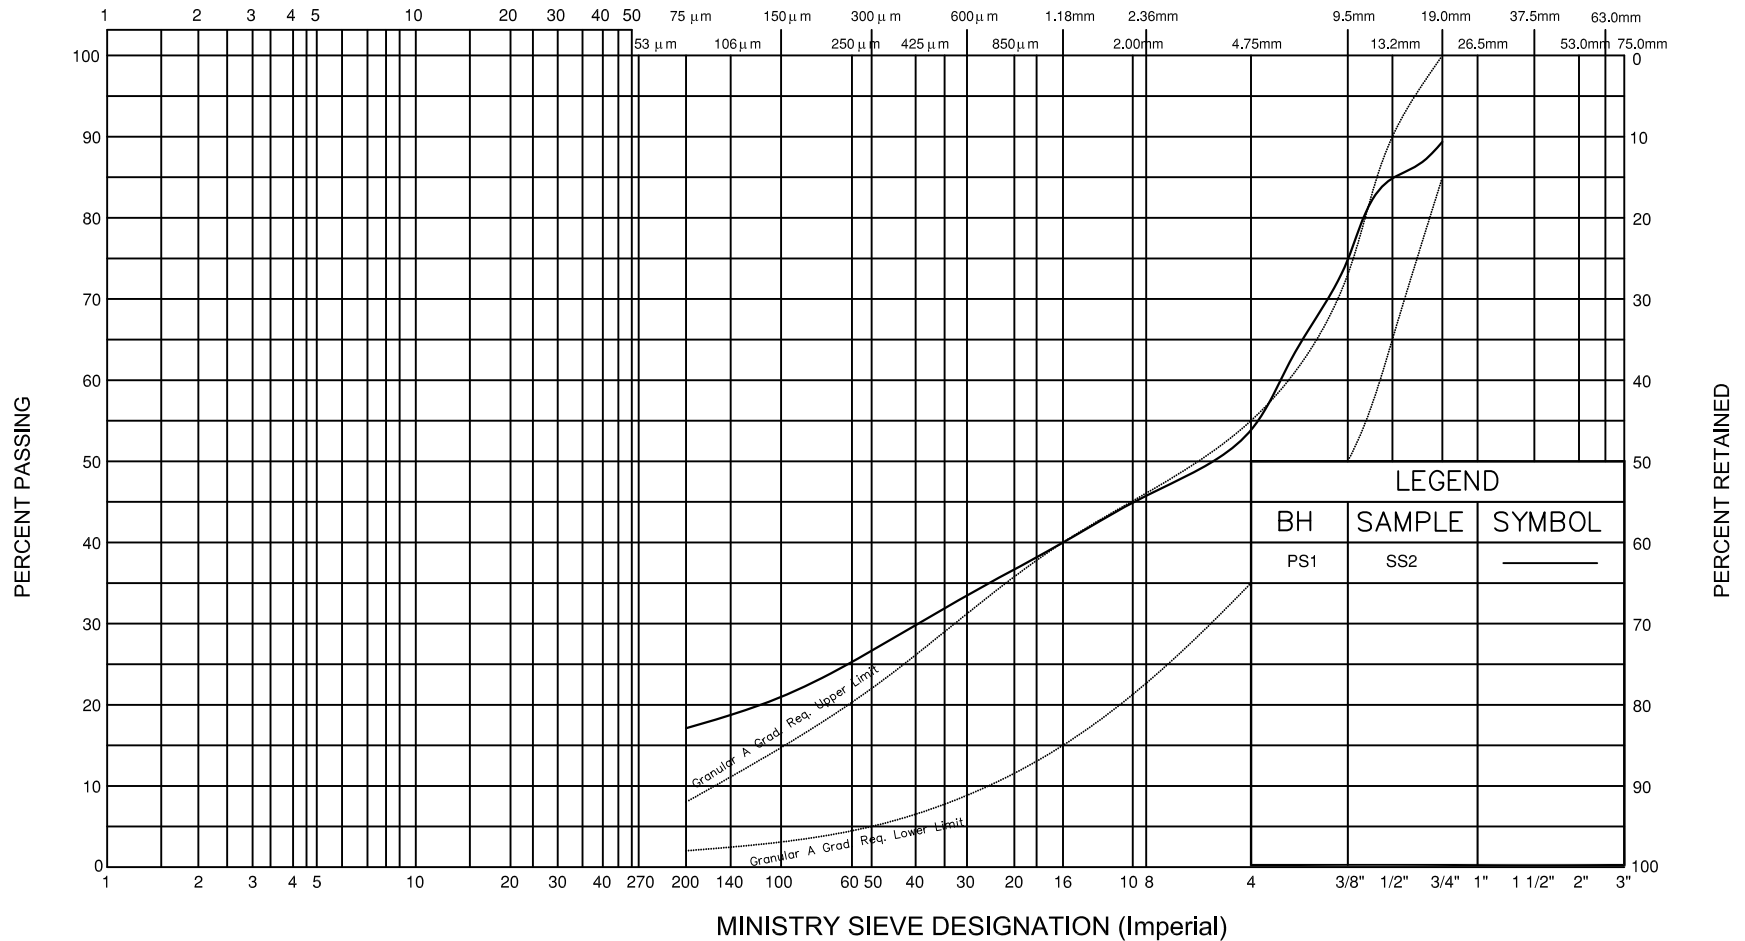
FIG. No RW-GS-1
HWY 7A Retaining Wall
TASK No. 2013-E-0039-008

Underlying the topsoil at a depth of 0.3 m in borehole PS-1 was granular fill. The non-cohesive fill layer comprised sandy gravel with 17% silt and organics inclusions. The sandy gravel fill was loose to compact in relative density (SPT-'N' values of 5 to 21) and was penetrated at a depth of 1.8 m (elevation 261.7). The moisture content of the granular fill was determined to range between 2 and 21%. The higher moisture content is attributed to the organic inclusions contained within the fill deposit.

GRAIN SIZE DISTRIBUTION
SANDY GRAVEL, some silt
(FILL)

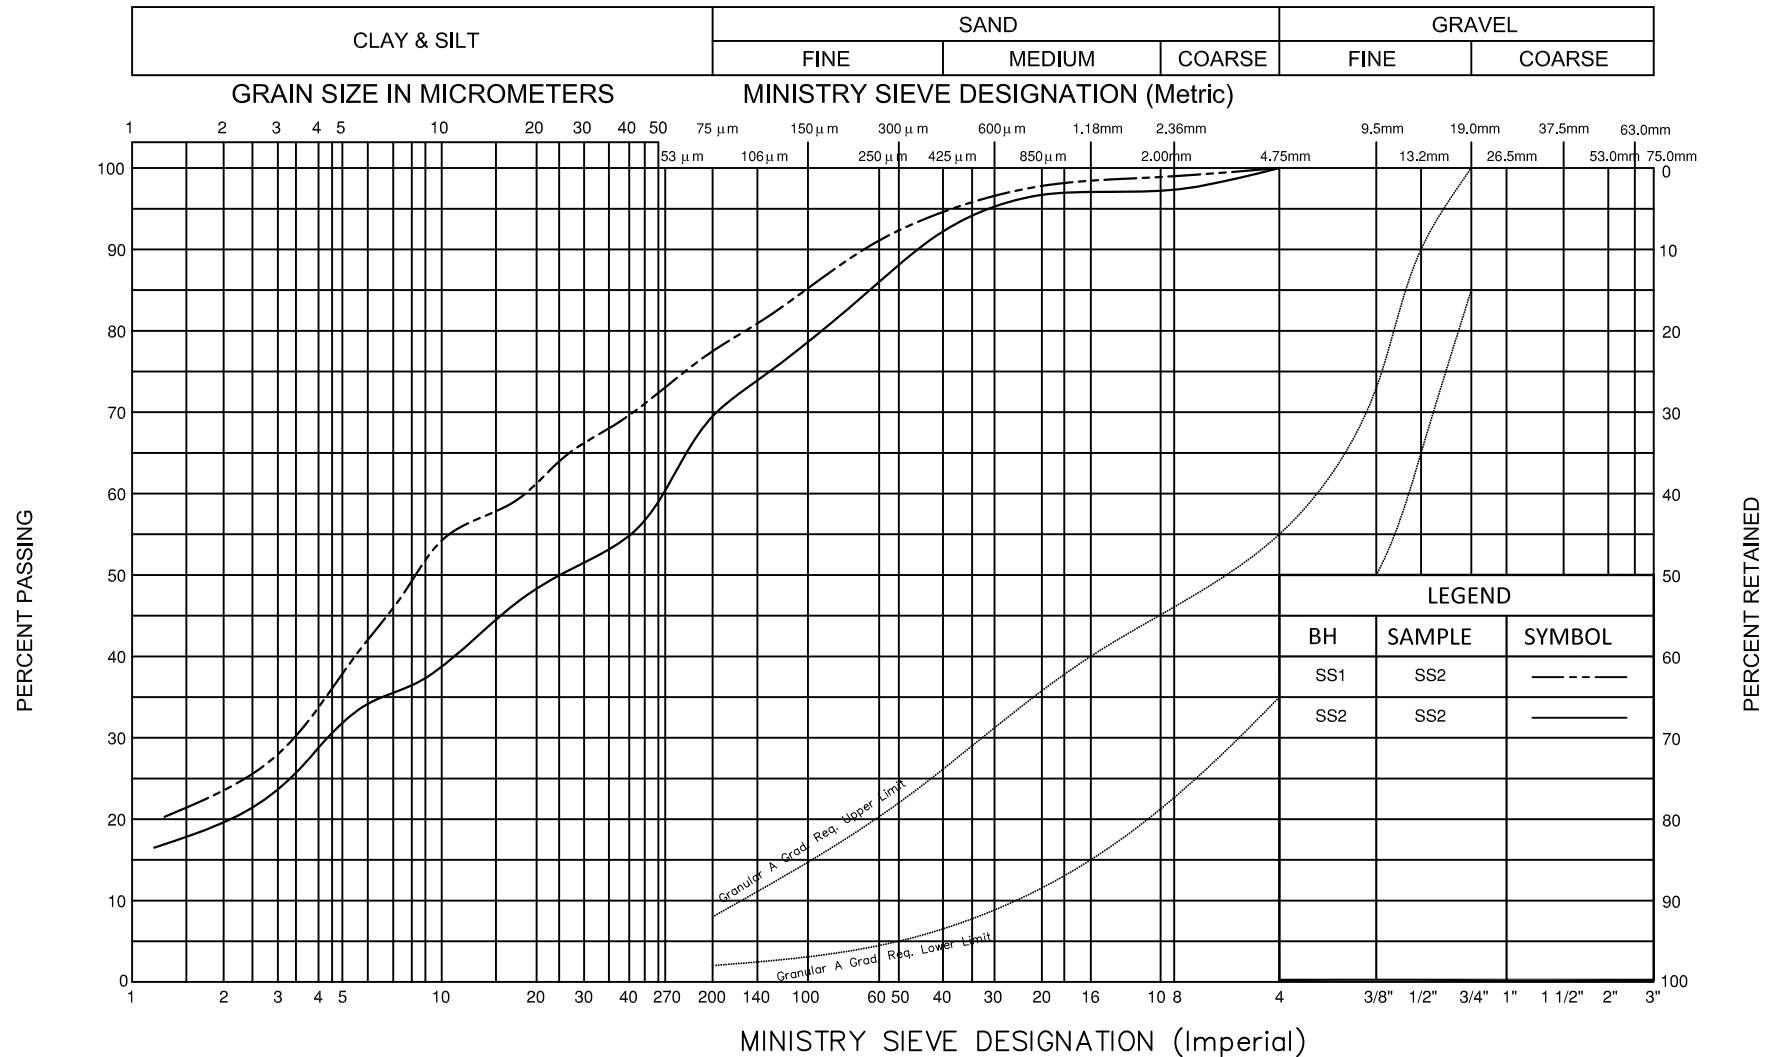
FIG. No RW-GS-2
HWY 7A Retaining Wall
TASK No. 2013-E-0039-008

The results of Atterberg limits testing and grain size distribution analyses conducted on two samples of cohesive fill from boreholes SS-1 and SS-2 are presented in respective Figures RW-GS-2 and RW-PC-1. The liquid limits of the cohesive fill ranged from 18 to 21, while the plastic limit was 13 for both samples. The corresponding plasticity index was found to range from 5 to 8 for the cohesive fill.

GRAIN SIZE DISTRIBUTION
CLAYEY SILT, with sand to sandy (CL)
(FILL)

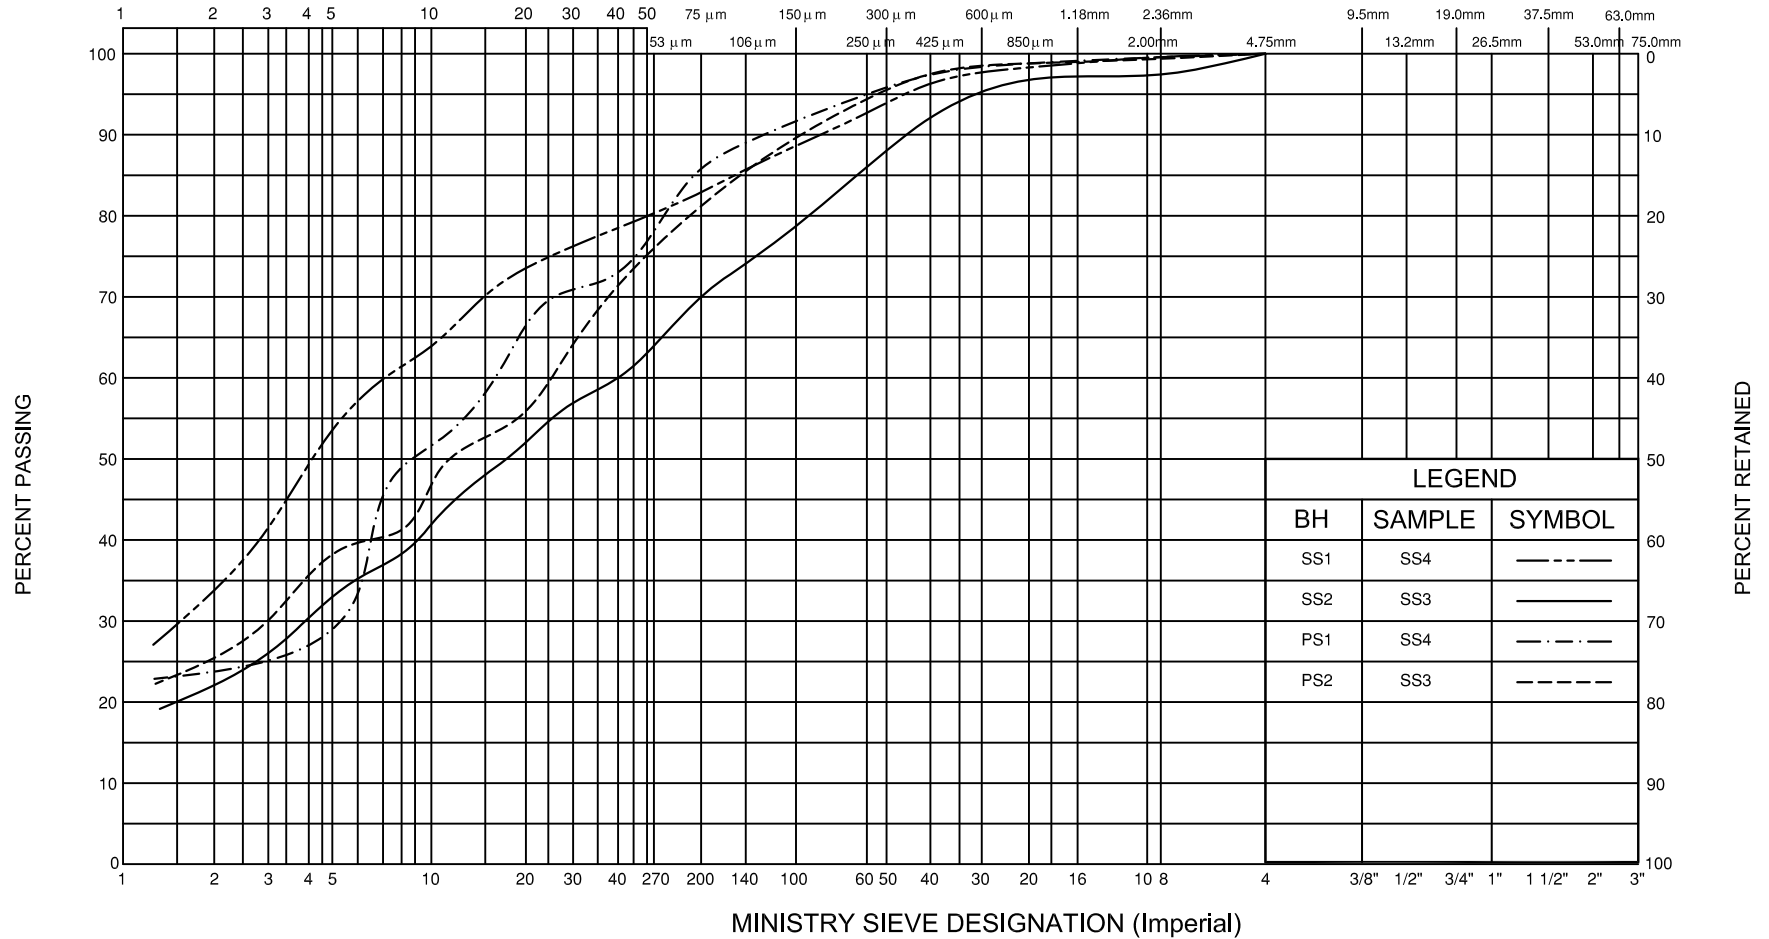
FIG. No RW-GS-3
HWY 7A Retaining Wall
TASK No. 2013-E-0039-008

GRAIN SIZE DISTRIBUTION
CLAYEY SILT, some sand to sandy (CL)
(TILL)

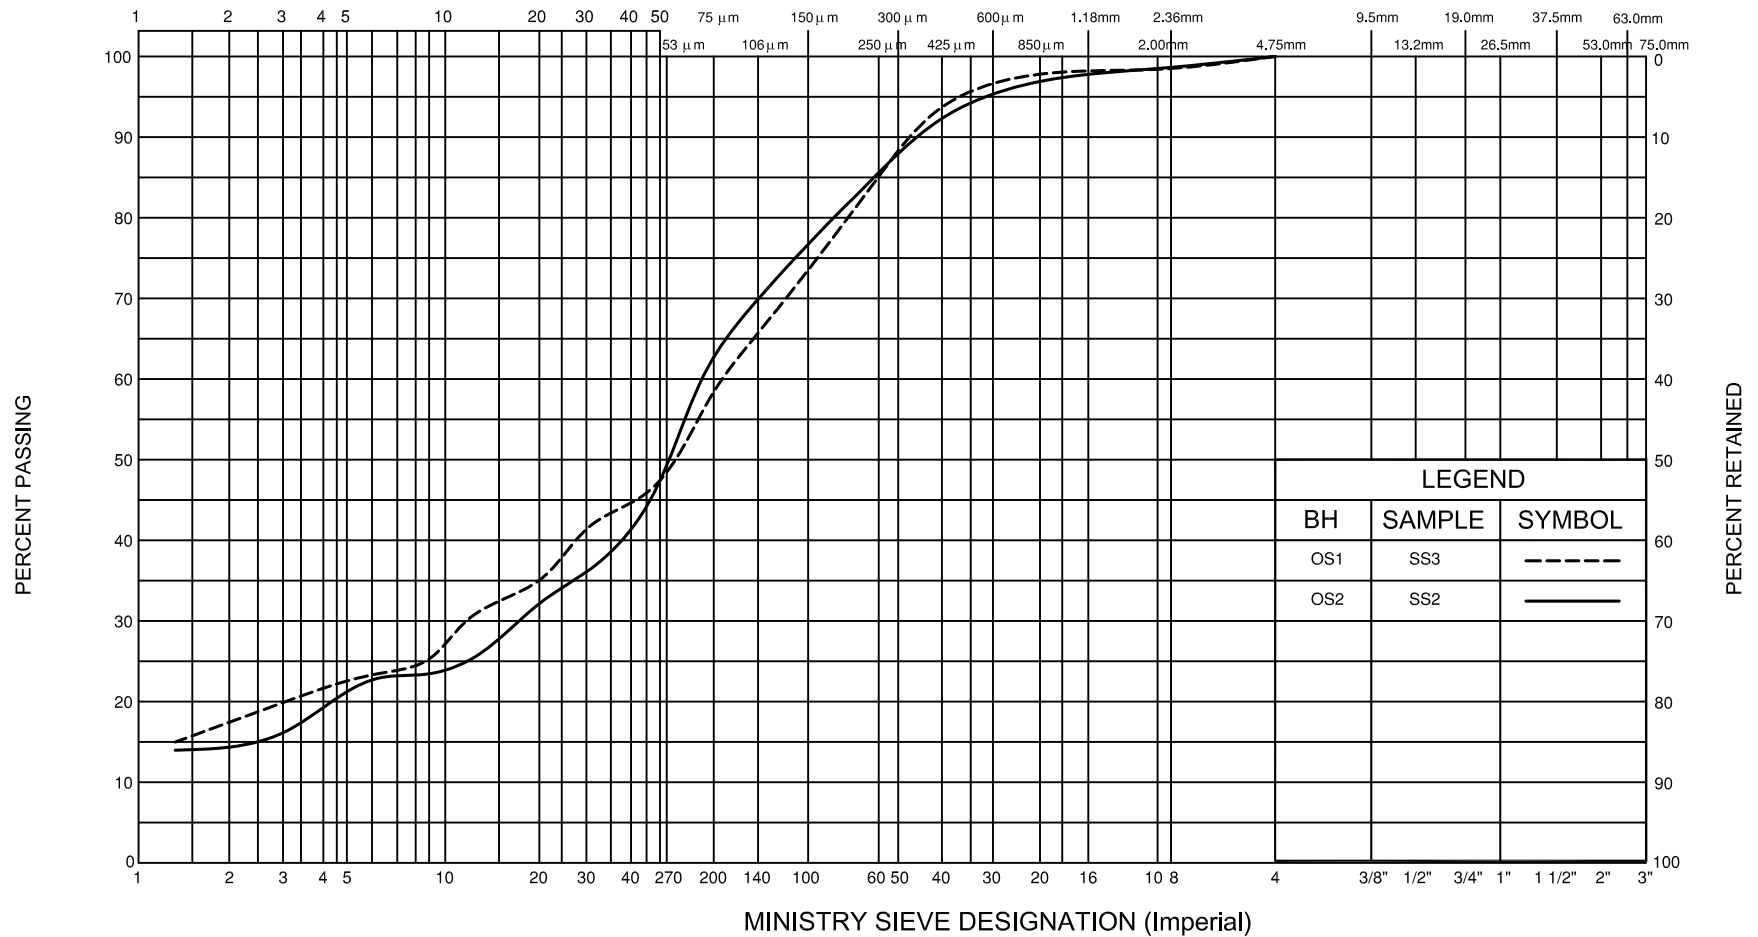
FIG. No RW-GS-4
HWY 7A Retaining Wall
TASK No. 2013-E-0039-008

GRAIN SIZE DISTRIBUTION
SAND AND SILT to SANDY SILT, some clay (ML)
(TILL)

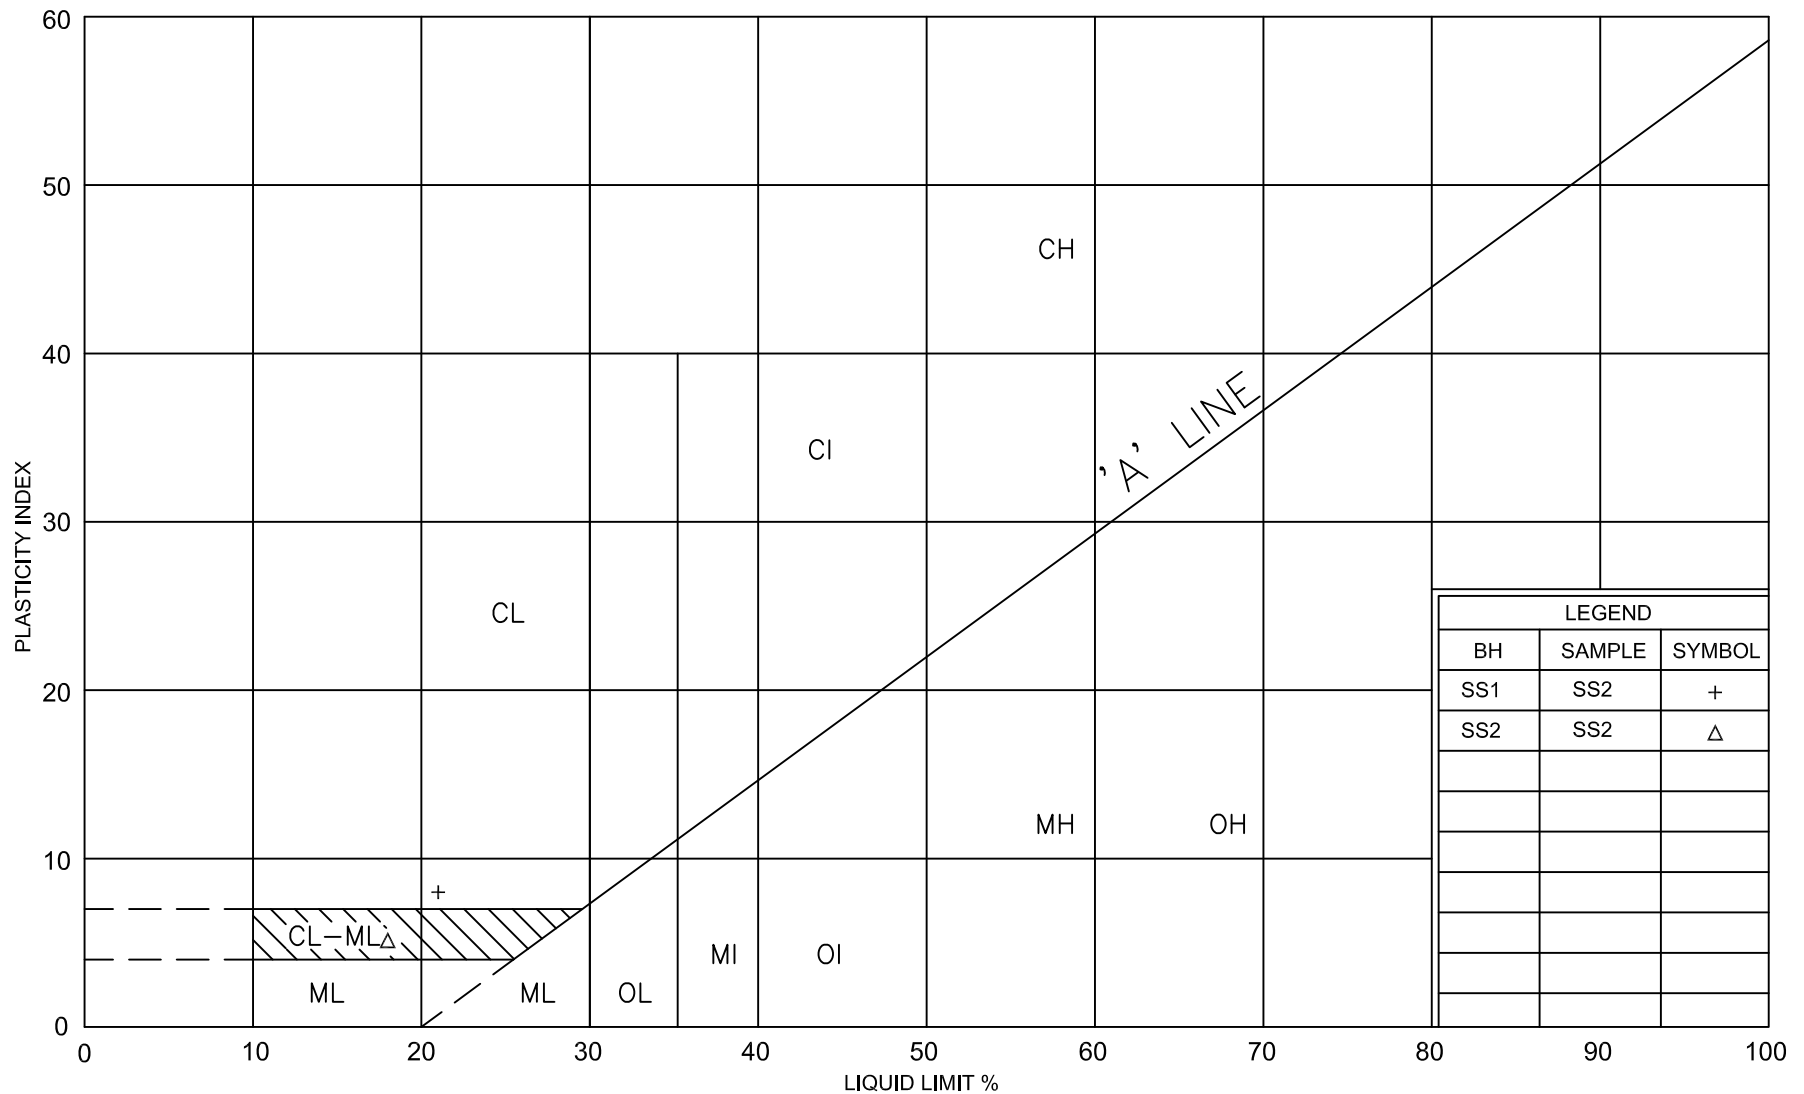
FIG. No RW-PC-1
 HWY 7A Retaining Wall
 TASK No. 2013-E-0039-008

PLASTICITY CHART
 CLAYEY SILT, with sand to sandy (CL-ML / CL)
 (FILL)

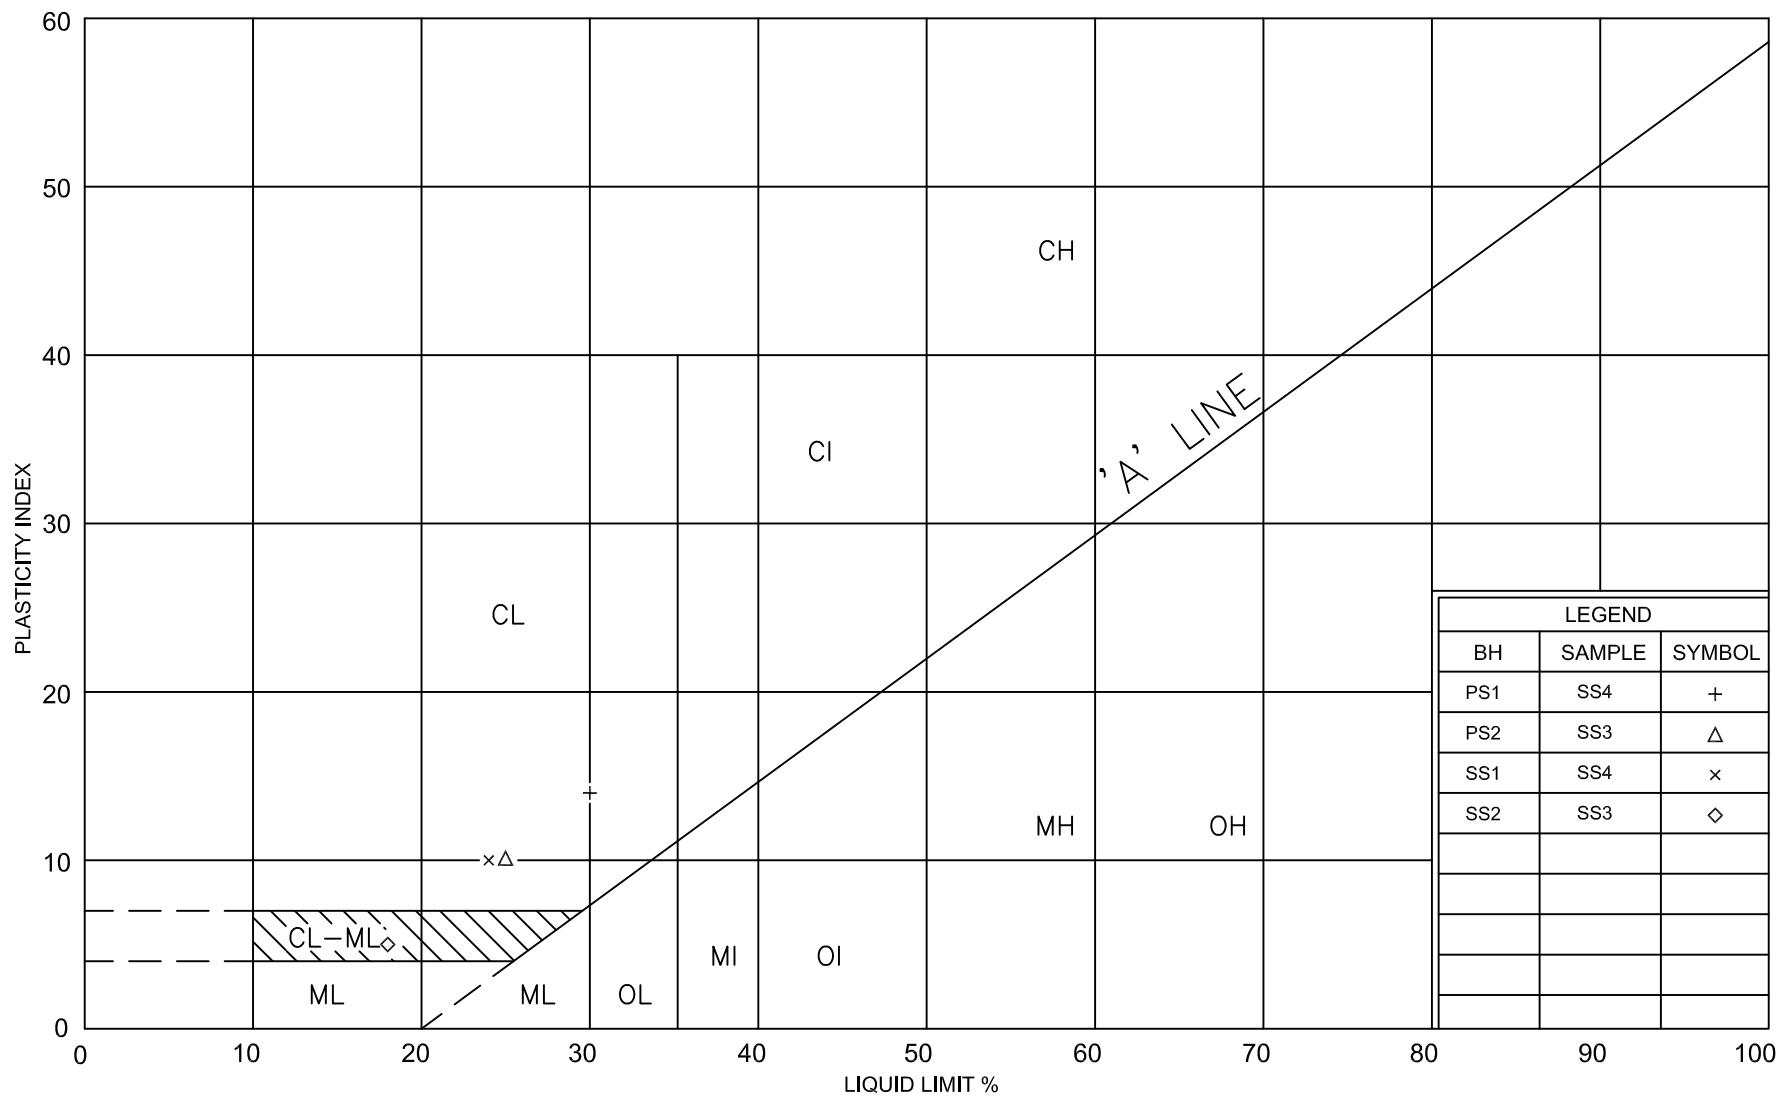
FIG. No RW-PC-2
HWY 7A Retaining Wall
TASK No. 2013-E-0039-008

PLASTICITY CHART
CLAYEY SILT, with sand to sandy (CL-ML / CL)
(TILL)

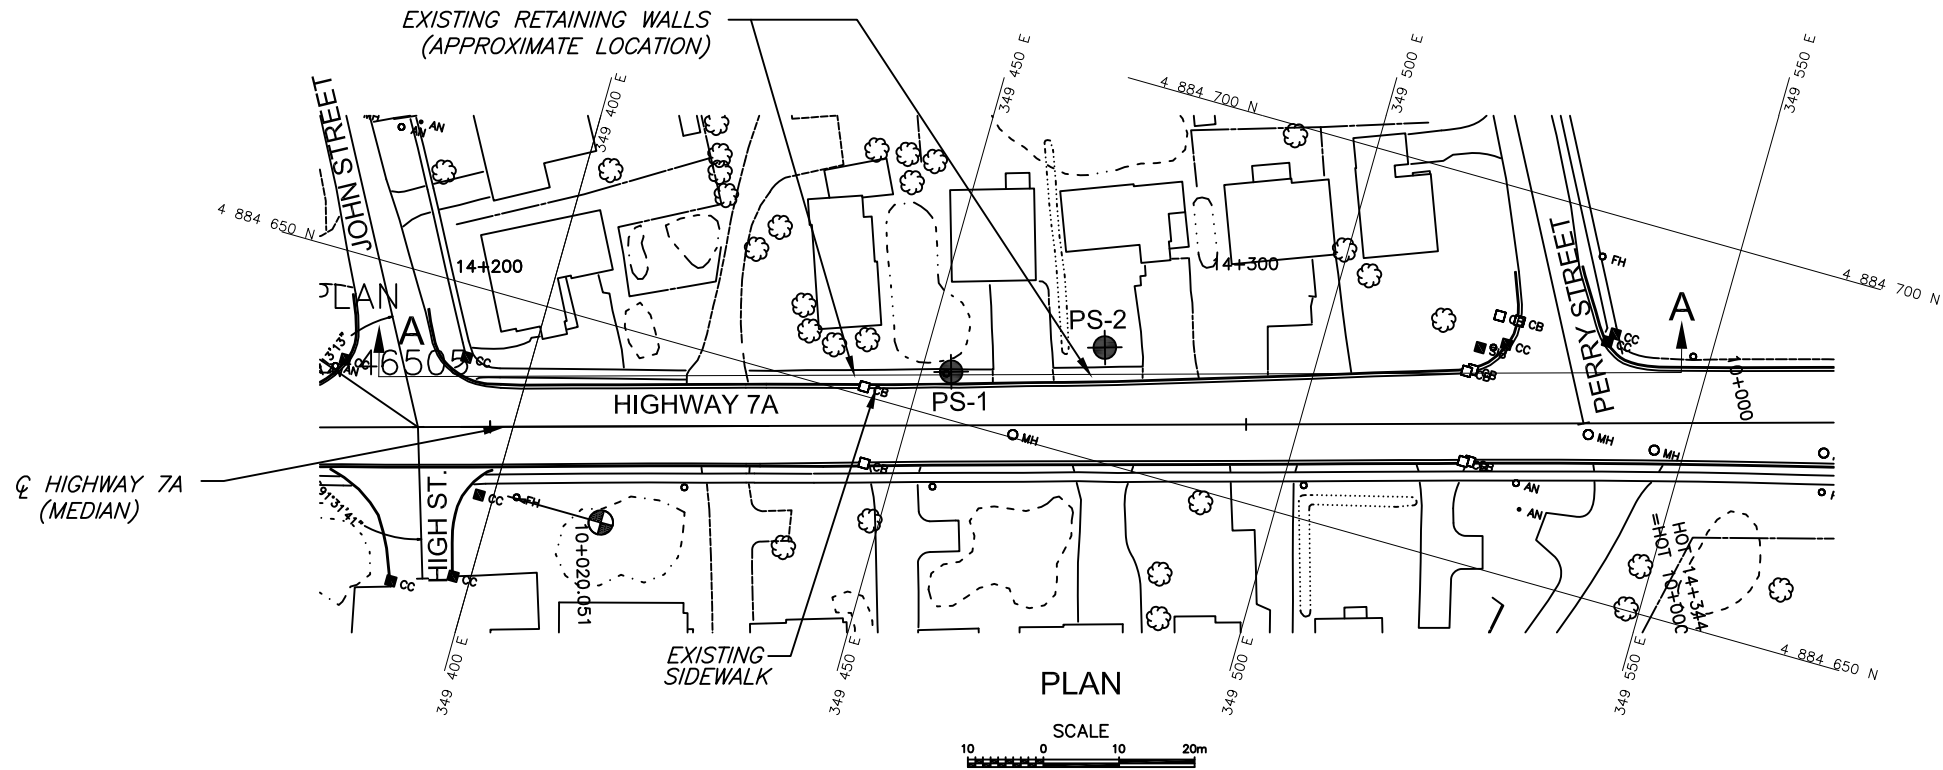
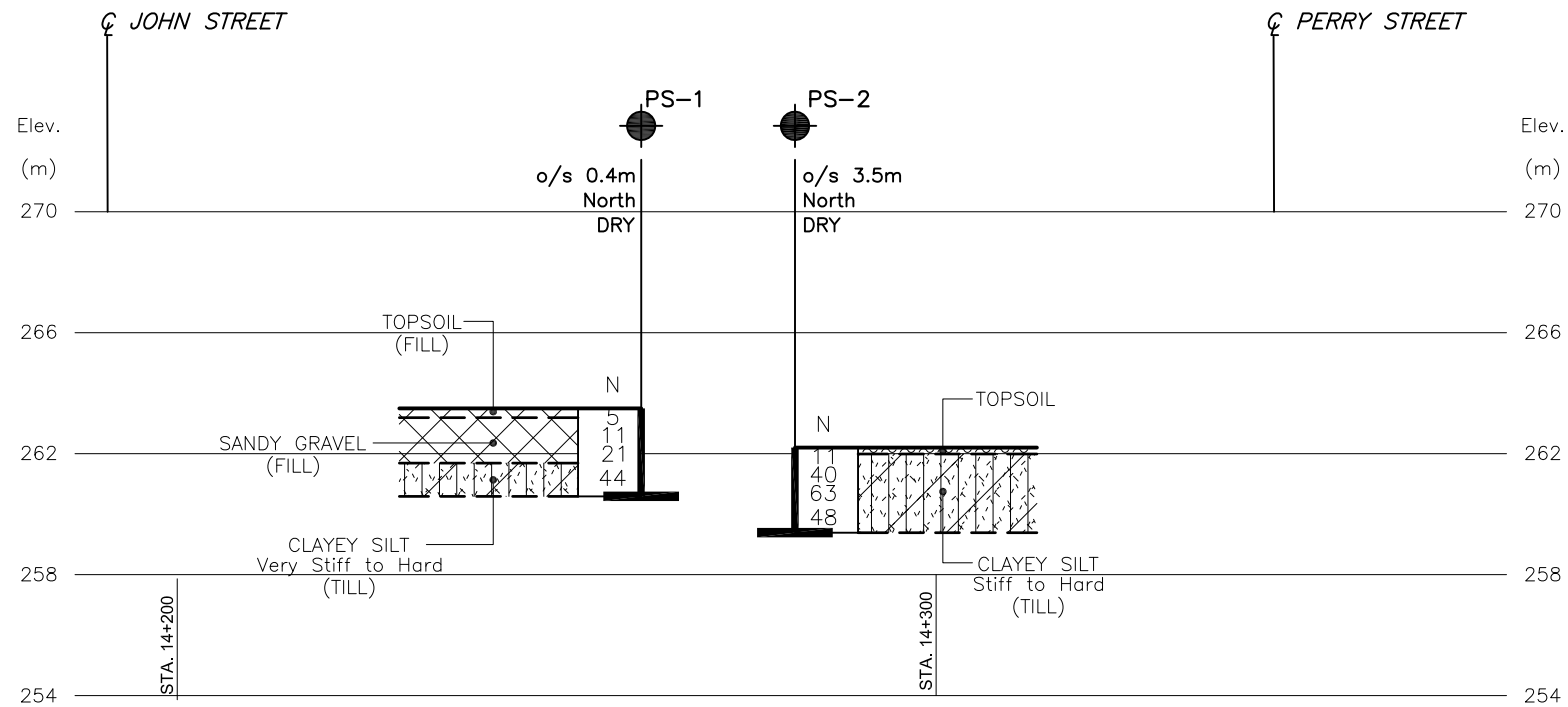
CONT No	
TASK No 2013-E-0039-008	
PERRY STREET RETAINING WALL HIGHWAY 7A	SHEET
BOREHOLE LOCATIONS AND SOIL STRATA

Clayey silt glacial till was revealed below the granular fill in borehole PS-1 and below the topsoil in borehole PS-2. The clayey silt till was encountered at depths of 1.8 and 0.2 m (elevation 261.7 and 262.0) in boreholes PS-1 and PS-2 respectively. This stratum was stiff to hard in consistency (SPT-'N' values of 11 to 63) and had a moisture content ranging from 10 to 16%. With a measured thickness of 1.1 and 2.7 m, the clayey silt glacial till was not penetrated upon termination of the boreholes at a depth of 2.9 m (elevation 260.6 and 259.3) in boreholes PS-1 and PS-2 respectively.

PROFILE A-A

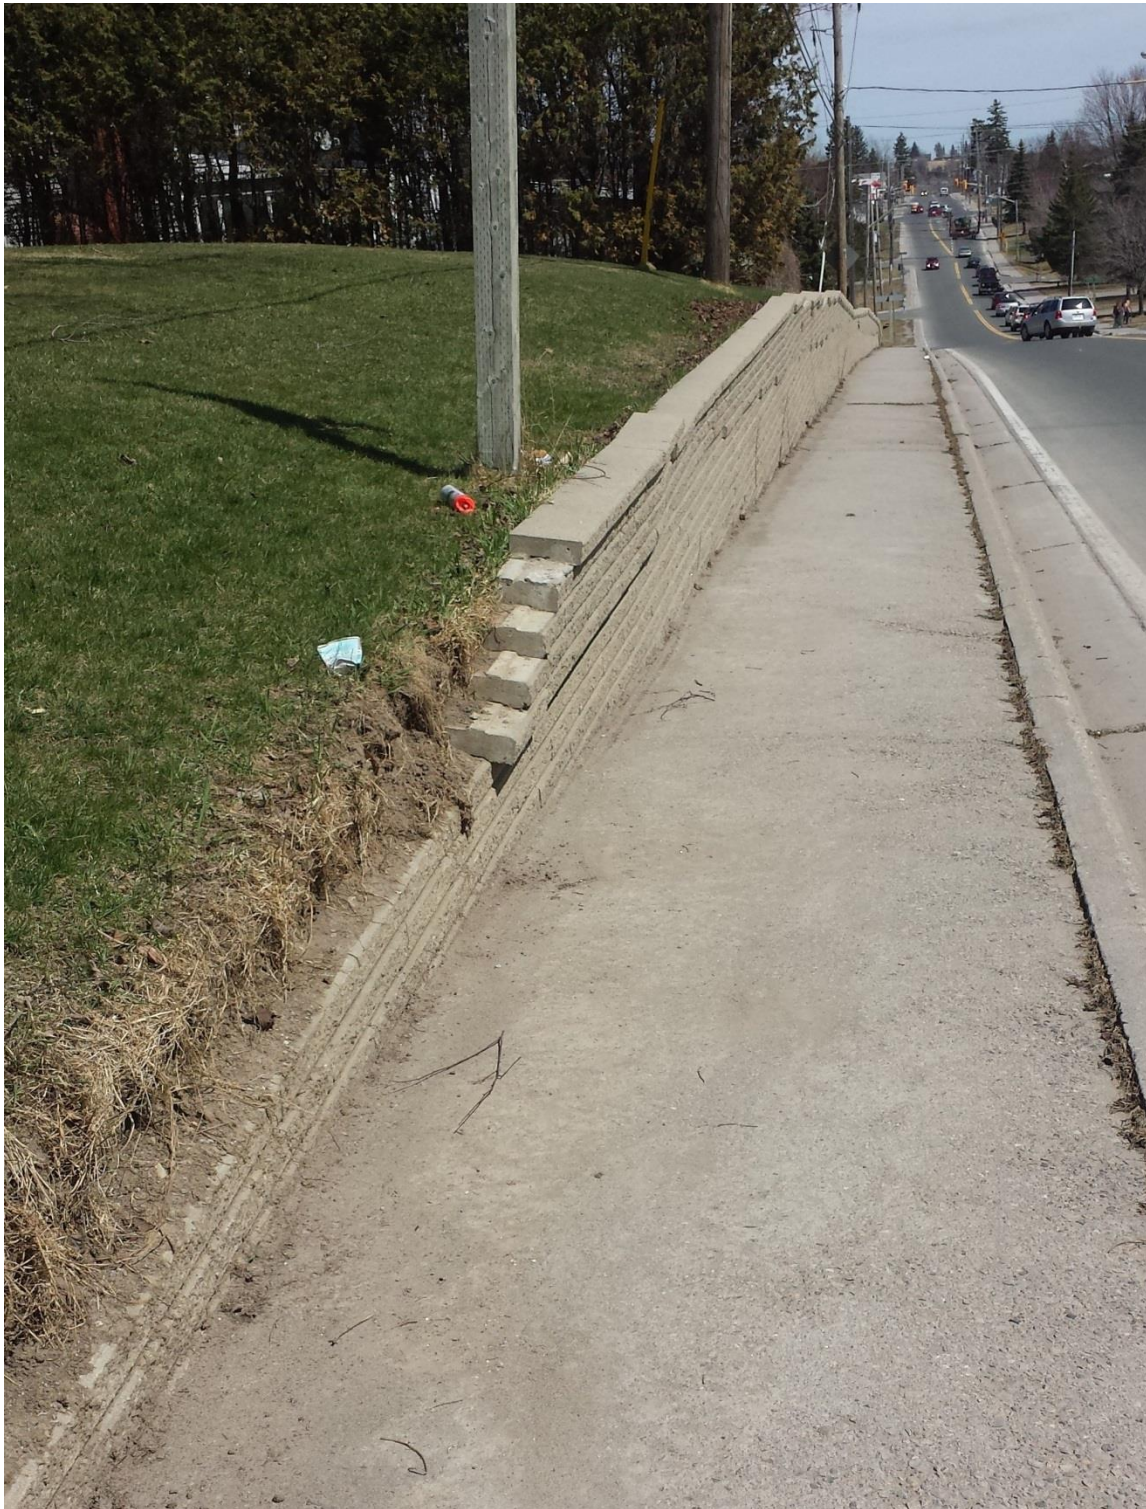
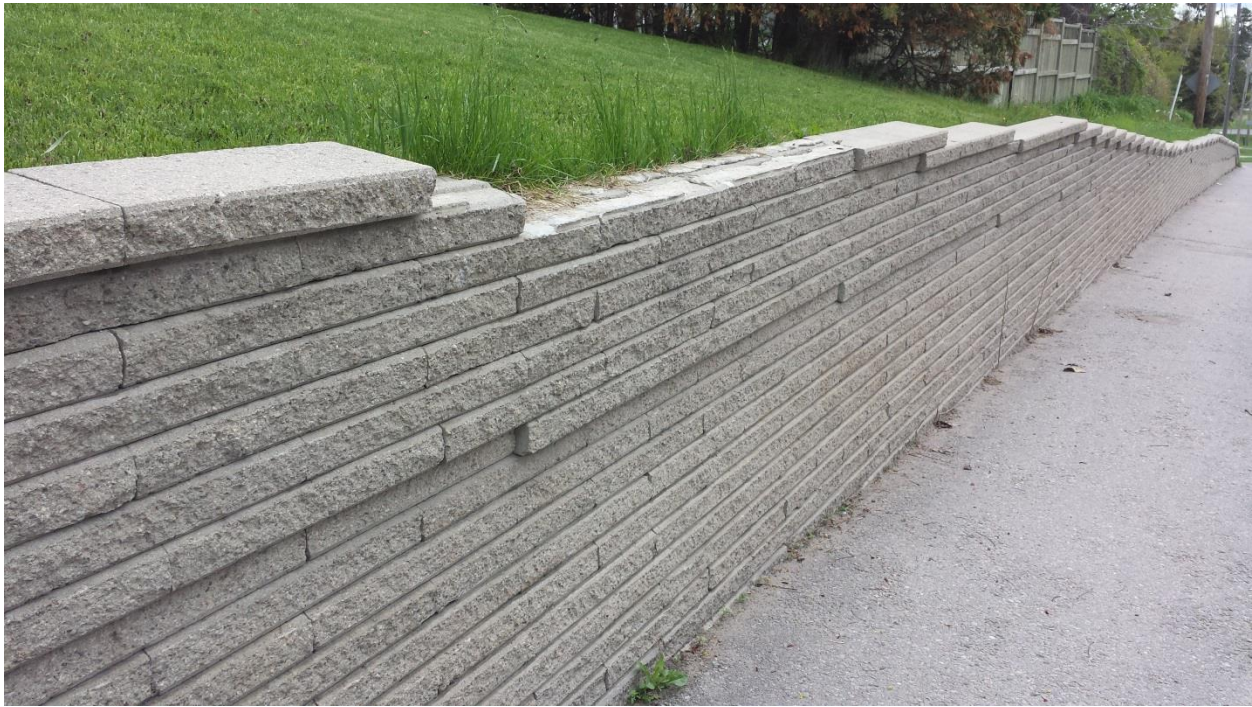
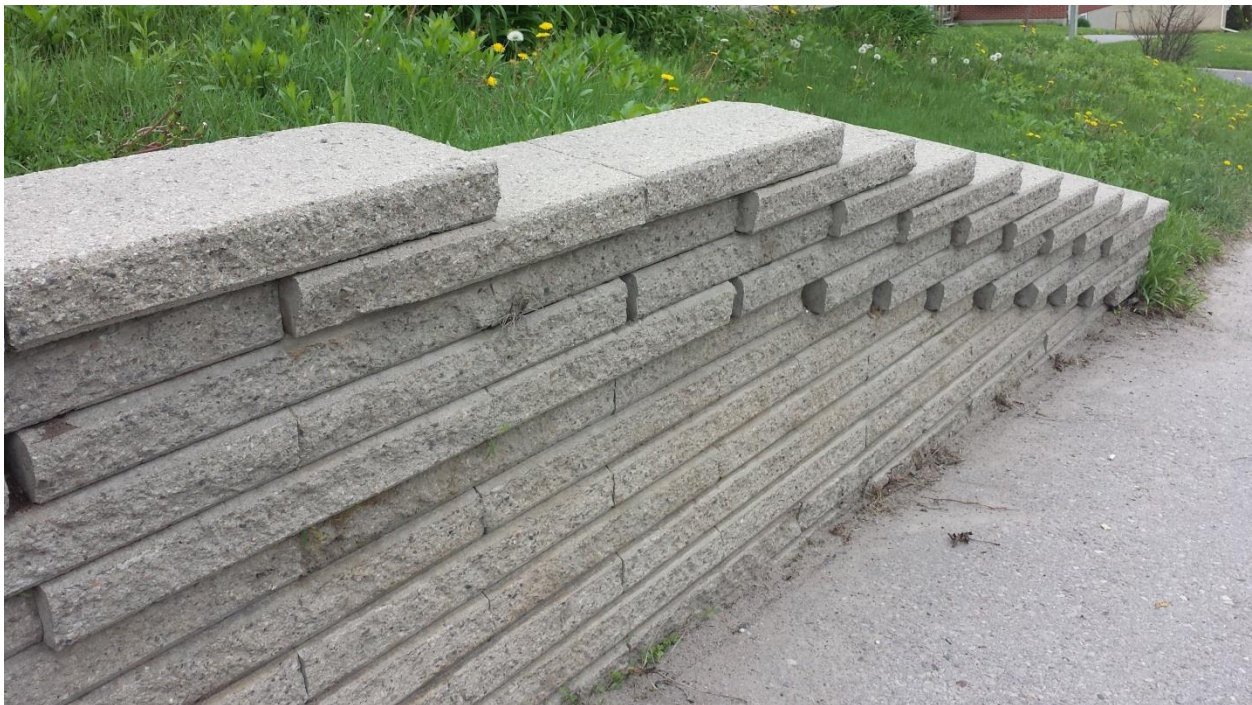
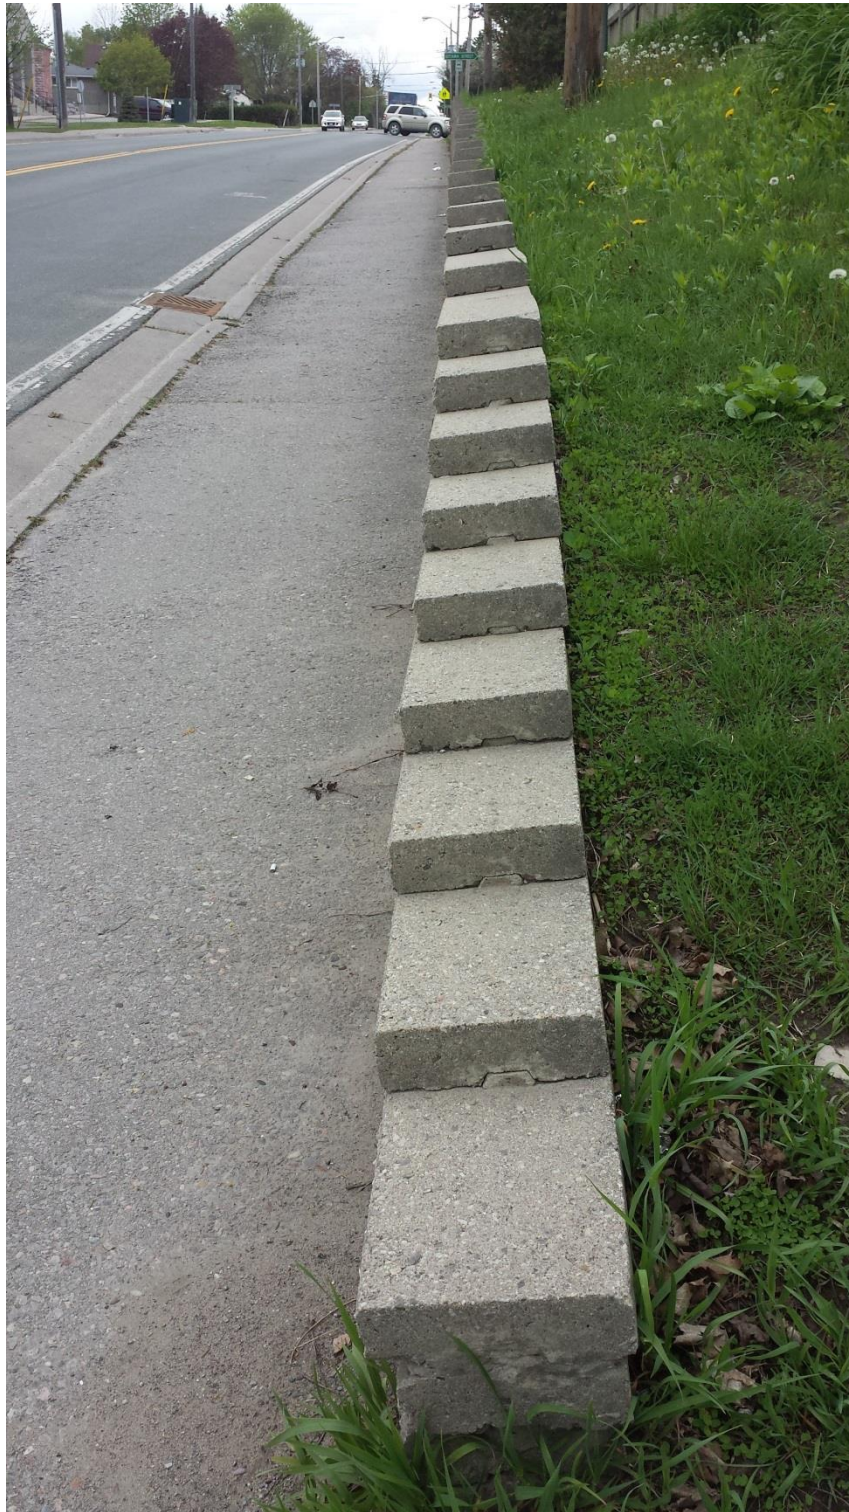
The Ottawa Street retaining wall (photographs 1 to 4) experienced forward movement / sliding or possible overturning in the top four to five lifts of stone near the far west end of the wall, as these layers of stones have been removed (see photograph 1). Forward movement, spacing between stones and outward / forward leaning within the upper portion of the wall was observed throughout the reconnaissance and borehole investigation of the Ottawa Street retaining wall (see photographs 2, 3 and 4). The upper portion of the Ottawa Street retaining wall was measured to be leaning forward / outward at an approximate slope of 1H:10V. Based on photographs 2 and 3, this wall may have been raised by up to 6 rows of stones (450 mm) in the past. No visible weeping holes for drainage of water infiltration that may exist behind the retaining wall were observed, indicating that drainage is being made through the retaining wall stone spaces. The retaining wall also shows signs of missing and / or cracked stones and spacing between blocks near the east end of the walls.

Photograph 1: Taken at the west end of the Ottawa Street retaining wall, facing east.
(April 16, 2015)

Photograph 2: Taken at the Ottawa Street retaining wall, facing northeast. (May 13, 2015)

Photograph 3: Taken near the east end of the Ottawa Street retaining wall, facing northeast. (May 13, 2015)

Photograph 4: Taken at the east end of the Ottawa Street retaining wall, facing west. (May 13, 2015)
