FOUNDATION INVESTIGATION REPORT

RETAINING WALLS

HIGHWAY 7A

TASK NO. 2013-E-0039-008

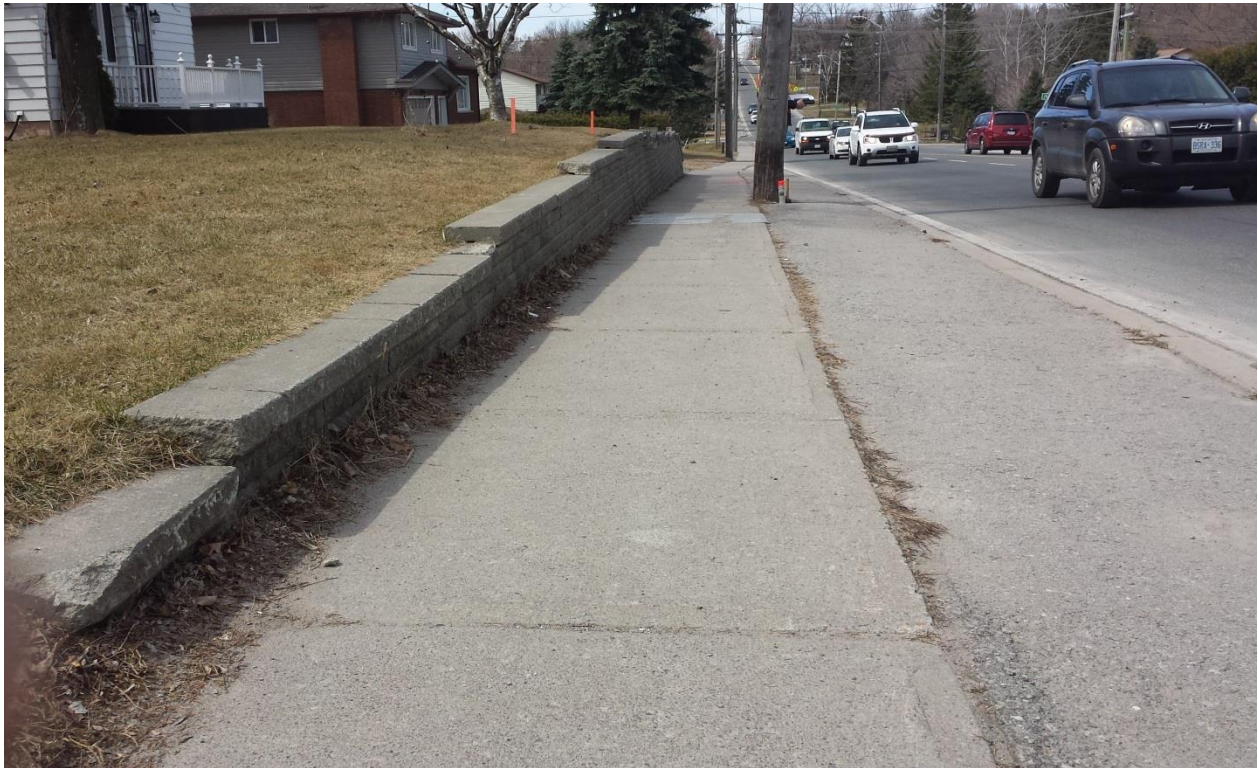
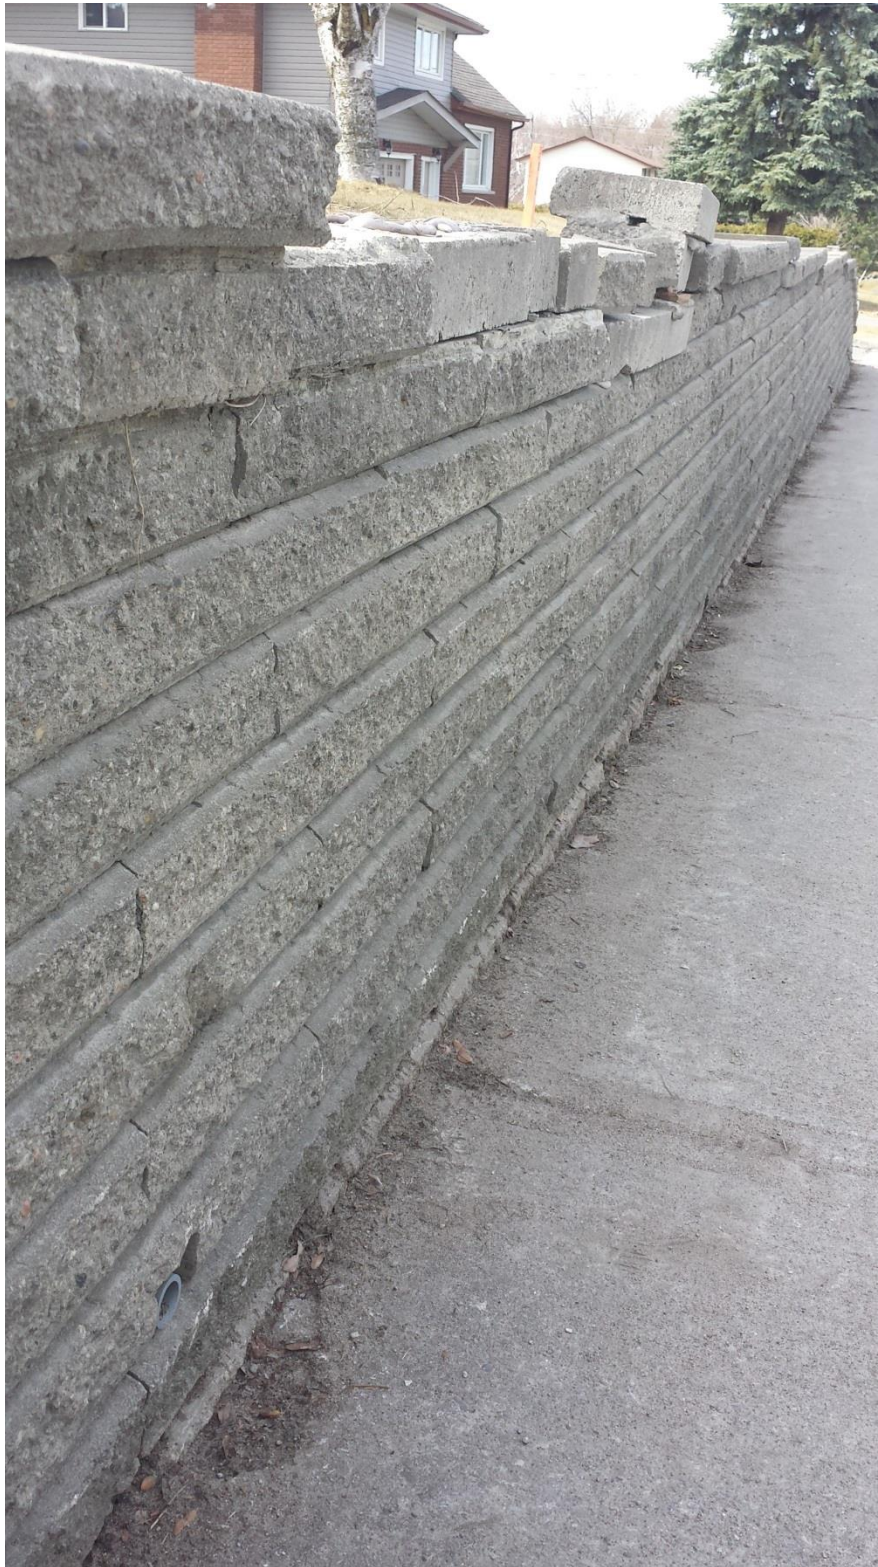
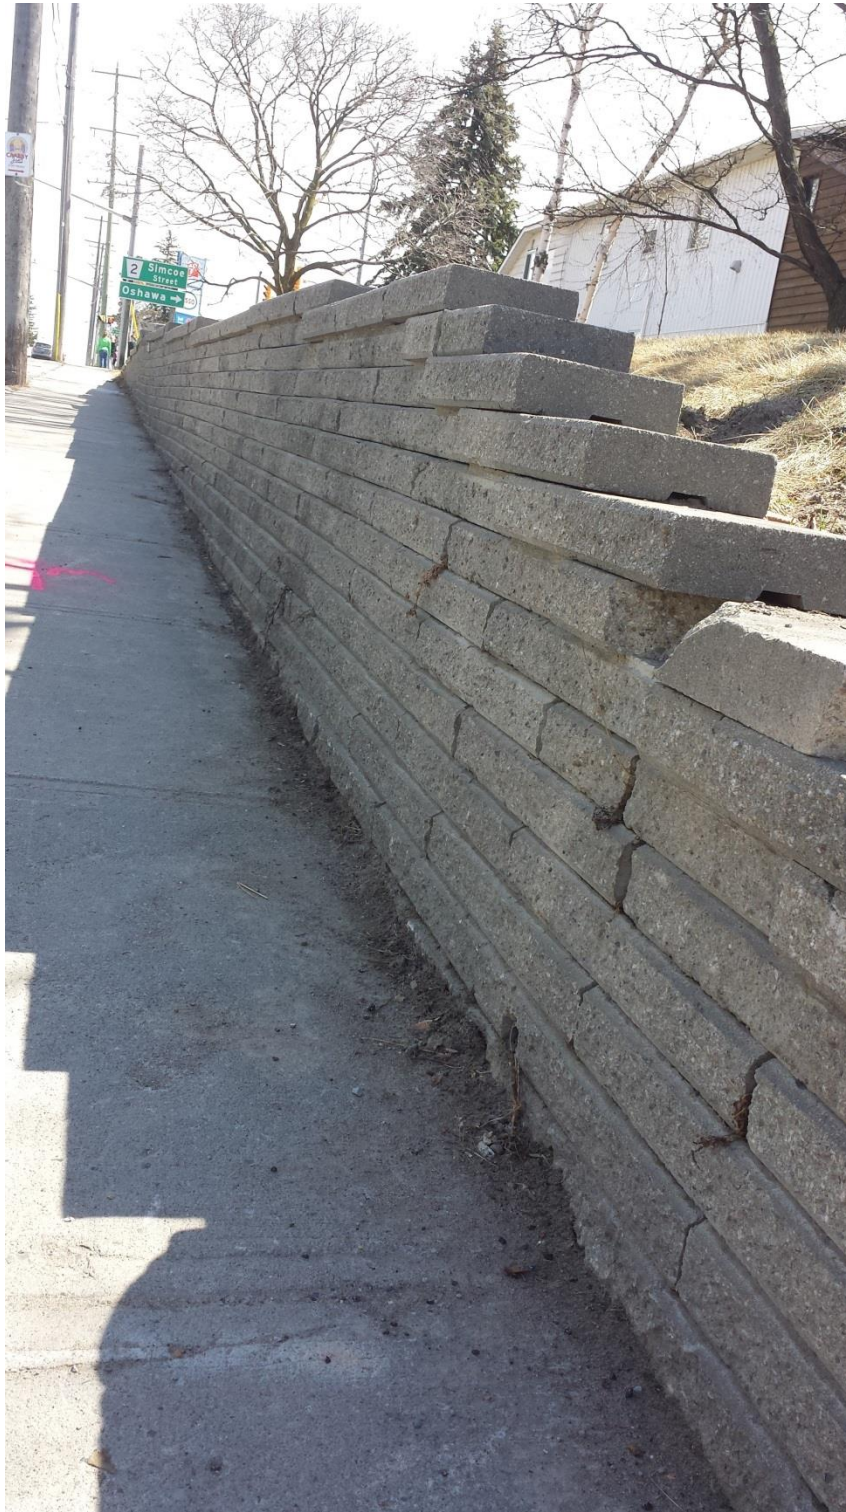
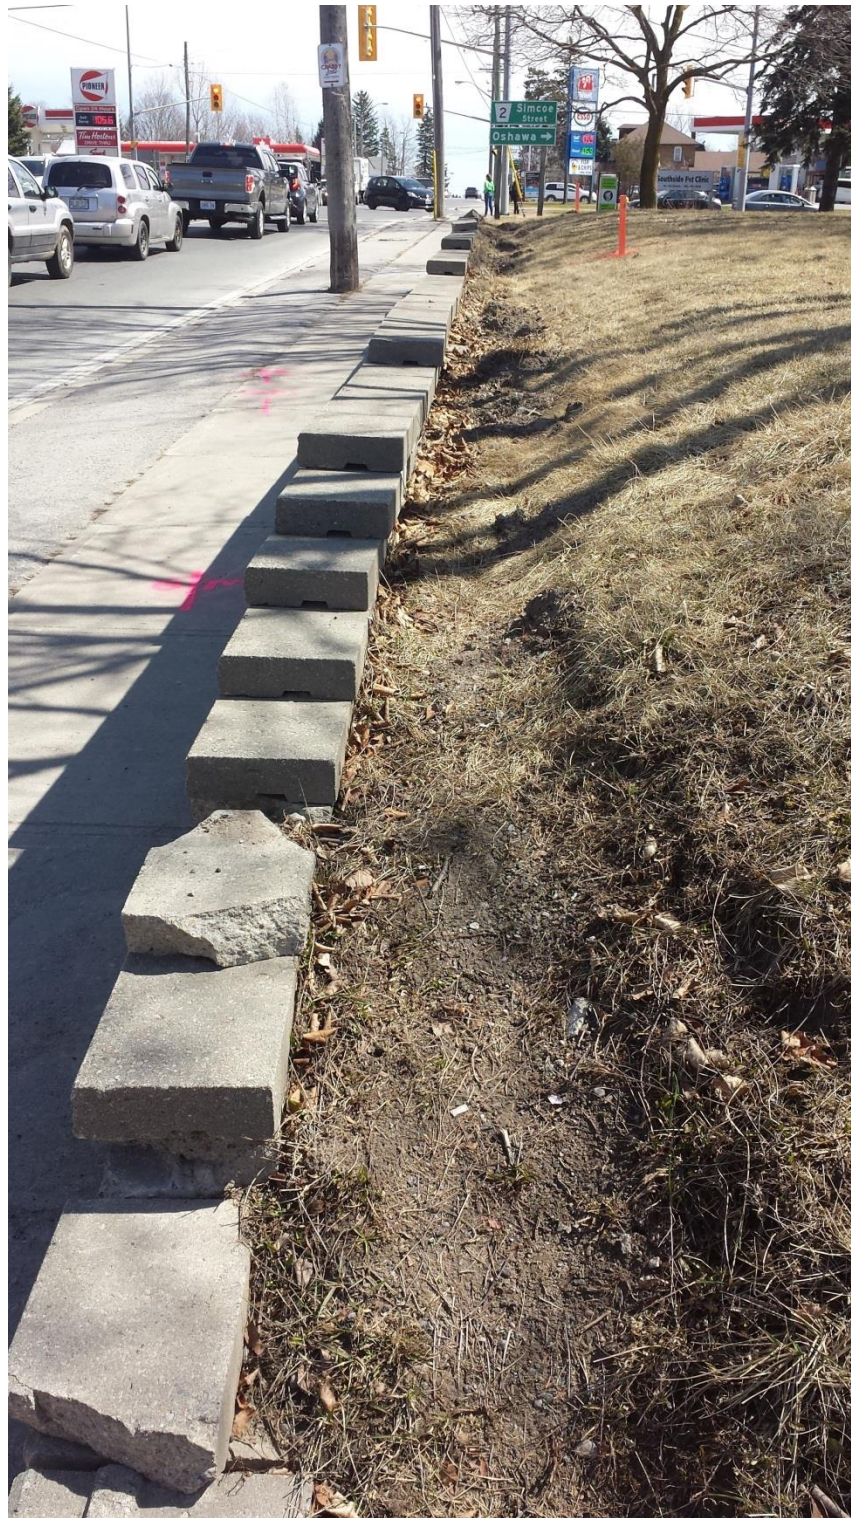
The Simcoe Street retaining wall (photographs 5 to 8) was measured to be near vertical and shows evidence of deteriorated / cracked stones, loose stones that may have been removed and replaced (see photographs 6 to 8). Visible weeping holes were observed and noted at approximate 3 m intervals along the Simcoe Street retaining wall during the site reconnaissance.

Photograph 5: Taken at the east end of the Simcoe Street retaining wall, facing west.
(April 16, 2015)

Photograph 6: Taken at the Simcoe Street retaining wall, facing southwest. (April 16, 2015)

Photograph 7: Taken at the Simcoe Street retaining wall, facing southeast. (April 16, 2015)

Photograph 8: Taken at the west end of the Simcoe Street retaining wall, facing east. (April 16, 2015)

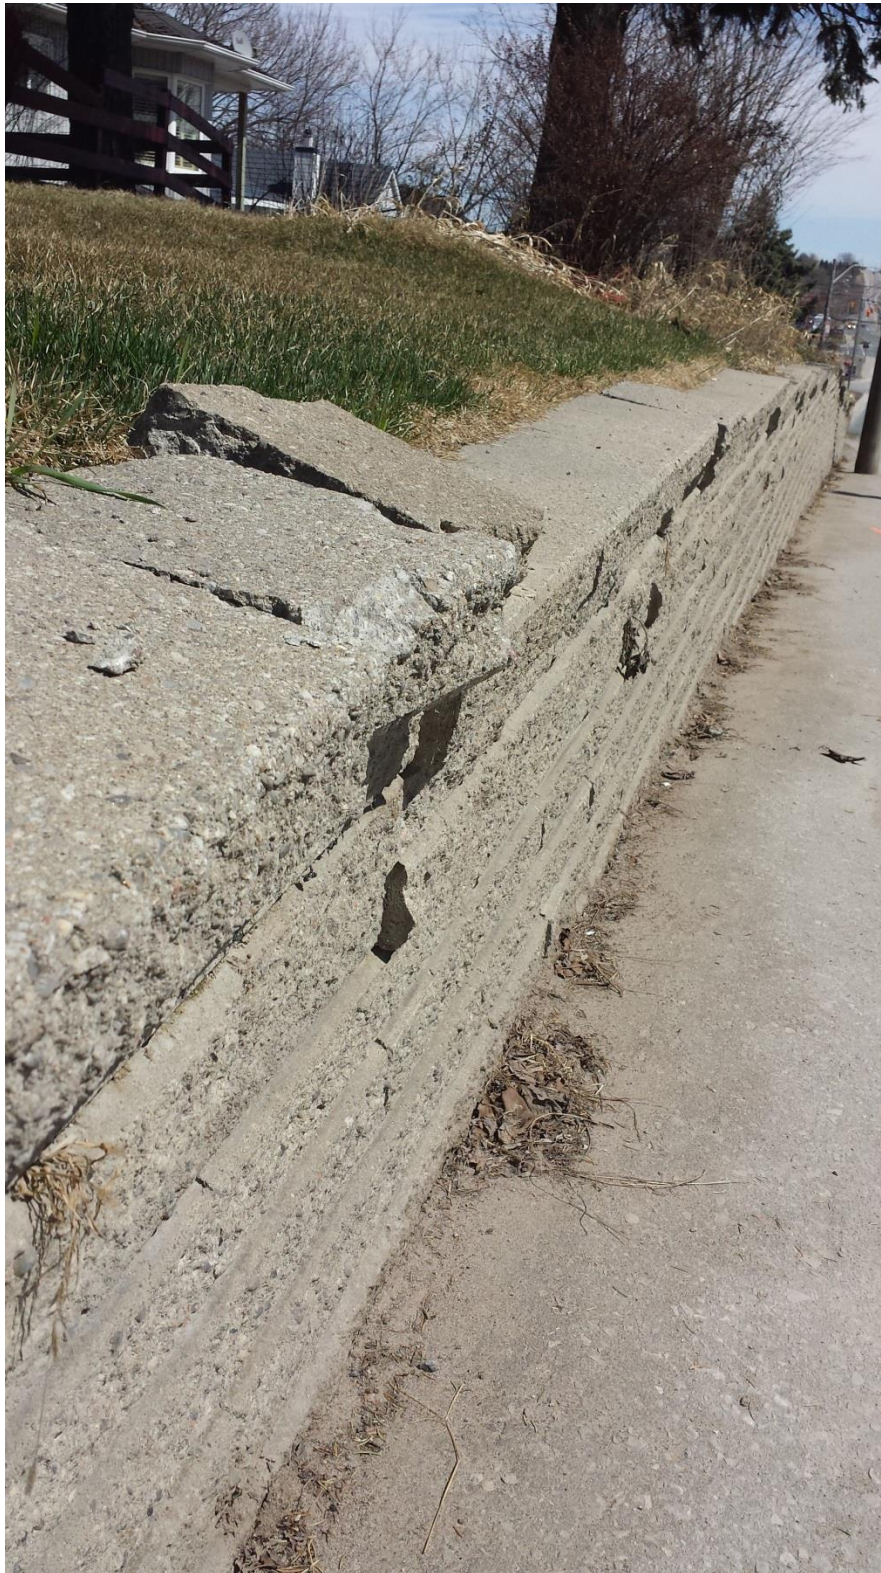
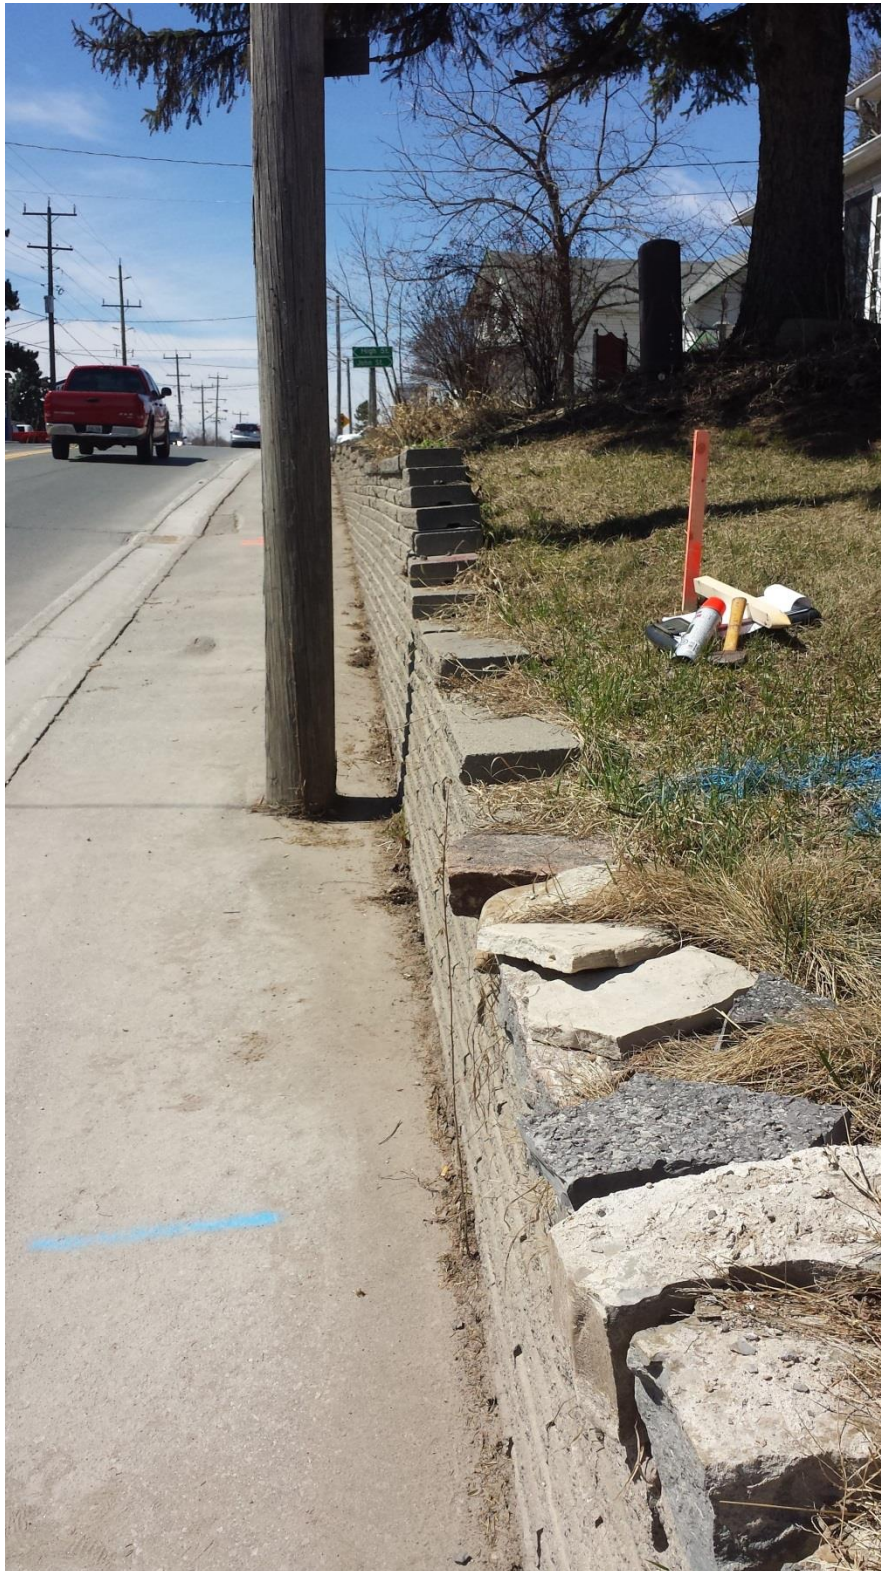
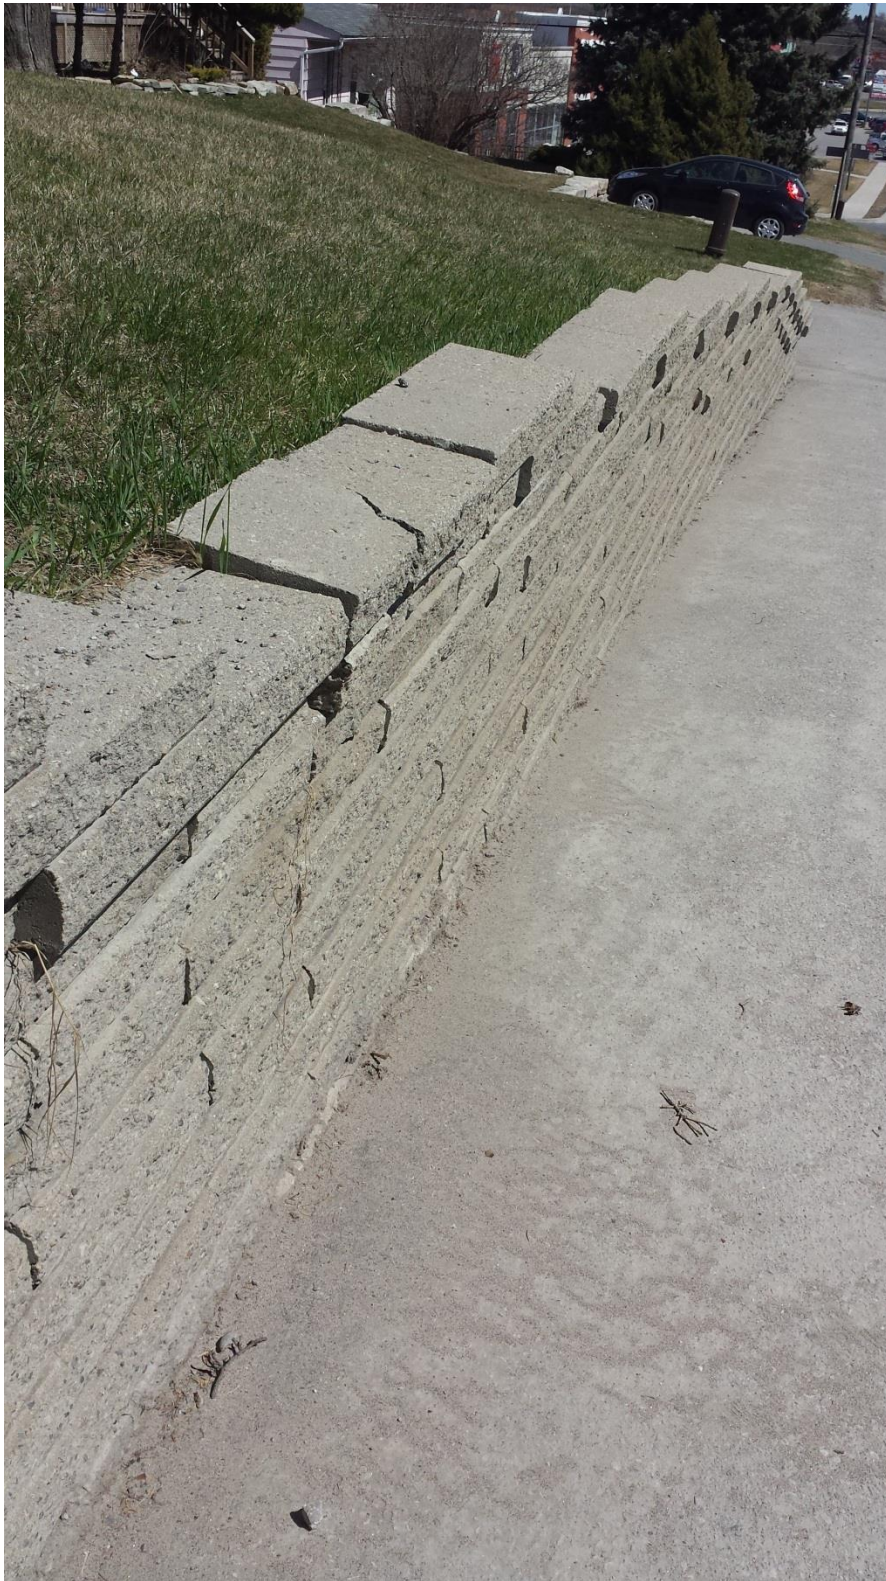
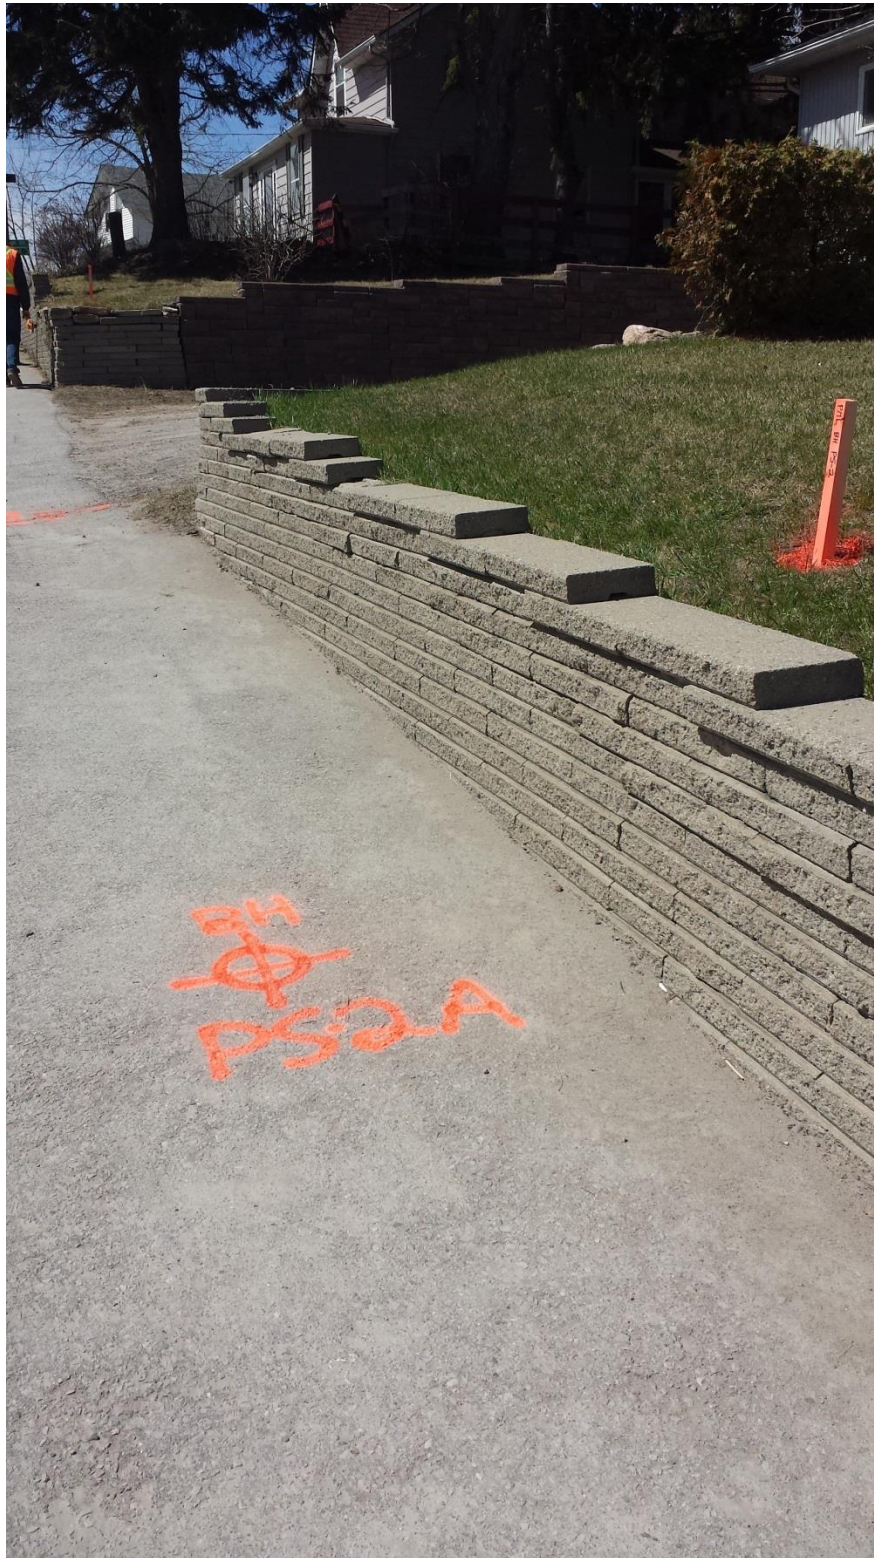
The Perry Street retaining walls (photographs 9 to 12) were also measured to be near vertical with a section of the upper portion of the wall leaning forward at an approximate slope of 1H:15V. The stones illustrate deterioration as some stones have been removed while others show vertical cracking and spacing between the stones through which vegetation has grown (see photographs 9 to 11). No visible weeping holes for drainage of water that may exist behind the

retaining walls were observed during the investigation and reconnaissance of the Perry Street retaining walls.

Photograph 9: Taken at the Perry Street retaining wall, facing east.
(April 16, 2015)

Photograph 10: Taken at the Perry Street retaining wall, facing west.
(April 16, 2015)

Photograph 11: Taken at the Perry Street retaining wall, facing northeast. (April 16, 2015)

Photograph 12: Taken at the Perry Street retaining wall, facing west.
(April 16, 2015)
