**PRELIMINARY FOUNDATION INVESTIGATION AND DESIGN REPORT
for
FEASIBILITY STUDY FOR THE REHABILITATION OR REPLACEMENT
OF THE HIGHWAY 3 BRIDGE OVER THE GRAND RIVER AT CAYUGA
GWP 3501-01-00, SITE 9-43
HIGHWAY 3, DISTRICT 31**

PML Ref.: 04HF058A
Index No. 015FIR and 016FDR
Geocres No: 30L13-18
July 9, 2009

PRELIMINARY FOUNDATION INVESTIGATION REPORT

**FEASIBILITY STUDY FOR THE REHABILITATION OR REPLACEMENT
OF THE HIGHWAY 3 BRIDGE OVER THE GRAND RIVER AT CAYUGA
GWP 3501-01-00, SITE 9-43
HIGHWAY 3, DISTRICT 31**

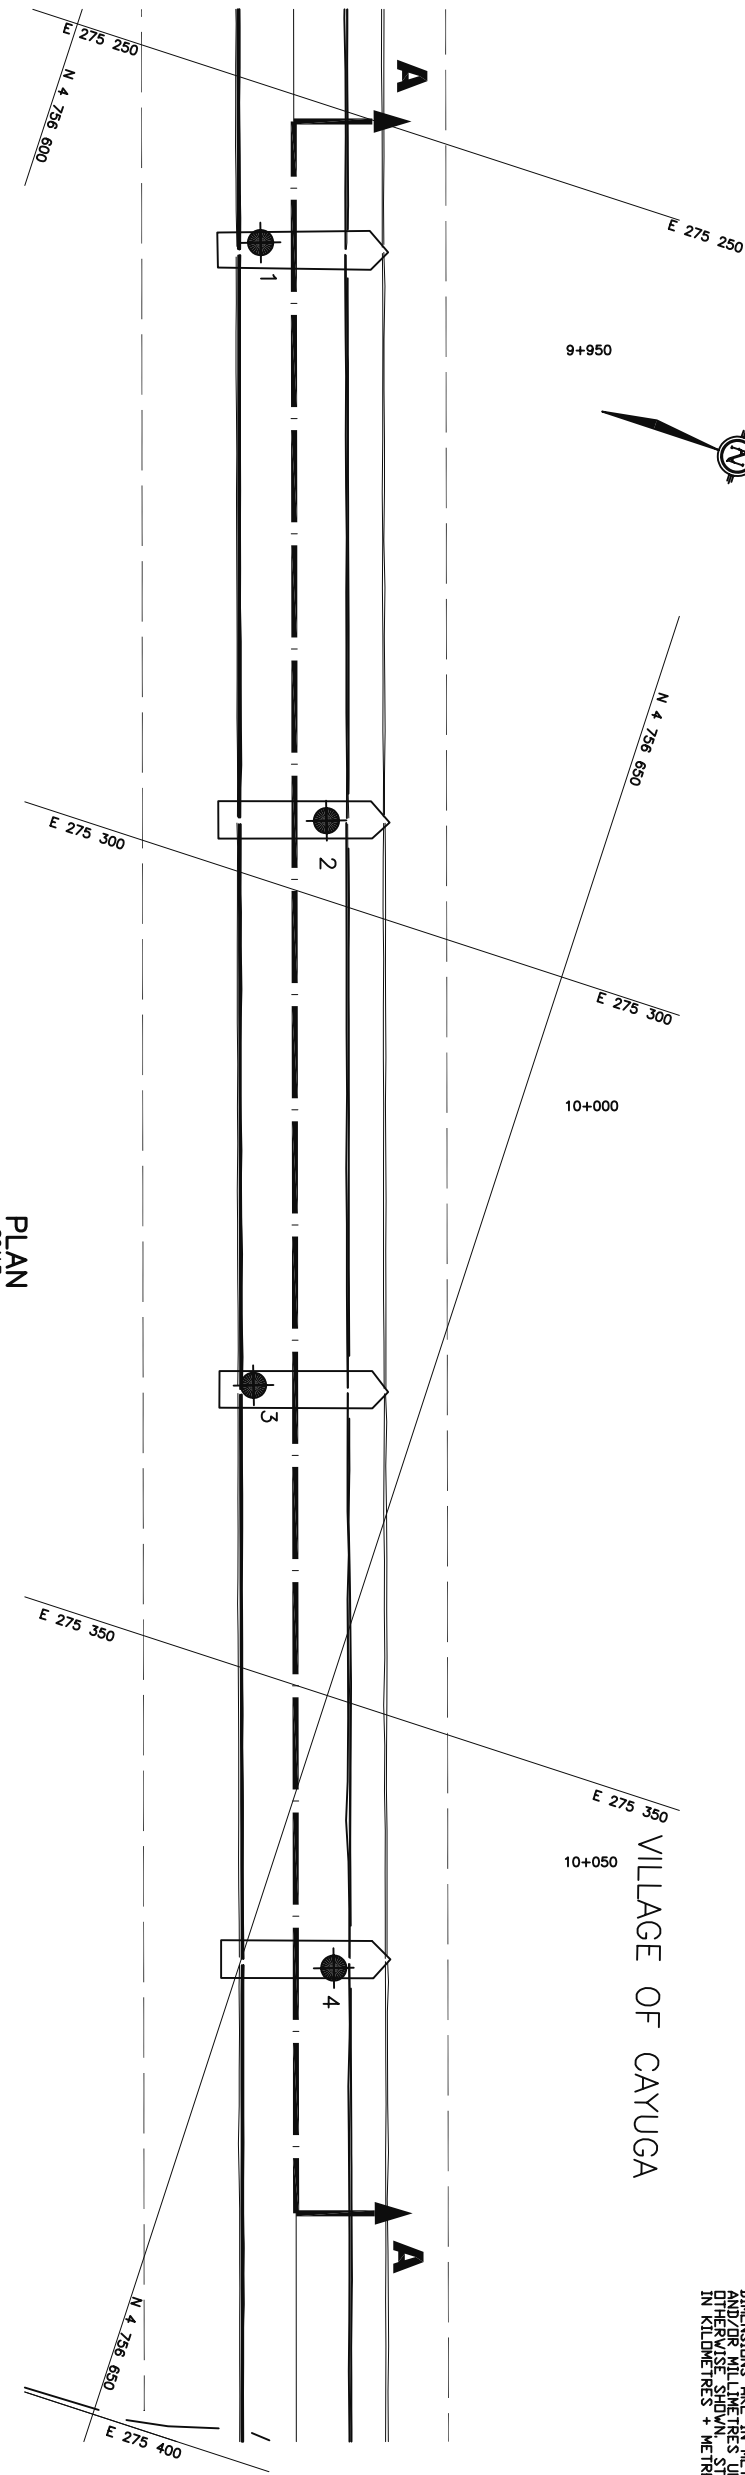
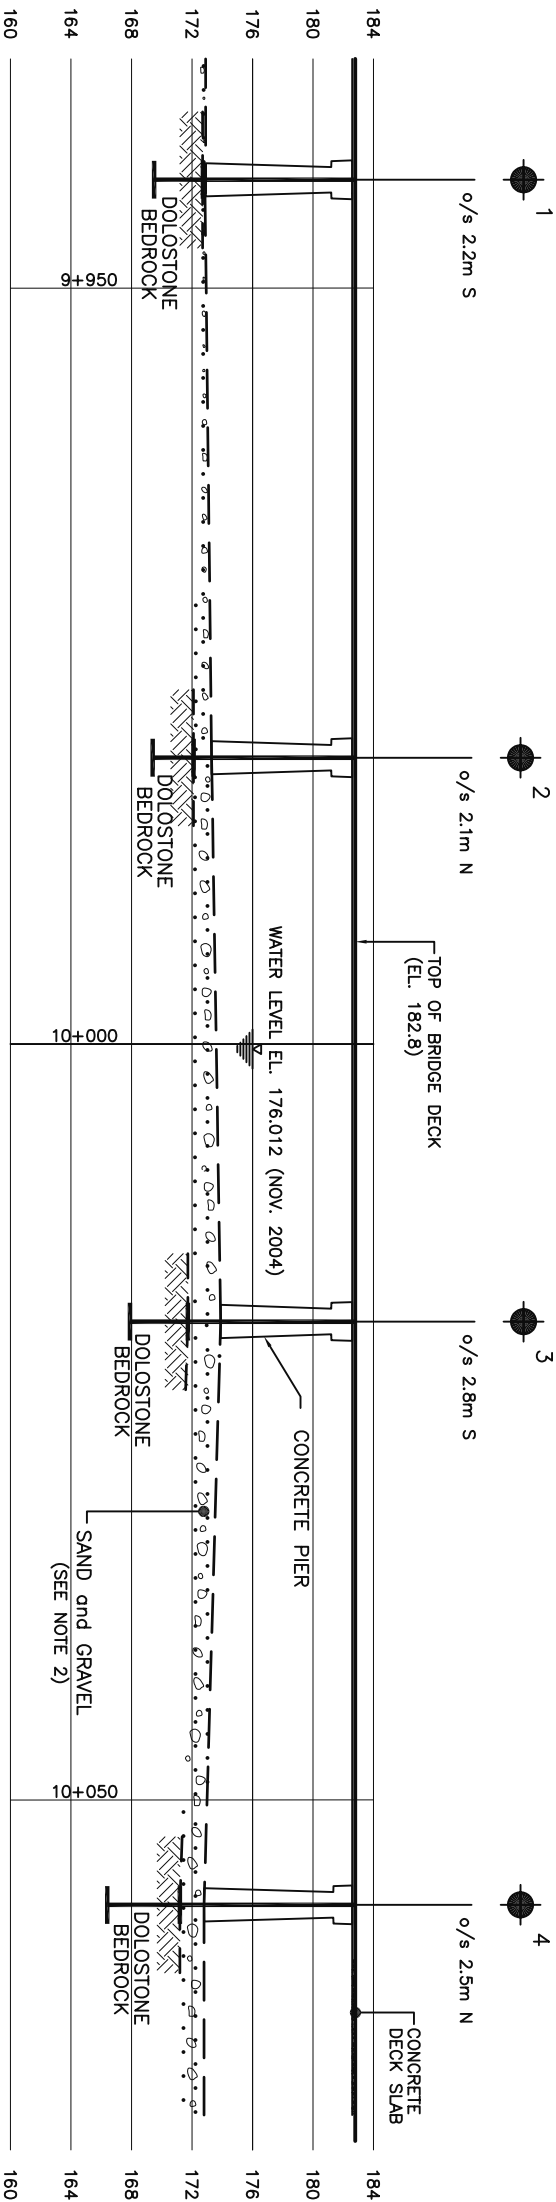
A-A
SECTION

The field investigation for this study was carried out during the period of September 12 to 15, 2005 and comprised four boreholes advanced at each of the bridge pier locations as shown on Drawing 1.

The borehole locations are presented on Drawing 1.

Bedrock was contacted in all boreholes approximately 10.1 to 11.6 m below the bridge deck (elevation 171.2 to 172.7 m). The bedrock surface gently slopes down towards the east at about 1.5%.

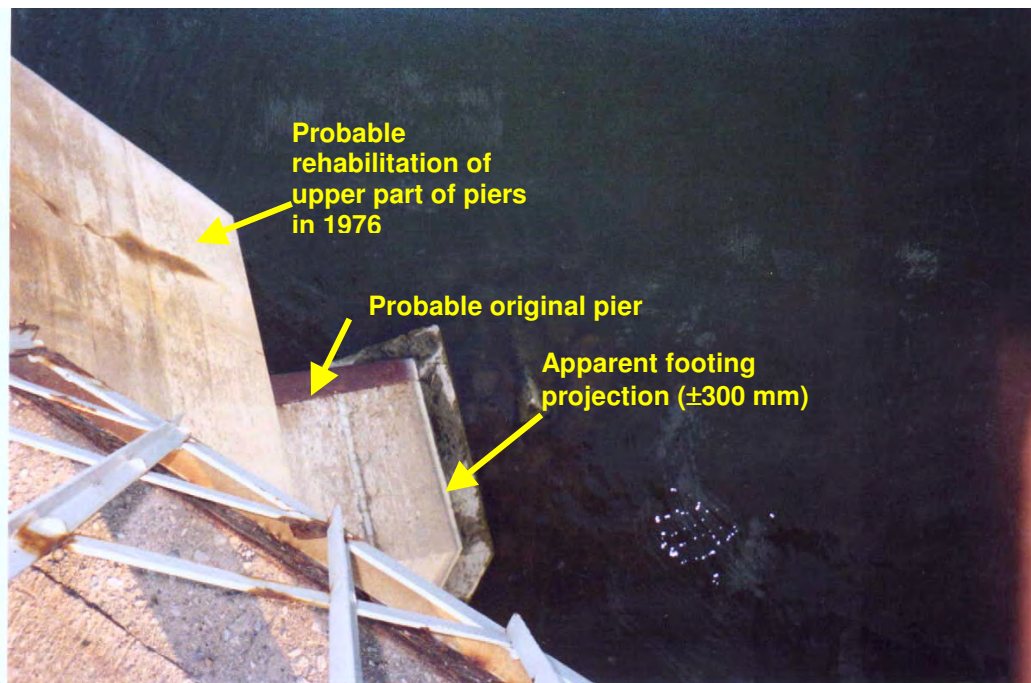
Photograph 5: View of typical pier. Note: footing projection; probable original pier; probable rehabilitation of upper part of pier in 1976. (August 2004).

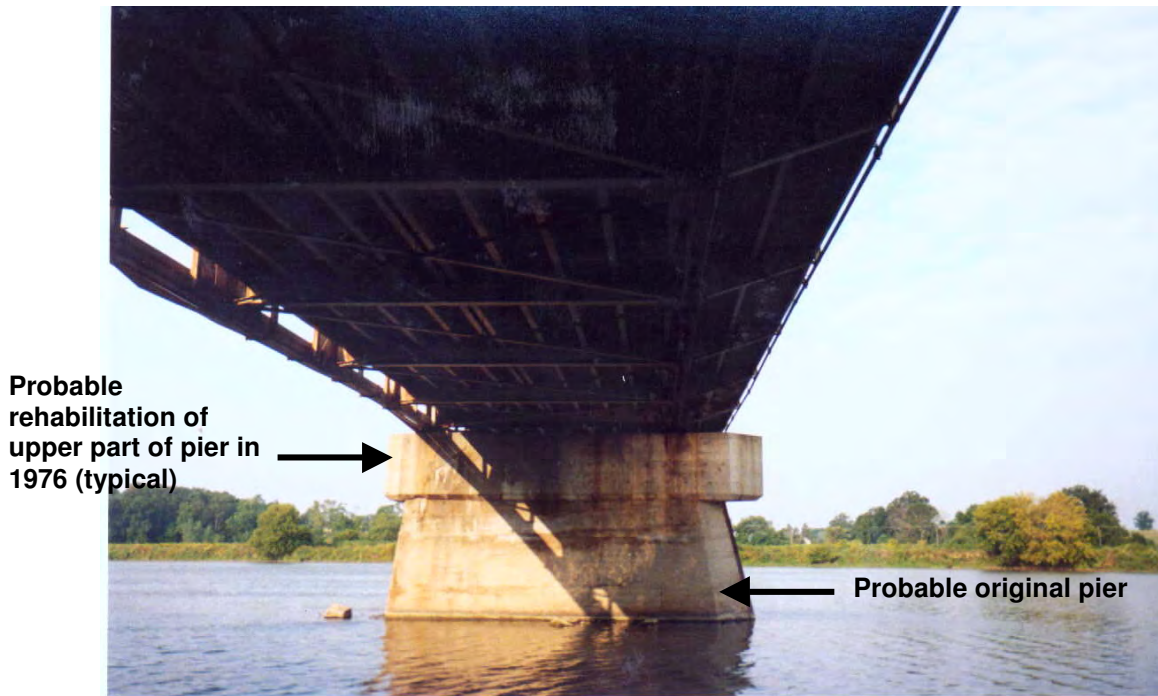
Photograph 6: View west of east pier from east side of Grand River (August 2004).

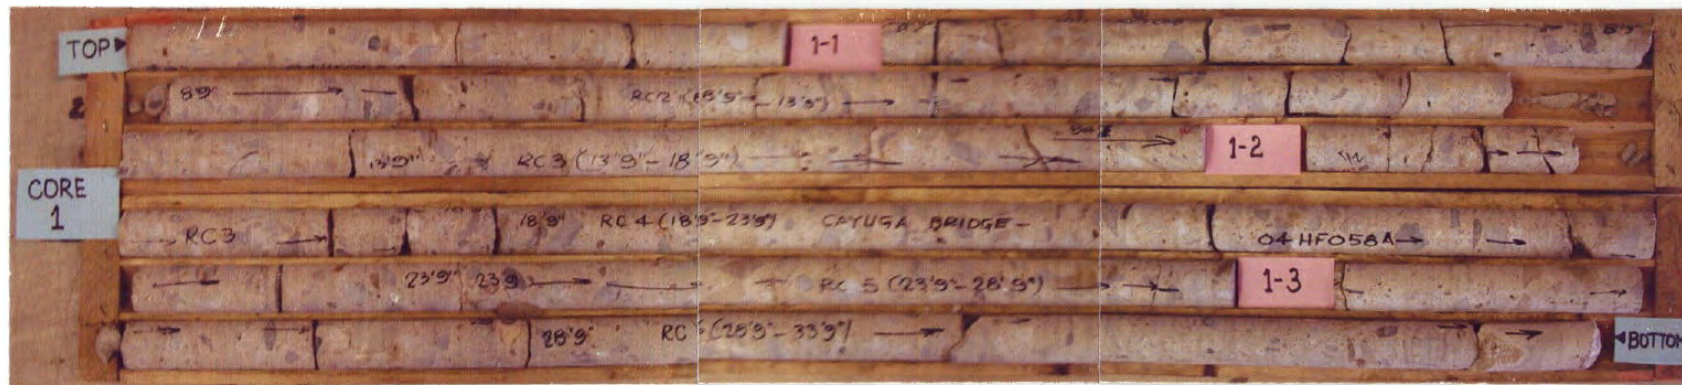
Core 1 - Borehole 1

It is apparent from examination of the cores that the same type of concrete was used for the full height in each pier.

Each core had many horizontal fractures/core breaks over the total core length. Based on visual examination, it is considered that most of the fractures/breaks result from the drilling and sampling process and the size and quality of the coarse aggregate in the concrete. Construction/cold joints which would normally be expected in piers of this height were ruled out as a contributing cause as no visual indication of horizontal construction joints/cold joints was observed in any of the cores.

Apart from the upper 600 mm of Core 3, all sections of core located between the core breaks were sound and unfractured with no evidence of honeycombing, significant porosity, voiding or microcracking.

The coarse aggregate used in the concrete is considered to be poor to fair quality and consists mainly of crushed buff to brown coloured limestone particles and grey dolomite, appearing to have a maximum of size of 50 to 75 mm. In Pier 4 one large (approximate 300 mm in size) cobble sized piece of grey dolomite was noted.

Test specimens (100 mm long) were cut from various sections of each core to determine the unconfined compressive strength and density of the concrete. Due to the large size particles of the coarse aggregate in the concrete and in order to furnish compressive strength results that would be representative of the concrete, these test specimens were cut from sections of the core in which the coarse aggregate particles did not exceed 20 mm in size. The locations of each of these test specimens are noted on the Log of Borehole sheets and on the photographs of the concrete core (identified as 1-2, typical).

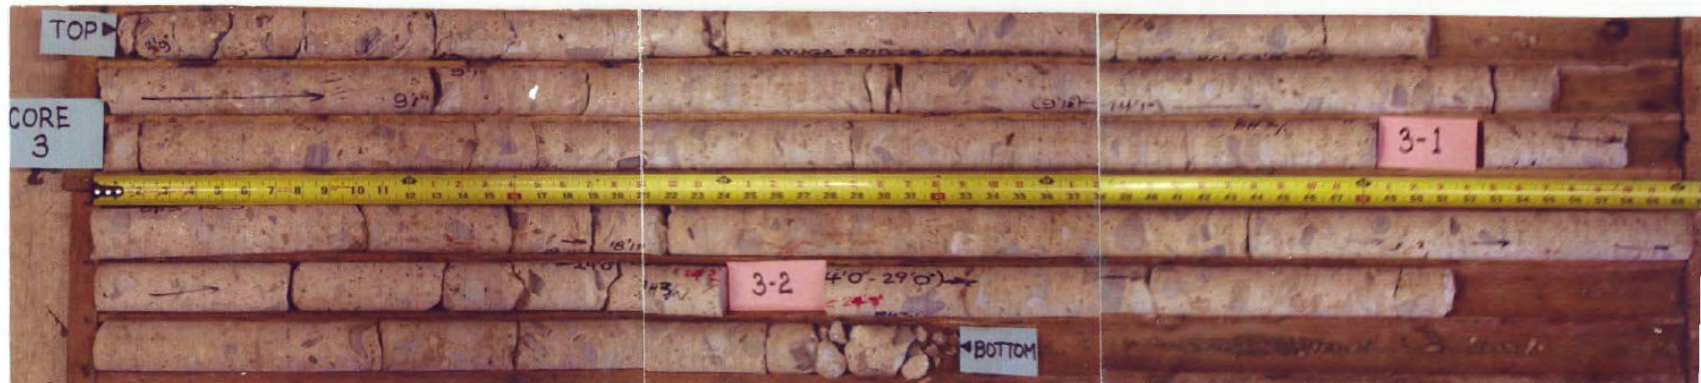
Core 3 - Borehole 3

The upper 600 mm section of the core from Pier 3 was the only section in which other evidence of horizontal cracking or fracturing was noted. This section of core contained seven actual breaks and several other fracture lines/planes, although the core was still intact across these planes. This fracturing may be evidence of horizontal delamination that is often associated with freeze/thaw deterioration. This phenomenon is not present in Piers 1, 2 or 4.

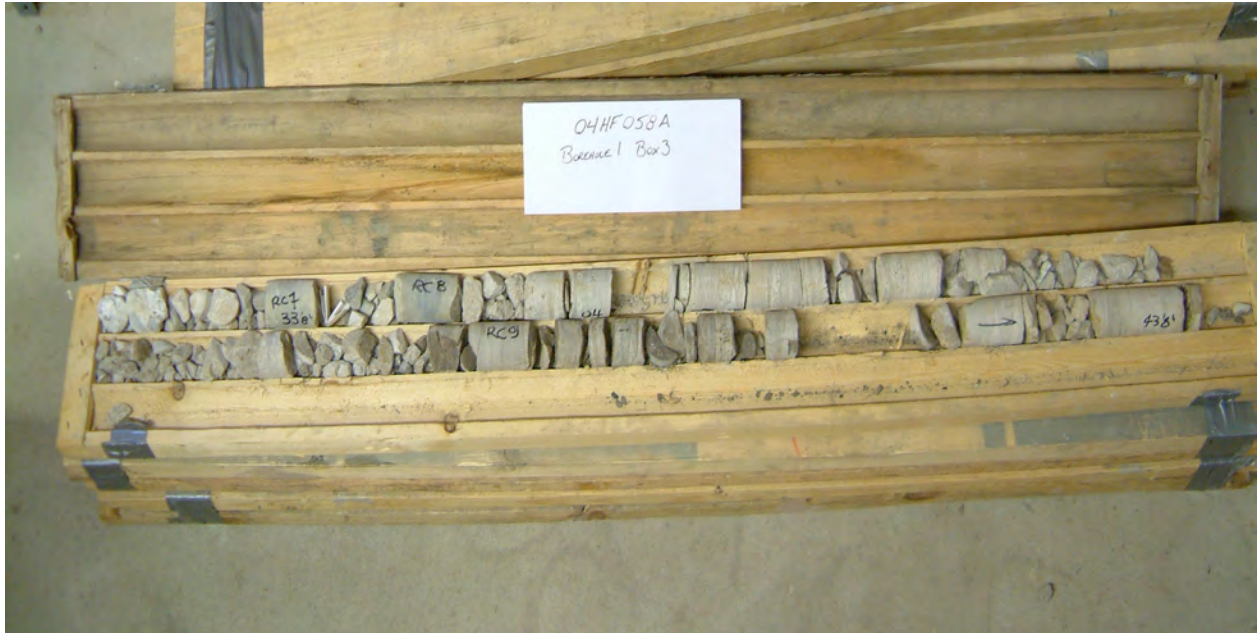
Borehole 1, Rock Cores 7 and 8

The dolostone contains light brown to buff and dark grey 'layers'. The light brown to buff 'layers' are typically slightly to moderately weathered and of low to medium strength. Numerous 'fine' voids/vugs were observed in the rock core; large voids were identified in two cores (430 and 250 mm in Pier 1; 600 and 175 mm in Pier 4). The dark grey 'layers' are typically unweathered and of medium strength.

Core Recovery					Core Description	
BH	RC	Depth (m)	Rec (%)	RQD (%)	Depth (m)	Description
1	7	10.3 – 11.8	61	0	10.3 – 12.7	DOLOSTONE: Light brown to buff, fine crystalline to aphanitic, numerous fine voids, with 430 mm void at 11.3 m depth, low to medium strength, slightly to moderately weathered, very close to close spaced bedding joints, smooth planar, oxidized to slightly altered, very poor quality.
	8	11.8 – 13.3	83	0		
					12.7 – 13.3	DOLOSTONE: Dark grey, laminated, shaley, fine crystalline to aphanitic, 250 mm void at 12.8 m depth, medium strength, unweathered, very close to close spaced flat bedding joints, smooth planar, tight, very poor quality.

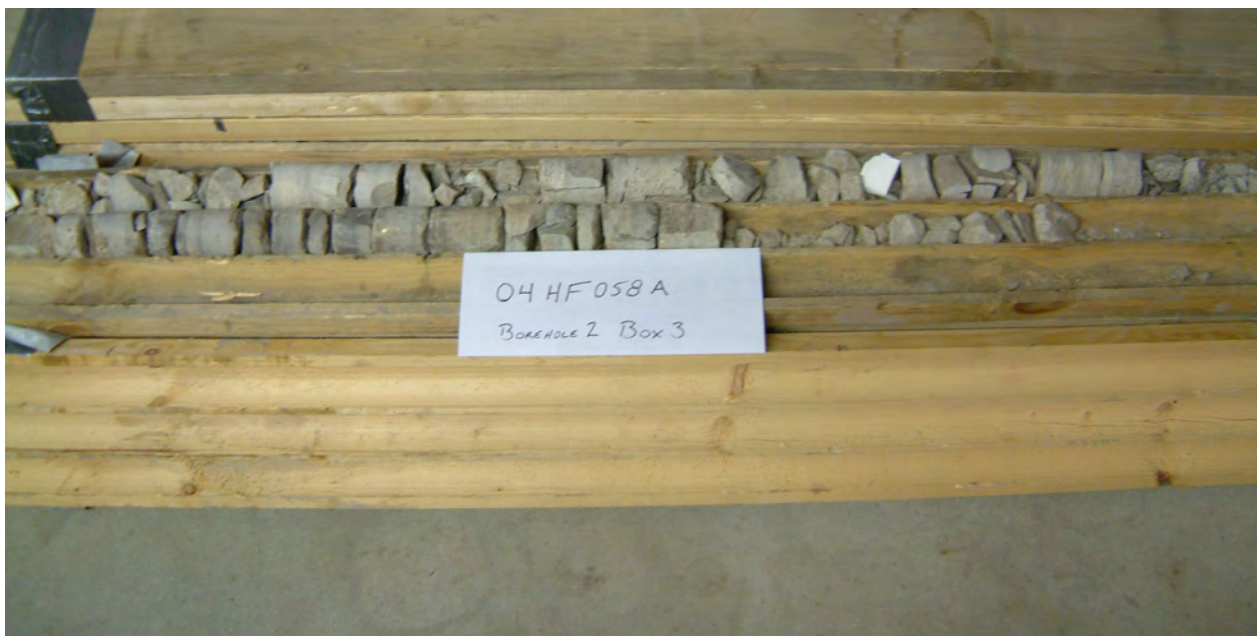
Borehole 2, Rock Cores 8 and 9

Core Recovery					Core Description	
BH	RC	Depth (m)	Rec (%)	RQD (%)	Depth (m)	Description
2	7	10.3 – 11.6	97	0	10.7 – 11.9	DOLOSTONE: Light brown to buff, aphanitic to cryptocrystalline, occasional layers with numerous fine voids, occasional layers with cross bedding, low to medium strength, slightly to moderately weathered, very close to close spaced flat bedding joints, smooth planar, oxidized to slightly altered, very poor quality.
	8	11.6 – 11.8	100	0		
	9	11.8 – 13.4	60	0		
					11.9 – 13.4	DOLOSTONE: Dark grey, shaley, fine crystalline to aphanitic, medium strength, unweathered, very close spaced flat bedding joints, smooth planar, tight, very poor quality.

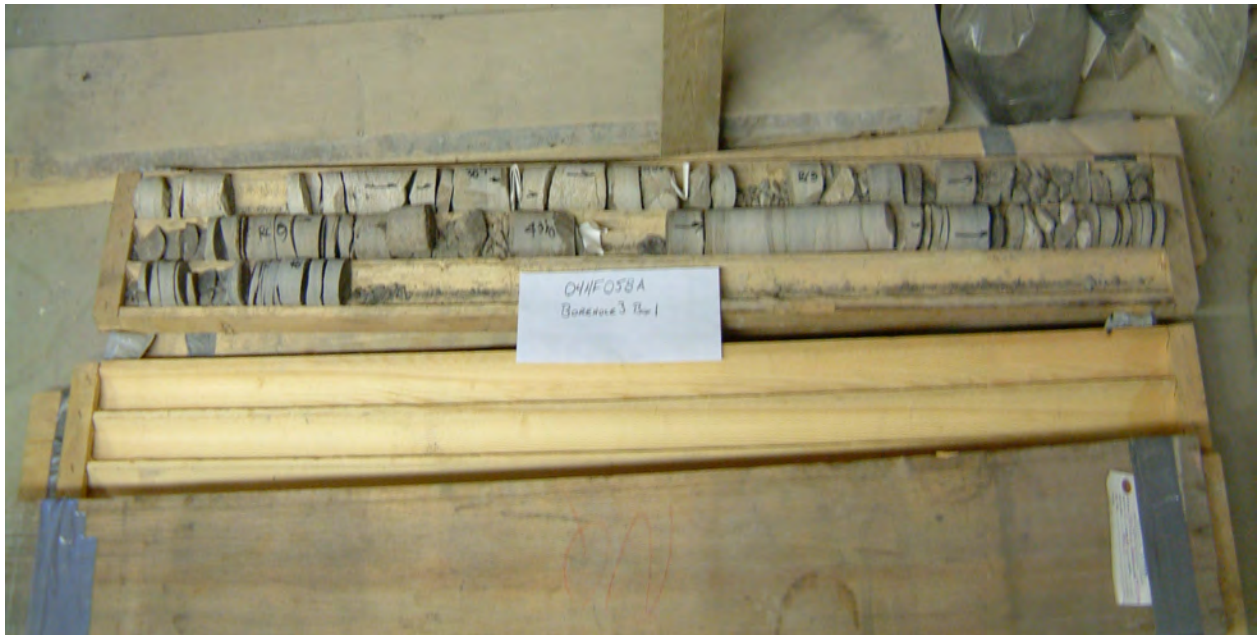
Borehole 3, Rock Cores 7, 8, 9 and 10

Core Recovery					Core Description	
BH	RC	Depth (m)	Rec (%)	RQD (%)	Depth (m)	Description
3	7	10.3 – 11.8	77	0	11.1 – 12.3	DOLOSTONE: Light brown to buff, fine crystalline to aphanitic, with numerous fine voids, occasional layers without voids, occasional black shaley partings, low to medium strength, slightly to moderately weathered, very close to close spaced flat to dipping bedding joints, smooth planar, oxidized to slightly altered, occasional with white scaling on surface, very poor quality.
	8	11.8 – 12.2	100	0		
	9	12.2 – 13.4	78	0		
	10	13.4 – 14.9	65	19

12.3 – 13.4	DOLOSTONE: Dark grey, shaley, fine crystalline to aphanitic, low strength, moderately weathered, very close spaced flat bedding joints, rough planar, up to 2 mm aperture with dark brown silty filling, very poor quality.

13.4 – 14.9	DOLOSTONE: Light brown to buff, aphanitic, with occasional fine voids, occasional black shaley partings, medium strength, unweathered, very close to close spaced flat bedding joints, smooth planar, tight, very poor quality.

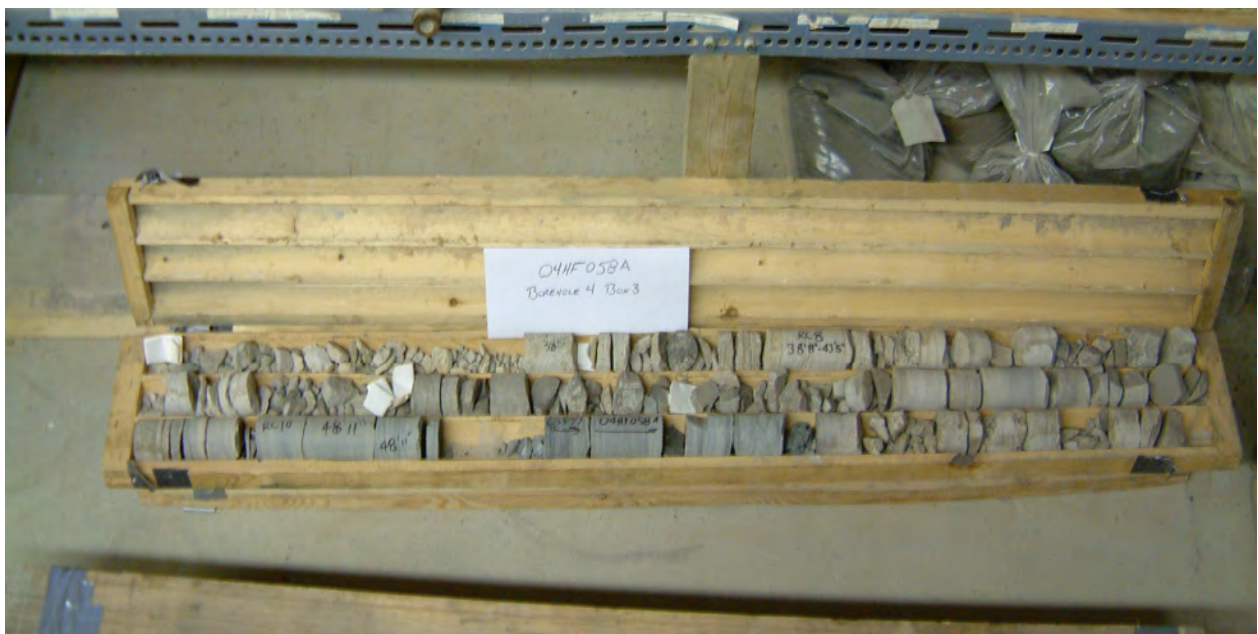
Borehole 4, Rock Cores 8, 9 and 10

Core Recovery					Core Description	
BH	RC	Depth (m)	Rec (%)	RQD (%)	Depth (m)	Description
4	7	10.2 – 11.8	23	0	11.6 – 14.6	DOLOSTONE: Light brown to buff, fine crystalline to aphanitic, numerous fine voids becoming less frequent at depth, occasionally to 2 mm, occasional vugs, with 600 mm void at 14.0 m depth, generally low to medium strength with occasional high strength layers, slightly to moderately weathered, very close to close spaced flat bedding joints, smooth planar, oxidized to slightly altered, occasional with black residue on parting, vertical cross joint, smooth planar, oxidized with minor white scale on parting, very poor quality
	8	11.8 – 12.9	73	13		
	9	12.9 – 13.4	37	0		
	10	13.4 – 14.9	63	7		
	11	14.9 – 16.4	76	9

14.6 – 15.4	DOLOSTONE: Dark grey, shaley, laminated with cross bedding, fine crystalline to aphanitic, medium to high strength, slightly weathered, close spaced flat bedding joints, smooth planar, tight, vertical cross joint, smooth planar, oxidized with minor white scaling on parting, very poor quality.

15.4 16.4	DOLOSTONE: Light brown to buff, aphanitic, with numerous fine voids, 175 mm void at 16.0 m, low to medium strength, unweathered, very close spaced flat bedding joints, smooth planar, tight, very poor quality.
