**FEASIBILITY FOUNDATION INVESTIGATION AND DESIGN
REPORT 4 – GEOGRAPHICAL TOWNSHIP OF HOWARD
for
HIGHWAY 401 – CHATHAM-KENT
FROM 0.9 KM EAST OF ESSEX COUNTY ROAD 42
EASTERLY 66.1 KM TO THE ELGIN COUNTY BOUNDARY
AGREEMENT NUMBER 3004-E-0001
GWP NO. 80-00-00
for
MCCORMICK RANKIN CORPORATION**

PML Ref.: 05TF060-4
Index No.: 115FIDR
GEOCRES No.: 40I5-9
January 29, 2010

**Feasibility Foundation Investigation and Design
Report 4 – Geographical Township of Howard**
for
Highway 401 – Chatham-Kent
From 0.9 Km East of Essex County Road 42
Easterly 66.1 Km to the Elgin County Boundary
Agreement Number 3004-E-0001
GWP No. 80-00-00

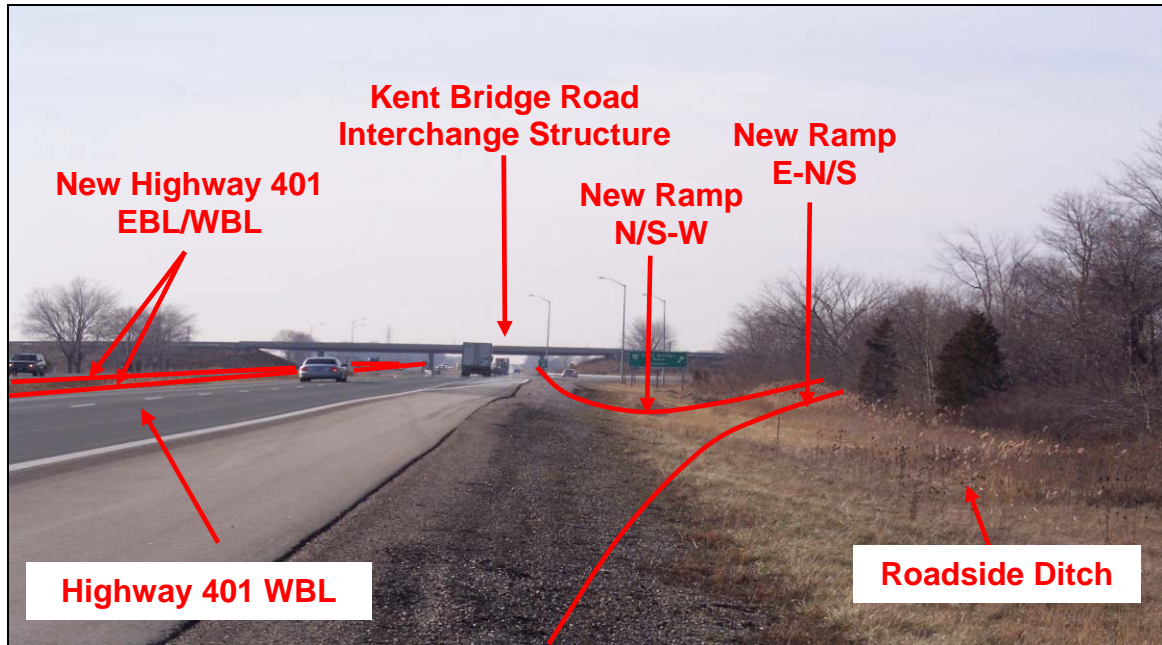
PHOTOGRAPH 4-1: Kent Bridge Road I/C Underpass. Looking west from north shoulder of Highway 401. Note generally flat terrain, built-up approach embankments to four-span structure. Preferred Option: Future Highway 401 EBL and WBL, N/S-W and E-N/S ramps are depicted. (January 27, 2006)

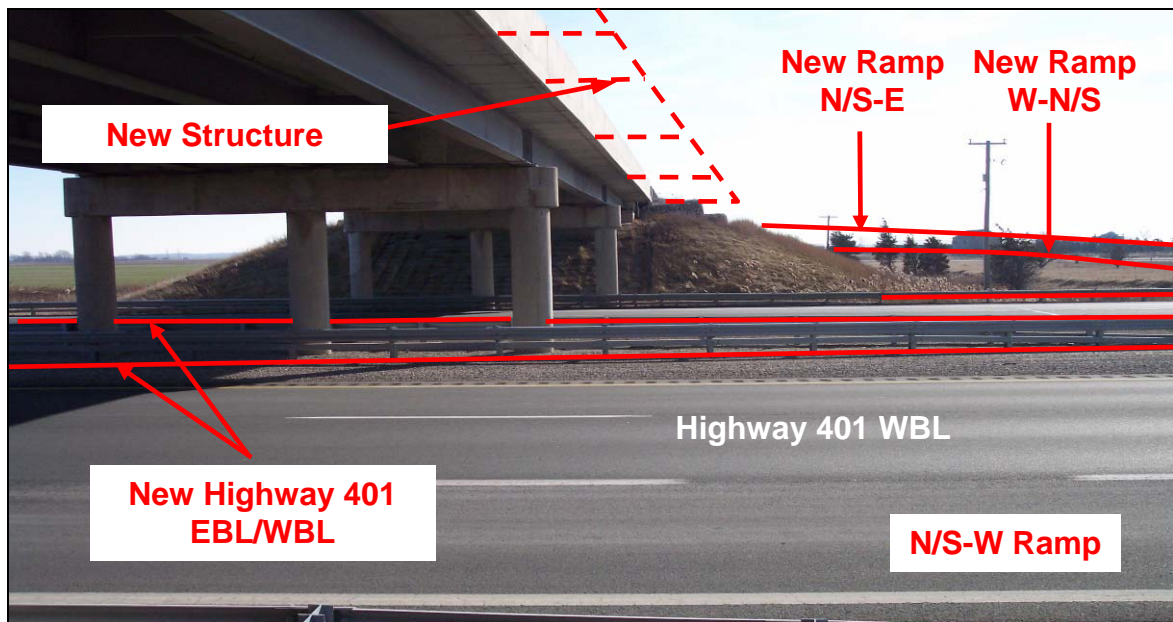
PHOTOGRAPH 4-2: Kent Bridge Road I/C Structure. Looking south along west side of structure. Note flat terrain beyond embankment, hydro pole line. Evergreens demark drainage ditch. Preferred Option: Future structure at the underpass in addition to new Highway 401 EBL and WBL, N/S-E and W-N/S ramps are depicted. (January 27, 2006)

- The visual inspection of the underpass structure foundations did not reveal signs of distress such as settlements or other distortion (photographs 4-2, 4-20 and 4-32).

- It was judged that the bridge approach embankments are currently stable and without visible settlements. No major signs of distress such as erosion or sliding of the bridge approach embankments were noted (photographs 4-2, 4-3, 4-21, 4-24 and 4-38).

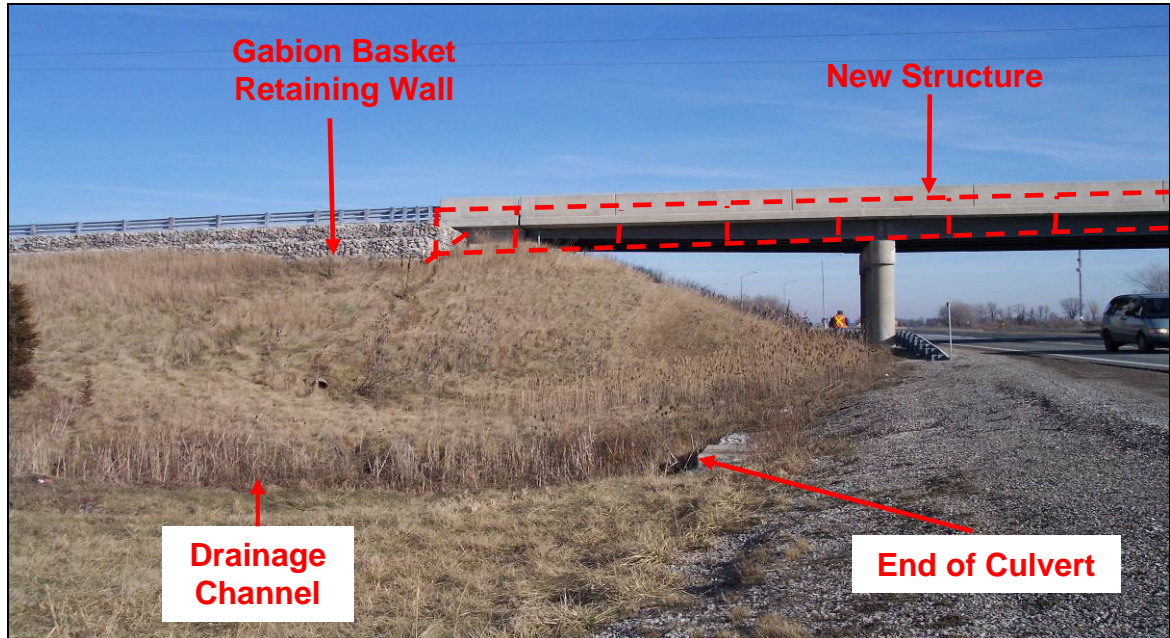
PHOTOGRAPH 4-3: Kent Bridge Road I/C Structure. Looking east from north shoulder of Highway 401. Note gabion basket retaining wall atop embankment, end of culvert in foreground. Preferred Option: Future structure at the underpass is depicted. (January 27, 2006)

- Localized surficial sloughing of the southeast approach embankment at the Scane Road underpass was noted (photographs 4-22 and 4-23).
- Gabion basket retaining walls were erected atop the approach embankments of the Kent Bride Road underpass (photographs 4-3, 4-6, 4-7).

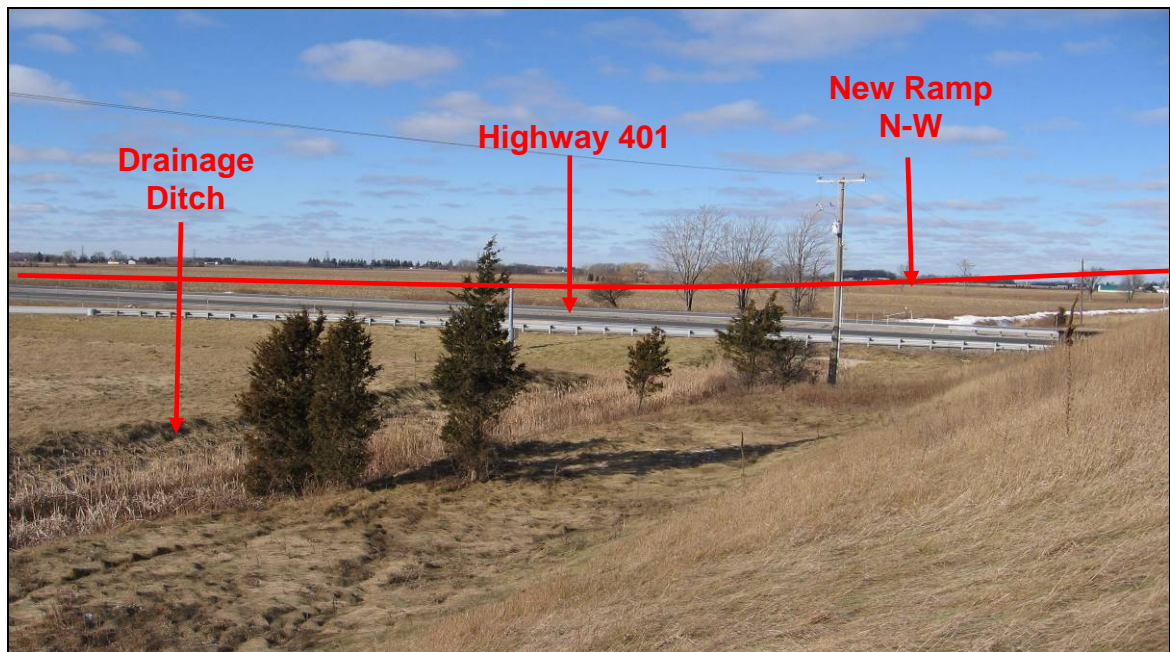
PHOTOGRAPH 4-4: Kent Bridge Road Interchange. Looking northwesterly from mid slope of south approach embankment. Note flat terrain, drainage ditch along evergreens south of Highway 401. Snow demarks drainage ditch north of highway. Preferred Option: Future N-W ramp is depicted. (January 26, 2006)

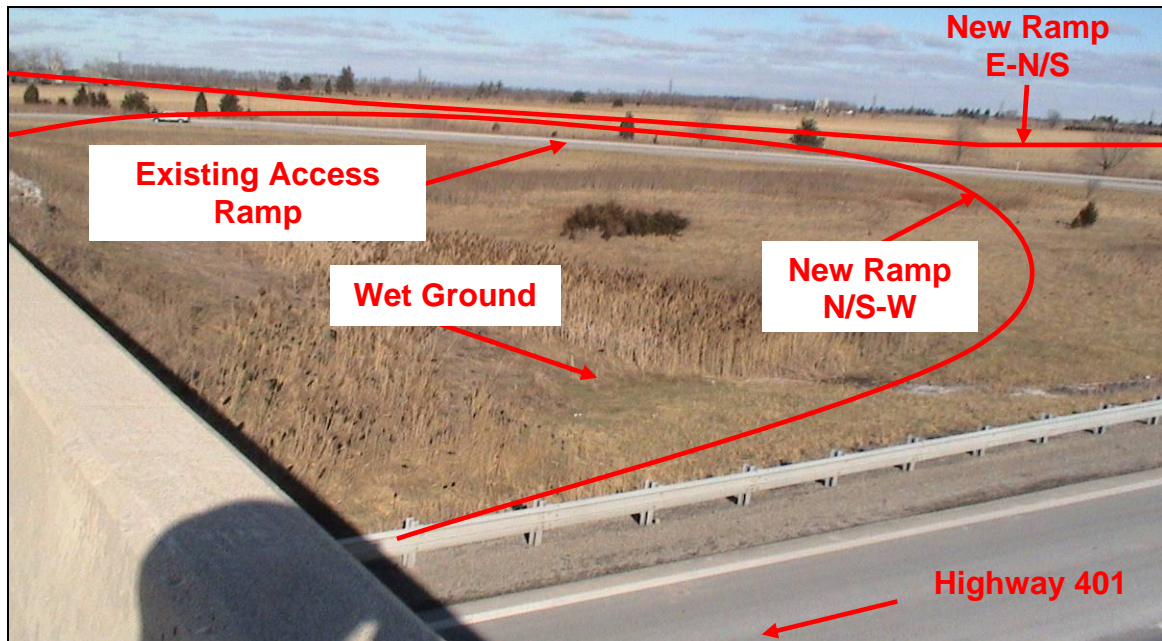
PHOTOGRAPH 4-5: Kent Bridge Road Interchange. Looking northeasterly at south end of north approach embankment and N/S-W and E-N/S ramp. Note flat terrain with no visible wetland except at toe of approach embankment likely due to poor drainage. Preferred Option: Future N/S-W and E-N/S ramps are depicted. (January 26, 2006)

- Swampy ground was not noted within or near the structures or culverts within the alignment. However, some areas were wet possibly due to poor drainage on the relatively flat terrain (photographs 4-5, 4-6, 4-24, 4-33, 4-35 and 4-36).

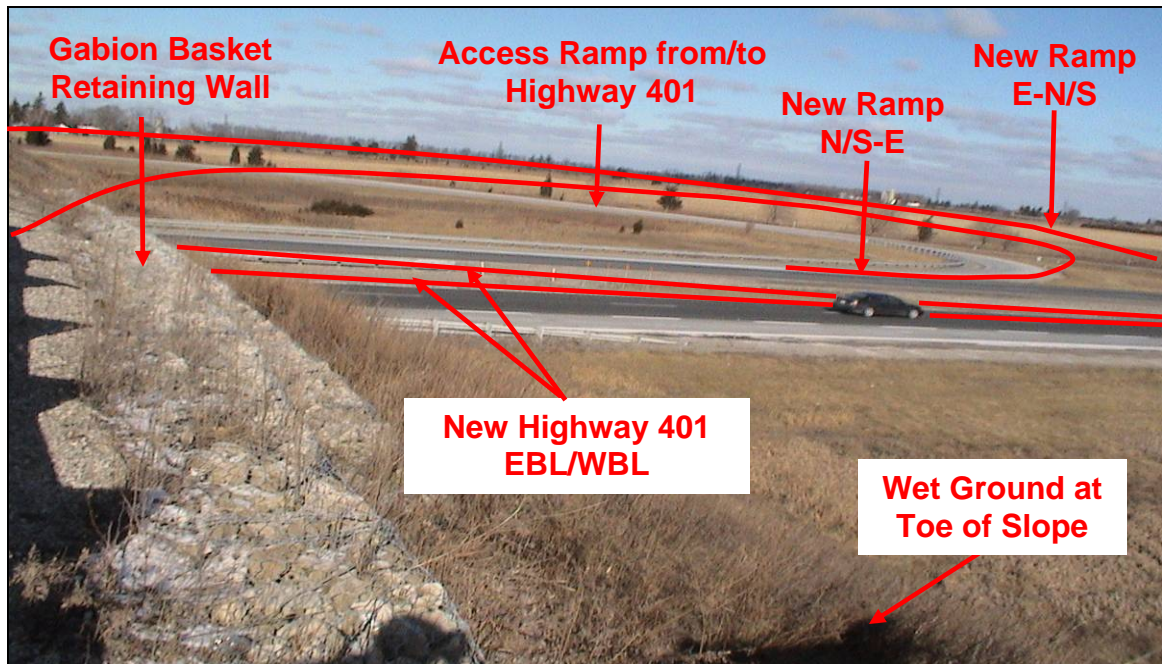
PHOTOGRAPH 4-6: Kent Bridge Road Interchange. Looking northeasterly from east end of underpass structure at existing N/S-W and E-N/S access ramps. Note the wet ground near toe of south approach embankment. Preferred Option: Future Highway 401 EBL and WBL, N/S-W and E-N/S ramps are depicted. (January 26, 2006)

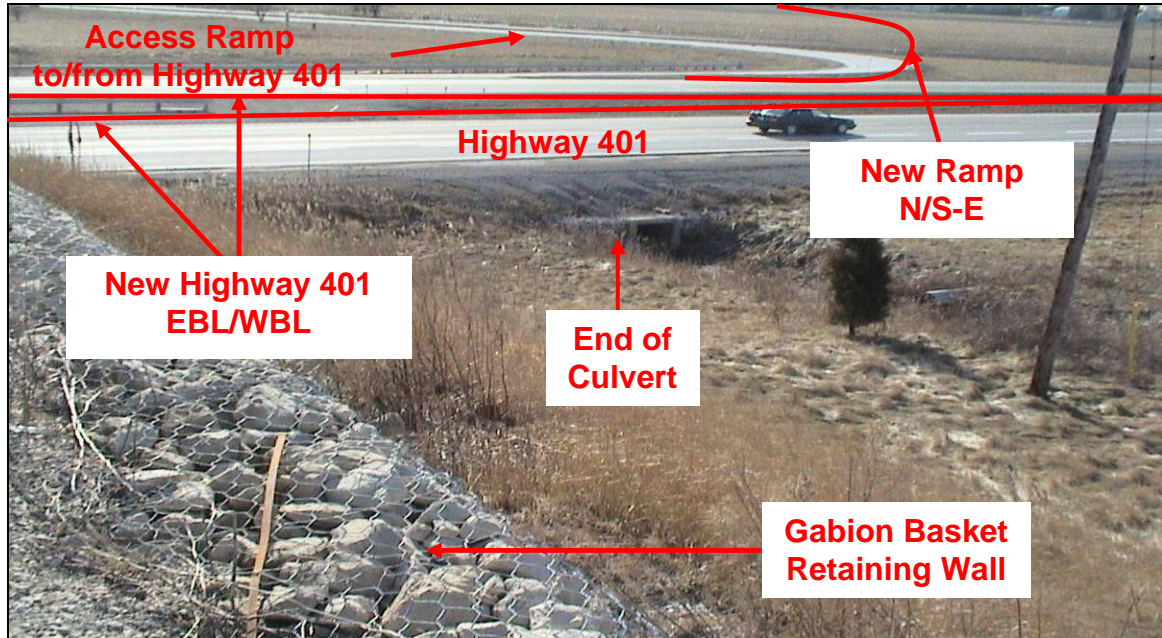
PHOTOGRAPH 4-7: Kent Bridge Road Interchange. Looking southwesterly at W-N/S and N/S-E ramps from top of north approach embankment. Note flat terrain without wetlands, end of culvert under Highway 401 and hydro pole. Gabion basket retaining wall in the foreground is atop of approach embankment. Preferred Option: Future Highway 401 EBL and WBL and N/S-E ramp are depicted. (January 26, 2006)

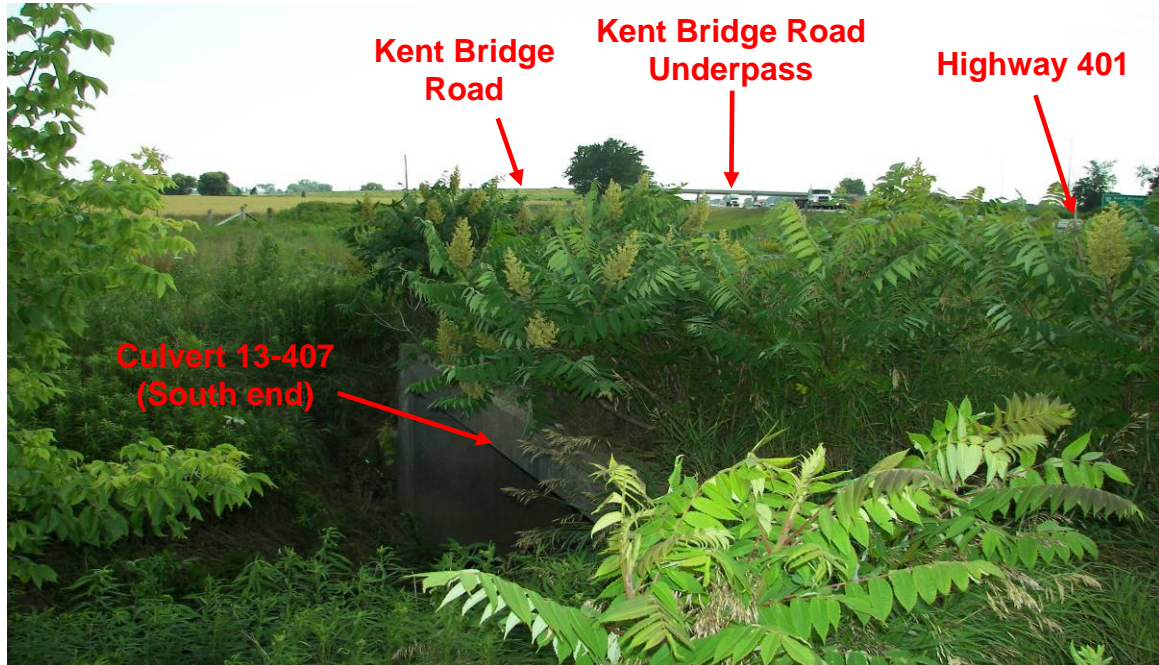
PHOTOGRAPH 4-9: Culvert 13-407. Looking westerly at south end of culvert 13-407. Note flat terrain beyond culvert ditch and south approach embankment to Kent Bridge Road underpass. (June 29, 2006)

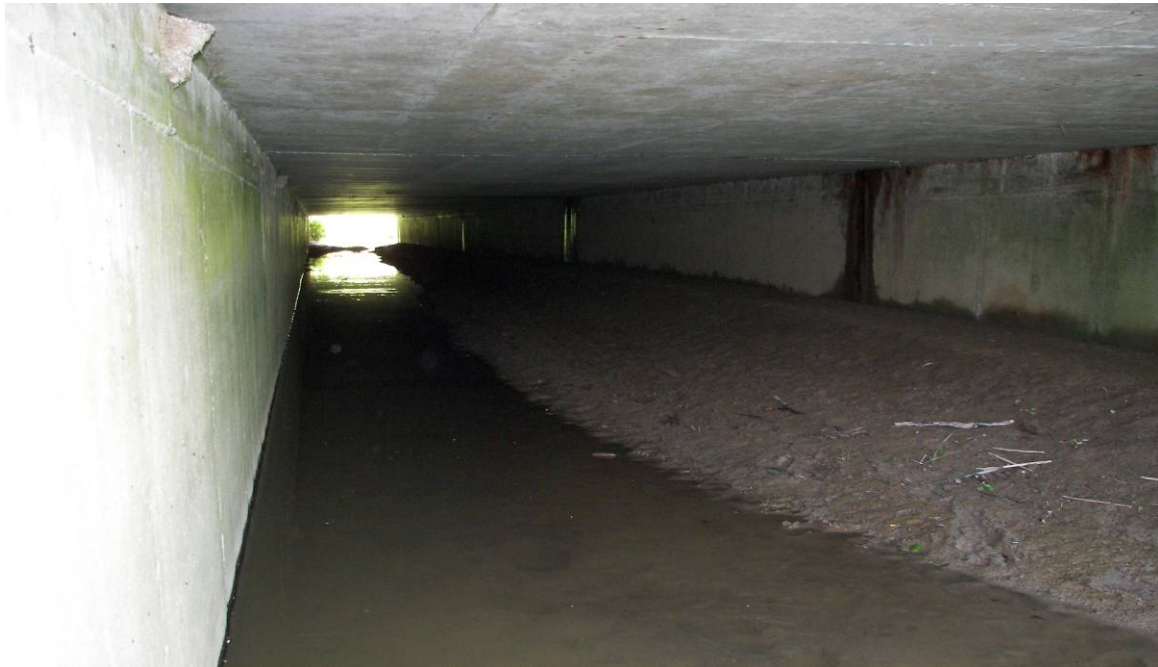
PHOTOGRAPH 4-10: Culvert 13-407. View through culvert from south end. Note continuous construction. (June 29, 2006)

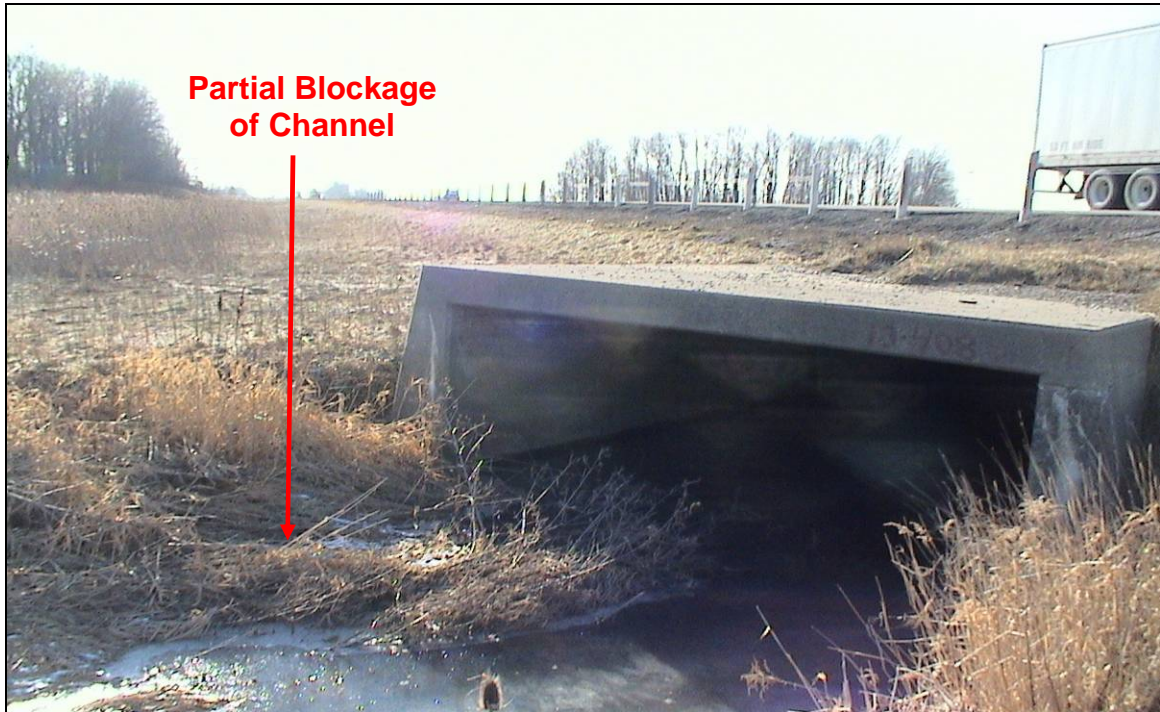
PHOTOGRAPH 4-11: Culvert 13-408. Looking northwesterly at south end of culvert. Note partial blockage of channel on west side. (January 26, 2006)

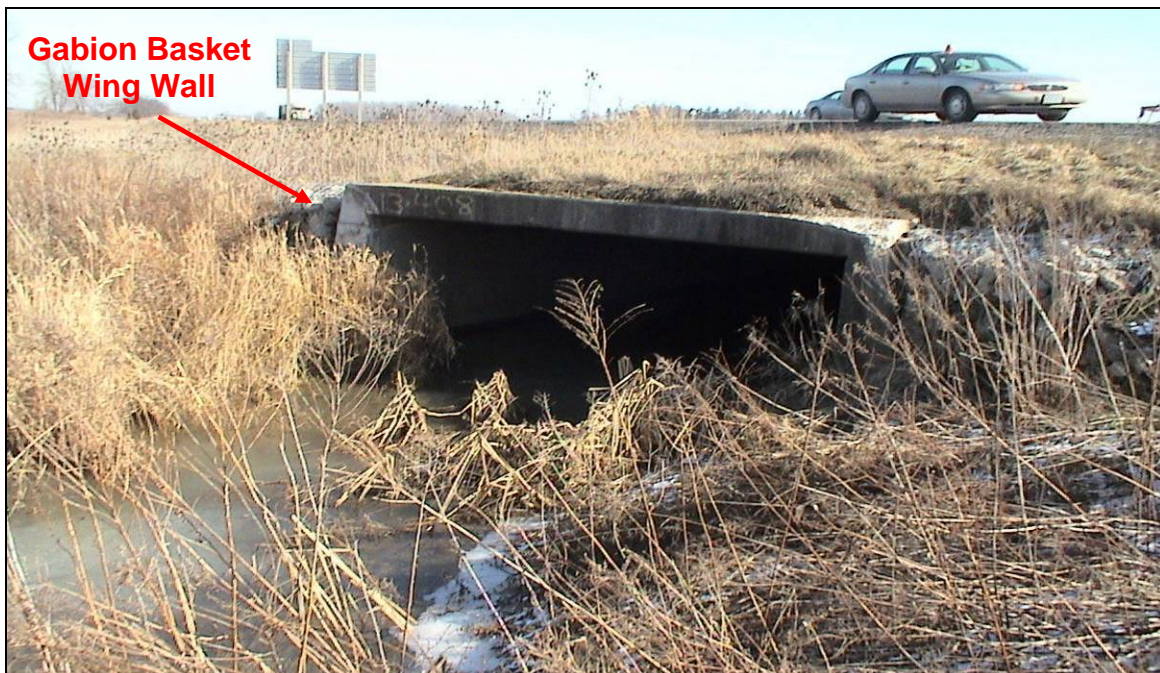
PHOTOGRAPH 4-12: Culvert 13-408. Looking southeasterly at north end of culvert. Note wide channel and gabion baskets used for wing walls. (January 27, 2006)

- It is inferred that the concrete wing walls of several culverts were removed and replaced with gabion basket walls (photographs 4-12, 4-13, 4-14, 4-17, 4-26, 4-28 and 4-30). Displacement and rotation of the original concrete wing walls of some of the culverts was noted (photographs 4-16 and 4-25).

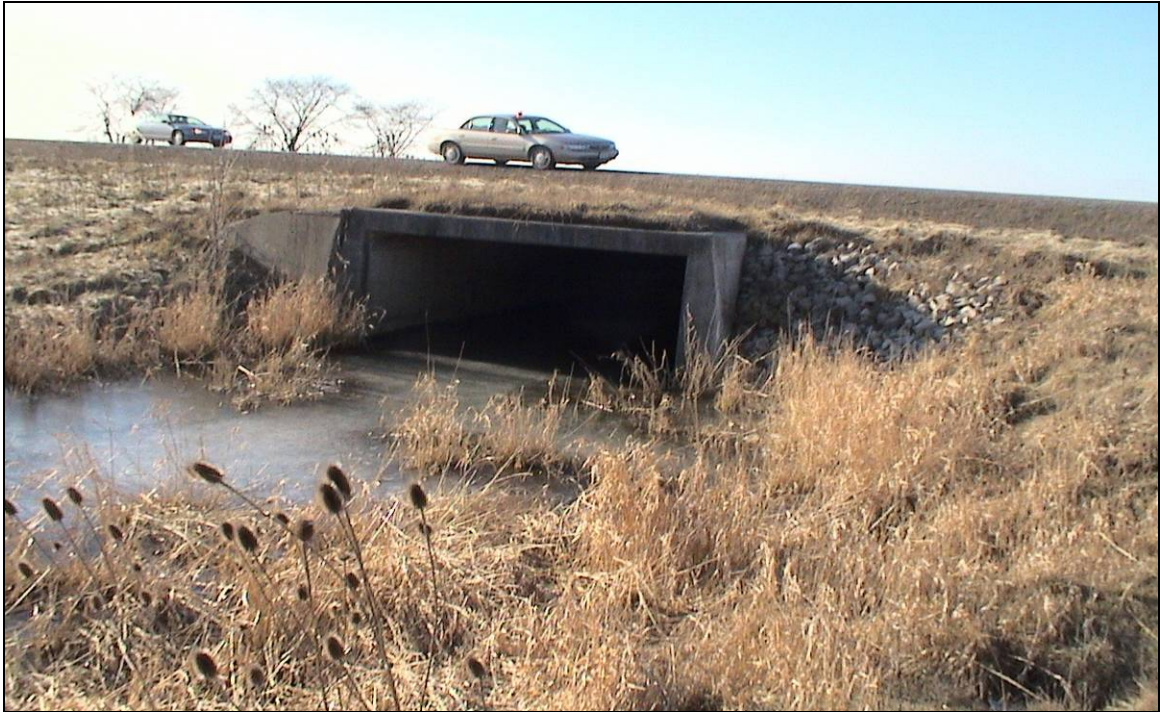
PHOTOGRAPH 4-13: Culvert 13-409. Looking north at south end of culvert. Note east wing wall replaced with rock fill cover. Shallow road embankment over top of culvert, grass covered roadside ditches. (January 26, 2006)

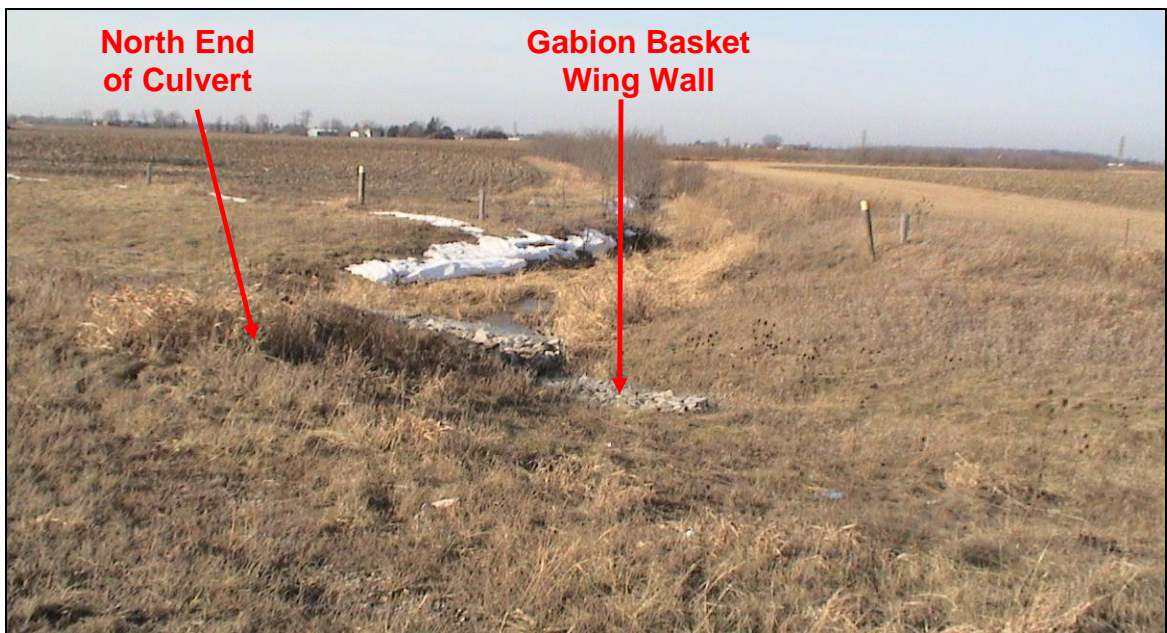
PHOTOGRAPH 4-14: Culvert 13-409. Looking north across top of north end of culvert. Note gabion basket used for east wing wall (same for west side). Note gently undulating terrain beyond Highway 401 R.O.W. and farming land use. (January 27, 2006)

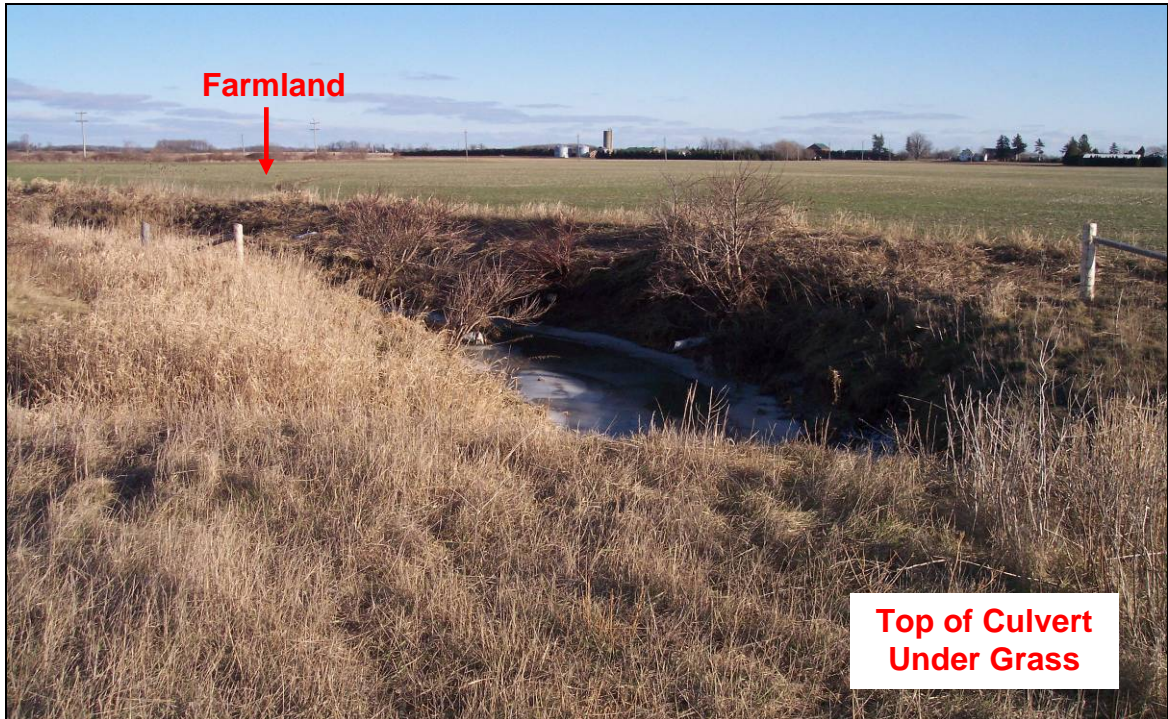
PHOTOGRAPH 4-15: Culvert 13-410. Looking south across top of south end of culvert. Note flat to gently undulating terrain and farming land use, deep culvert channel. (January 26, 2006)

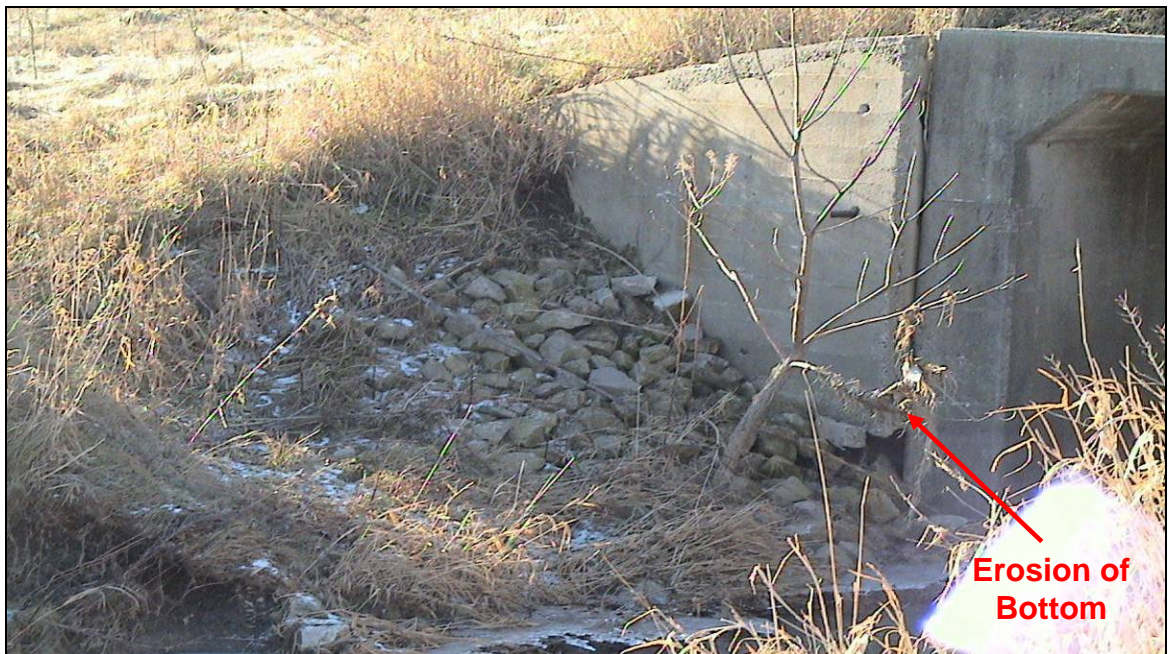
PHOTOGRAPH 4-16: Culvert 13-410. Looking west at west wing wall of south end of culvert. Note leaning wall, erosion at bottom of wall and rock fill cover placed for erosion protection. (January 26, 2006)

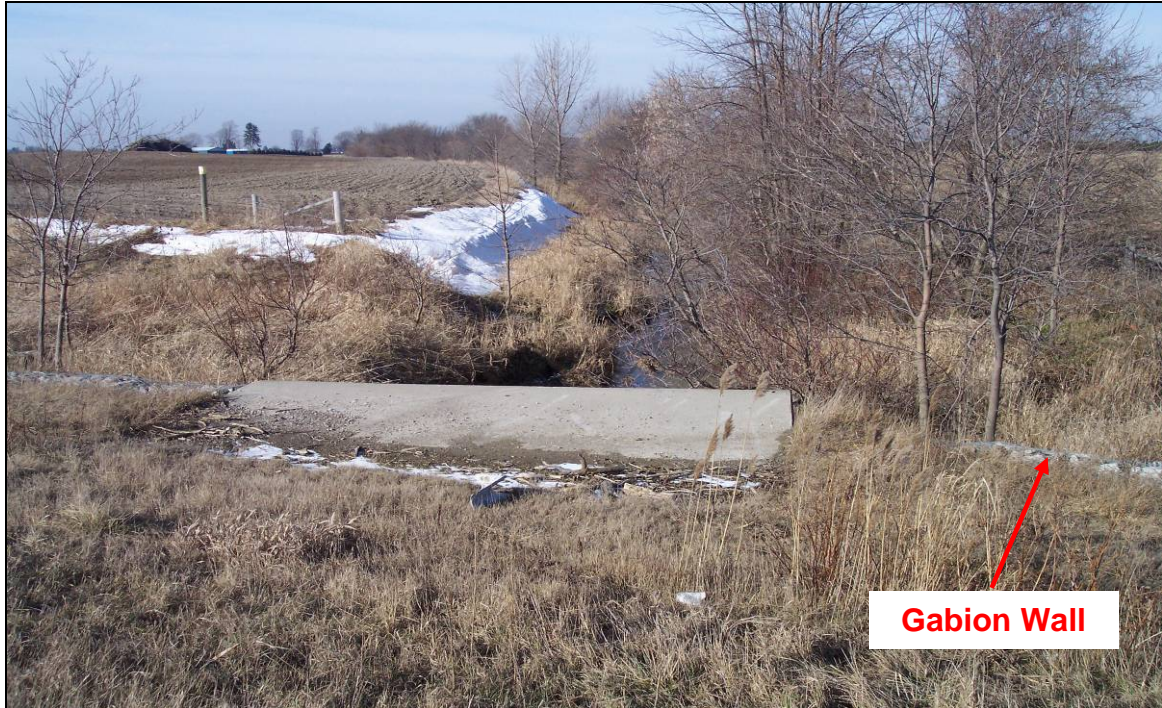
PHOTOGRAPH 4-17: Culvert 13-410. Looking north across top of north end of culvert. Note gabion baskets used for wing walls, deep drainage channel. (January 27, 2006)

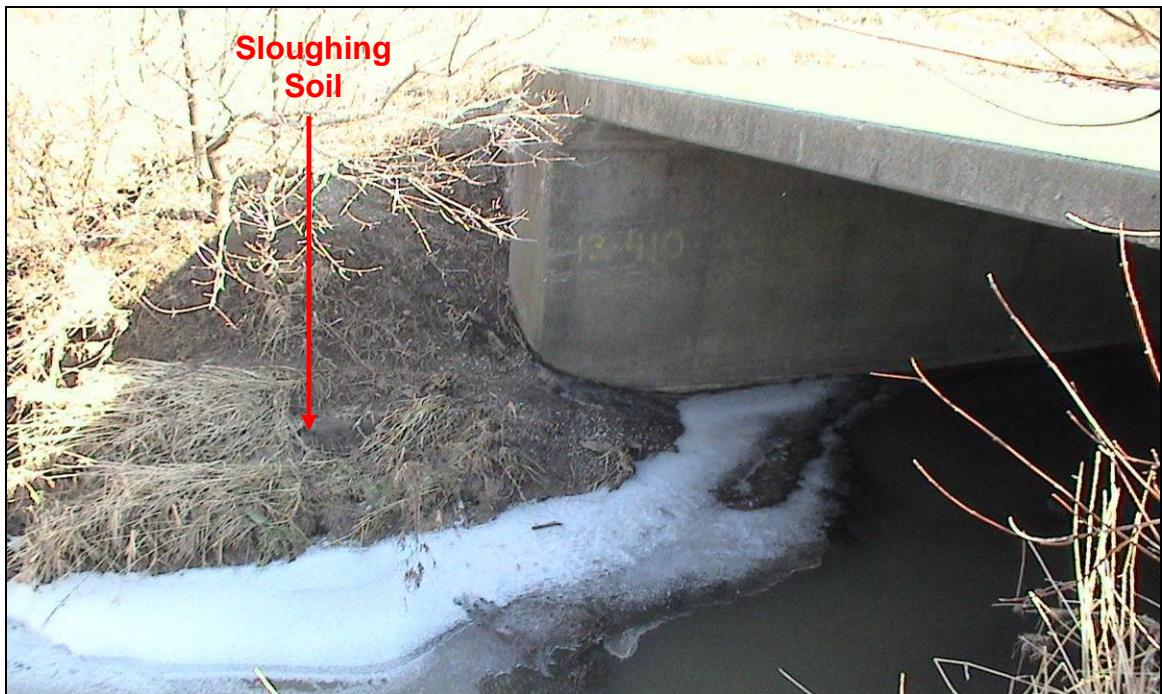
PHOTOGRAPH 4-18: Culvert 13-410. Looking east at north end of culvert. Note sloughing soil partially blocking the drainage channel. (January 27, 2006)

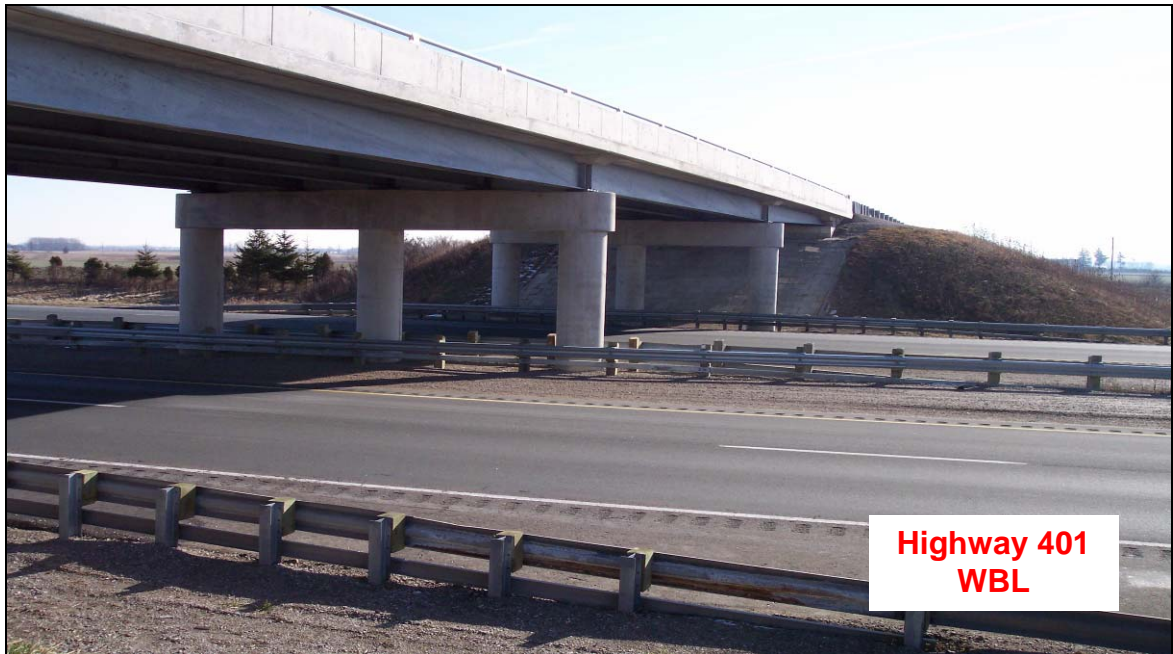
PHOTOGRAPH 4-20: Scane Road Underpass. Looking southeasterly from north shoulder of Highway 401. Note good condition of foundations, typically flat terrain in background. (January 27, 2006)

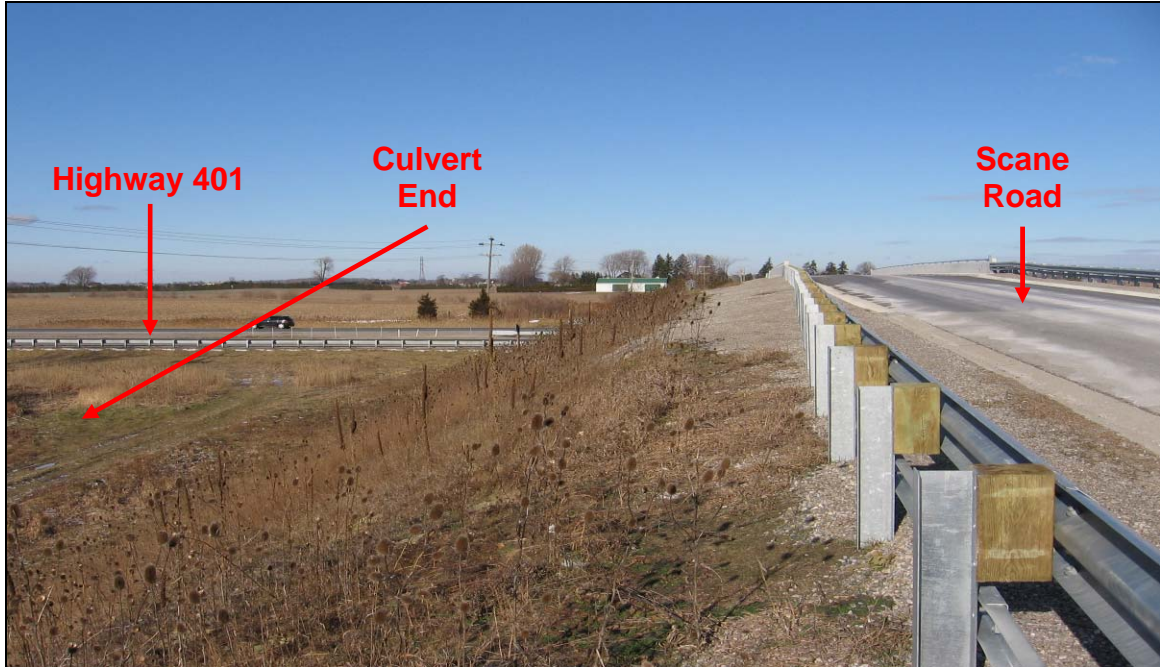
PHOTOGRAPH 4-21: Scane Road Underpass. Looking north along west side of south approach embankment. Note gravel cover on top of slope from 2005 bridge rehabilitation work in foreground. Note flat terrain beyond bridge and culvert end at left centre of photograph. (January 26, 2006)

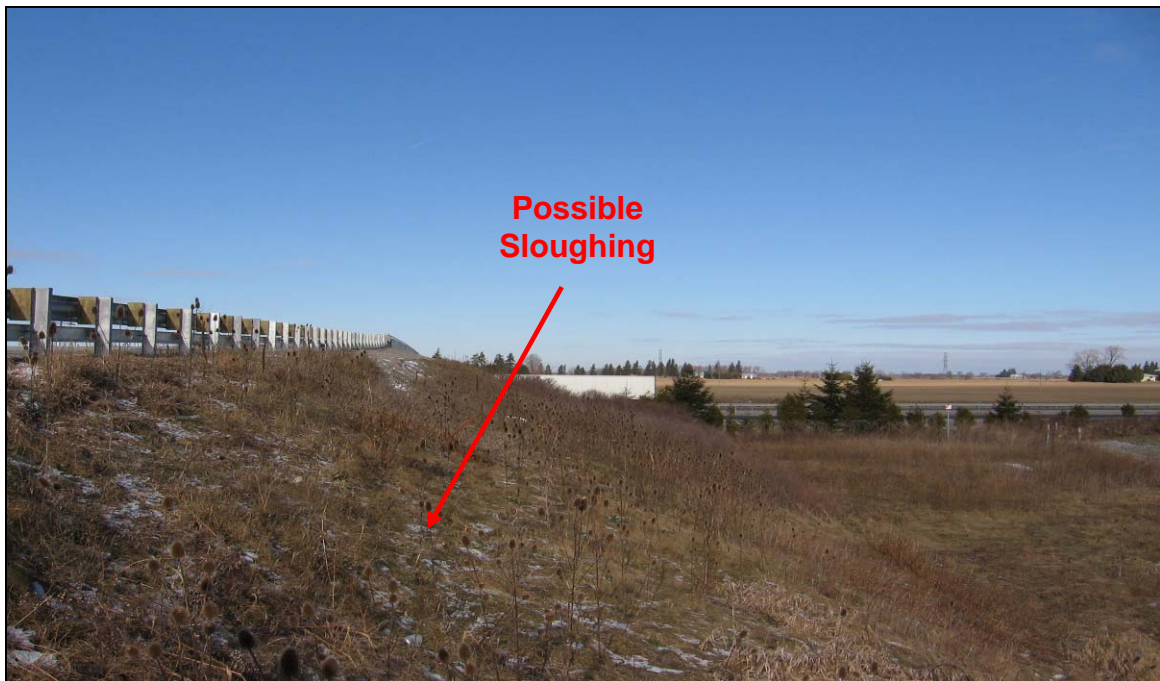
PHOTOGRAPH 4-22: Scane Road Underpass. Looking north at east slope of south approach embankment. Note possible surficial soil sloughing in foreground. (January 26, 2006)

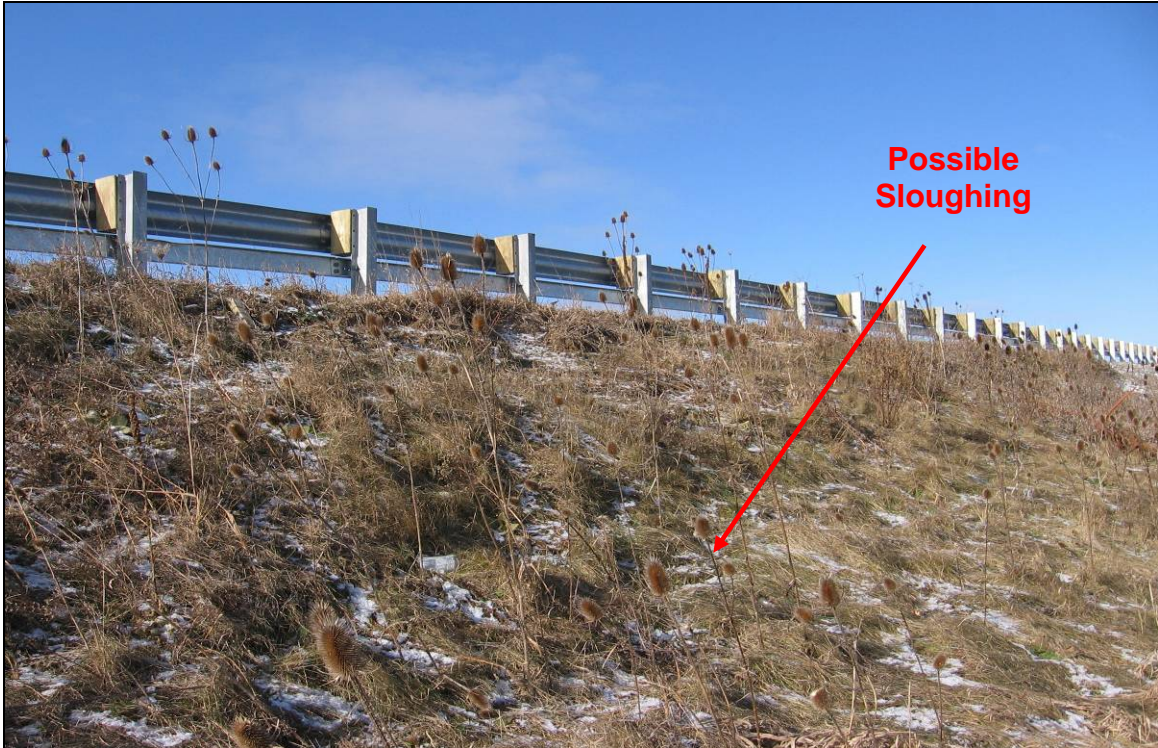
PHOTOGRAPH 4-23: Scane Road Underpass. Looking at east slope of south approach embankment. Note rough appearance indicating possible surficial sloughing. (January 26, 2006)

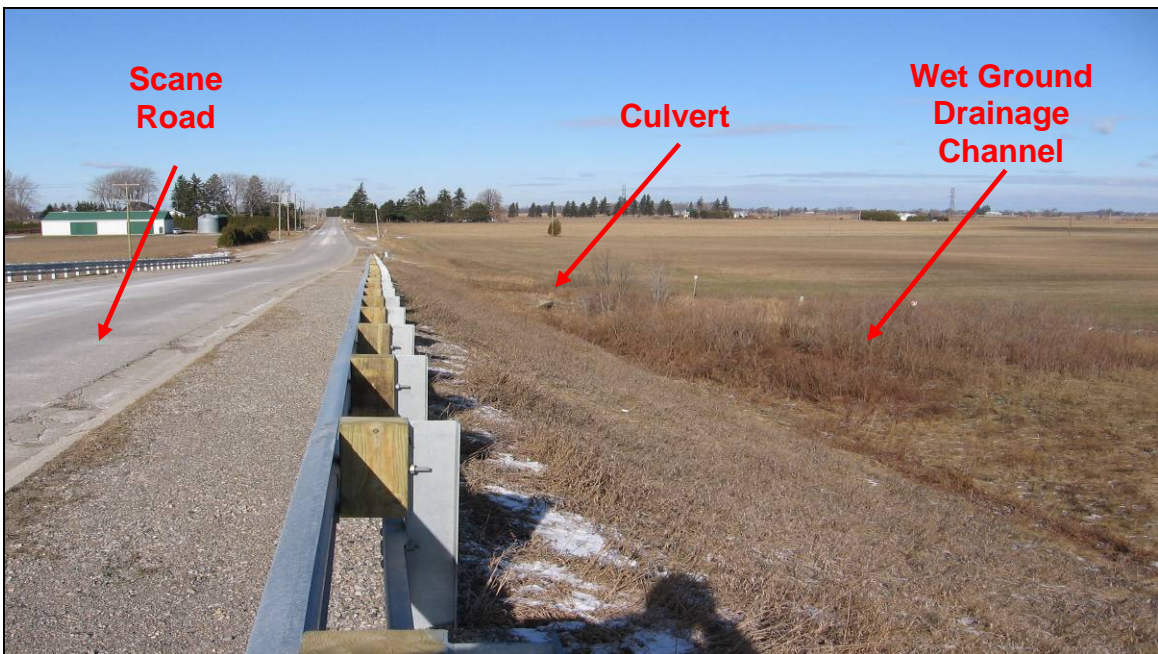
PHOTOGRAPH 4-24: Scane Road Underpass. Looking north east of Highway 401 and Scane Road. Note wet ground at drainage channel at toe of slope of north approach embankment, flat terrain in distance. (January 26, 2006)

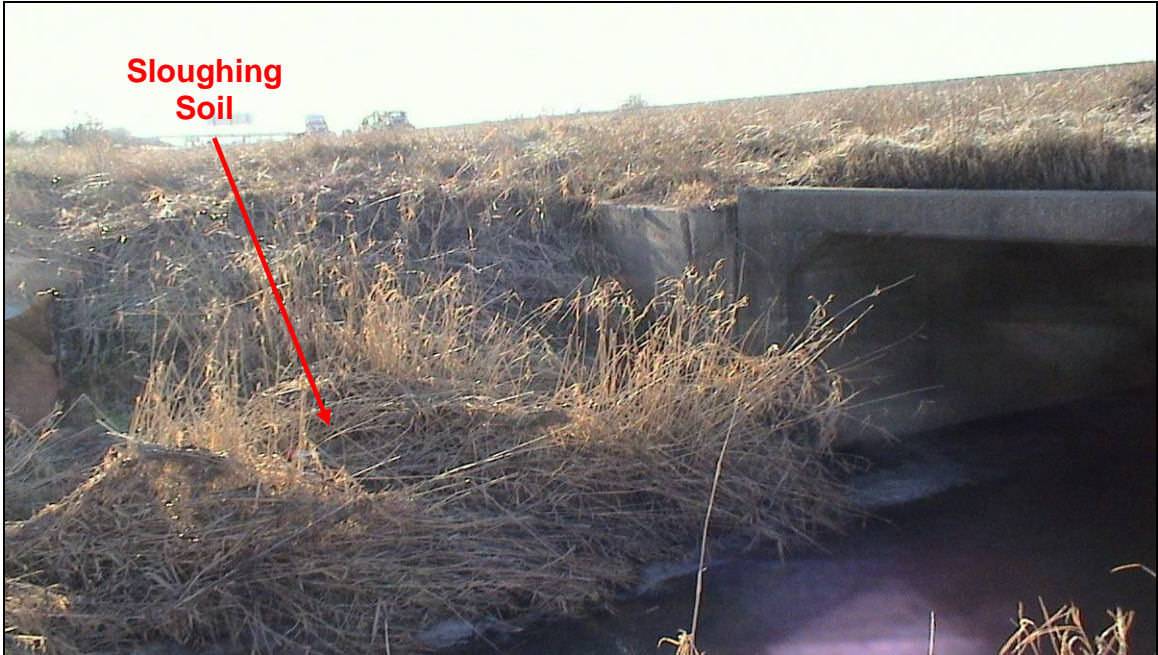
PHOTOGRAPH 4-25: Culvert 13-412. Looking west at south end of culvert. Note leaning west wing wall and soil sloughing into channel. (January 26, 2006)

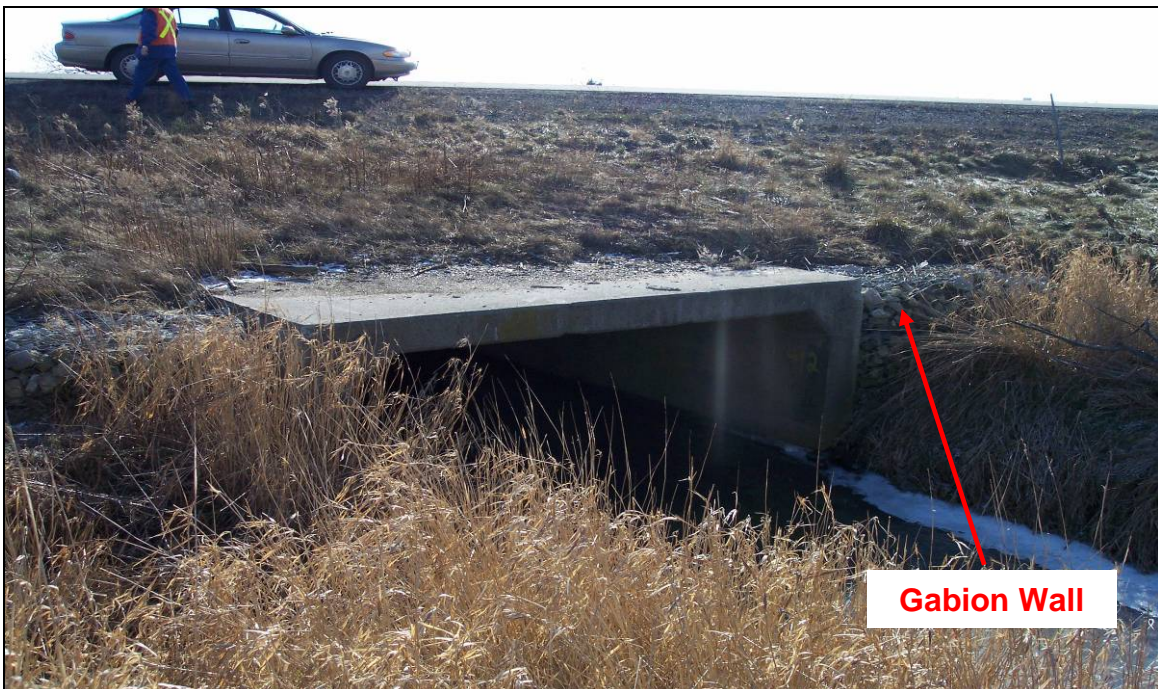
PHOTOGRAPH 4-26: Culvert 13-412. Looking southeasterly at north end of culvert. Note wing walls made up of gabion basket walls. (January 27, 2006)

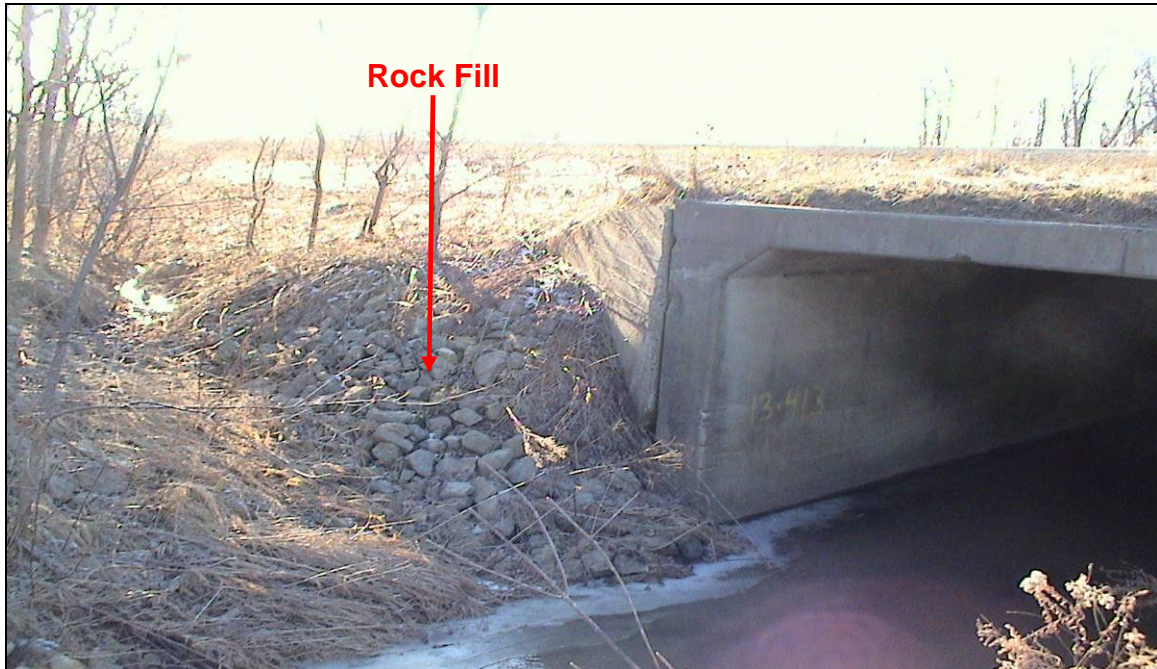
PHOTOGRAPH 4-27: Culvert 13-413. Looking northwesterly at south end of culvert. Note rock fill cover placed on roadside ditch and beside culvert to control erosion. (January 26, 2006)

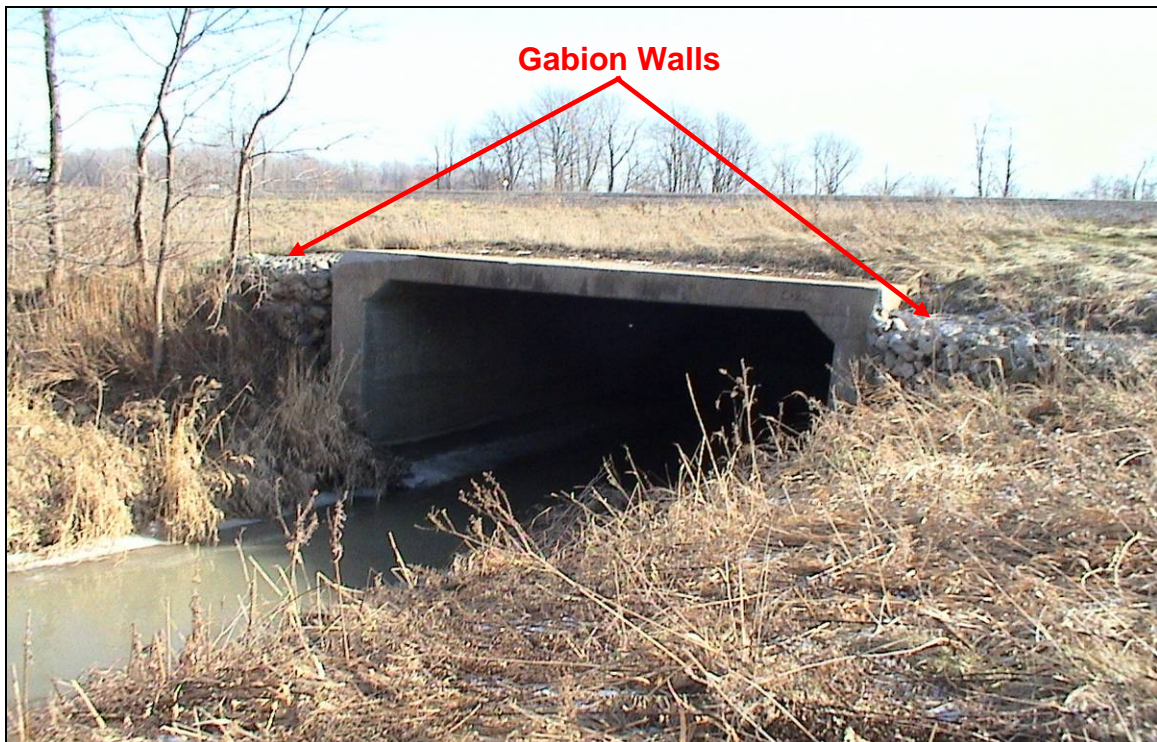
PHOTOGRAPH 4-28: Culvert 13-413. Looking southeasterly at north end of culvert. Note gabion basket wing walls. (January 27, 2006)
