**FEASIBILITY FOUNDATION INVESTIGATION AND DESIGN
REPORT 4 – GEOGRAPHICAL TOWNSHIP OF HOWARD
for
HIGHWAY 401 – CHATHAM-KENT
FROM 0.9 KM EAST OF ESSEX COUNTY ROAD 42
EASTERLY 66.1 KM TO THE ELGIN COUNTY BOUNDARY
AGREEMENT NUMBER 3004-E-0001
GWP NO. 80-00-00
for
MCCORMICK RANKIN CORPORATION**

PML Ref.: 05TF060-4
Index No.: 115FIDR
GEOCRES No.: 40I5-9
January 29, 2010

**Feasibility Foundation Investigation and Design
Report 4 – Geographical Township of Howard**
for
Highway 401 – Chatham-Kent
From 0.9 Km East of Essex County Road 42
Easterly 66.1 Km to the Elgin County Boundary
Agreement Number 3004-E-0001
GWP No. 80-00-00

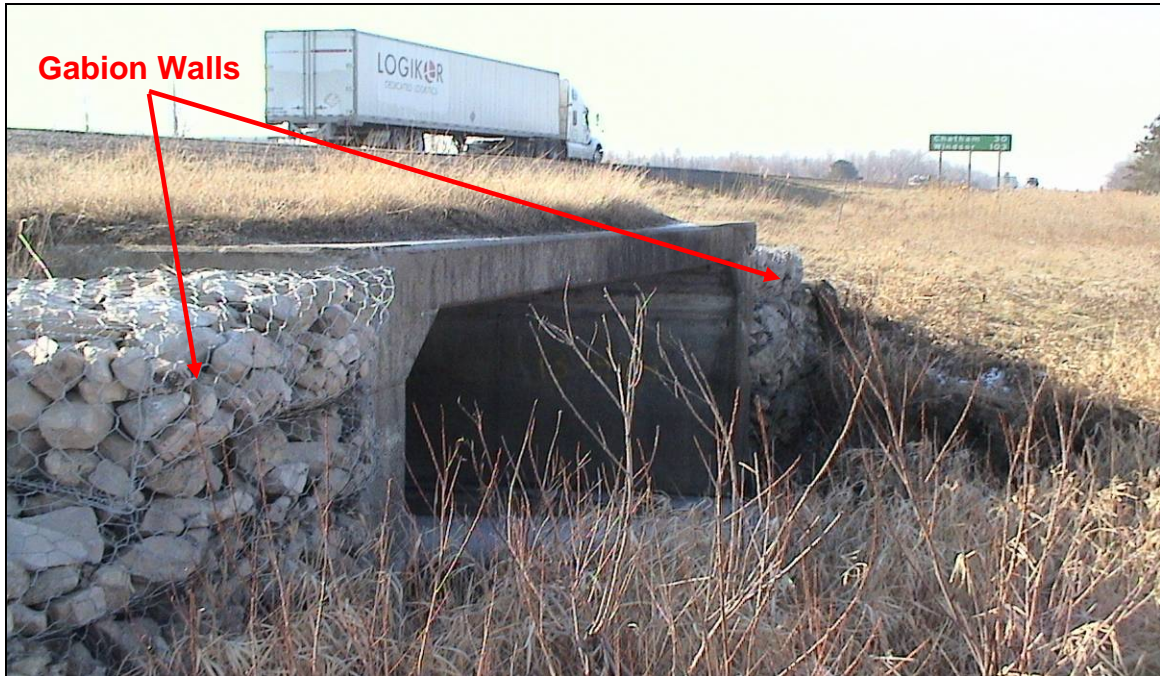
PHOTOGRAPH 4-29: Culvert 13-414. Looking southwesterly at north end of culvert. Note gabion basket used for wing walls. (January 27, 2006)

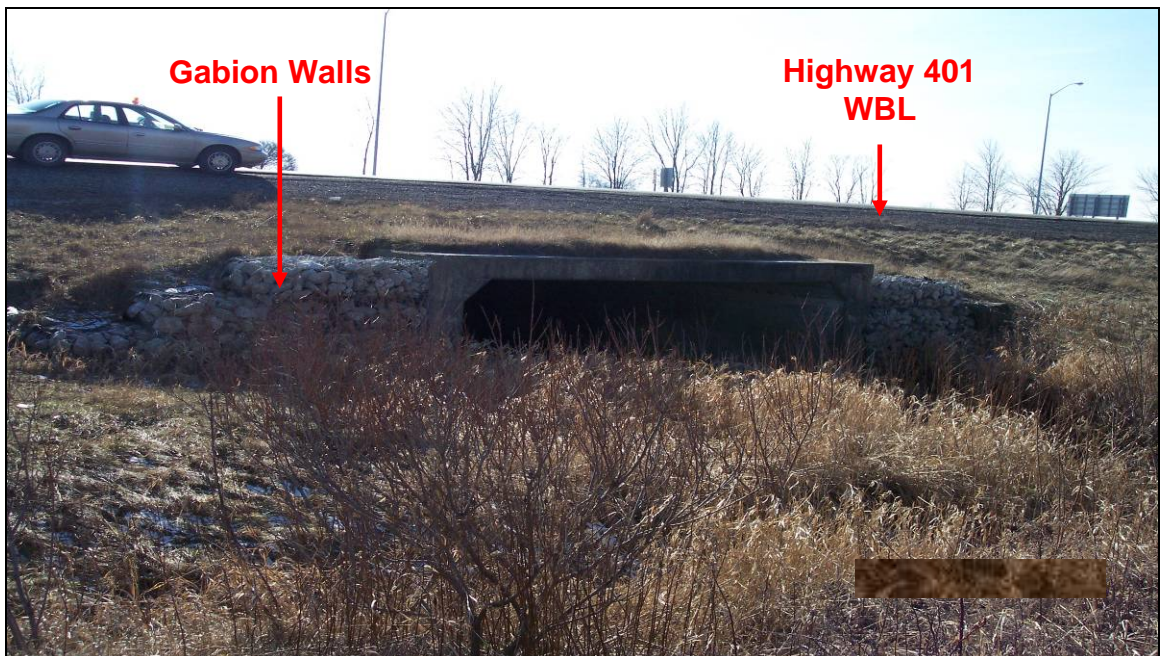
PHOTOGRAPH 4-30: Culvert 13-414. Looking southerly at north end of culvert. Note gabion basket detail and low Highway 401 embankment over top of culvert. (January 27, 2006)

- It is inferred that the concrete wing walls of several culverts were removed and replaced with gabion basket walls (photographs 4-12, 4-13, 4-14, 4-17, 4-26, 4-28 and 4-30). Displacement and rotation of the original concrete wing walls of some of the culverts was noted (photographs 4-16 and 4-25).

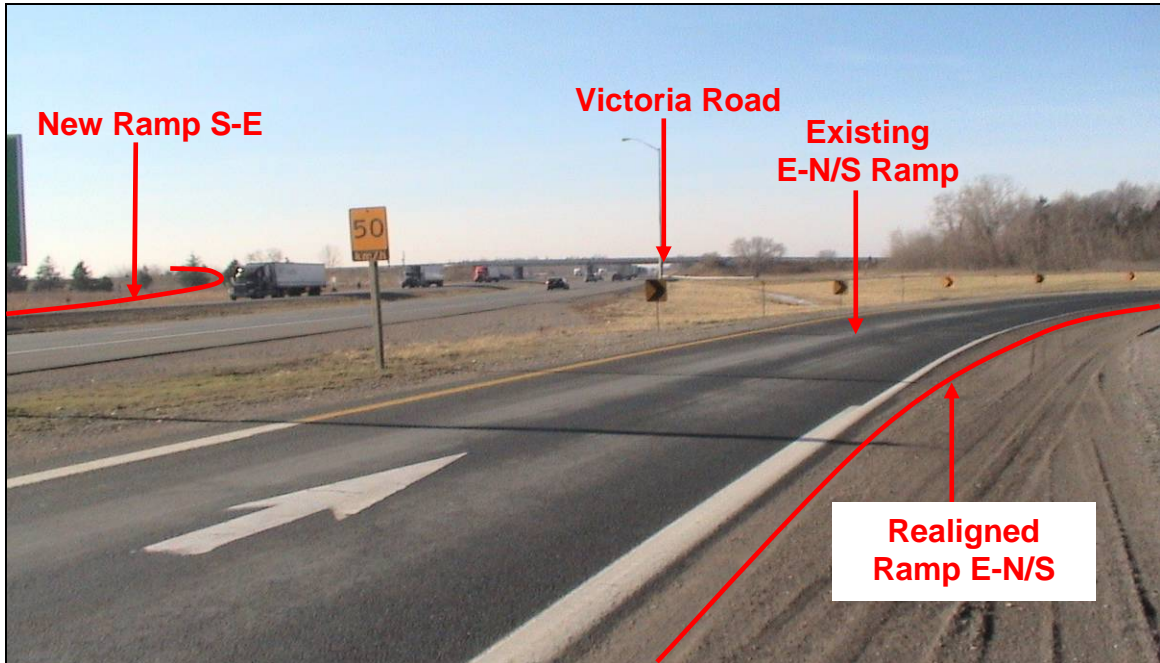
PHOTOGRAPH 4-31: Victoria Road Interchange. Looking west from E-N/S ramp from Highway 401. Note flat to gently rolling terrain beyond bridge. Future S-E ramp and realigned E-N/S ramp are depicted. (January 27, 2006)

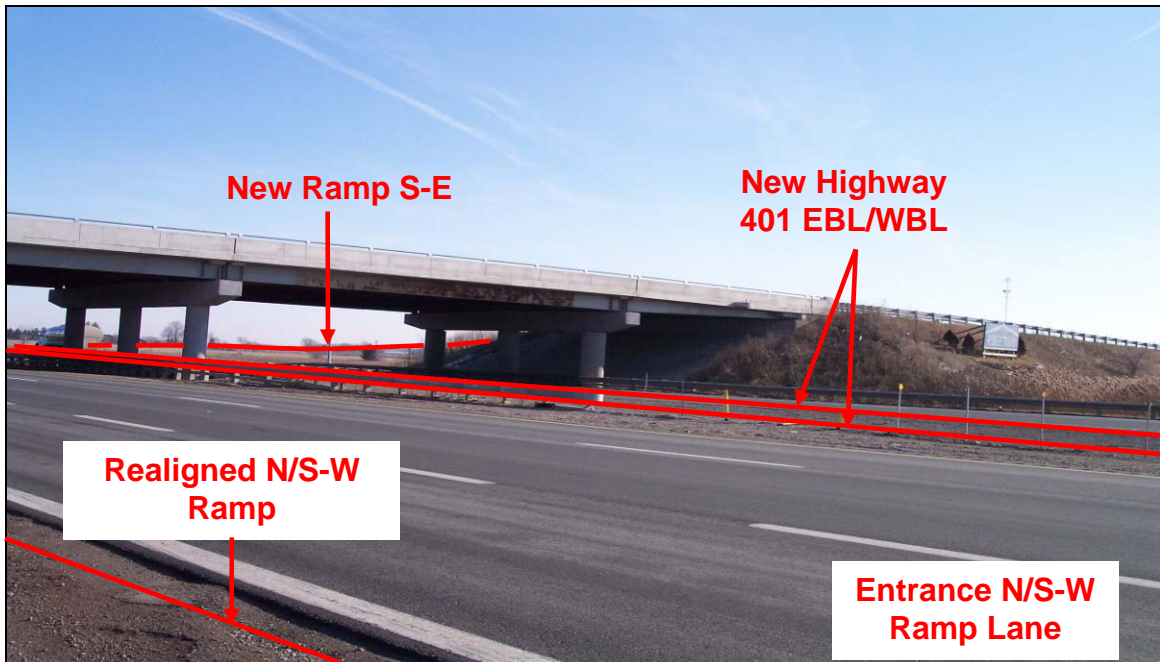
PHOTOGRAPH 4-32: Victoria Road Interchange. Looking southeasterly from north shoulder of Highway 401. Note N/S-W on-ramp on foreground, built-up south approach embankment and typically flat terrain beyond bridge. Future Highway 401 EBL and WBL, S-E ramp and realigned N/S-W ramp are depicted. (January 27, 2006)

- The visual inspection of the underpass structure foundations did not reveal signs of distress such as settlements or other distortion (photographs 4-2, 4-20 and 4-32).

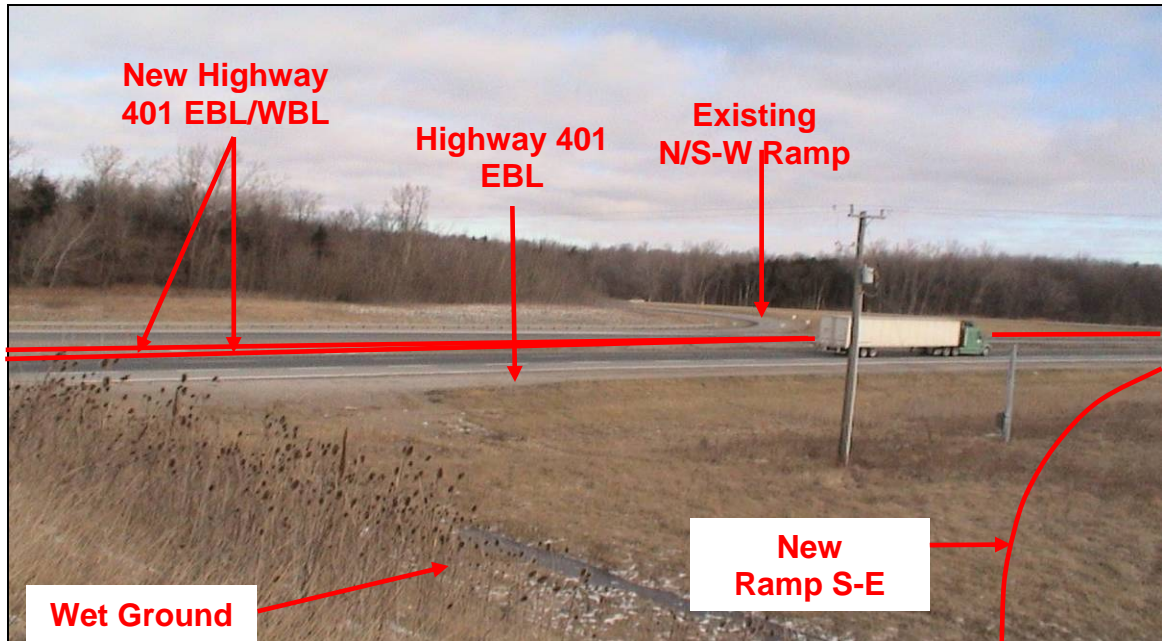
PHOTOGRAPH 4-33: Victoria Road Interchange. Looking northeast from south approach embankment. N/S-W ramp start behind treed area. Note also wet ground at toe of south approach embankment in foreground. Future Highway 401 EBL and WBL and S-E ramp are depicted. (January 26, 2006)

- Swampy ground was not noted within or near the structures or culverts within the alignment. However, some areas were wet possibly due to poor drainage on the relatively flat terrain (photographs 4-5, 4-6, 4-24, 4-33, 4-35 and 4-36).

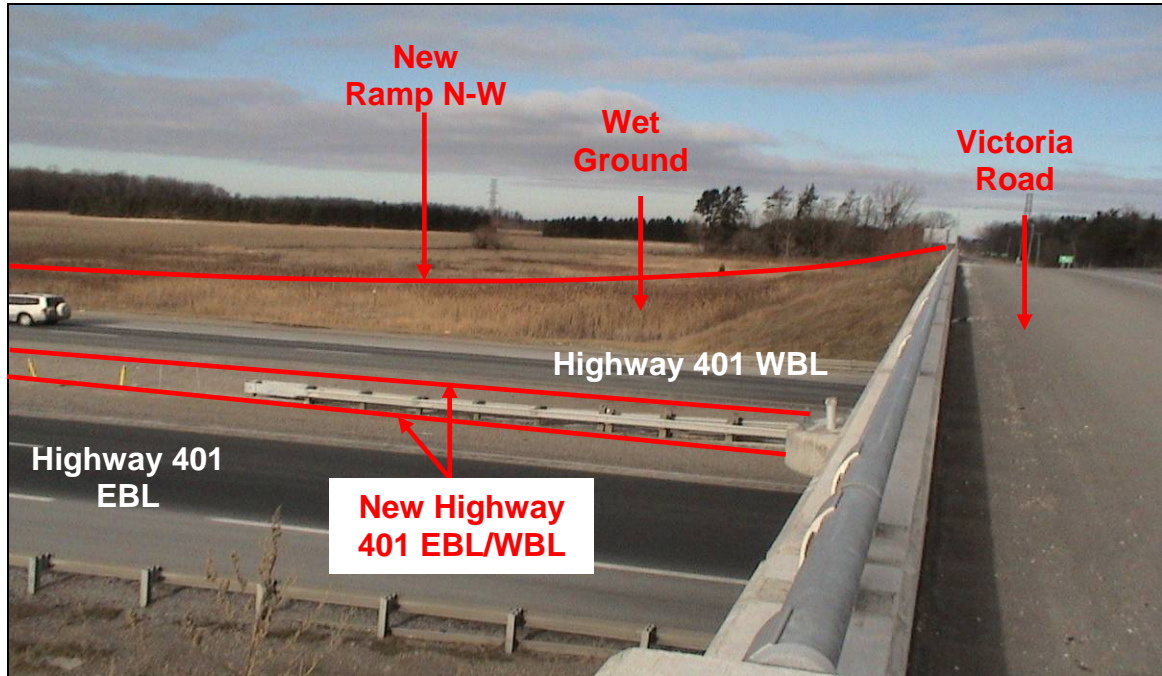
PHOTOGRAPH 4-35: Victoria Road Interchange. Looking north from southwest corner of bridge deck. Toe of slope area of north approach has open water. Note also flat to gently undulating terrain. Future Highway 401 EBL and WBL and N-W ramp are depicted. (January 26, 2006)

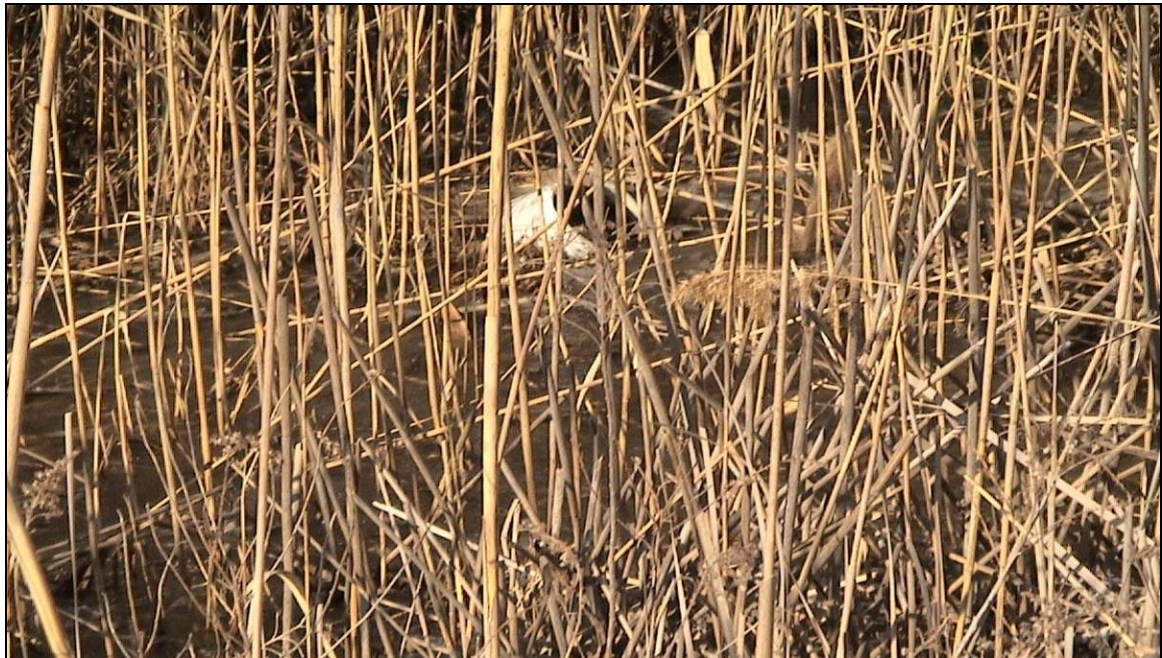
PHOTOGRAPH 4-36: Victoria Road Interchange. Close-up of surface water in ditch located at the west toe of slope of the north approach embankment. (January 27, 2006)

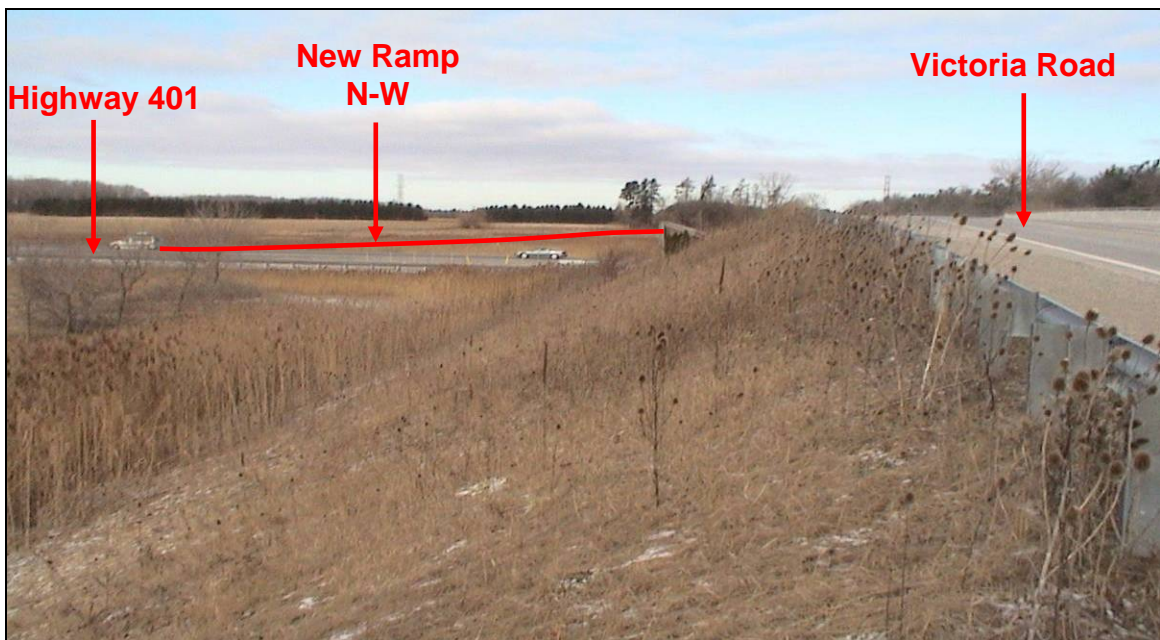
PHOTOGRAPH 4-38: Victoria Road Interchange. Looking north along west side from south approach embankment. Note typical grass cover and generally good condition of embankment, flat terrain beyond. Future N-W ramp is depicted. (January 26, 2006)

- It was judged that the bridge approach embankments are currently stable and without visible settlements. No major signs of distress such as erosion or sliding of the bridge approach embankments were noted (photographs 4-2, 4-3, 4-21, 4-24 and 4-38).

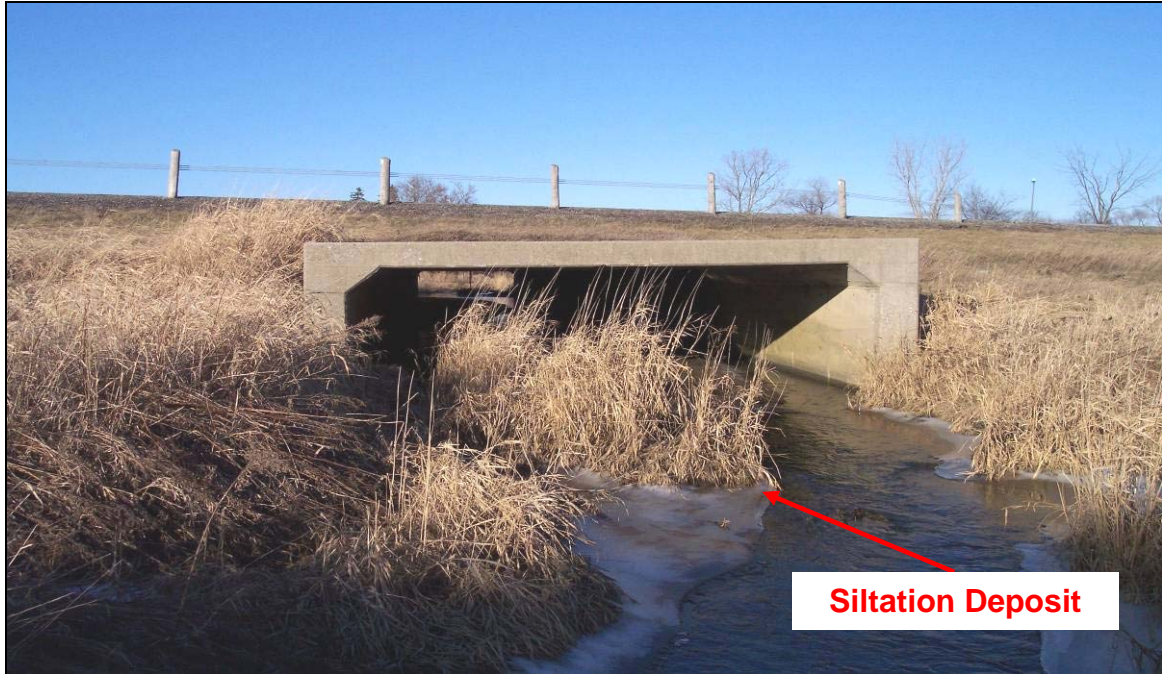
PHOTOGRAPH 4-39: Culvert 13-415. Looking northeasterly at south end of culvert. Note partially blocked channel due to siltation at end of culvert. (January 26, 2006)

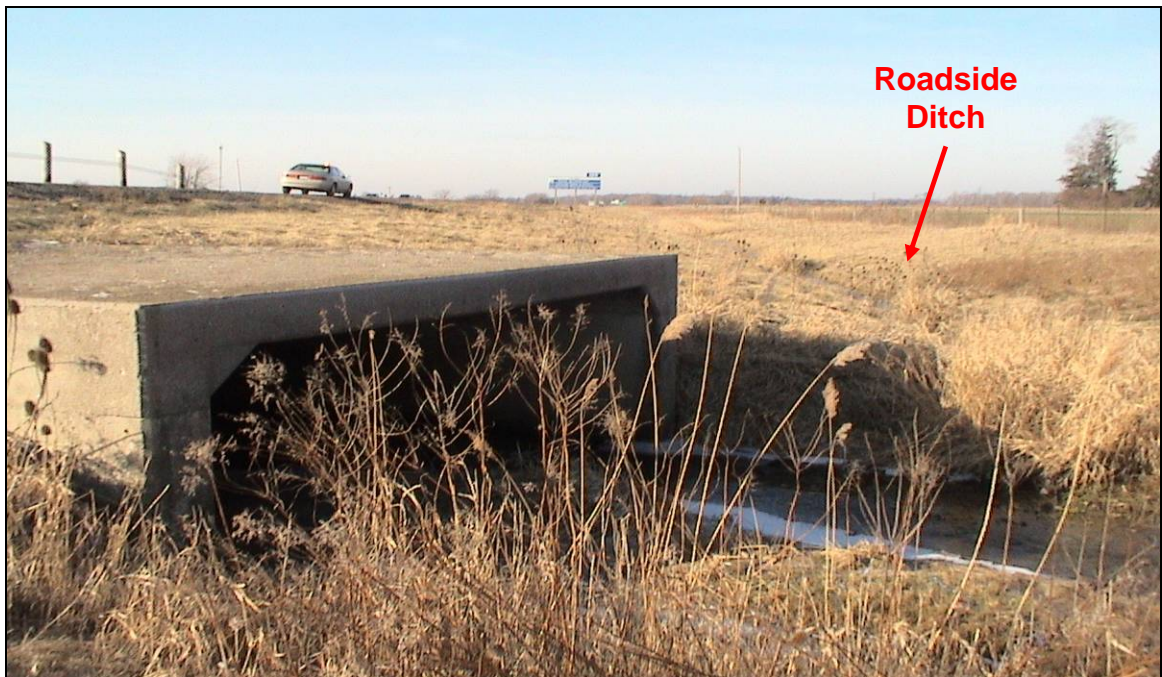
PHOTOGRAPH 4-40: Culvert 13-415. Looking westerly at north end of culvert. Note grass covered roadside ditch. (January 27, 2006)

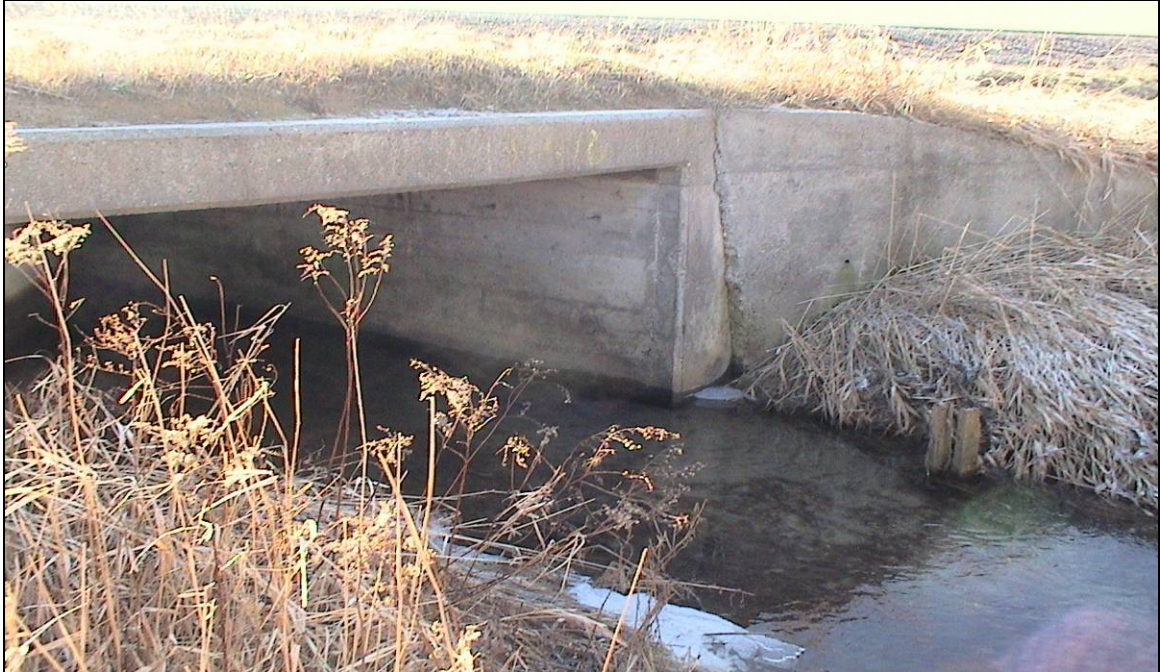
PHOTOGRAPH 4-41: Culvert 13-416. Looking westerly at north end of culvert. Note minor sloughing of bank in foreground. (January 27, 2006)

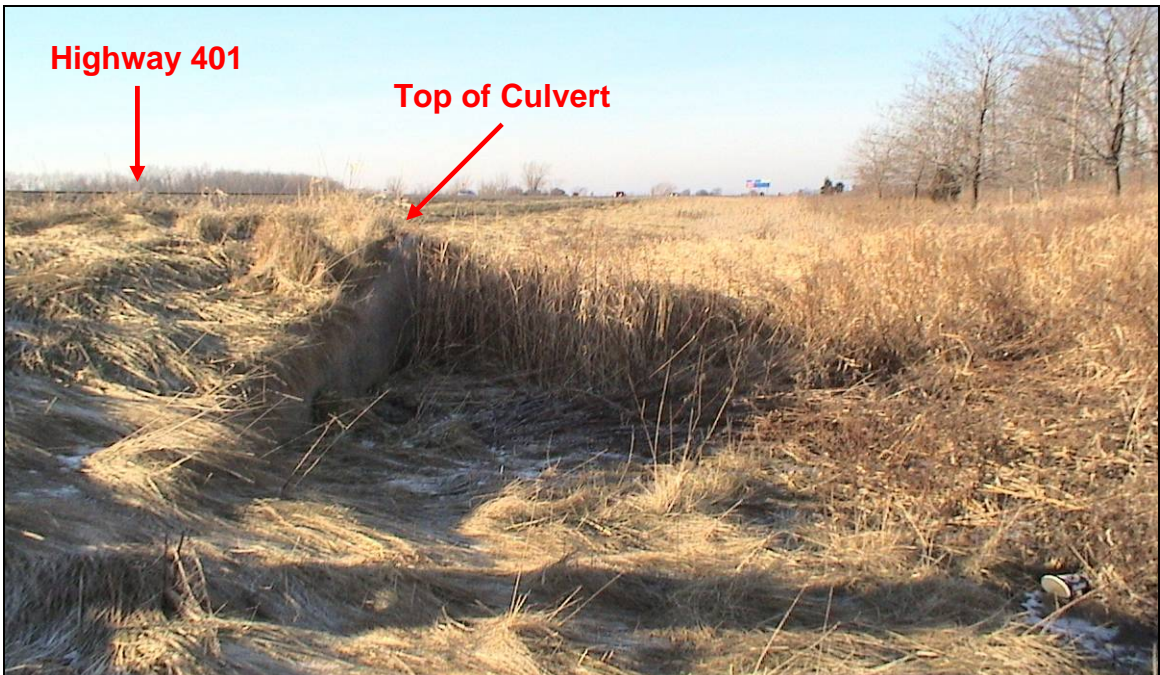
PHOTOGRAPH 4-42: Culvert 13-416. Looking west along sideroad ditch. Note heavy grass cover of ditches, flat terrain in background. (January 27, 2006)

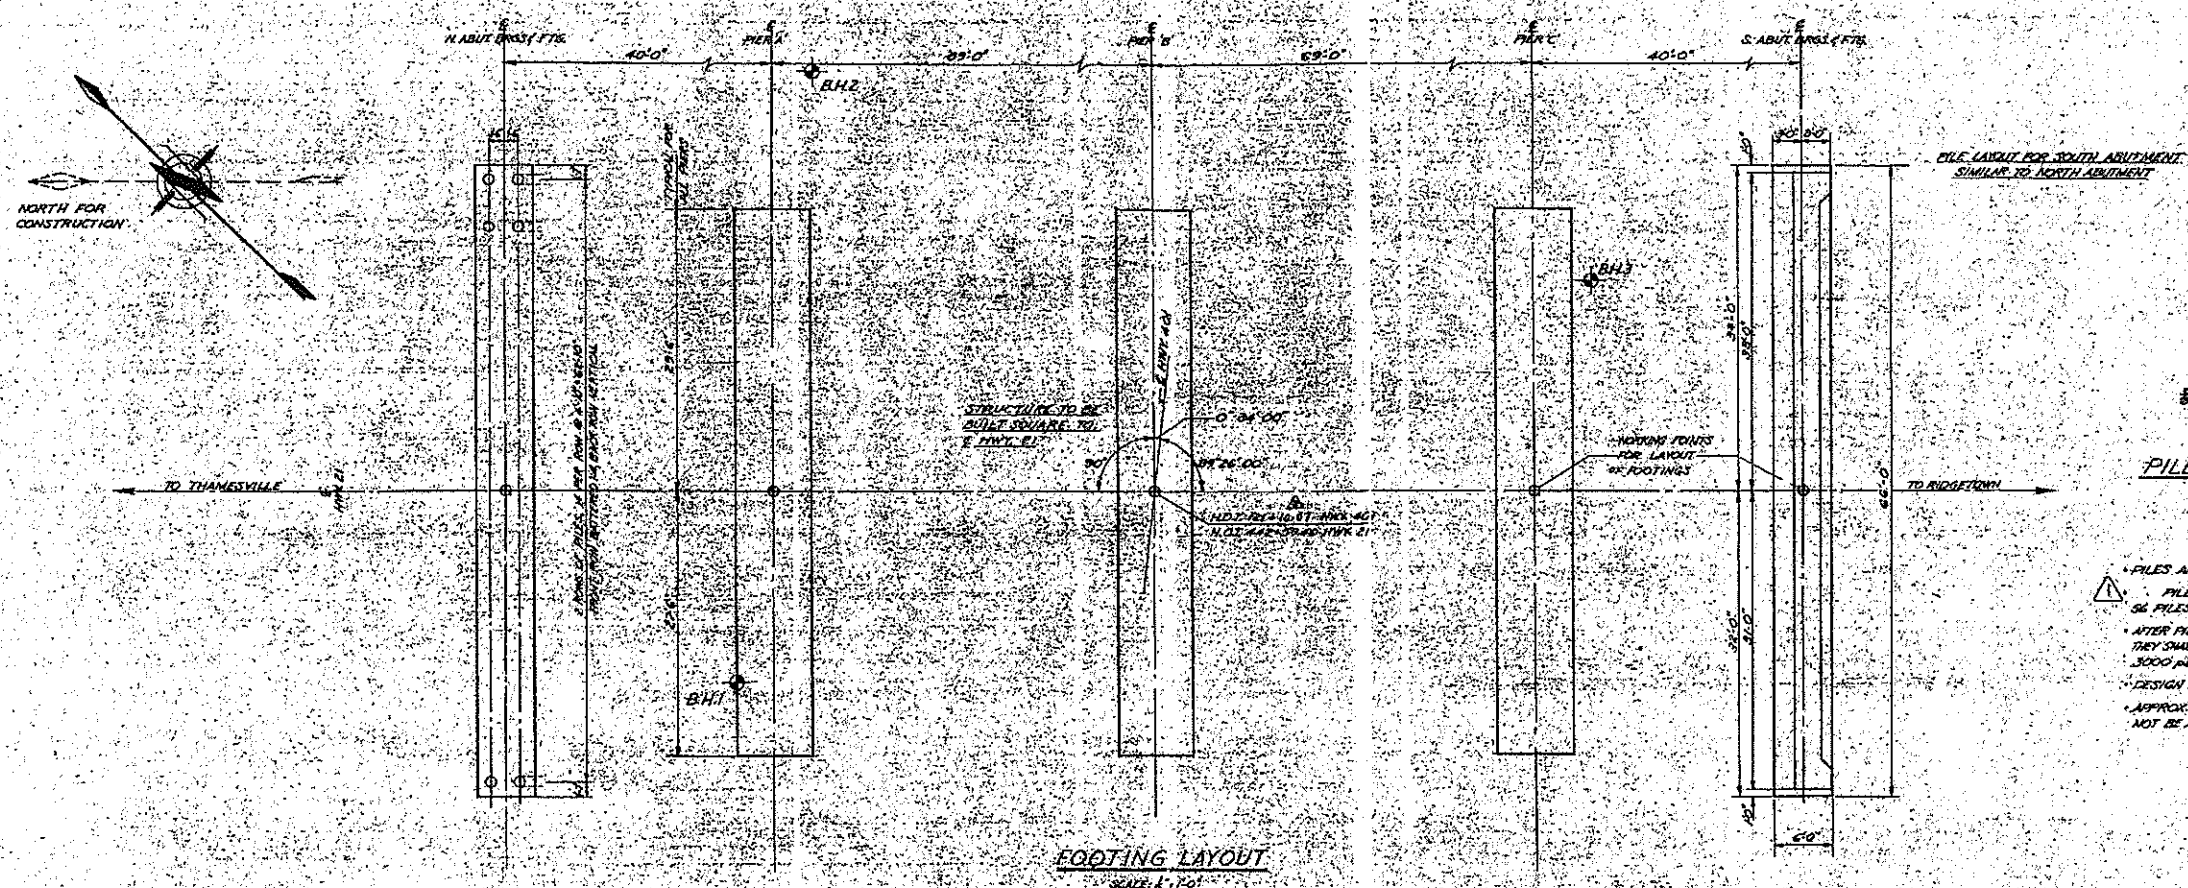
- FILES ARE 12" O.D. STEEL TUBE, 0.250" THICK WALL.
- PILE LENGTH TO BE SUPPLIED - 24'-0" 56 FILES REQUIRED.
- AFTER FILES HAVE BEEN INSTALLED AND INSPECTED THEY SHALL BE FILLED WITH CONCRETE OF 3000 P.S.I. @ 28 DAYS STRENGTH.
- DESIGN LOAD FOR PILE 25 TONS.
- APPROX. PILE TIP ELEVATION 622.0 - THE FILES SHALL NOT BE ADVANCED BEYOND EL. 622.0.
