**DETAIL FOUNDATION INVESTIGATION REPORT
REHABILITATION OF THE ARGYLE STREET SOUTH BRIDGE
FORMER HIGHWAY 6, CALEDONIA, SITE 9-2
GWP 3147-06-00, AGREEMENT NO. 3006-E-0049
MINISTRY OF TRANSPORTATION, ONTARIO
– SOUTHWESTERN REGION**

January 2, 2008

07-1130-023-0
Geocres No. 30M4-111

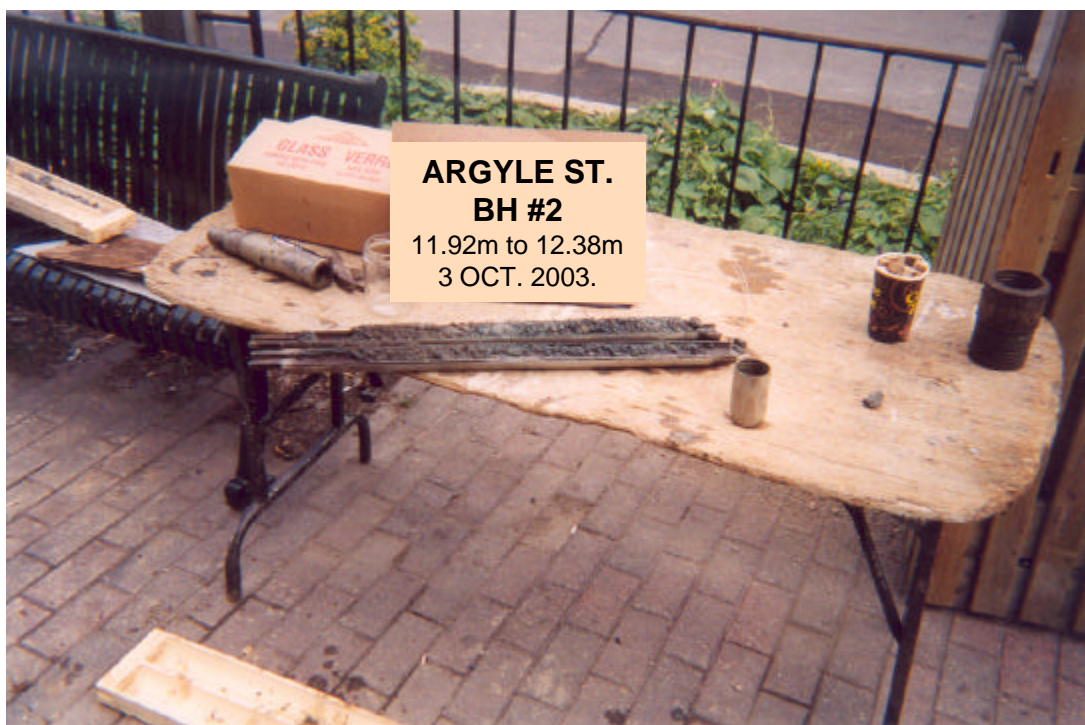
Photo 2 Borehole No. 2 – Split spoon in rock
Elevation 178.31m to 177.85m.

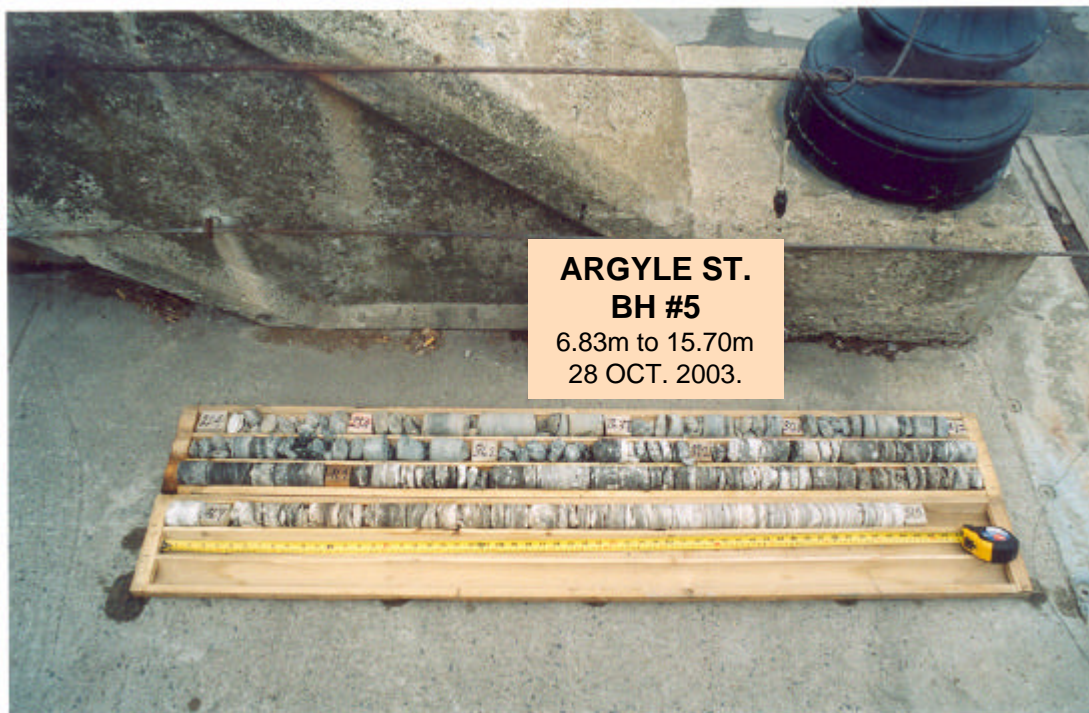
Photo 3 Borehole No. 5 – Rock core
Elevation 184.59m to 175.72m.

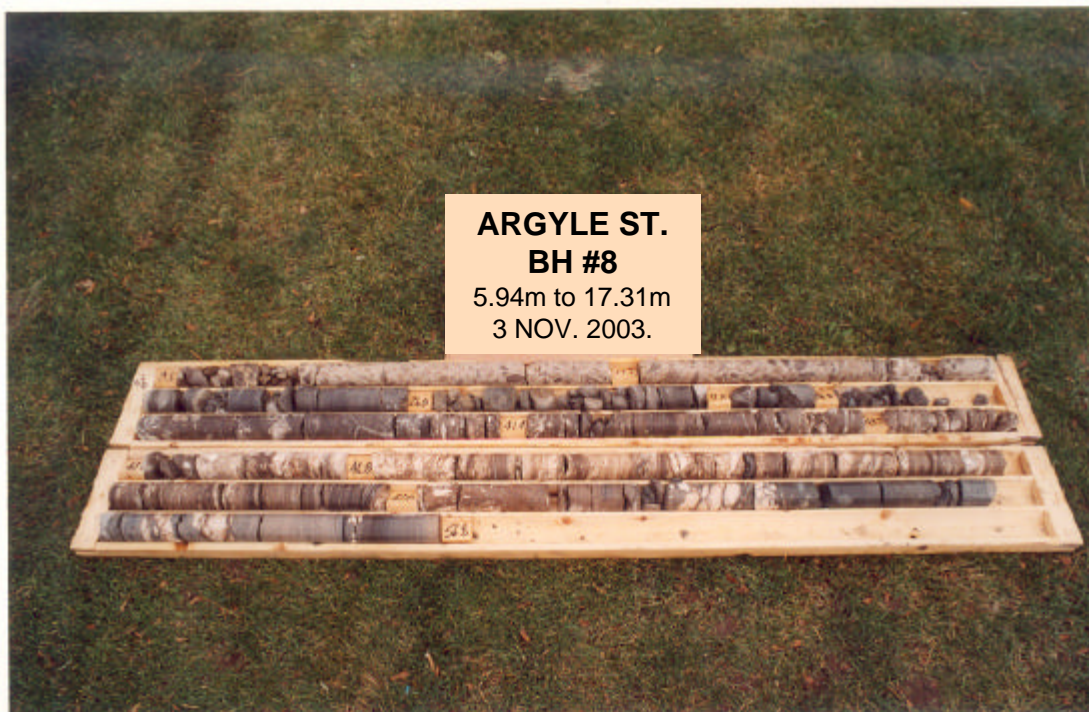
Photo 4 Borehole No. 8 – Rock core. Note concrete.
Elevation 185.29m to 173.92m.

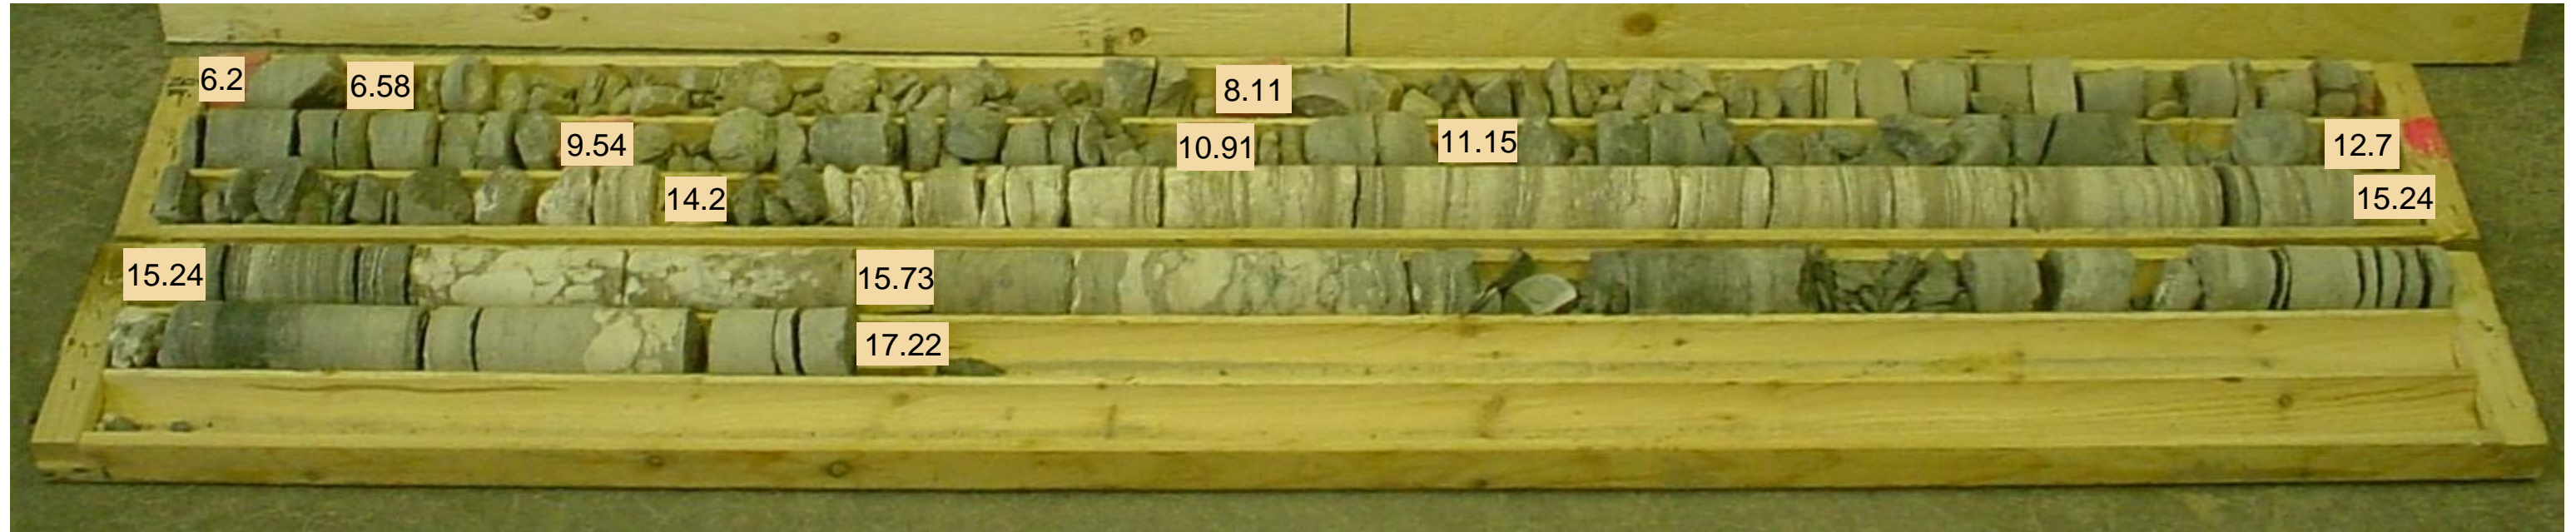
Photo 5: Borehole No. 101 – Rock Core. Possible concrete to approximate elevation 184.0 metres. Elevation 184.87 metres to 173.93 metres.

A 430 millimetre thick fill layer of cobbles and boulders was encountered from elevation 185.3 metres over the possible concrete pier footing in borehole 101. A 160 millimetre thick layer of sandy silt fill was encountered at elevation 185.4 metres over the concrete pier foundation in borehole 105. Possible rock fill was encountered at elevation 185.3 metres but not recovered in borehole 102.

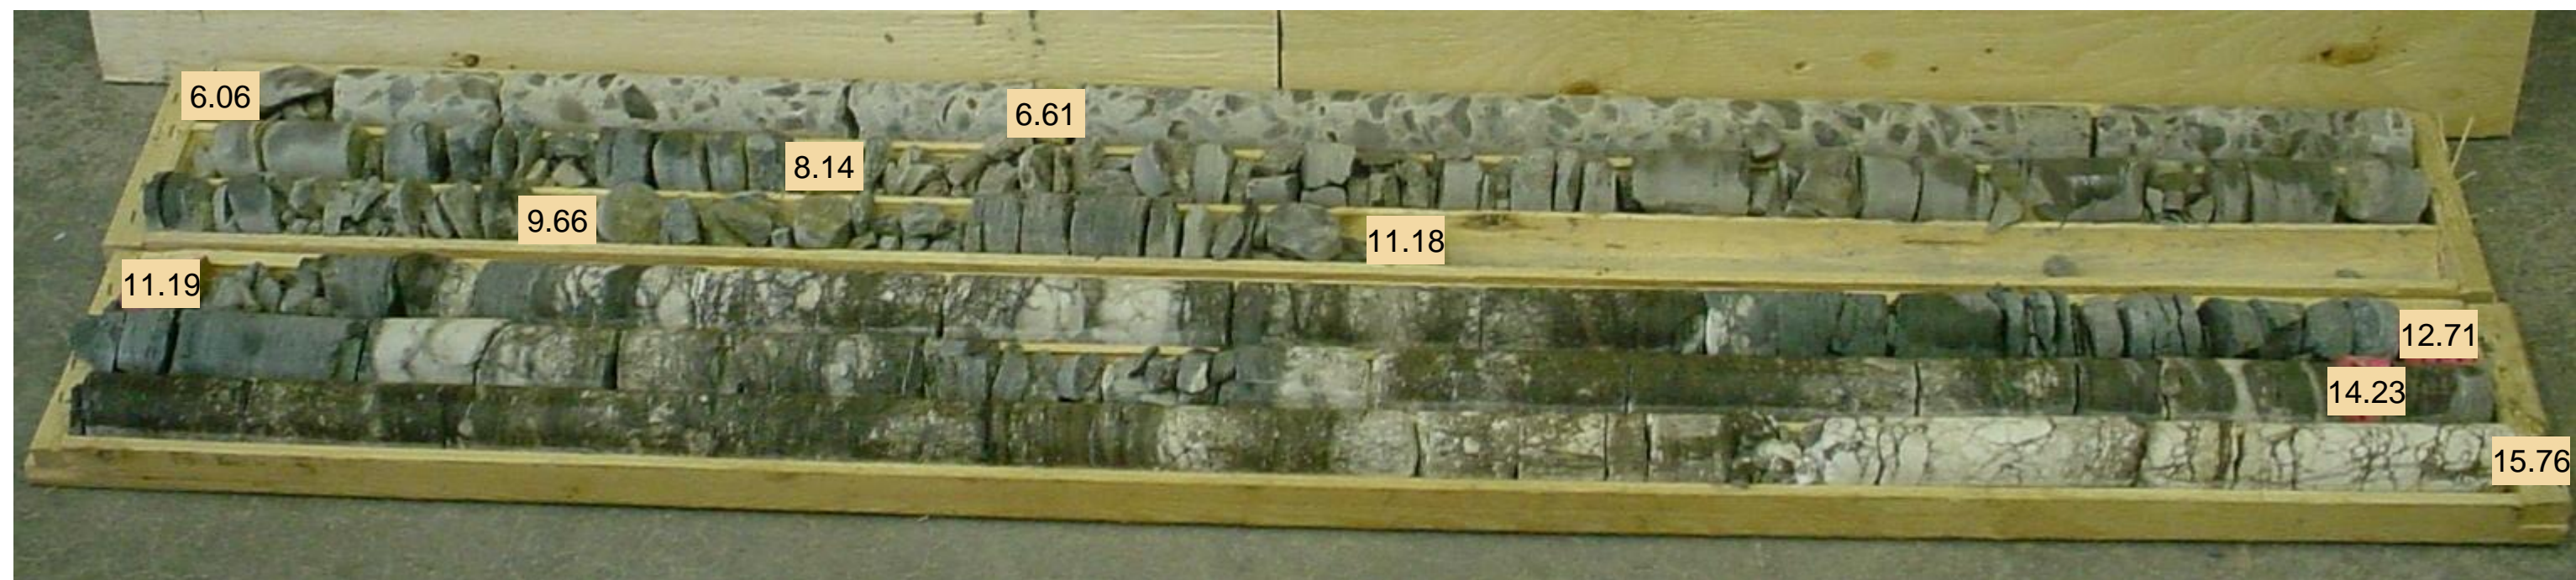
Photo 9: Borehole No. 105 – Rock Core. Concrete to approximate elevation 183.8 metres. Elevation 185.27 metres to 175.58 metres.
