WINDSOR-ESSEX PARKWAY

Subsurface Conditions Interpretation Report

REVISED REPORT

Report Number: 07-1130-207-0-R02 / 05-1140-003

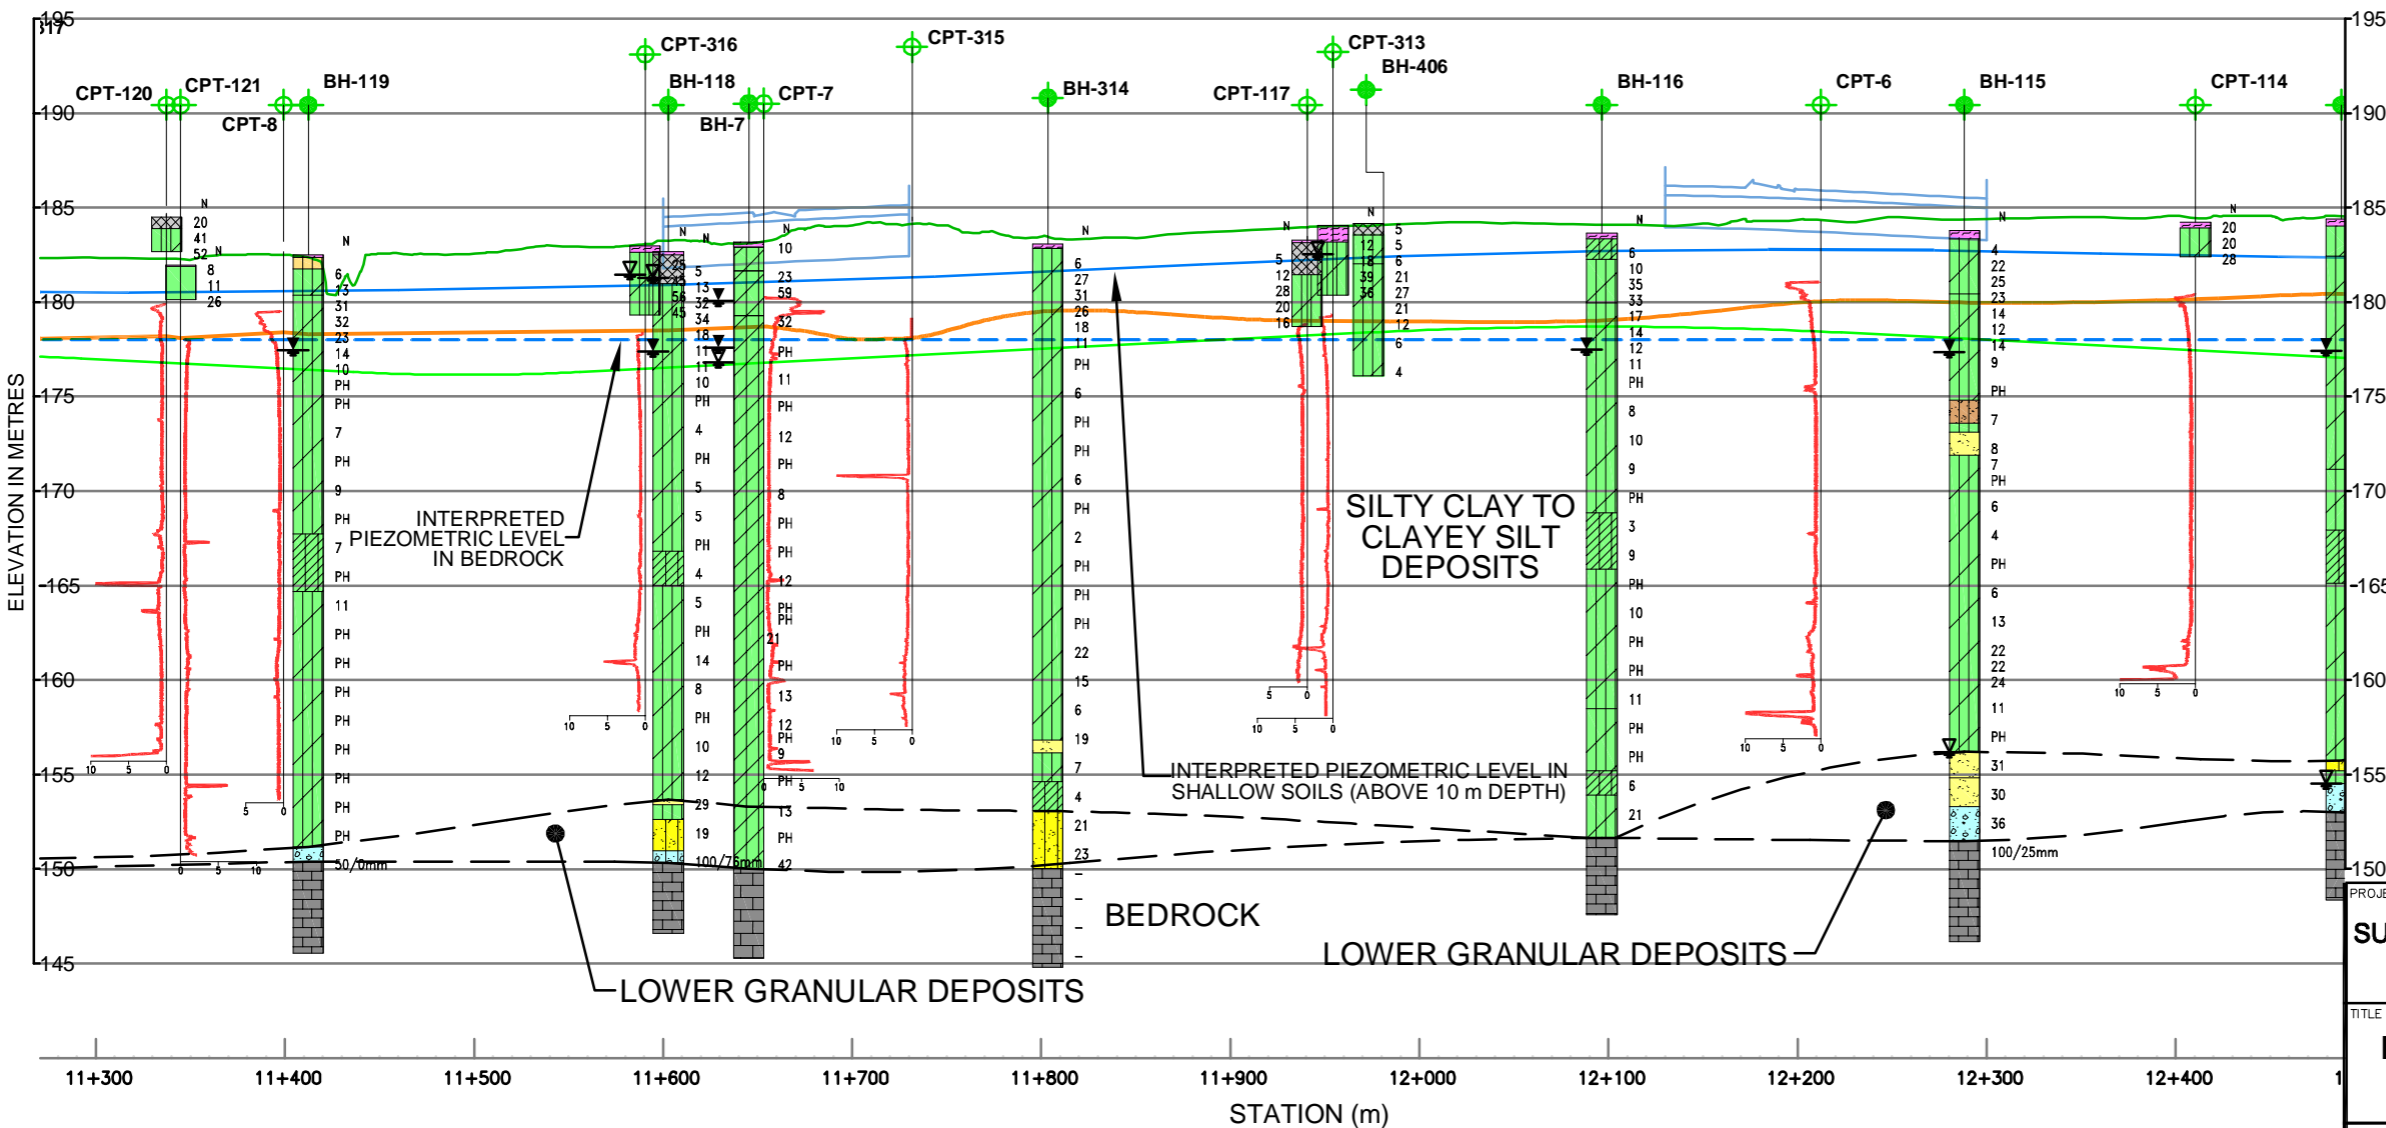
INTERPRETED STRATIGRAPHIC PROFILE STN 11+300 TO 12+500

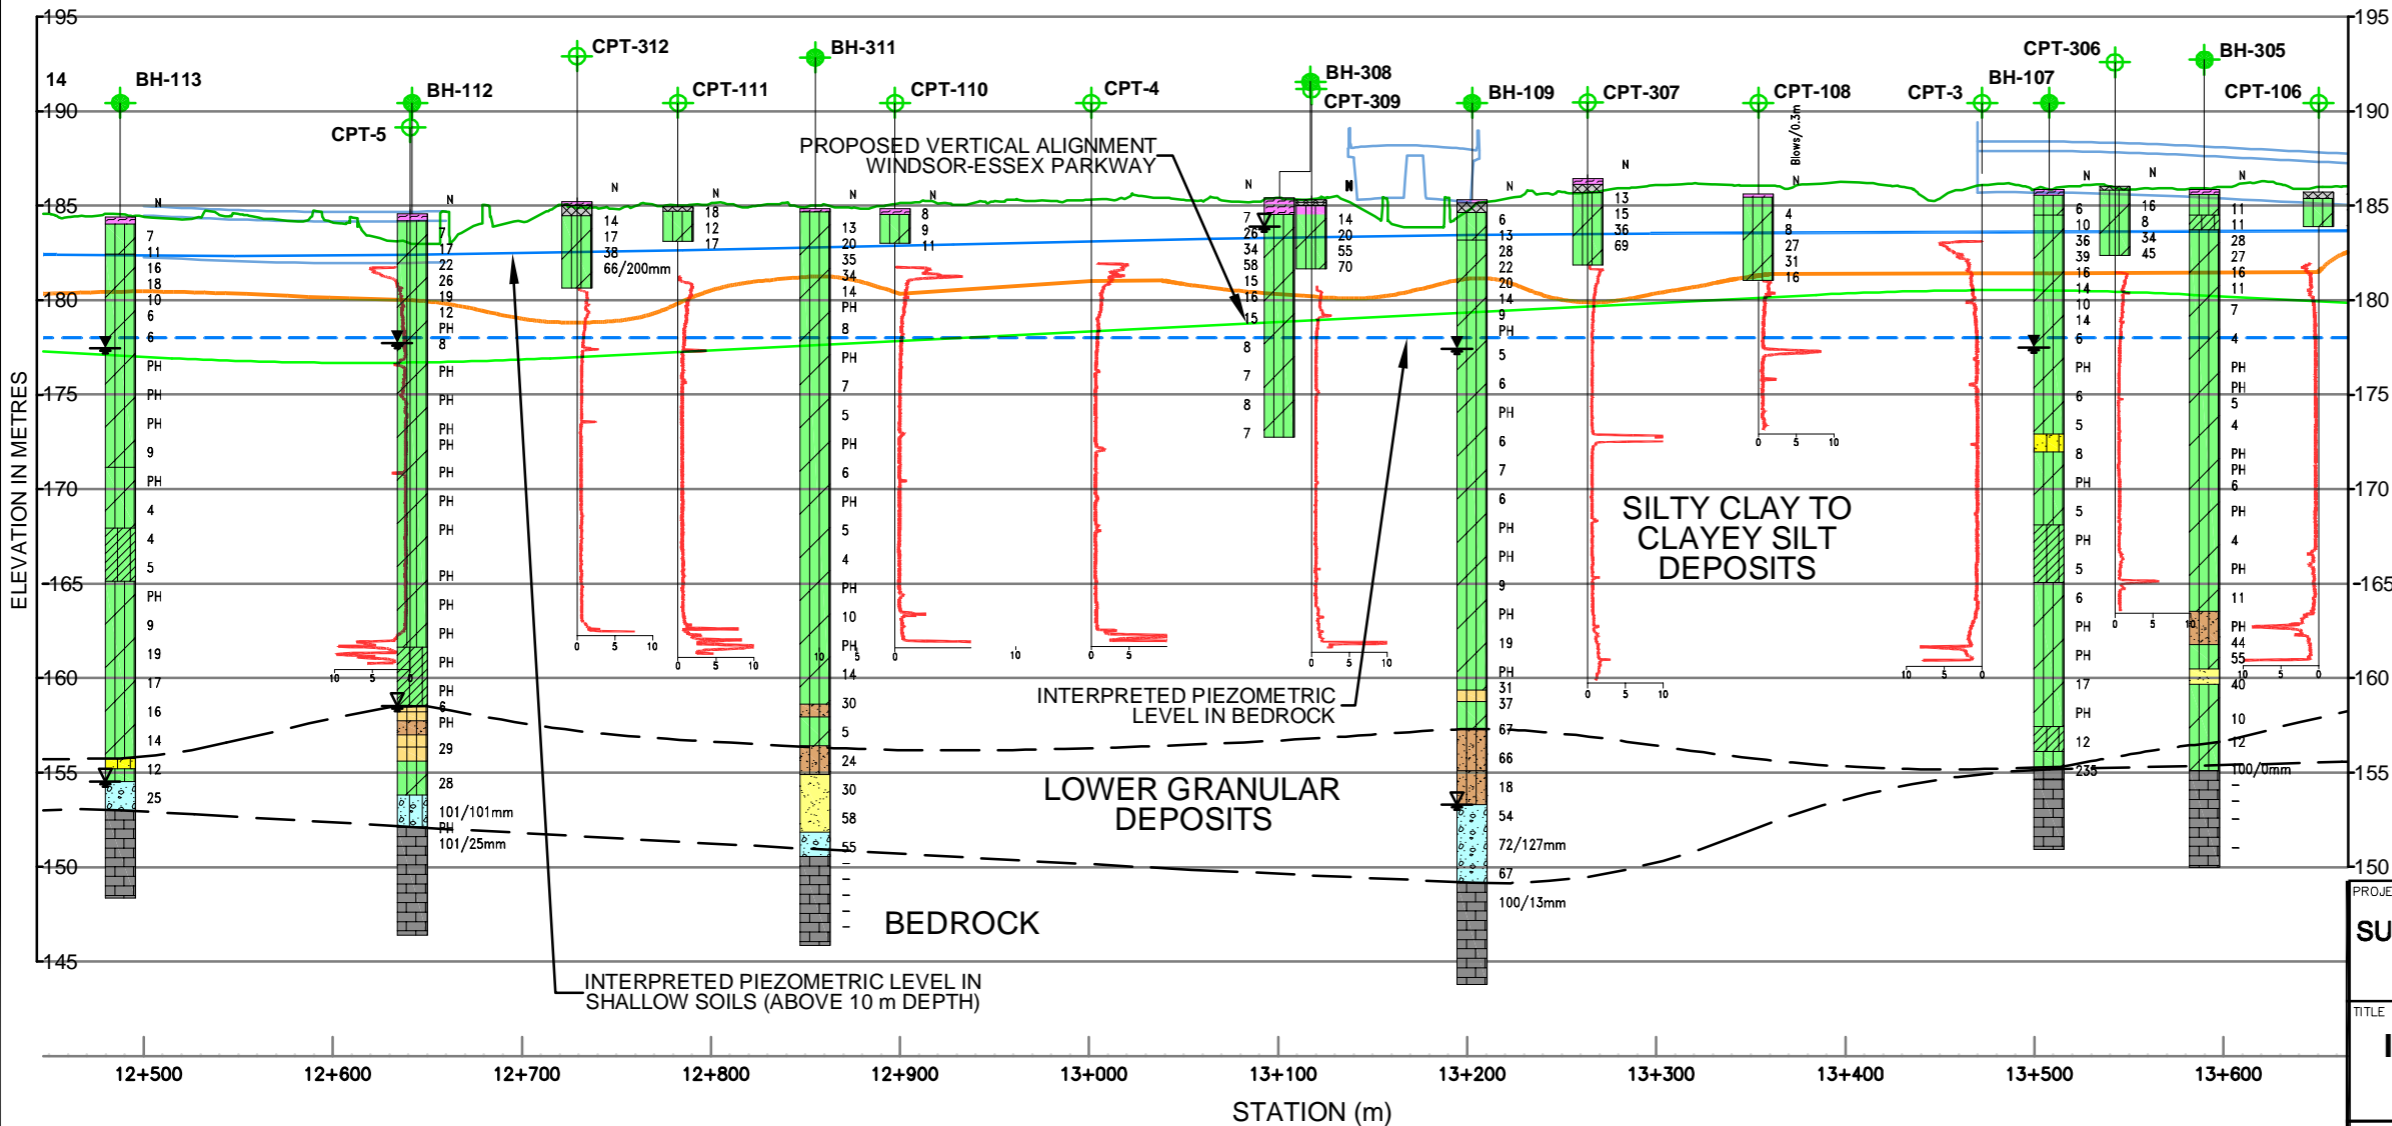
PROJECT			
SUBSURFACE CONDITIONS INTERPRETATION REPORT WINDSOR - ESSEX PARKWAY WINDSOR, ONTARIO			
TITLE			
INTERPRETED STRATIGRAPHIC PROFILE STN 12+500 TO 13+600			
PROJECT No. 07-1130-207-0		FILE No. 0711302070-R02051	
CADD	JR/WFH	Dec. 11/10	SCALE AS SHOWN REV. 2
CHECK			5.1H
Golder Associates LONDON, ONTARIO

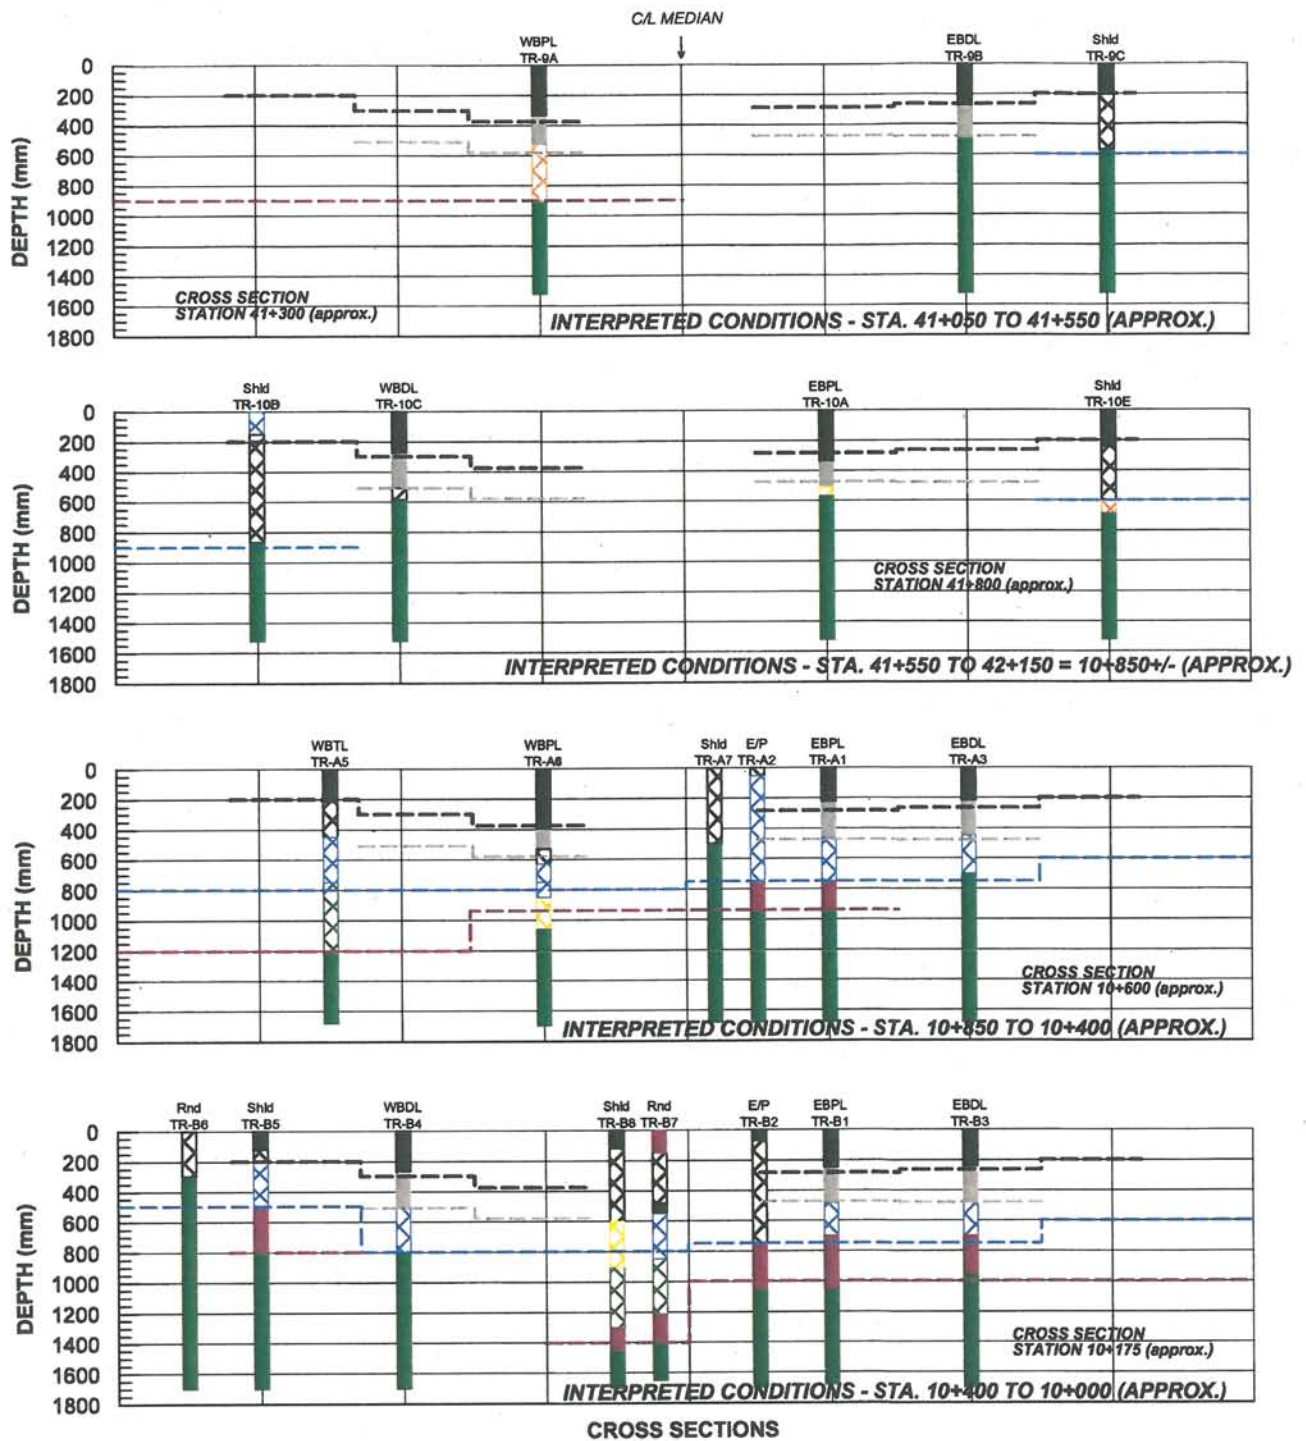
WESTBOUND

EASTBOUND

Figure 5.2B: Interpreted Pavement and Shallow Subsurface Conditions, Existing Highway 3/Talbot Road

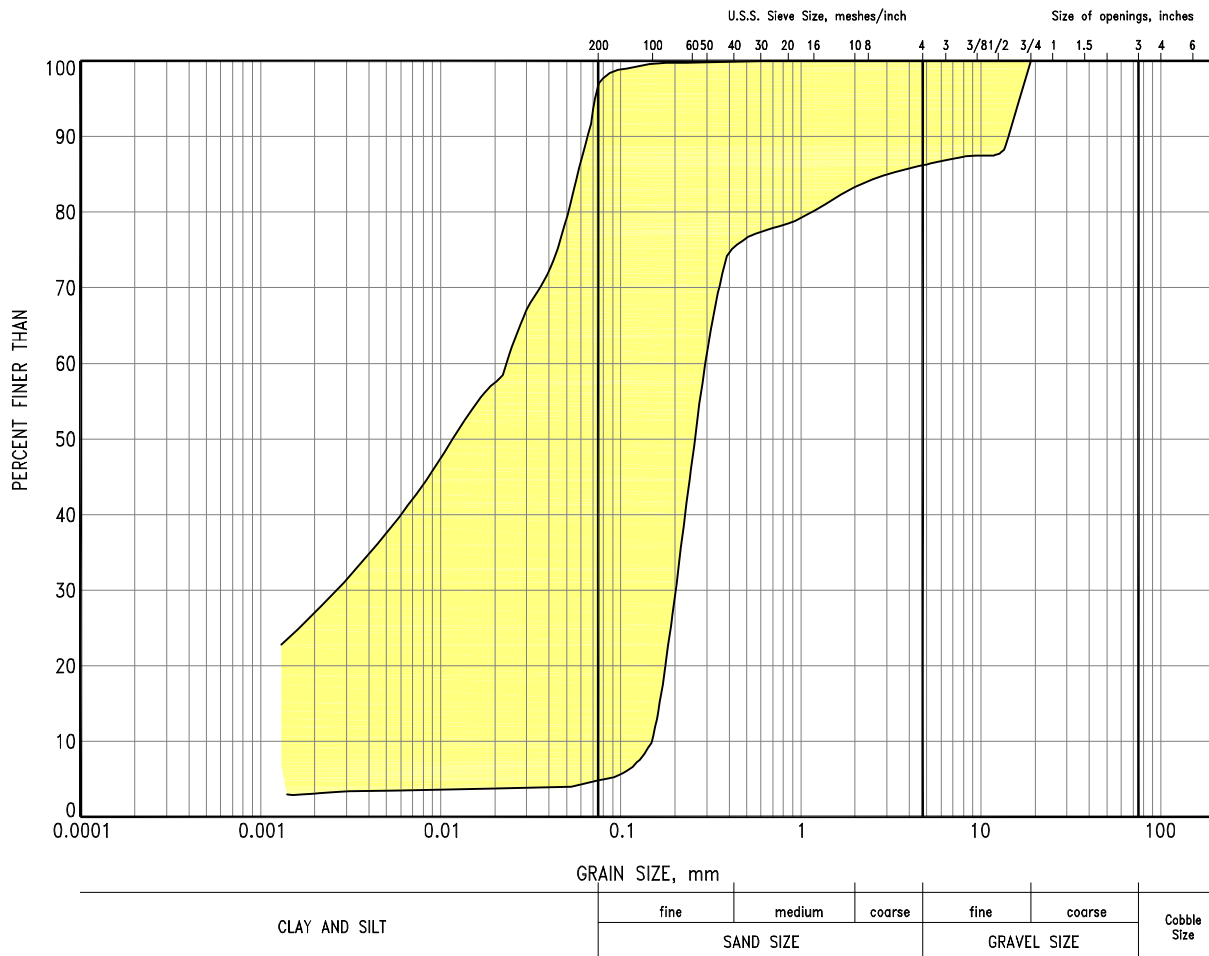
PROJECT SUBSURFACE CONDITIONS INTERPRETATION REPORT WINDSOR-ESSEX PARKWAY WINDSOR, ONTARIO			
TITLE GRAIN SIZE DISTRIBUTION ENVELOPE UPPER GRANULAR DEPOSITS			
PROJECT No. 07-1130-207-0		FILE No. 0711302070-R02053	
CADD LMK/DCH Dec. 11/10		SCALE AS SHOWN REV. 2	
CHECK		FIGURE 5.3

The grain size distribution envelope shown above is based on all grain size distribution analyses conducted on samples obtained from the Upper Granular Deposits. For individual test results refer to the Geotechnical Data Report referenced in section 3.1. The samplers used for the explorations limit the maximum particle size that can be sampled and tested to about 40mm. Larger particles are known to be present in the deposit as discussed in the report text.

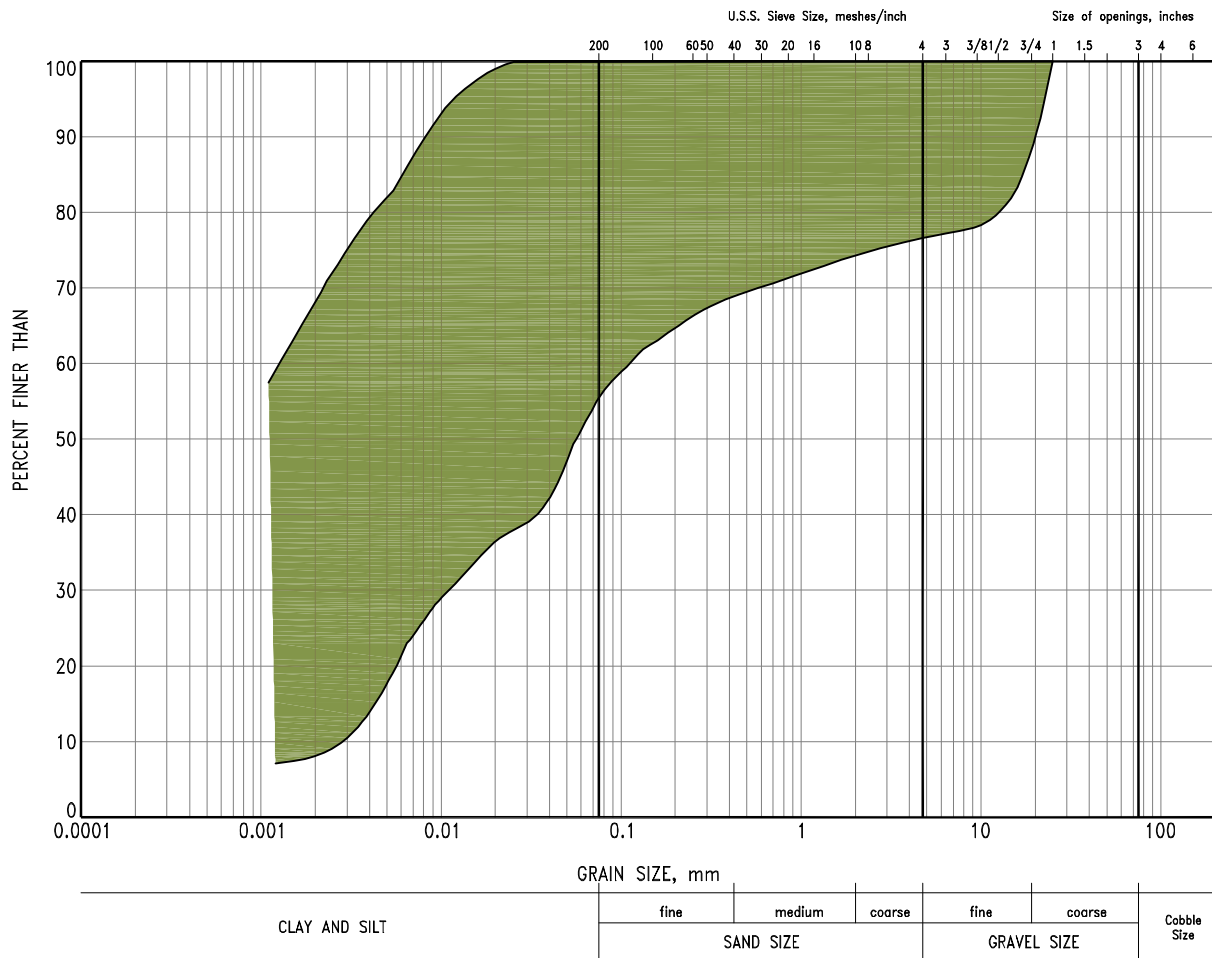
Golder Associates LONDON, ONTARIO			FIGURE 5.4

The grain size distribution envelope shown above is based on all grain size distribution analyses conducted on samples obtained from the Silt and Clay Deposits. For individual test results refer to the Geotechnical Data Report referenced in section 3.1. The samplers used for the explorations limit the maximum particle size that can be sampled and tested to about 40mm. Larger particles are known to be present in the deposit as discussed in the report text.

PROJECT			
SUBSURFACE CONDITIONS INTERPRETATION REPORT			
WINDSOR-ESSEX PARKWAY			
WINDSOR, ONTARIO			
TITLE			
GRAIN SIZE DISTRIBUTION ENVELOPE			
CLAYEY SILT TO SILTY CLAY DEPOSITS			
PROJECT No.		07-1130-207-0	
FILE No.		0711302070-R02054	
CADD	LMK/DCH	Dec. 11/10	SCALE AS SHOWN
CHECK			REV. 2

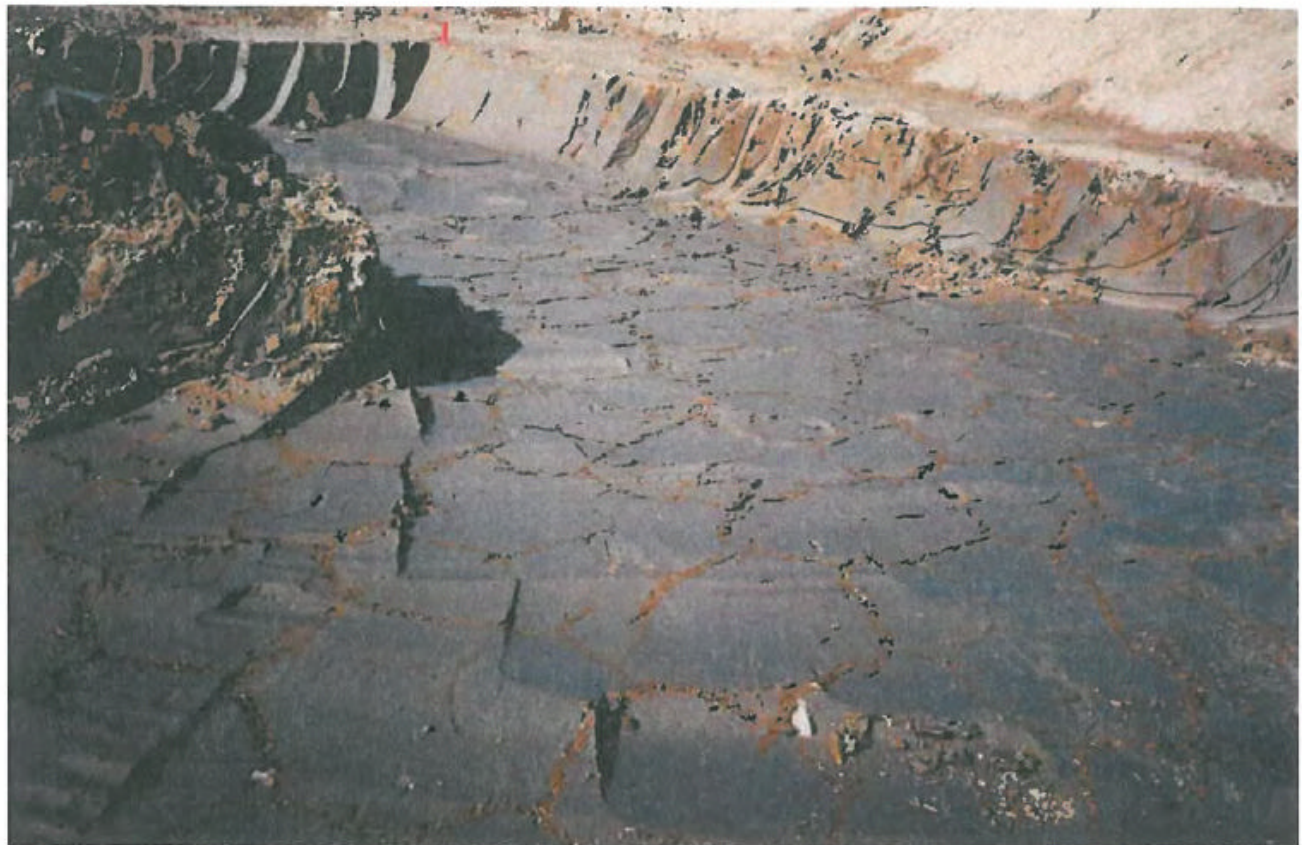
Golder Associates LONDON, ONTARIO		PROJECT No. 07-1130-207-0		FILE No. 0711302070R02055	
				SCALE AS SHOWN	
		DRAWN MK Nov. 18/10		REV. 2	
		CHECK		FIGURE 5.5

Natural fissuring of silty clay to clayey silt deposit exposed during excavation in Sarnia, Ontario.

Figure 5.5: Fissuring of Clayey Silt to Silty Clay Deposits

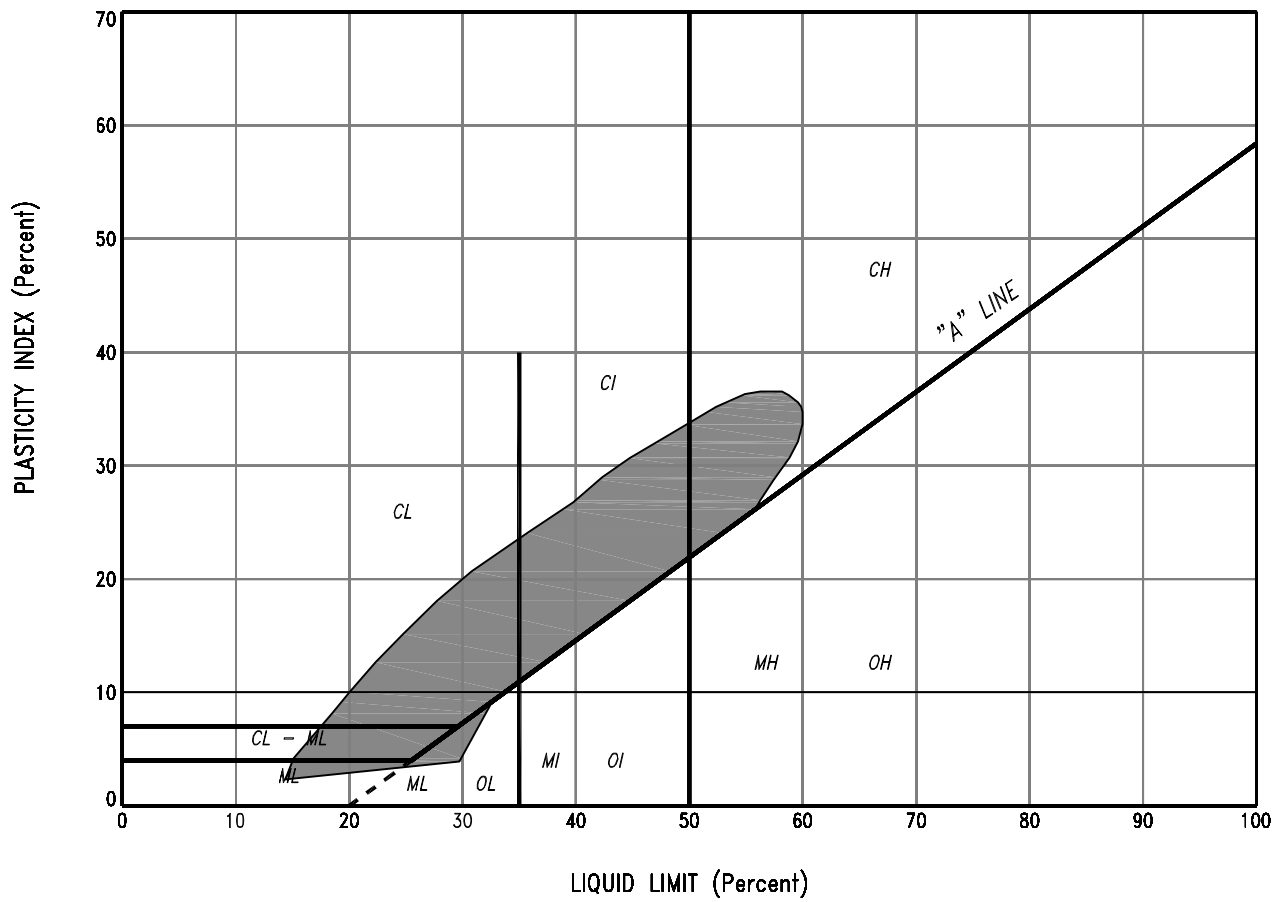
PROJECT			
SUBSURFACE CONDITIONS INTERPRETATION REPORT			
WINDSOR-ESSEX PARKWAY			
WINDSOR, ONTARIO			
TITLE			
ATTERBERG LIMITS ENVELOPE			
PROJECT No.		FILE No.	
07-1130-207-0		0711302070-R02056	
DESIGN		SCALE	AS SHOWN
CADD	LMK/DCH	REV.	2
CHECK		FIGURE 5.6	
REVIEW

SOIL TYPE PLASTICITY
 C = Clay L = Low
 M = Silt I = Intermediate
 O = Organic H = High

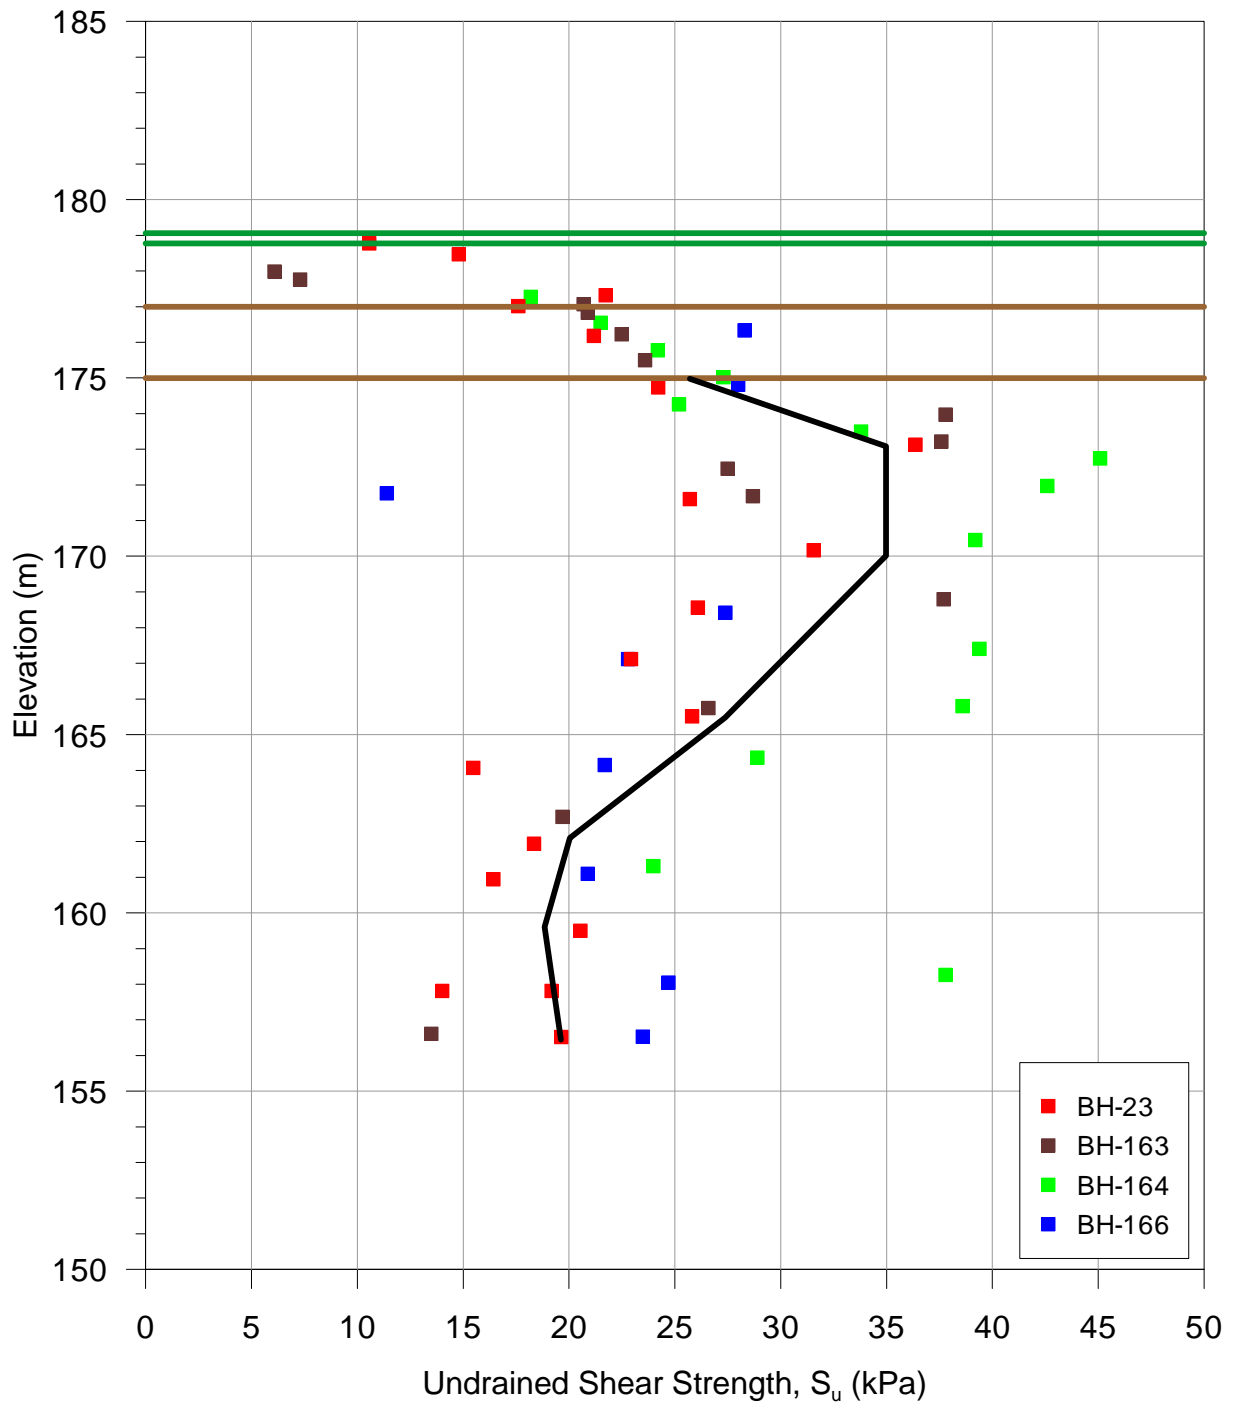
PROJECT No.	0711302070	FILE No.	0711302070R0257A
DRAWN	MK	Nov. 11/10	SCALE AS SHOWN
CHECK			REV. 2
FIGURE 5.7A

— RANGE OF INTERPRETED CRUST
BOUNDARY ELEVATIONS AT
BOREHOLE AND CPT LOCATIONS.
SEE TEXT AND FIGURES 5.1A TO 5.1I

— RANGE OF GROUND SURFACE
ELEVATIONS AT BOREHOLE
AND CPT LOCATIONS

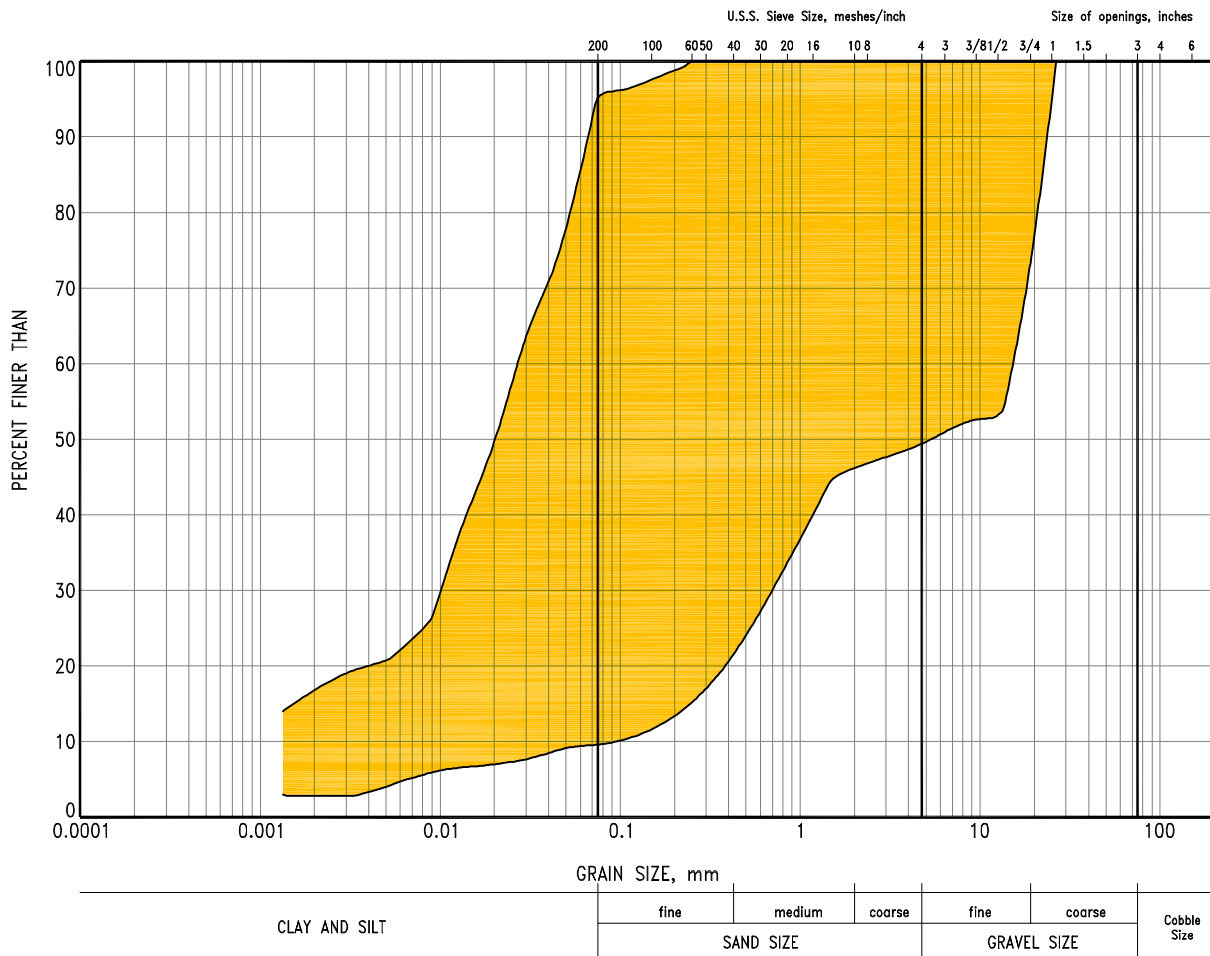
The grain size distribution envelope shown above is based on all grain size distribution analyses conducted on samples obtained from the Lower Granular Deposits. For individual test results refer to the Geotechnical Data Report referenced in section 3.1. The samplers used for the explorations limit the maximum particle size that can be sampled and tested to about 40mm. Larger particles are known to be present in the deposit as discussed in the report text.

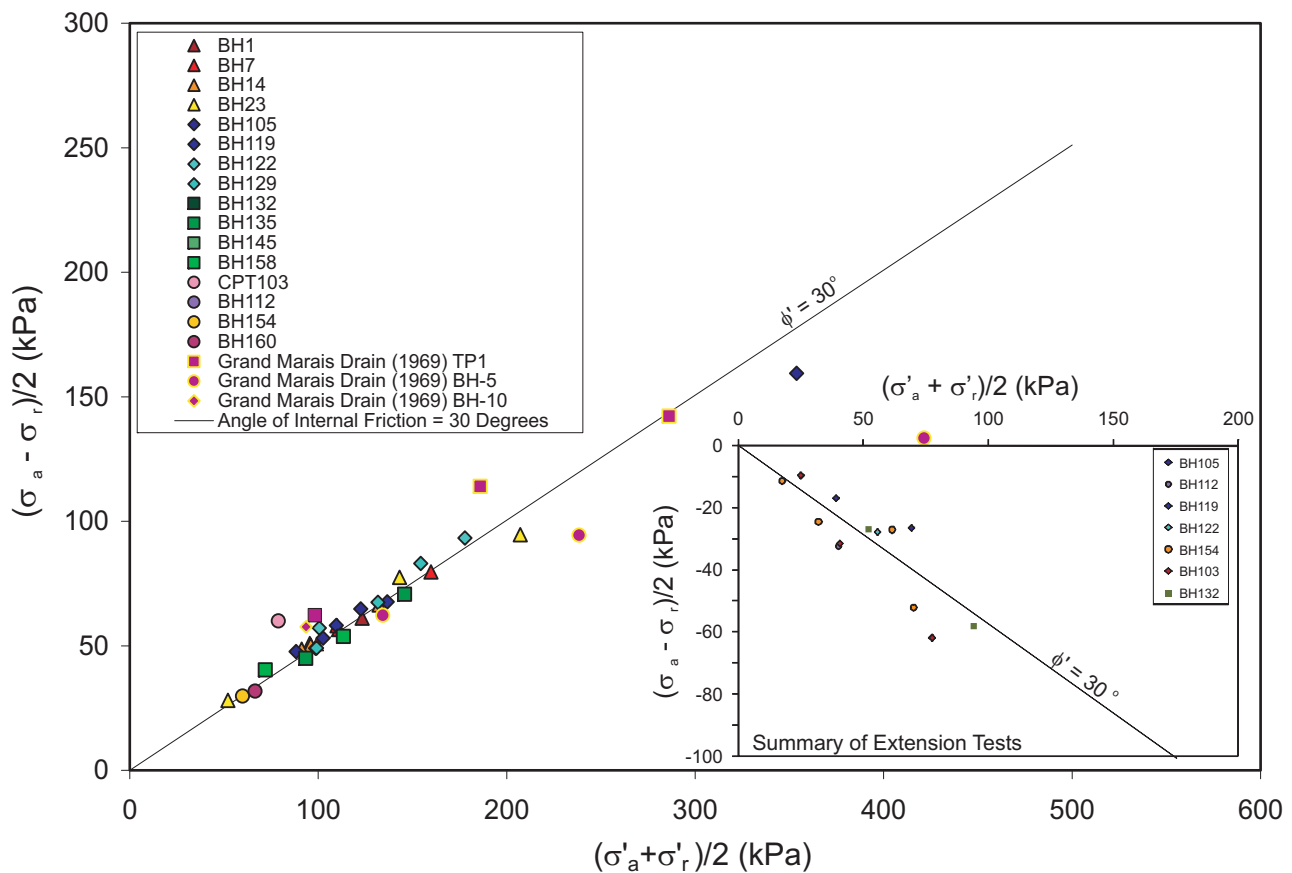
FIGURE 6.9

σ'_a = axial effective stress at failure
 σ'_r = radial effective confining stress at failure
 OCR = overconsolidation ratio
 A_f = pore water parameter at failure
