**Bridge Rehabilitation – Boshkung Lake Bridge
Highway 118
Stations 15+782.5 to 15+822.5 – Township of Stanhope
Site No. 40-011
GWP 5140-13-00**

FINAL FOUNDATION INVESTIGATION AND DESIGN REPORT

Date: October 24, 2016
Ref. No: 15/03/15019-F10

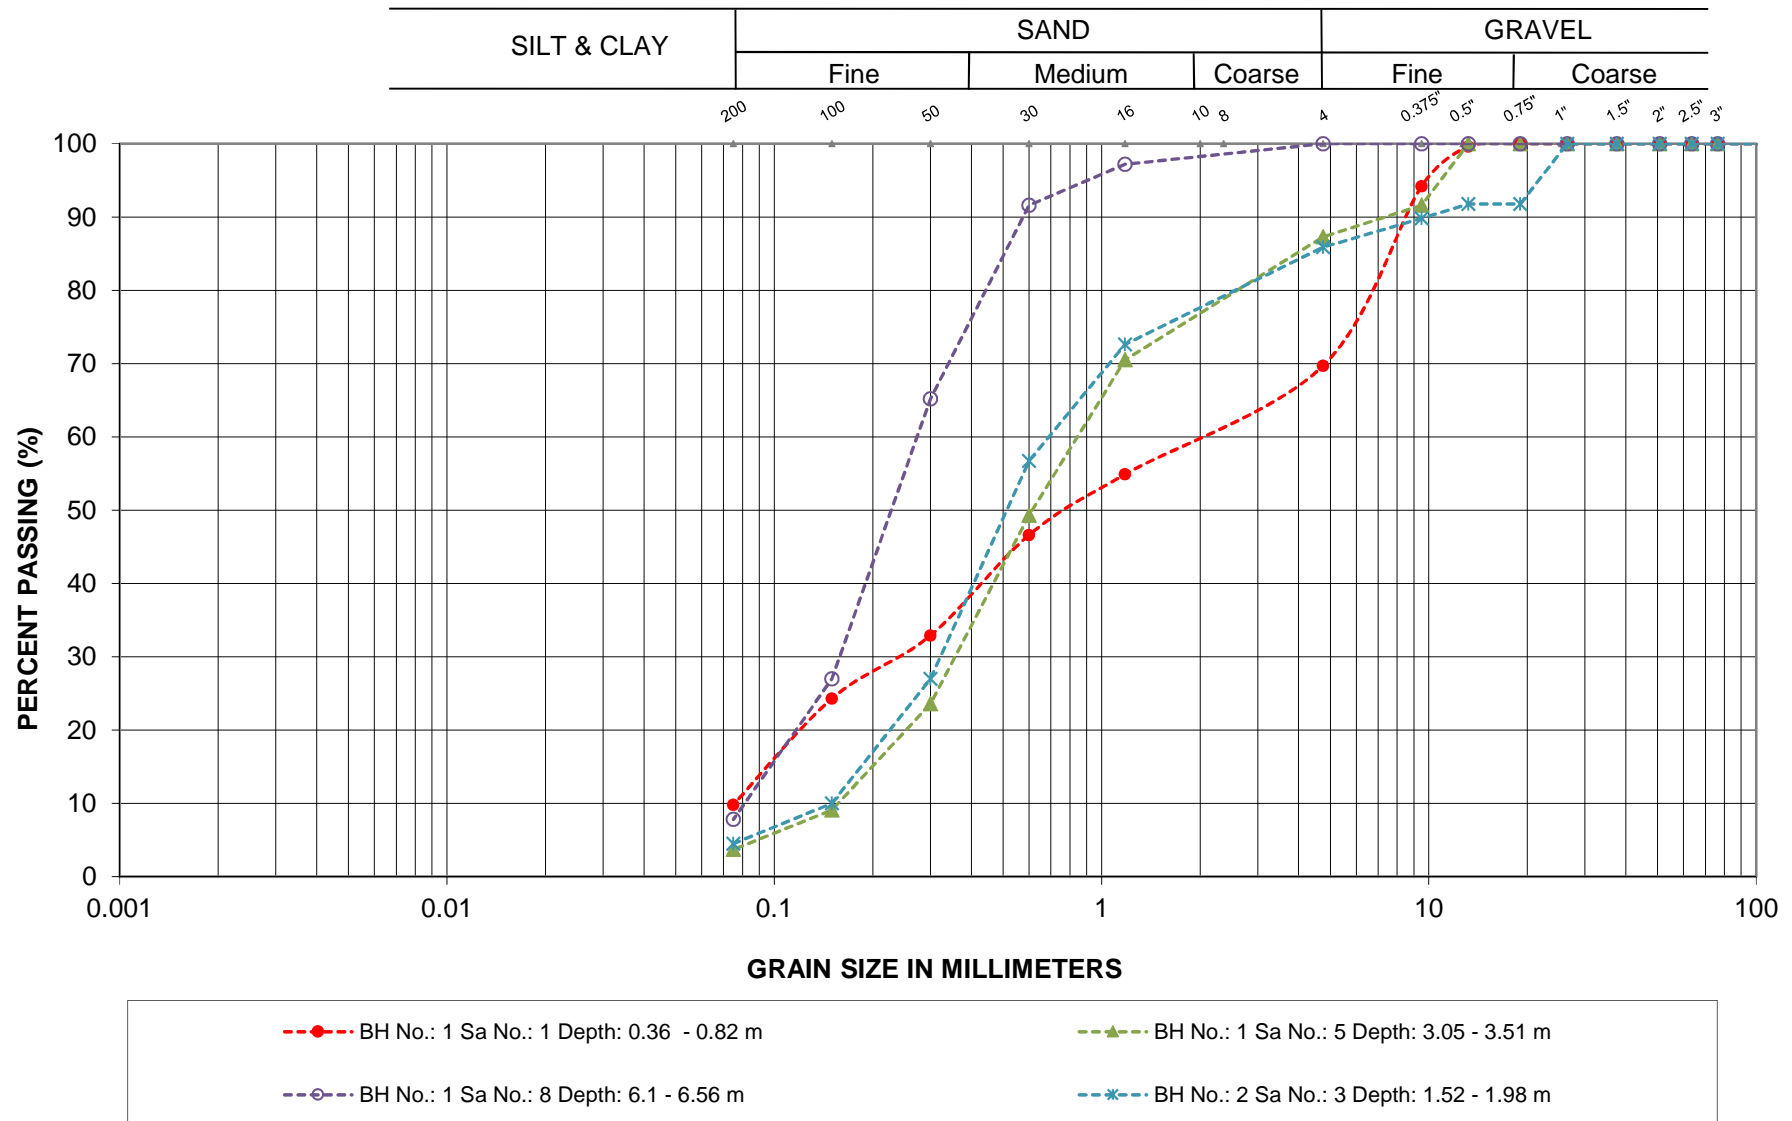
FIGURE L-1

GRAIN SIZE ANALYSIS

LOCATION: Boshkung Lake Bridge
 Hwy 118, Station 15+782.5 to 15+822.5
 TWP of Stanhope

Sand FILL
 Englobe Corp.

The fieldwork for this investigation was carried out under the full time direction of a senior member of the Englobe engineering staff, who was responsible for locating the boreholes, clearing the borehole locations of underground services, in-situ sampling and testing operations, logging of the boreholes, labeling and preparation of samples for transport to the Englobe North Bay laboratory, plus overall drill supervision. All samples received a visual confirmatory inspection in the laboratory. Laboratory testing of select samples included routine testing for natural moisture content determination and particle size analysis. The results of the laboratory testing are presented on the individual Record of Borehole Sheets (Appendix 2), with a summary of results presented on the laboratory sheets in Appendix 3 (Figures Nos. L-1 to L-3 and Table No. L-4).

Underlying the concrete approach slab at Borehole Nos. 1 and 2, a layer of brown sand fill, gravelly to trace gravel, trace silt, trace clay was penetrated. The natural moisture contents measured on samples of this deposit recovered from Borehole Nos. 1 and 2 were in the order of 3% to 12%, with the exception of a 23% natural moisture content measured on the one sample recovered near the bottom of the fill in Borehole No. 1. Gradation analyses were carried out on four (4) samples of this deposit recovered from Borehole Nos. 1 and 2, the results of which indicated 0% to 30% gravel size particles, 60% to 92% sand size particles, and 4% to 10 % silt and clay size particles (Figure No. L-1, Appendix 3). Results of grain size distribution testing carried out on four samples recovered from Borehole Nos. 1 and 2 indicate that the sand fill generally meets requirements of Granular "B" Type II stated in OPSS.PROV 1010. Based on SPT 'N' values of 4 to 73 blows per 300 mm penetration and 41 blows per 152 mm penetration, the relative density of this deposit was described as loose to very dense. This deposit was encountered to depths of 7.8 m and 3.4 m below grade at Borehole Nos. 1 and 2, respectively (Elevation 304.9 m and 310.3 m, respectively).

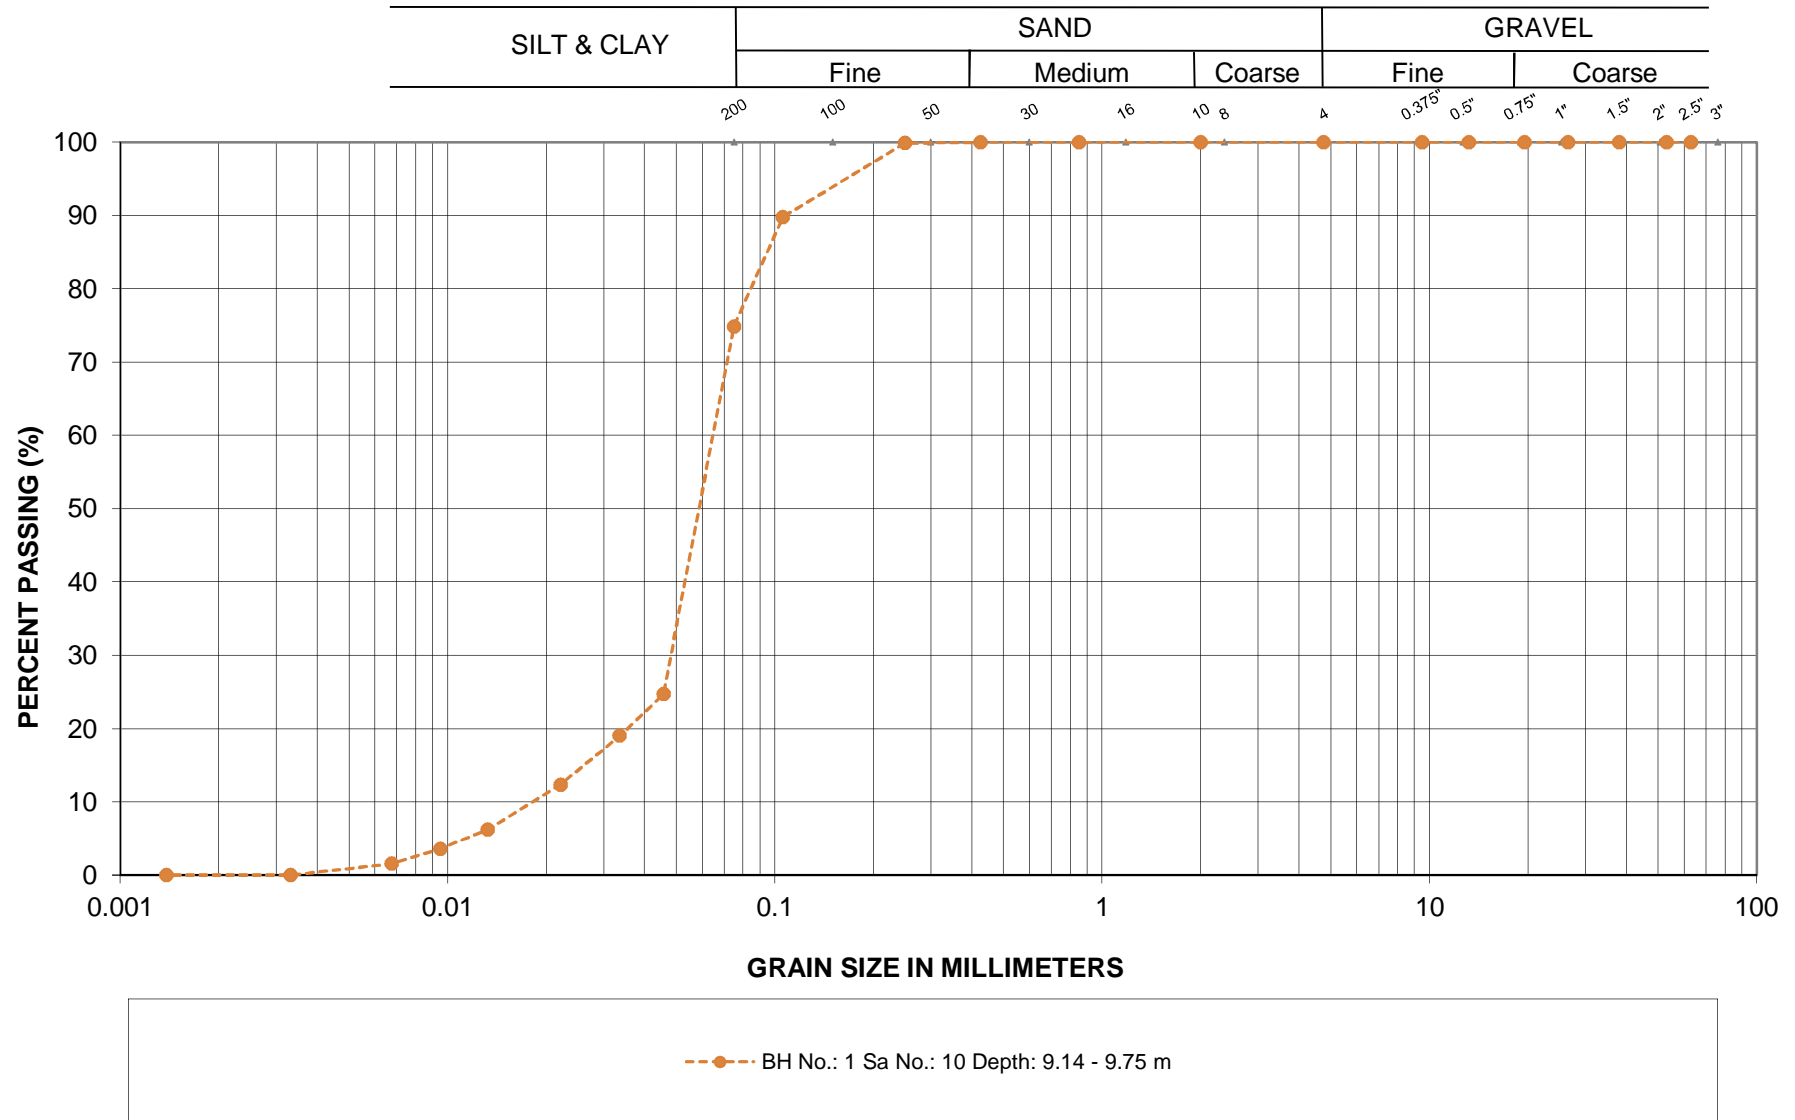
GRAIN SIZE ANALYSIS

LOCATION: Boshkung Lake Bridge
Hwy 118, Station 15+782.5 to 15+822.5
TWP of Stanhope

SILT
Englobe Corp.

Underlying the sand fill deposit at Borehole No. 1, a deposit of grey silt, with sand, trace clay was penetrated. The natural moisture contents measured on samples of this deposit were in the order of 26 to 34%. An hydrometer analysis was carried out on one (1) sample of this deposit, the results of which indicated 0% gravel size particles, 25% sand size particles, 75% silt size particles, and 0% clay size particles (Figure No. L-2, Appendix 3). Based on observation of the spilt spoon sampler advanced 300 mm using the static weight of hammers for the SPT testing in the deposit, the relative density of this deposit was described as very loose. Borehole No. 1 was terminated in this deposit at a depth of 9.8 m below grade (Elevation 302.9 m).

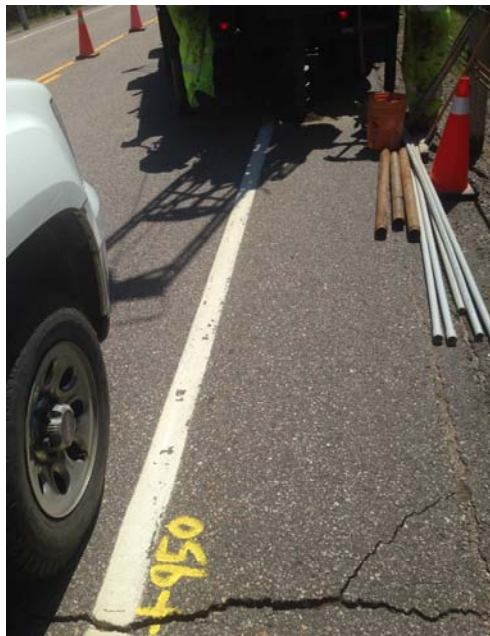
Photo: 2

Bridge East side– Pavement Cracks at East of Borehole No.2

The Boshkung Lake Bridge is located on Highway 118, between approximately Stations 15+782.5 to 15+822.5, Township of Stanhope (Site No. 40-011). The bridge is a single span steel girder structure of 40 m in length, which we understand was constructed in 1970s. The topography at the site is generally of low to moderate relief. The existing approach embankments for the bridge currently support two undivided lanes of highway, running in a west-east direction. Boshkung Lake flows from the north to the south at the bridge location (left to right). A visual review of the highway to the west and the east of the bridge indicates that, in general, the approaches are in fair to good condition (see Photo Essay in Appendix 4).

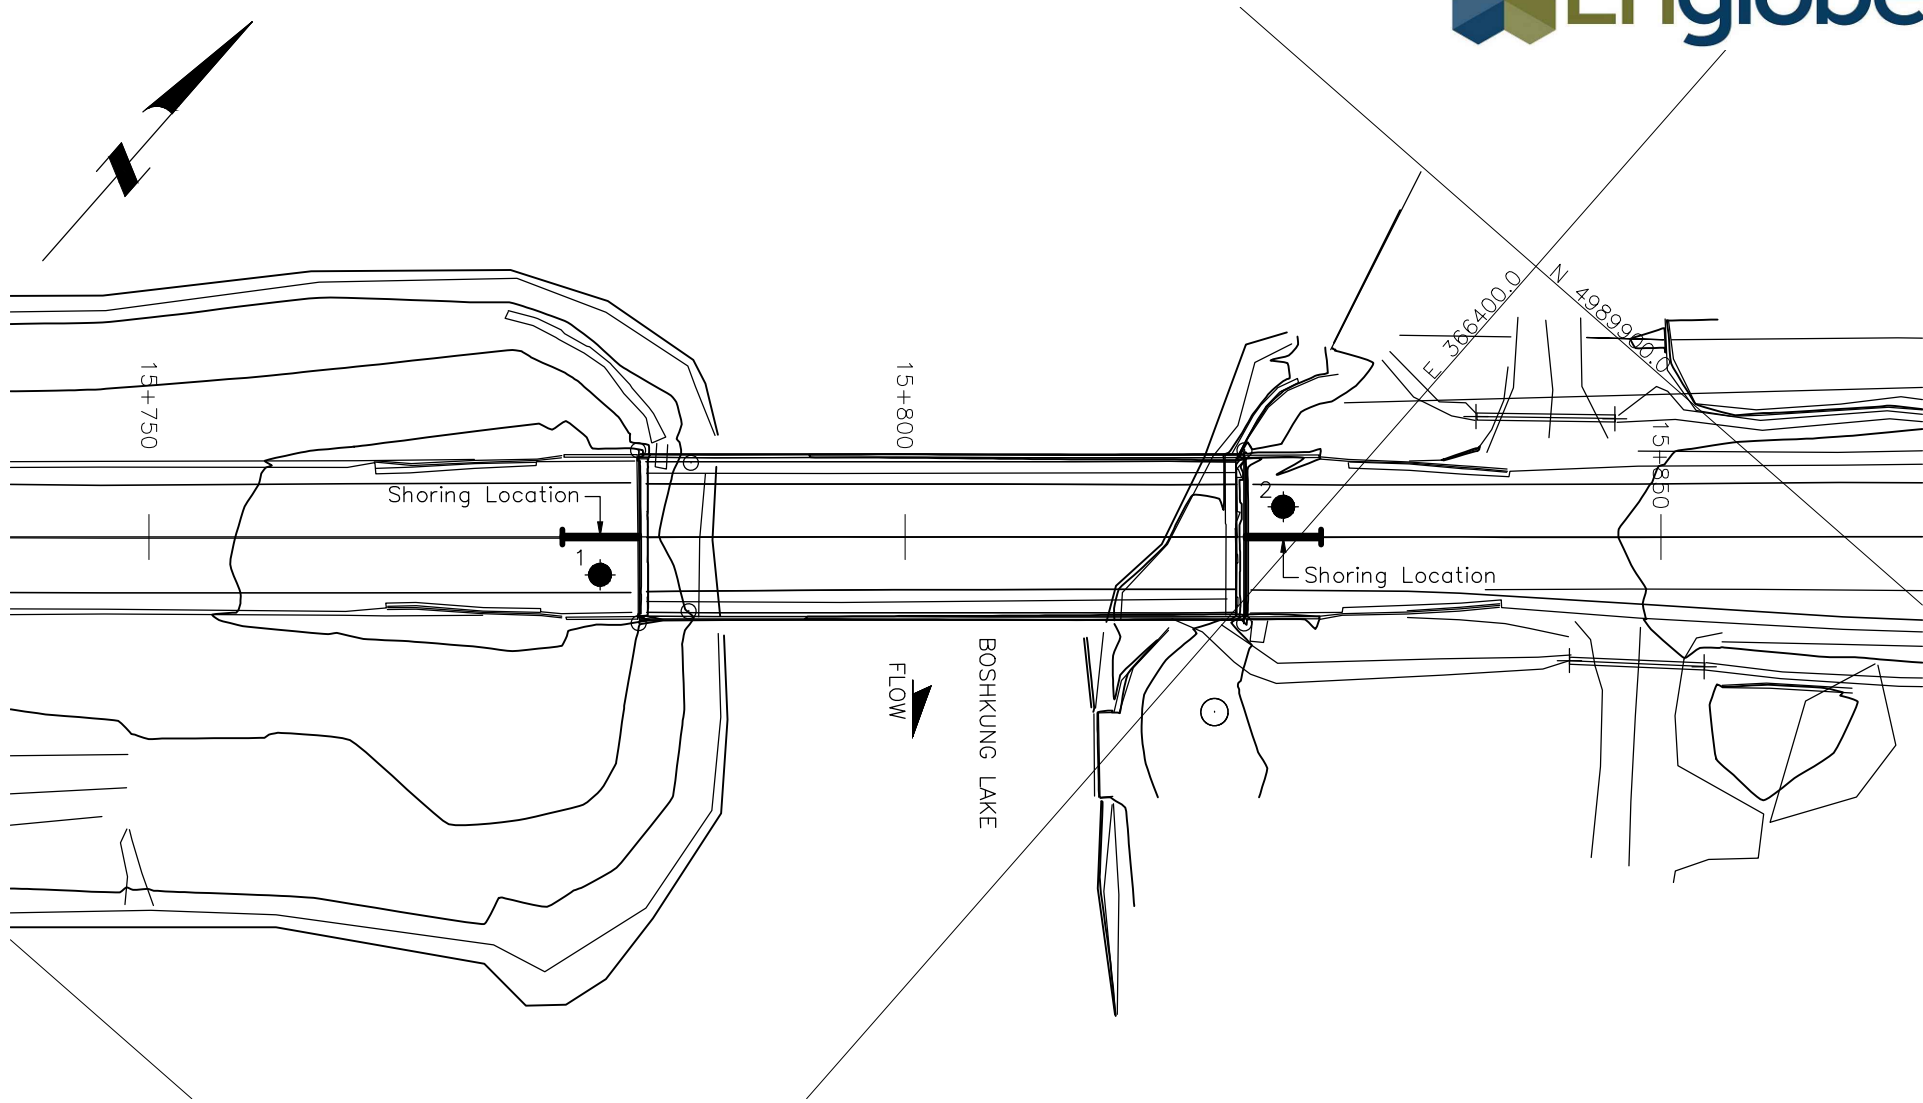
The fill below the pavement structure and approach slabs is considered as a Type 3 soil in accordance with the Occupational Health and Safety Act and Regulations for Construction Projects. As such, to remain stable above the water table, side walls of temporary open excavations would have to be cut back to an angle not exceeding 1H:1V. Some additional 1.2 m deep excavations (i.e. to Elevation 311.5 m at the bridge west end, and to Elevation 312.5 m at the bridge east end) will be required at the rear of the abutments to allow the rehabilitation work to be carried out on the ballast walls. The existing width of the bridge approach is insufficient to allow the construction of a 1H:1V slope parallel to the active traffic lane. As such, a vertical excavation adjacent to the active traffic lane will be required and a protection system, installed perpendicular to the abutments, will be needed to support the active traffic lane. Conceptual shoring locations are illustrated on Figure No. SK-1 in Appendix 6.
