**Bridge Rehabilitation – Oxtongue River Bridge
Highway 35
Stations 21+570 to 21+625 – Township of Franklin
Site No. 42-002
GWP 5126-13-00**

FINAL FOUNDATION INVESTIGATION AND DESIGN REPORT

Date: August 31, 2015
Ref. Nº: 15/03/15019-F9

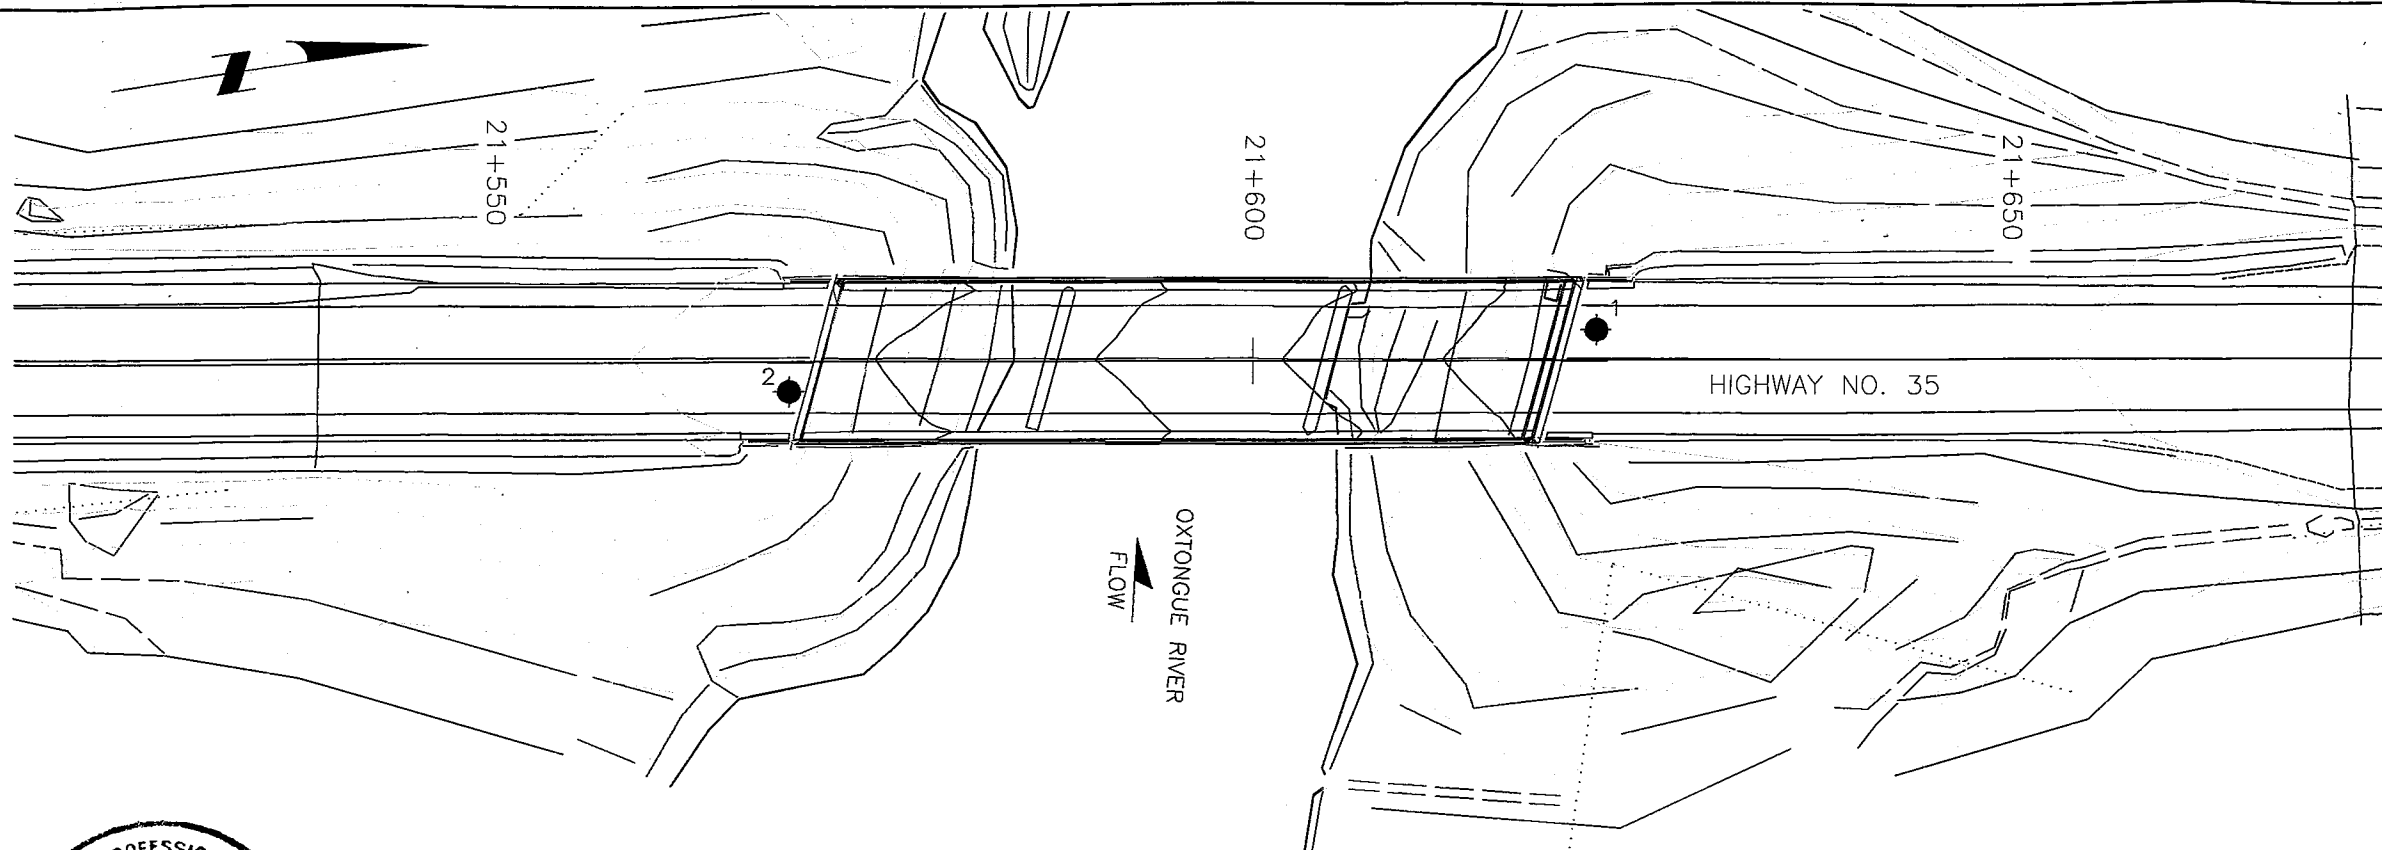
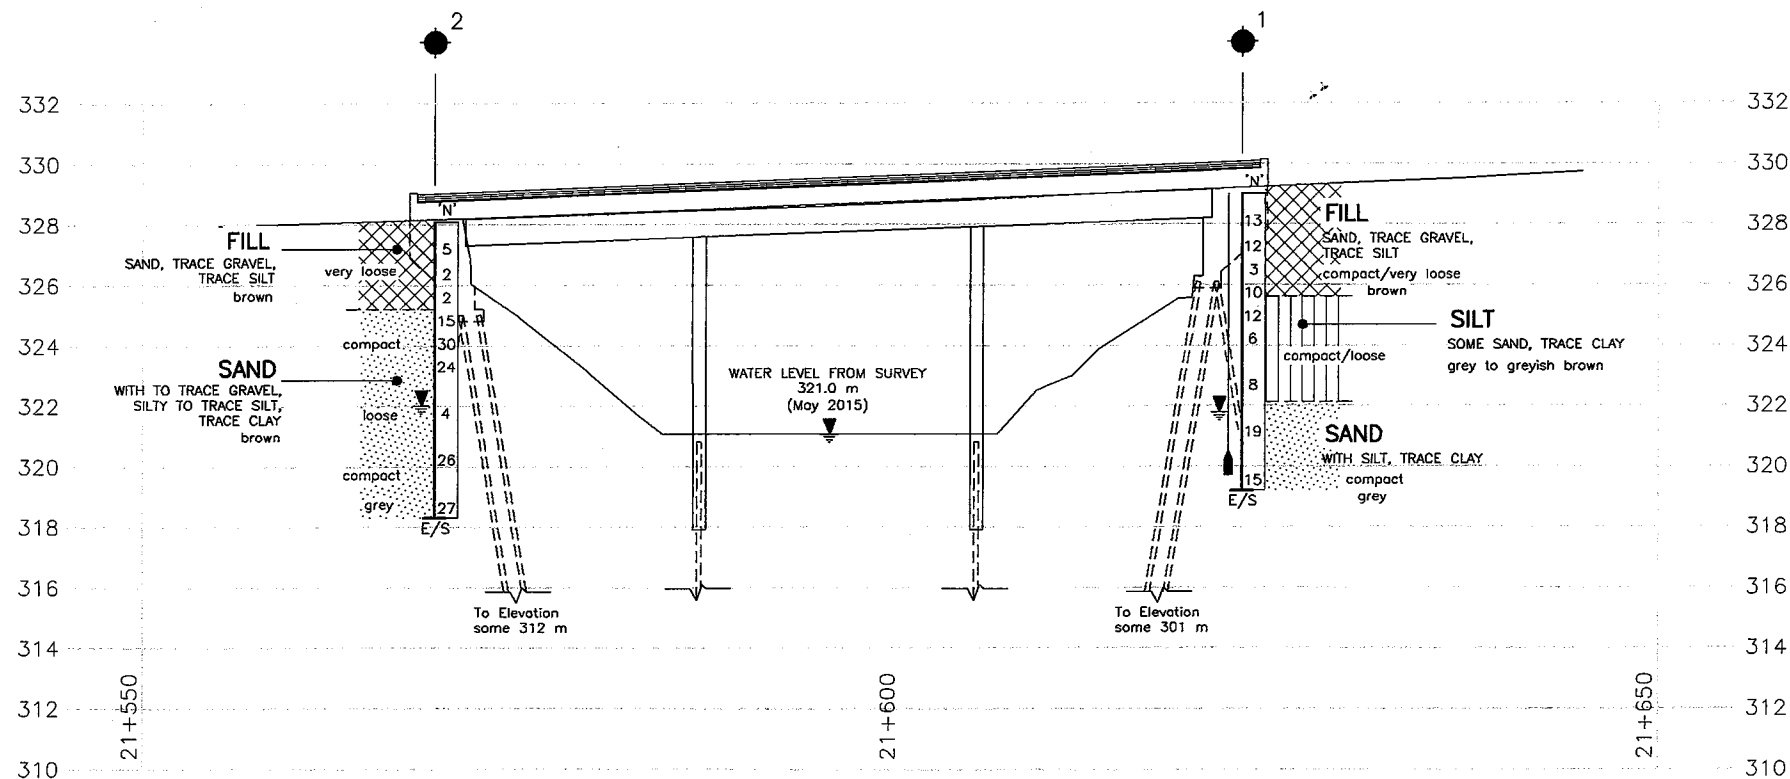
PLAN 5m SCALE 5m

A plan and profile illustrating the borehole locations and stratigraphic sequences is shown on Drawing No. 2, Appendix 3. During the course of the exploration program, two (2) sampled boreholes were put down at this site, with Borehole No. 1 advanced behind the north abutment to the left of centerline (left side), and Borehole No. 2 advanced behind the south abutment to the right of centerline (right side).

This drawing is for subsurface information only. Surface details and features are for conceptual illustration. The proposed structure location is shown for illustration purposes only and may not be consistent with the final design configuration as shown elsewhere in the Contract Documents.

Details of the subsurface conditions revealed by the investigation program are presented on the enclosed Records of Borehole Logs (Appendix 2) and on Drawing No. 2 (Appendix 3). Please note that stratigraphic delineations presented on the borehole logs and soil strata plot are the results of non-continuous sampling, response to drilling progress, the results of SPT, plus field observations. Typically such boundaries represent transitions from one zone to another and are not an exact demarcation of specific geological unit. Additional consideration should be given to the fact that subsurface conditions may vary markedly between adjacent boreholes and beyond any specific boring location, and are shown on the drawings for illustration purposes only.

These levels are recorded on the individual Record of Borehole Log Sheets (Appendix 2) and shown on the Borehole Locations and Soil Strata Drawing No. 2 in Appendix 3.

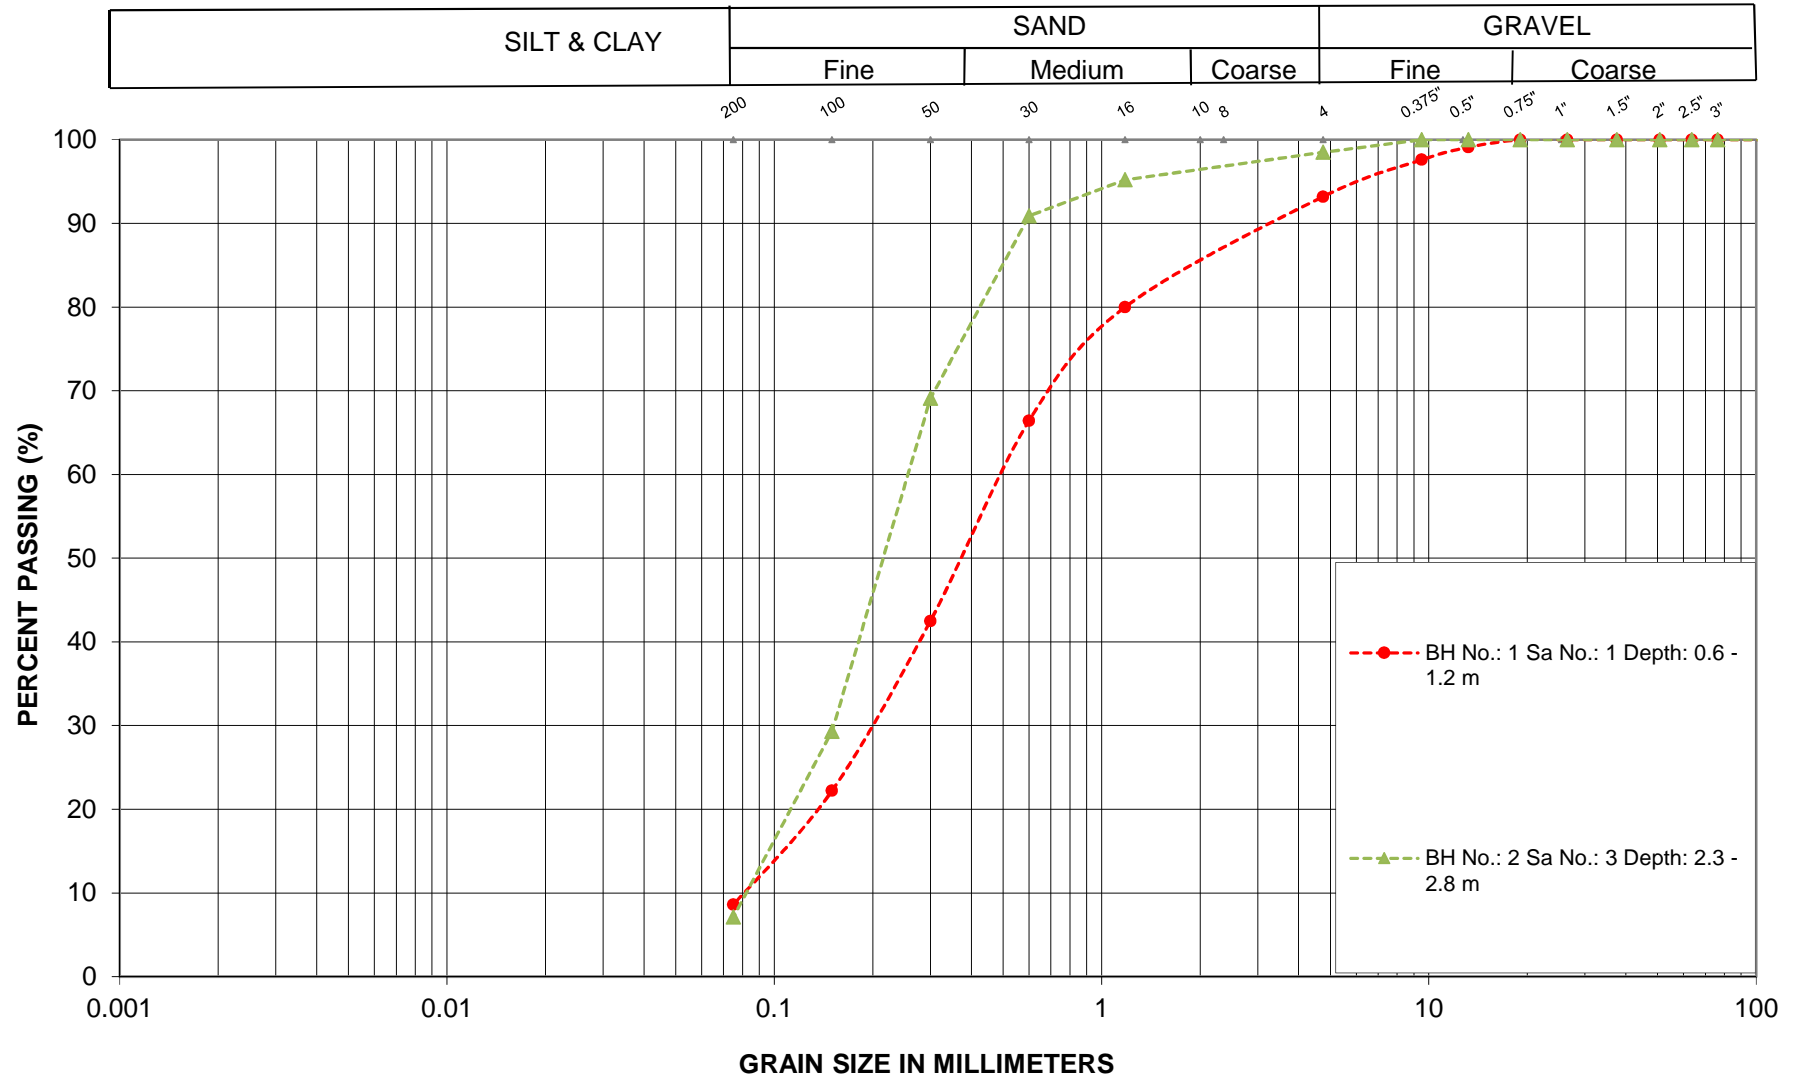
FIGURE L-1

Sand FILL

Underlying the concrete approach slab at Borehole Nos. 1 and 2, a layer of brown sand fill, trace gravel, trace silt was penetrated. The natural moisture contents measured on samples of this deposit recovered from Borehole Nos. 1 and 2 were in the order of 2% to 7%, with the exception of a natural moisture content measured at 15% on the one sample recovered near the bottom of the fill from Borehole No. 1. Gradation analyses were carried out on two (2) samples of this deposit, recovered from Borehole Nos. 1 and 2, the results of which indicated 1% to 7% gravel size particles, 84% to 92% sand size particles, and 7% to 9 % silt and clay size particles (Figure No. L-1, Appendix 3). Results of grain size distribution testing carried out on two samples recovered from Borehole Nos. 1 and 2 indicate that the sand fill generally meets requirements of Granular "B" Type I stated in OPS.PROV 1010. Based on SPT 'N' values of 2 to 13 blows per 300 mm penetration, the compactness of this deposit was described

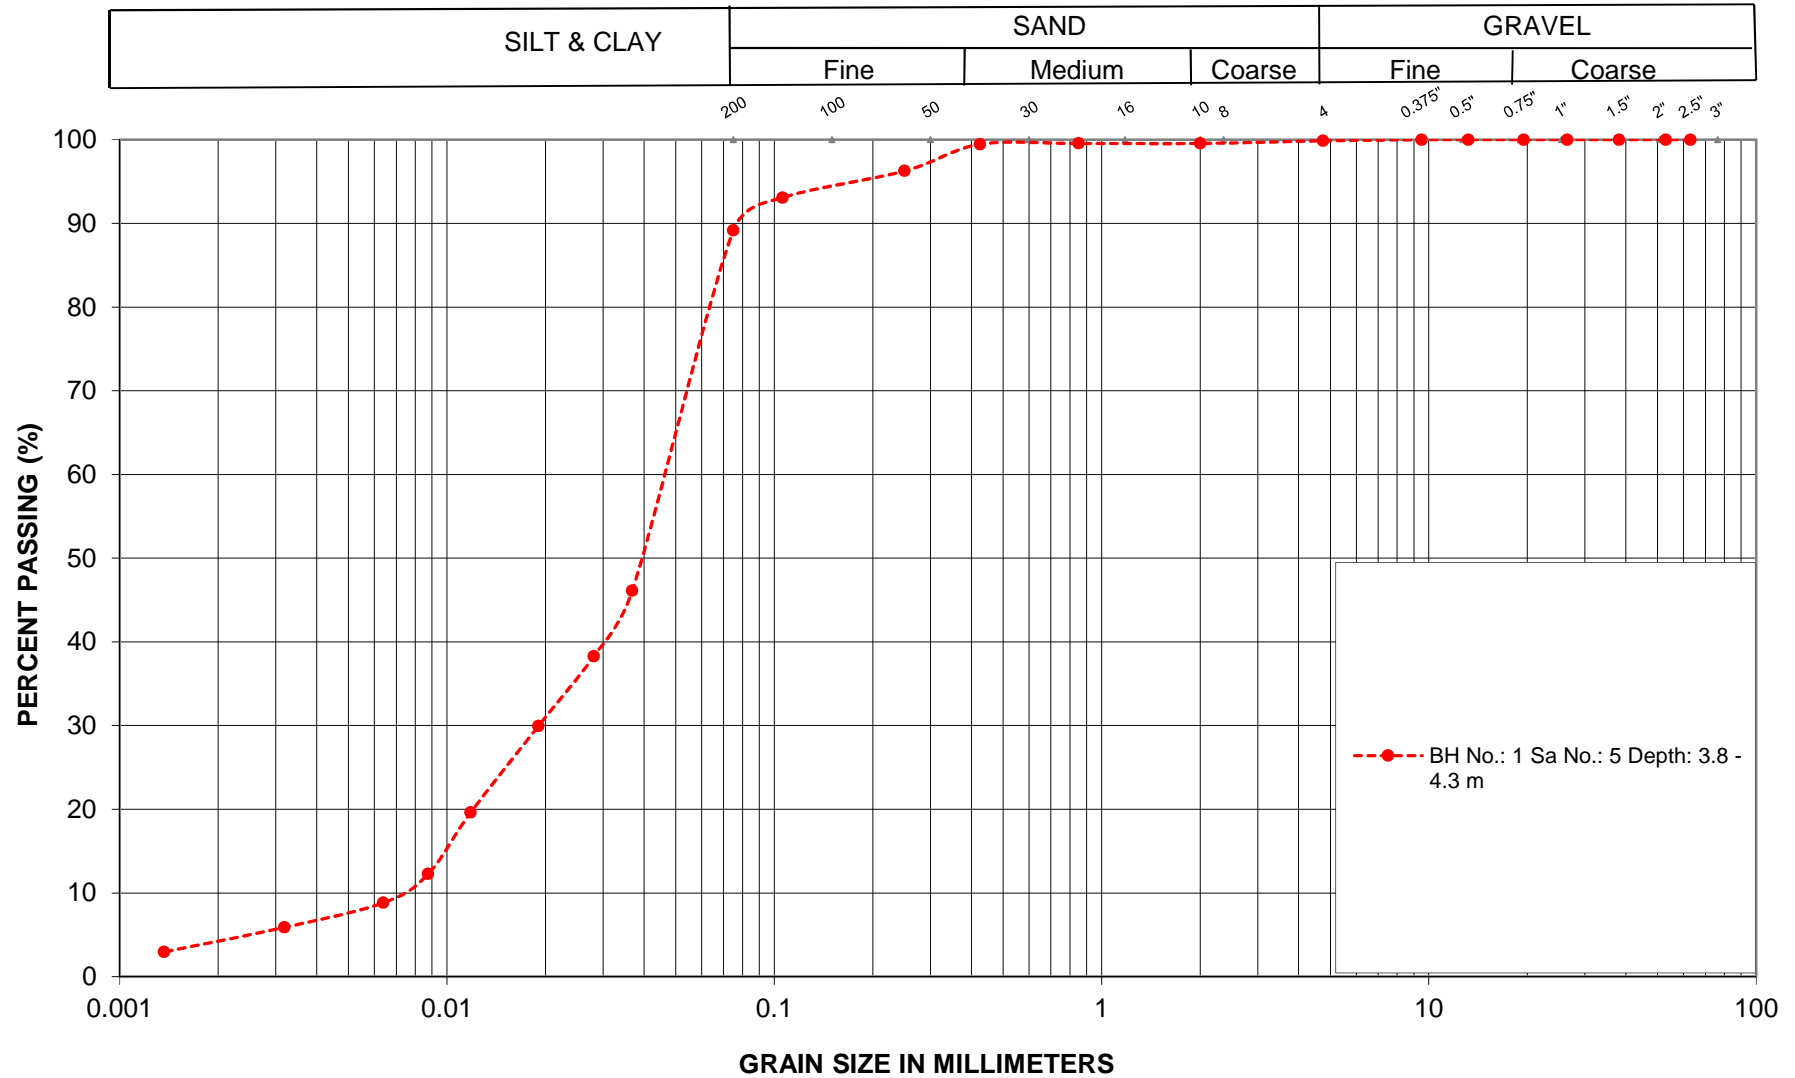
FIGURE L-2

SILT

Underlying the sand fill deposit at Borehole No. 1, a deposit of grey to greyish brown silt, some sand, trace clay was penetrated. The natural moisture content measured on samples of this deposit was in the order of 17 to 19%. Hydrometer analysis was carried out on one (1) sample of this deposit, the results of which indicated 0% gravel size particles, 11% sand size particles, 86% silt size particles, and 3% clay size particles (Figure No. L-2, Appendix 3). Based on SPT 'N' values of 6 to 12 blows per 300 mm penetration, the compactness of this deposit was described as loose to compact. This deposit was encountered to a depth of 6.9 m below grade at Borehole No. 1 (elevation 322.1 m).

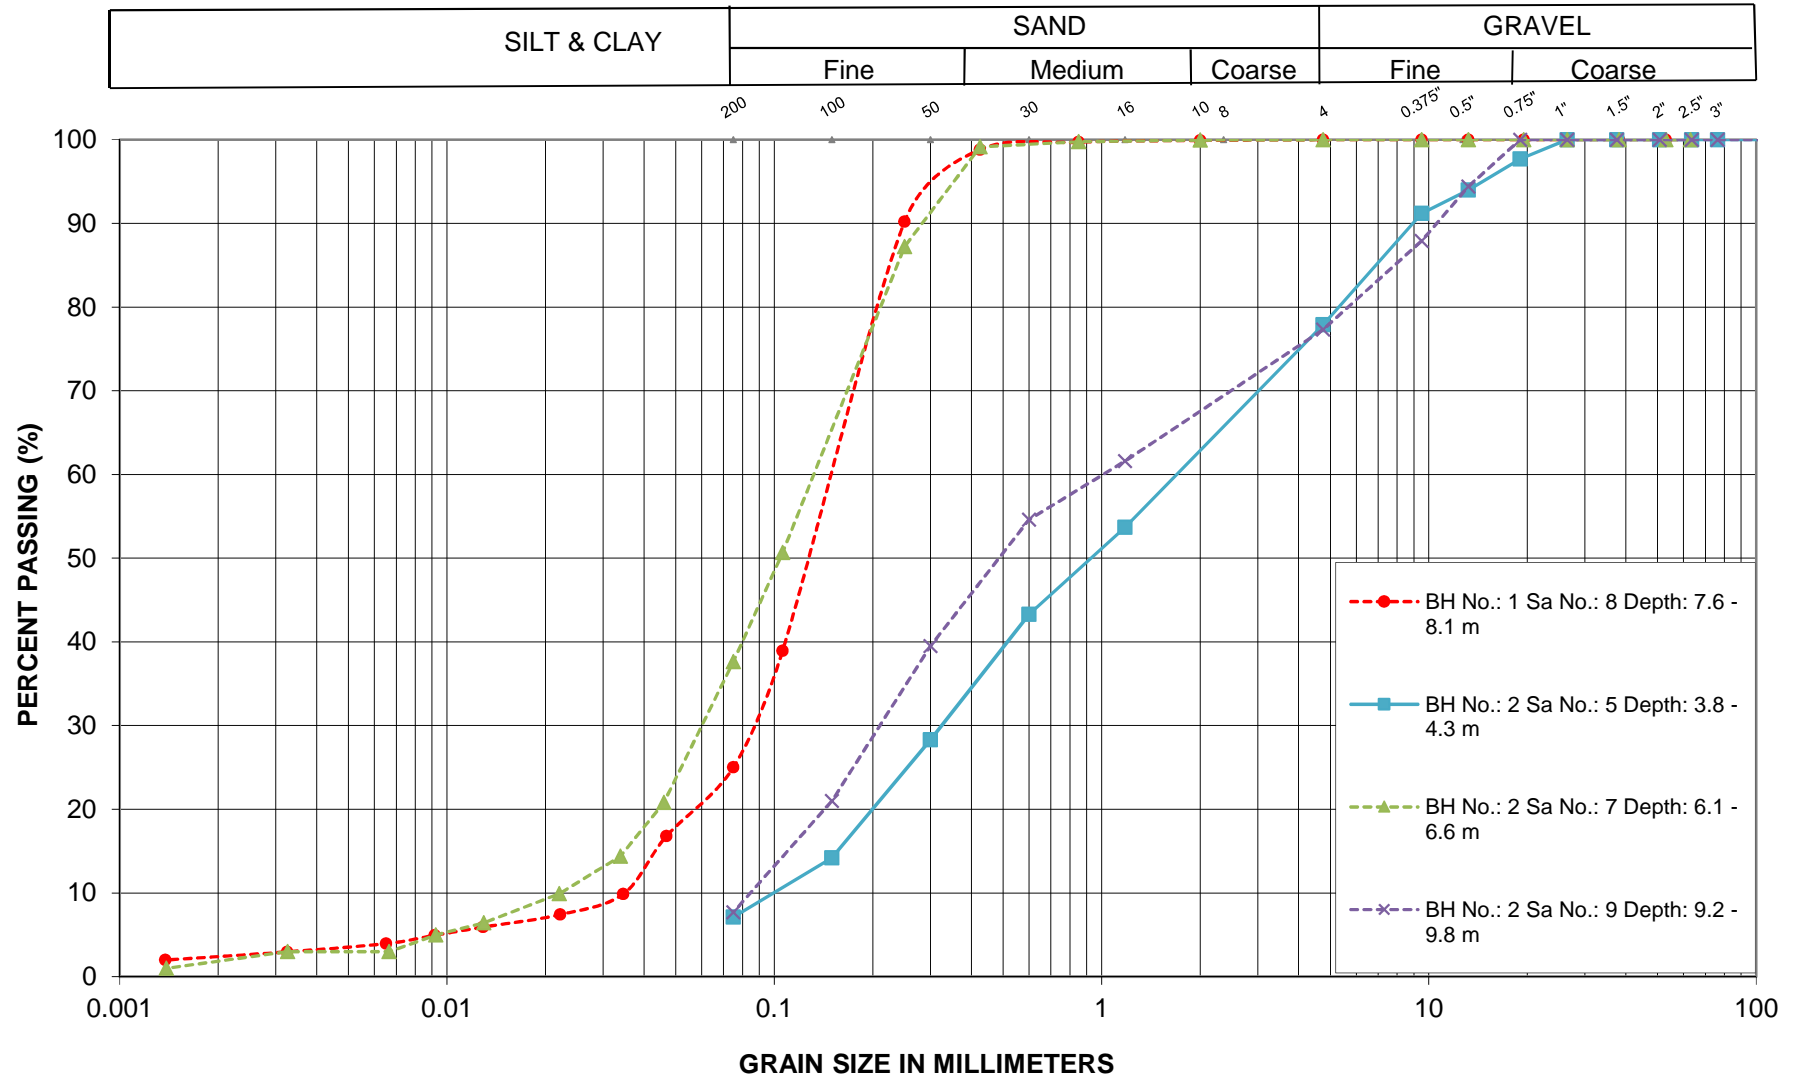
SAND to Silty SAND

Underlying the silt deposit at Borehole No.1, and underlying sand fill deposit at Borehole No. 2, a layer of brown sand, with to trace gravel, silty to trace silt, trace clay was penetrated. The natural moisture content measured on samples of this deposit was in the order of 3% to 34%. Gradation analyses were carried out on four (4) samples of this deposit, the results of which indicated 0% to 23% gravel size particles, 62% to 75% sand size particles, 8% to 37% silt size particles, and 1% to 2% clay size particles (Figure Nos. L-3 in Appendix 3). Based on SPT 'N' values of 4 to 30 blows per 300 mm penetration, the compactness of this deposit was described as loose to compact, generally compact. This deposit was encountered to a depth of 9.8 m below grade at Borehole Nos. 1 and 2, respectively (elevations 319.2 m and 318.3 m, respectively), where both boreholes were terminated.

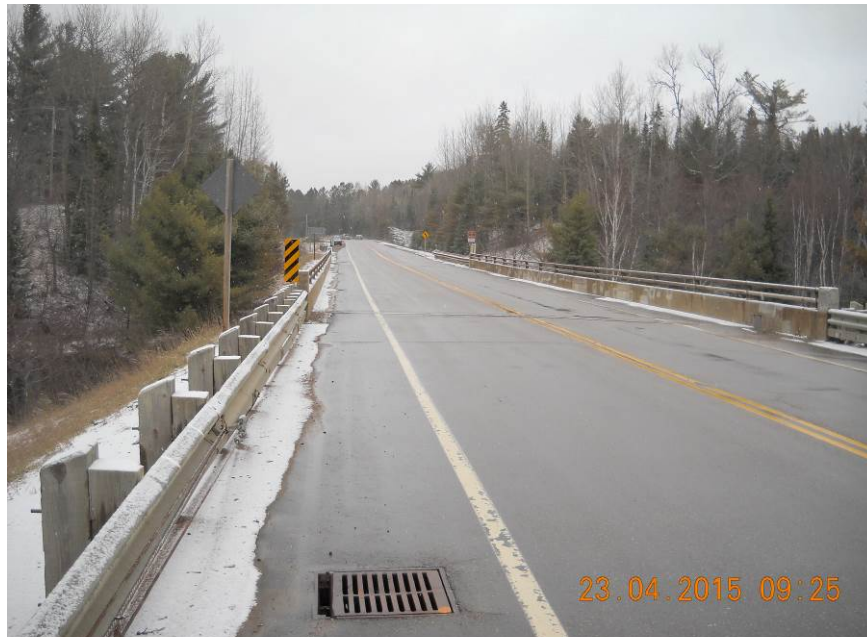
Photo: 1

Bridge South side– Looking Northwest

The Oxtongue River Bridge is located on Highway 35, between approximately Stations 21+570 to 21+625, Township of Franklin (Site No. 42-002). The bridge is a three-span structure, 56 m in length, which was constructed in 1970. The topography at the site is generally of low to moderate relief. The existing approach embankments for the bridge currently support two undivided lanes of highway, running in a south-north direction. The Oxtongue River flows from the east to the west at the bridge location (right to left). A visual review of the highway to the north and south of the bridge indicates that, in general, the approaches are in fair to good condition (see Photo Essay in Appendix 4).

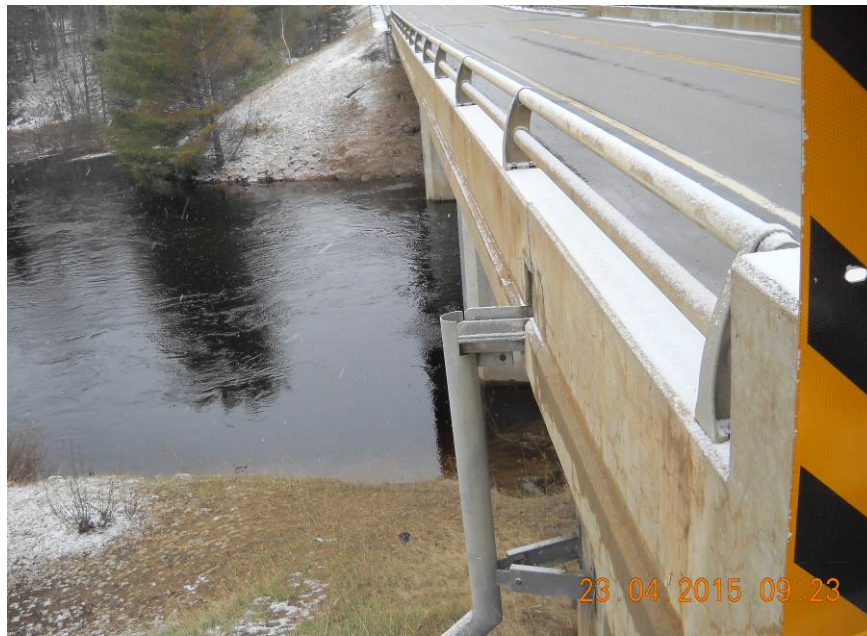
Photo: 2

Downstream at West Side of Bridge – Looking North

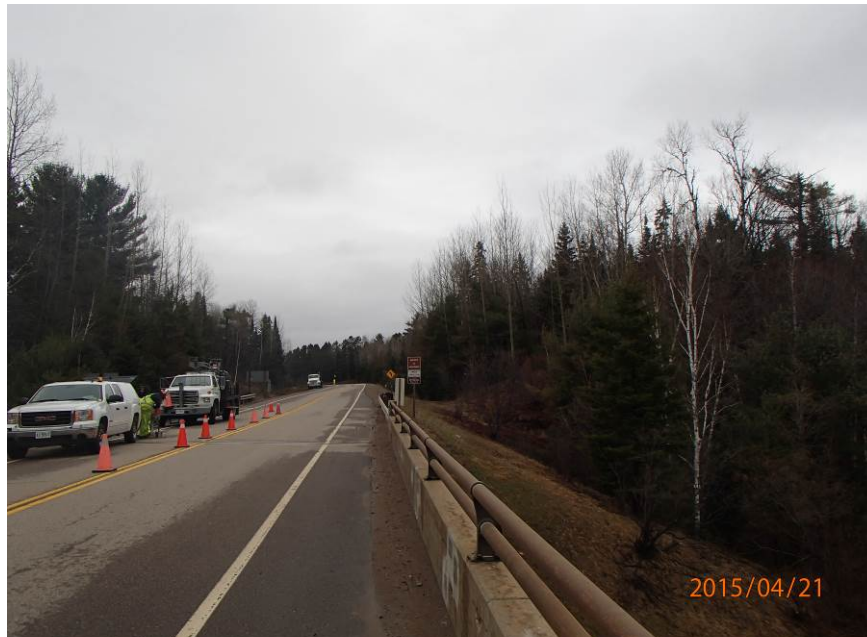
Photo: 3

Bridge North side– Looking Northwest

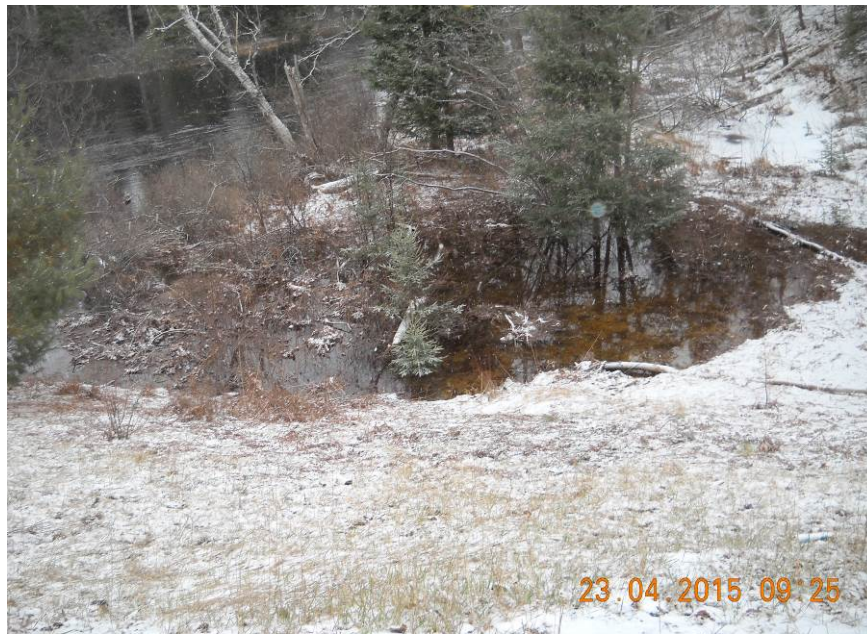
Photo: 4

Embankment at Southeast Side of Bridge – Looking East

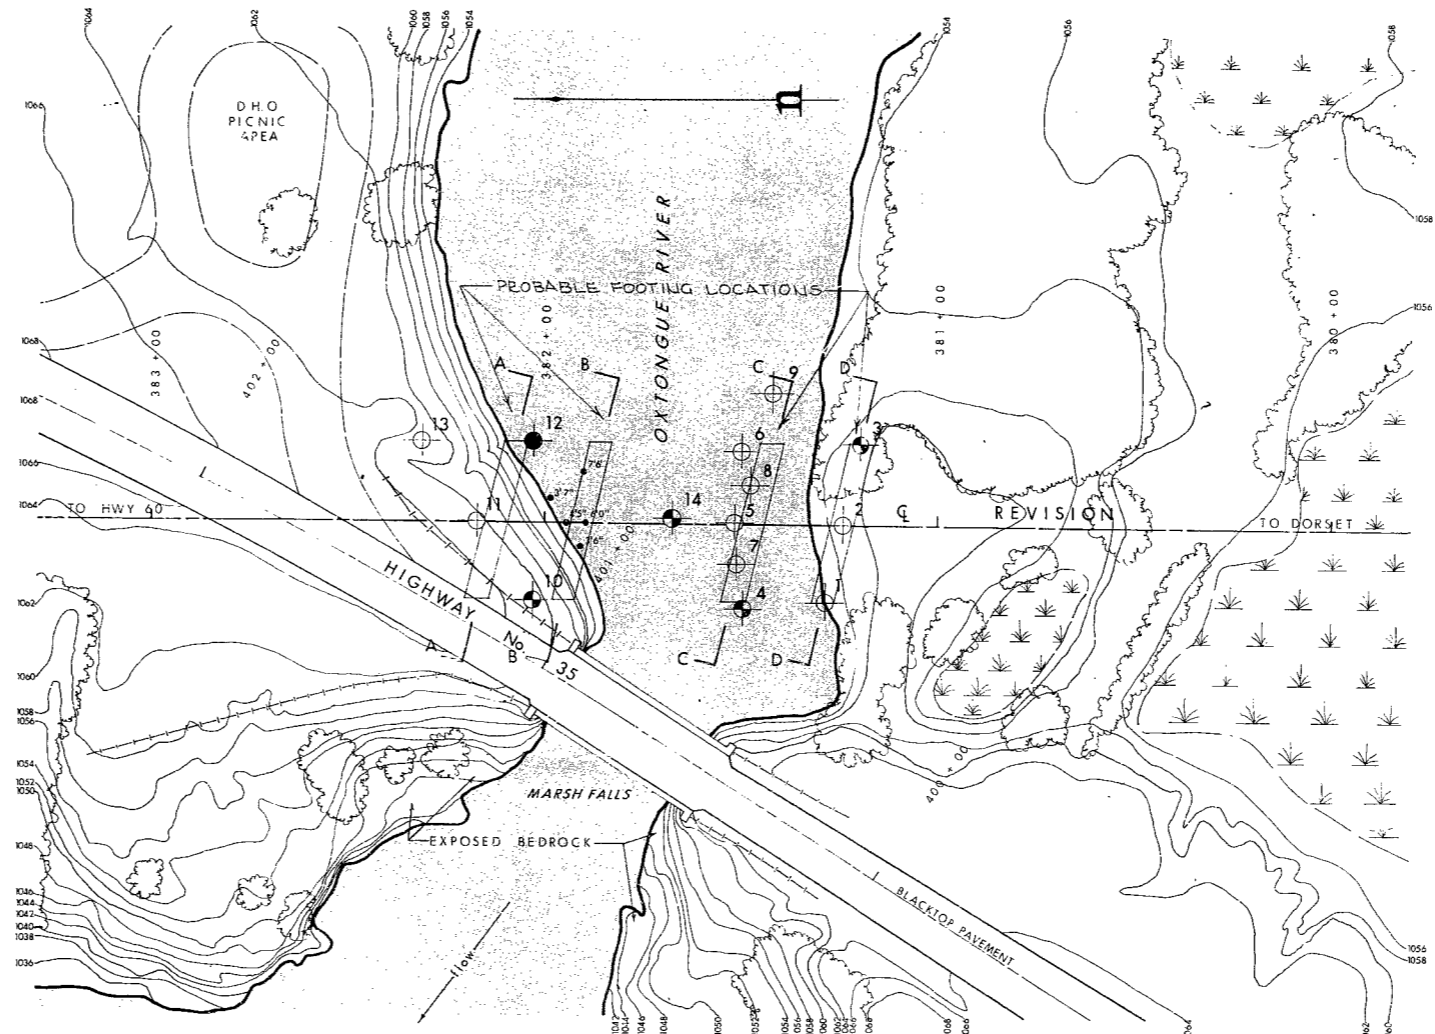
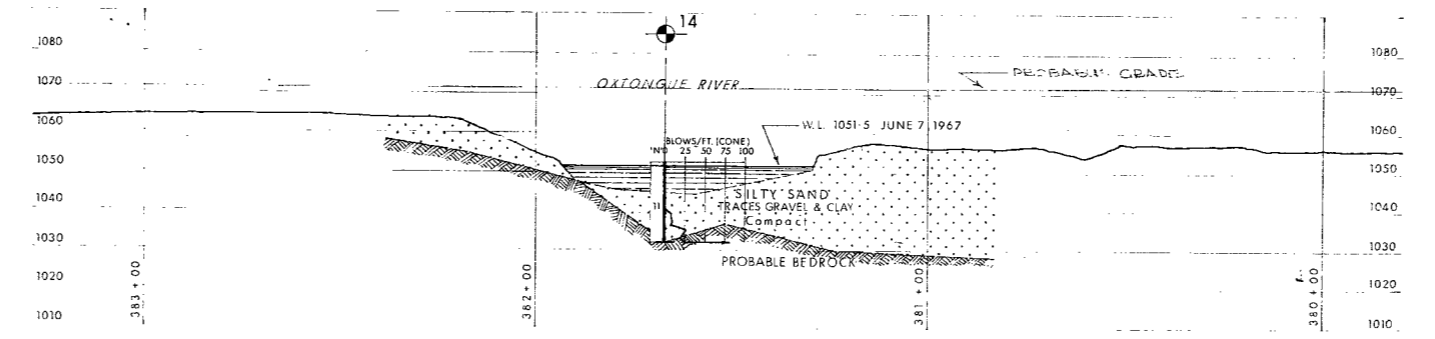
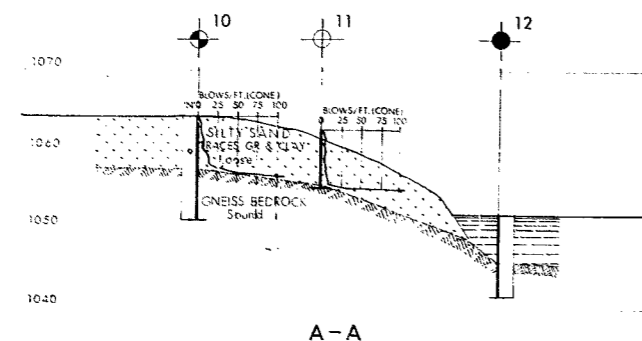
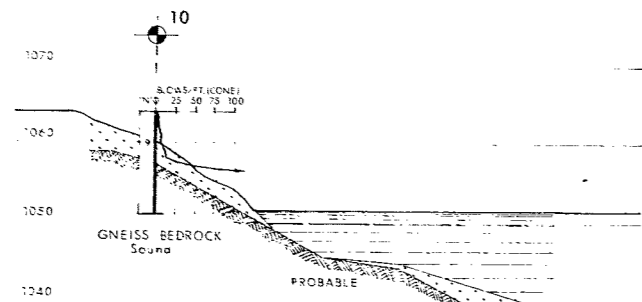
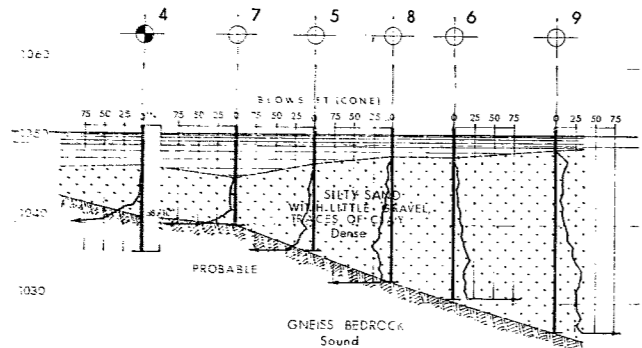
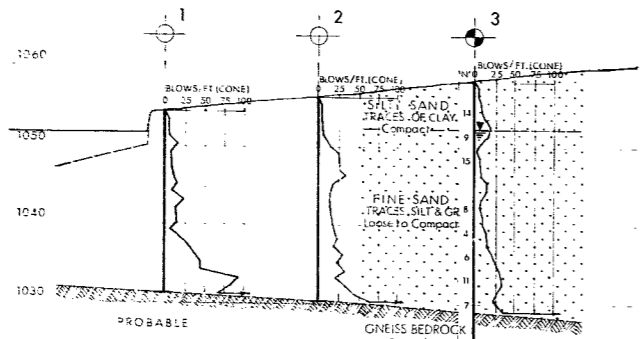
BORE HOLE LOCATIONS & SOIL STRATA

SUBM'D A.P.	CHECKED	WP NO. 337-61	M.B.T. DRAWING NO.
DRAWN P.G.O.	CHECKED	JOB NO. 67-F-46	67-F-46A
DATE JULY 10, 1967	SITE NO.	BRIDGE DRAWING NO.	
APPROVED <i>A. J. Thomas</i>	CONT NO.

A previous foundation investigation, W.P. 337-61, was carried out at this location in 1967 by the Ontario Ministry of Transportation. Results of the previous investigation shown on a Drawing No. 67-F-46A indicated the subsurface soils at the north approach consisted of silty sand overlying the gneiss bedrock encountered at elevations ranging from 318.5 m to 321.5 m. The subsurface soils at the south approach consisted of silty sand overlying the gneiss bedrock encountered at elevation 314.0 m (see Enclosure No. 5, Appendix 5). Based on a Drawing No. TWP 571-2-1-B of Contract No. 70-214, the existing bridge was founded on deep foundations (H piles driven to refusal) at both of the north and the south abutments (Enclosure No. 6, Appendix 5).

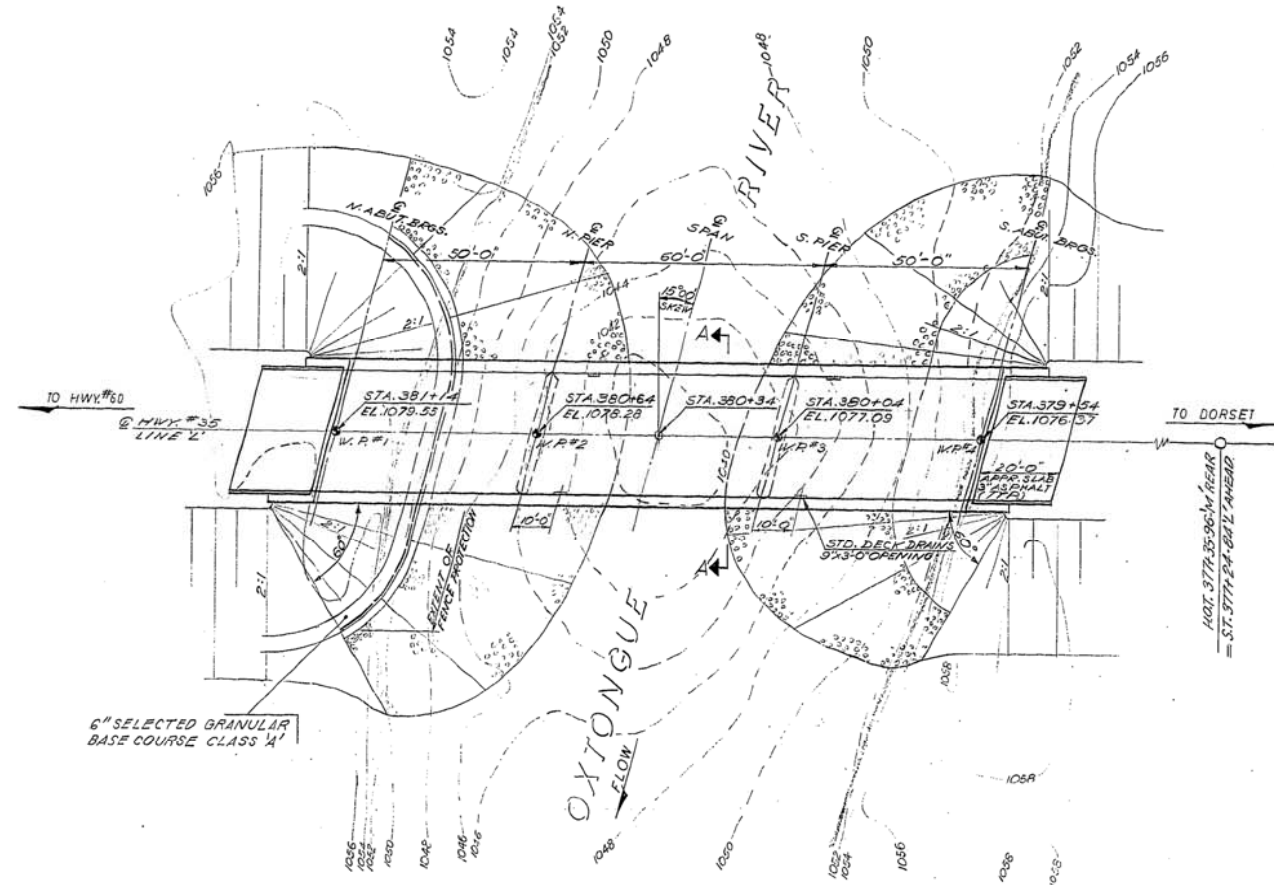
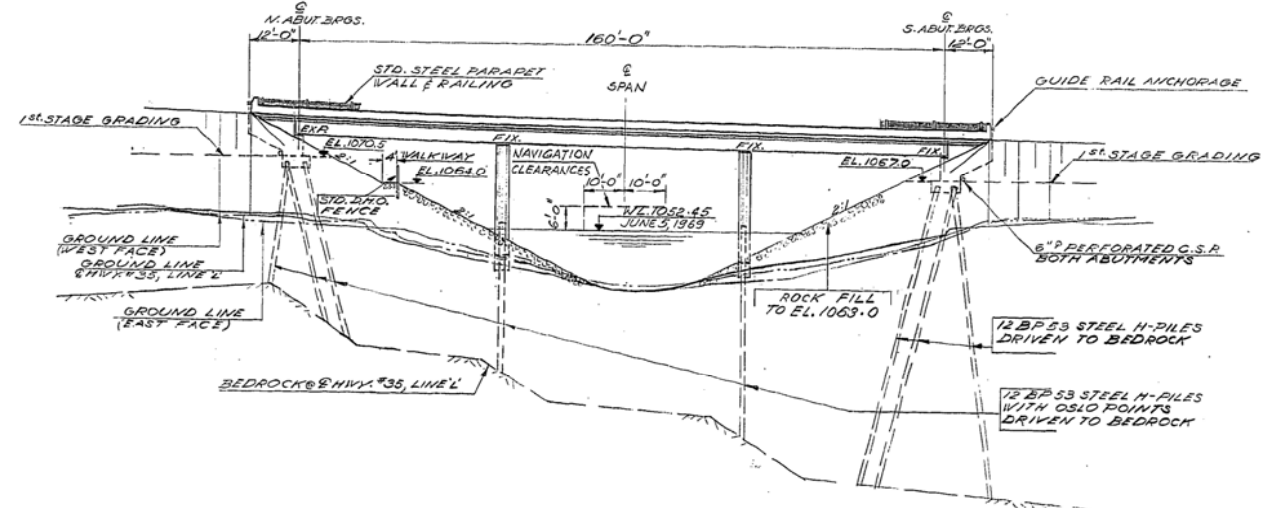
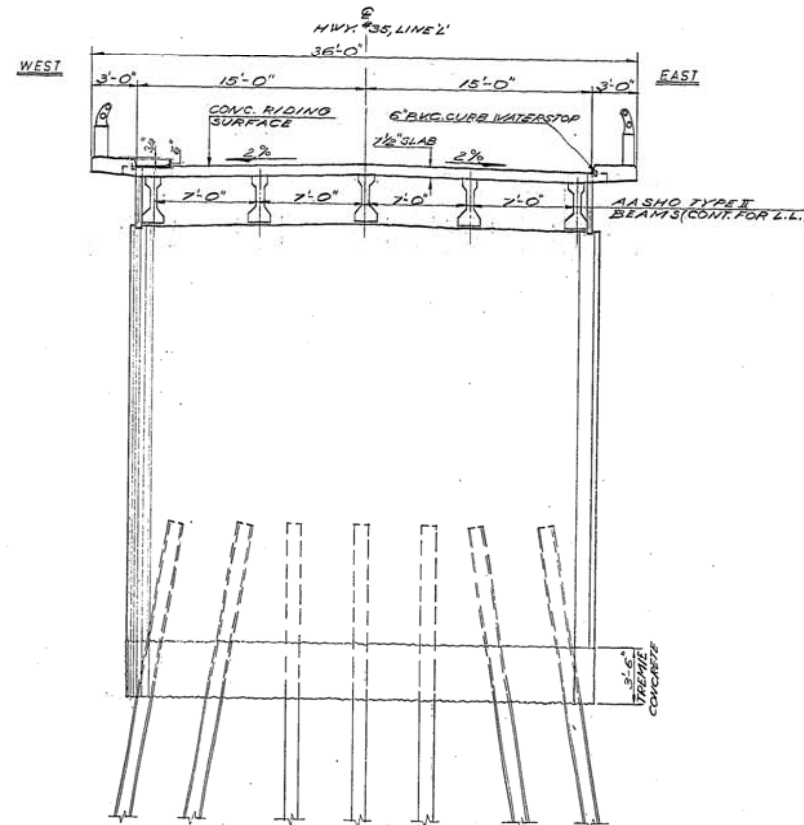
PLAN
SCALE: 1 IN. = 20 FT.

WEST ELEVATION
SCALE: 1 IN. = 20 FT.

SECTION A-A
SCALE: 3/4 IN. = 1 FT.

Based on the Contract No. 70-214, the existing bridge was founded on deep foundations (H piles driven to refusal) at both of the north and the south abutments (Enclosure No. 6, Appendix 5). The conversion to semi-integral abutments will require the removal of the ballast walls. It is anticipated that, to carry out the bridge rehabilitation and convert the Oxtongue River Bridge to a semi-integral abutment, an excavation some 1.5 m deep will be required behind the existing abutments. As such, a protection system will be required at the north and south abutments of the bridge to support an excavation some 1.5 m deep behind the abutments and maintain an active lane of traffic. Based on data from this foundation investigation, the embankment fill behind the abutments supporting the approach slabs and pavement structure generally consists of sand fill. No obstructions were encountered in either borehole.

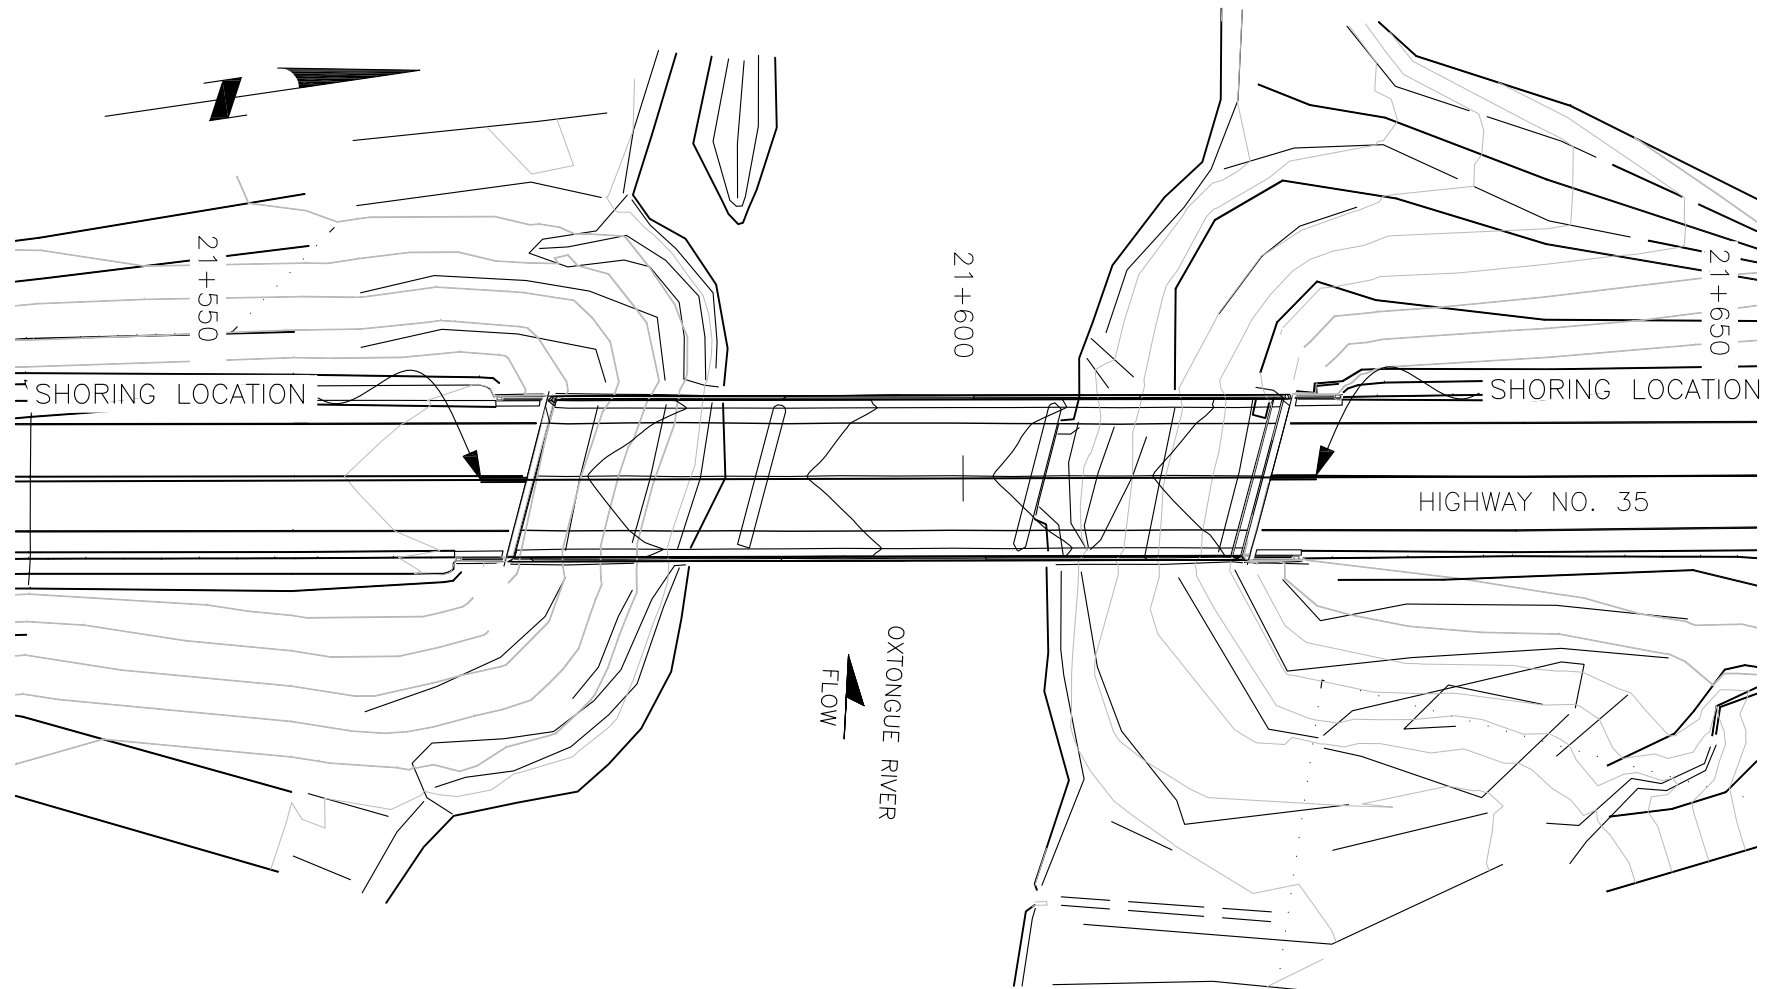
Dimensions are in meters
and/or millimeters unless
otherwise shown. Stations are
in kilometers + meters.

The fill below the pavement structure and approach slabs is considered as a Type 3 soil in accordance with the Occupational Health and Safety Act and Regulations for Construction Projects. As such, to remain stable above the water table, side walls of temporary open excavations would have to be cut back to an angle of 1H:1V. Some 1.5 m deep excavation (i.e. to elevation 327.7 m at the bridge north end, and to elevation 326.6 m at the bridge south end) will be required to the rear of the abutments to allow the rehabilitation work to be carried out on the ballast walls. The existing width of the approach is insufficient to allow the construction of a 1H:1V slope parallel to the active traffic lane. As such, a vertical excavation adjacent to the active traffic lane will be required and a protection system, installed perpendicular to the abutments, will be needed to support the active traffic lane. Conceptual shoring locations are illustrated on Figure No. SK-5 in Appendix 6.
