**Bridge Rehabilitation  
Highway 11  
Simcoe County Road 20 UP (Oro Line 11)  
Site No 30-472  
GWP 2295-17-00**

## **FINAL FOUNDATION INVESTIGATION REPORT**

Date: February 20, 2018  
Ref. Nº: P-0014012-0-00-100-01-F3

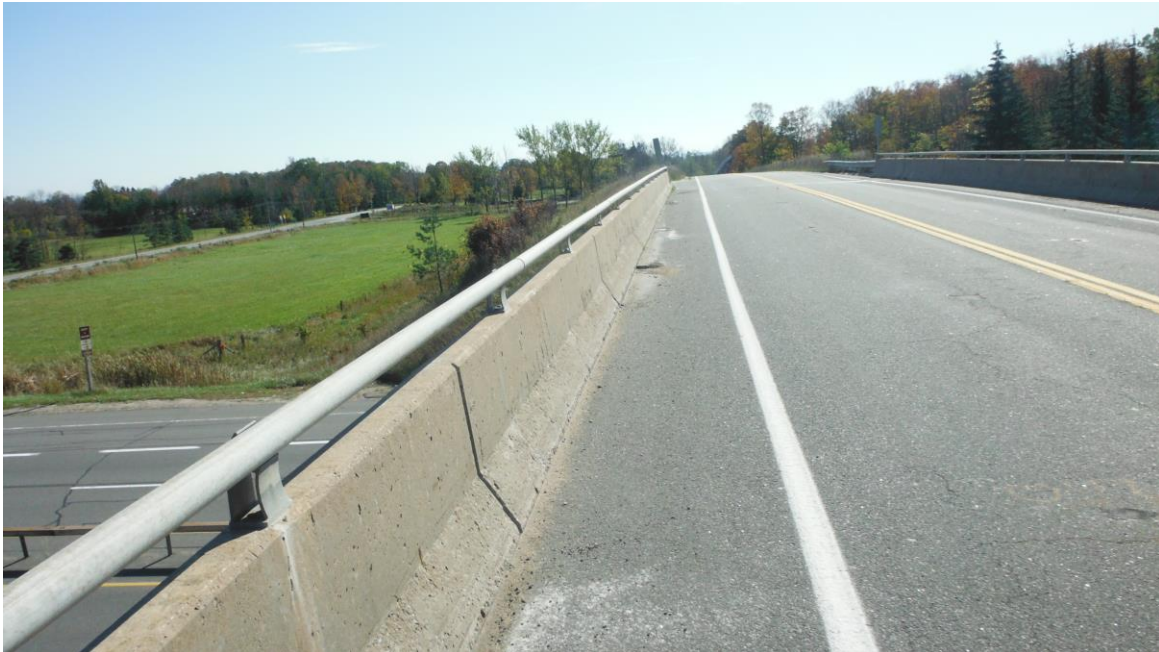
Photo: 1

Existing Bridge – Looking South

The existing bridge underpass is located approximately between Stations 0+013 and 0+055 on Oro Line 11 (Simcoe County Road 20) and crosses over Highway 11 in the Township of Oro-Medonte. The existing Simcoe County Road underpass embankment currently supports two undivided lanes, locally running in a south-north direction. A visual review of the roadway to the north and the south of the bridge approaches indicates that, in general, the approaches are in fair to good condition (see Photo Essay in Appendix 4).
