**Bridge Rehabilitation
Highway 11
Orillia Road Concession No. 8 – Structure
Site No 30-476
GWP 2295-17-00**

FINAL FOUNDATION INVESTIGATION REPORT

Date: February 20, 2018
Ref. Nº: P-0014012-0-00-100-01-F4

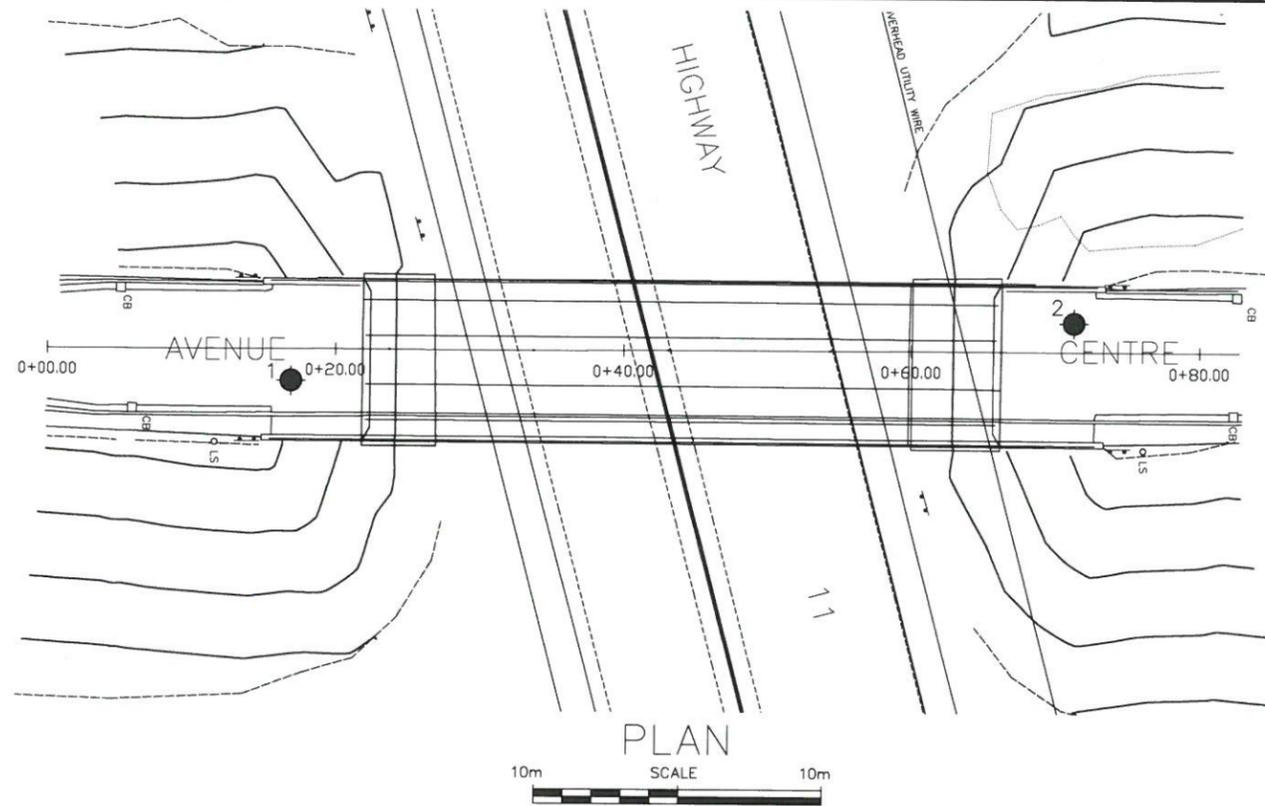
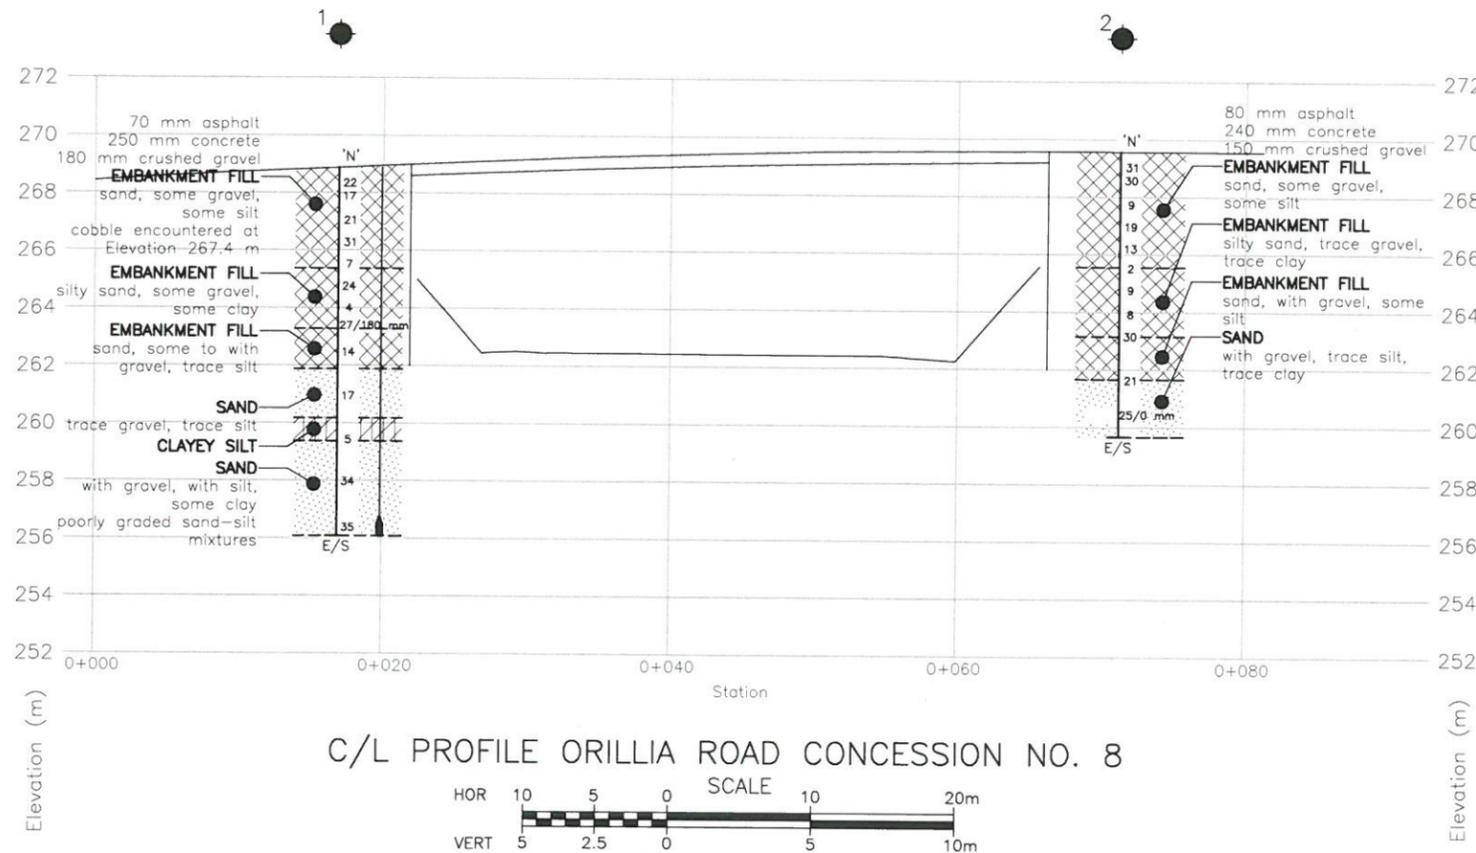
SHEET
2

C/L PROFILE ORILLIA ROAD CONCESSION NO. 8

BOREHOLE LOCATIONS
AND SOIL STRATIGRAPHY

Details of the subsurface conditions revealed by the investigation program are presented on the enclosed Records of Borehole Logs (Enclosure Nos. 2 and 3, Appendix 2) and on Drawing No. 2 (Appendix 3). Please note that stratigraphic delineation presented on the borehole logs and soil strata plot are the results of non-continuous sampling, response to drilling progress, the results of SPT, plus field observations. Typically such boundaries represent transitions from one zone to another and are not an exact demarcation of specific geological unit. Additional consideration should be given to the fact that subsurface conditions may vary markedly between adjacent boreholes and beyond any specific boring location, and are shown on the drawings for illustration purposes only.

A plan and profile illustrating the borehole locations and stratigraphic sequences is shown on Drawing No. 2, Appendix 3. During the course of the exploration program, two (2) sampled boreholes were put down at this site, with Borehole No. 1 advanced through the south approach and Borehole No. 2 was advanced through the north approach. At the time of the subsurface investigation, the ground surface elevations at Borehole Nos. 1 and 2 were recorded at Elevations 268.9 and 269.6 m, respectively.

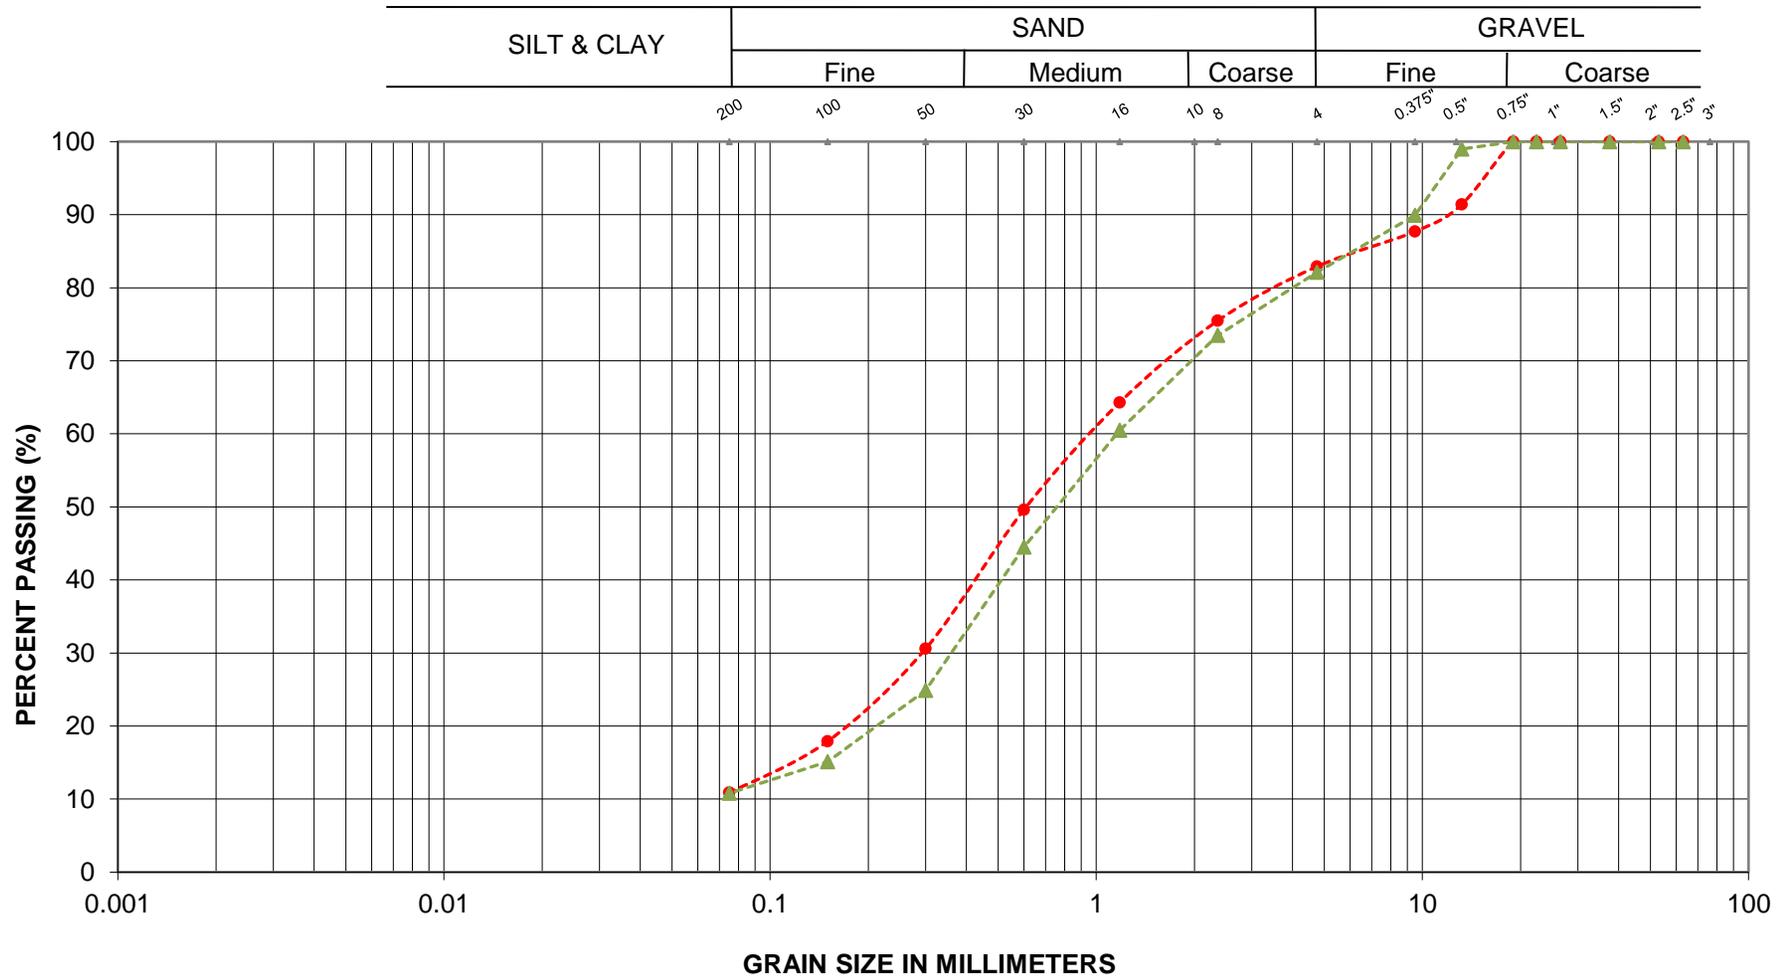
GRAIN SIZE ANALYSIS

EMBANKMENT FILL, sand

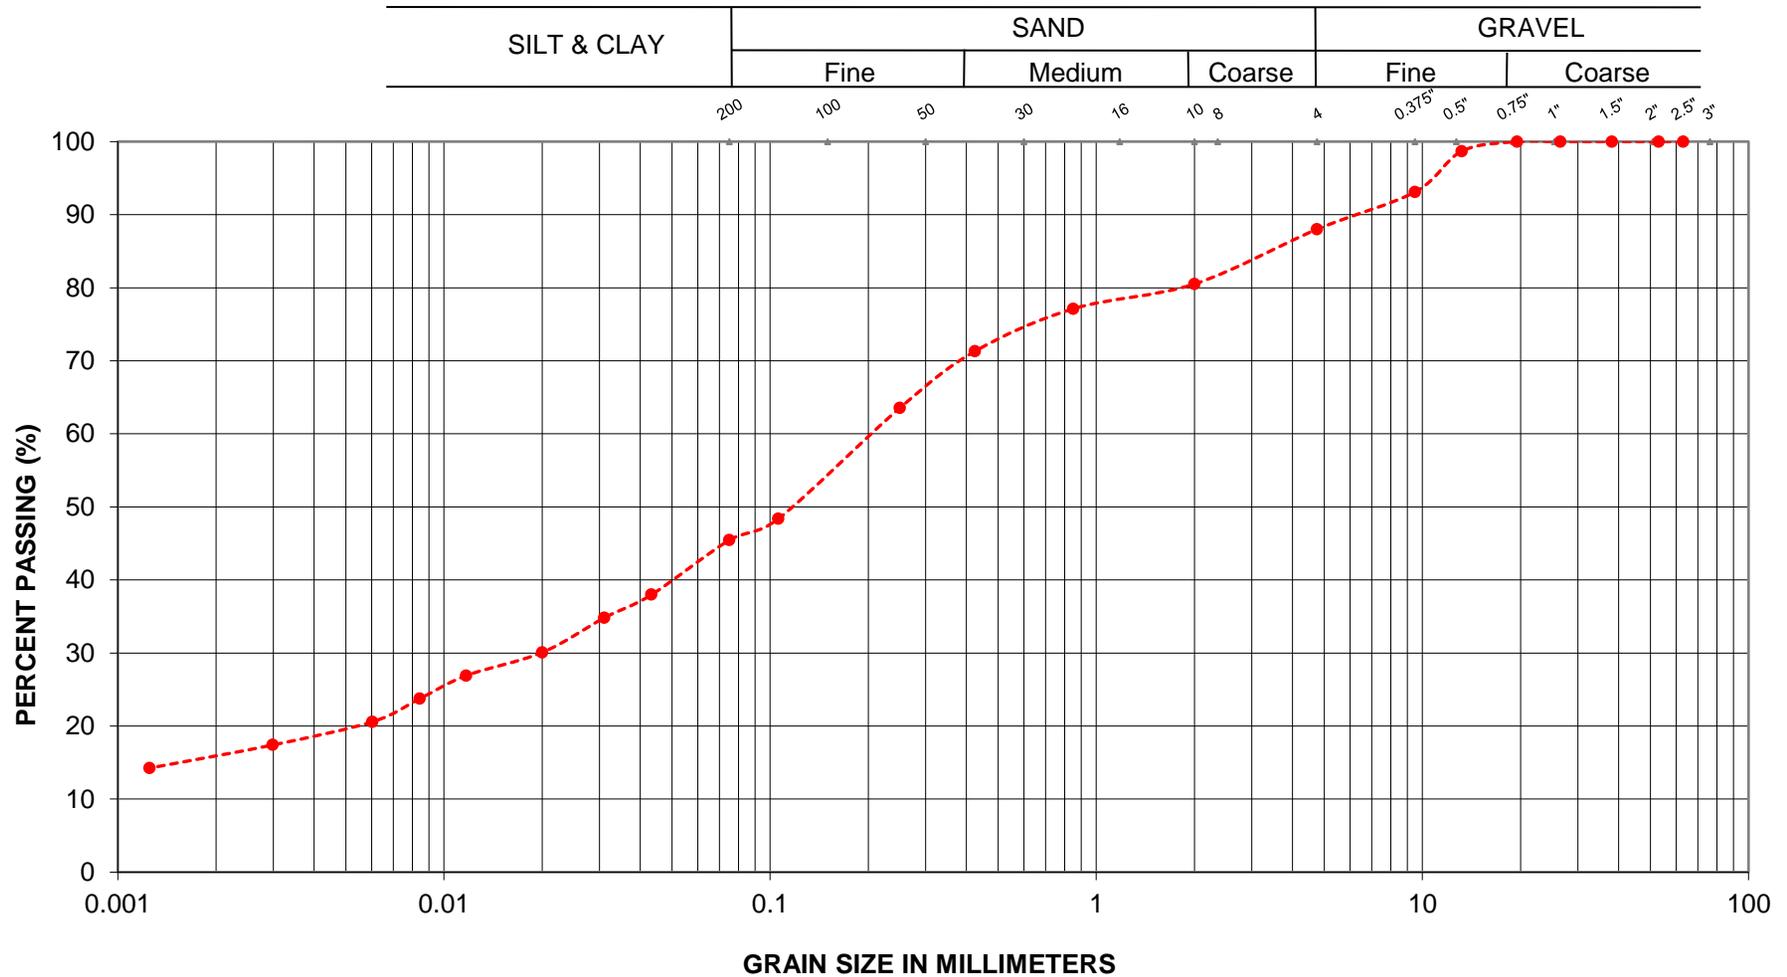
GRAIN SIZE ANALYSIS

---●--- BH No.: 1 Sa No.: 7B Depth: 0.3 - 0.8 m

EMBANKMENT FILL, silty sand, poorly graded sand-silt mixtures

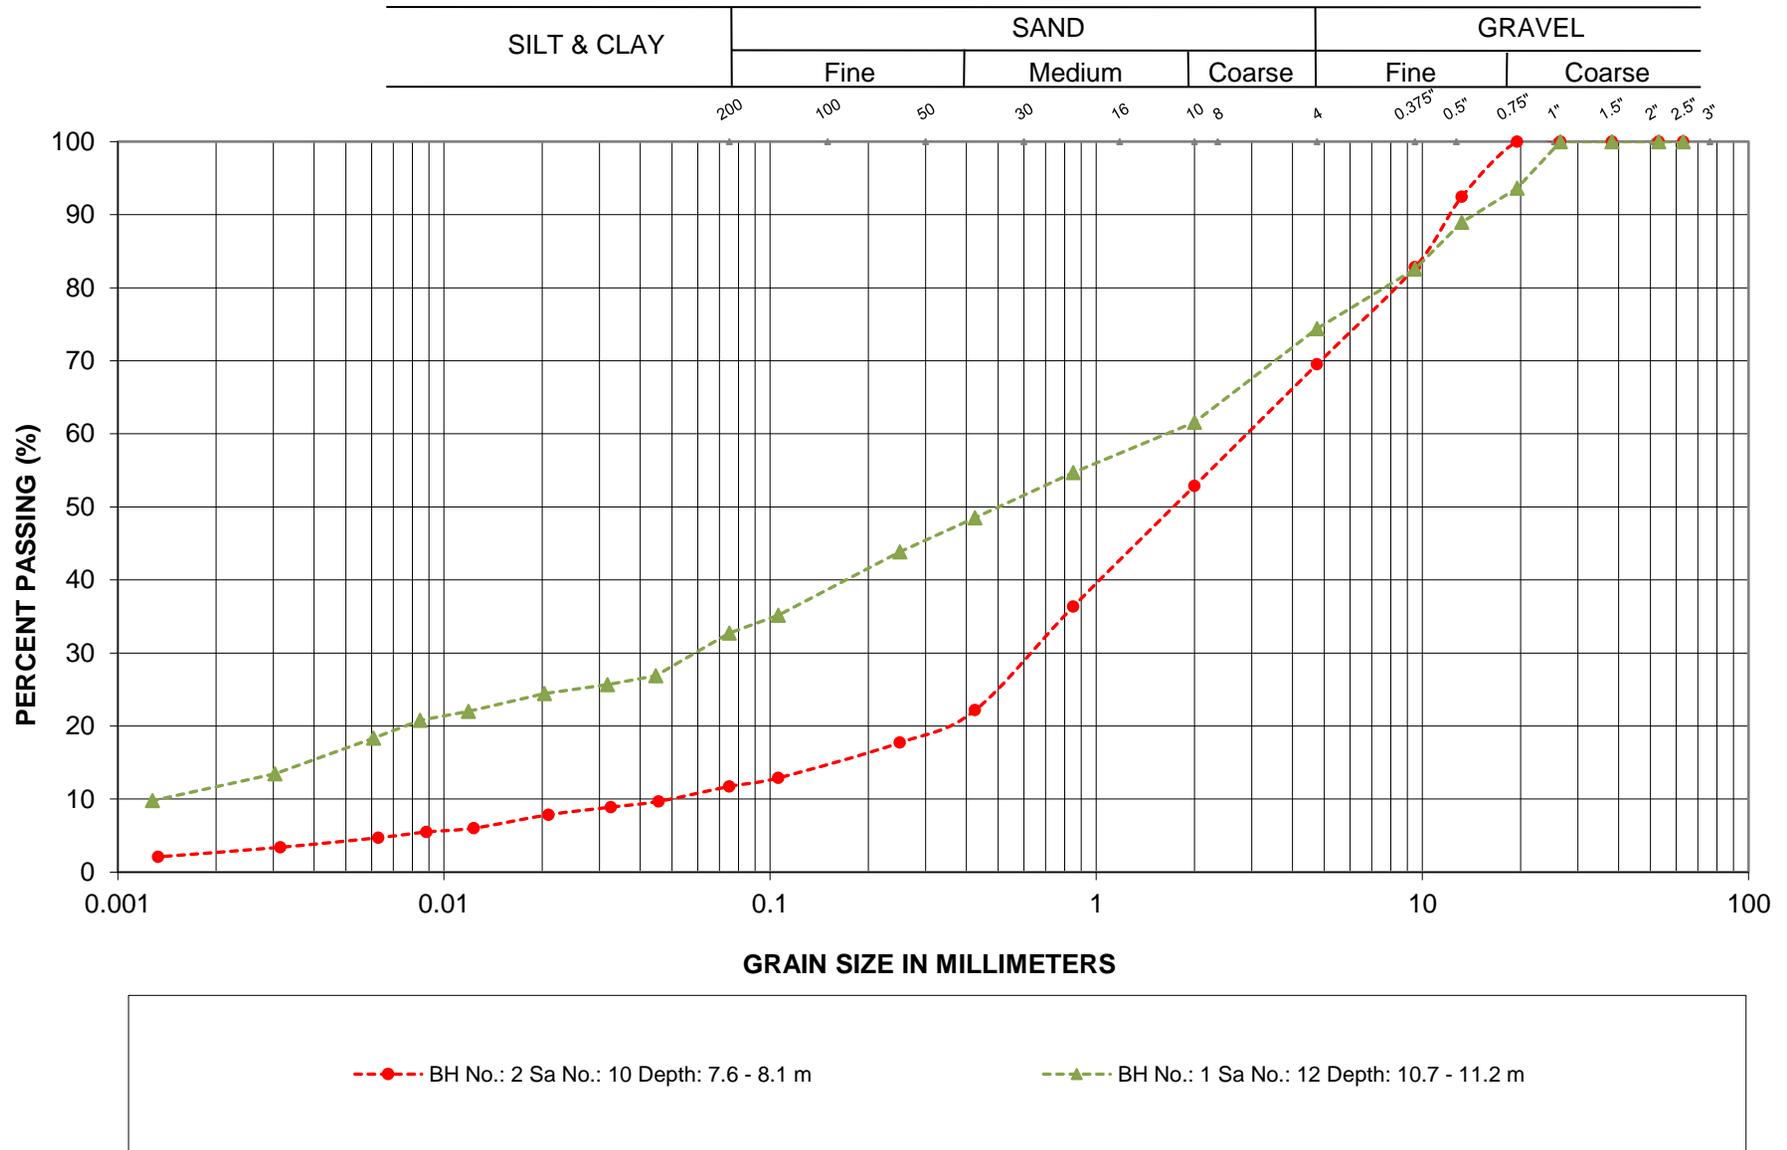
FIGURE L-3

SAND, with gravel

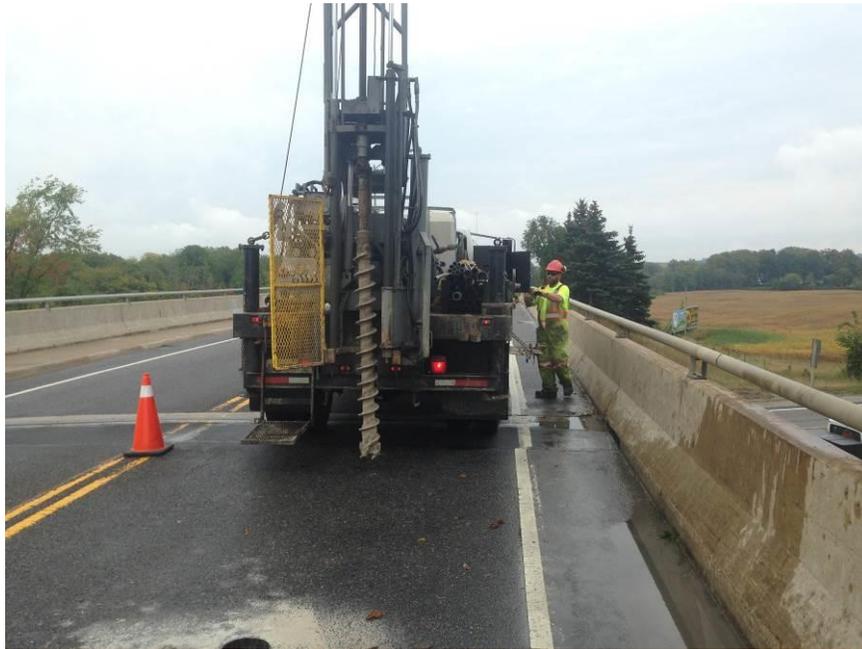
Photo: 1

Existing Bridge – Looking South

The existing bridge underpass is located approximately between Stations 0+022 and 0+066.5 on Orillia Road Concession No. 8 - Structure and crosses over Highway 11 in the Township of Oro-Medonte. The existing embankment of Orillia Road Concession No. 8 currently supports two undivided lanes, locally running in a south-north direction. A visual review of the roadway to the north and the south of the bridge approaches indicates that, in general, the approaches are in fair to good condition (see Photo Essay in Appendix 4).
