**FOUNDATION INVESTIGATION AND DESIGN REPORT
FERGUS ROAD BRIDGE REPLACEMENT
TOWNSHIP OF OPASATIKA, SITE 38C-150
COCHRANE / NEW LISKEARD DISTRICT
G.W.P. NO. 5141-14-00**

GEOCRES No. 42G-63

Date: November 8, 2016
File: 11532

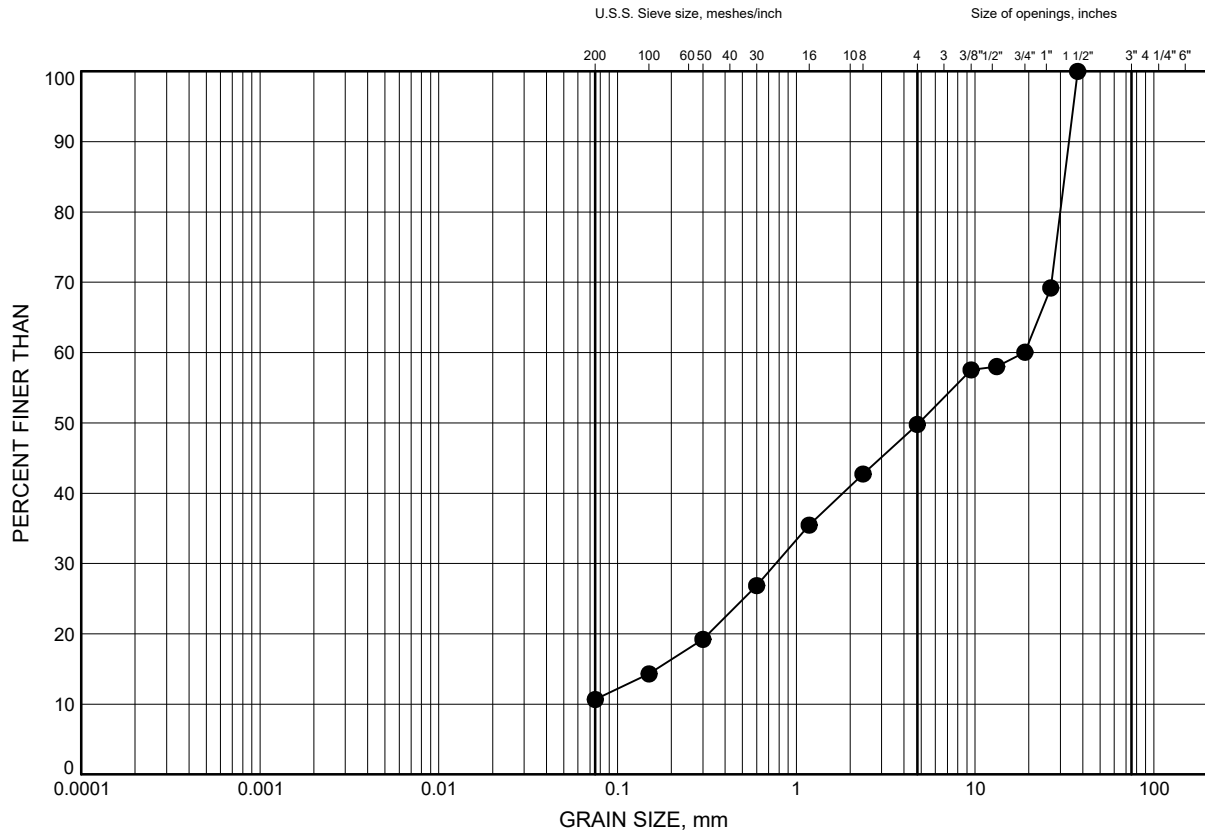
FIGURE B1

SAND and GRAVEL FILL

A layer of sand and gravel fill forming a road base was encountered extending from the ground surface to approximately 0.3 m depth, except in Borehole 16F-04 where the fill was found extending to 0.8 m depth. Some silt and occasional cobbles were encountered in this fill. A layer of geogrid was noted beneath the road base fill separating it from the underlying silty clay fill.

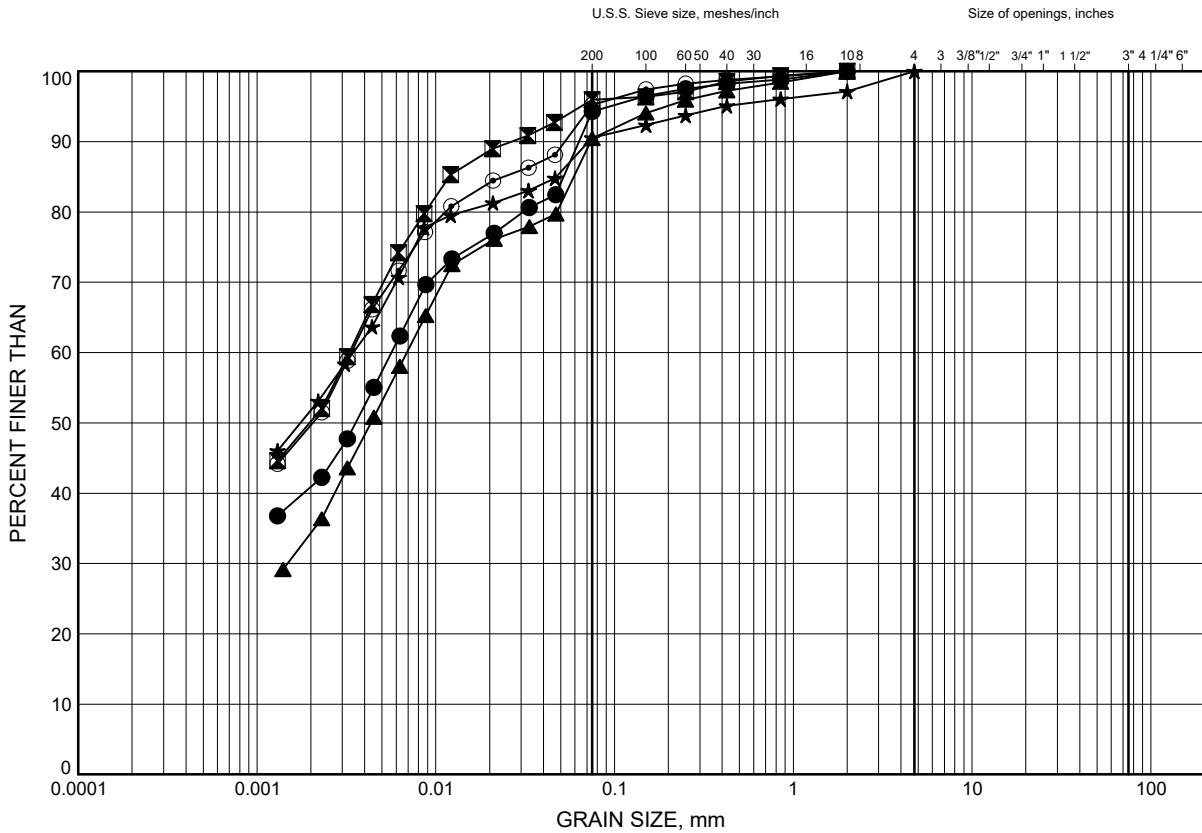
FIGURE B2

Silty CLAY FILL

Underlying the road base was a silty clay fill with trace to some sand and trace to some gravel. Occasional cobbles and lenses of organic matter, including rootlets and wood fragments, were observed in the fill. The silty clay fill layer varied in thickness from 1.9 m to 2.7 m with the underside at depths between 2.4 m and 3.0 m (Elev. 256.0 and 256.8).

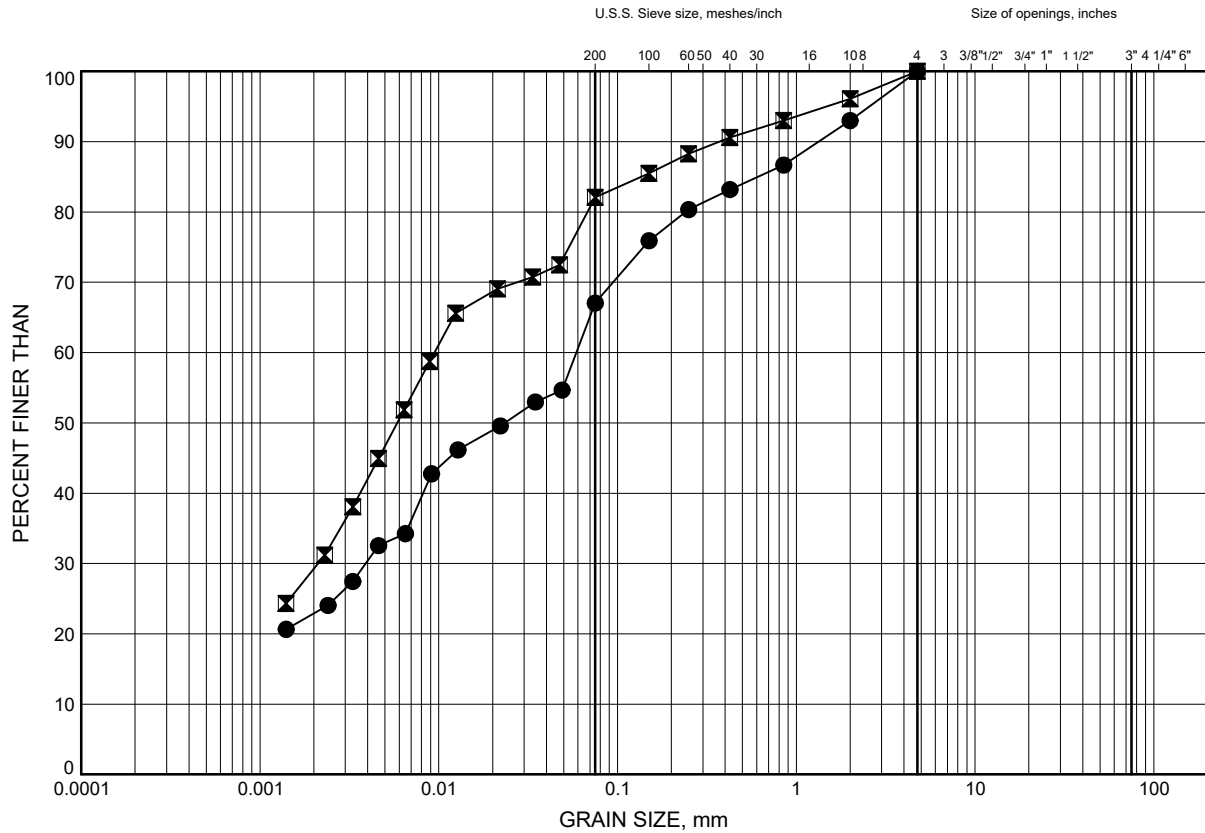
FIGURE B3

Sandy, Silty CLAY TILL

A glacial till was encountered underlying the river bed deposit. The till ranged in composition from silty clay, some to with sand, on the south side of the river to sandy silt with some clay on the north side of the river. Trace to some gravel and occasional cobbles were noted in the deposit. Trace organic matter was noted in the upper zone immediately underlying the cohesionless deposit. The thickness of till varied from 0.4 m to 2.3 m at the borehole locations. The underside of the till was observed between depths of 4.1 m and 6.6 m (Elev. 252.1 and Elev. 254.8).

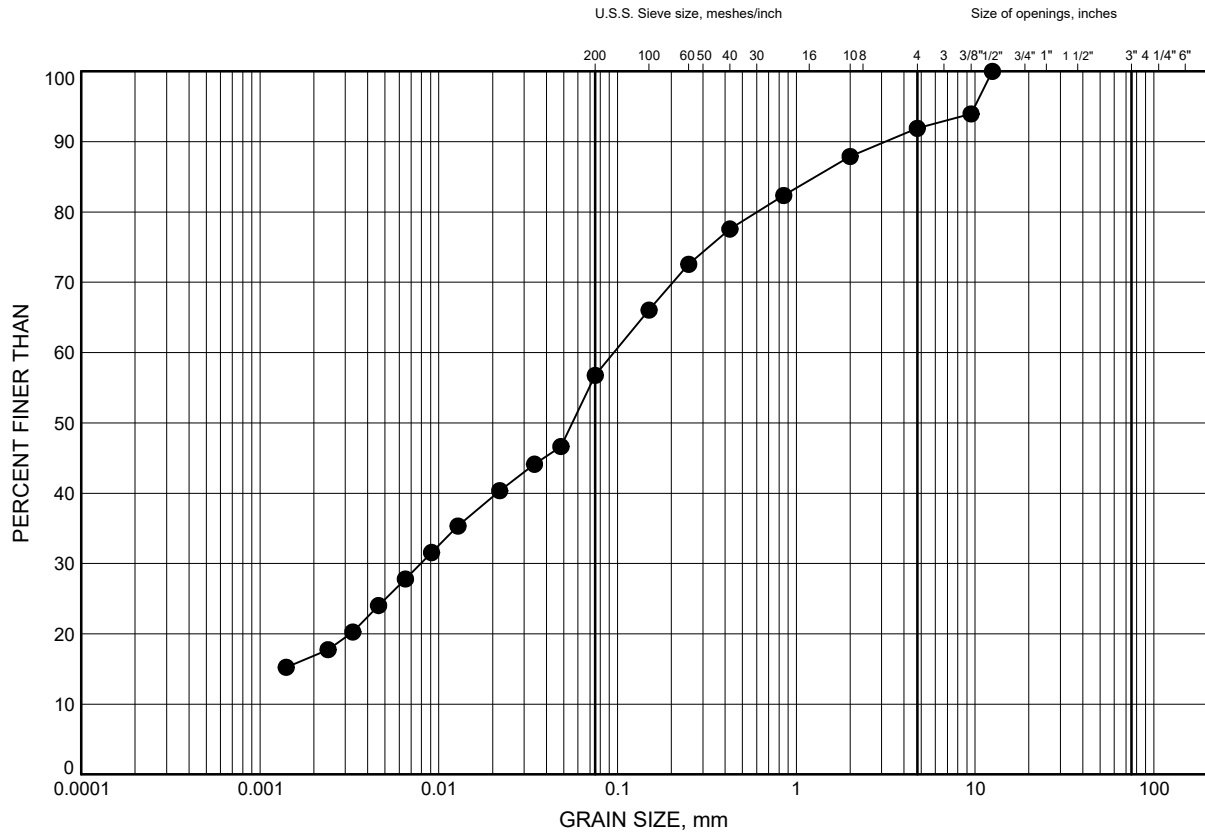
FIGURE B4

Sandy SILT TILL

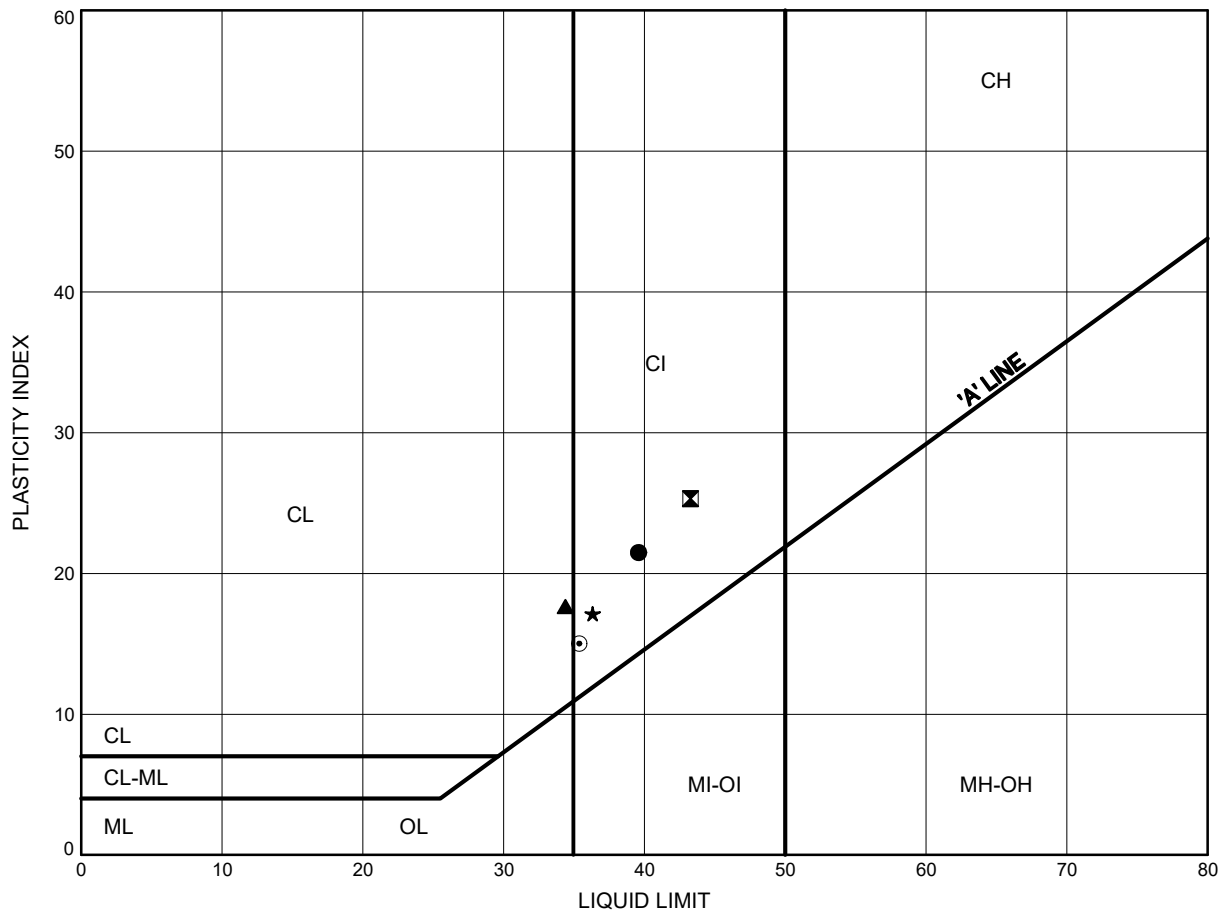
FIGURE B5

Silty CLAY FILL

SYMBOL	BOREHOLE	DEPTH (m)	ELEV. (m)
●	16F-01	1.83	257.37
⊠	16F-02	1.83	257.37
▲	16F-03	1.83	257.37
★	16F-04	2.26	256.44
⊙	16F-05	1.83	256.87

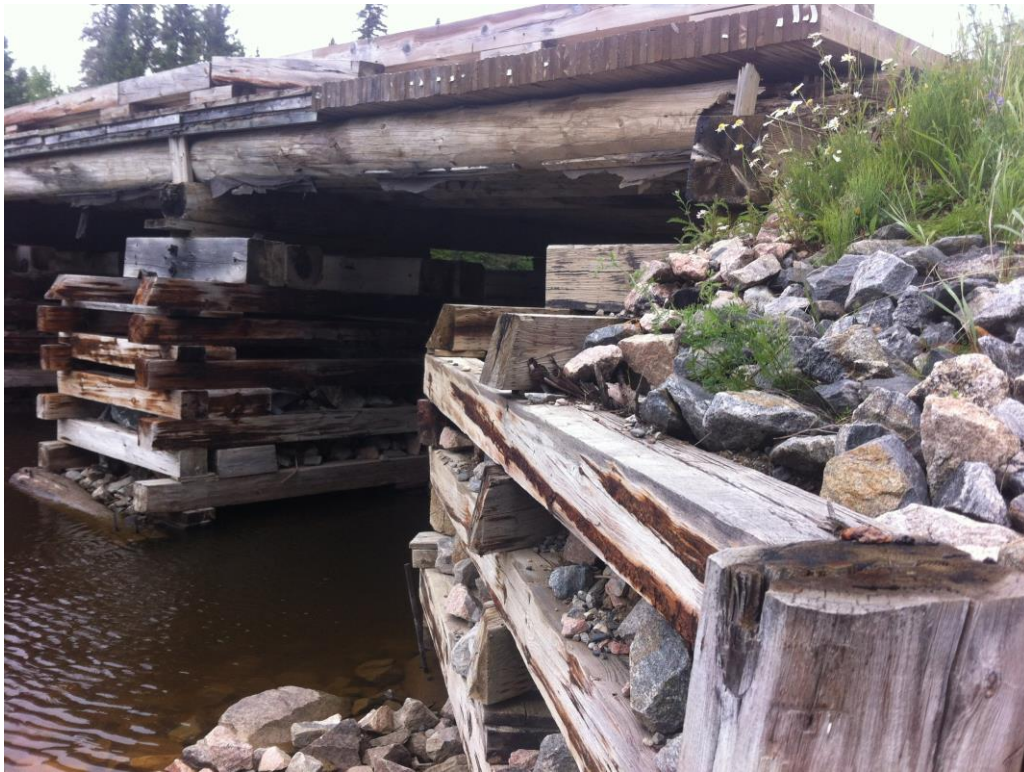
Photograph 5 – Fergus Road Bridge, south abutment looking east

The preliminary GA drawing indicates that the new abutment will be located some distance behind the existing abutments. In light of distress and erosion observed at the existing abutments, placement of new abutments some distance behind the existing timber cribs is considered to be beneficial.

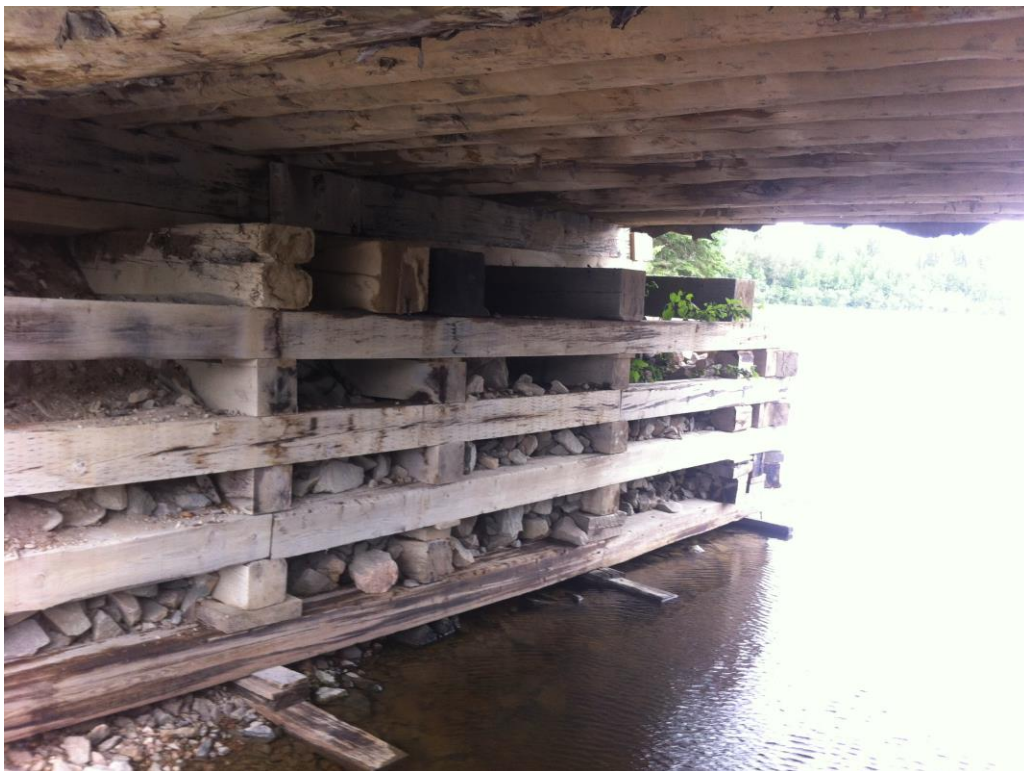
Photograph 6 – Fergus Road Bridge, south abutment looking south

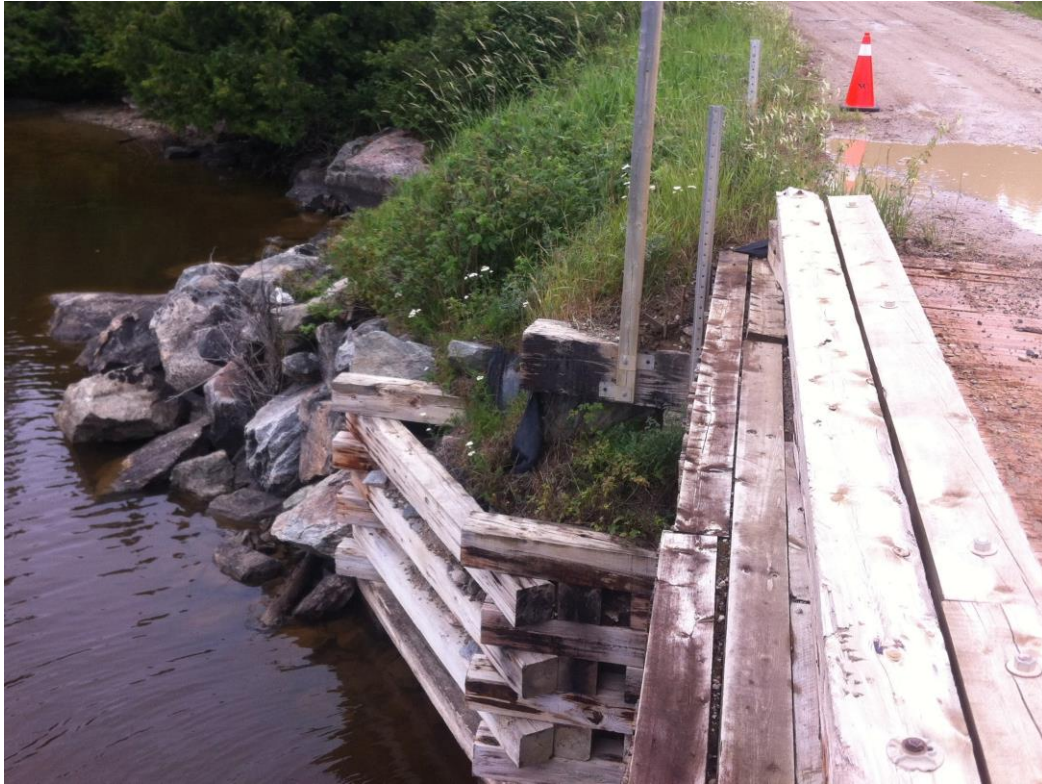
Photograph 7 – Fergus Road Bridge; west approach and north abutment

The existing approach embankments vary in height and could be as high as 3 m near the abutments. No evidence of instability of the existing approach embankments were noted during the time of the foundation investigation, although settlements at the abutments were evident. These settlements could be related to the river bank erosion leading to the undermining of the timber cribs and loss/washout of the abutment fill.

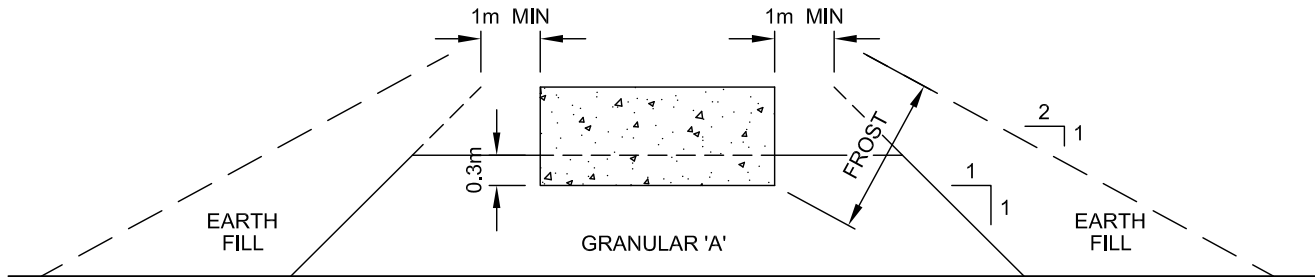
CROSS-SECTION

Abutment on Compacted Fill

The engineered fill pad should be at least 1 m in thickness. The engineered fill should consist of OPSS Granular "A" or Granular B Type II placed in 150 mm lifts and compacted to 100% of its SPMDD at $\pm 2\%$ of optimum moisture content. The top of the engineered fill pad should be at least 1 m wider than the footprint of the spread footing. The subgrade for the engineered fill pad should be inspected and all organics, soft/loose soils, and deleterious materials should be removed from the footprint of the engineered fill excavation. Dewatering measures should be provided, as required, to place the engineered fill in the dry. A sketch of the abutment placed on compacted fill is enclosed in Appendix E.
