**PRELIMINARY  
FOUNDATION INVESTIGATION AND DESIGN REPORT  
PROPOSED TWINNING AND NORTH APPROACH EMBANKMENT  
HIGHWAY 62 NORRIS WHITNEY BRIDGE EA  
BELLVILLE, ONTARIO  
SITE No. 28-28  
G.W.P. 4194-15-00**

**GEOCRES Number: 31C-308**

Date: July 8, 2021  
File: 11566

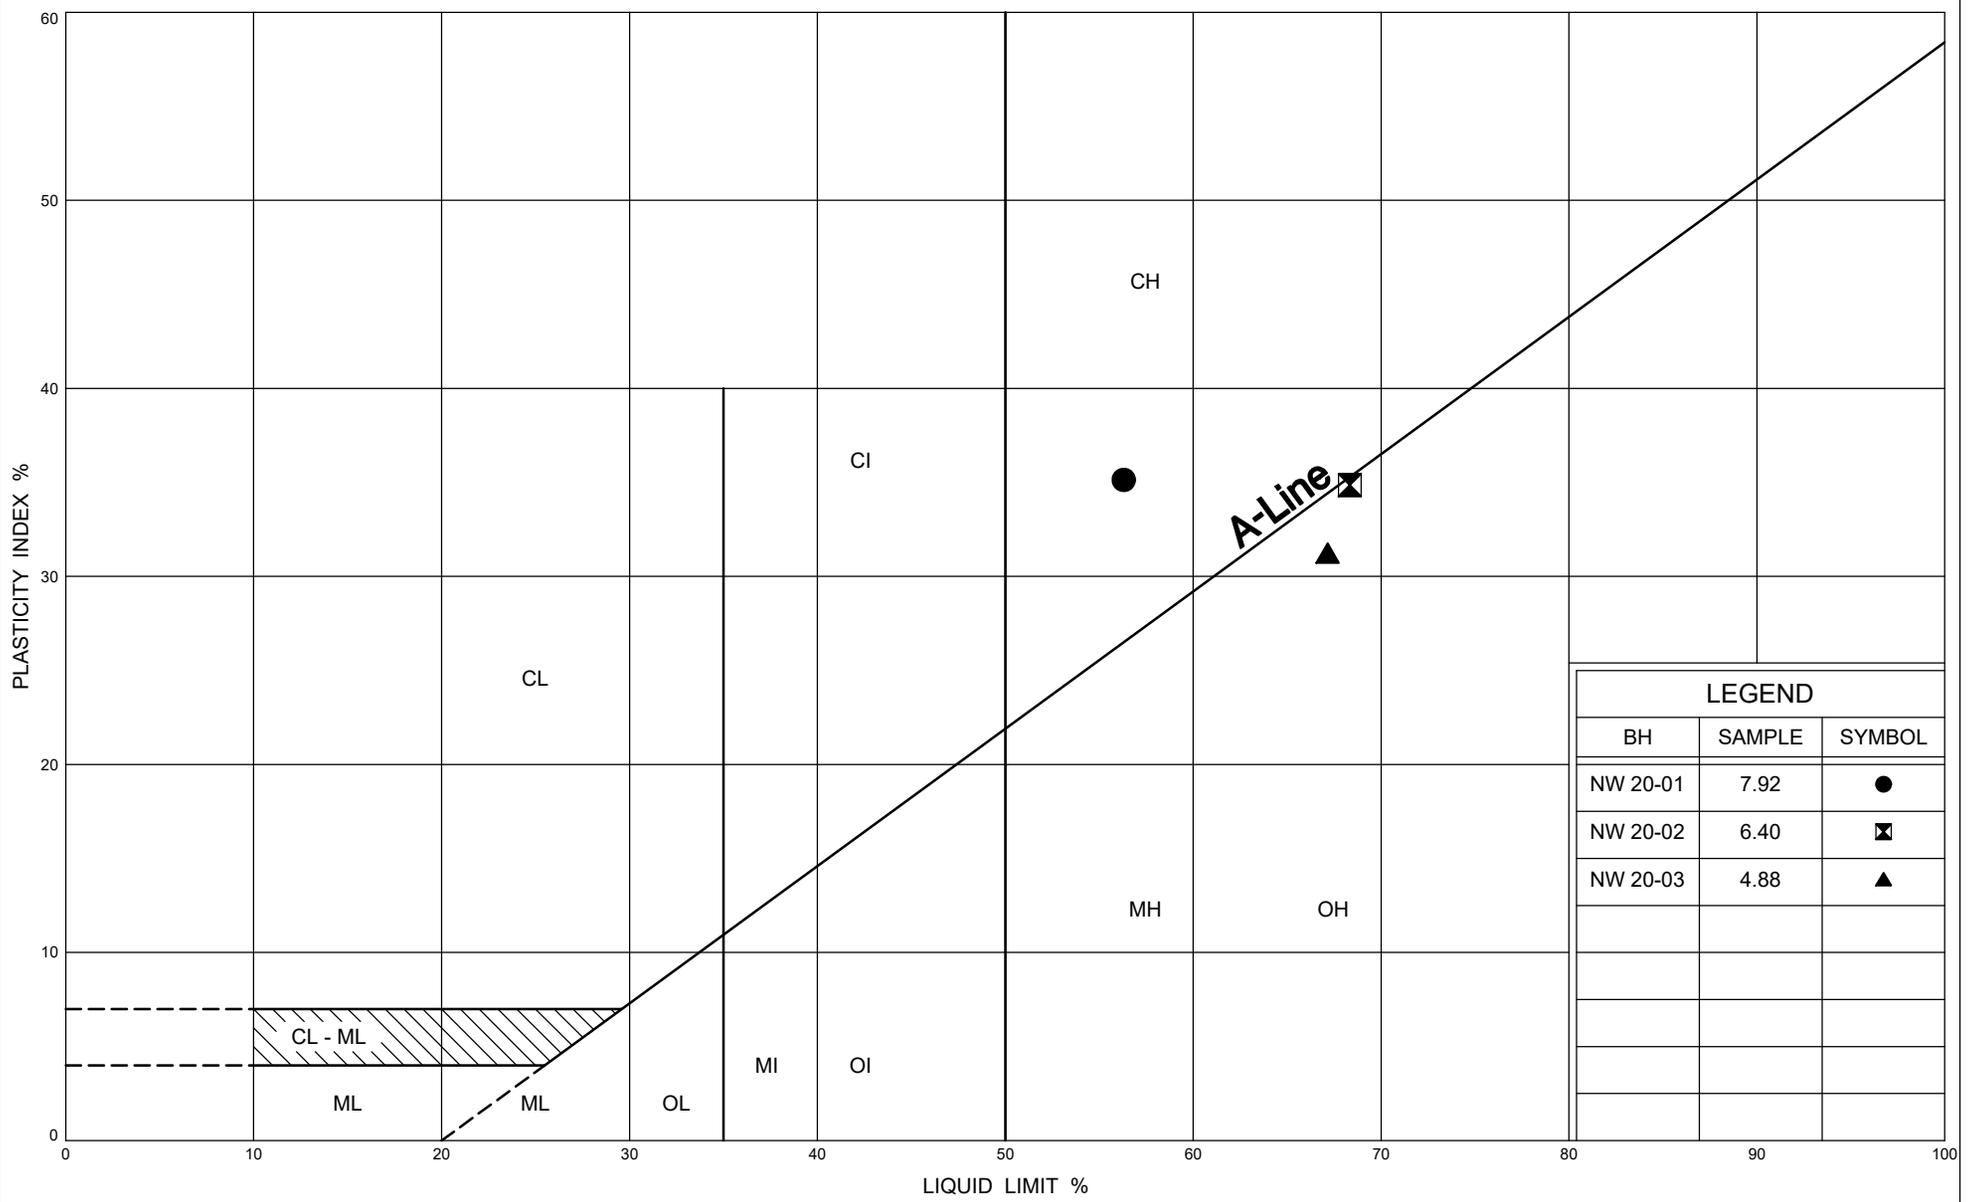
FIG No B5  
W P 4194-15-00  
Norris Whitney Bridge

LEGEND		
BH	SAMPLE	SYMBOL
NW 20-01	7.92	●
NW 20-02	6.40	⊠
NW 20-03	4.88	▲

**PLASTICITY CHART**  
Silty CLAY

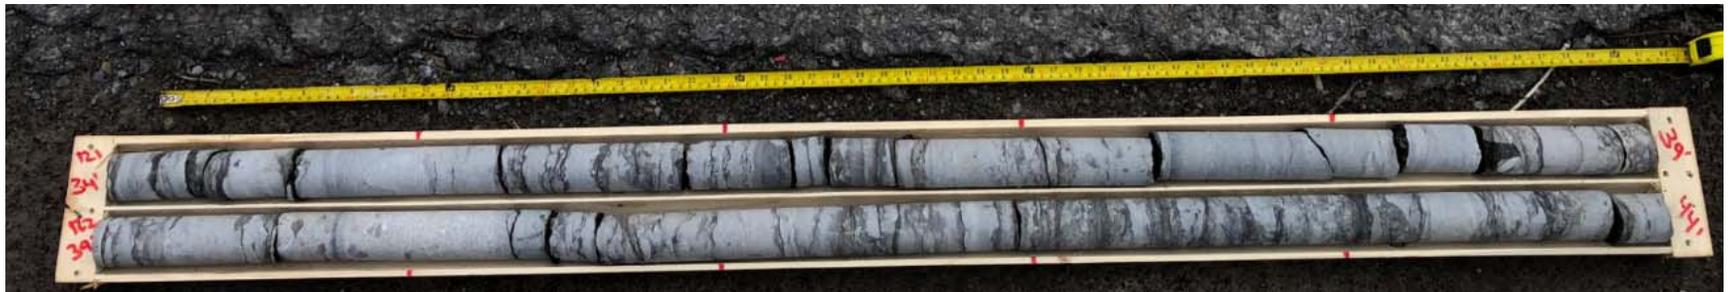
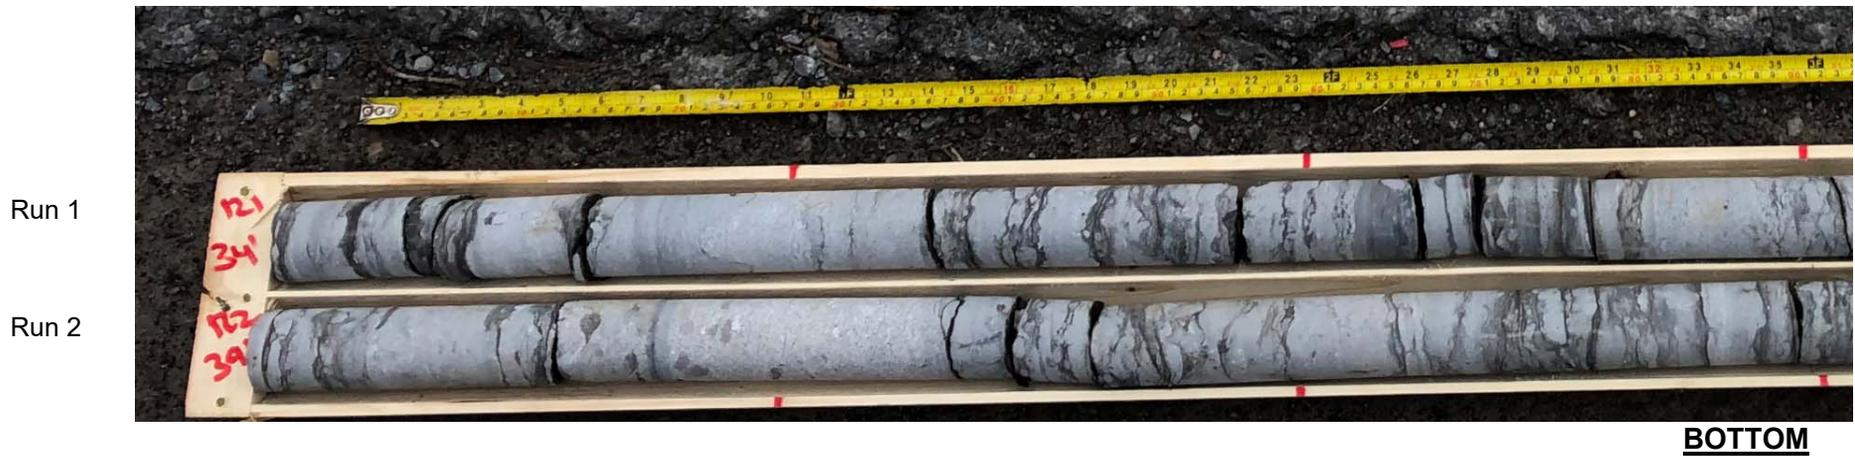
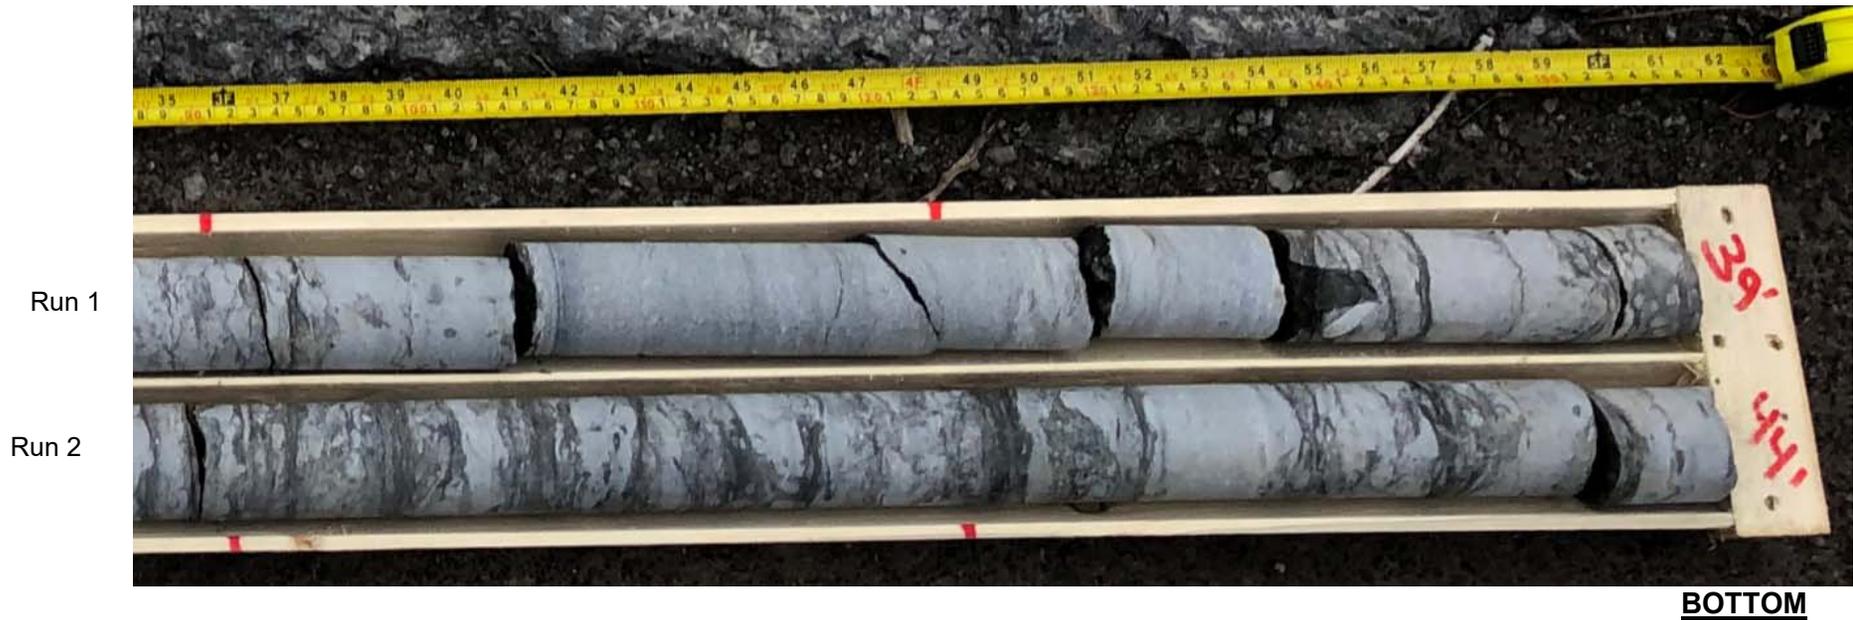
BOREHOLE NW 20-01  
RUNS 1 AND 2

Run #	Depth (m)
1	10.3 – 11.9
2	11.9 – 13.4

Run #	Depth (m)
1	10.3 – 11.2
2	11.9 – 12.8

PHOTOGRAPHS OF ROCK CORES

Run #	Depth (m)
1	11.2 – 11.9
2	12.8 – 13.4

The Total Core Recovery (TCR) and Solid Core Recovery (SCR) in the core runs was 100 percent, while the Rock Quality Designation (RQD) values ranged from 82 percent to 97 percent indicating that the rock is of good to excellent quality. The Fracture Index (FI) of the rock, expressed as number of fractures per 0.3 m of core, ranged from 0 to 3.

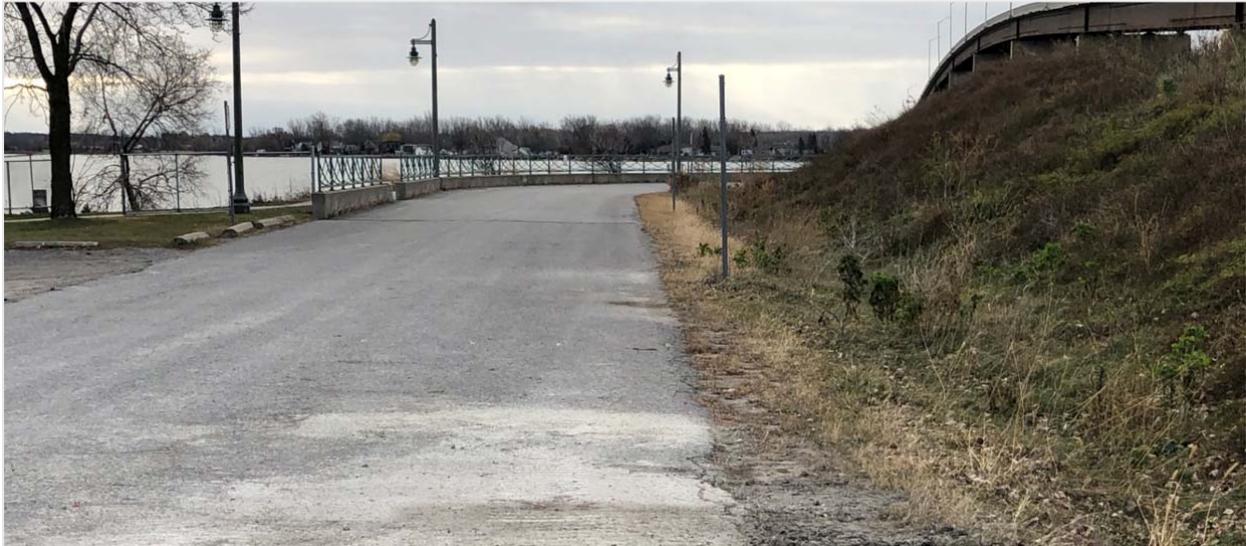
**Photo 1- Norris Whitney Bridge, northeast side  
Location of Borehole NW20-01  
Photo taken on November 18, 2020**

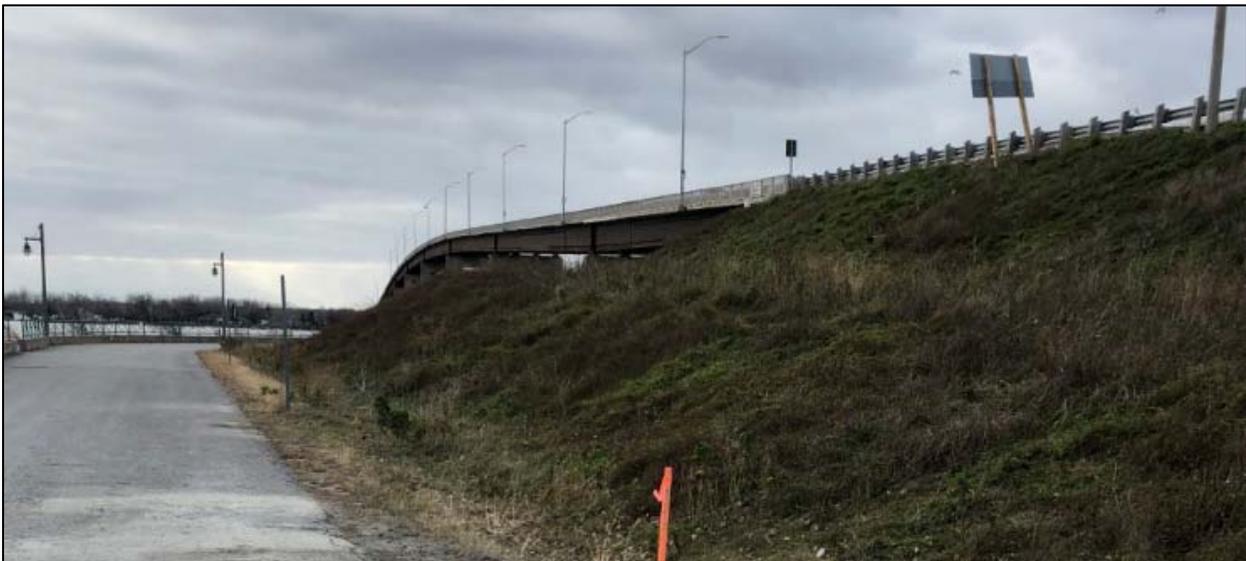
**Photo 2- Norris Whitney Bridge, northeast side  
Location of Borehole NW20-01  
Photo taken on November 18, 2020**

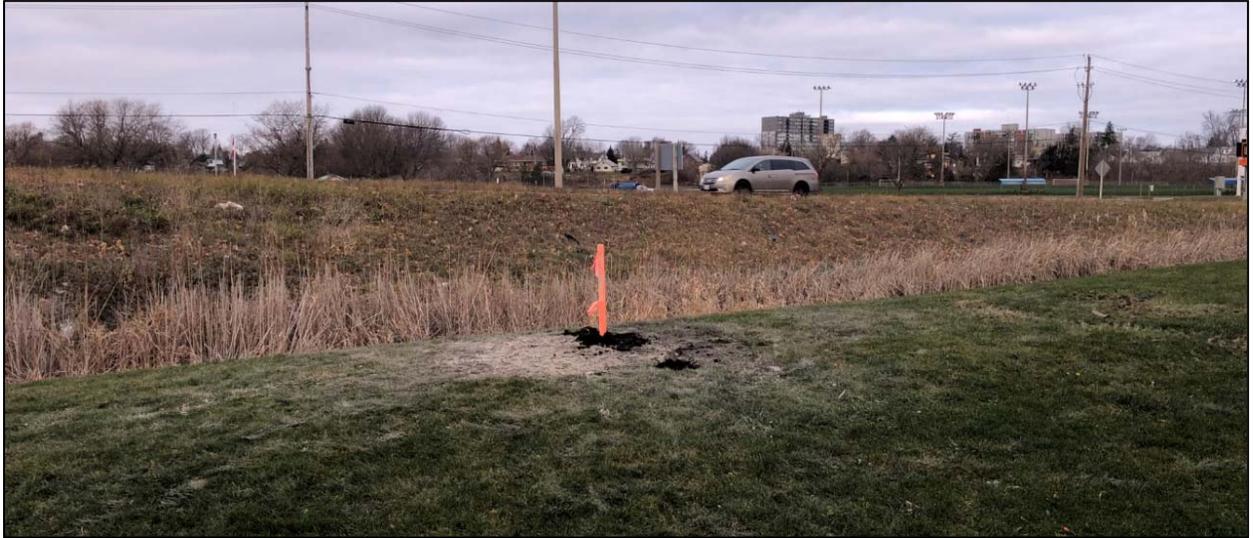
**Photo 3- Norris Whitney Bridge, northeast side  
Location of Borehole NW20-03  
Photo taken on November 18, 2020**

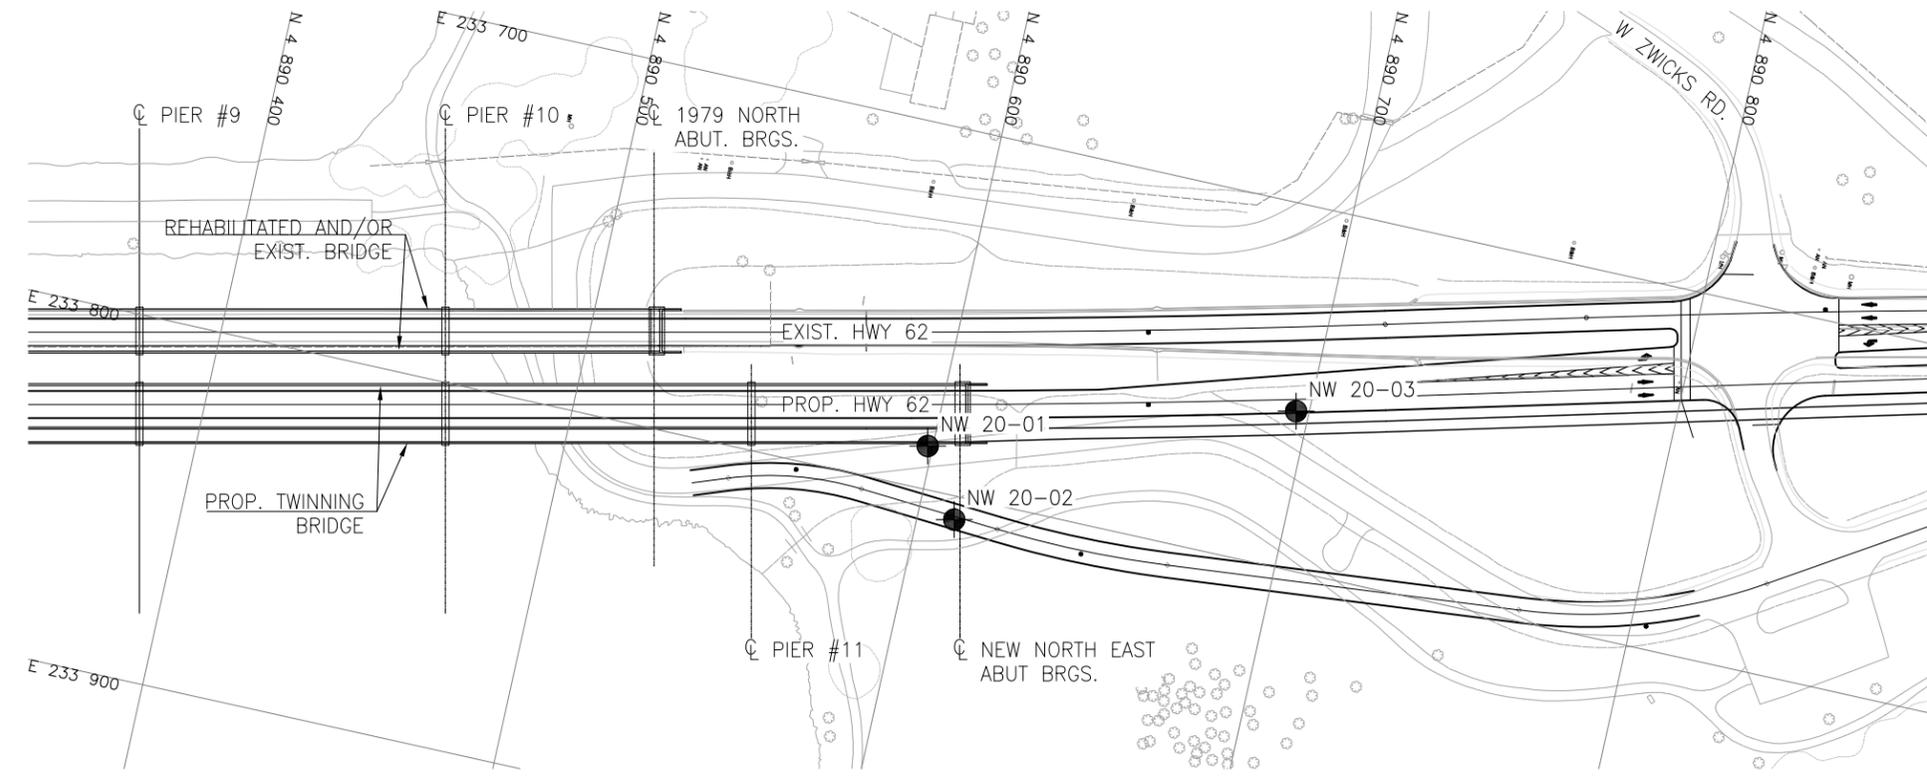
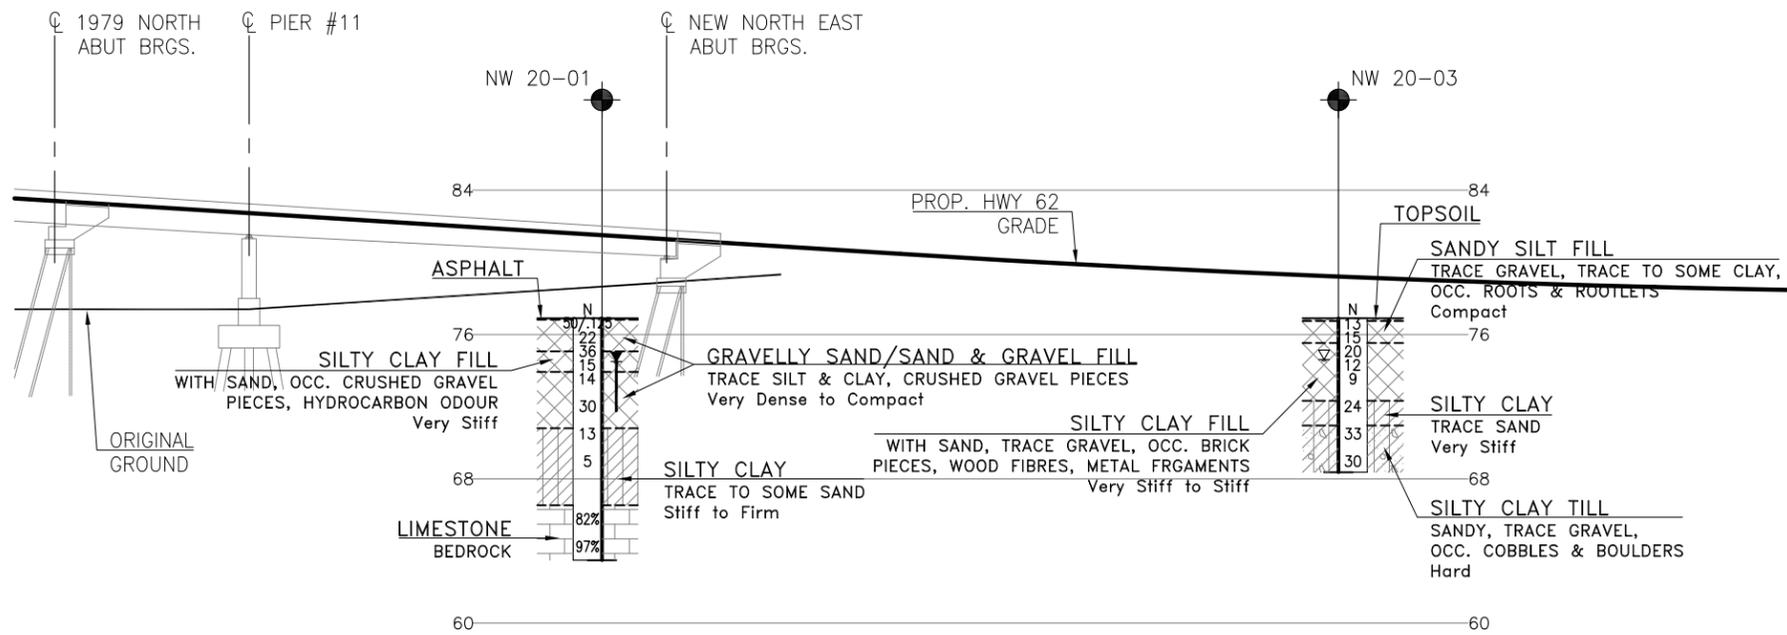
HIGHWAY 62  
NORRIS WHITNEY BRIDGE TWINNING  
AT THE NORTH EMBANKMENT  
BOREHOLE LOCATIONS AND SOIL STRATA

PLAN

PROFILE ALONG PROP. CL HWY 62

Details of the encountered soil and rock stratigraphy are presented on the Record of Borehole sheets included in Appendix A, and on the Borehole Locations and Soil Strata drawings in Appendix E. A general description of the stratigraphy is given in the following paragraphs. However, the factual data presented in the Record of Borehole Sheets governs any interpretation of the site conditions. It must be recognized and anticipated that subsurface conditions may vary between and beyond the borehole locations.

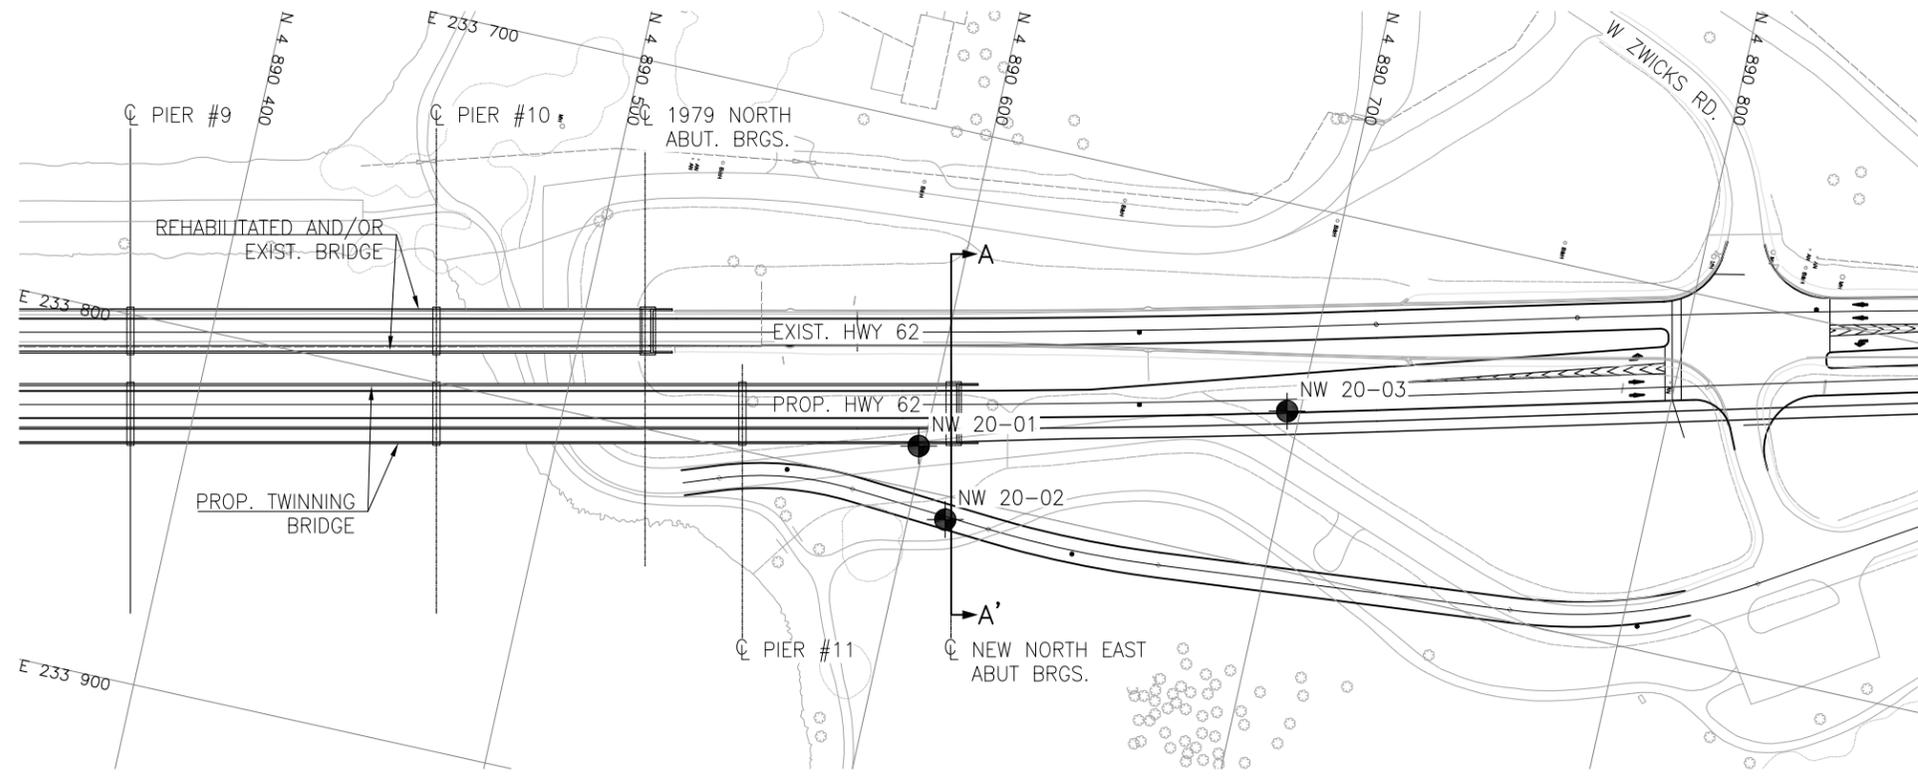
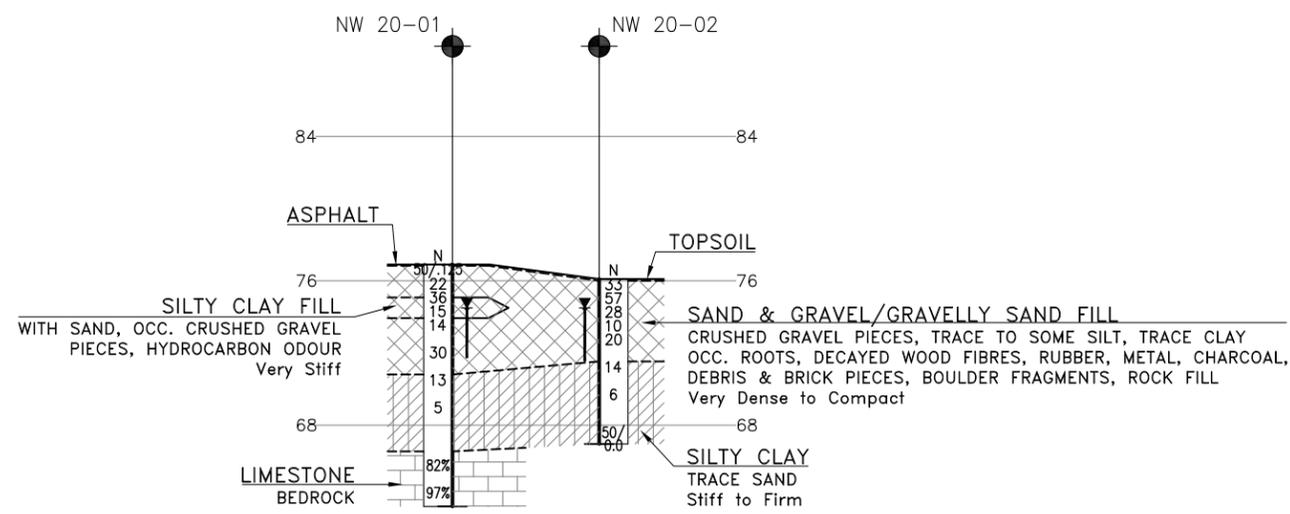
**PLAN**  
SCALE 1:2000

**SECTION A-A'**  
H 1:1000  
V 1:400

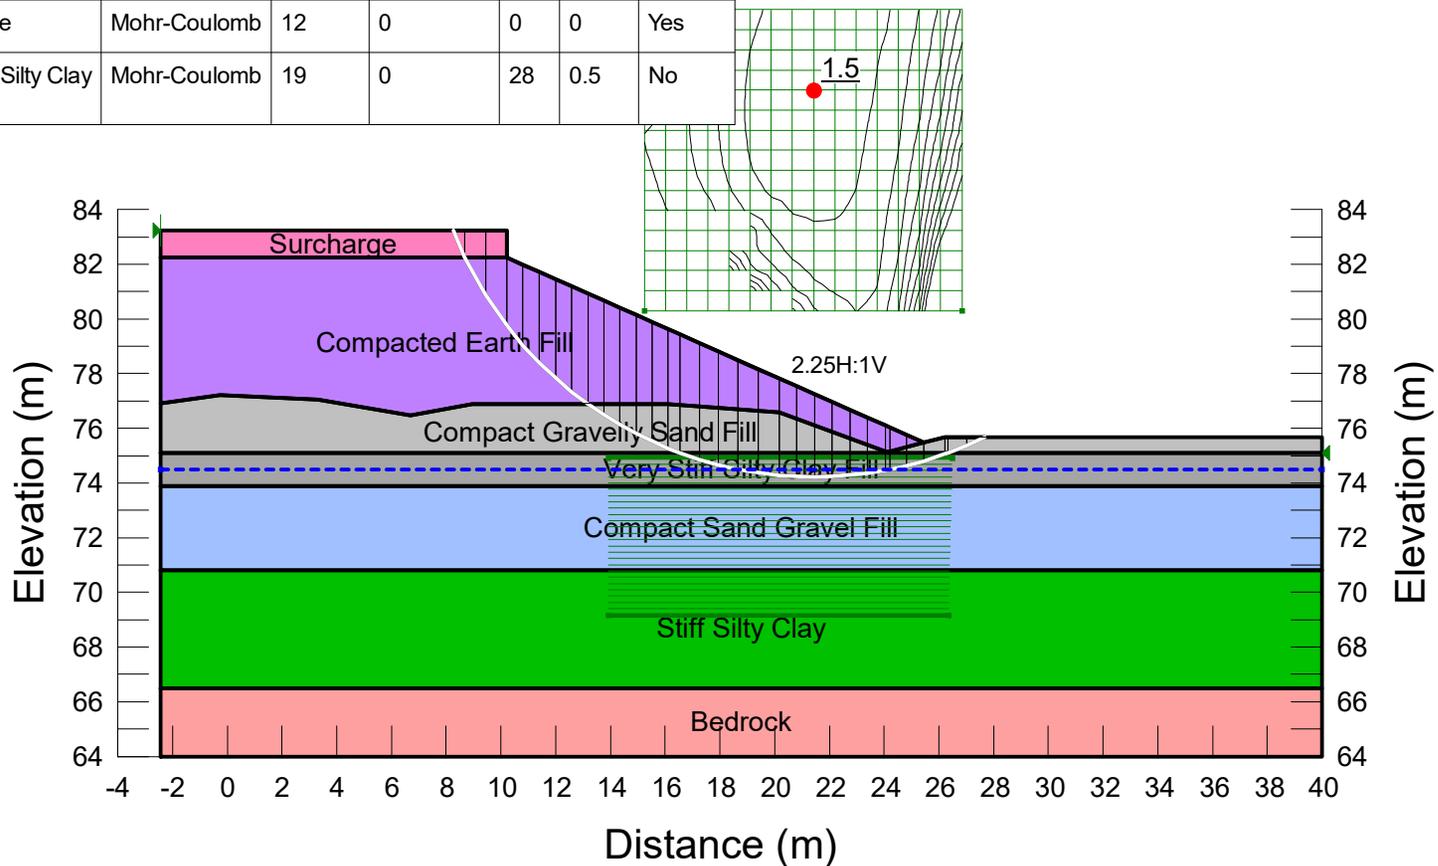
FIGURE 6

# NORRIS WHITNEY BRIDGE NORTH APPROACH (STA 21+250) 2.25H:1V EARTH FILL (LONG-TERM)

Color	Name	Model	Unit Weight (kN/m <sup>3</sup> )	Cohesion' (kPa)	Phi' (°)	B-bar	Add Weight
	Bedrock	Bedrock (Impenetrable)				0	No
	Compact Gravelly Sand Fill	Mohr-Coulomb	21	0	31	0	No
	Compact Sand Gravel Fill	Mohr-Coulomb	21	0	30	0	No
	Compacted Earth Fill	Mohr-Coulomb	21	0	30	0	Yes
	Stiff Silty Clay	Mohr-Coulomb	18	0	21	0	No
	Surcharge	Mohr-Coulomb	12	0	0	0	Yes
	Very Stiff Silty Clay Fill	Mohr-Coulomb	19	0	28	0	No

Station	Fill Height (m)	Slope Inclination	Fill Material	Loading Condition	Factor of Safety	Figure No.
21+250	5.3	2H : 1V	Compacted Granular A or B Type II	Short-Term	1.4	1
		2H : 1V	Compacted Granular A or B Type II	Long-term	1.5	2
		2H : 1V	Compacted Earth Fill	Short-Term	1.4	3
		2H : 1V	Compacted Earth Fill	Long-term	1.4	4
		2.25H : 1V	Compacted Earth Fill	Short-Term	1.5	5
		2.25H : 1V	Compacted Earth Fill	Long-term	1.6	6

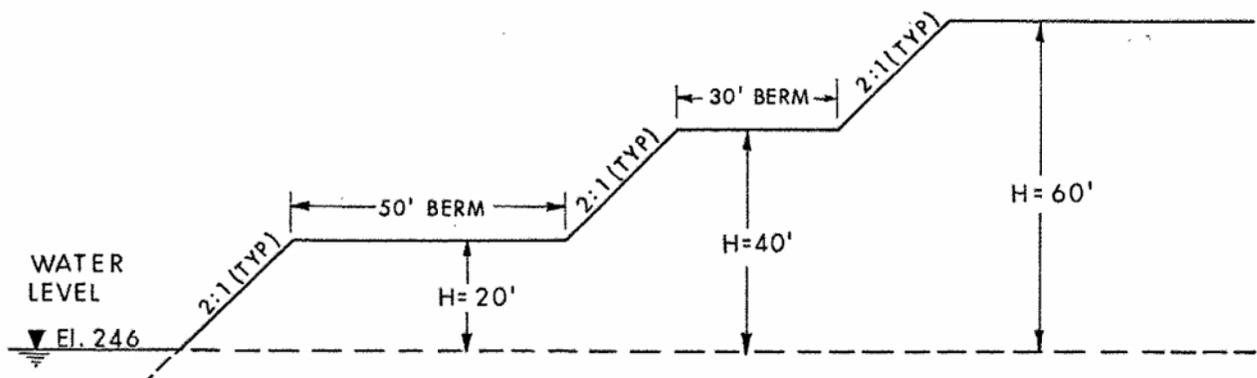
- Fill heights up to 20 feet above the water line will be stable with side slopes of 2:1.
- Fills up to 40 feet above the waterline with 50 foot long counterbalancing berms at midheight on both the forward and side slopes of the embankment would be stable with 2:1 slopes.
- Fill heights of up to 60 feet above the water line would require the following berm configuration for stability against deep seated rotational failure (also see sketch below):

berm at 1/3 height 50 feet long  
berm at 2/3 height 30 feet long  
all side slopes 2:1 maximum

A minimum of 50 foot transition taper should be provided between the different geometrical configuration, i.e. between a Case C and Case A or between a Case A and Case B condition.

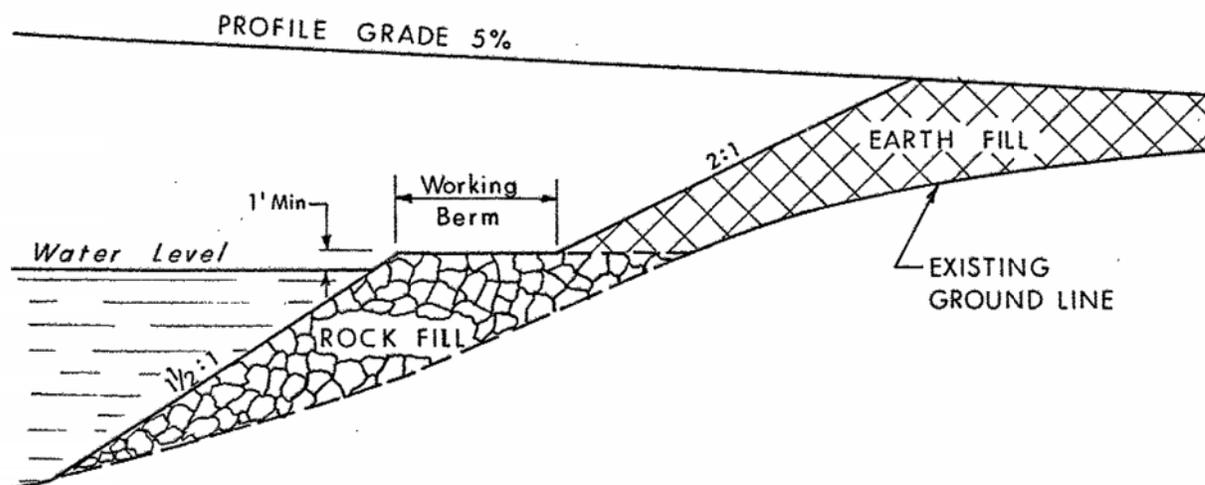
The subsoil is such that the anticipated fill heights will be stable with respect to deep seated rotational failure with forward and side slopes of 2 horizontal to 1 vertical. If the forward slopes extend into the bay the embankment should be constructed by placing rockfill to extend to a height of one

foot above the water level with side and forward slopes of  $1\frac{1}{2}$  to 1. The fill may then be completed by the placing of earthfill with a slope of 2 to 1. It may be advantageous for construction to provide a 10 foot berm between the crest of the rockfill slope and the toe of the earthfill slope. See sketch below.

Furthermore, the earthfill should be protected against wave action by rip-rapping to an elevation as per hydrological requirements.
