**FOUNDATION INVESTIGATION REPORT
for
REPLACEMENT OF SHALLOW LAKE BRIDGE
OVER STONEY CREEK, HIGHWAY 6
SITE NO. 8-9
SHALLOW LAKE, ONTARIO
G.W.P. 43-00-00**

PML Ref.: 11KF065A
Index No. 093FIR
GEOCRES No. 41A - 223
October 15, 2012

For
Replacement of Shallow Lake Bridge over Stoney Creek
Site No. 8-9
Highway 6, G.W.P. 43-00-00
Shallow Lake, Ontario

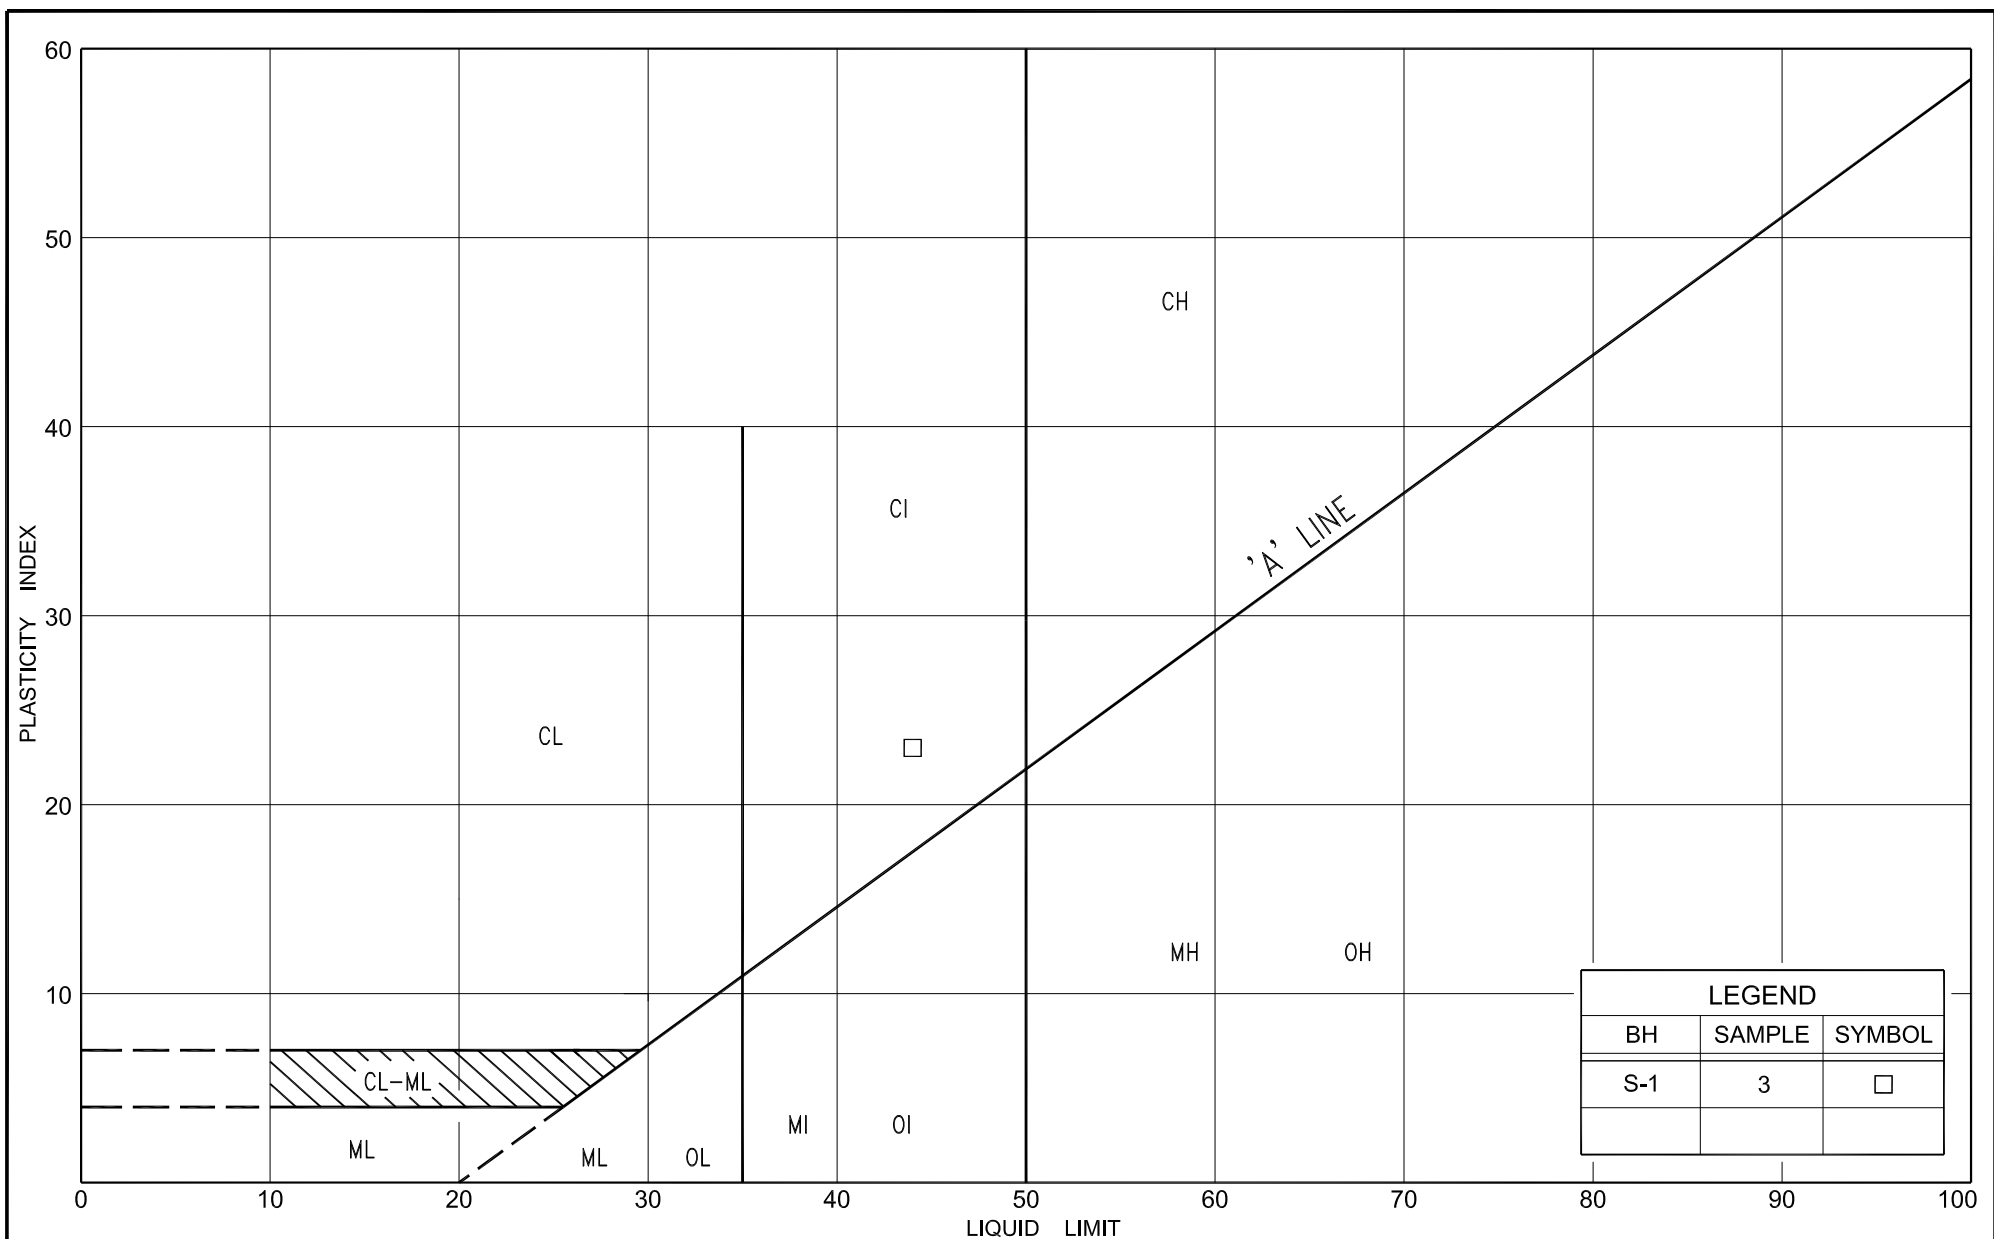
FIG No. SL-PC-1
 HWY: 6
 G.W.P. No. 43-00-00

PLASTICITY CHART
 SILTY CLAY, trace sand (CI)

A grain size distribution chart of the recovered silty clay sample is presented in Figure SL-GS-2. The sample comprised 50% clay, 47% silt, and 3% sand size particles. A plasticity chart of the silty clay sample is presented in Figure SL-PC-1. The Atterberg liquid and plastic limit were 44 and 21 respectively, with a plasticity index of 23. The natural moisture content of the silty clay sample was 30%.

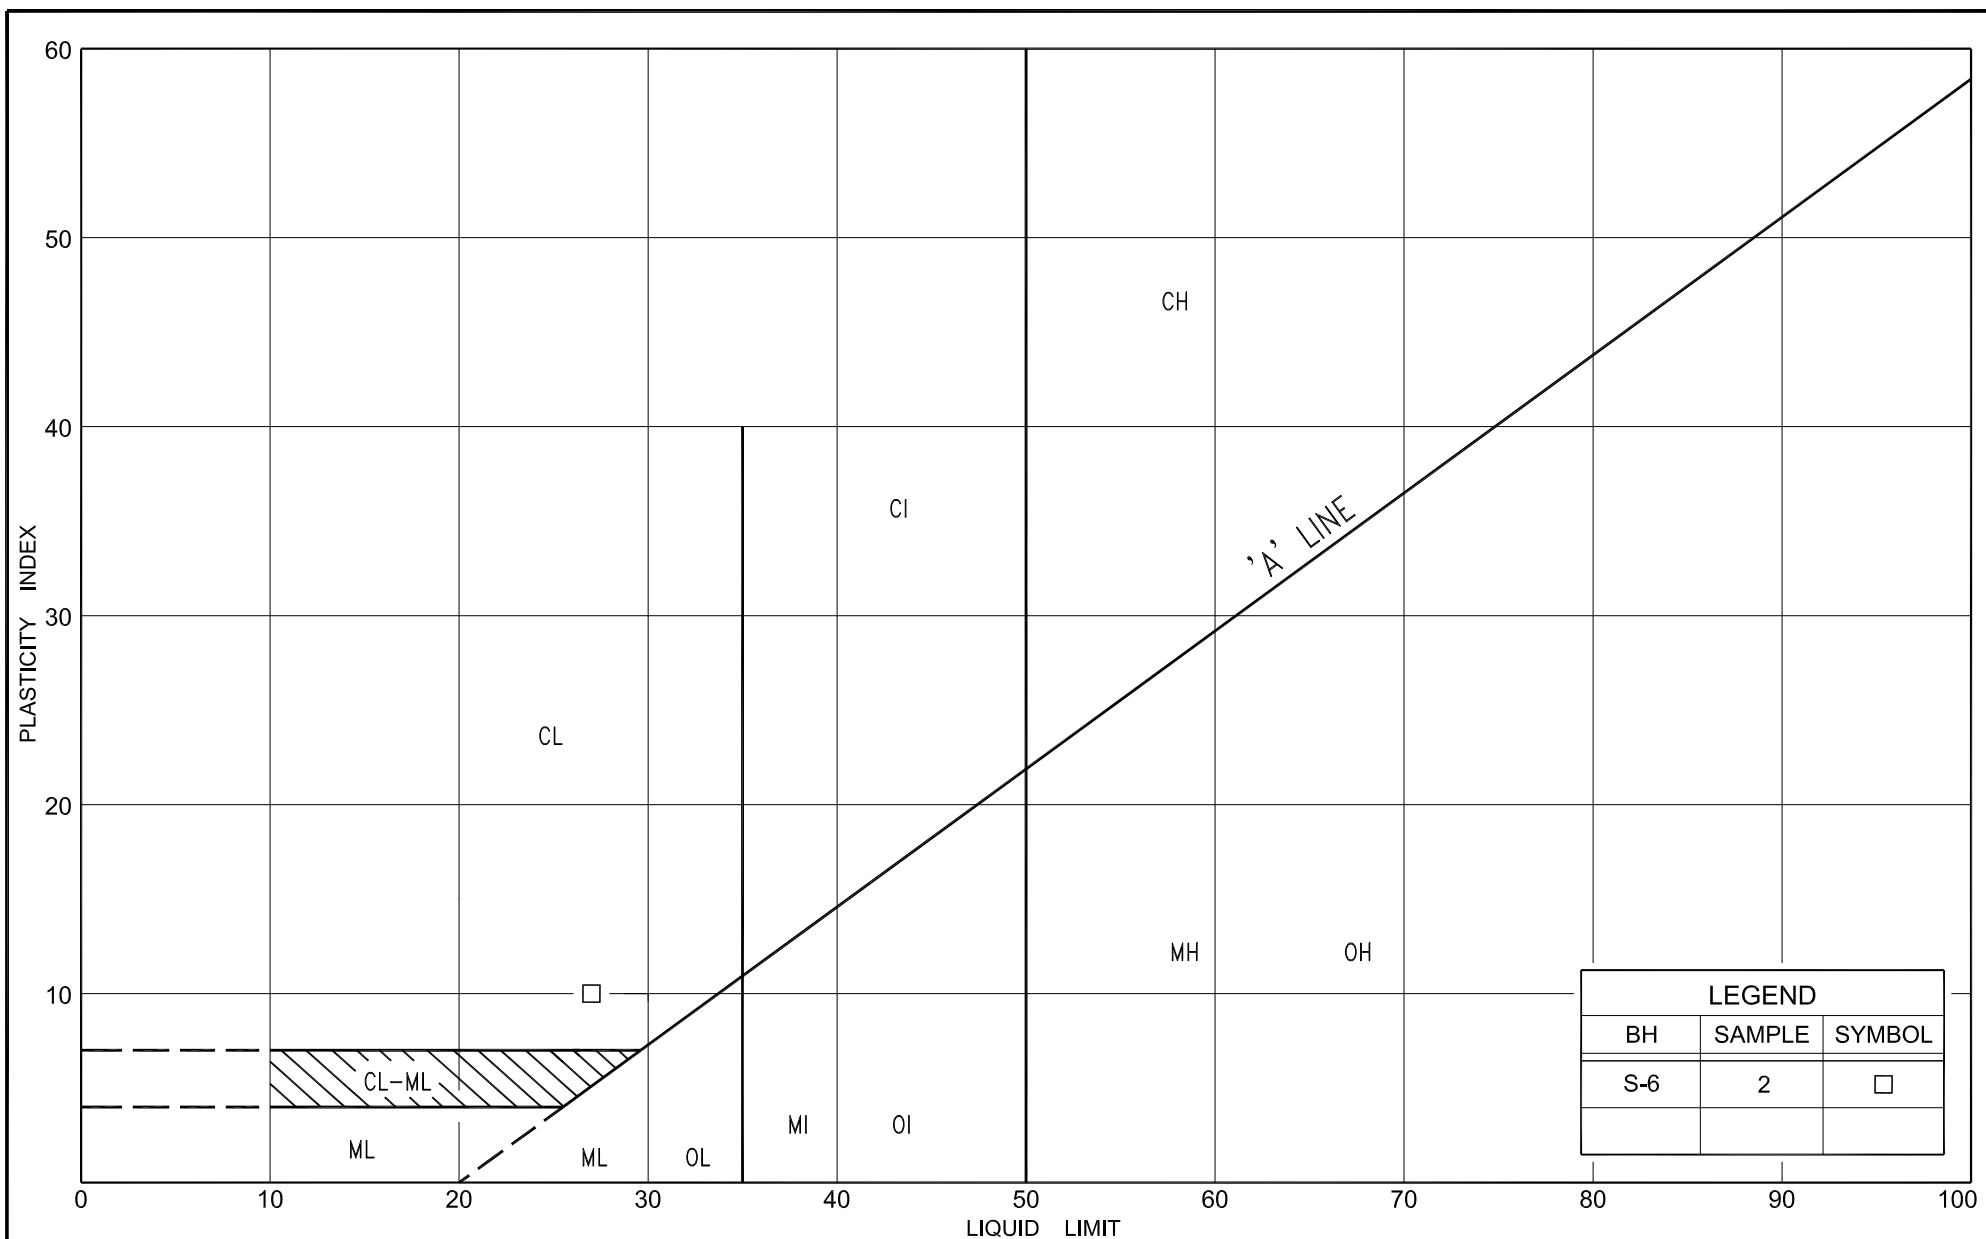
FIG No. SL-PC-2

PLASTICITY CHART CLAYEY SILT, trace sand (CL)

A grain size distribution chart of the recovered clayey silt sample is presented in Figure SL-GS-3. The sample comprised 68% silt, 27% clay and 5% sand size particles. A plasticity chart of the clayey silt sample is presented in Figure SL-PC-2. The Atterberg liquid and plastic limit were 27 and 17 respectively, with a plasticity index of 10. The natural moisture content of the clayey silt sample was 22%.

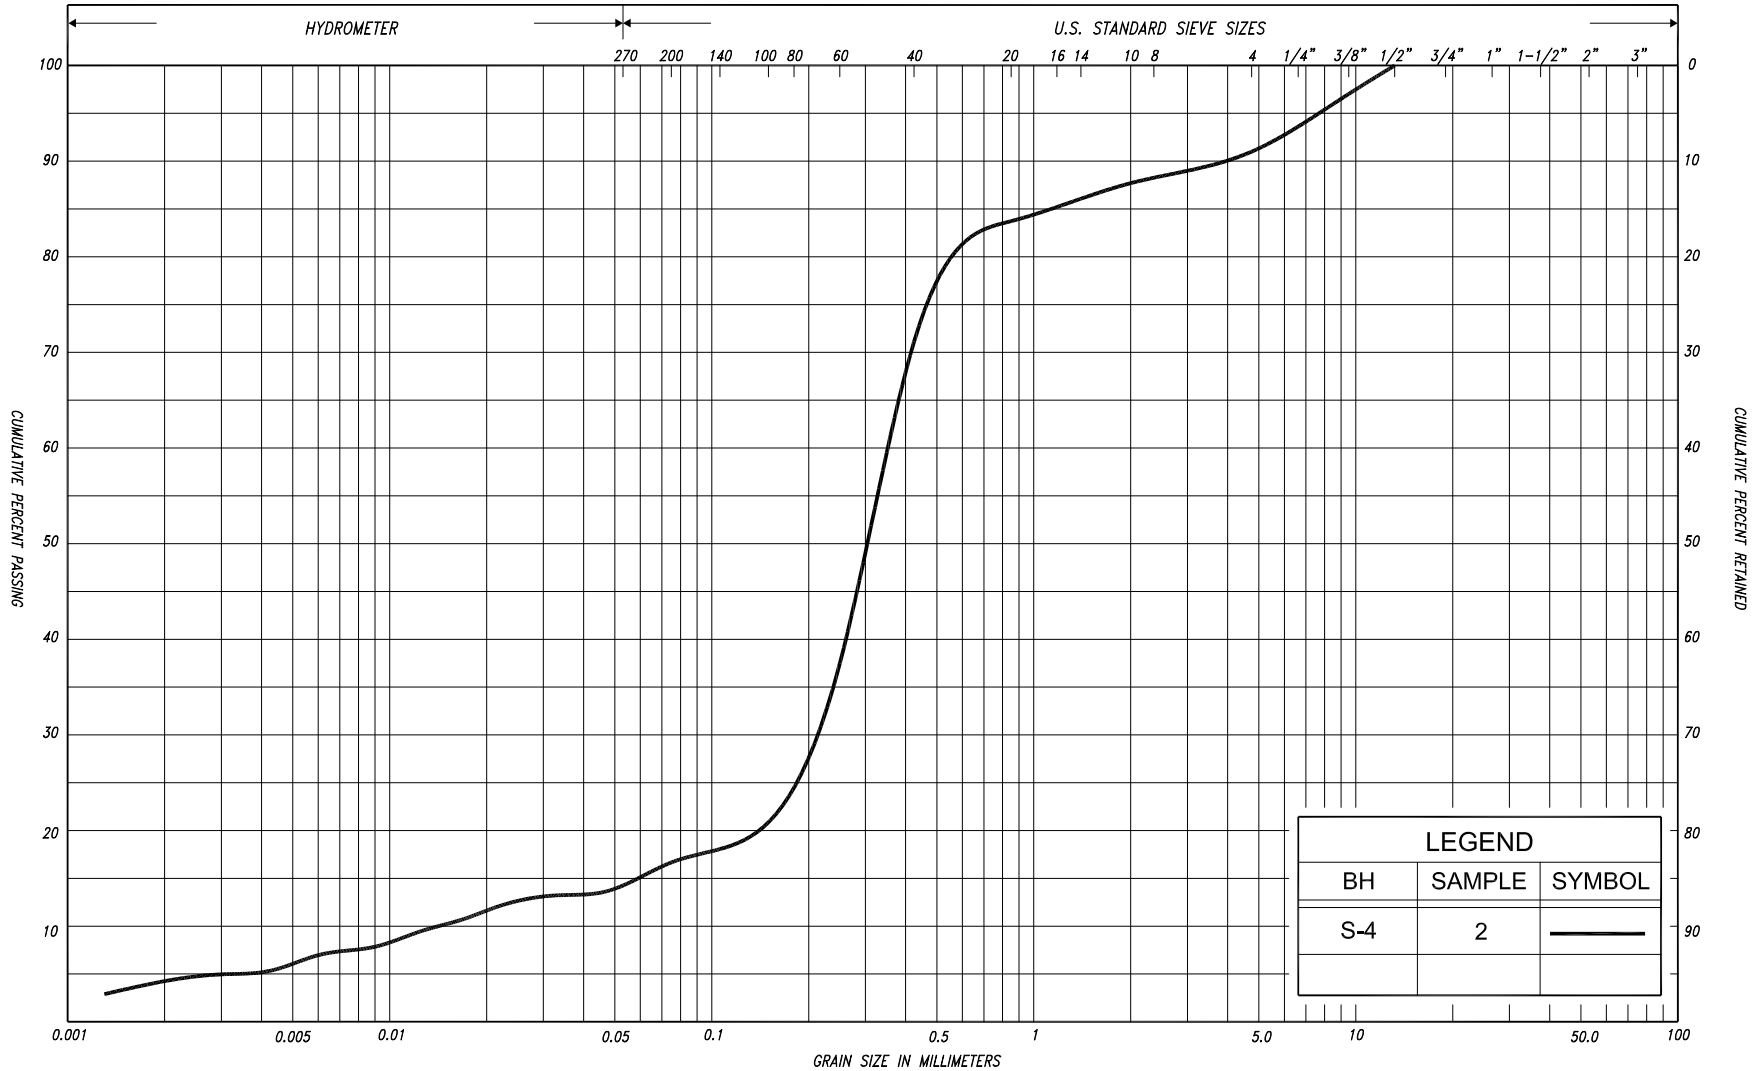
FIG No. SL-GS-1
HWY: 6
G.W.P. No. 43-00-00

GRAIN SIZE DISTRIBUTION

SAND, some silt, trace clay, trace gravel
(FILL)

A grain size distribution chart of the recovered sand fill sample is presented in Figure SL-GS-1. The sample comprised 74% sand, 13% silt, 9% gravel and 4% clay size materials.

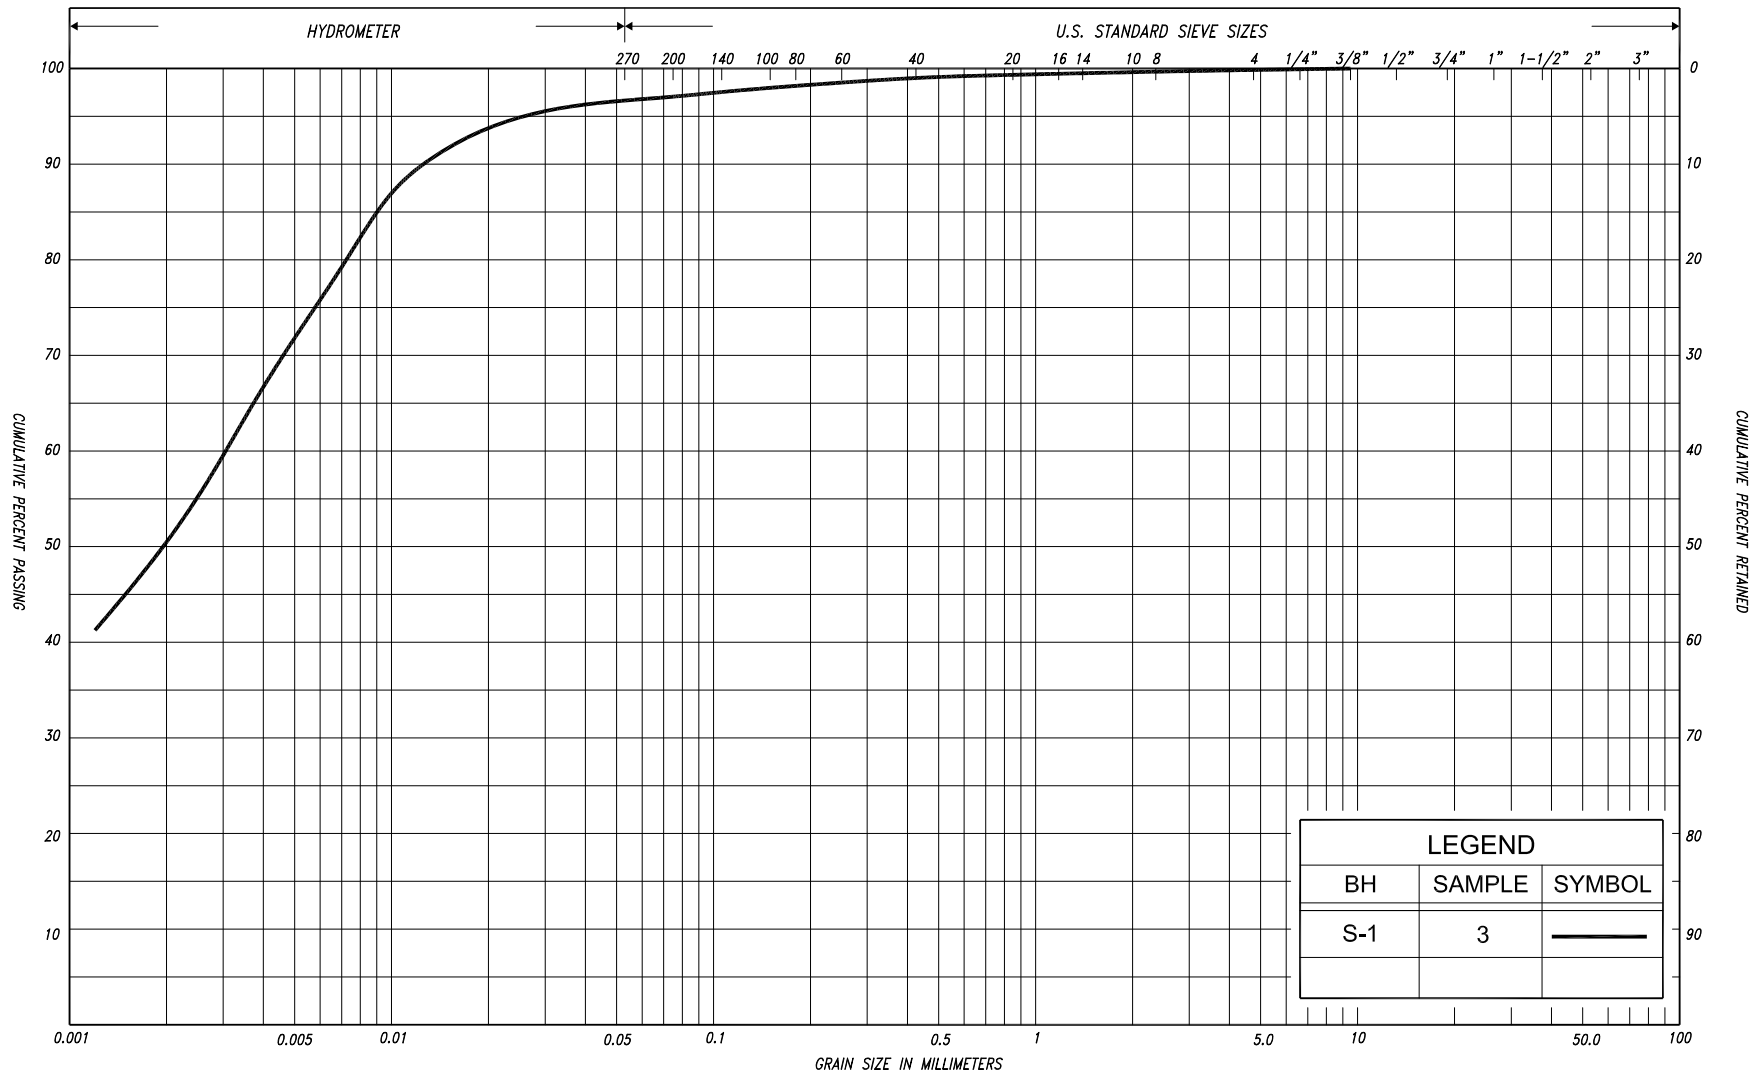
FIG No. SL-GS-2

GRAIN SIZE DISTRIBUTION

SILTY CLAY, trace sand (CI)

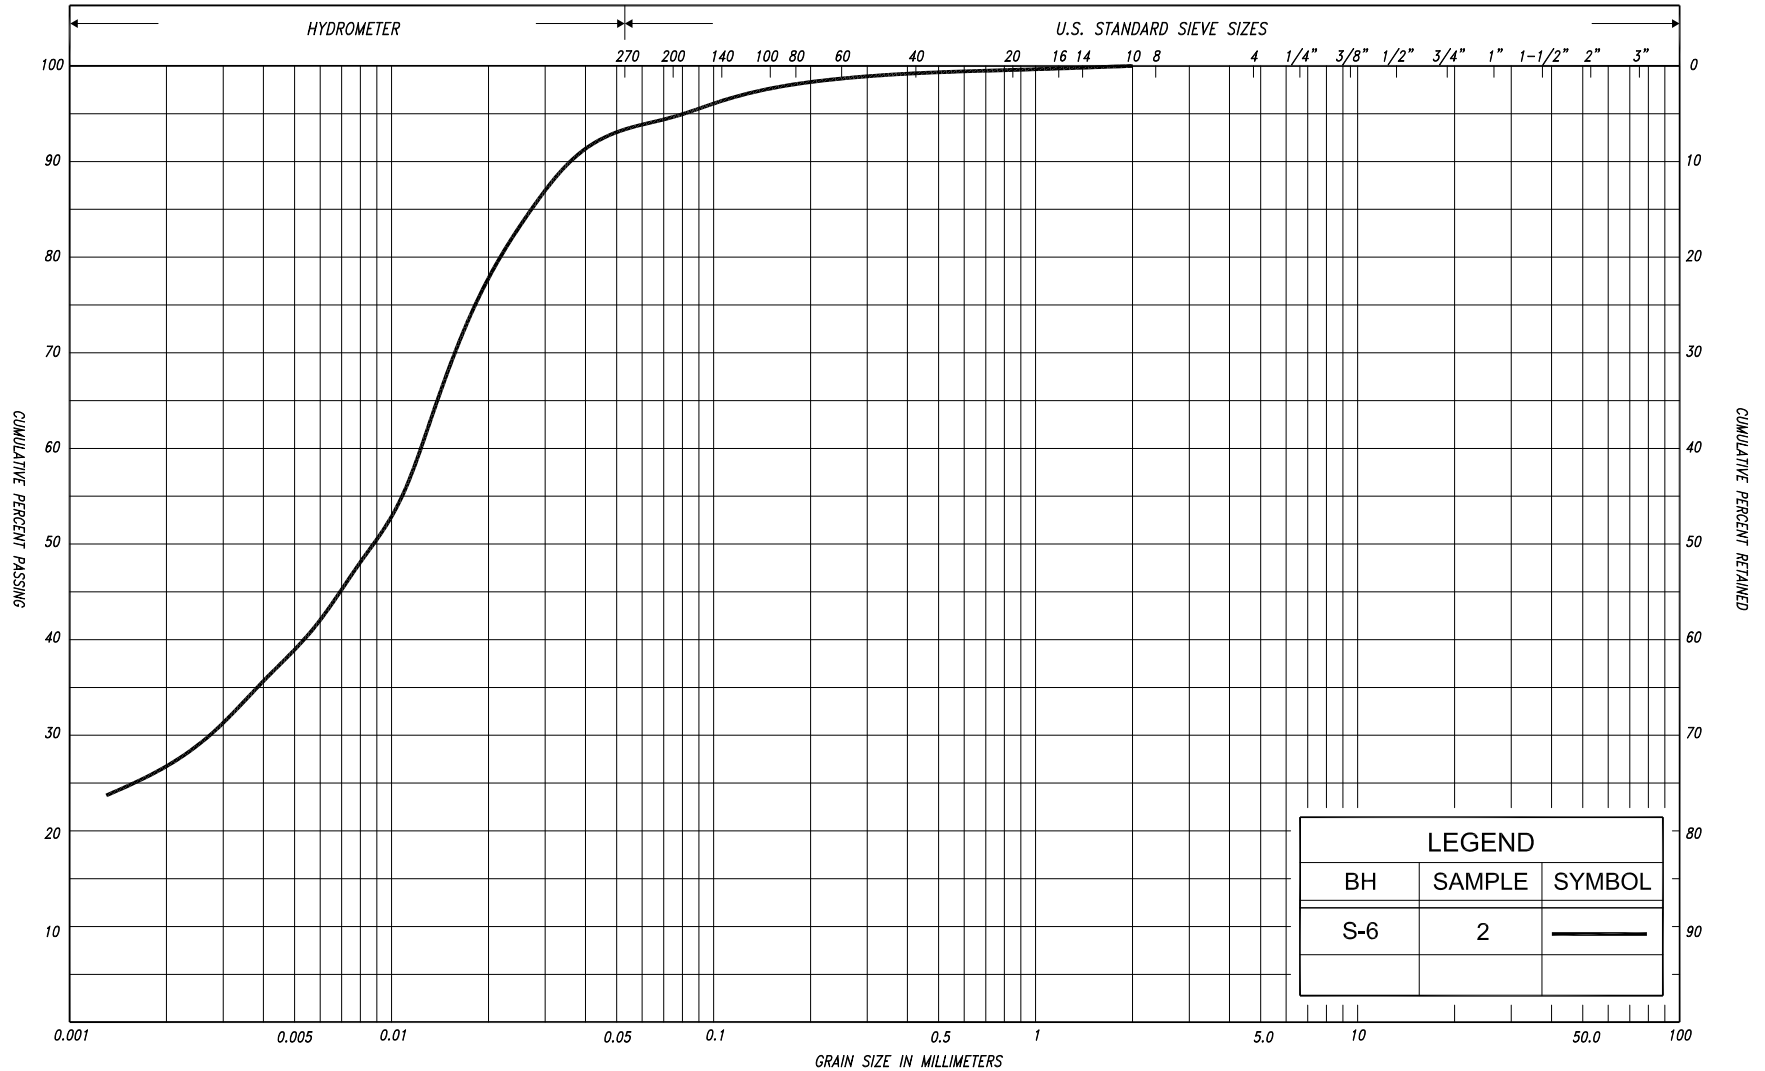
FIG No. SL-GS-3

GRAIN SIZE DISTRIBUTION CLAYEY SILT, trace sand (CL)

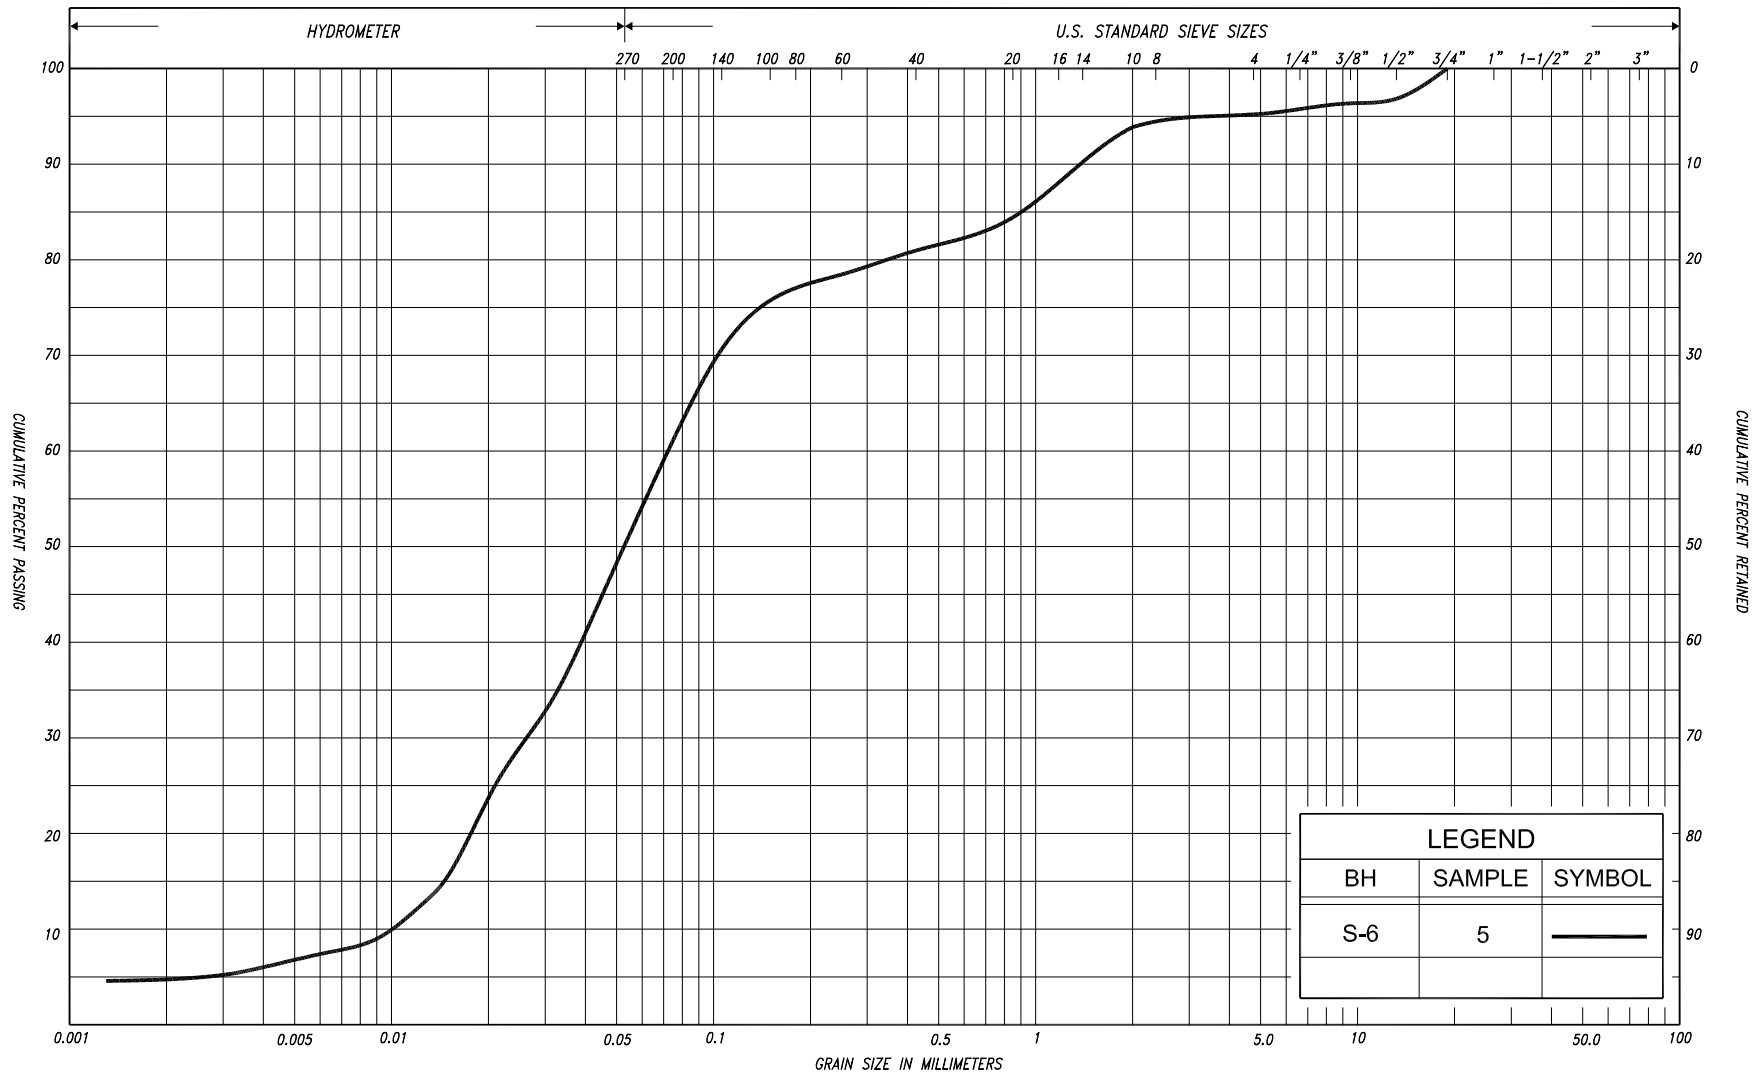
FIG No. SL-GS-5
HWY: 6
G.W.P. No. 43-00-00

GRAIN SIZE DISTRIBUTION
SANDY SILT, trace clay, trace gravel

A grain size distribution chart of the recovered sandy silt sample is presented in Figure SL-GS-5. The sample comprised 56% silt, 34% sand, 5% clay and 5% gravel.

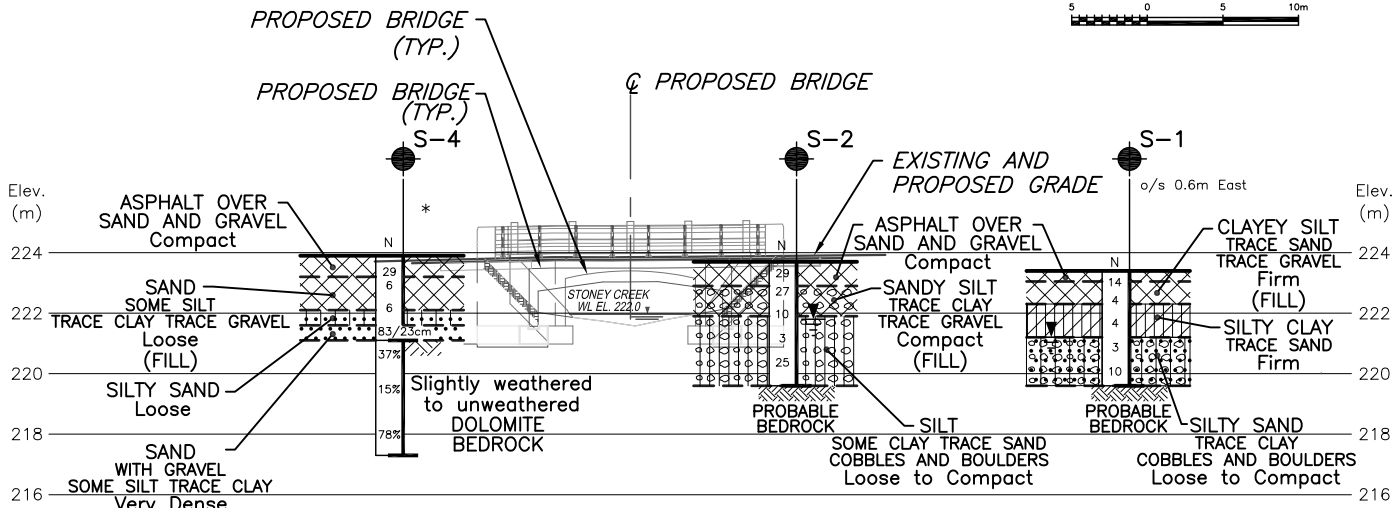
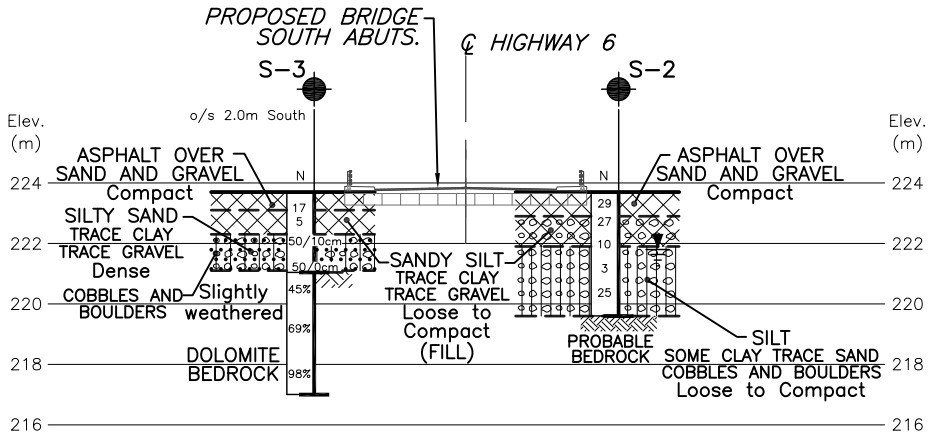
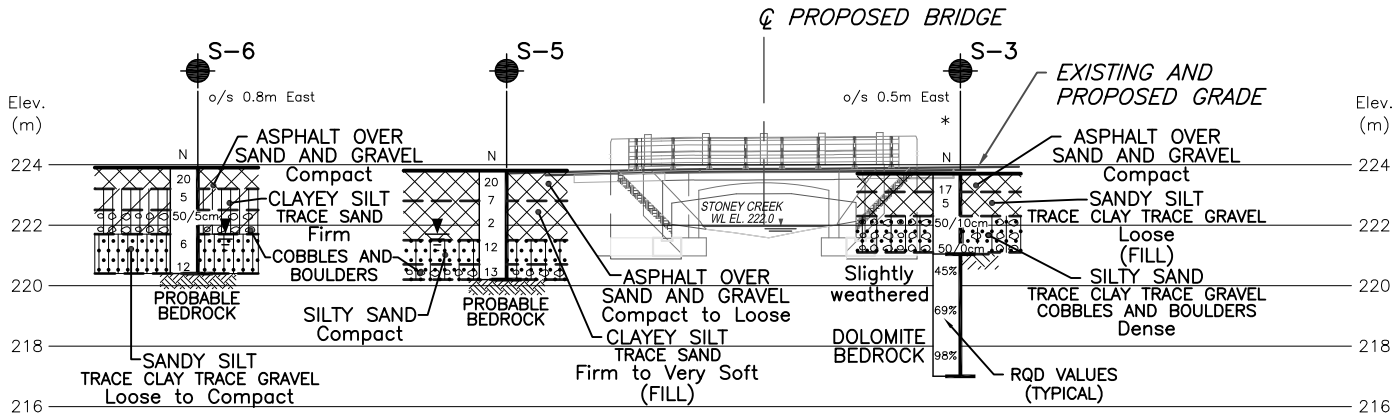
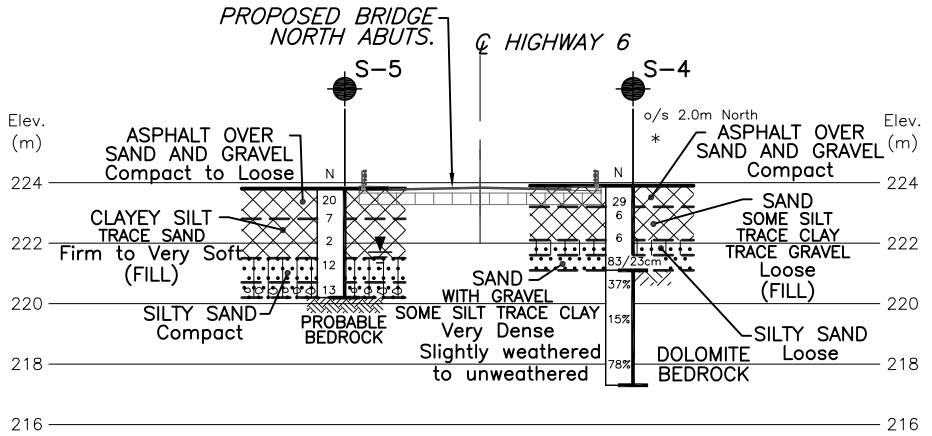
HWY No	6	CHECKED	HG	DATE	OCT. 12, 2012	DIST	London
SUBM'D	NA	CHECKED	BRG	APPROVED	CN	SITE	8-9
DRAWN	NA	CHECKED	BRG	APPROVED	CN	DWG	SL-1

PROFILE A-A

SECTION C-C

PROFILE B-B

SECTION D-D

PROFILES AND SECTIONS

The borehole locations, stratigraphic profile and cross-sections prepared from the borehole data are presented on the foundation Drawing SL-1.

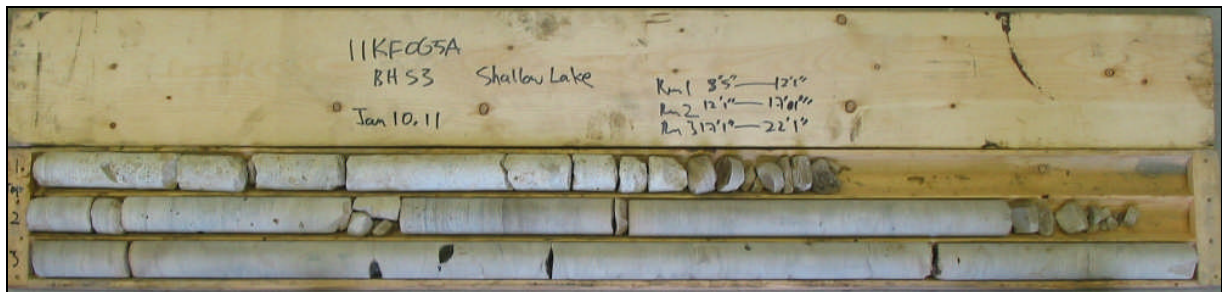
Photograph 1: Cores retrieved from borehole S3. Cores 5 to 7 from 2.6 to 6.7 m depth. RQD values ranged from 45 to 98%, indicating poor, fair to excellent rock quality.

The measured core recovery varied from 90 to 98%. The Rock Quality Designation (RQD) for the recovered cores ranged from 45 to 98%, increasing with depth indicating poor to excellent rock quality.

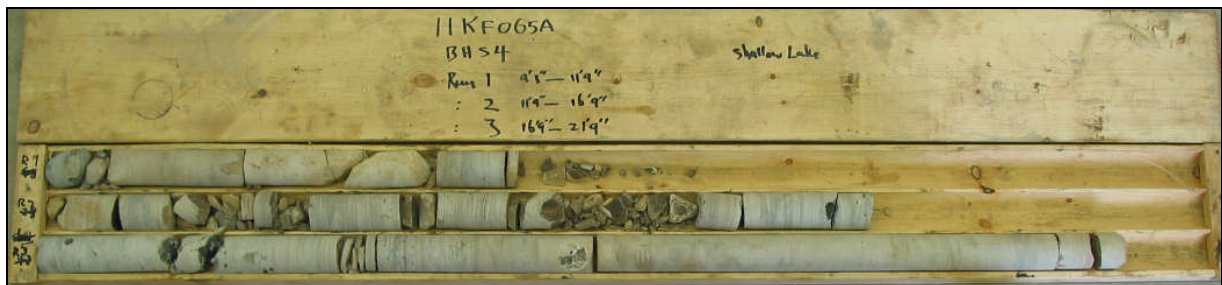
Photograph 2: Cores retrieved from borehole S4. Cores 5 to 7 from 2.8 to 6.6 m depth. RQD values ranged from 15 to 78%, indicating very poor to good rock quality.

The measured core recovery varied from 67 to 90%. The RQD for the recovered cores ranged from 15 to 78%, indicating very poor to good rock quality.
