**Highway 631 Rehabilitation - GWP 548-00-00  
Culvert Replacement – Picnic Lake Culvert  
Station 11+758 - Twp. of Hunt**

## **FINAL FOUNDATION INVESTIGATION REPORT**

Date: March 11, 2014  
Ref. N°: 13/03/13042-F1

**Geocres No. 42C-29**

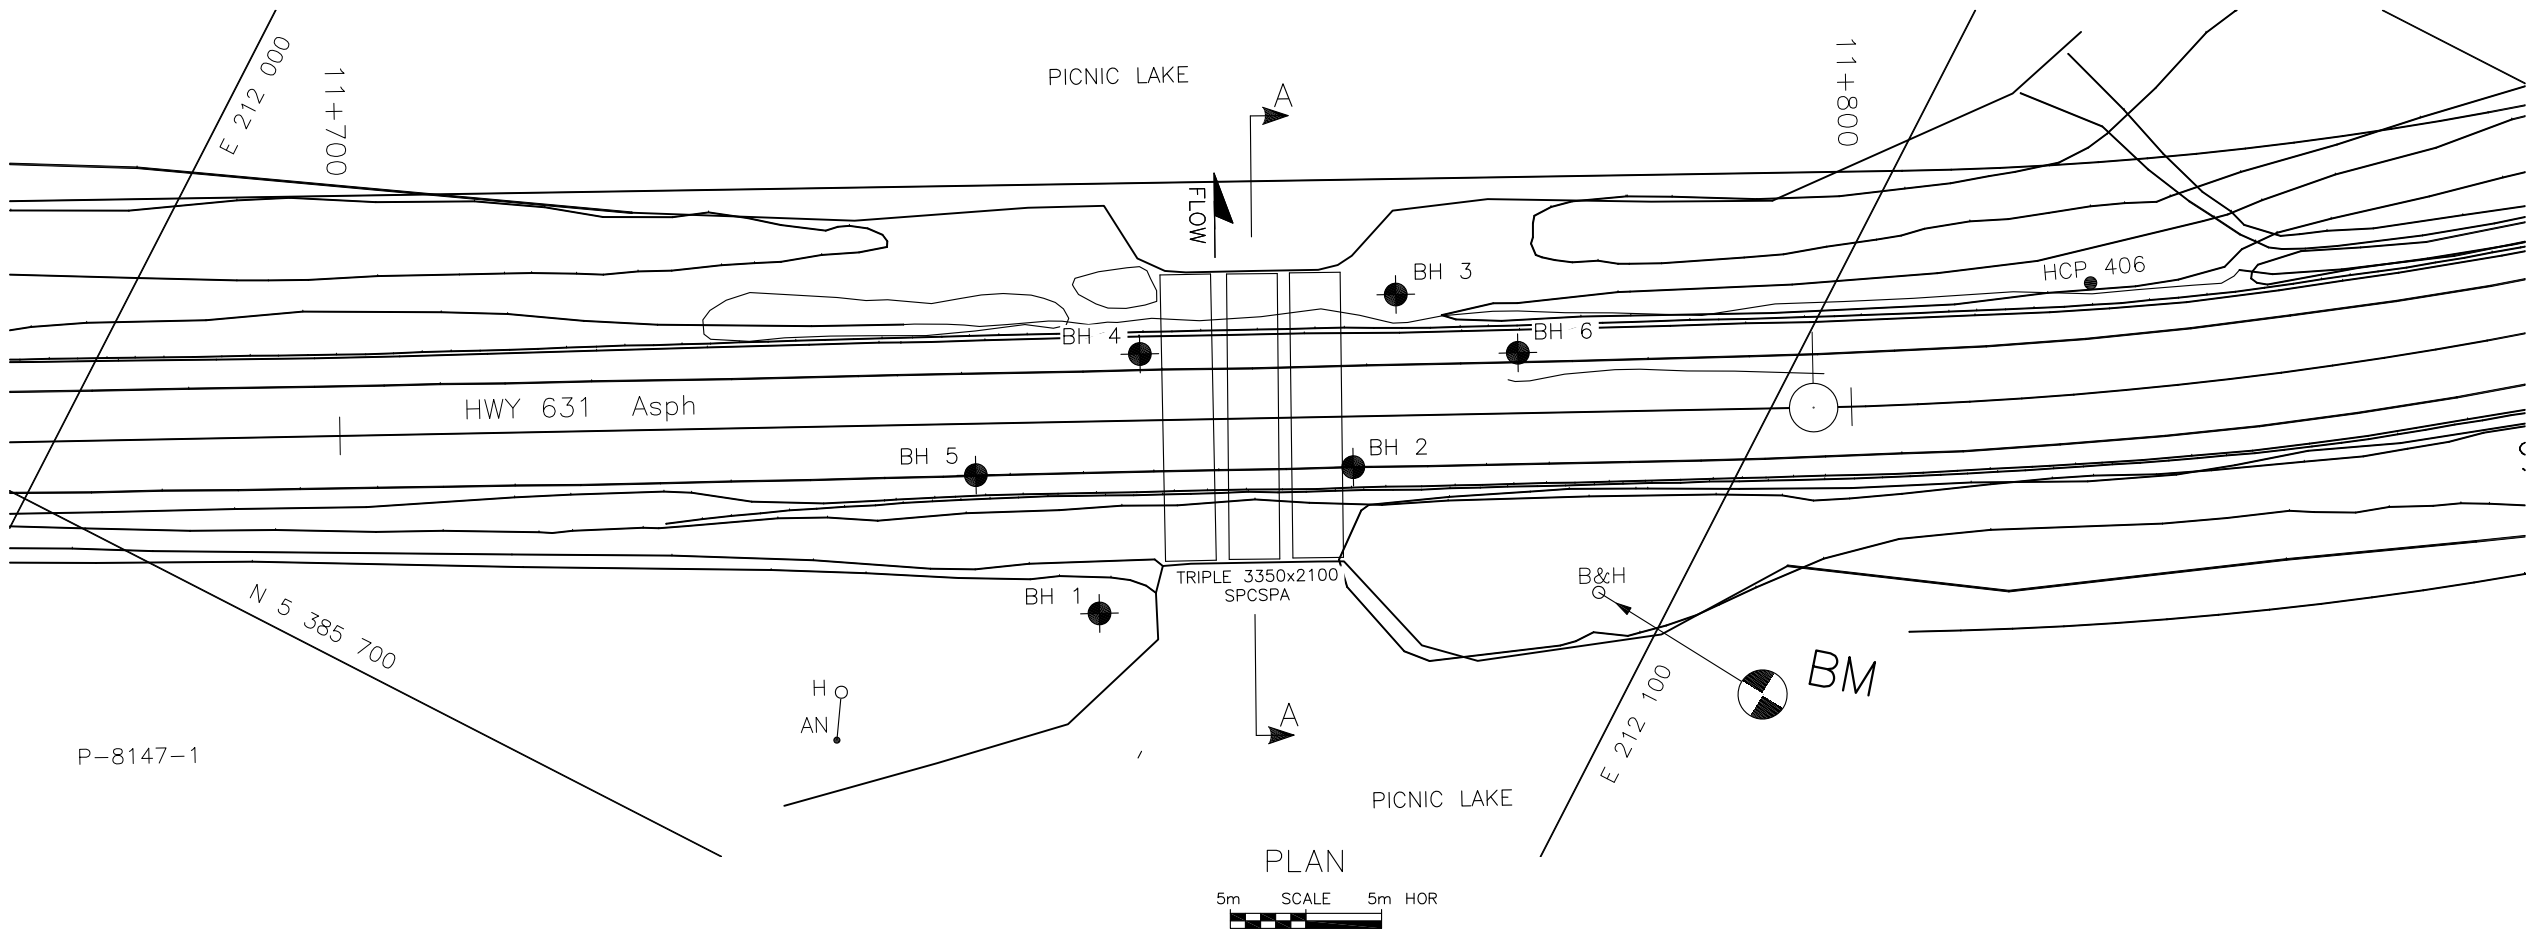
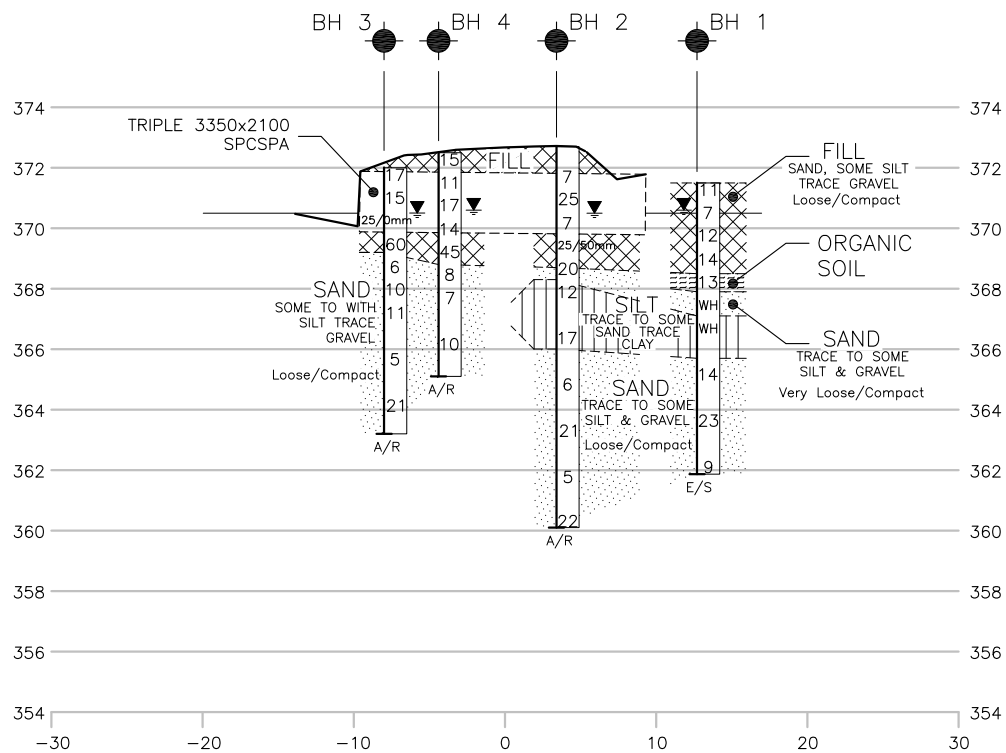
HWY 631  
PICNIC LAKE CULVERT (SITE 38C-072)  
HUNT TOWNSHIP  
BOREHOLE LOCATIONS & SOIL STRATA

CROSS SECTION A - A

CENTRELINE PROFILE

Details of the subsurface conditions revealed by the investigation program are presented on the enclosed Record of Borehole Logs (Appendix 2) and on Drawing No. 2 (Appendix 3). It should be noted that the stratigraphic delineations presented on the borehole logs and soil strata plot are the result of non-continuous sampling, response to drilling progress, SPT and Dynamic Cone Penetration Test (DCPT) results, plus field observations at the time of drilling. Typically such boundaries represent transitions from one zone to another and are not an exact demarcation of a specific geological unit. Additional consideration should therefore be given to the fact that subsurface conditions may vary markedly between adjacent boreholes and beyond any specific boring location, and are shown on the drawings for illustration purposes only.

A plan and profile illustrating the borehole locations and stratigraphic sequences is provided on Drawing No. 2, Appendix 3. During the course of the exploration program, six (6) sampled boreholes were put down at this site, with Borehole Nos. 2, 4, 5, and 6 advanced through the embankment, and Borehole Nos. 1 and 3 advanced at the culvert outlet and inlet, respectively. At the time of the subsurface investigation, the ground surface elevations at Boreholes Nos. 1 to 6 were recorded at 371.5, 372.7, and 372.0, 372.7, 372.7, and 372.7 m, respectively.

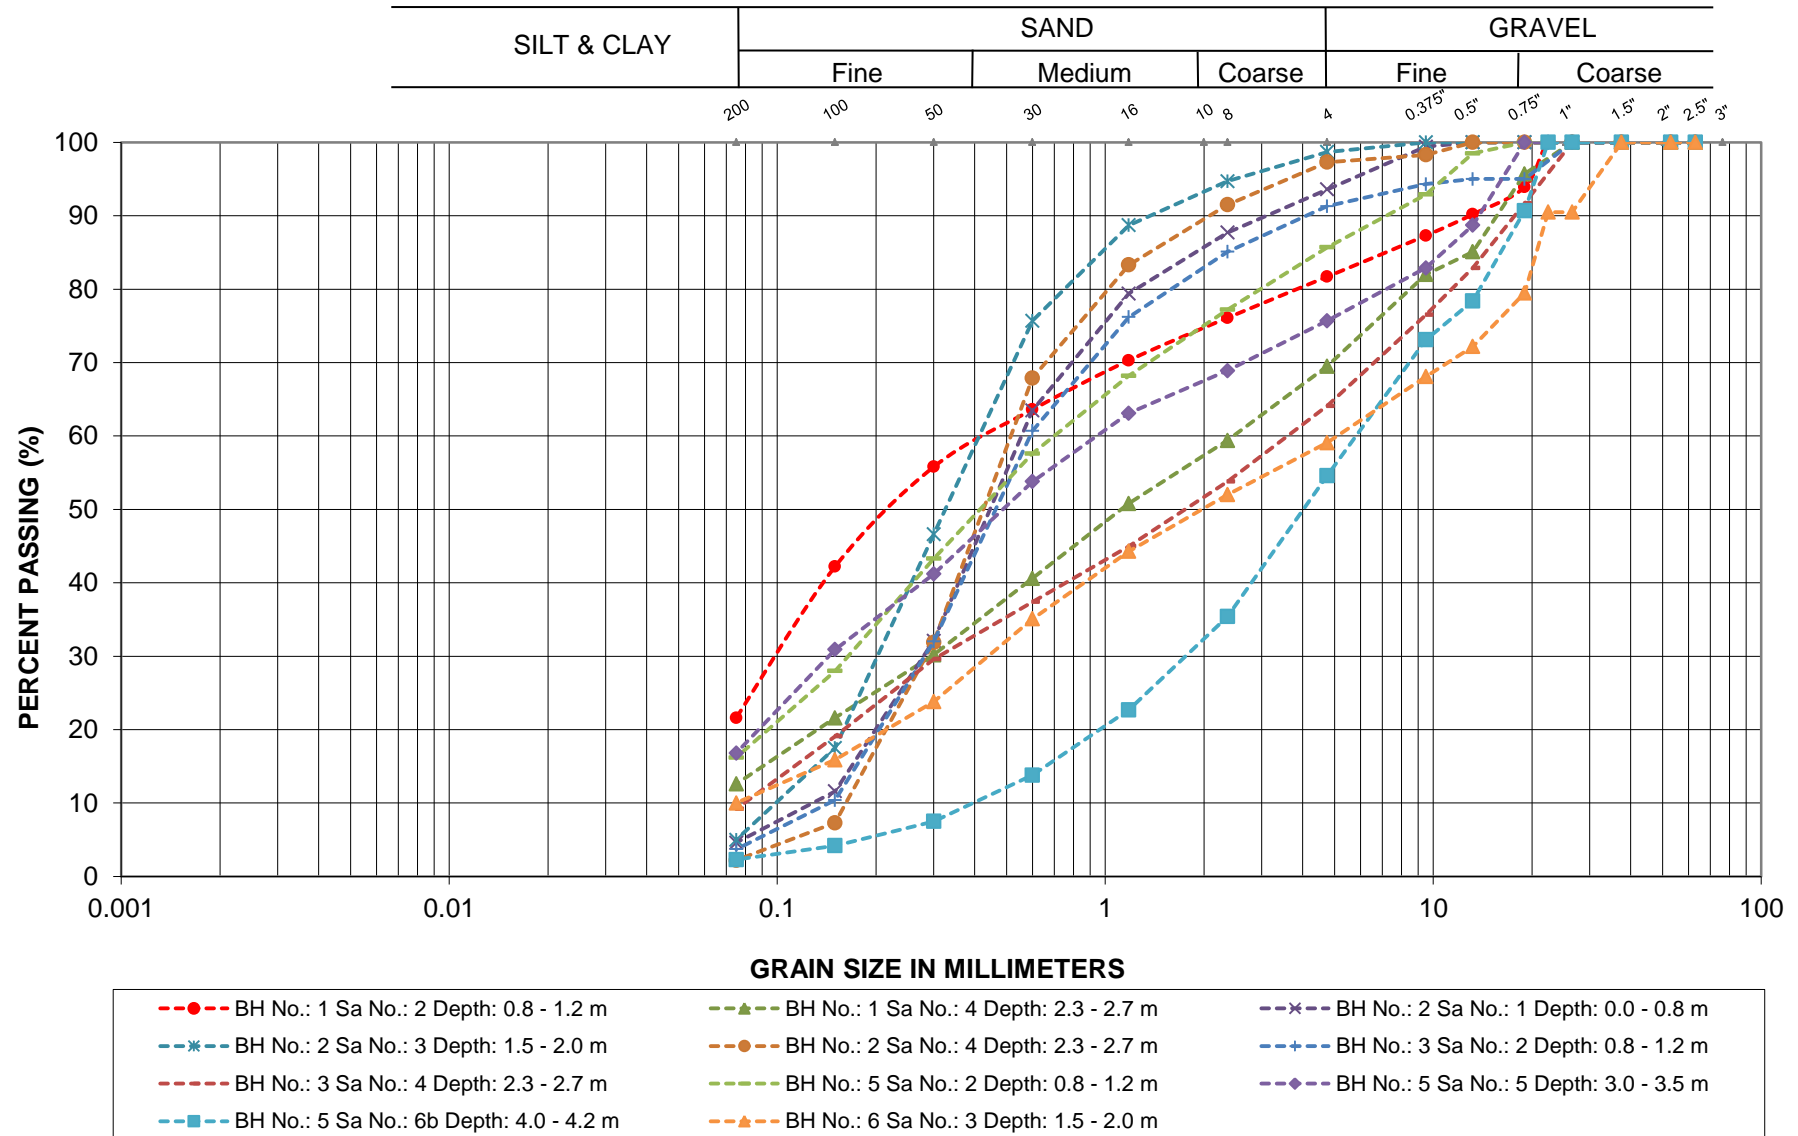
**GRAIN SIZE ANALYSIS**

FILL

on eleven (11) samples of this deposit, the results of which indicated 1 to 45% gravel size particles, 53 to 96% sand size particles, and 1 to 22% silt and clay size particles (Figure No. L-1, Appendix 3). Based on SPT 'N' values of 7 to 60 blows per 300 mm penetration, the compactness of this deposit was described as loose to very dense, generally compact. The fill layer was encountered to depths of 2.8 to 4.4 m below grade (Elevation 369.2 to 368.3 m)

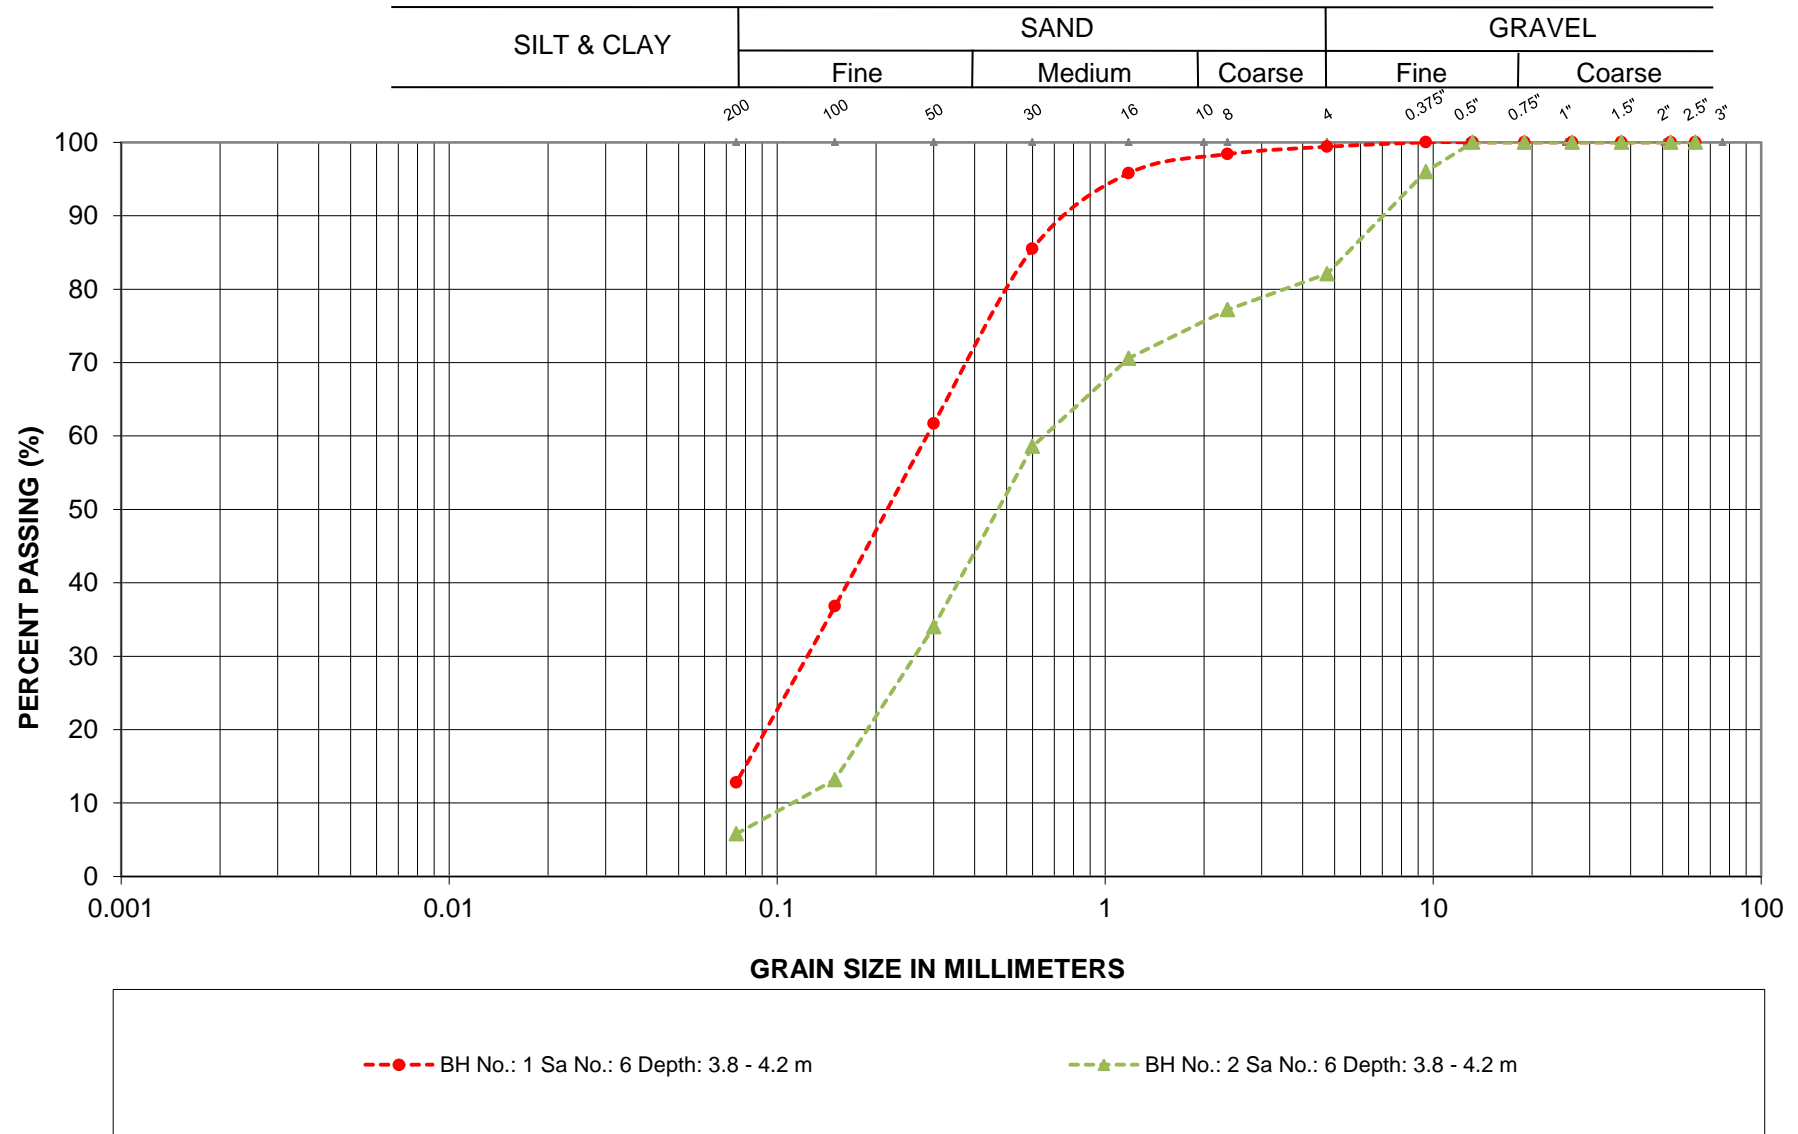
### GRAIN SIZE ANALYSIS

SAND

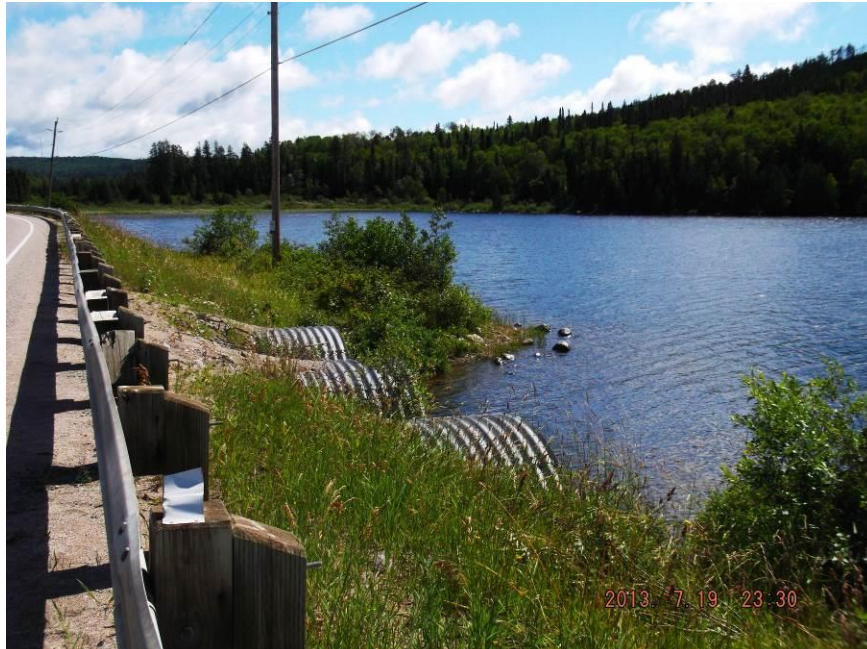
Photo: 1

Culvert Inlet – Right Side, Looking North

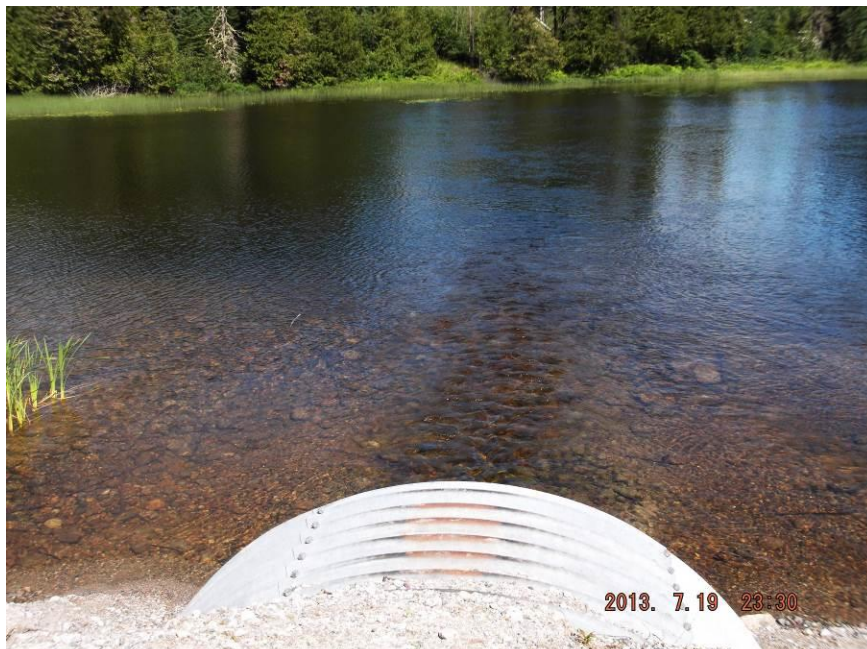
Photo: 2

Culvert Outlet – Left Side Looking West

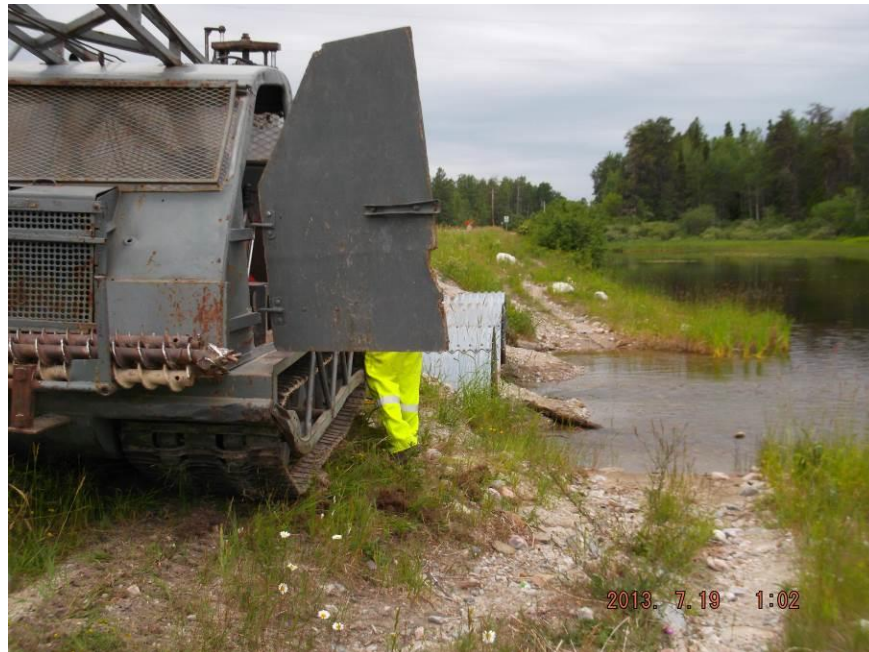
Photo: 3

Culvert Outlet – Left Side, Looking South

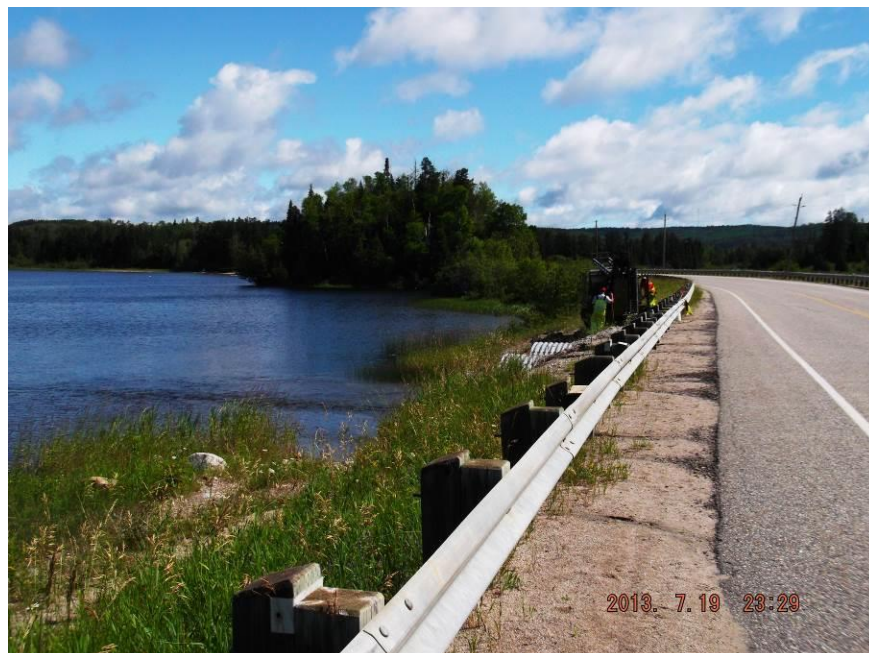
Photo: 4

Culvert Outlet – Left Side Looking North
