**PRELIMINARY FOUNDATION INVESTIGATION REPORT
for
GRAND RIVER BRIDGE, EBL AND WBL
HIGHWAY 403
MTO WEST REGION 59 STRUCTURE REHABILITATIONS
CONTRACT 1
GWP 3503-01-01/02
CITY OF BRANTFORD, ONTARIO**

FOUNDATION INVESTIGATION REPORT

Grand River Bridge, EBL and WBL, Highway 403
MTO West Region 59 Structure Rehabilitations
Contract 1, GWP 3503-01-01/02
City of Brantford, Ontario

FOUNDATION TECHNICAL MEMORANDUM

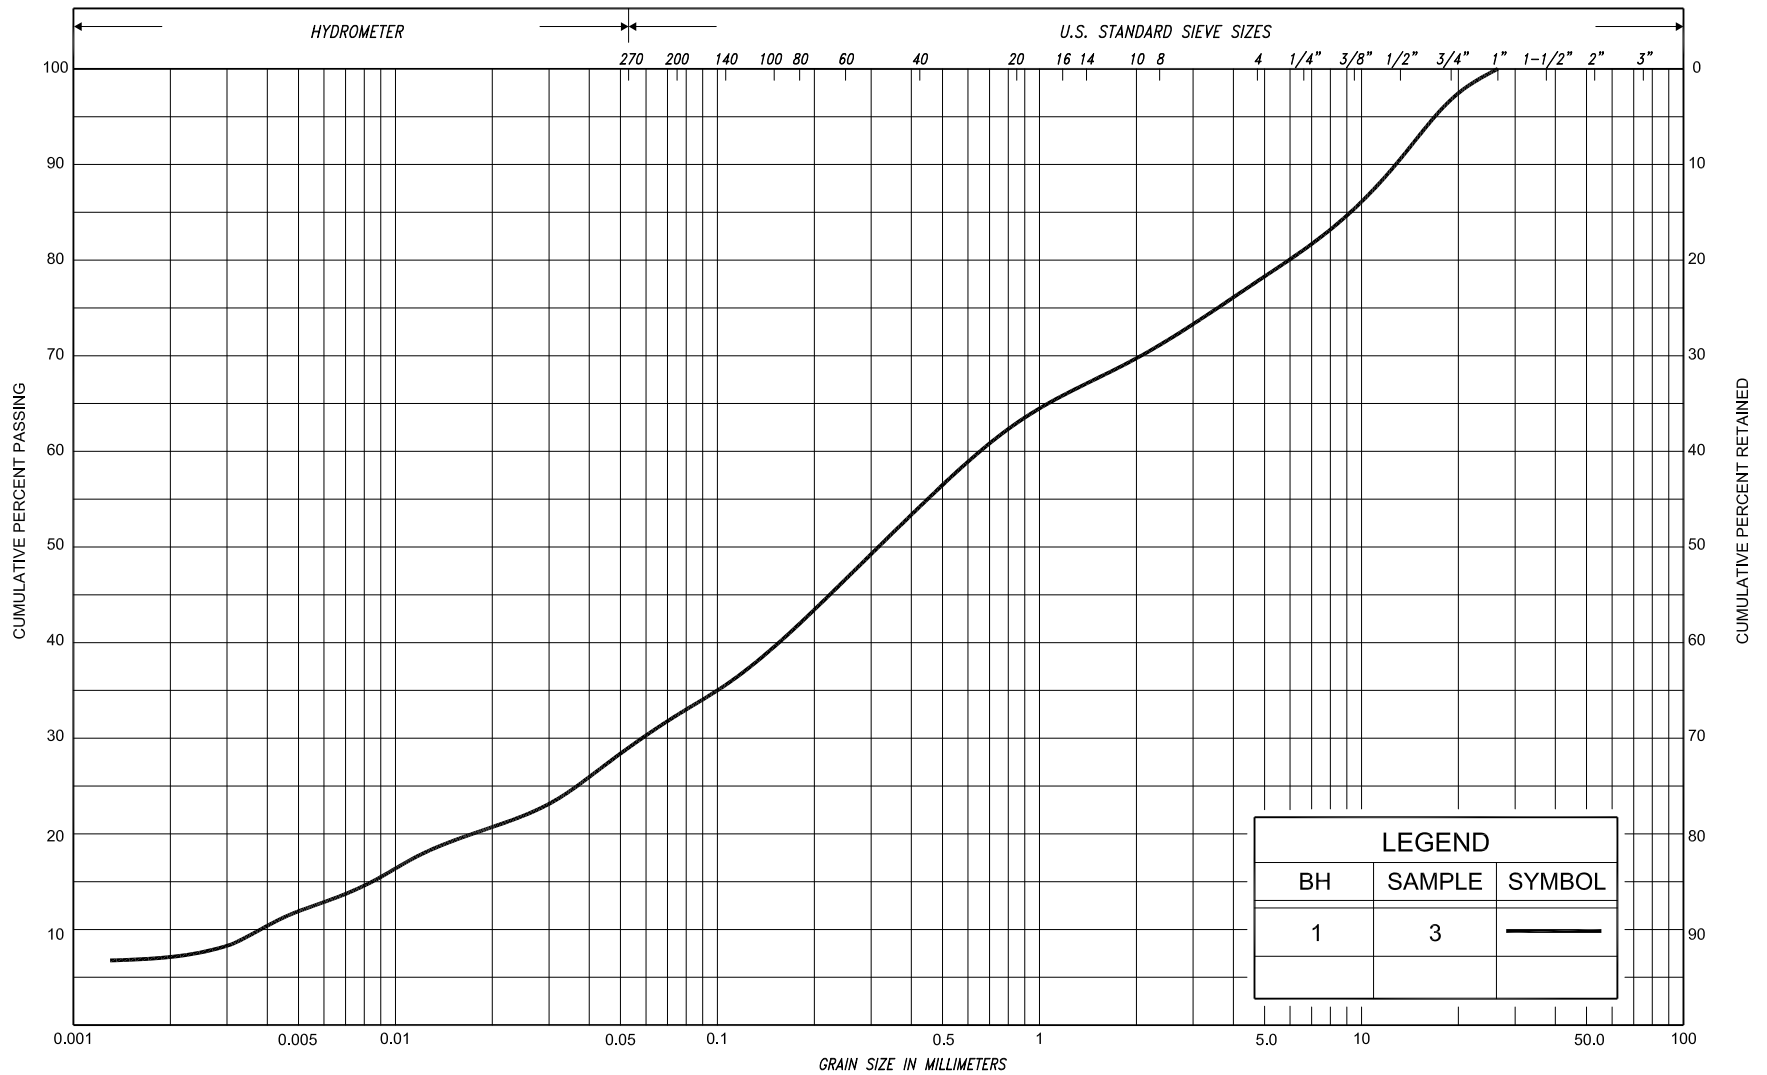
FIG No.	GR-GS-1
HWY:	403
W.P. No.	3503-01-01/02

GRAIN SIZE DISTRIBUTION SAND, with gravel, with silt, trace clay (FILL)

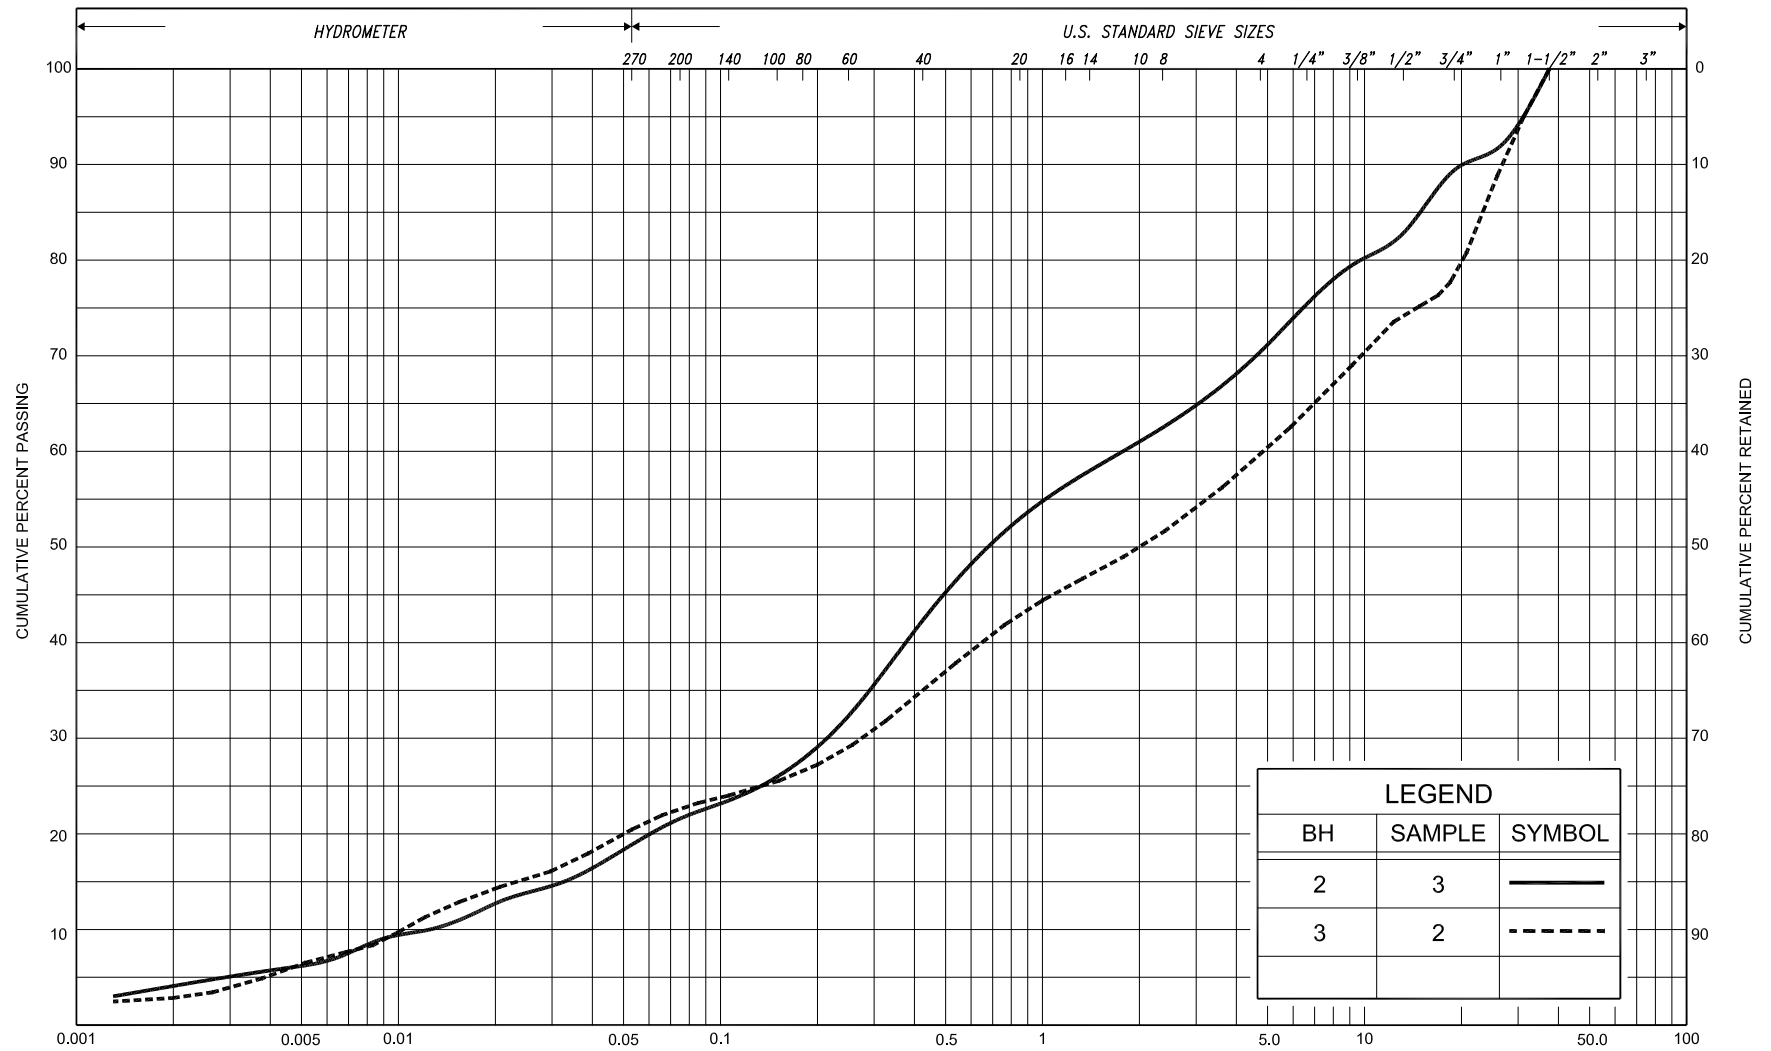
FIG No.	GR-GS-2
HWY:	403
G.W.P. No.	3503-01-01/02

GRAIN SIZE DISTRIBUTION GRAVELLY SAND to SAND AND GRAVEL, some silt, trace clay (FILL)

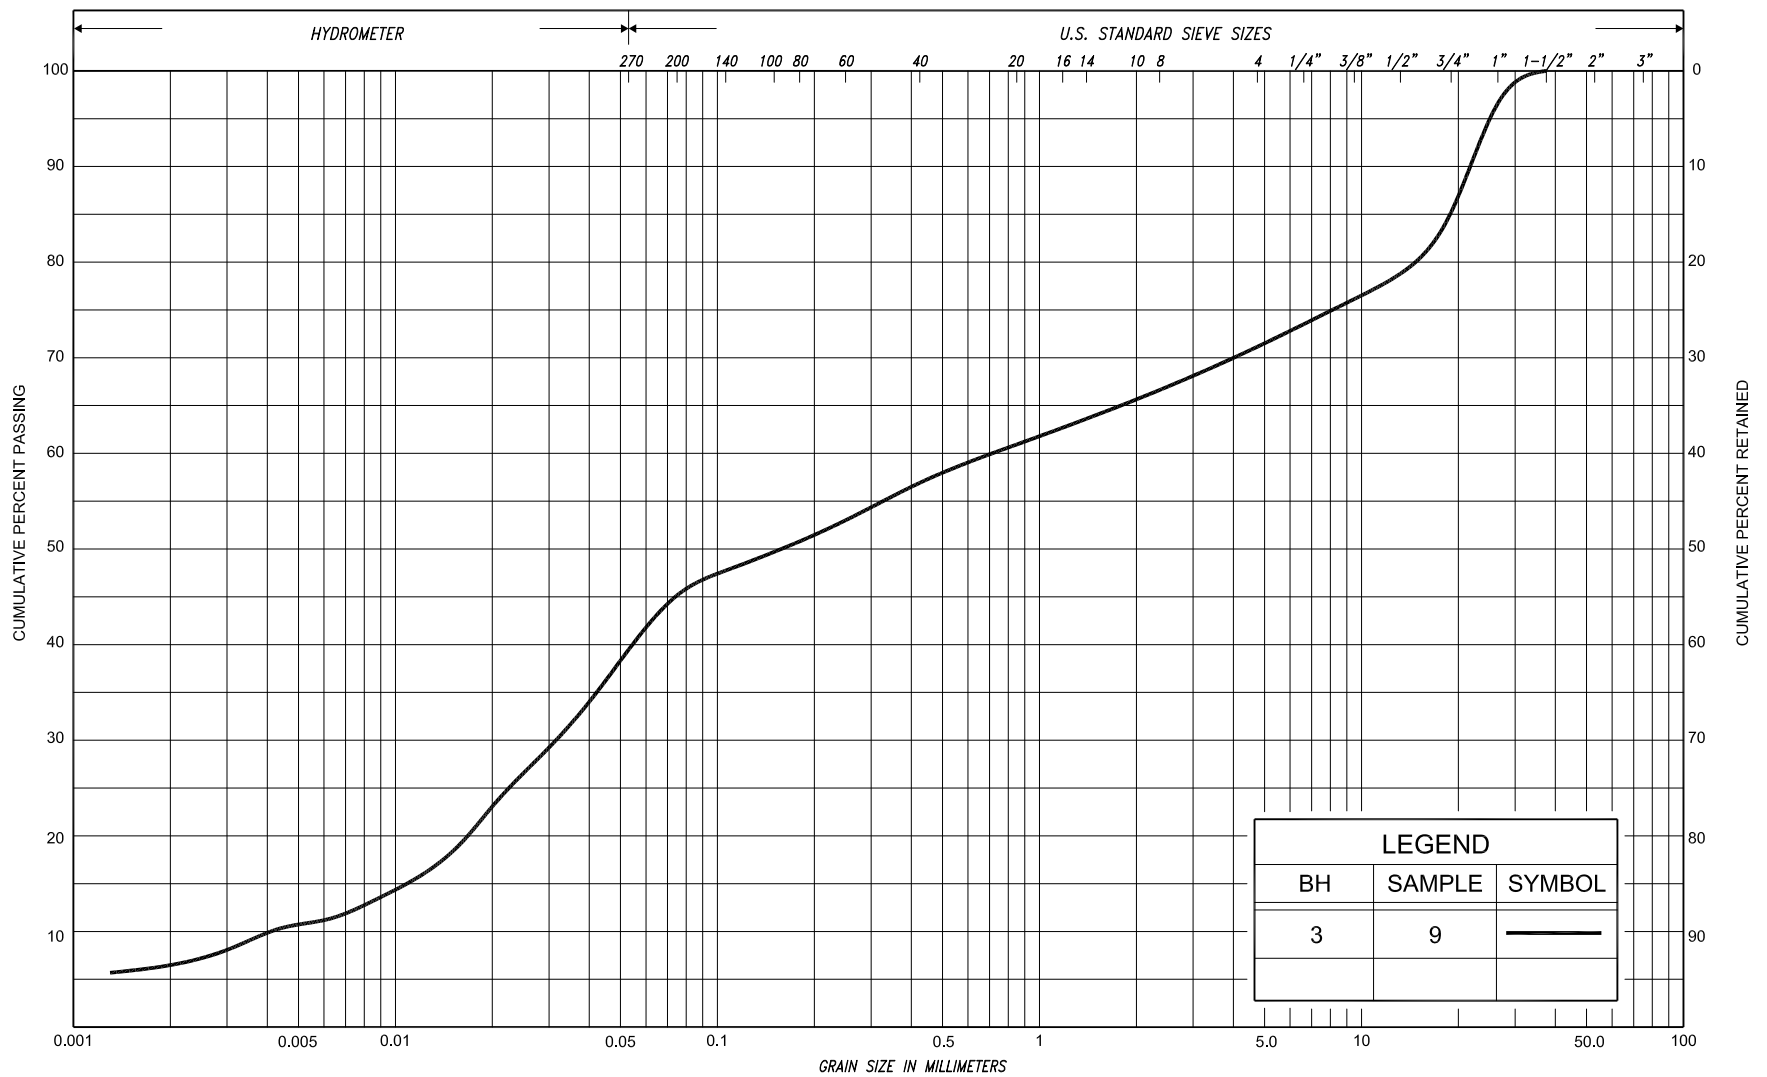
FIG No.	GR-GS-4
HWY:	403
W.P. No.	3503-01-01/02

GRAIN SIZE DISTRIBUTION SILT, with sand, with gravel, trace clay (FILL)

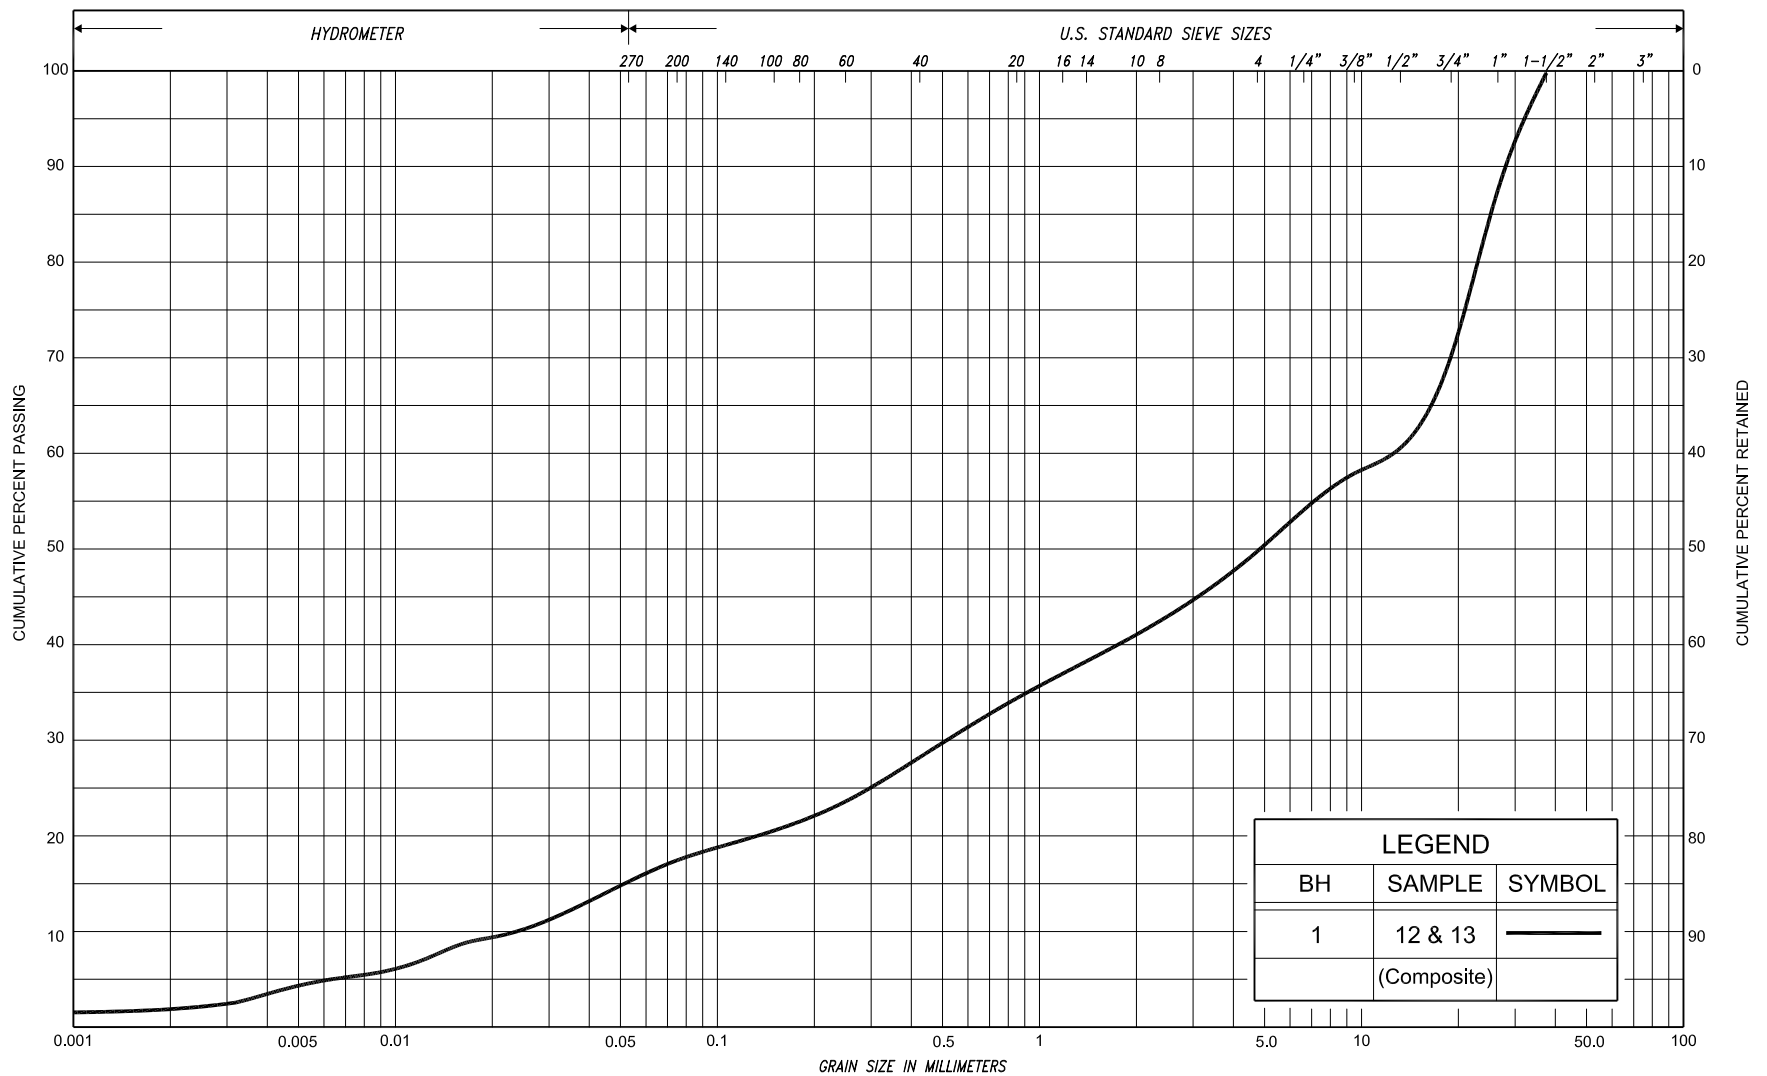
FIG No.	GR-GS-5
HWY:	403
W.P. No.	3503-01-01/02

GRAIN SIZE DISTRIBUTION SANDY GRAVEL, some silt, trace clay (FILL)

On the west side of the bridge a 2.1 and 5.0 m thick layer of sandy gravel to gravelly sand was contacted beneath the fill at 11.8 and 13.7 m (elevation 218.2 and 216.2) in boreholes 3 and 1, respectively. The sandy gravel to gravelly sand extended to the 13.9 and 18.7 m (elevation 216.1 and 211.2) borehole termination depths in boreholes 3 and 1, respectively. The material was very dense (SPT-“N” values of 77 blows to 50 blows for 10 cm) and moist (moisture contents of 5 and 6%). Cobbles and boulders were noted within the deposit. The result of a grain size distribution analysis is presented on figure GR-GS-5.

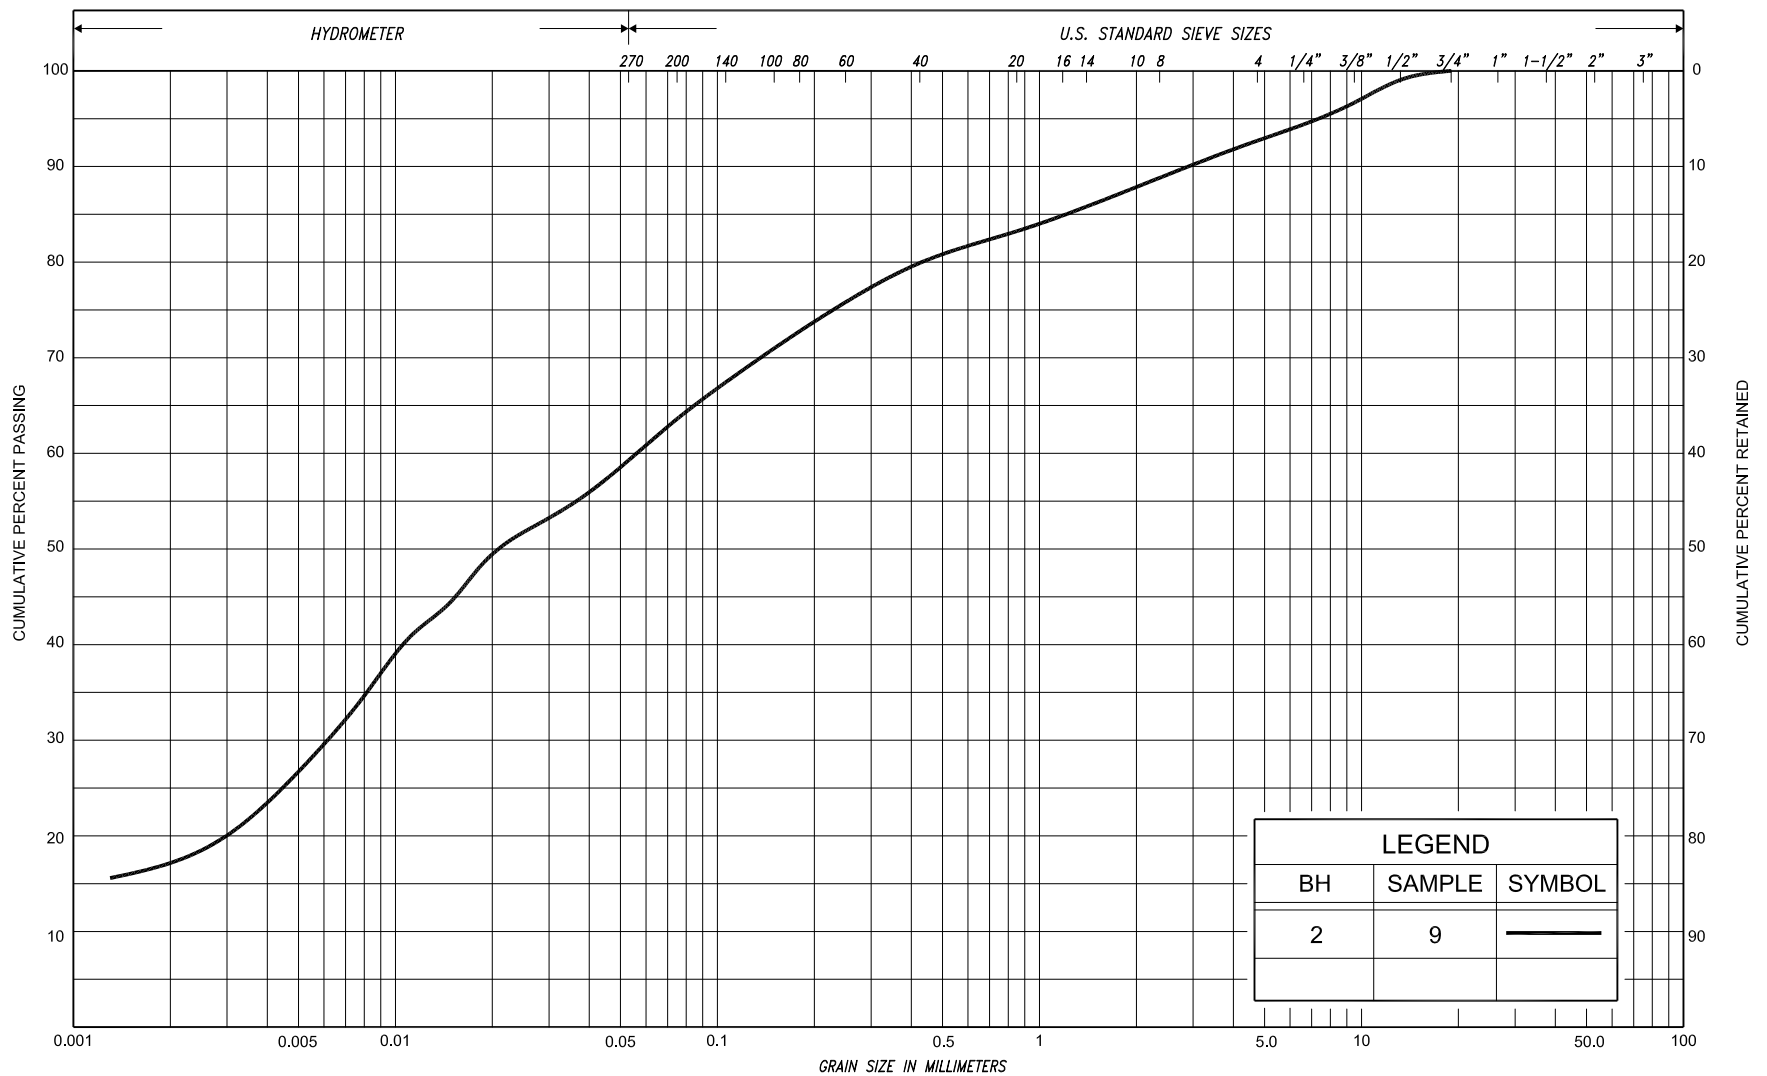
FIG No.	GR-GS-6
HWY:	403
W.P. No.	3503-01-01/02

GRAIN SIZE DISTRIBUTION CLAYEY SILT, with sand, trace gravel

A 2.8 m thick clayey silt layer was contacted on the east side of the bridge in borehole 2 below the fill at 8.5 m (elevation 225.7) that extended to the 11.3 m (elevation 222.9) borehole termination depth. The material was stiff to very stiff (SPT-"N" values of 14 and 16) and drier than the plastic limit (moisture contents of 12%). The results of a grain size distribution analysis and Atterberg Limit Test are presented on figures GR-GS-6 and GR-PC-1.

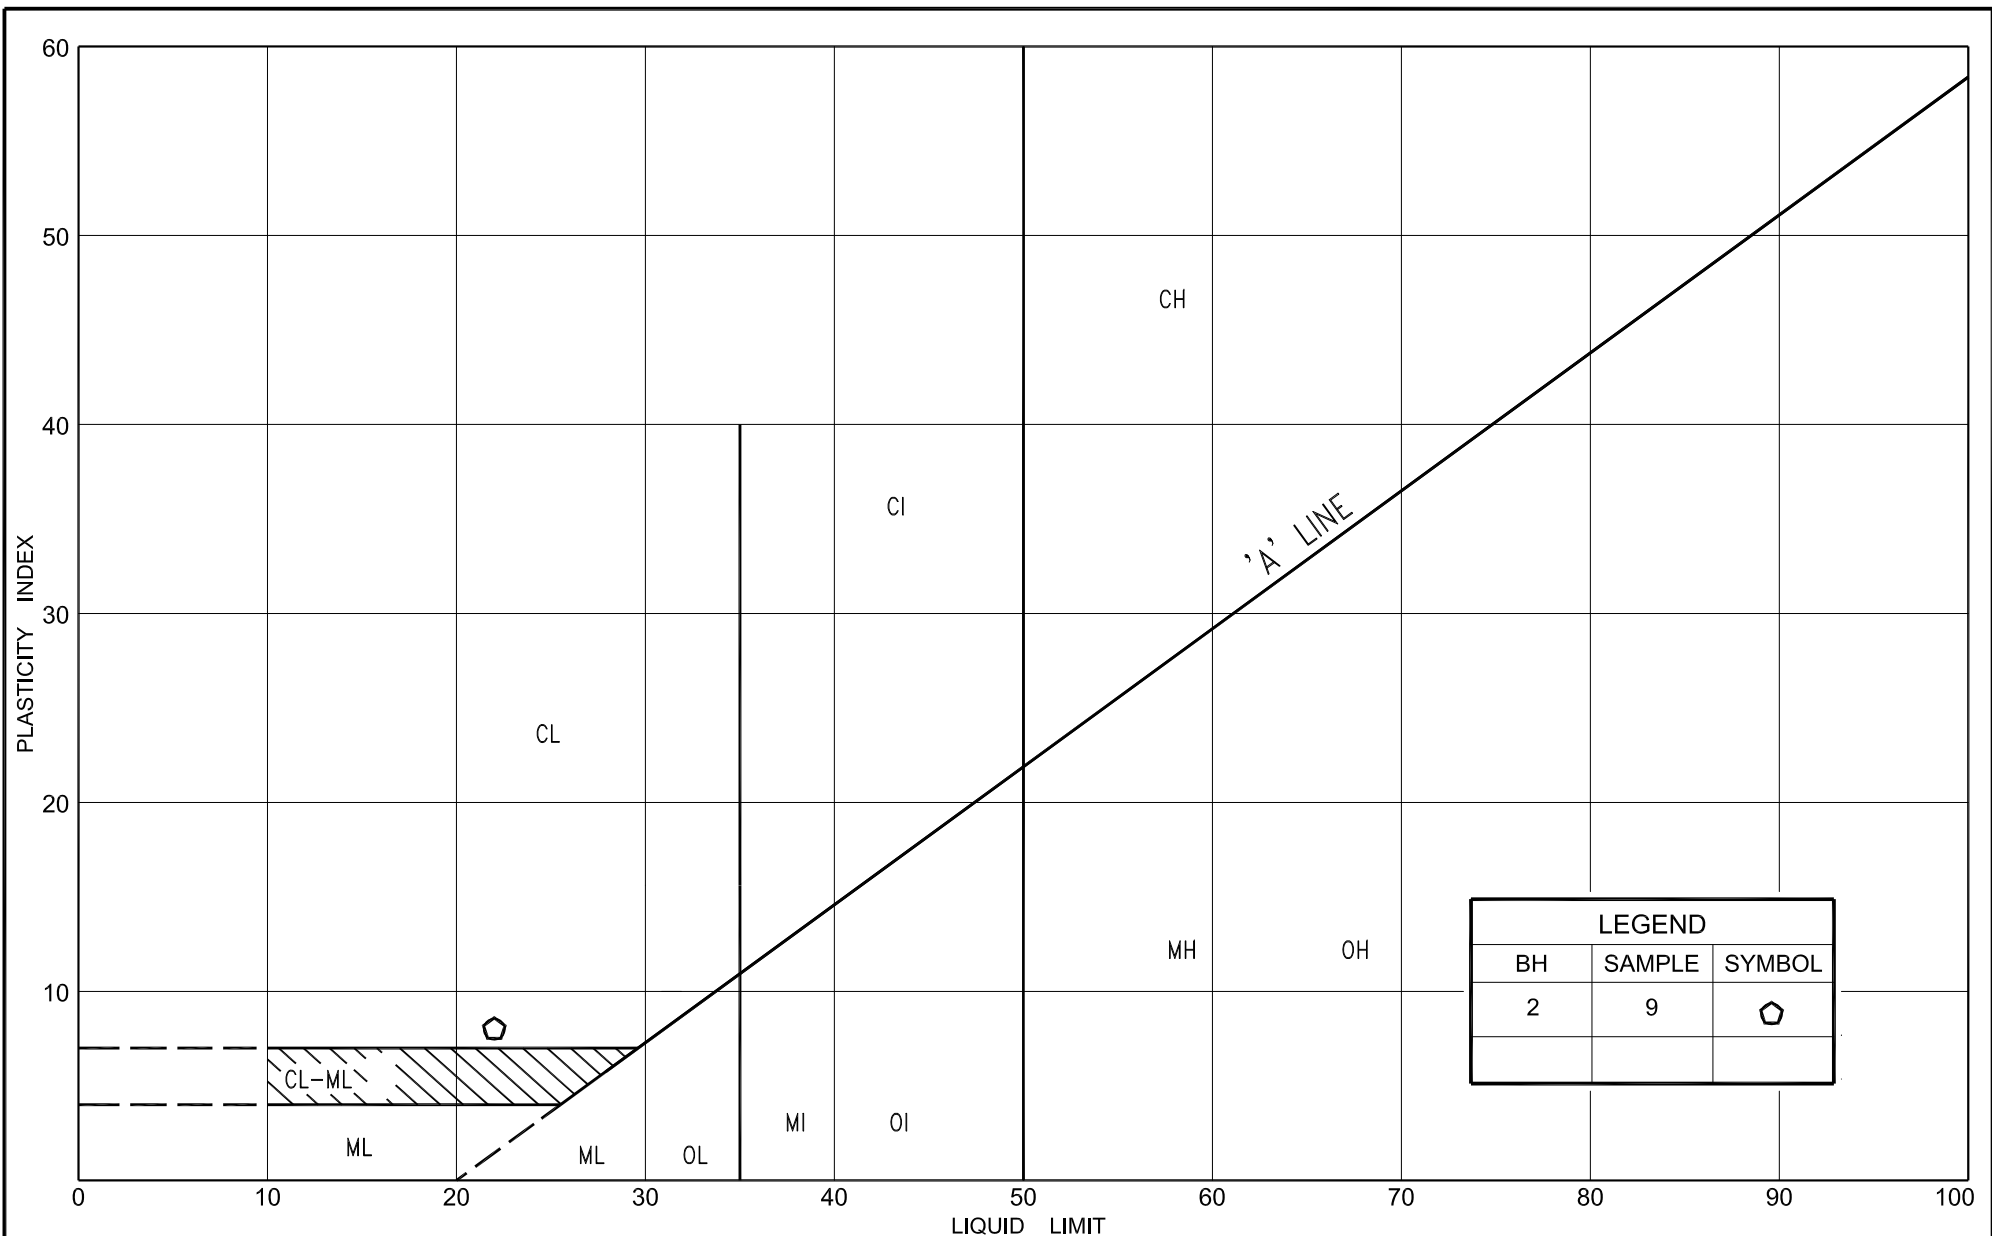
FIG No.	GR-PC-1
HWY:	403
W.P. No.	3503-01-01/02

PLASTICITY CHART
CLAYEY SILT, with sand, trace gravel

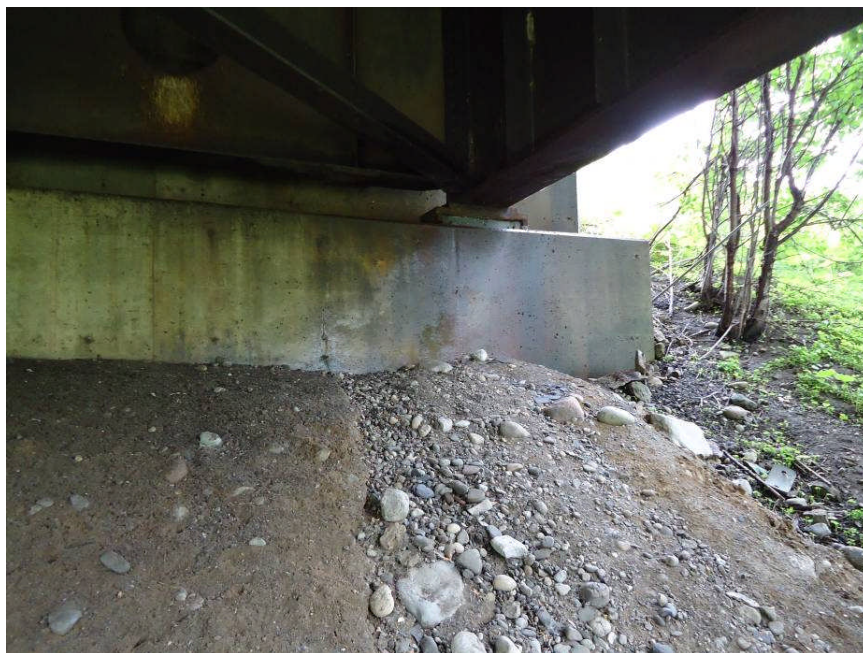
PHOTOGRAPH 18: Erosion on front slope of west abutment of EBL. (June 11, 2013)

The south and north slopes were covered with grasses, bushes and trees. However, no vegetation was growing on the front slope area. Some minor erosion was found on the front slope of west abutment of the EBL structure possibly due to water leaking from the superstructure. The surfaces of slopes were stable. There were no obvious cracks observed on the pier. However, the effect of scouring (photographs 21 and 22) around the west pier of the EBL structure was observed to be about 1.0 m depth.

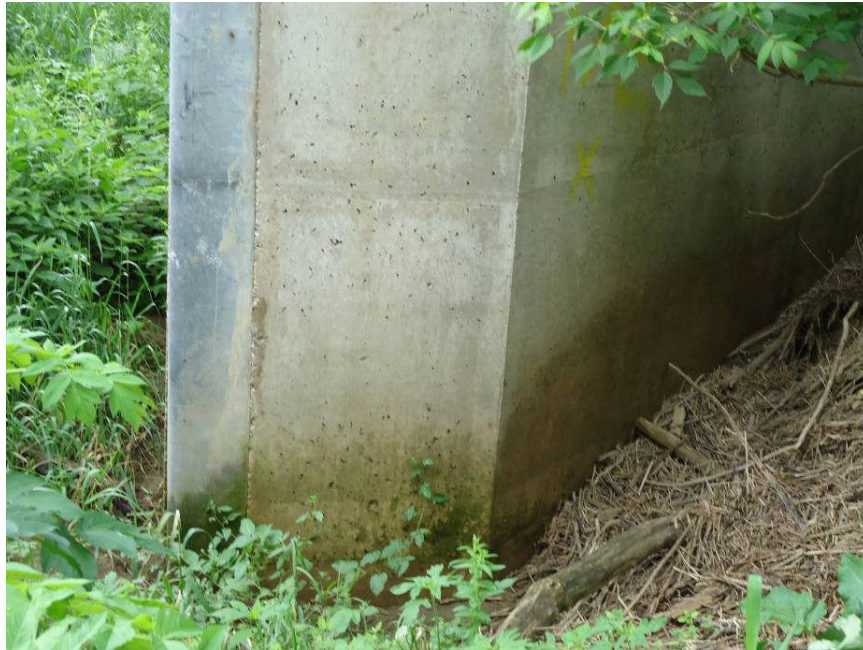
PHOTOGRAPH 21: Scour at north side of west pier of EBL. (June 11, 2013)

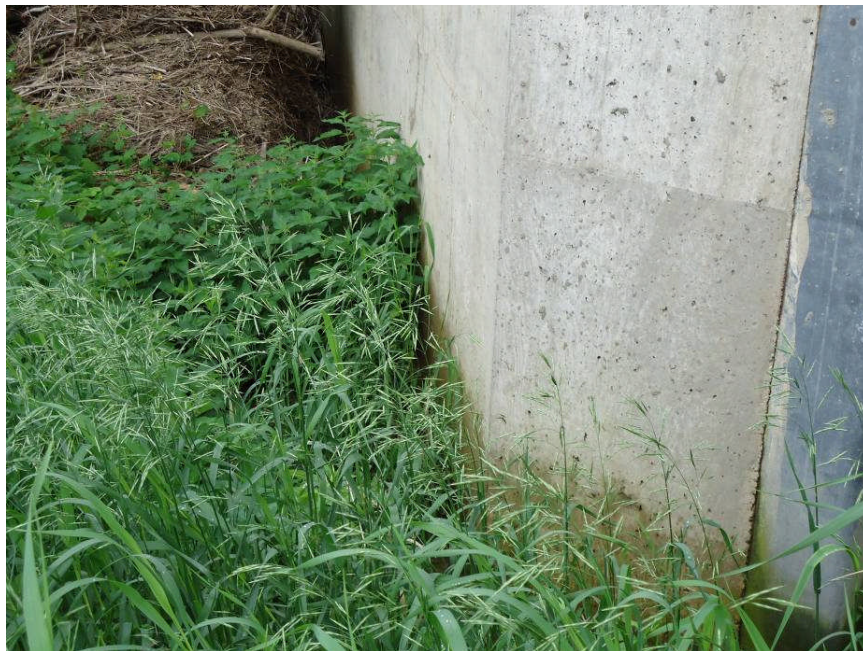
PHOTOGRAPH 22: Scour at north and east sides of west pier of EBL. (June 11, 2013)

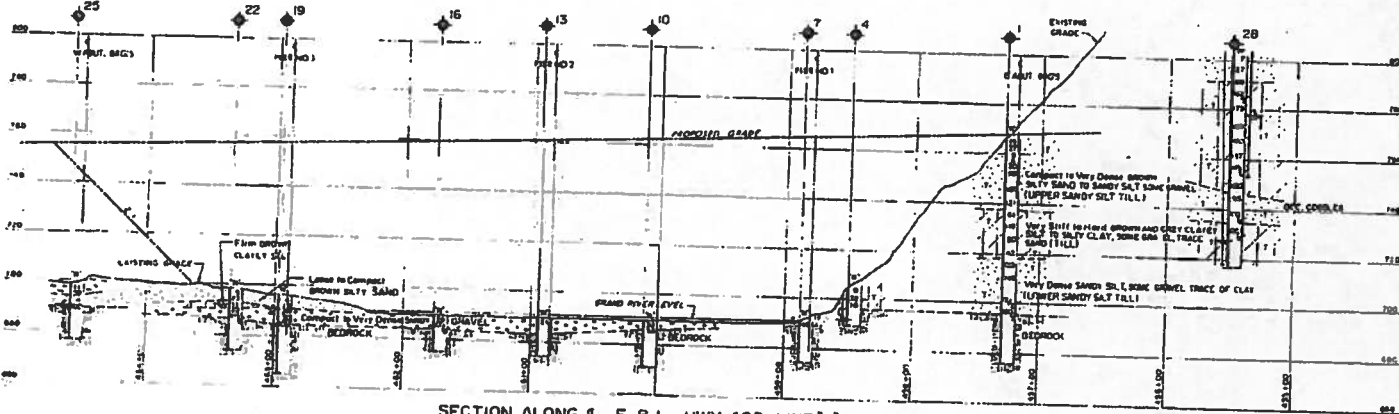
SECTION ALONG E.B.L., HWY. 403, LINE "K"

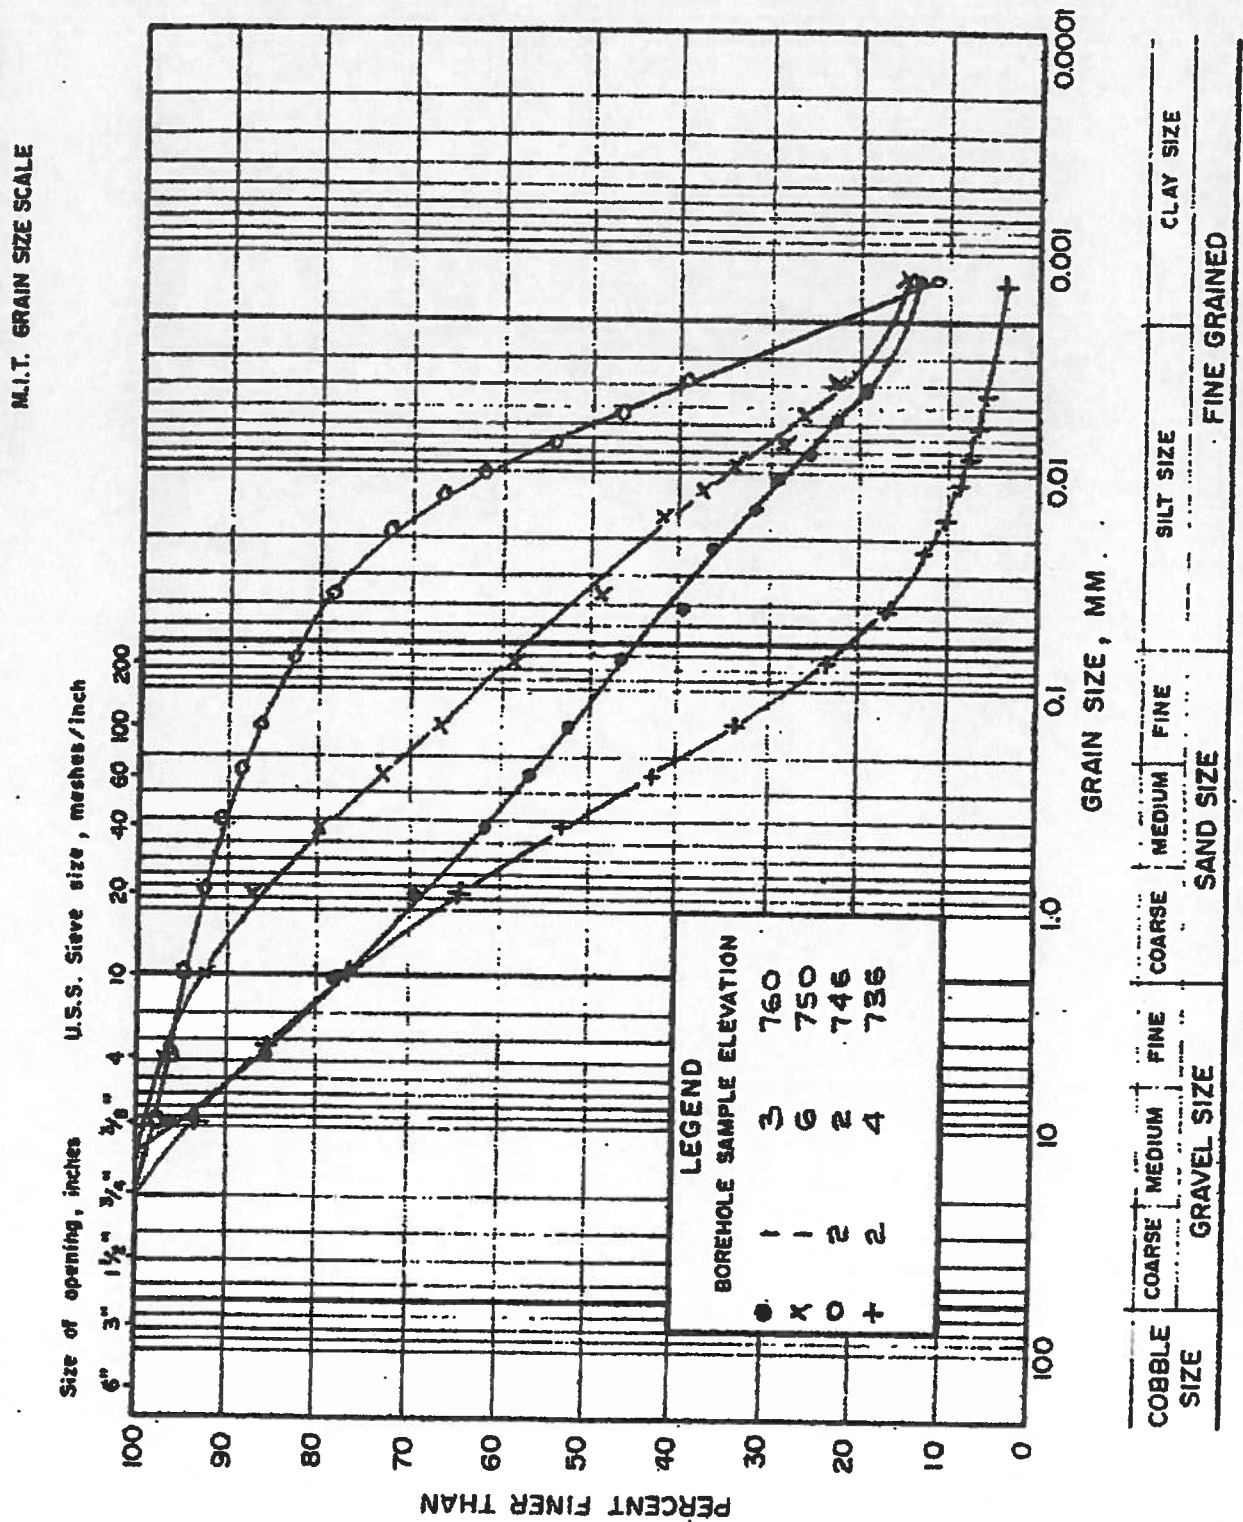
FIGURE 5

GRAIN SIZE DISTRIBUTION SILTY CLAY TILL
