**PRELIMINARY FOUNDATION INVESTIGATION AND DESIGN REPORT
for
HIGHWAY 4, KIPPEN RIVER BRIDGE #2
MTO WEST REGION 59 STRUCTURE REHABILITATIONS
CONTRACT 2
GWP 3125-03-01
TOWNSHIP OF TUCKERSMITH, HURON COUNTY, ONTARIO**

PML Ref.: 13KF006B
Index No.: 141FIR and 142FDR
GEOCRES No: 40P5-20
November 26, 2014

For
Highway 4, Kippen River Bridge #2
MTO West Region 59 Structure Rehabilitations
Contract 2, GWP 3125-03-01
Township of Tuckersmith, Huron County, Ontario

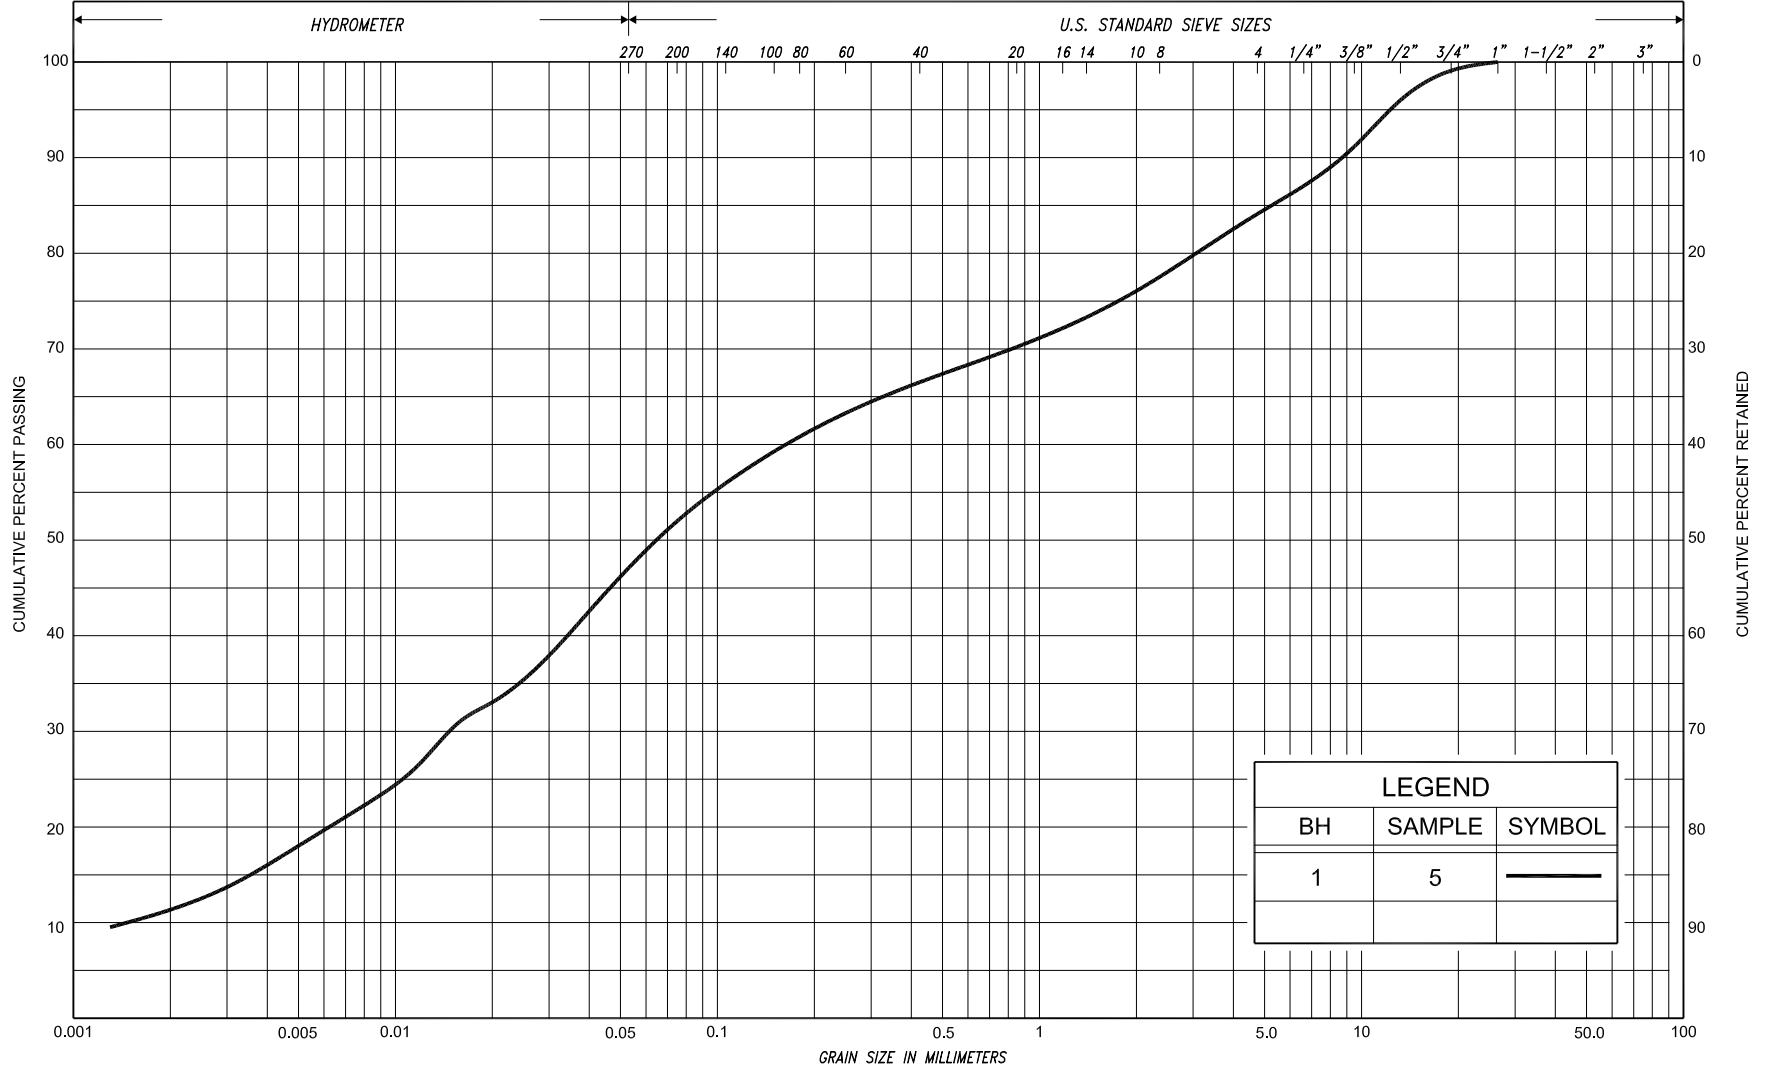
FIG No.	KR-GS-2
HWY:	4
W.P. No.	3125-03-01

GRAIN SIZE DISTRIBUTION
SANDY SILT, some clay, some gravel
(FILL)

The results of three grain size distribution analyses and two Atterberg Limit Tests performed on samples of the fill are presented in Figures KR-GS-1 to KR-GS-3, and KR-PC-1 to KR-PC-2, respectively.

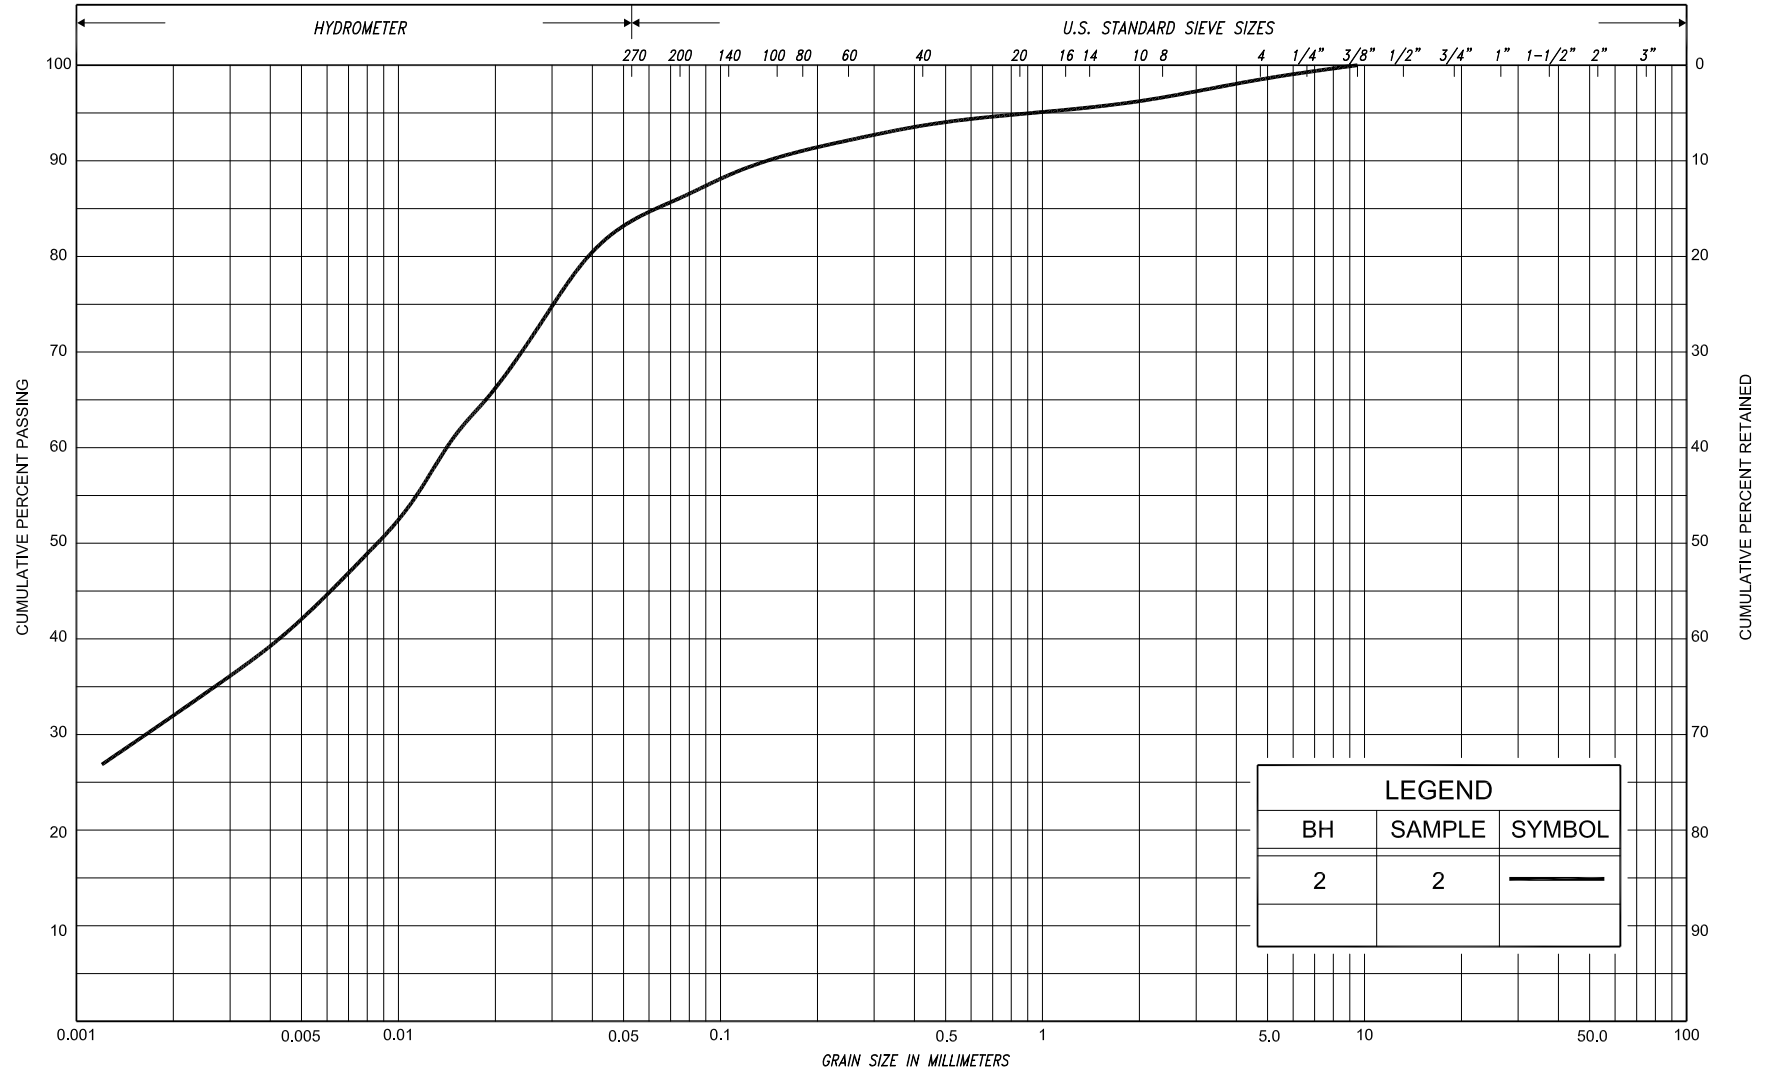
FIG No.	KR-GS-3
HWY:	4
W.P. No.	3125-03-01

GRAIN SIZE DISTRIBUTION **SILTY CLAY, some sand, trace gravel (CI)** **(FILL)**

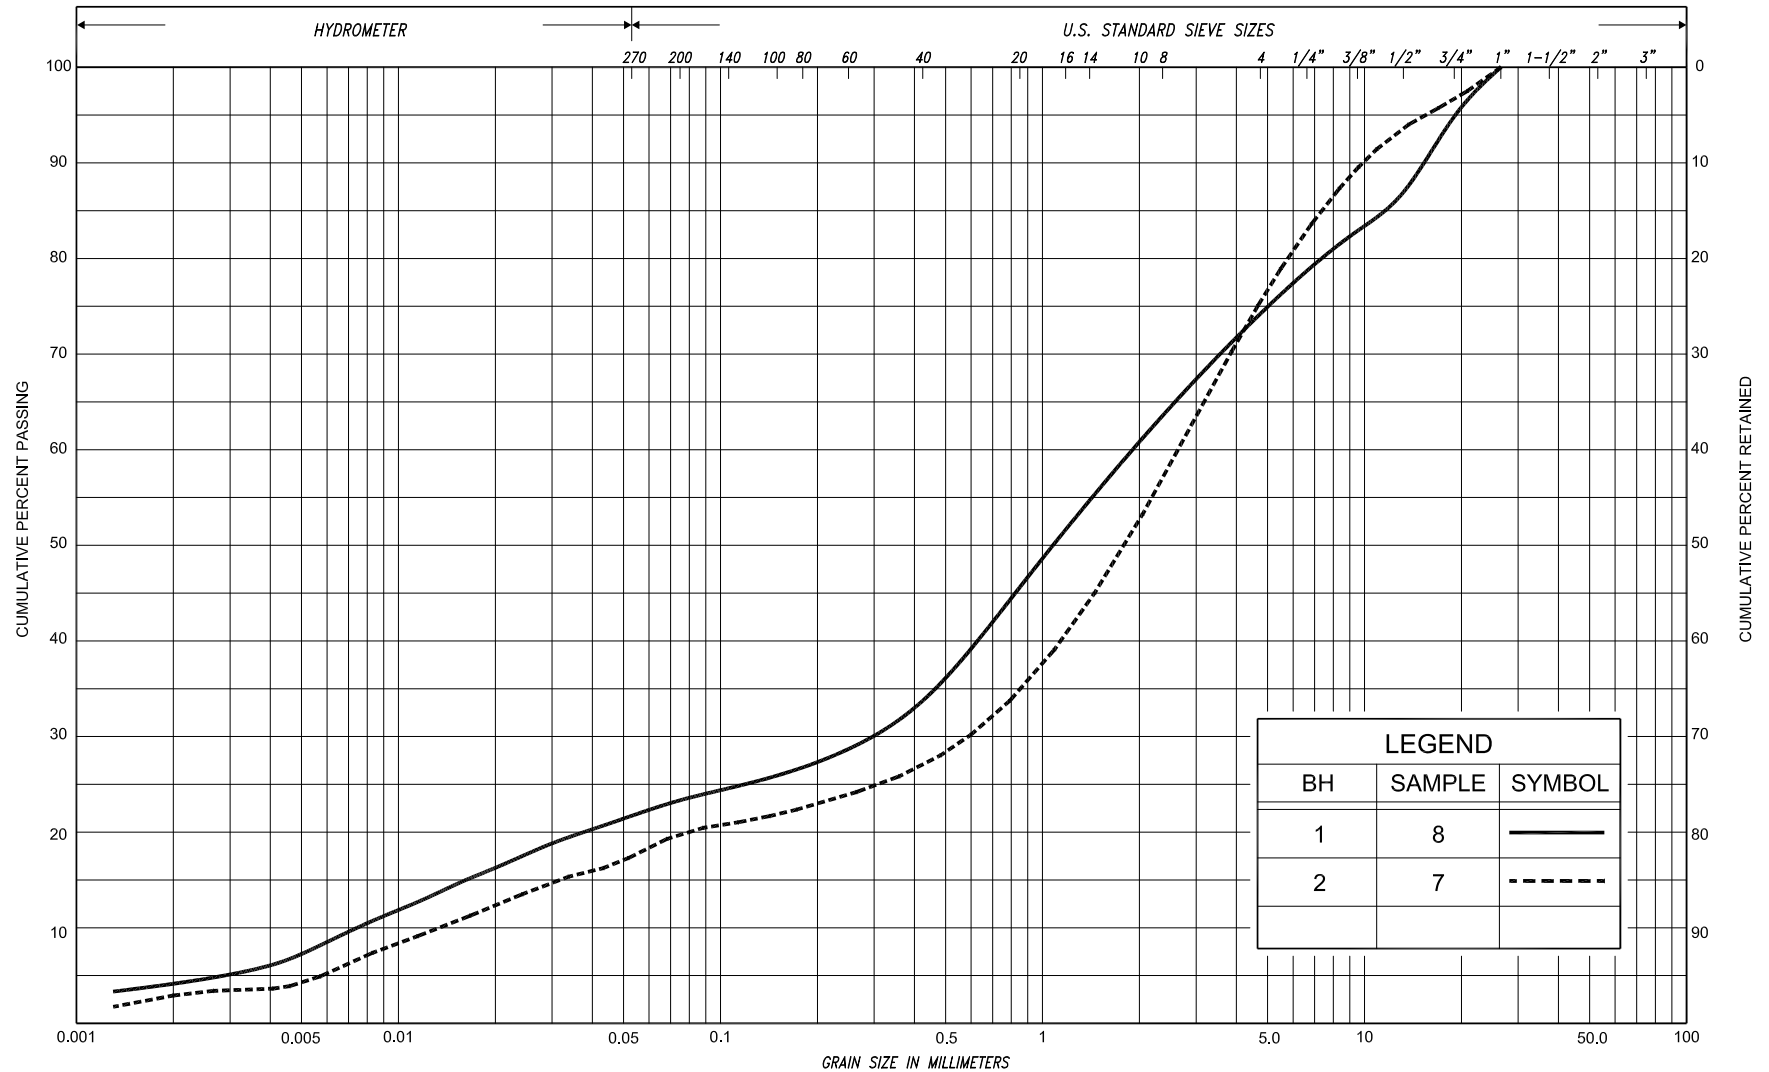
FIG No. KR-GS-5
 HWY: 4
 W.P. No. 3125-03-01

GRAIN SIZE DISTRIBUTION

GRAVELLY SAND, some silt, trace clay

A 5.1 and 6.7 m thick gravelly sand deposit was contacted beneath sandy silt and fill at 5.3 and 3.4 m (elevation 265.0 and 267.0) in boreholes 1 and 2 respectively. The deposit extended to the silt till at 10.1 and 10.4 m (elevation 260.3 and 259.9) in boreholes 2 and 1, respectively. The deposit was compact to very dense (SPT-'N' values of 26 to 50 blows for 10 cm) and moist (moisture contents of 7 to 19%). Cobbles and boulders were noted within the deposit in both boreholes. The results of grain size distribution analyses completed on two samples of the deposit are shown on Figure KR-GS-5.

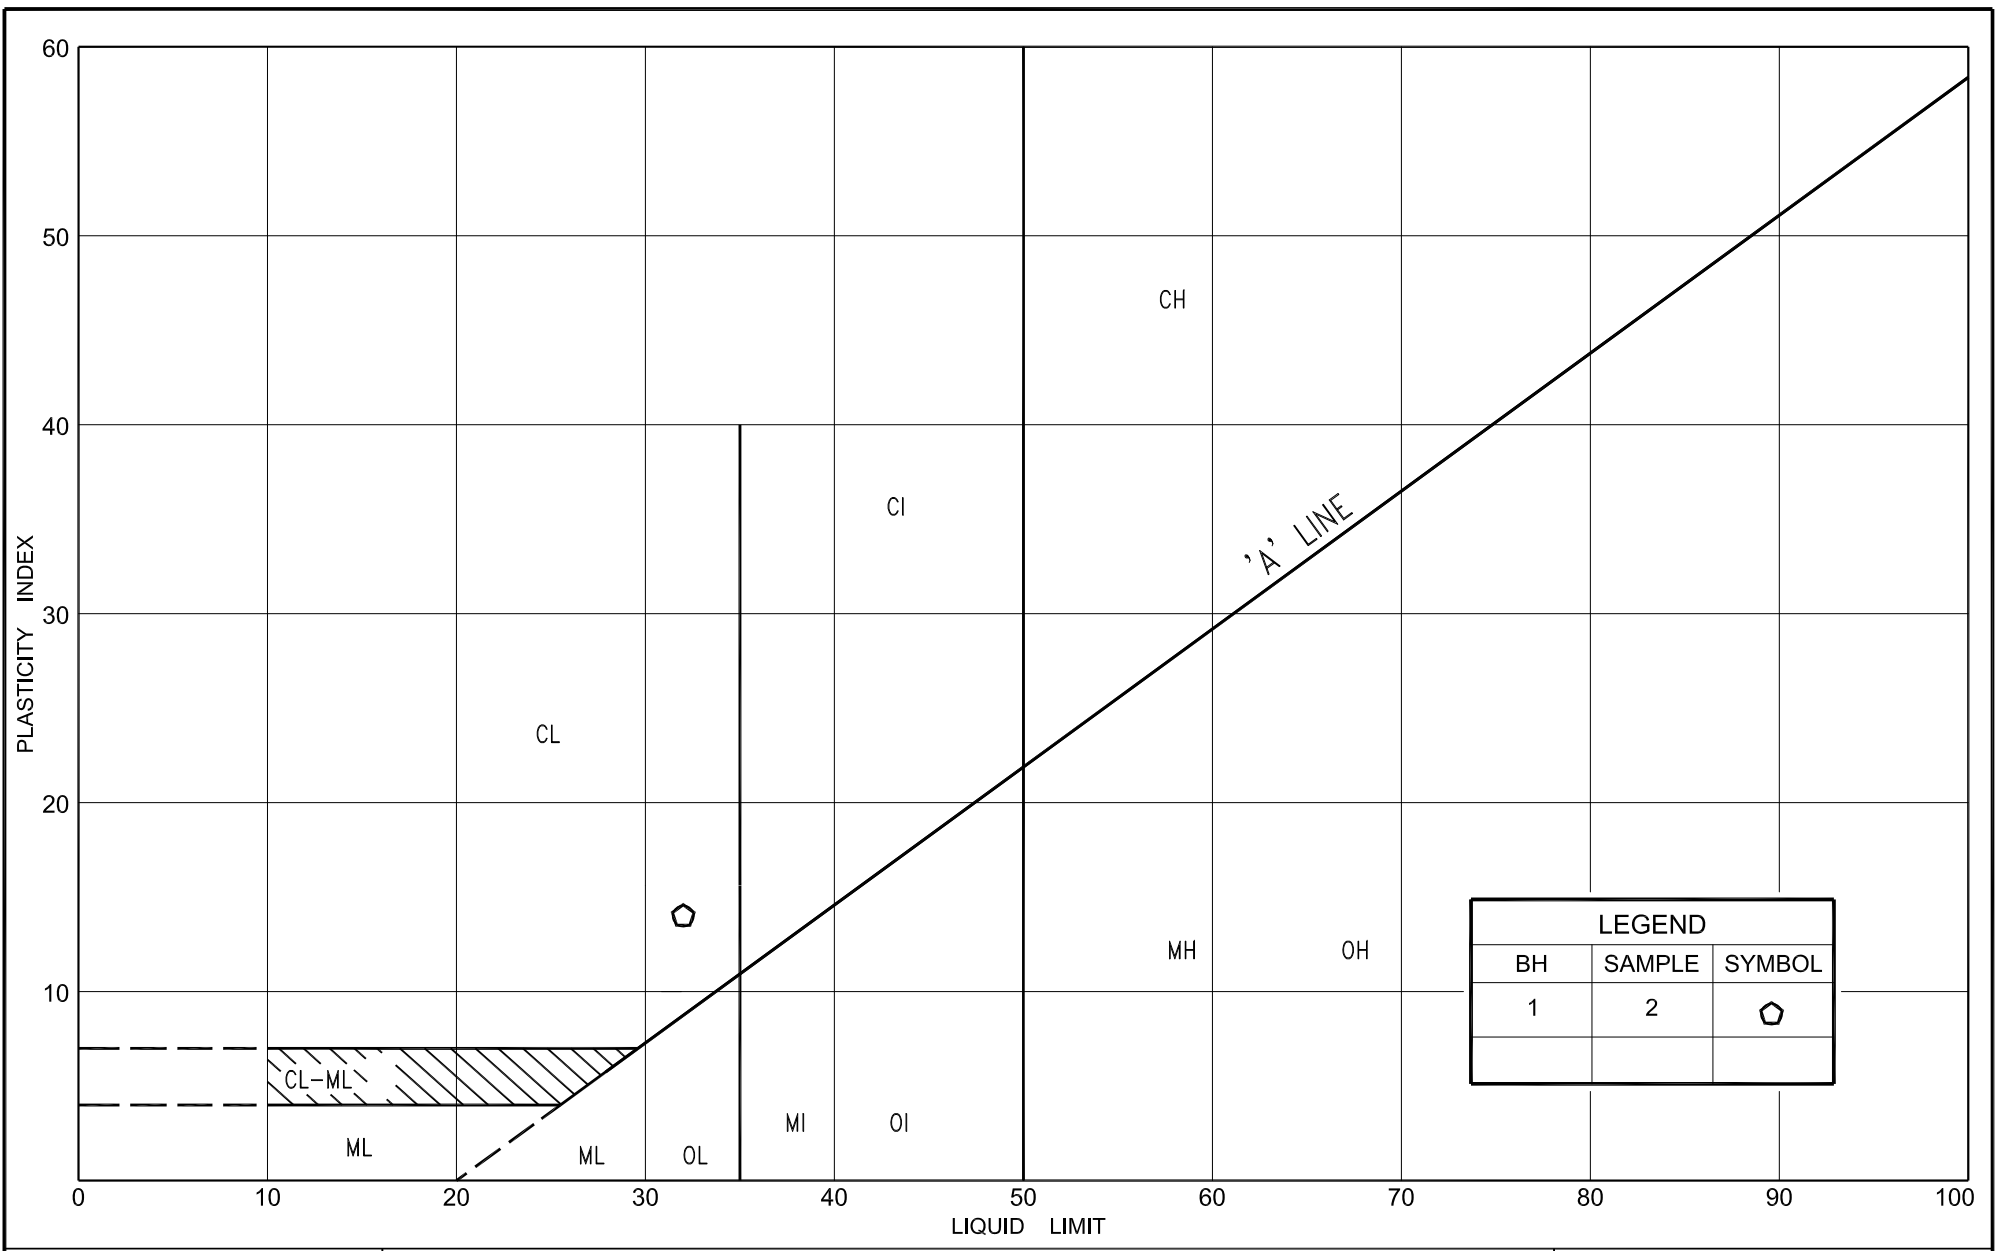
FIG No.	KR-PC-1
HWY:	4
W.P. No.	3125-03-01

PLASTICITY CHART
 CLAYEY SILT, some sand, trace gravel (CL)
 (FILL)

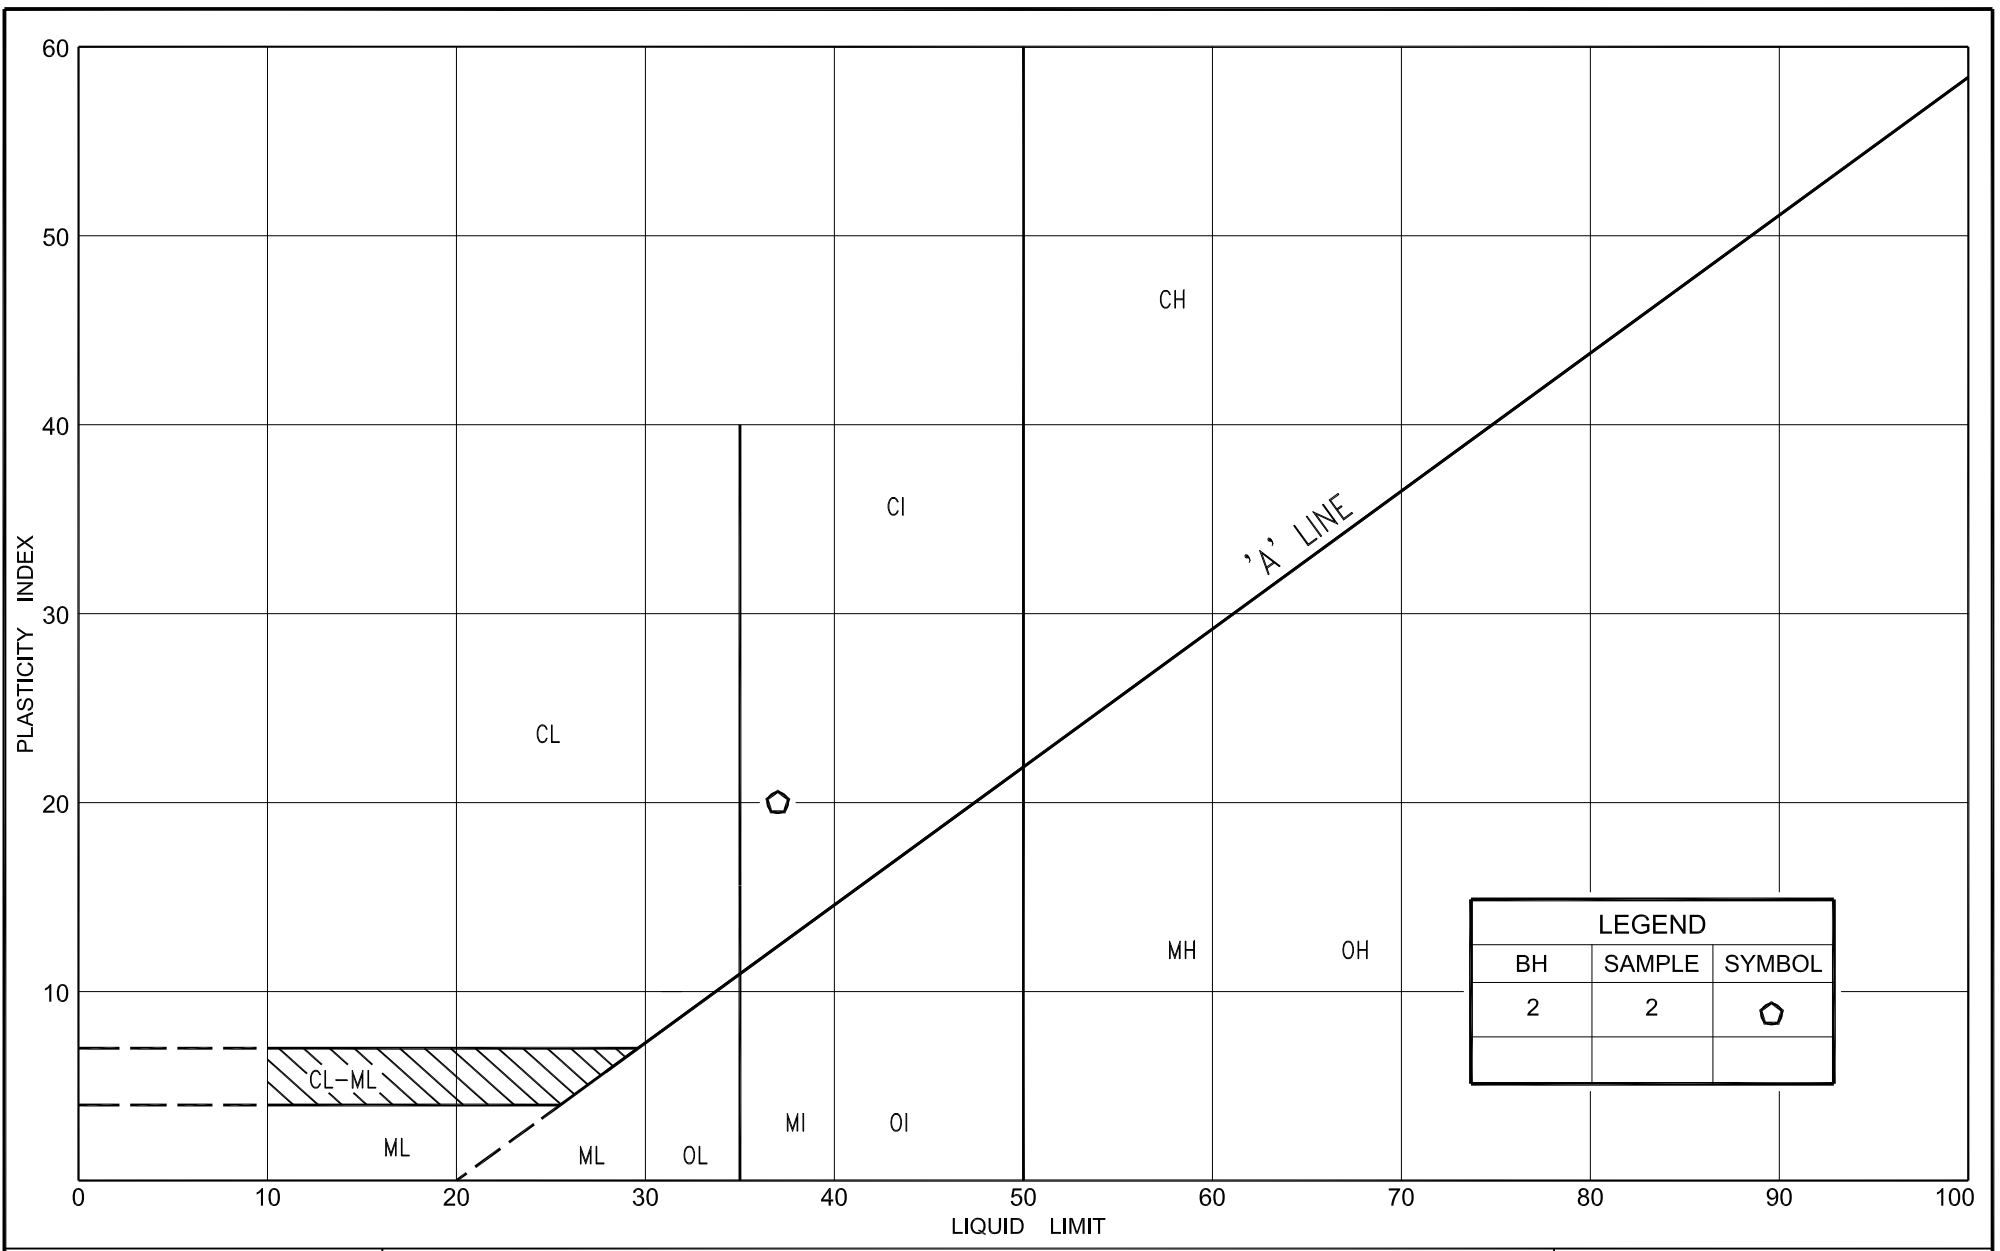
FIG No.	KR-PC-2
HWY:	4
W.P. No.	3125-03-01

PLASTICITY CHART
 SILTY CLAY, some sand, trace gravel (CI)
 (FILL)

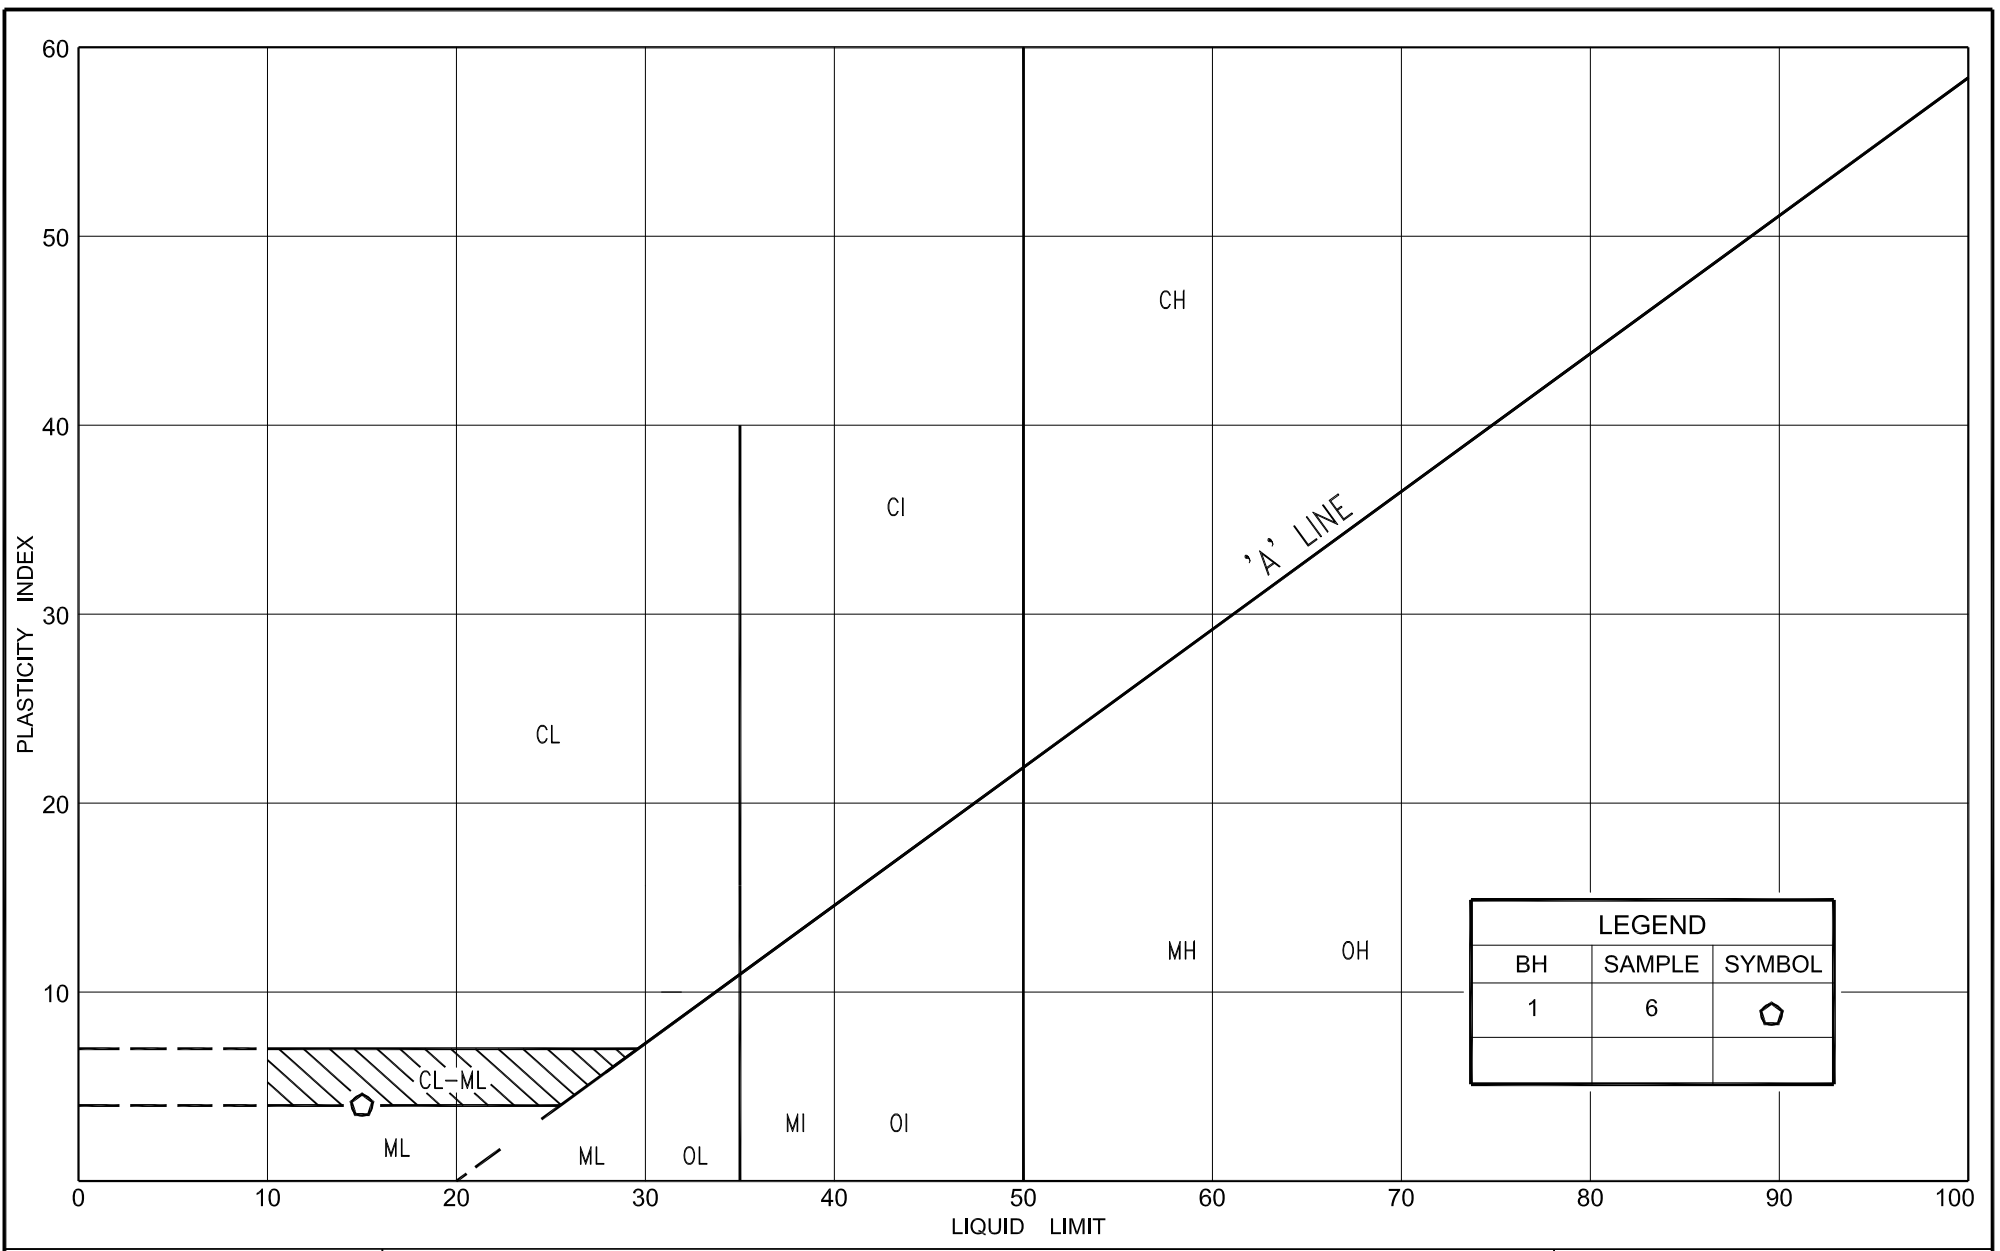
FIG No.	KR-PC-3
HWY:	4
W.P. No.	3125-03-01

PLASTICITY CHART

SANDY SILT, some clay, some gravel (ML)

A 1.0 m thick sandy silt layer was contacted beneath the fill in borehole 1 at 4.3 m (elevation 266.0) that extended to 5.3 m (elevation 265.0). The sandy silt was compact (SPT 'N' value of 19) and moist (moisture content of 10%). The results of a grain size distribution analysis and Atterberg Limit Test completed on a sample this layer is presented on Figures KR-GS-4 and KR-PC-3, respectively.

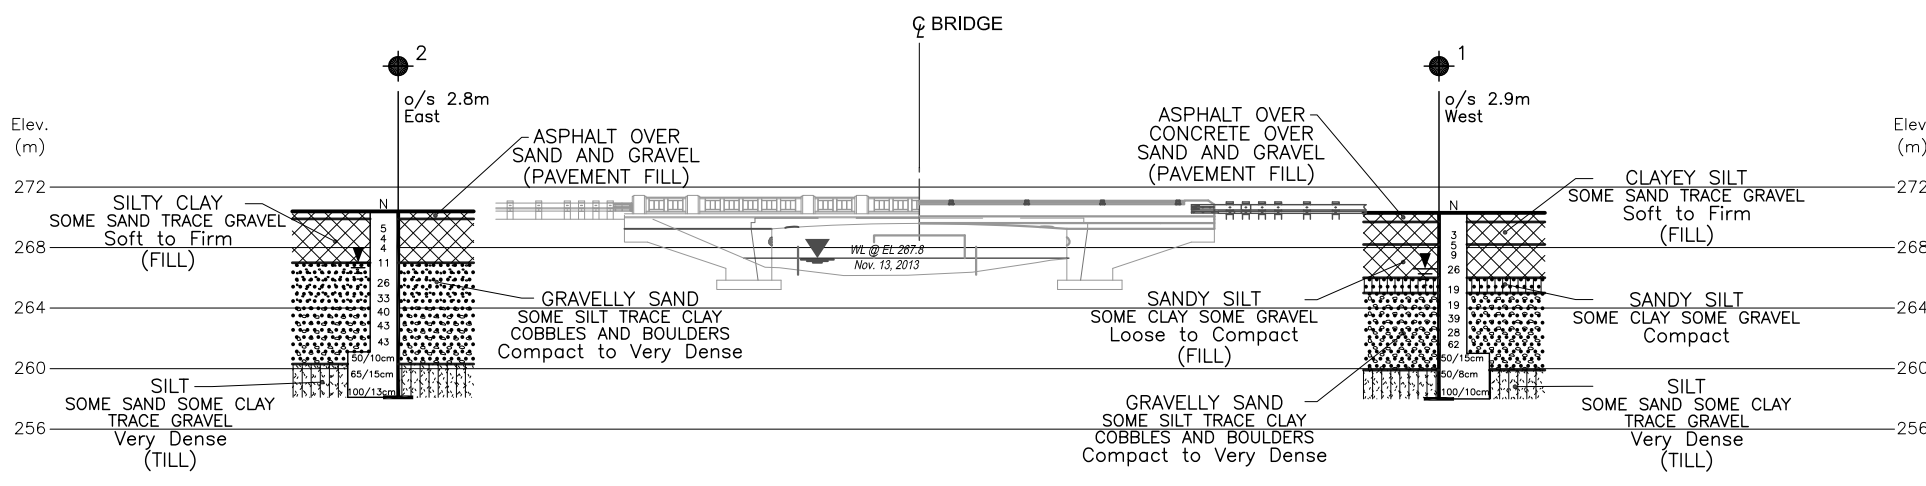
HWY No	4			DIST	LONDON
SUBMD	NA	CHECKED	AD	DATE	NOV. 26, 2014
DRAWN	NA	CHECKED	RN	APPROVED	BRG
					DWG 1

PROFILE ALONG Q HIGHWAY 4
SCALE
HORIZONTAL
VERTICAL

The field work for this study was carried out on November 13, 2013. The investigation included two boreholes, with one borehole drilled at both the south and north abutment areas as shown on Drawing 1, appended.

The borehole locations and stratigraphic profile prepared from the borehole data are shown on Drawing 1. The boundaries between soil strata have been established at the borehole locations only. Between and beyond the boreholes, the boundaries are assumed and may vary.

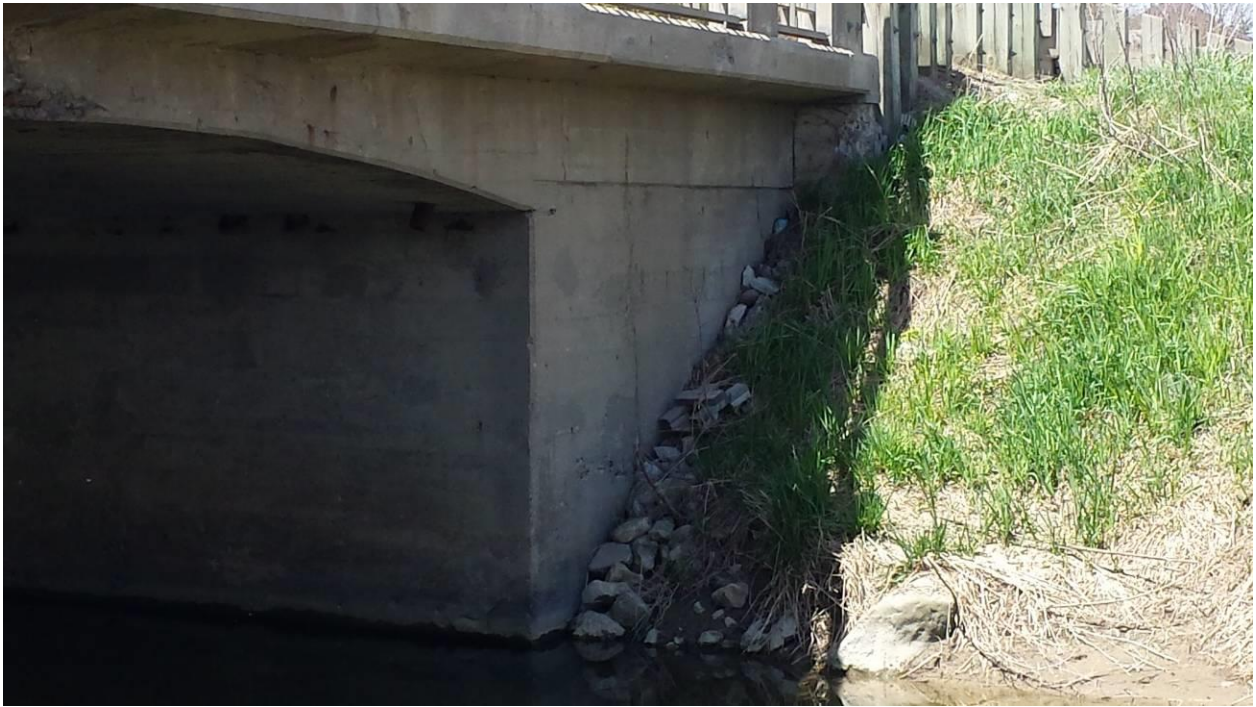
Photograph 1: Looking north at the adjacent east slope of the north abutment from the east slope of the south side of the bridge. Cracks were observed on the wingwall. Slight scouring of the slope toe edge was observed. (May 10, 2014)

At the time of the site reconnaissance, the depth of the river was about 0.5 to 0.7 m. Concrete cracking and spalling were observed on the wingwalls adjacent to the abutment walls (Photographs 1 to 4). Surface cracks with wall surface deterioration and visible cracks were observed on the north and south abutment walls above the water level (Photographs 5 and 6). Concrete spalling at water level was observed on the south abutment wall (Photograph 6).

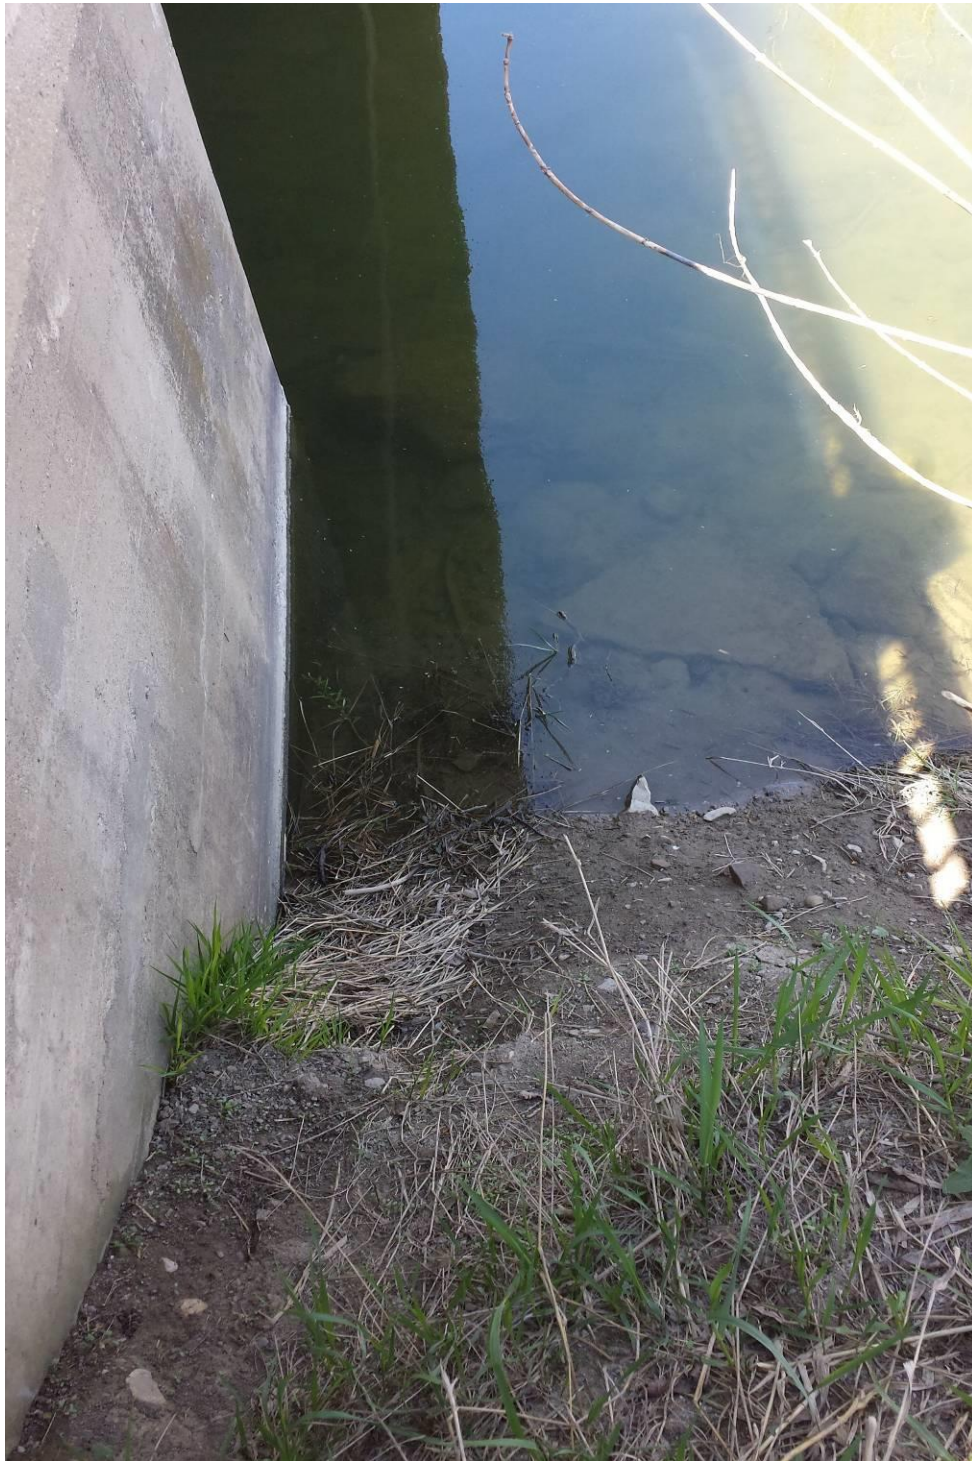
Photograph 2: Looking at the east slope adjacent to the south abutment. Scouring of the slope toe edge and erosion of the slope surface were observed. (May 10, 2014)

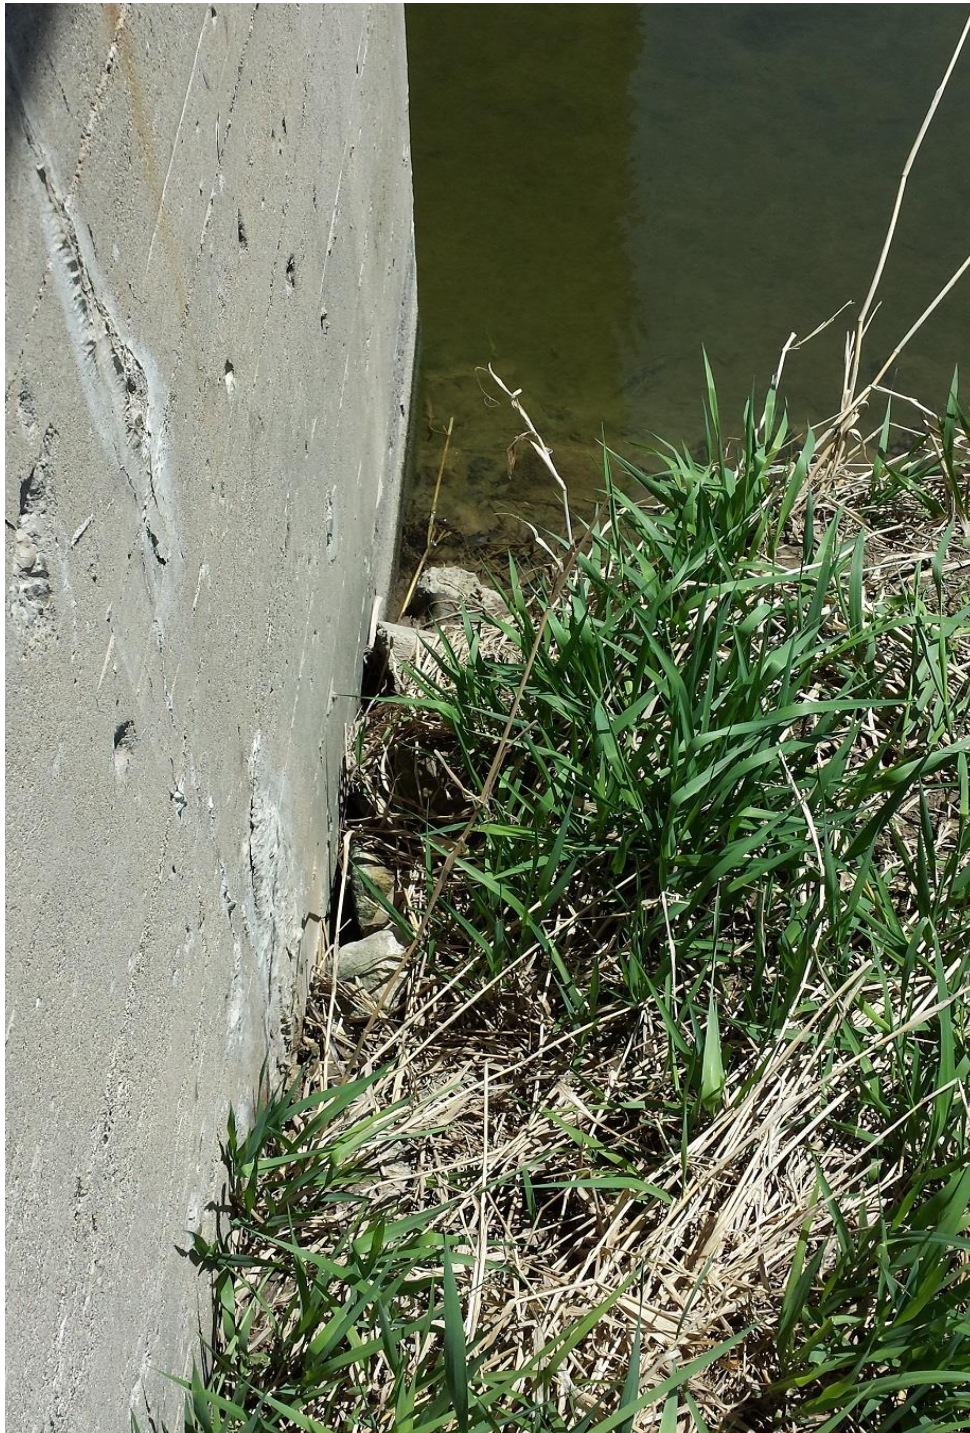
Photograph 3: Looking at the west slope adjacent to the north abutment. Scouring of the slope toe edge was observed. Concrete deterioration on wingwall was also observed. (May 10, 2014)

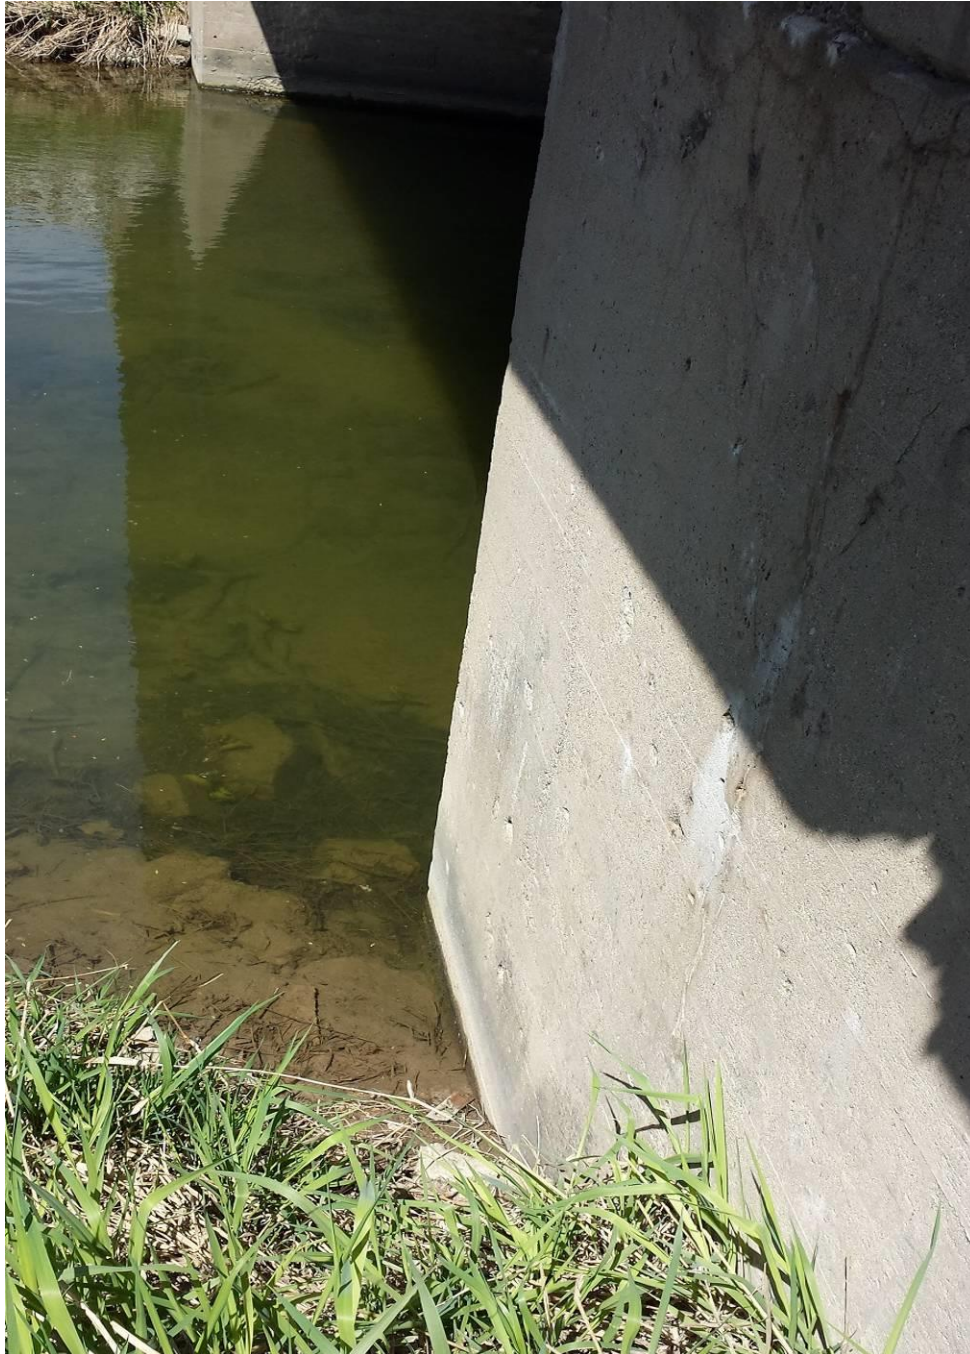
Photograph 4: Looking at the east slope adjacent to the south abutment. Scouring of the slope toe edge was observed. Concrete deterioration on east wingwall of the south abutment was also observed. (May 10, 2014)

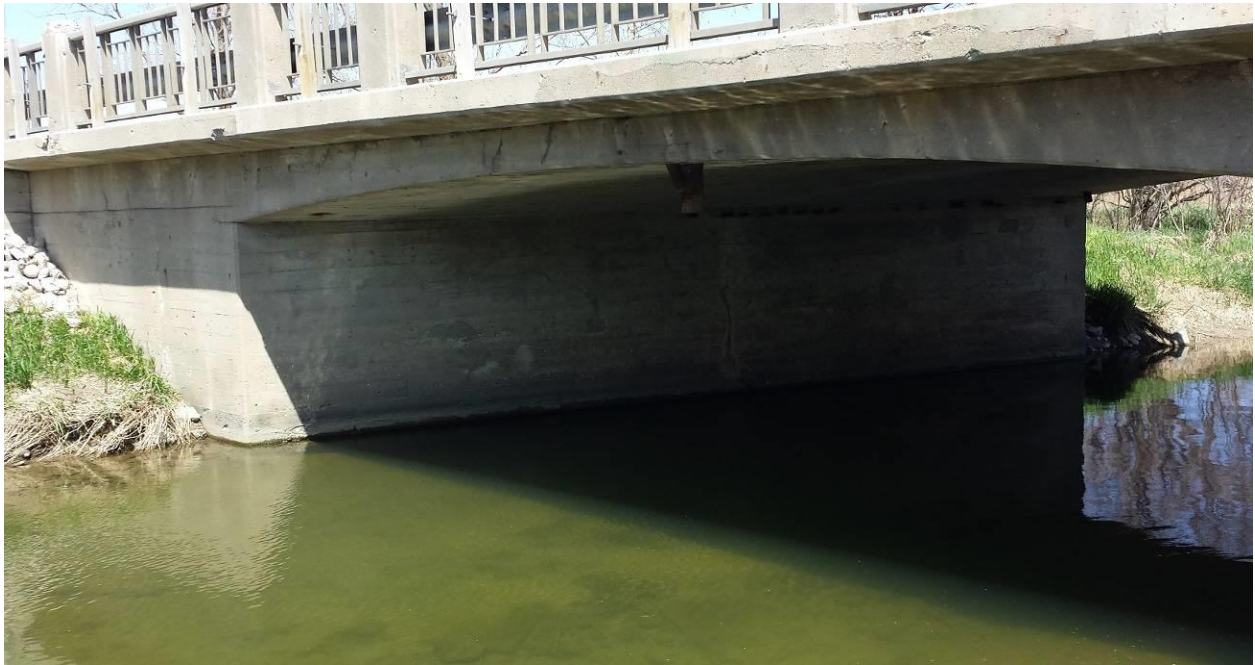
Photograph 5: Looking north from the west slope of the south side of the bridge. Minor surface cracks, wall surface deterioration and a visible crack on the north abutment wall were observed. Potential scouring effect could not be verified under the water at the abutment wall. (May 10, 2014)

The embankments on either side of the bridge are steep. Erosion of adjacent earth slopes to the north and south abutments was observed. On the west slope adjacent to the north abutment, rock protection was placed to prevent further erosion of the slope surface (Photograph 7). In addition, scouring of the slope toe edges due to river water course were also observed near the abutment walls (Photographs 1 to 4). It is possible that the surface water running along the face of the slopes may have caused erosion of the slope surface. Observation below the water level could not been made and thus, potential river scouring effect below the water at the abutment walls by visual observations could not been made (Photographs 5 and 6). No visible signs of foundation settlement were observed.

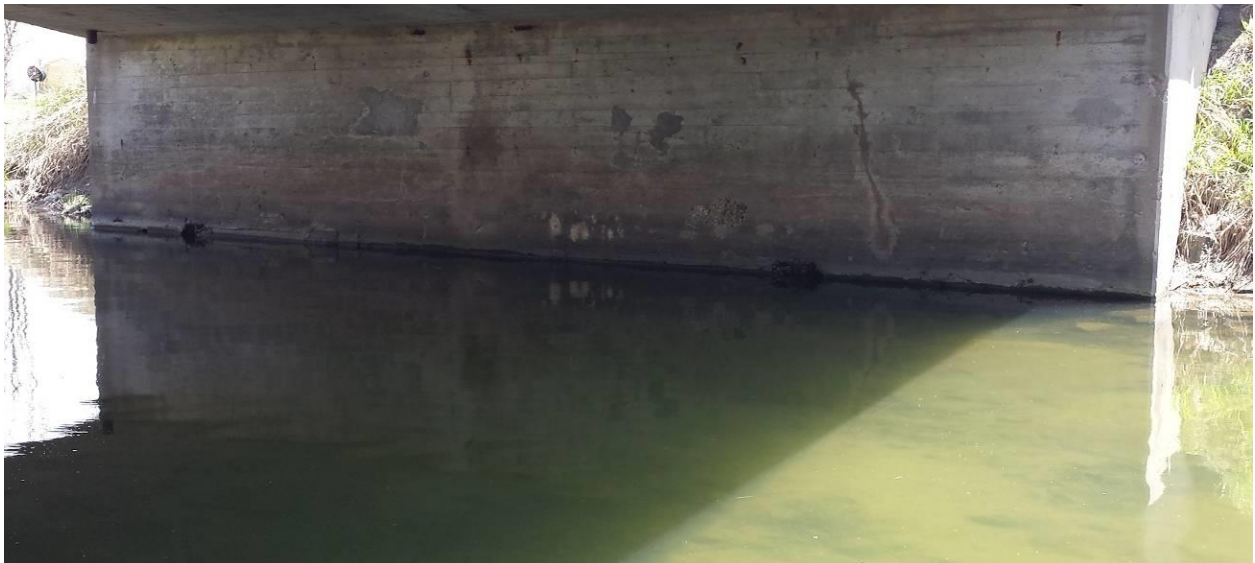
Photograph 6: Looking south from the west slope of the north side of the bridge. Minor surface cracks, wall surface deterioration and a visible crack on the south abutment wall were observed. Concrete spillings off the wall at the water level was also observed. Potential scouring effect could not be verified under the water at the abutment wall. (May 10, 2014)
