**PRELIMINARY FOUNDATION INVESTIGATION AND DESIGN REPORT
for
HIGHWAY 4, KIPPEN RIVER BRIDGE #2
MTO WEST REGION 59 STRUCTURE REHABILITATIONS
CONTRACT 2
GWP 3125-03-01
TOWNSHIP OF TUCKERSMITH, HURON COUNTY, ONTARIO**

PML Ref.: 13KF006B
Index No.: 141FIR and 142FDR
GEOCRES No: 40P5-20
November 26, 2014

For
Highway 4, Kippen River Bridge #2
MTO West Region 59 Structure Rehabilitations
Contract 2, GWP 3125-03-01
Township of Tuckersmith, Huron County, Ontario

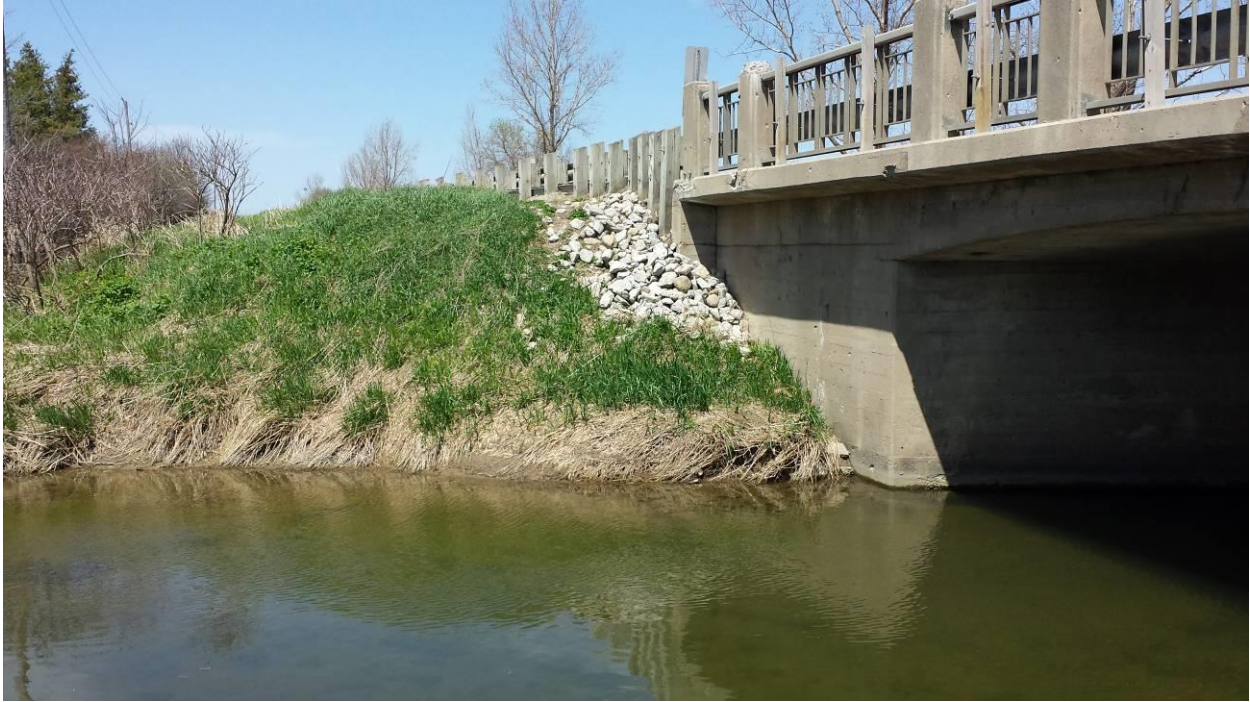
Photograph 7: Looking north at the west slope adjacent to the north abutment. Rock protection placed on the slope to prevent slope surface erosion. (May 10, 2014)

The embankments on either side of the bridge are steep. Erosion of adjacent earth slopes to the north and south abutments was observed. On the west slope adjacent to the north abutment, rock protection was placed to prevent further erosion of the slope surface (Photograph 7). In addition, scouring of the slope toe edges due to river water course were also observed near the abutment walls (Photographs 1 to 4). It is possible that the surface water running along the face of the slopes may have caused erosion of the slope surface. Observation below the water level could not been made and thus, potential river scouring effect below the water at the abutment walls by visual observations could not been made (Photographs 5 and 6). No visible signs of foundation settlement were observed.

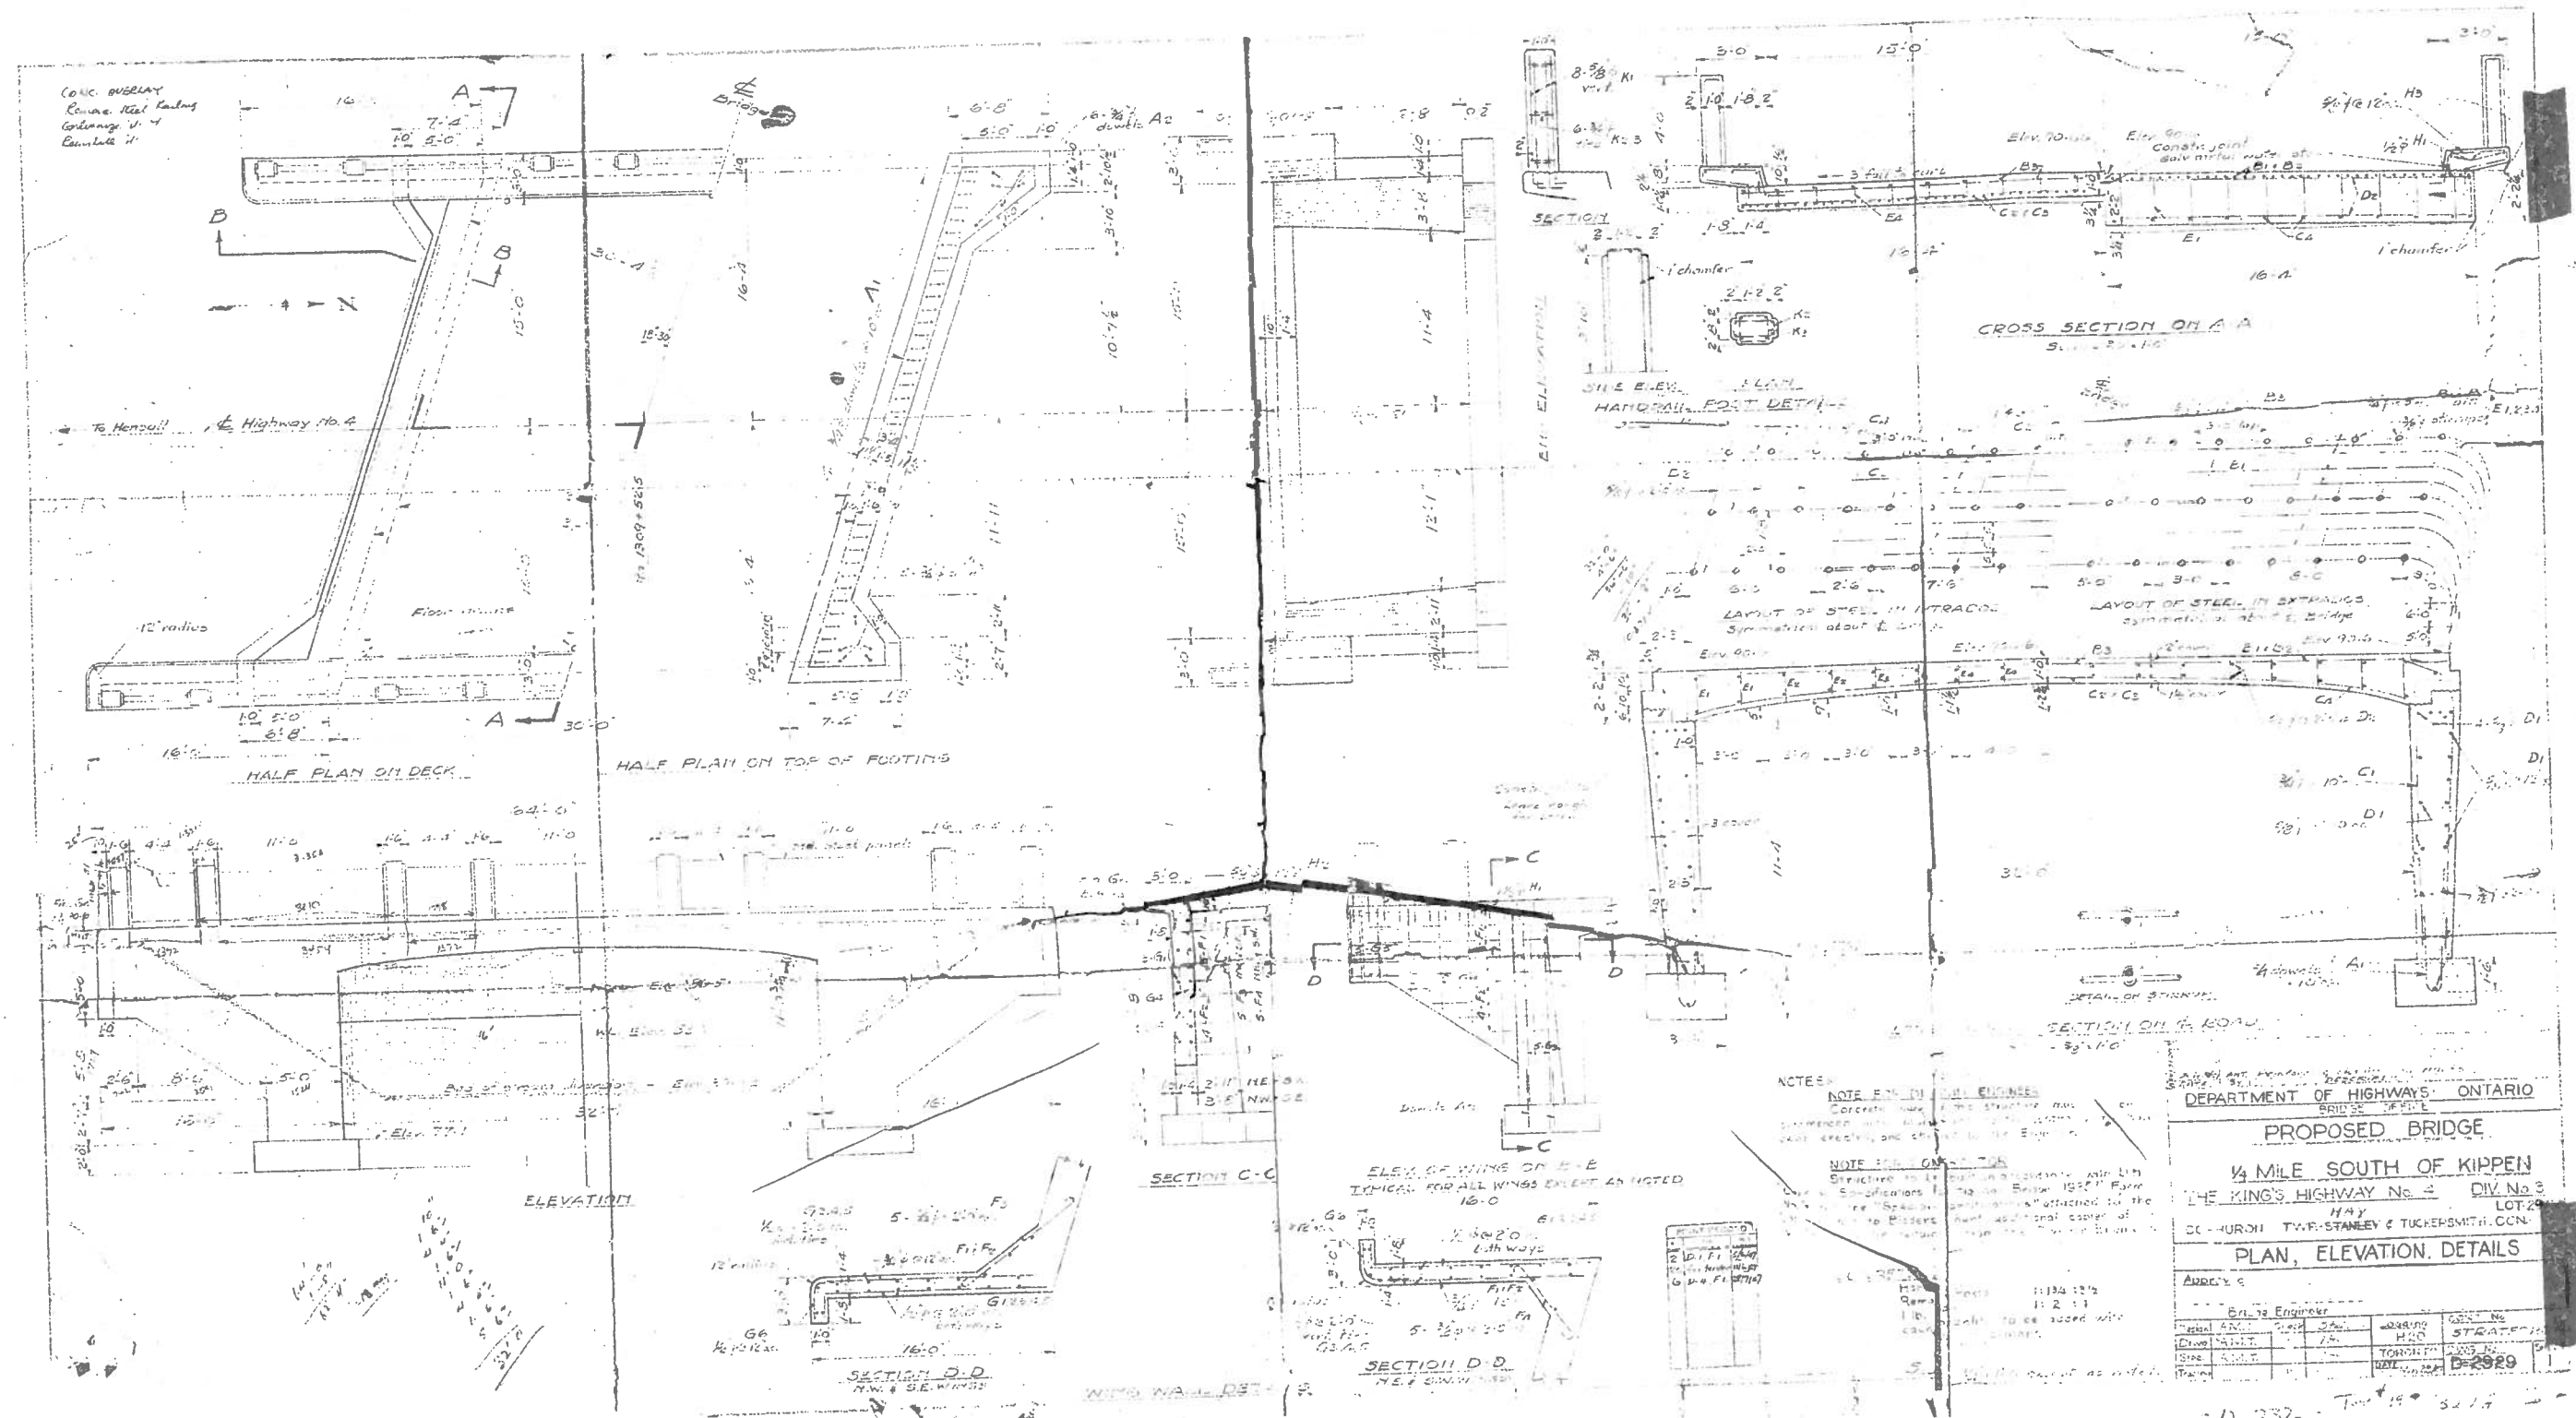
GENERAL ARRANGEMENT DRAWING MAY 28, 1947

Based on the general arrangement drawing "*Proposed Bridge*" from May 28, 1947 (attached) it is understood that the existing structure is supported on spread footings that are approximately 2.1 m wide and 0.6 m thick. These footings are founded approximately 5.0 m below the existing bridge deck, near elevation 265.3.
