FOUNDATION TECHNICAL MEMORANDUM

**THAMES RIVER BRIDGE EBL AND WBL
HIGHWAY 402
MTO WEST REGION 59 STRUCTURE REHABILITATIONS
SITE 19-536-1 AND 19-536-2, CONTRACT 4
GWP 3102-10-00
DELAWARE AND STRATHROY-CARADOC TOWNSHIP
COUNTY OF MIDDLESEX, ONTARIO**

PML Ref.: 13KF006D-TR
Index No.: 373FTM
GEOCRES No.: 40114-93
November 15, 2017

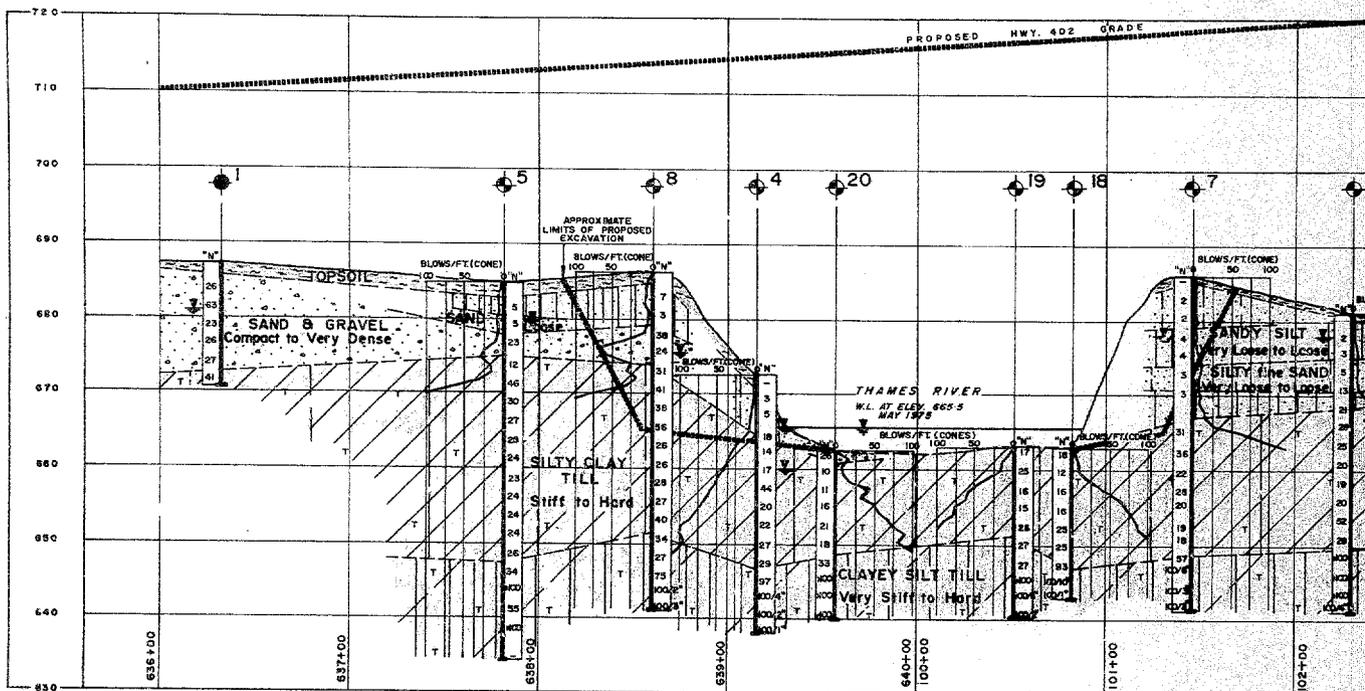
SECTION ALONG WEST-BOUND STRUCTURE

Groundwater levels were observed in the boreholes during drilling and perforated standpipes and piezometers were installed in the completed boreholes as detailed on the Record of Borehole sheets. The measured groundwater levels are shown on the Records of Boreholes and on the stratigraphic sections, Figures 1 and 2.

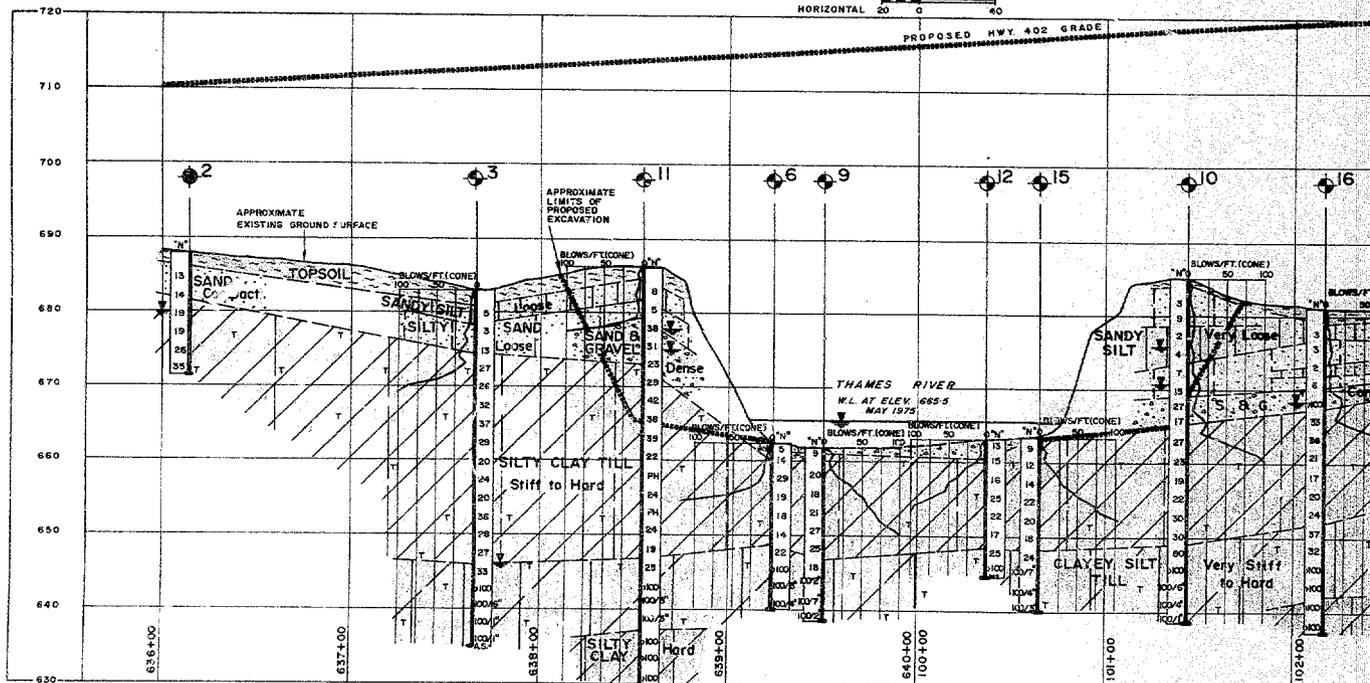
SECTION ALONG EAST-BOUND STRUCTURE

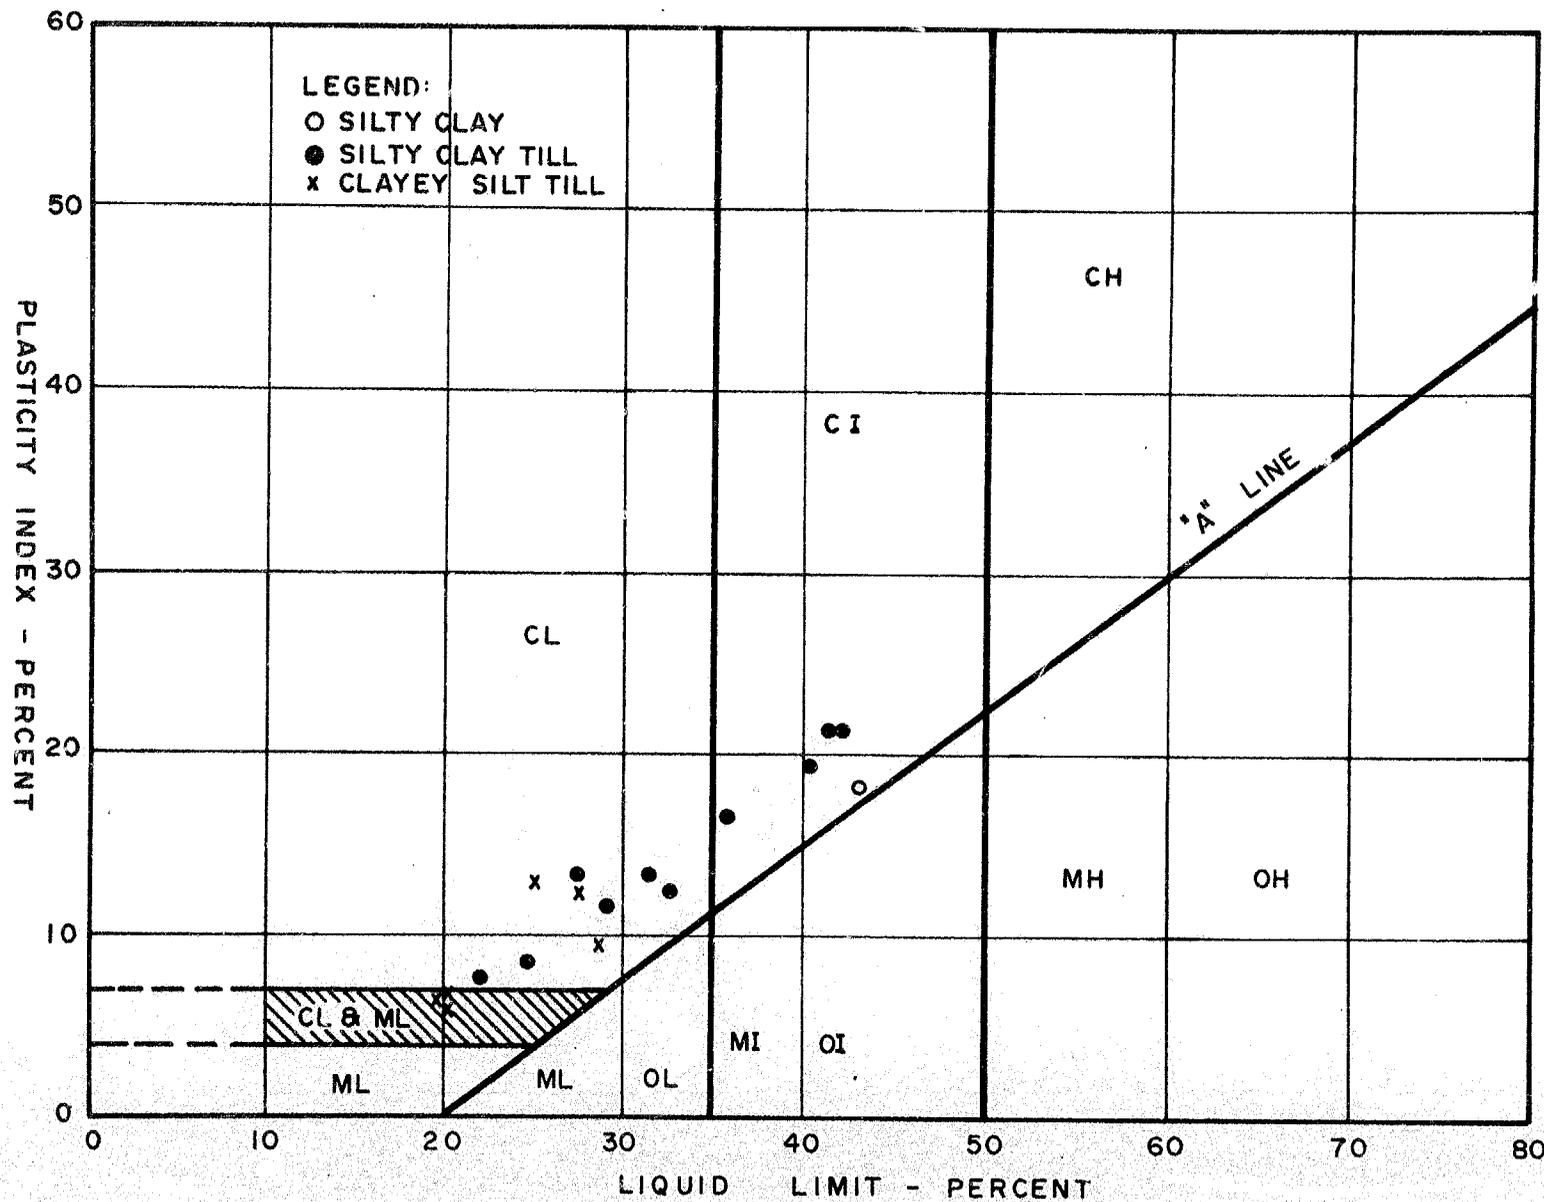
FIGURE 3

PLASTICITY CHART

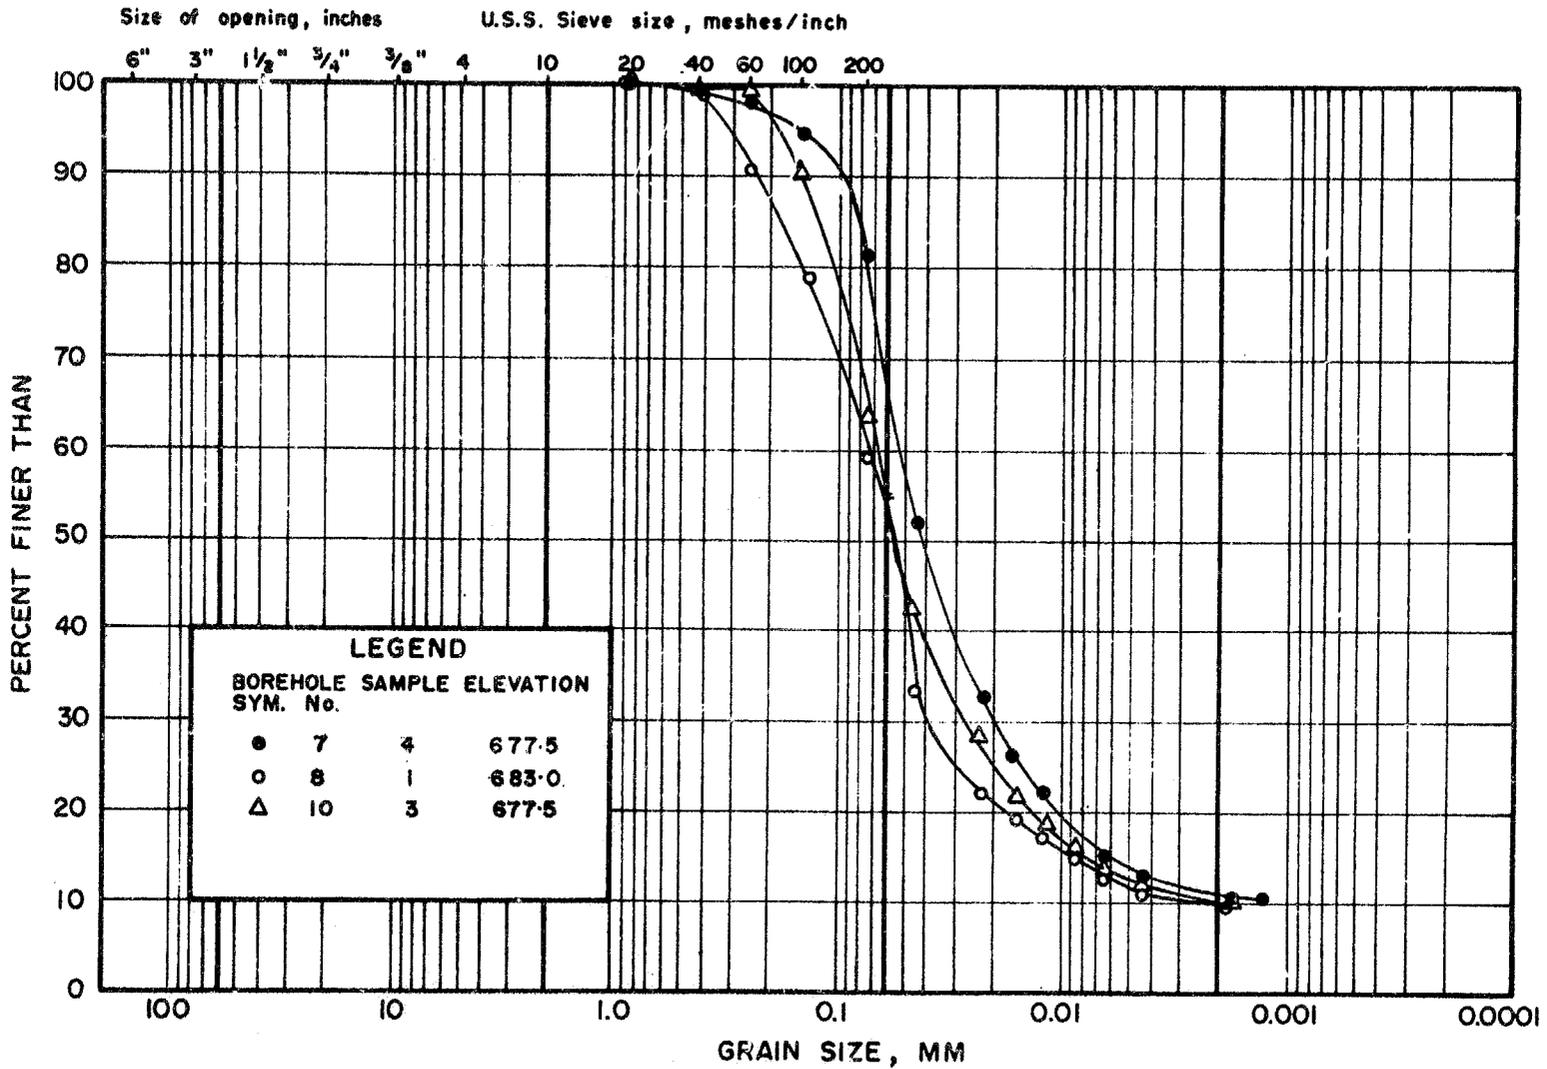
FIGURE 4

GRAIN SIZE DISTRIBUTION
SANDY SILT

Beneath the topsoil in boreholes 3, 5, 8, 11, 13, 16 and 17, and a layer of silty fine sand in boreholes 7 and 10, layers of very loose to loose sandy silt were encountered. These silt layers varied in thickness from 2 to 5 feet at borehole locations and had N values of from 2 to 8 blows per foot. The sandy silt was generally loose with a representative N value of 4 blows per foot. The natural water content of the sandy silt varied from 12 to 29 per cent with an average value of about 21 per cent. Typical grain size distribution curves for the sandy silt layers are shown on Figure 4.

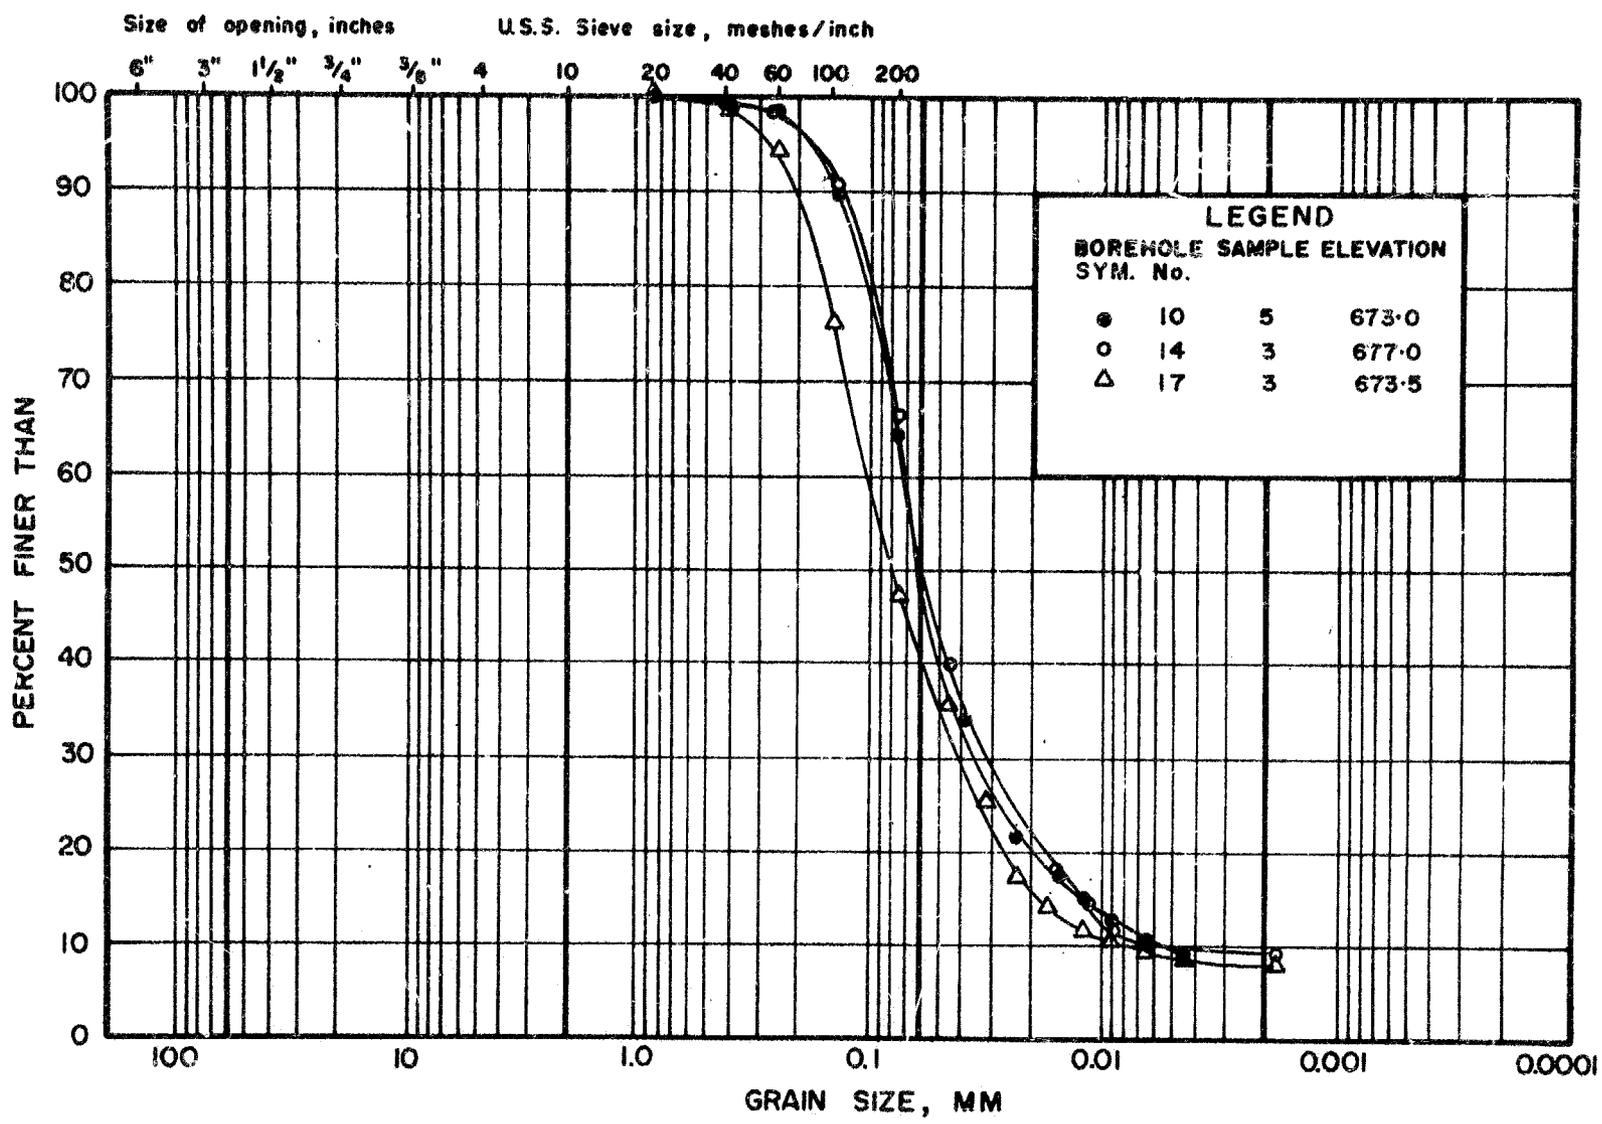
FIGURE 5

GRAIN SIZE DISTRIBUTION
SILTY fine SAND

Underlying the sandy silt in boreholes 3, 11, 16 and 17 and the topsoil in boreholes 4, 7 and 10, layers of very loose to loose silty fine sand were encountered. Additional layers of silty fine sand were found interlayered with the sandy silt in boreholes 7, 10 and 16. The silty fine sand layers varied in thickness from 2 to 8 feet. The measured N values varied from 2 to 15 blows per foot and the silty fine sand was generally loose with a representative N value of 6 blows per foot. The natural water content of the silty fine sand varied from 13 to 35 per cent with an average value of about 22 per cent. Typical grain size distribution curves for the silty fine sand layers are shown on Figure 5.

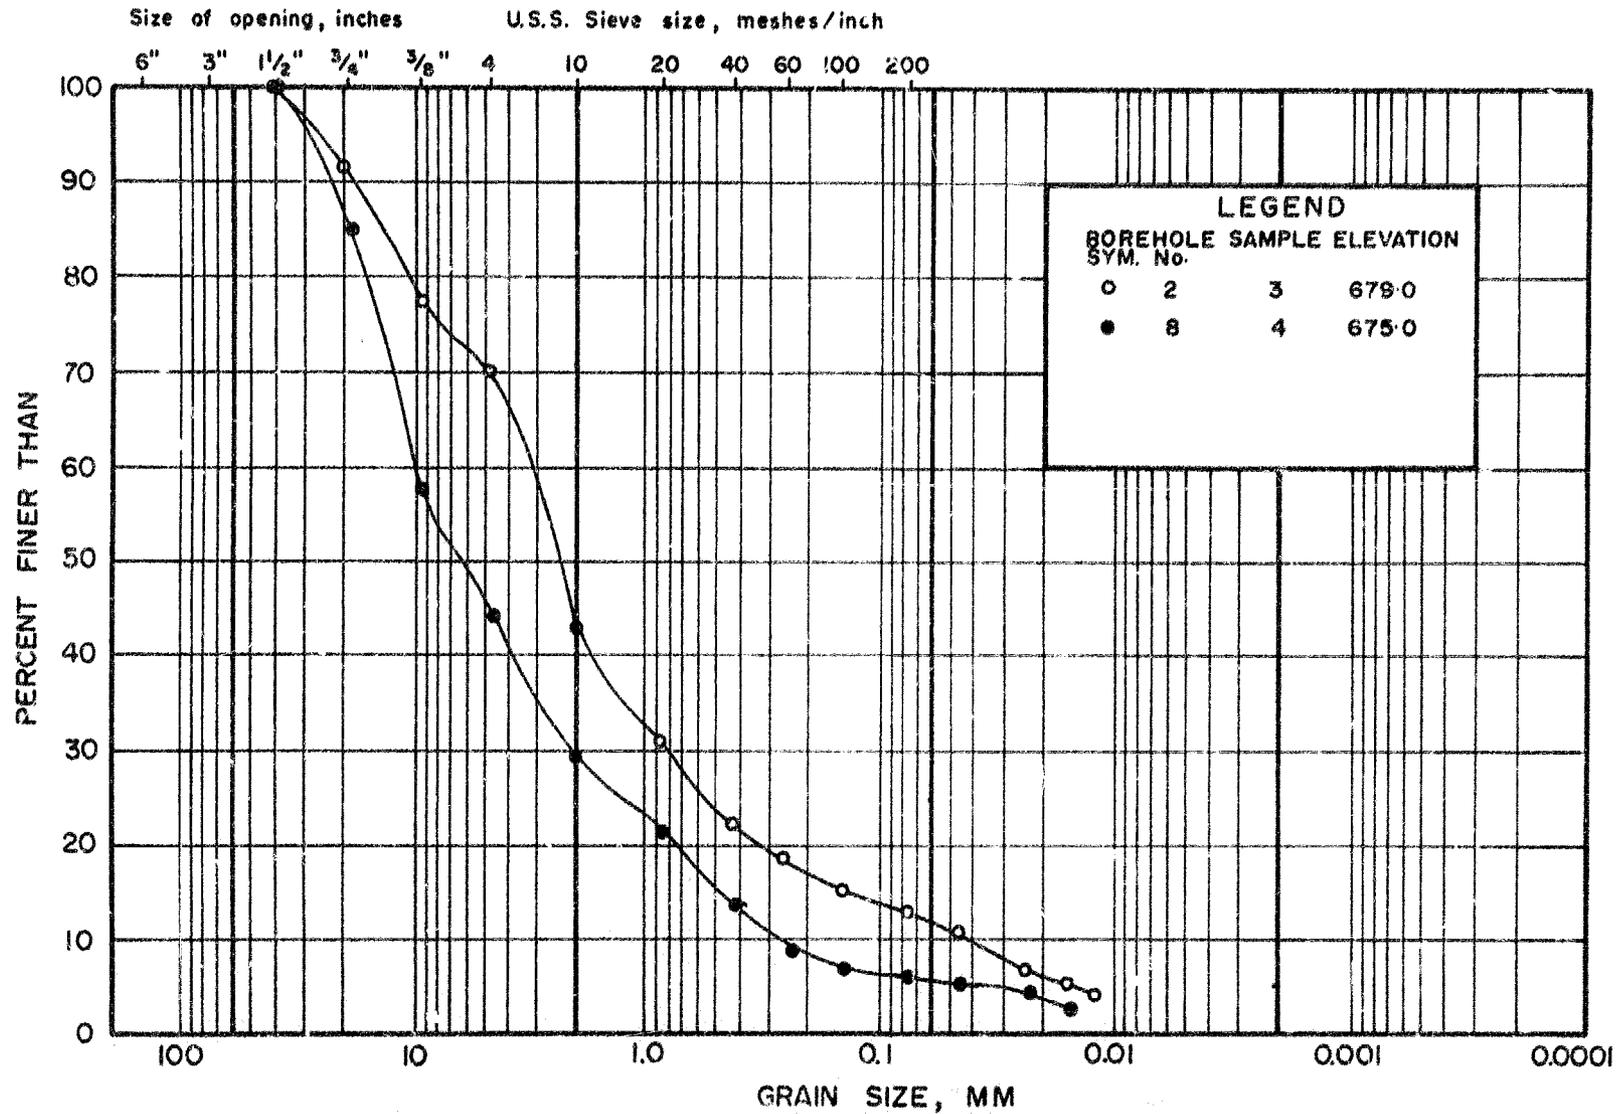
GRAIN SIZE DISTRIBUTION
SAND AND GRAVEL

Below the sandy silt and silty fine sand layers in boreholes 3, 5, 8, 10, 11, 16 and 17 and the topsoil in boreholes 1 and 2 and forming the river bed in boreholes 6, 9 and 12, strata of sand to sand and gravel were found. The sand and gravel strata varied in thickness from 1 to 13 feet at borehole locations and had N values of from 5 to greater than 100 blows per foot. The sand and gravel was generally compact with a representative N value of 23 blows per foot. The natural water content of the sand and gravel varied from 5 to 26 per cent with an average value of about 12 per cent. Typical grain size distribution curves for the sand and gravel strata are shown on Figure 6.

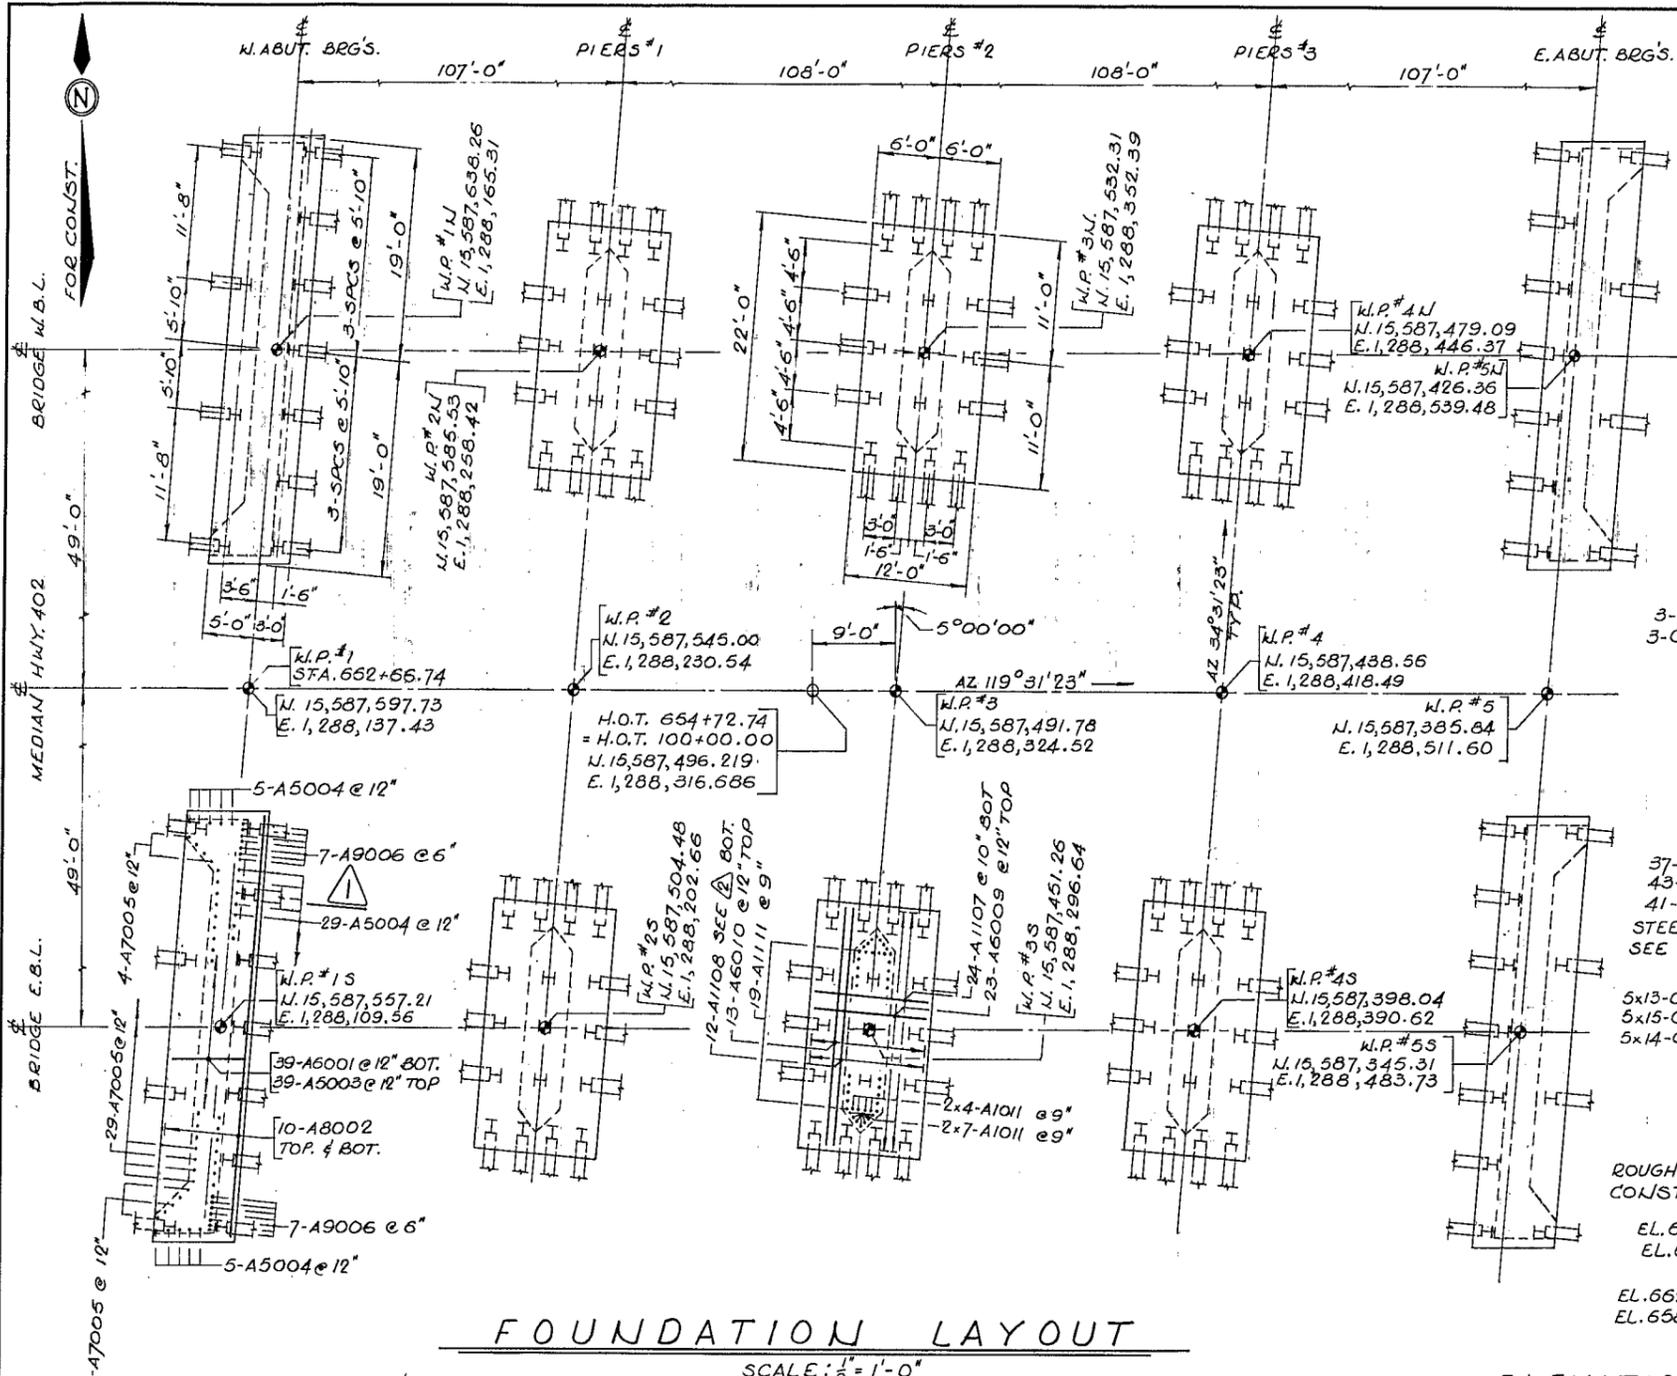
SHEET
139

THAMES RIVER BRIDGES
7.8 Miles West of Hwy.4
FOUNDATION LAYOUT & PIERS

FOUNDATION LAYOUT
SCALE: 1/8" = 1'-0"

- Notes:**
- Reference 3, Foundation Layout & Piers includes a Table titled Pile Data which shows the Pile Lengths. The pile tip elevation was computed from the pile cut off elevation and vertical pile component, as applicable. The actual construction records of the pile driving operations were not available for review and accordingly the pile tip elevations should only be considered approximate but nevertheless useful information. Working stress pile load is provided on Reference 3, Notes.
 - Working stress design values. The Serviceability Limit State design values are based on the working stress. No field verifications were made.
 - Resistance Factor = 0.4 for deep foundations (CFEM, 4th edition) for calculation of ULS.

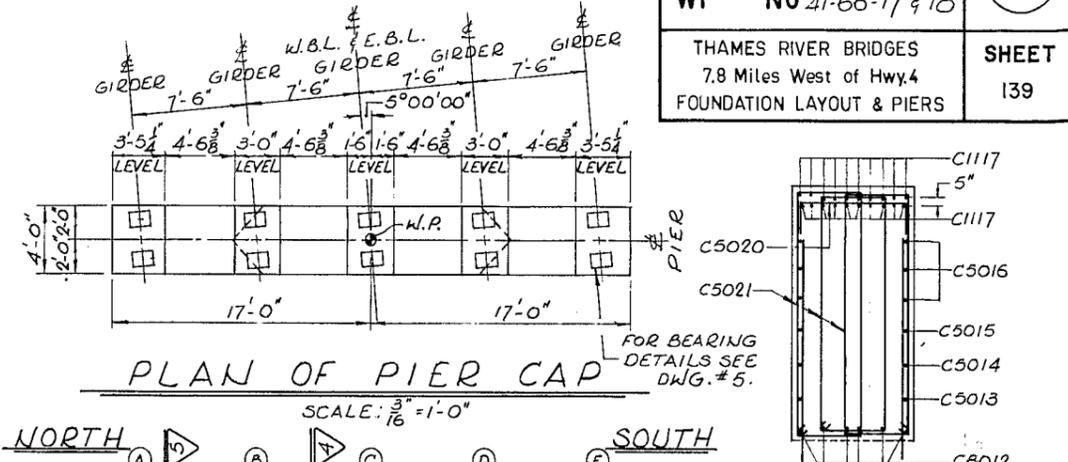
PLAN OF PIER CAP
SCALE: 3/16" = 1'-0"

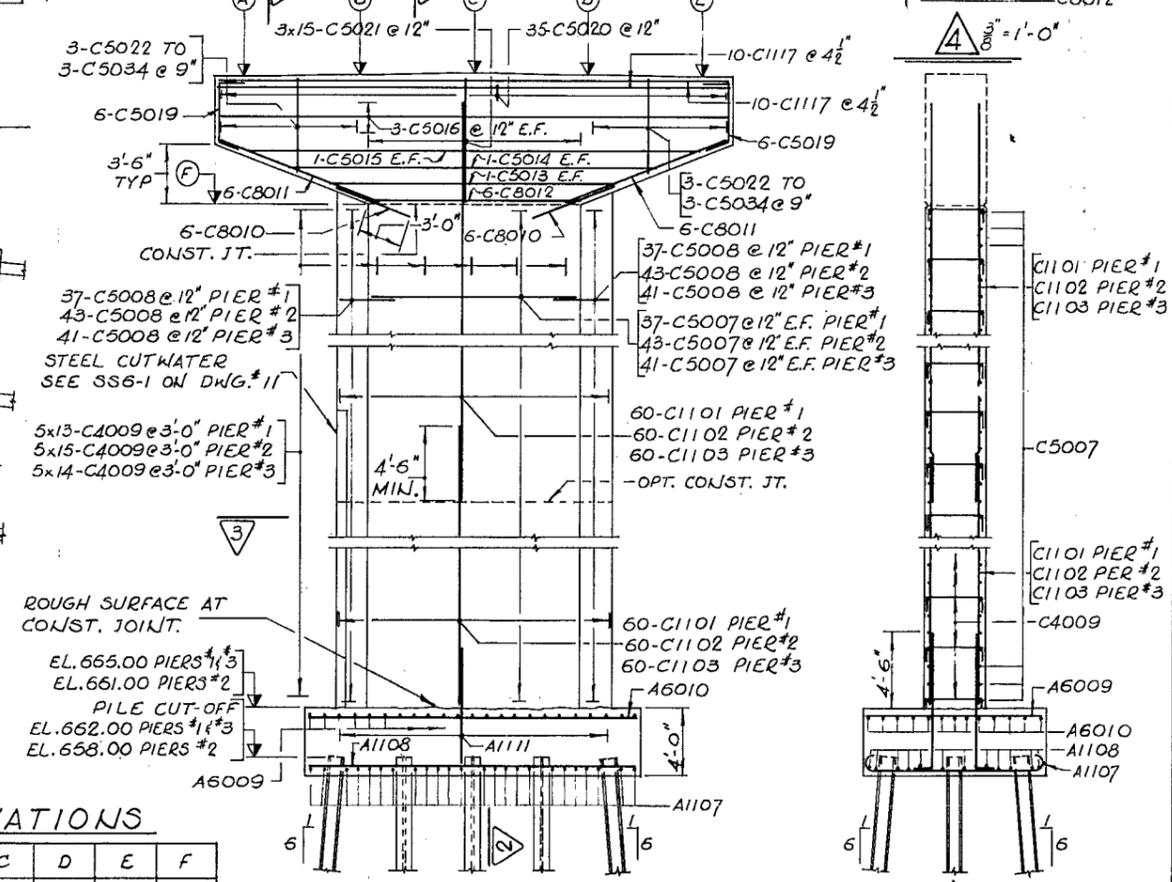
TYP. PIER ELEVATION
SCALE: 3/16" = 1'-0"

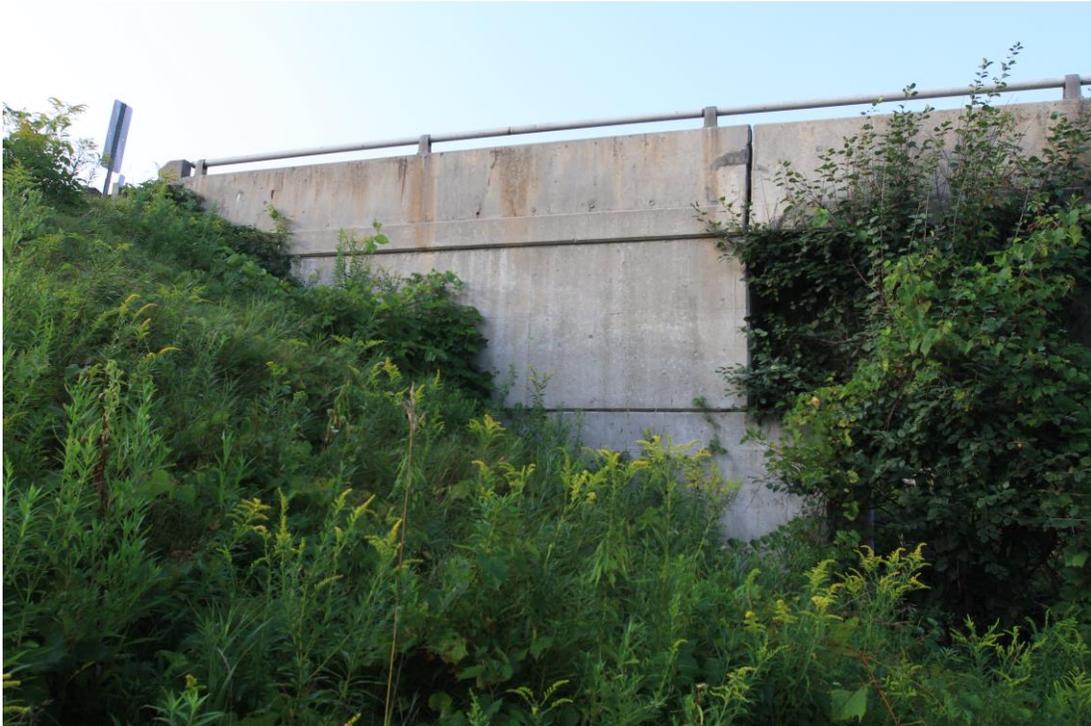
Photograph 1: Westbound Lane, East Abutment and North Wingwall. Abutment slopes are grass covered and no obvious signs of erosion observed on slope (September 2, 2015).

The north and south slopes of the EBL and WBL east and west abutments were grass covered during the site reconnaissance. The abutment slopes showed no obvious signs of erosion (Photographs 1, 2, and 5). The abutments for both the EBL and WBL structures generally appear to be free of major surficial cracks or defects (Photographs 3 and 7). The visible portion of the piers appear to be free of major surficial cracks or defects (Photographs 4 and 8). Noticeable spalling of the bridge deck concrete was observed on the south wingwall of the east abutment, EBL (Photograph 6).

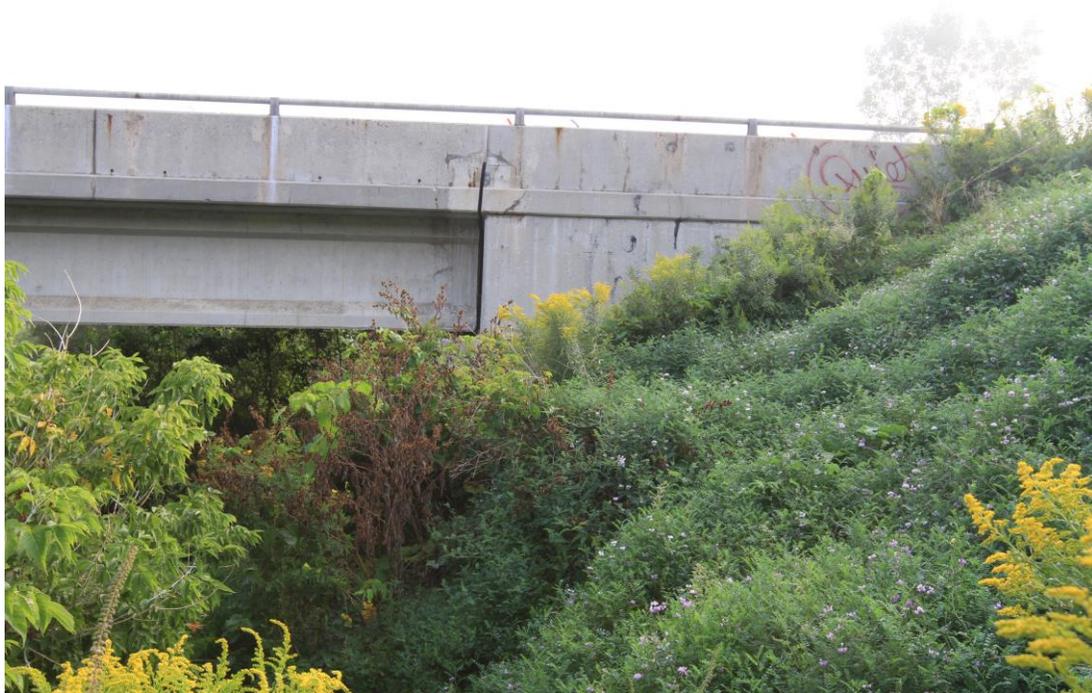
Photograph 2: Westbound Lane, West Abutment. Abutment side slopes are grass covered and no obvious signs of erosion observed on abutment side slopes (September 2, 2015).

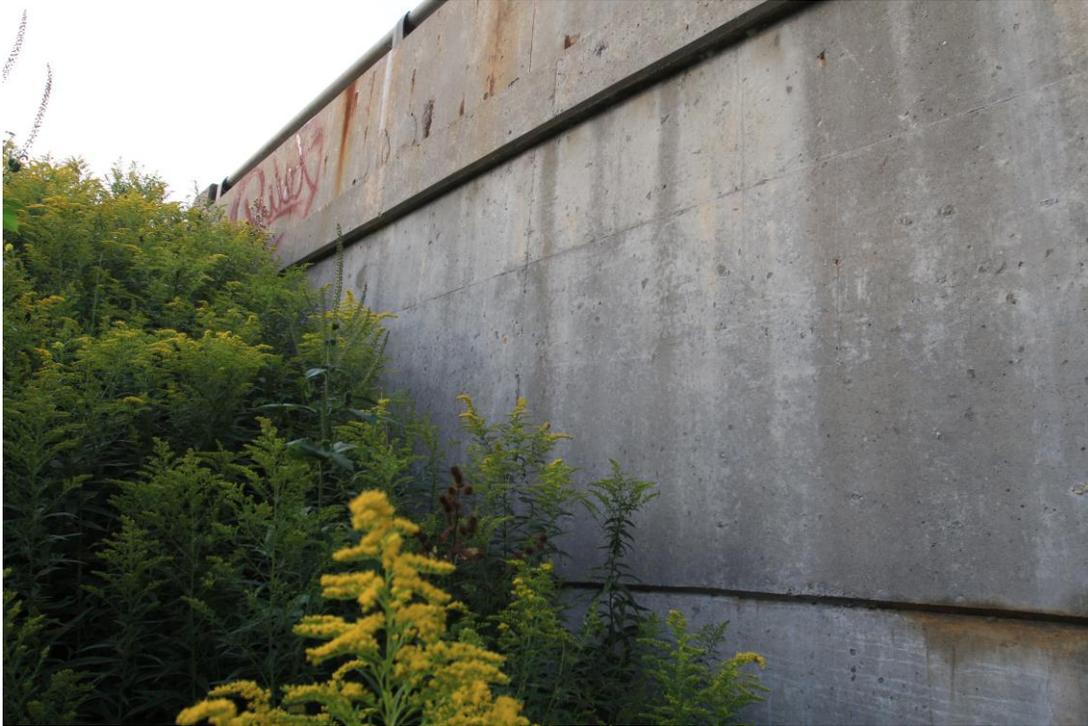
Photograph 5: Eastbound Lane, East Abutment and North Wingwall. Abutment side slopes are grass covered and no obvious signs of erosion observed on abutment side slopes (September 2, 2015).

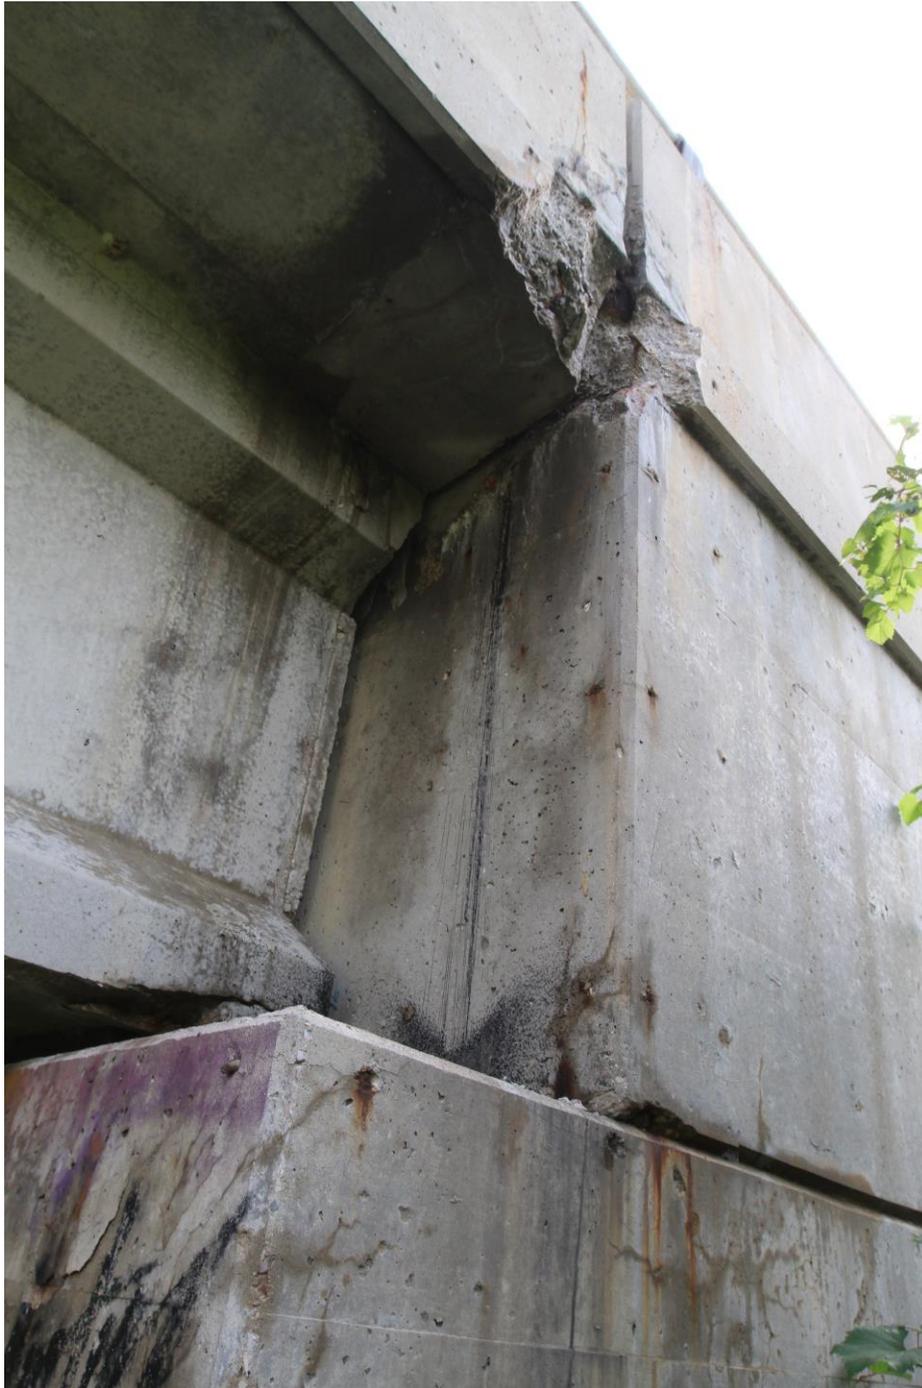
Photograph 6: Eastbound Lane, East Abutment and South Wingwall. Spalling of Bridge Deck Concrete observed (September 2, 2015).

Post construction, the faces of the adjacent slopes of the abutments should be suitably rehabilitated to mitigate erosion effects. The central portion of the abutments are protected with a vertical concrete retaining walls, which generally appear to be free of major surficial cracks or defects, however they must be evaluated by a structural engineer for age related deficiencies and general wear and tear. Bridge deck concrete spalling noted on the south wingwall of the east abutment, EBL must be remediated and the bridge deck inspected for structural defects.
