FOUNDATION TECHNICAL MEMORANDUM

**MCDUGALL DRAIN BRIDGE EBL ON HIGHWAY 401
MTO WEST REGION 59 STRUCTURE REHABILITATIONS
SITE 13-190-1, CONTRACT 7
GWP 3084-11-00
GEOGRAPHICAL TOWNSHIP OF TILBURY EAST
KENT COUNTY, ONTARIO**

PML Ref.: 13KF006E-MD
Index No.: 241TMEM
Geocres No.: 40J08-006
June 17, 2015

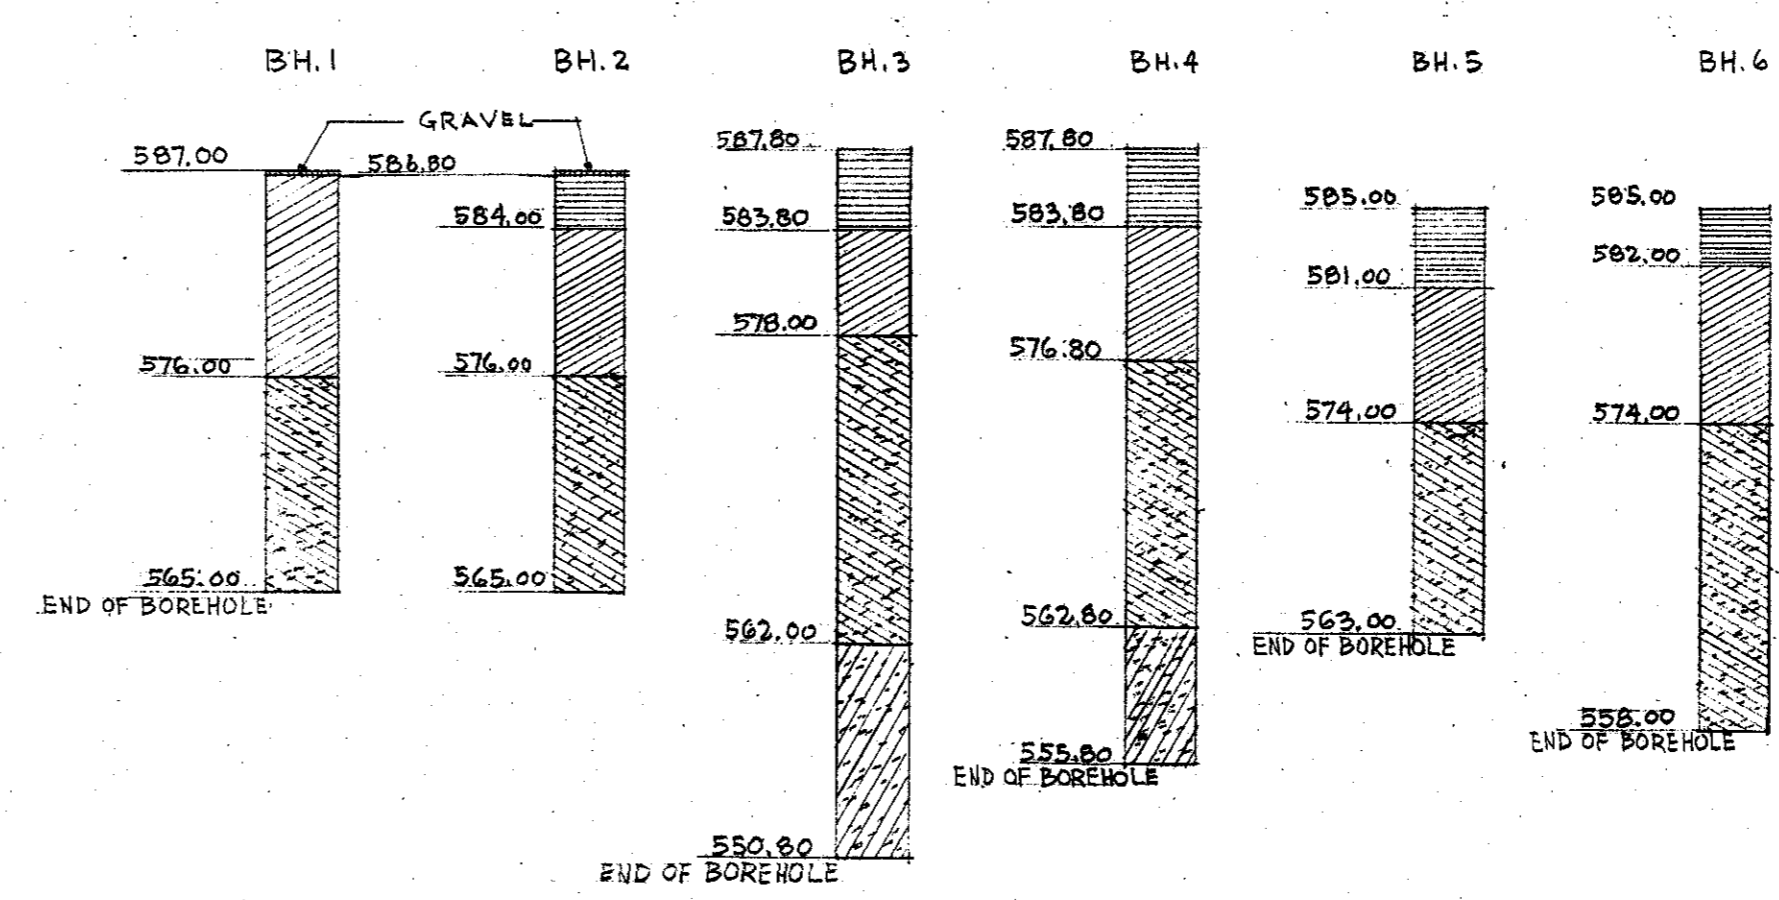
BOREHOLE DETAILS
SCALE: 1 INCH = 10'-0"

- LEGEND**
- BROWN SANDY CLAY.
 - STIFF BROWN SILTY CLAY.
 - STIFF GREY SILTY CLAY APPROX. 8% FINE TO MEDIUM GRAVEL.
 - SOFT TO MEDIUM GREY SILTY CLAY APPROX. 8% FINE TO MEDIUM GRAVEL.

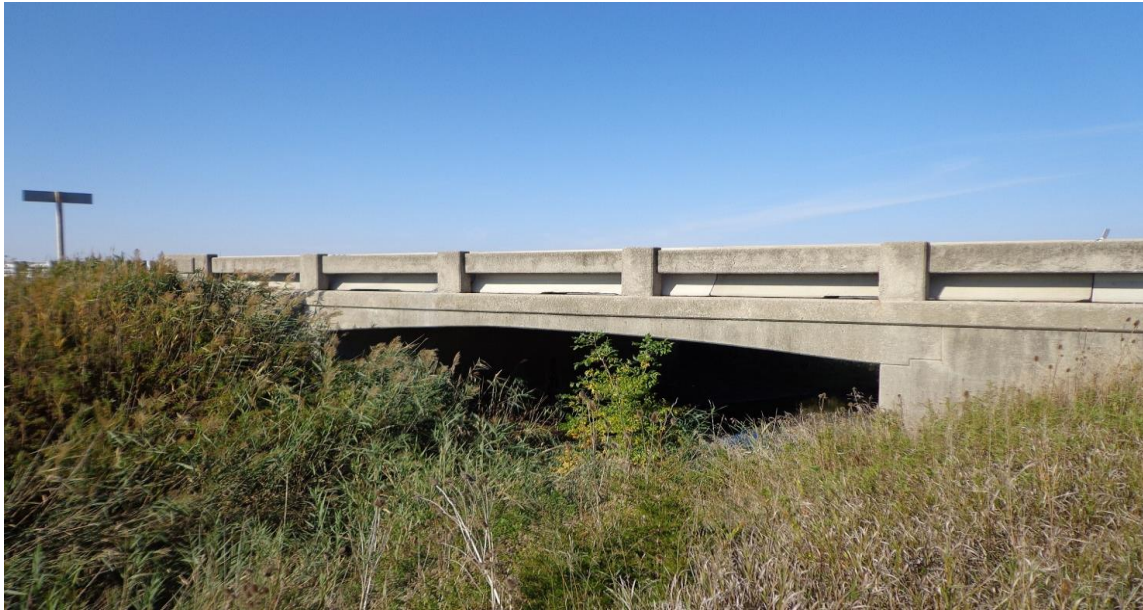
Photograph 1: Looking northwest at the McDougall Drain Bridge EBL from south side of the bridge. The two adjacent slopes flanking the drain on the south side of the bridge were heavily vegetated. No erosion of the slope faces was observed. (October 20, 2013)

The adjacent slopes were heavily vegetated with grasses and bushes (Photographs 1, 4 and 5). The slopes were not affected by erosion. Sheet piles were observed in front of the abutments (Photographs 2, 3, and 4) that protected the foundation of the abutments from scouring effects. No obvious major cracks were observed on the abutment walls, except some surficial cracks. Open weep holes were observed in the abutment walls (Photographs 2 and 3).

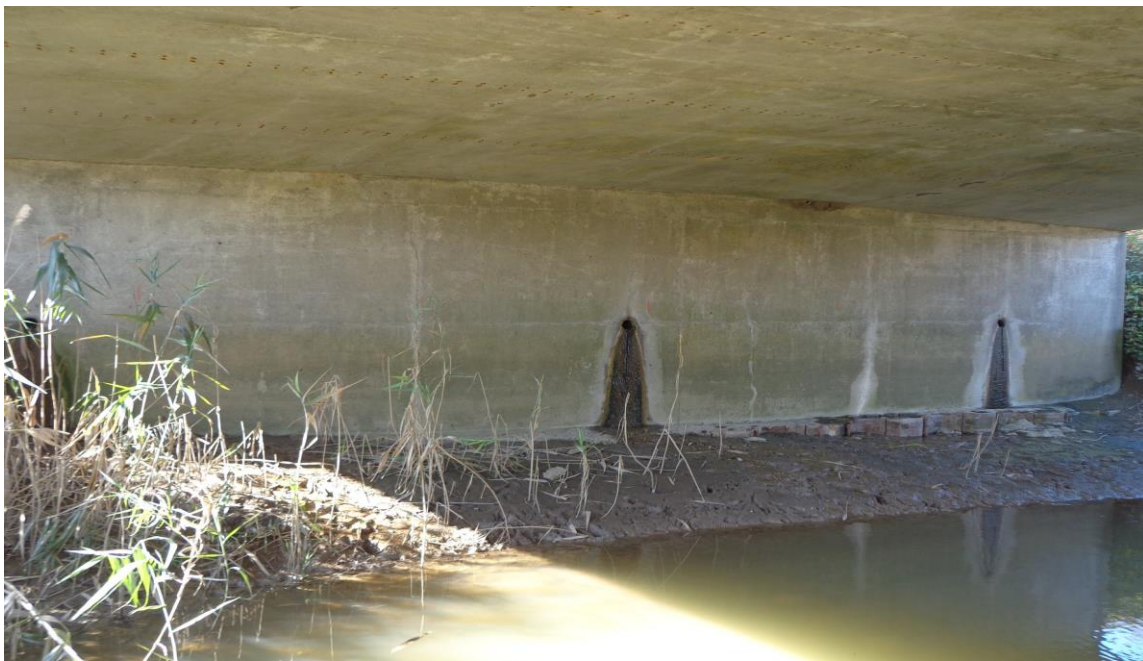
Photograph 2: Looking at the east abutment of the structure. The piling sheets driven were visible. The weep holes observed were open and wet. The exposed earth was affected by scouring. (October 20, 2013)

Further, it is suggested that the weep holes in the abutment walls should be maintained and cleaned at a regular basis to prevent any clogging of the holes. Regular maintenance of the weep holes will keep the water flowing from behind the abutment walls and will mitigate hydrostatic pressure to build-up behind the abutment and retaining walls.

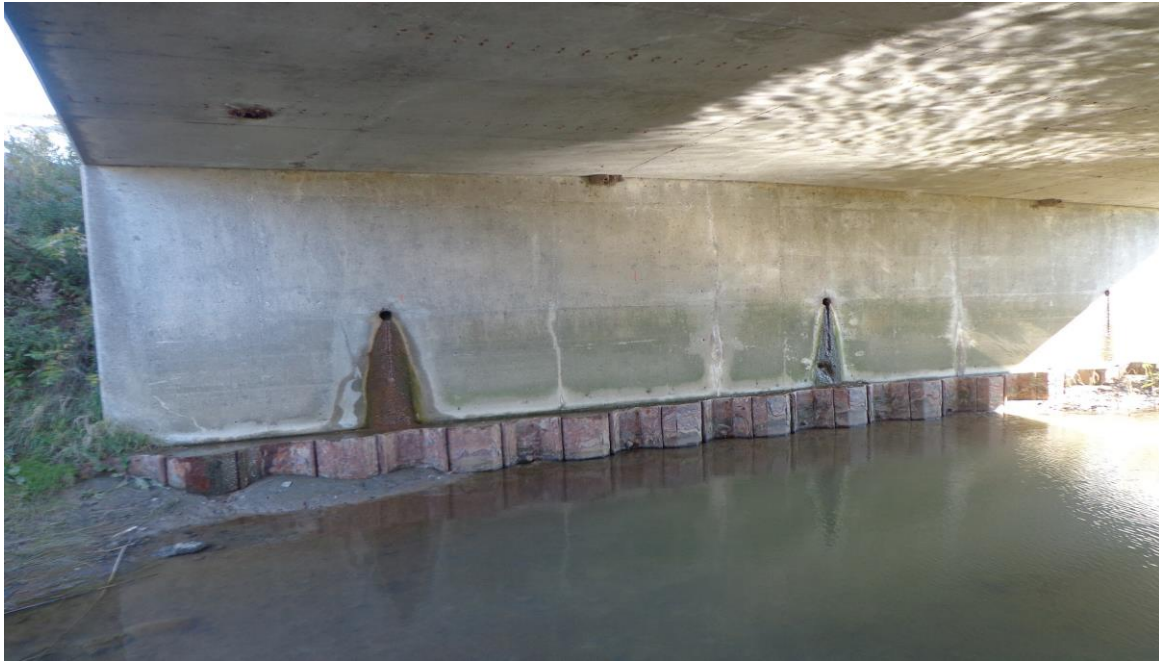
Photograph 3: Looking at the west abutment of the structure. The piling sheets driven were visible. The weep holes observed were open and wet. The exposed earth was affected by scouring. (October 20, 2013)

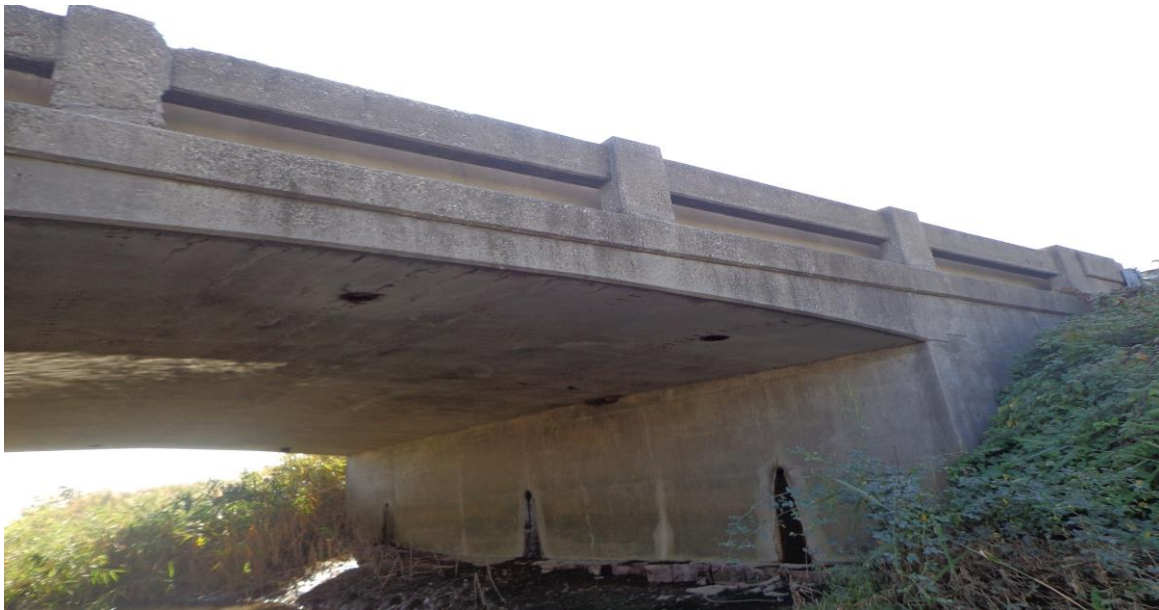
Photograph 4: Looking at the east abutment of the structure. The piling sheets driven were visible. The adjacent north slope of the abutment was vegetated and erosion of the slope face was not observed. (October 20, 2013)

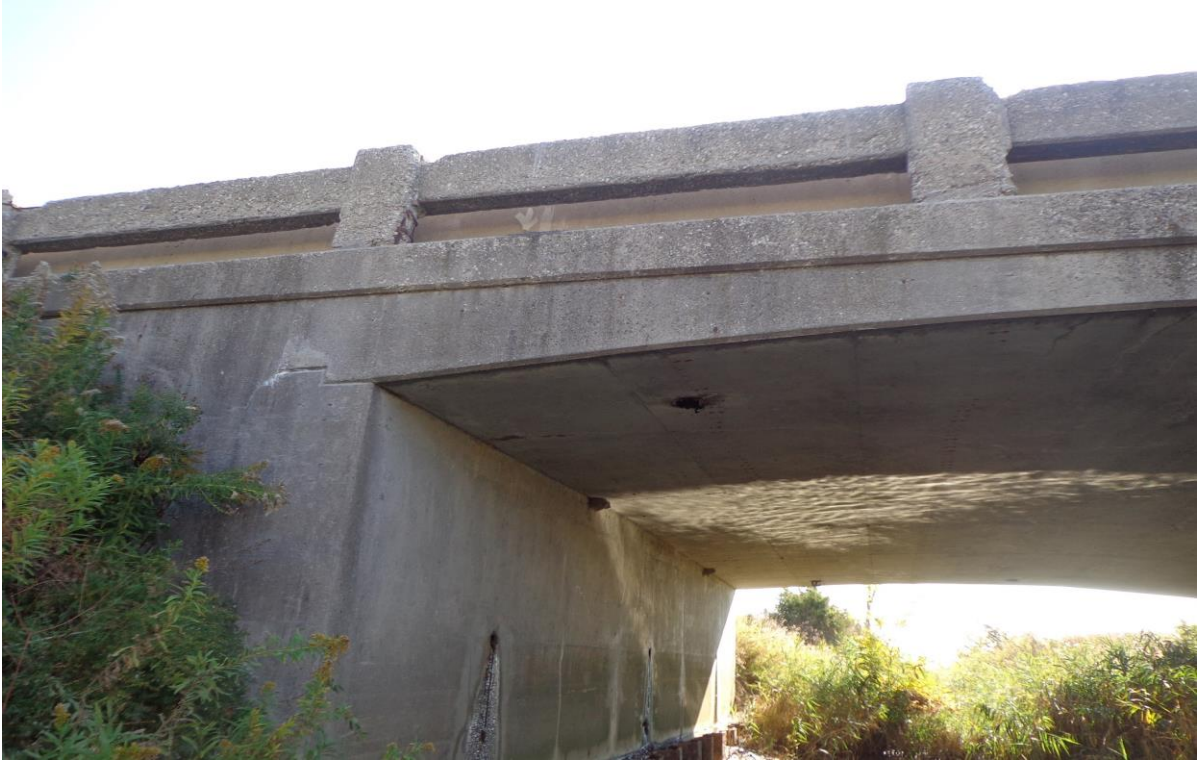
Photograph 5: Looking at the west abutment of the structure. The piling sheets driven were visible. The adjacent north slope of the abutment was vegetated and erosion of the slope face was not observed. (October 20, 2013)
