FOUNDATION TECHNICAL MEMORANDUM

**QUEEN STREET EBL OVERPASS ON HIGHWAY 401
MTO WEST REGION 59 STRUCTURE REHABILITATIONS
SITE 6-51-1, CONTRACT 7
GWP 3084-11-00
TOWNSHIP OF TILBURY NORTH
KENT COUNTY, ONTARIO**

PML Ref.: 13KF006E-Q
Index No.: 233TMEM
Geocres No.: 40J08-002
June 17, 2015

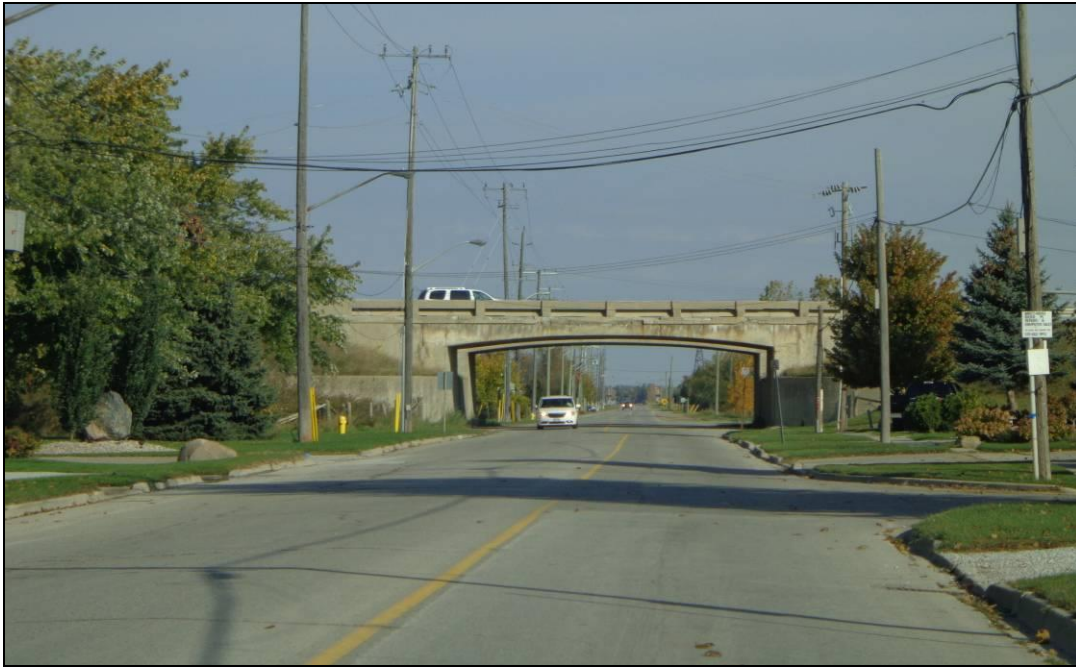
Photograph 1: Looking north at the Queen Street Overpass EBL structure from about 200 m south of the overpass on Queen Street North. (October 20, 2013)

As part of the current foundation engineering assessment study, a site reconnaissance of the Queen Street EBL Overpass (Photograph 1) was carried out on October 20, 2013. A photographic record of the site visit is attached in Appendix B.

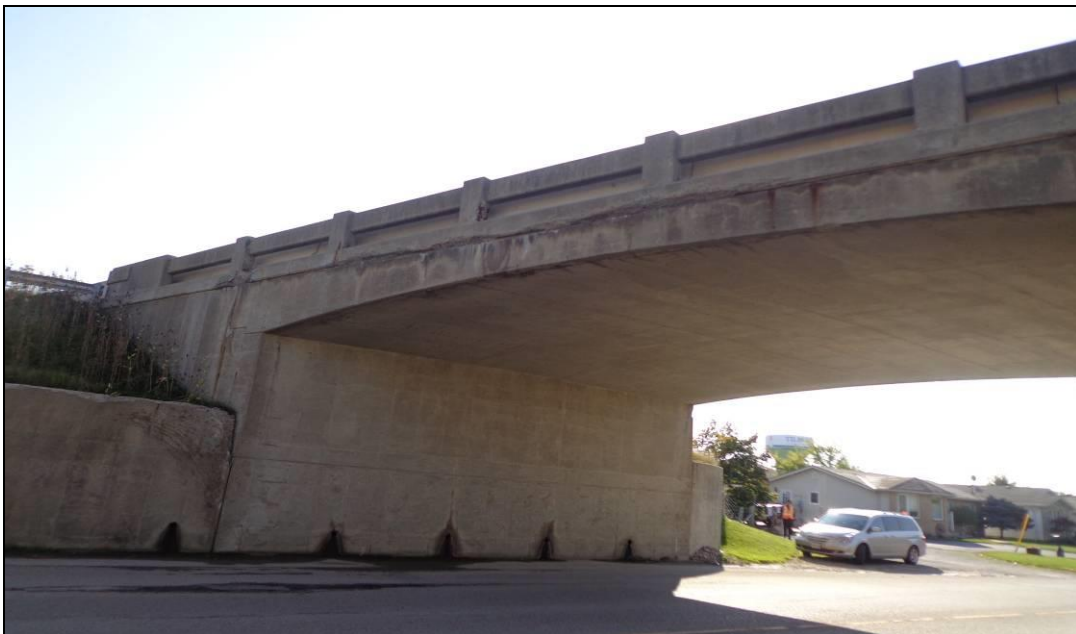
Photograph 2: Looking at the east abutment of the structure from northwest corner of the structure. The north and south slopes adjacent to the east abutment were vegetated with no signs of erosion. The slopes were retained with retaining wall structures. Weep holes were visible coming out the abutment and retaining walls. (October 20, 2013)

The adjacent slopes of the abutments were observed to be vegetated and were restrained by retaining wall structures (Photographs 2 and 3). No erosion of the slope faces was observed. No obvious major cracks were observed on the abutment walls except for some minor cracks. Open weep holes were observed in the abutment walls (Photographs 2 and 3). Concrete deteriorations and rebar exposure was observed on the wingwalls, deck and barriers, which will require rehabilitation.

Further, it is suggested that the weep holes in the abutment walls should be maintained and cleaned at a regular basis to prevent any clogging of the holes. Regular maintenance of the weep holes will keep the water flowing from behind the abutment walls and will mitigate hydrostatic pressure to build-up behind the abutment and retaining walls.

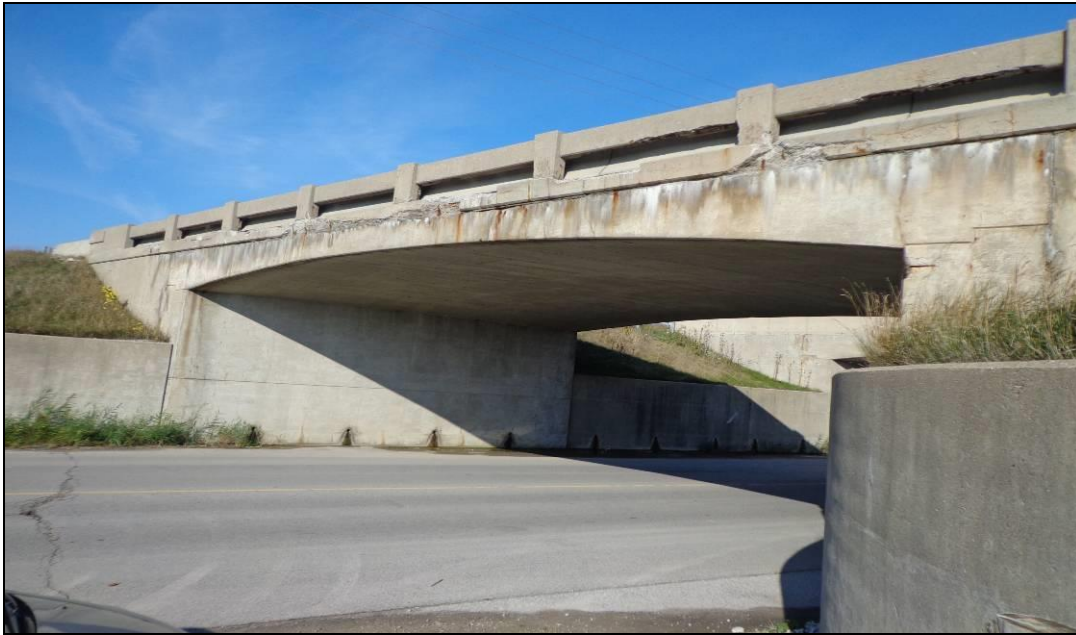
Photograph 3: Looking northwest at the west abutment wall of the structure from the southeast corner of the structure. The north and south slopes adjacent to the west abutment were vegetated with no signs of erosion. The slopes were retained with retaining wall structures. Weep holes were visible coming out the abutment and retaining walls. (October 20, 2013)
