FOUNDATION TECHNICAL MEMORANDUM

**MEDWAY CREEK BRANCH BRIDGE (BIRR)
MTO WEST REGION 59 STRUCTURE REHABILITATIONS
HIGHWAY 4, SITE 19-160, CONTRACT 5
GWP 3062-11-00
GEOGRAPHIC TOWNSHIP OF LONDON
MIDDLESEX COUNTY, ONTARIO**

PML Ref.: 13KF006F-M3
Index No.: 223TMEM
Geocres No.: 40P03-003
June 17, 2015

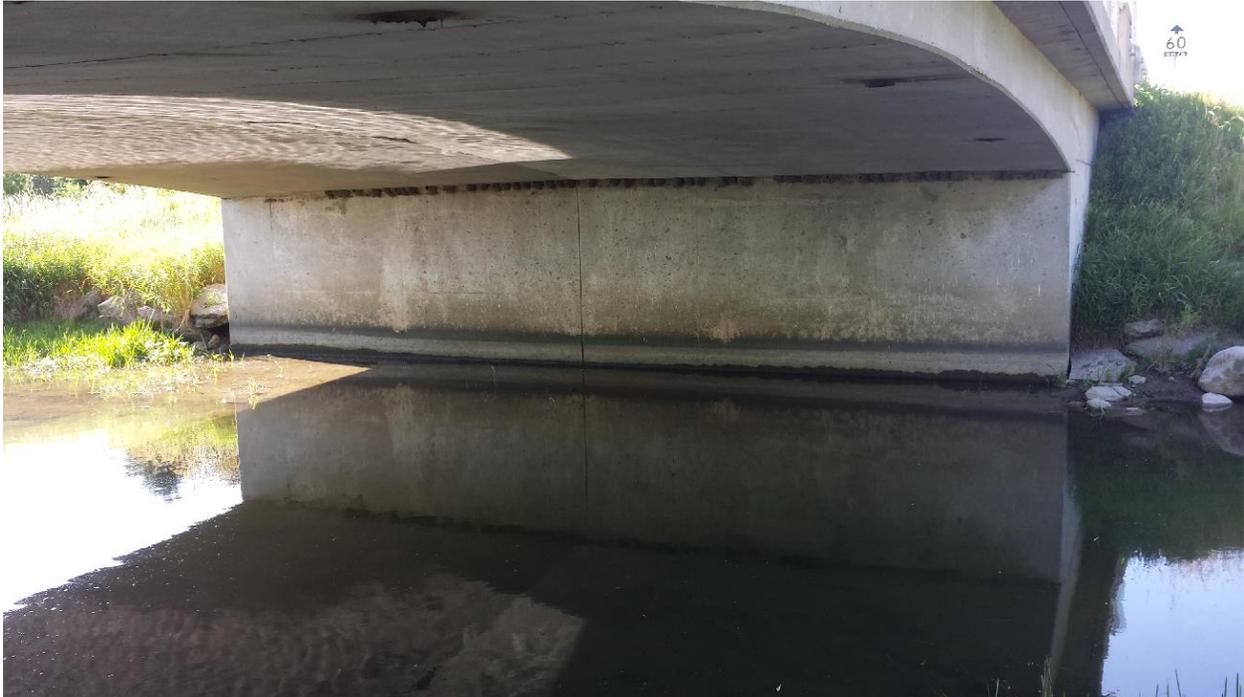
Photograph 1: Looking at the north abutment from the southeast corner of the bridge site. No obvious cracks were observed on concrete. Scouring effect below the water could not be established. (July 24, 2014)

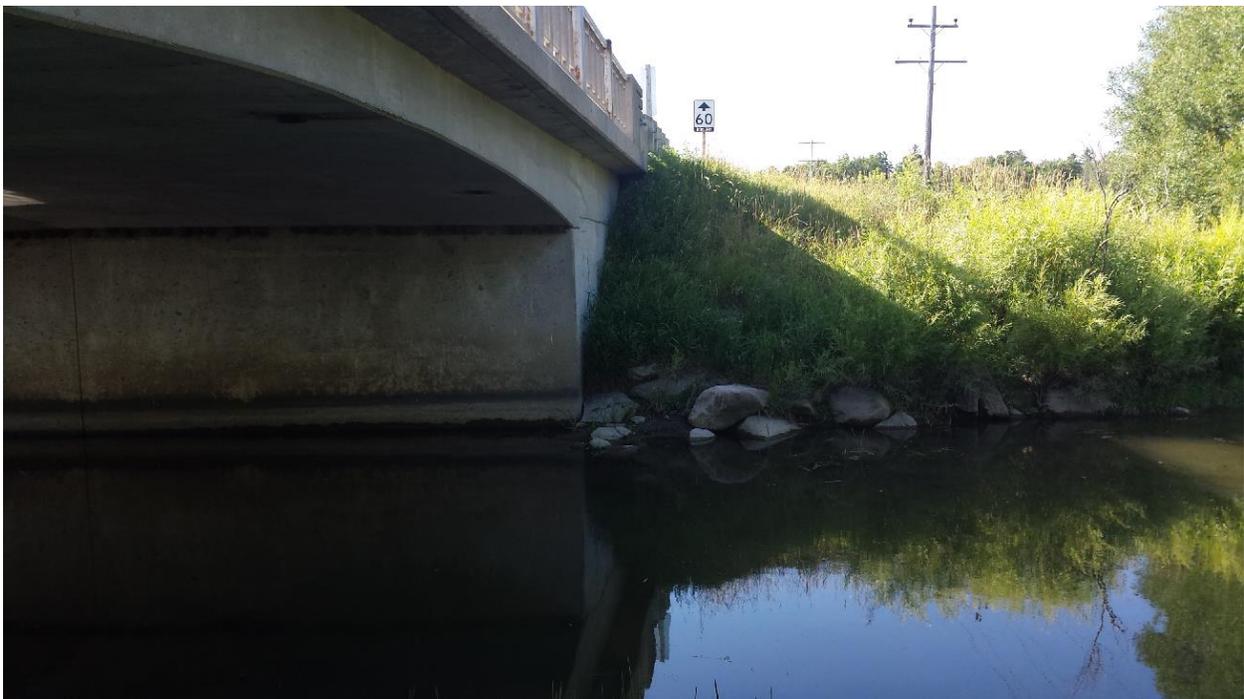
Photograph 2: Looking north at the east adjacent slope. The slope was covered with grass and bushes. Rock pieces were observed at the slope toe to protect from scouring effects. (July 24, 2014)

The slopes adjacent to the abutments were vegetated (Photographs 2, 3, 5 and 6). Rocks placed on slope faces and at the toes were observed to protect against erosion and scouring of exposed earth soils. The slopes were visibly in stable condition. Slight scouring was observed at the slope toes. No obvious major cracks were observed on the abutment walls except for some surficial cracks (Photographs 1 and 4). The effect of erosion or scouring at the abutment walls could not be established below the creek water level. No weep holes or drainage systems were observed in the abutment walls or adjacent slopes.

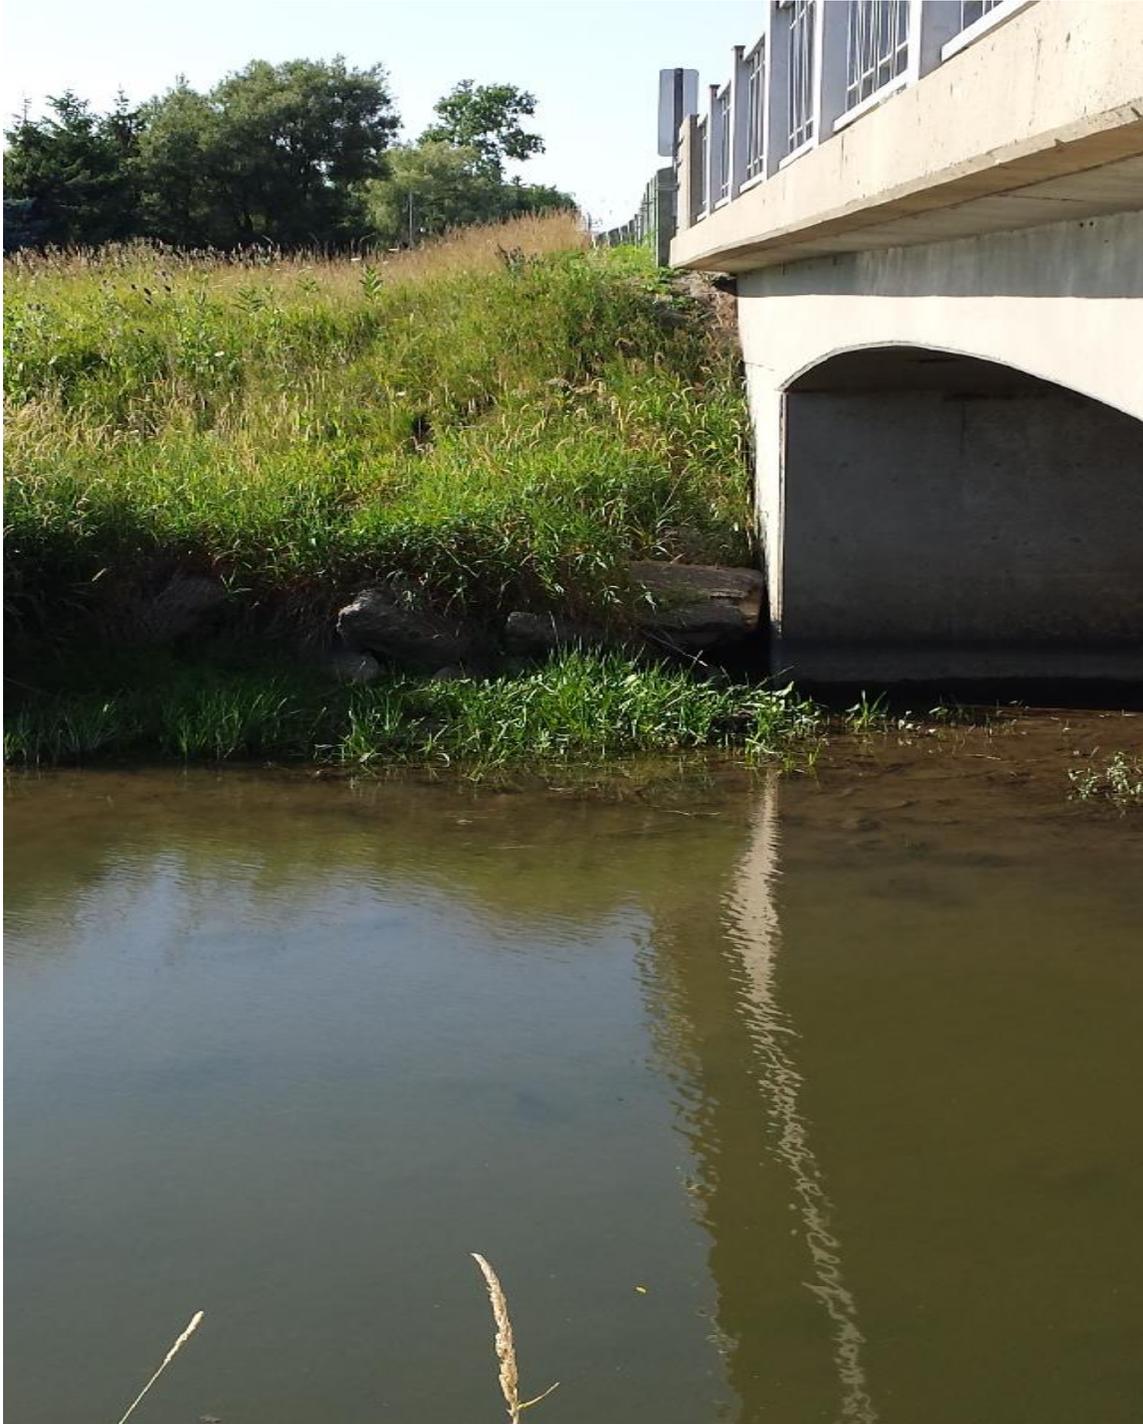
Photograph 3: Looking north at the adjacent west slope of the north abutment. The slope was covered by bushes. Rocks were observed at the toe of the slope to prevent further scouring. (July 24, 2014)

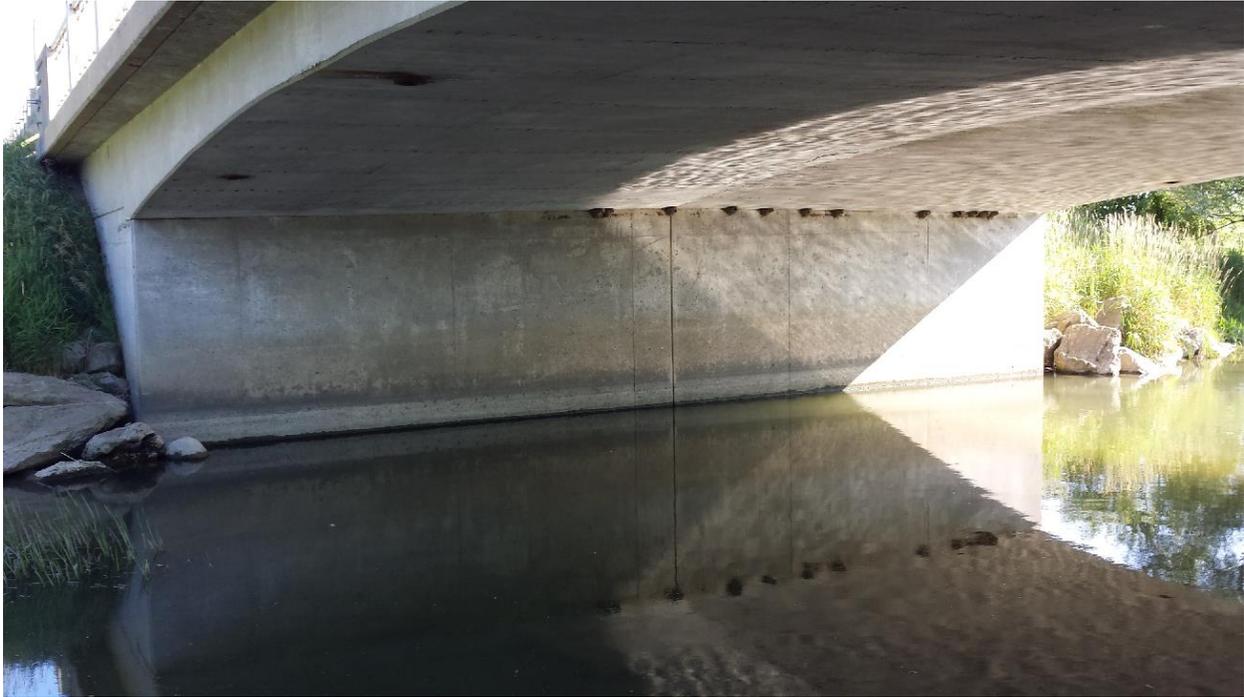
Photograph 4: Looking at the south abutment wall from the northeast corner of the bridge site. No obvious cracks were observed except for some surface cracks. Scouring effect below the water could not be established. (July 24, 2014)

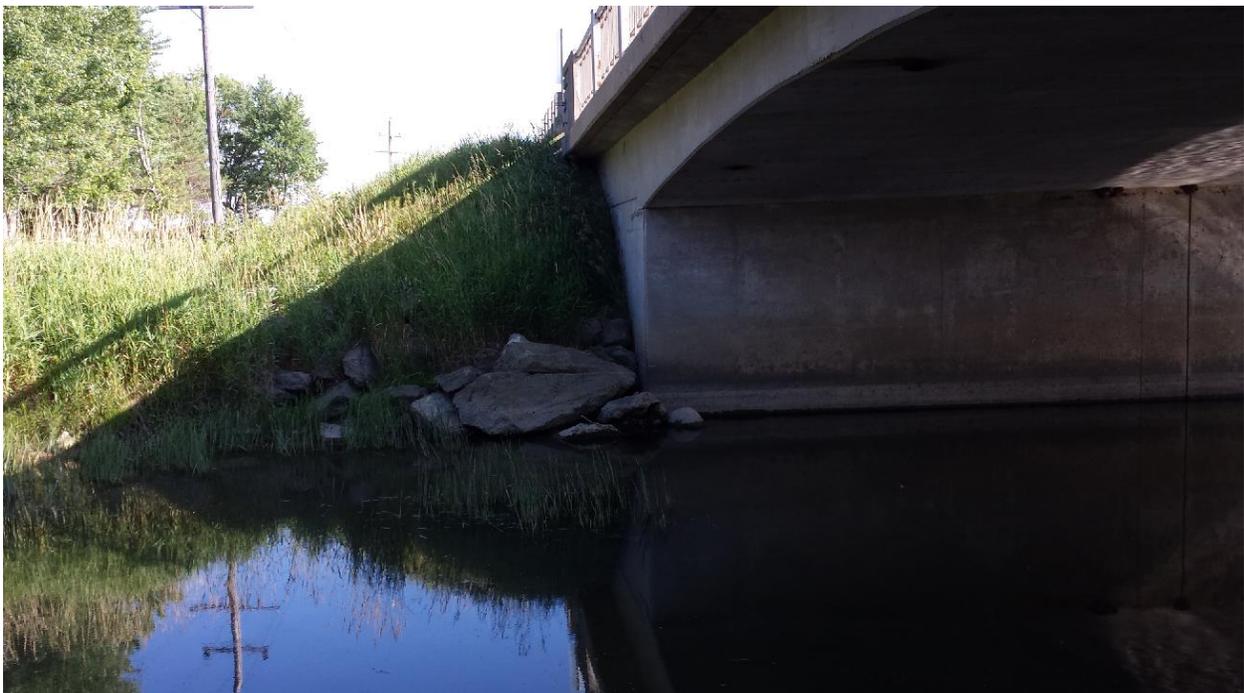
Photograph 5: Looking south at the east slope adjacent to the south abutment. Rocks were placed at the toe and face of the slope to prevent erosion and scour. (July 24, 2014)

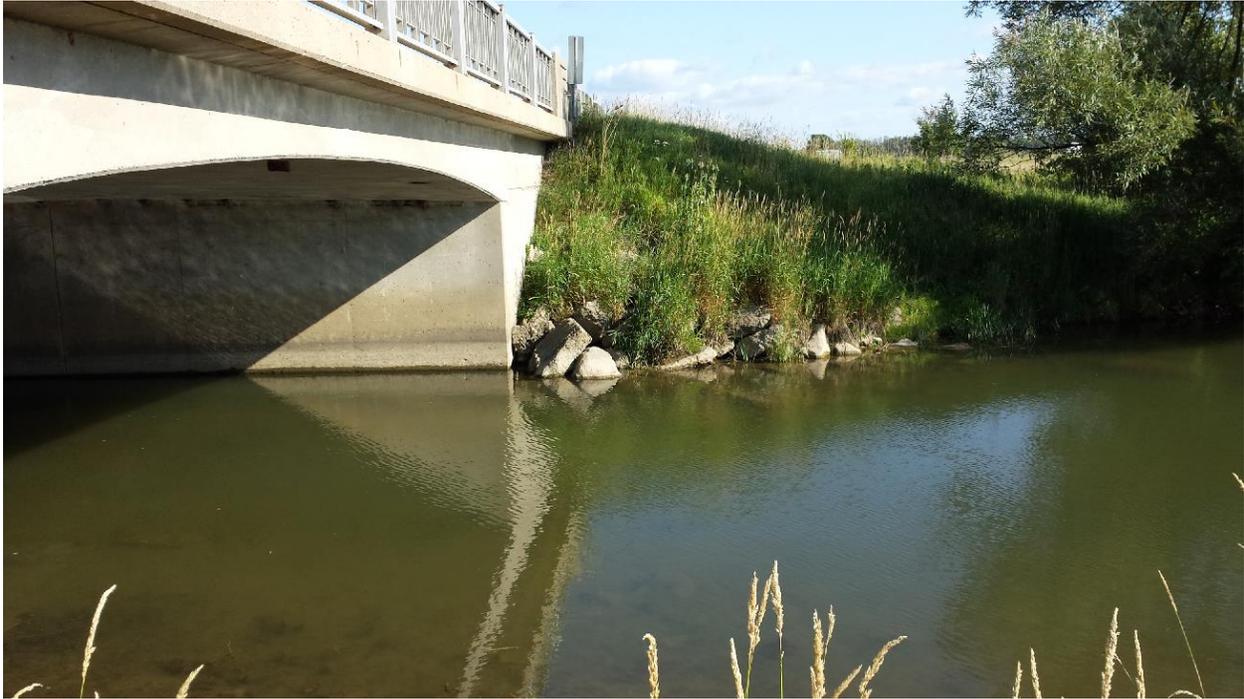
Photograph 6: Looking south at the west slope adjacent to the south abutment wall. Rocks were placed at the toe and face of the slope to prevent erosion and scouring. (July 24, 2014)
