**TECHNICAL MEMORANDUM
for
PRELIMINARY FOUNDATION INVESTIGATION AND DESIGN
PLAINS ROAD UNDERPASS
HWY 403/HWY 6 INTERCHANGE
WP 2537-09-00; SITE NO. 36-27
CENTRAL REGION, ONTARIO**

PML Ref.: 13TF017A-3
Index No.: 068TMEM
Geocres No.: 30M5-304
November 10, 2014

Plains Road Underpass, Highway 403 – 6 Interchange
WP 2537-09-00; Site No.36-27
Central Region, Ontario

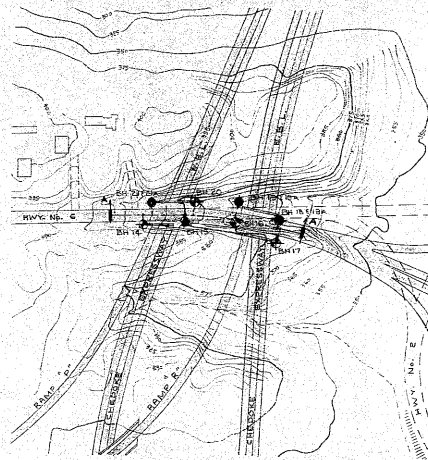
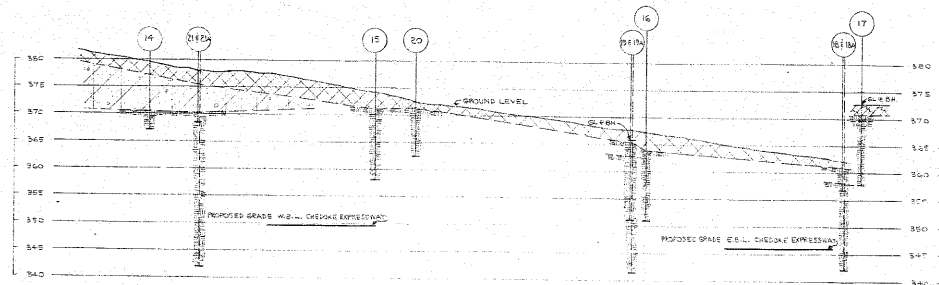
DEPARTMENT OF HIGHWAYS, ONTARIO
TORONTO
PROPOSED CHEDOK EXPRESSWAY
HIGHWAY 6 OVER CHEDOK E.W.B.L.
HAMILTON
BORING PLAN AND SOIL STRATIGRAPHY

SECTION A-A

- SILTY TOPSOIL
- GRANULAR ROAD FILL
- HARD REDDISH-BROWN CLAYEY SILT TILL
- WEATHERED REDDISH-BROWN SHALE
- SOFT SOUND REDDISH-BROWN SHALE BEDROCK

- Eight (8) boreholes, numbered 14, 15, 16, 17, 18, 19, 20, and 21, were advanced. Additional bedrock core holes 18A, 19A and 21A were put down adjacent to boreholes 18, 19 and 21. Boreholes were advanced up to 8 m deep. A section illustrating the borehole locations and Soil Strata is provided in Appendix A.

- Refer to the Appendix A for a borehole location plan and stratigraphical profile for the 1960 foundation investigation. The Record of Borehole sheets and groundwater information of the 8 boreholes are presented in Appendix B.
