**Foundation Investigation and Design
Retaining Wall Rehabilitation
March Road Underpass
Site No. 3-357
Highway 417
Ottawa, Ontario
W.P. 4104-13-01**

Report Number: 1417217-1100

Drawings 1 & 2 Retaining Wall Rehabilitation, March Road Underpass, Highway 417, Borehole Locations and Soil Strata

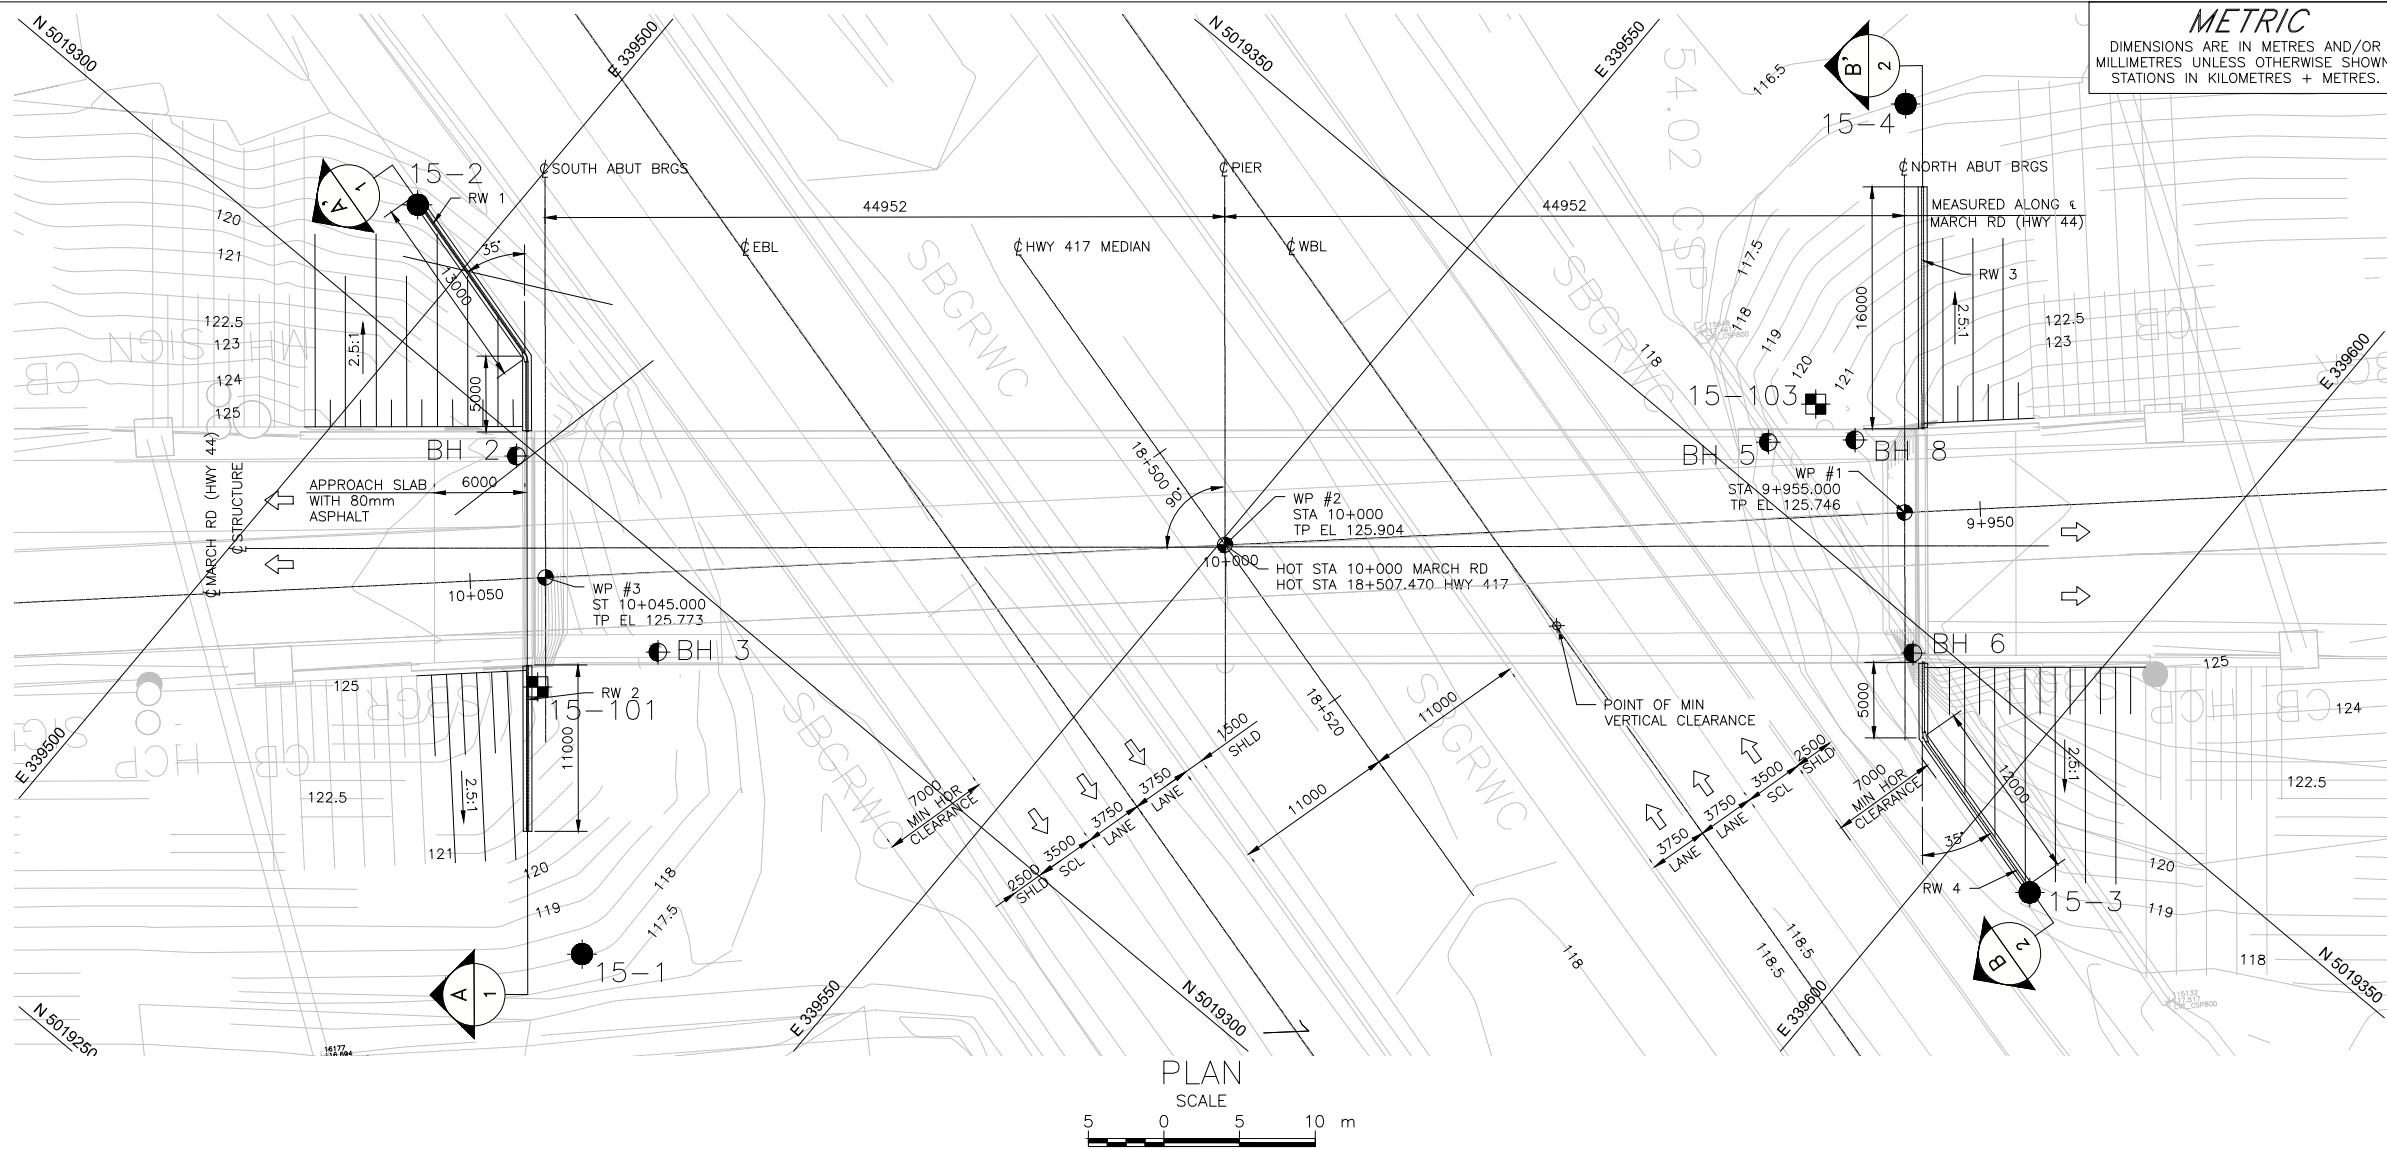
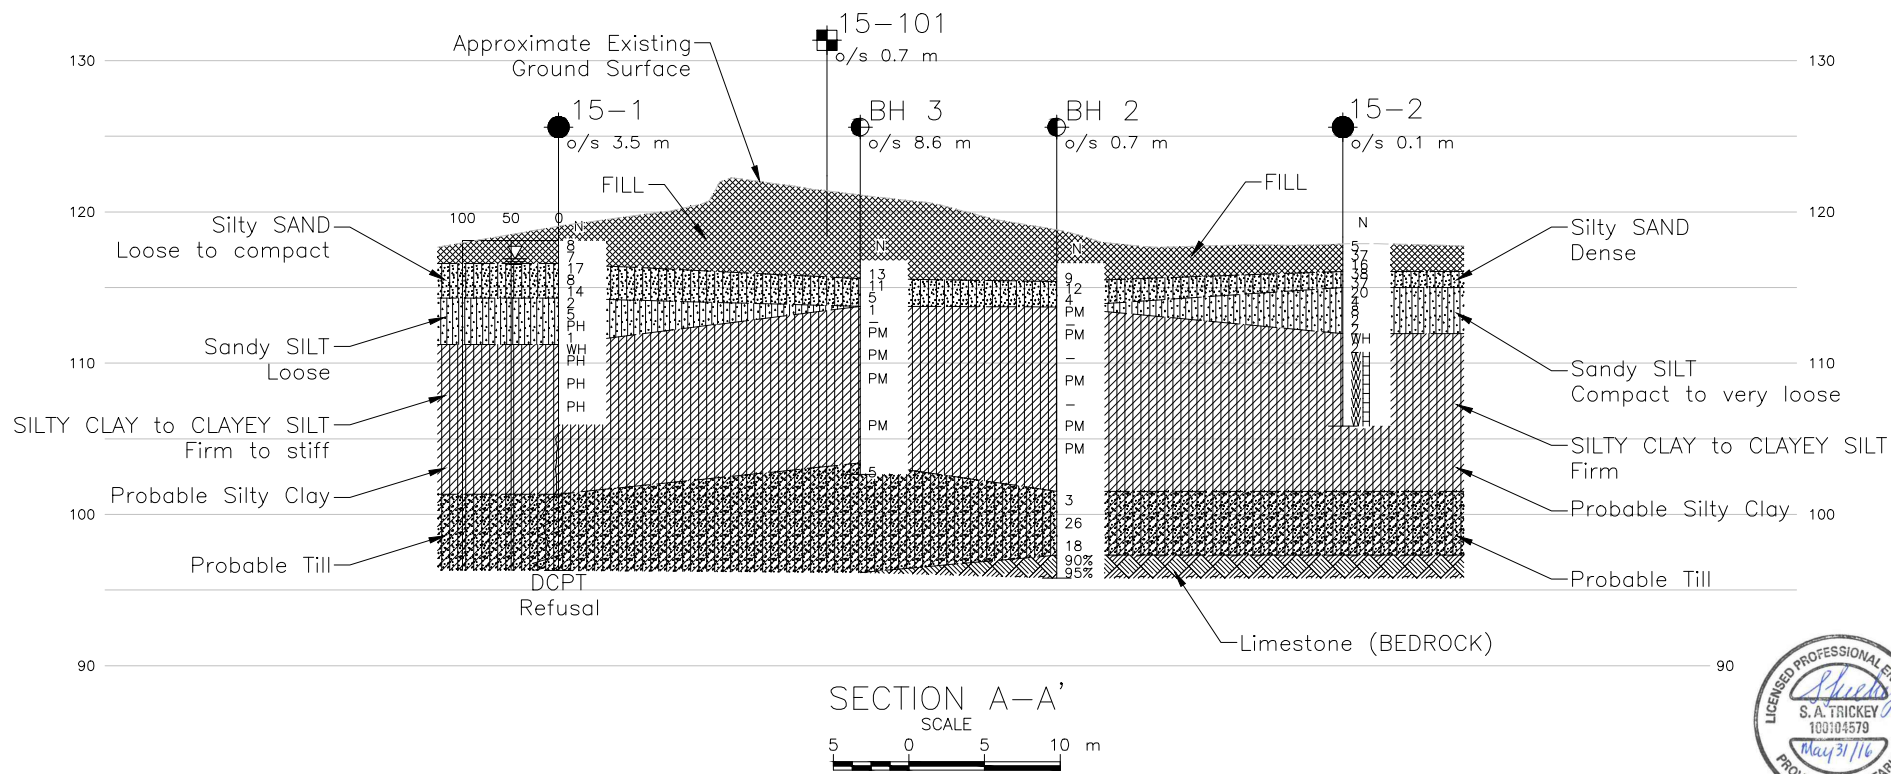
CONT No. 2016-4032
WP No. 4104-13-01RETAINING WALL REHABILITATION
MARCH ROAD UNDERPASS
HIGHWAY 417
BOREHOLE LOCATIONS AND SOIL STRATA

The interpreted stratigraphic conditions along the centreline of the south and north abutments are shown on Drawings 1 and 2. The stratigraphic boundaries shown on the Record of Borehole and Test Pit sheets and on the interpreted stratigraphic sections included on Drawings 1 and 2 are inferred from non-continuous sampling and, therefore, represent transitions between soil types rather than exact planes of geological change. The subsoil conditions will vary between and beyond the borehole and test pit locations.

The subsurface investigation for the retaining wall rehabilitation was carried out between November 30 and December 8, 2015, at which time four boreholes (numbered 15-1 to 15-4, inclusive) and two test pits (numbered 15-101 and 15-103) were advanced at the locations shown on Drawings 1 and 2. The boreholes were advanced as follows:

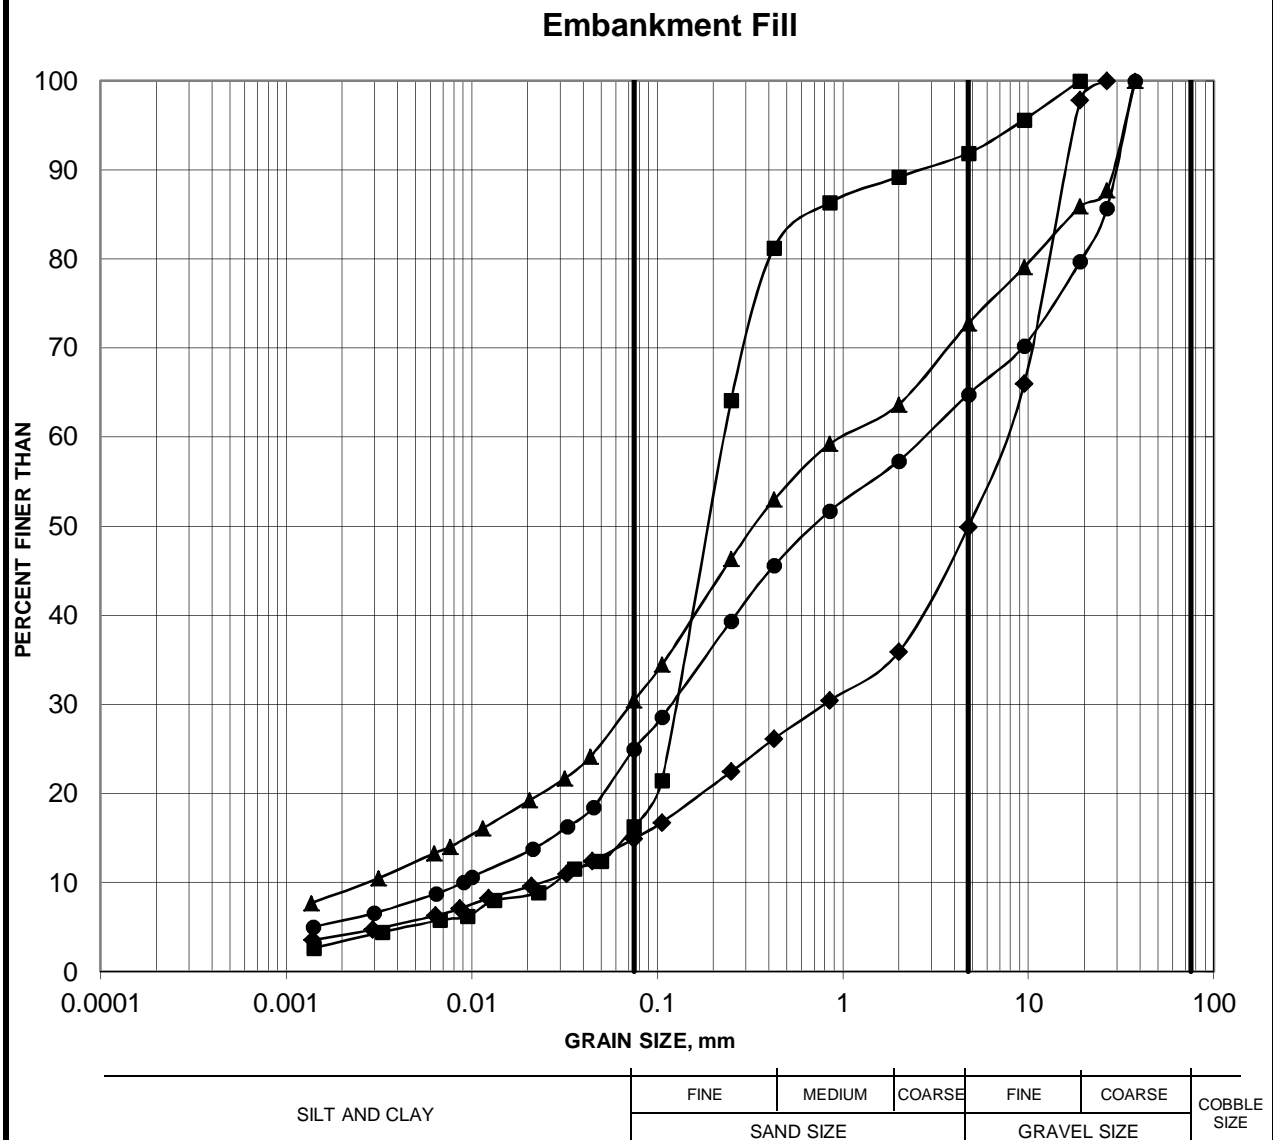
FIGURE C1

GRAIN SIZE DISTRIBUTION

Borehole	Sample	Depth (m)
■ 15-3	2	0.76-1.37
◆ 15-101	1	0.13-0.90
▲ 15-101	3	1.20-1.60
● 15-103	4	1.40-1.70

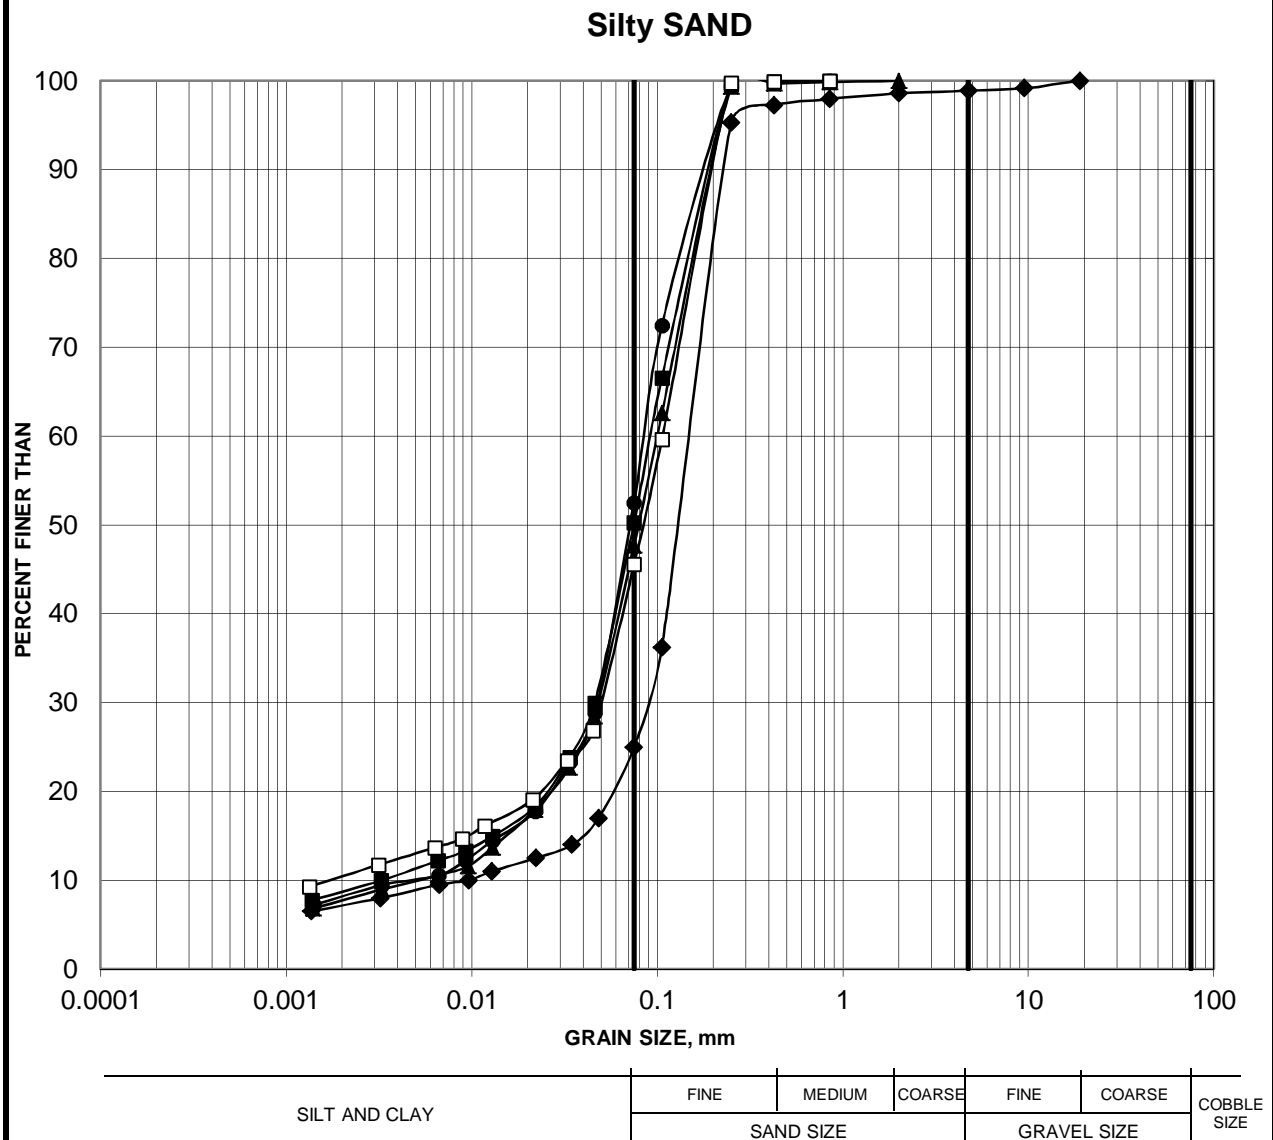
FIGURE C2

GRAIN SIZE DISTRIBUTION

Borehole	Sample	Depth (m)
■ 15-1	4	2.28-2.89
◆ 15-2	4	2.13-2.74
▲ 15-3	5	3.05-3.66
● 15-3	6	3.81-4.42
□ 15-4	3	1.52-2.13

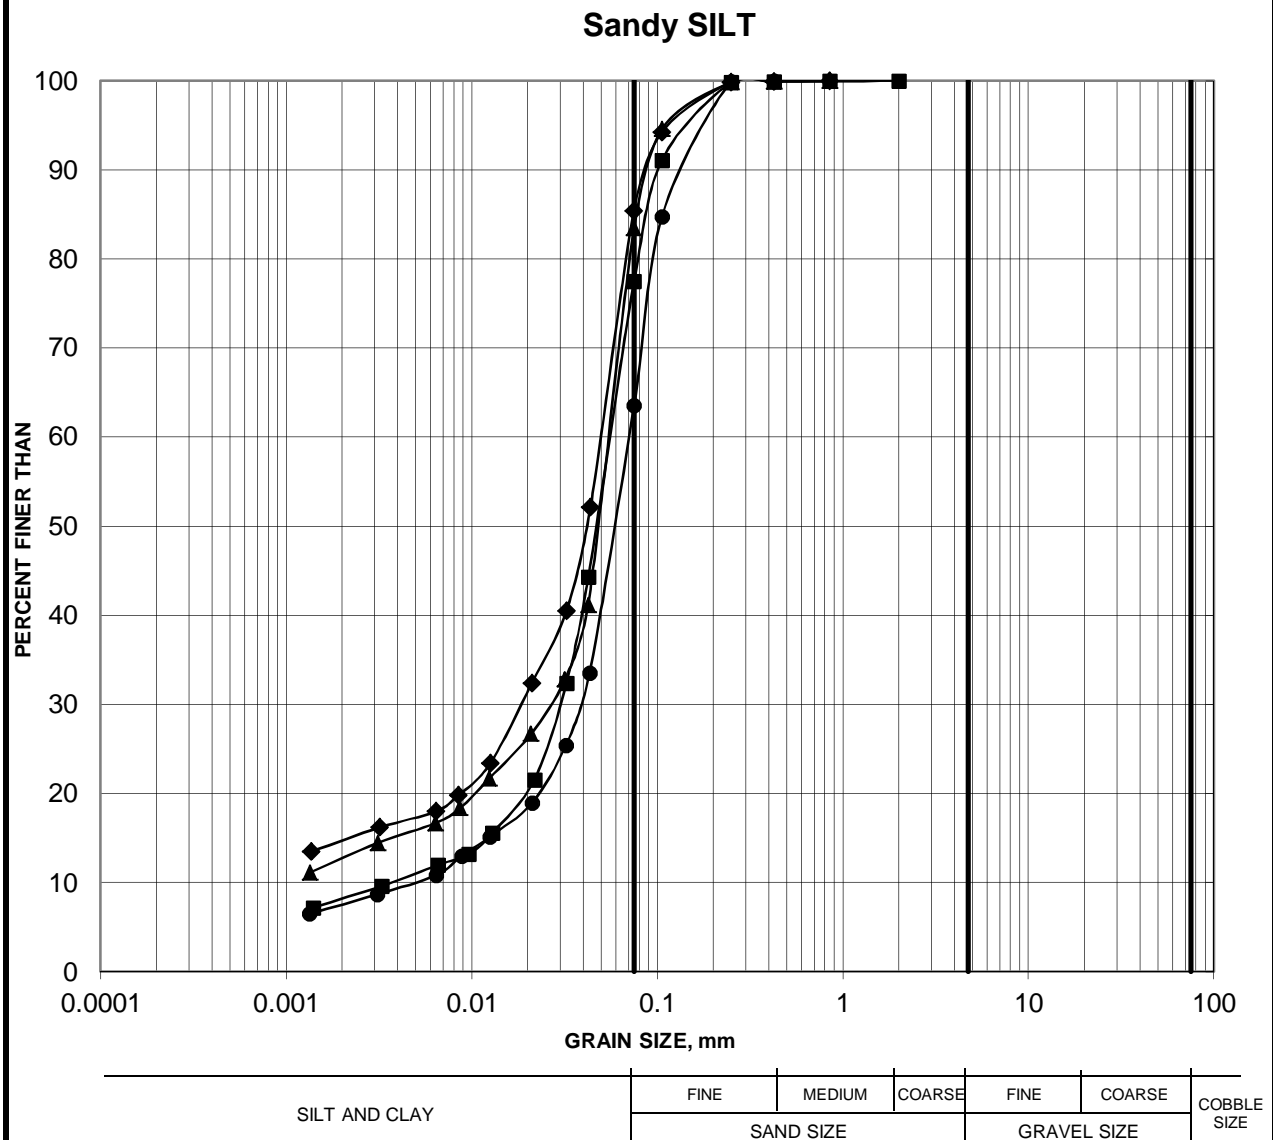
FIGURE C3

GRAIN SIZE DISTRIBUTION

Borehole	Sample	Depth (m)
15-1	7	4.57-5.18
15-2	8	4.57-5.18
15-3	7	4.57-5.18
15-4	5	3.05-3.66

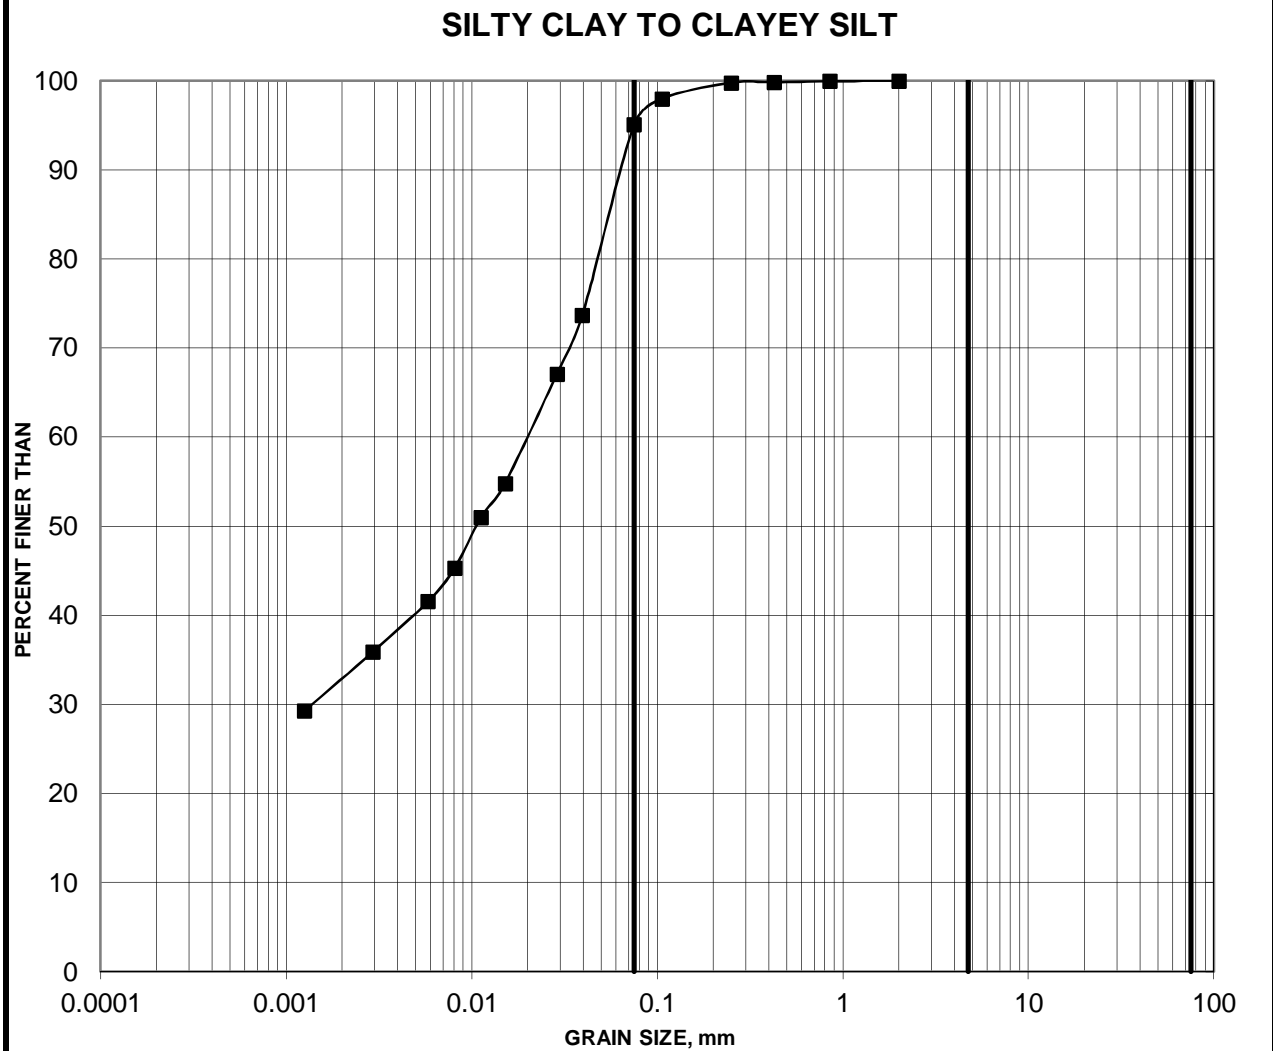
FIGURE C5

GRAIN SIZE DISTRIBUTION

Borehole	Sample	Depth (m)
—■— 15-2	14	8.23-8.84

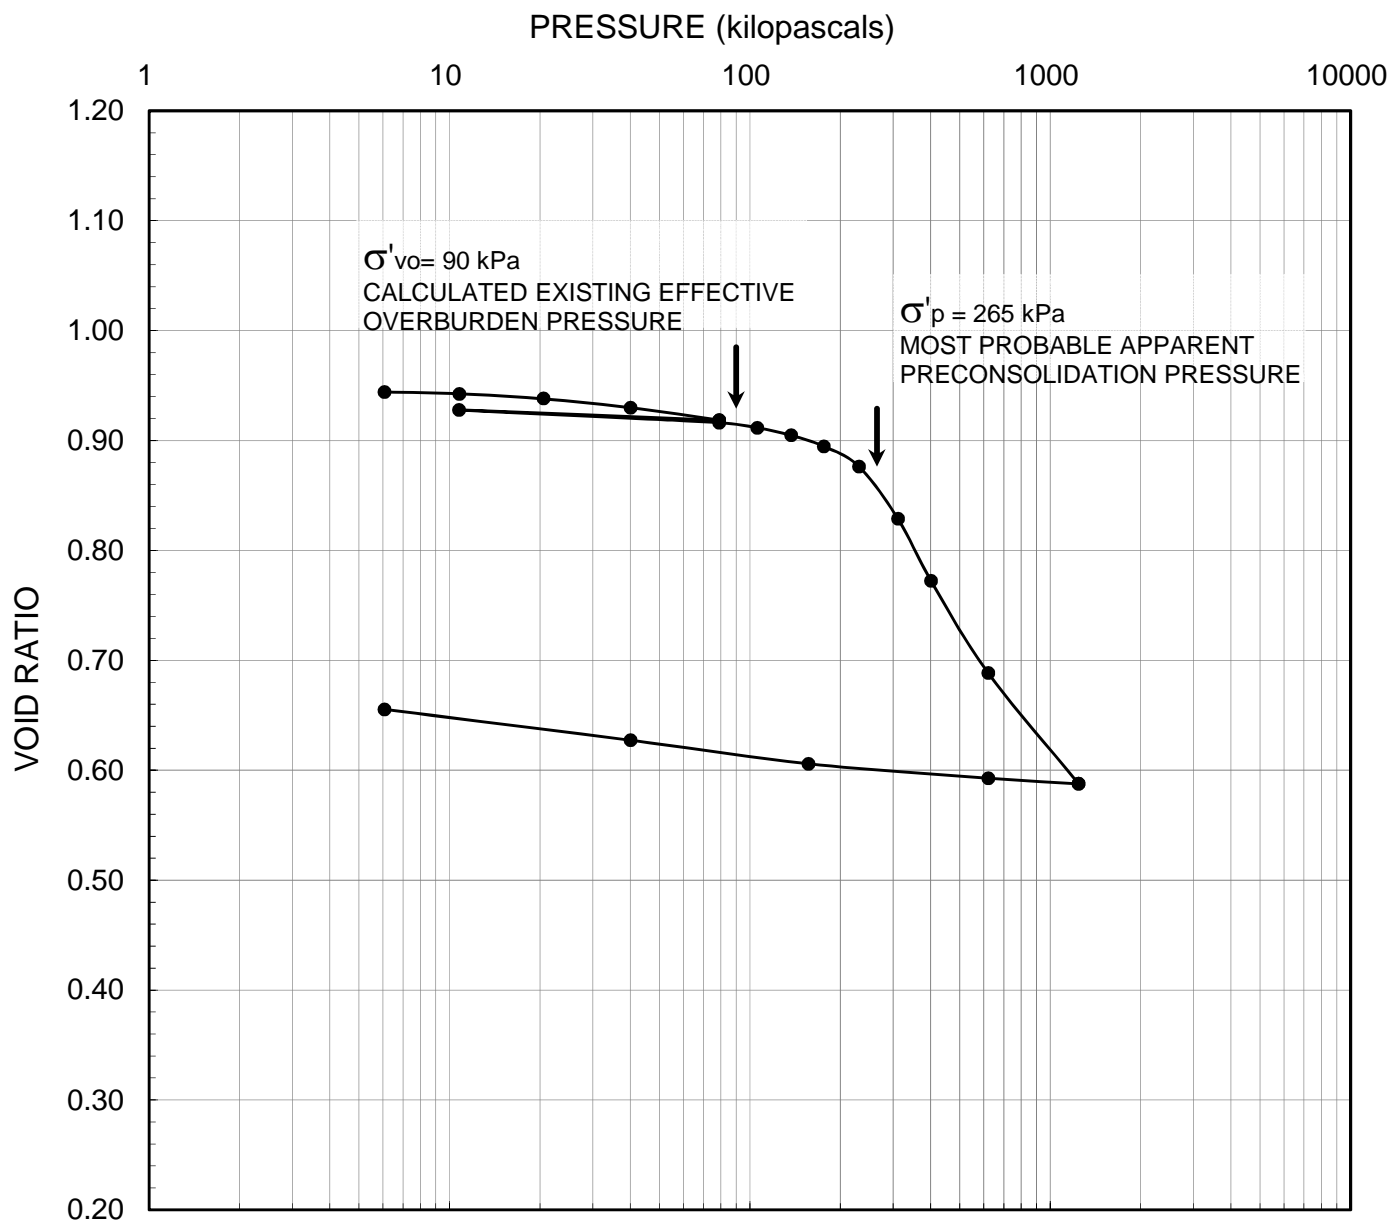
Borehole: 15-1	$w_i = 34\%$	$S_o = 98\%$	$\gamma = 18.6 \text{ kN/m}^3$
Sample: 11	$w_f = 24\%$	$e_o = 0.95$	$G_s = 2.77$
Depth (m): 7.6-8.1	$w_l = 19\%$	$C_c = 0.51$	
Elevation (m): 110.5-110.0	$w_p = 13\%$	$C_r = 0.013$

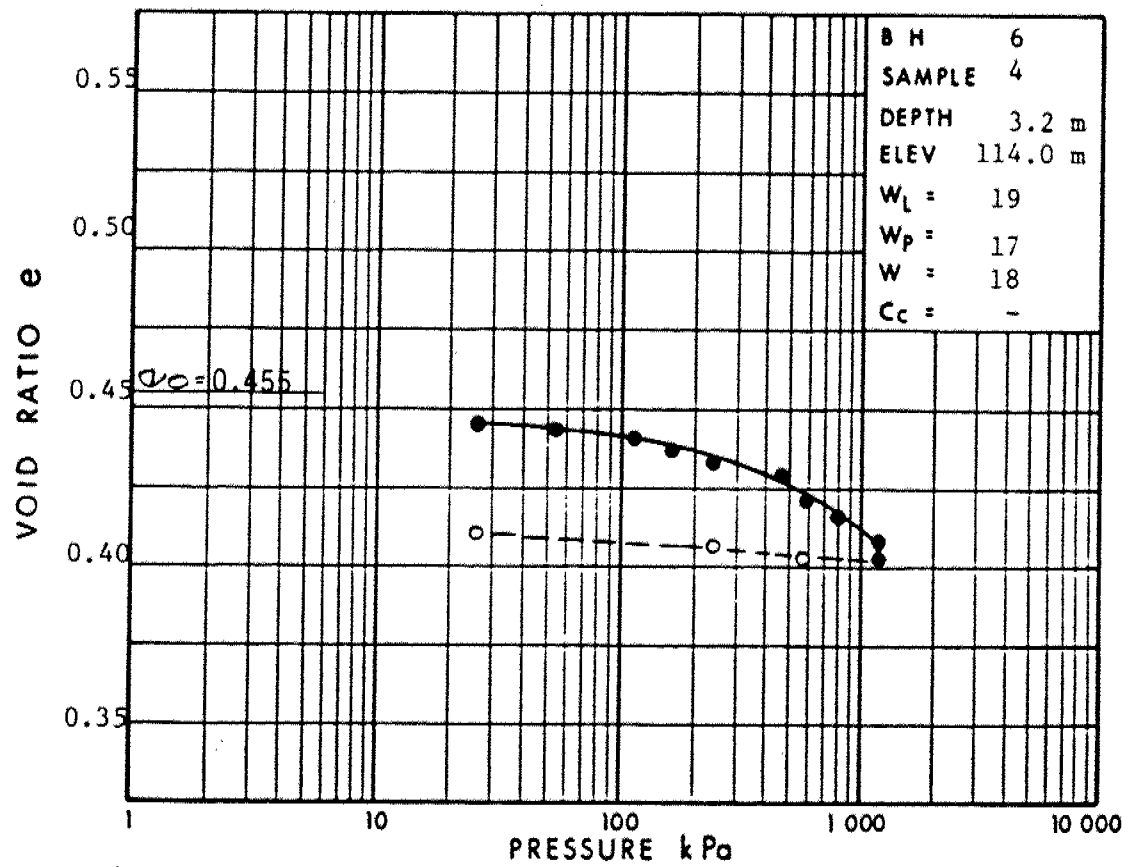
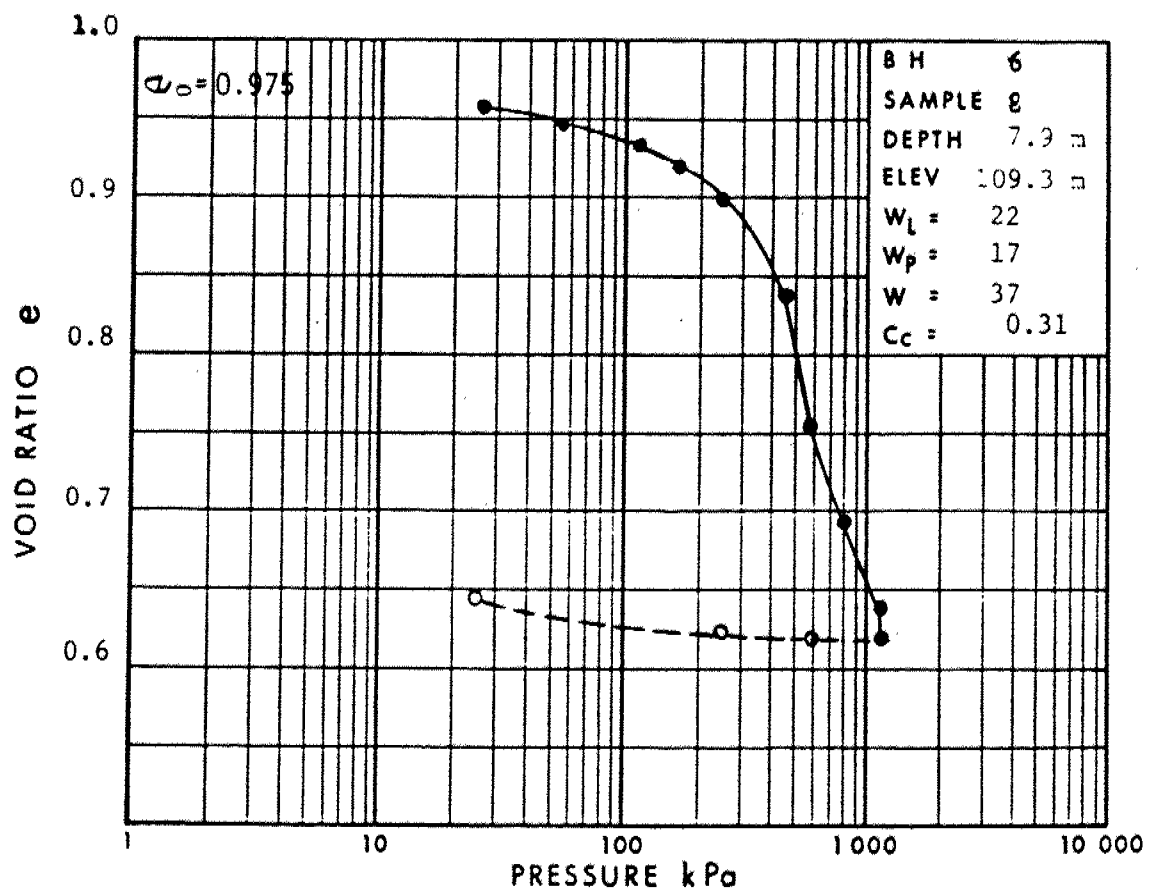
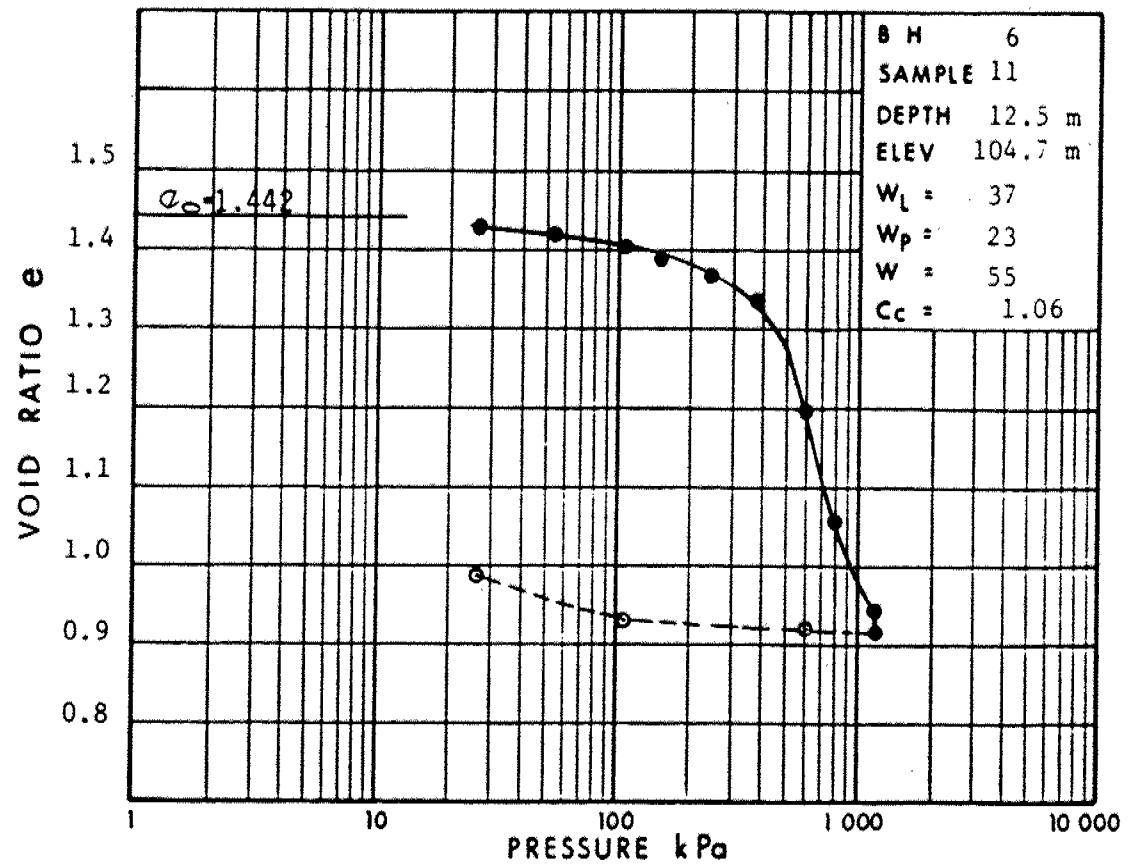
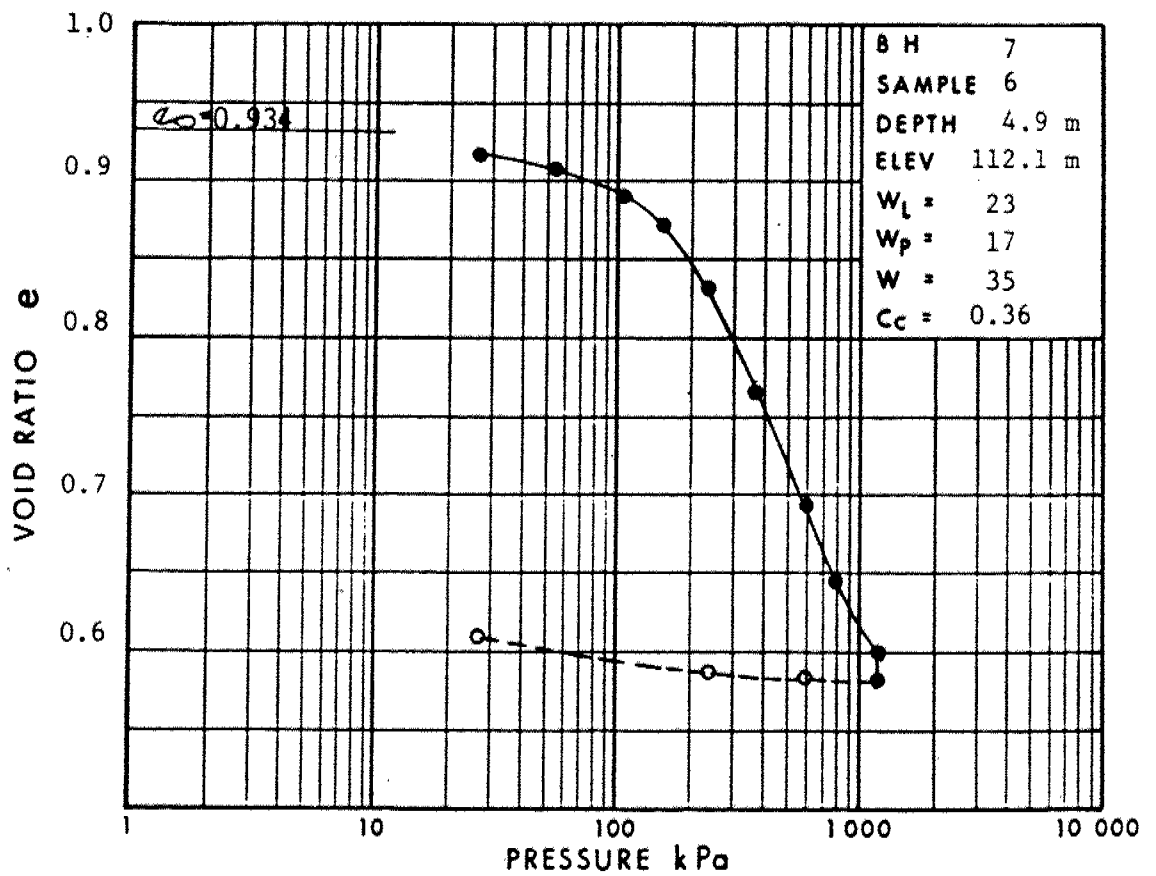
Fig No 5

Consolidation Test Results, Previous Investigation (1990)
