**FOUNDATION INVESTIGATION REPORT AND
PRELIMINARY FOUNDATION DESIGN REPORT
for
DRAINAGE PIPE REMEDIATION
DON RIVER BRIDGE NORTH WEST EMBANKMENT
HIGHWAY 401
CITY OF TORONTO, ONTARIO
AGREEMENT NO. 2013-E-0039
TASK NO. 2013-E-0039-006**

PREPARED FOR MINISTRY OF TRANSPORTATION OF ONTARIO

PML Ref.: 14TF033
Index No.: 010FIR and 011FDR
GEOCRES No.: 30M14-412
May 10, 2017

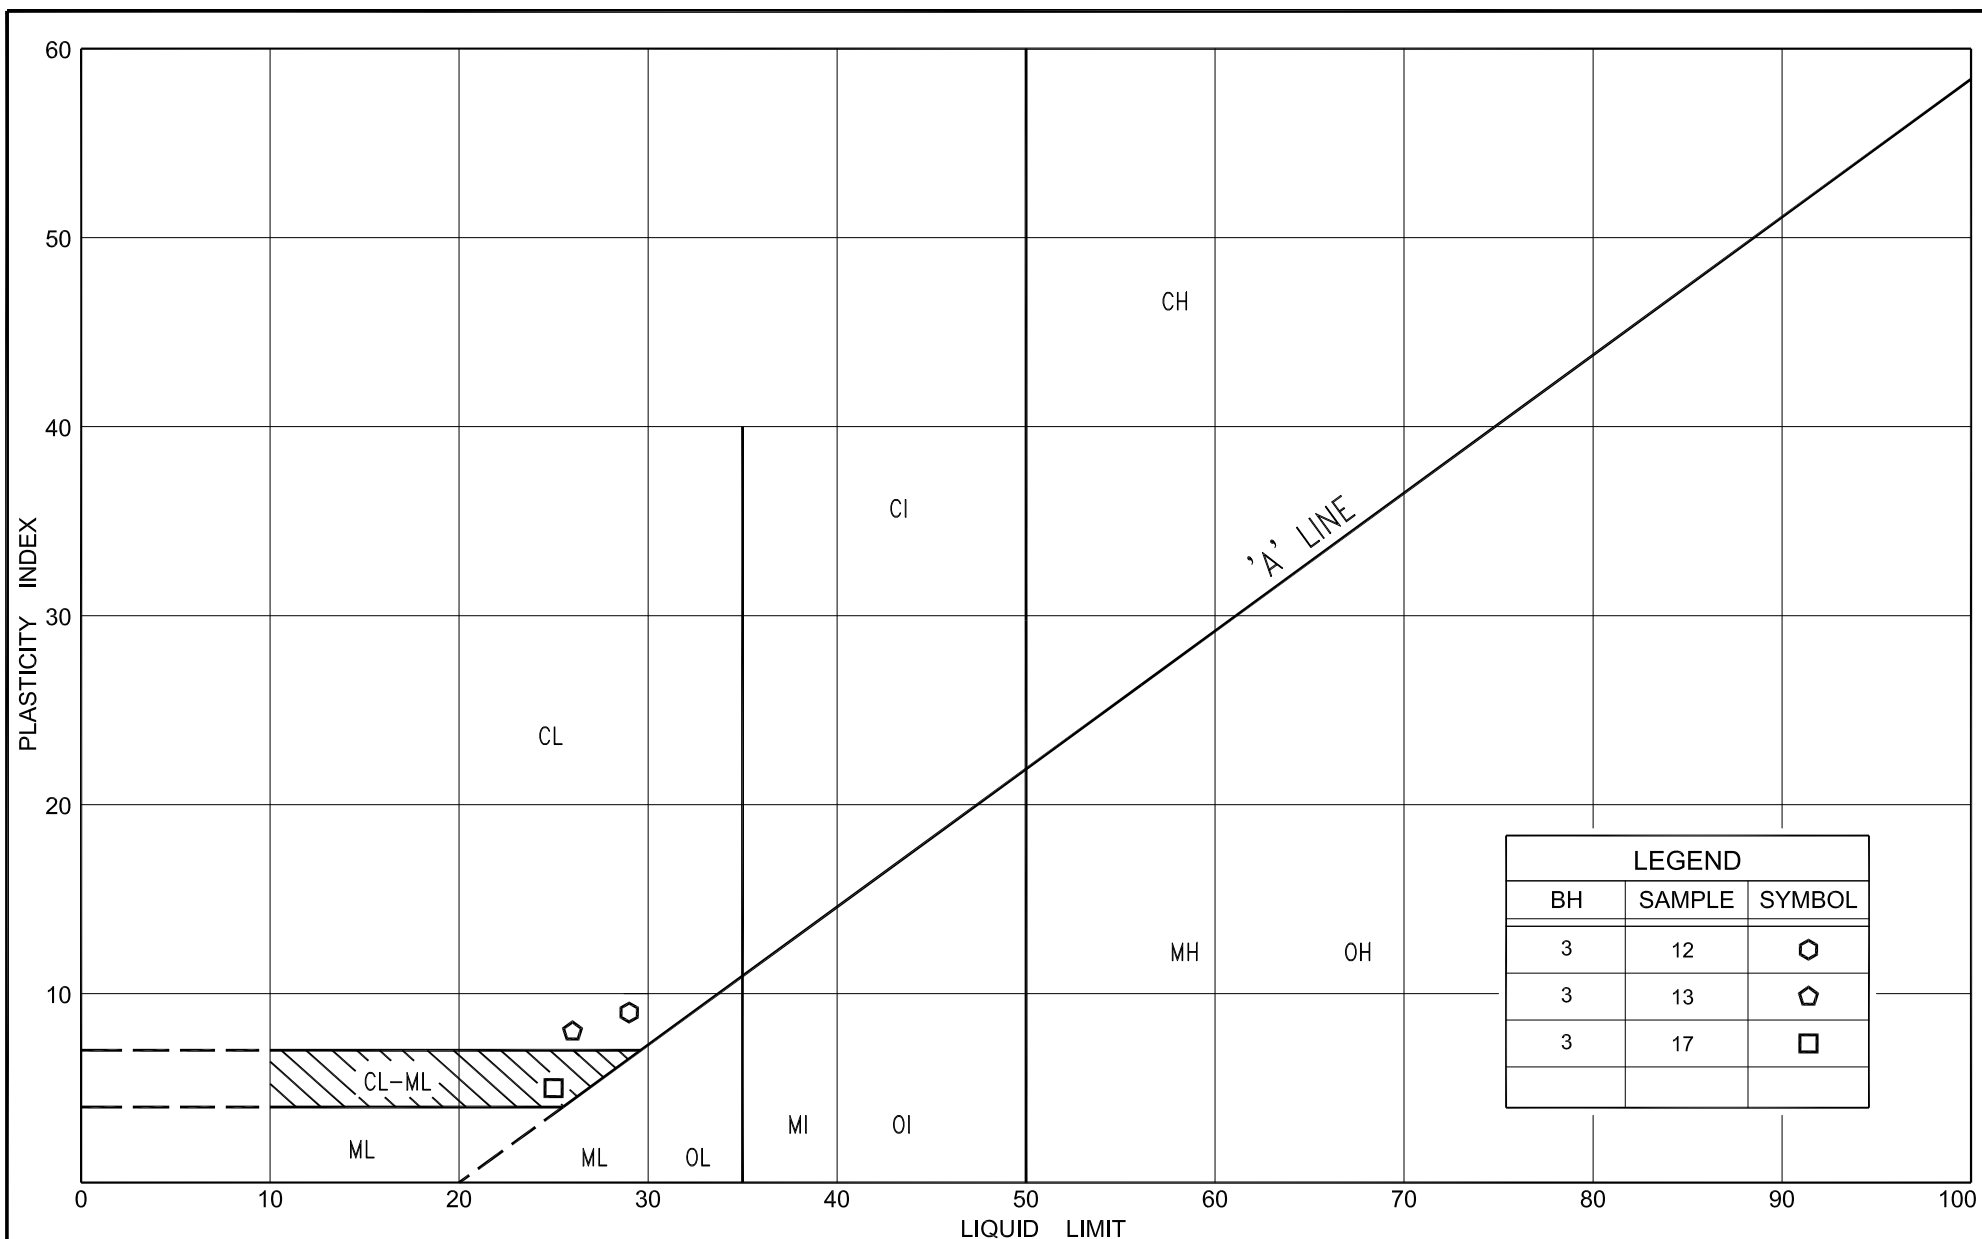
FIG No. DP-PC-1
 HWY: 401
 TASK No. 2013-E-0039-006

The results of grain size distribution analyses and Atterberg Limit tests conducted on 4 samples of the deposit are shown in figures DP-GS-2 and DP-PC-1, respectively. The clayey silt had liquid limits of 25 to 29, plastic limits of 18 to 20 and a plasticity index of 5 to 9. The moisture content of the cohesive fill varied between 11 and 28%.

PLASTICITY CHART
 CLAYEY SILT, trace to with sand, trace gravel
 (FILL)

The results of the laboratory grain size distribution analysis and Atterberg Limit Test are presented in Figures DP-GS-1 to DP-GS-4 and DP-PC-1, respectively. All of the test results are summarized on the Record of Borehole Sheets.

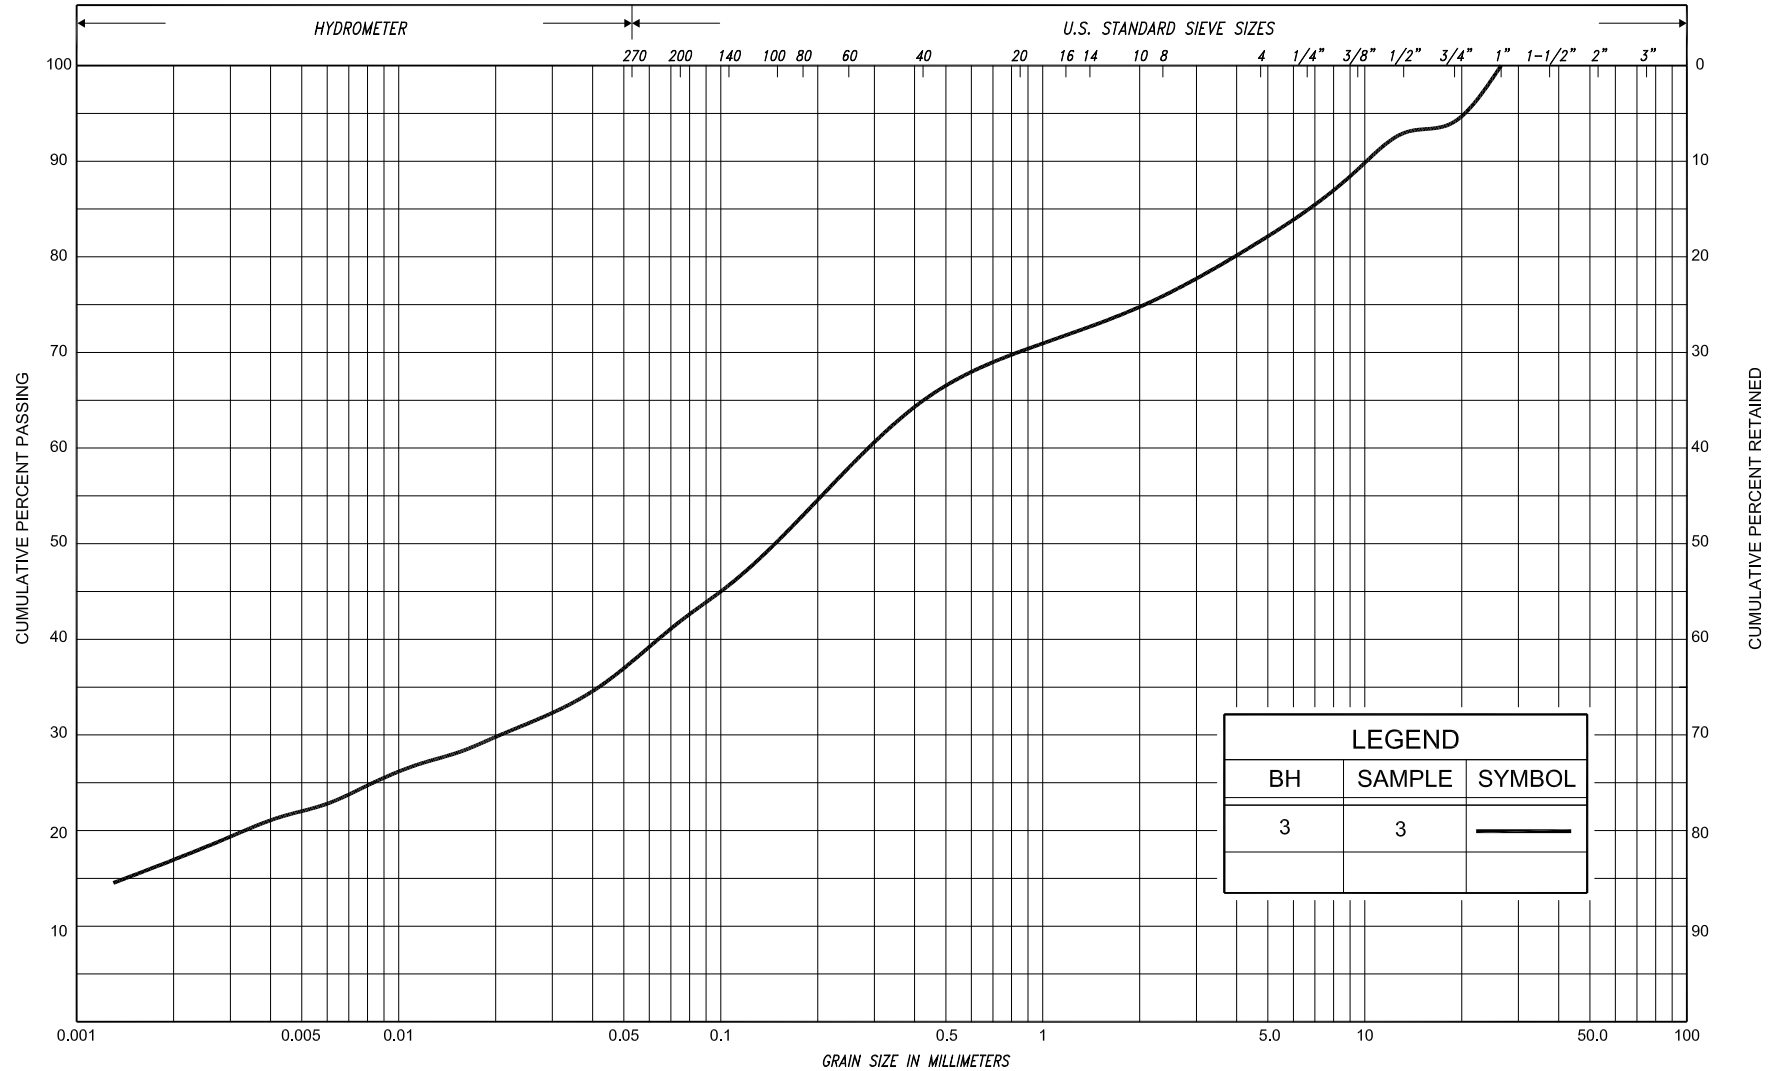
The results of grain size distribution analyses conducted on a sample of the fill are shown in figure DP-GS-1. The moisture content of the silty/sandy fill varied between 3 and 20%.

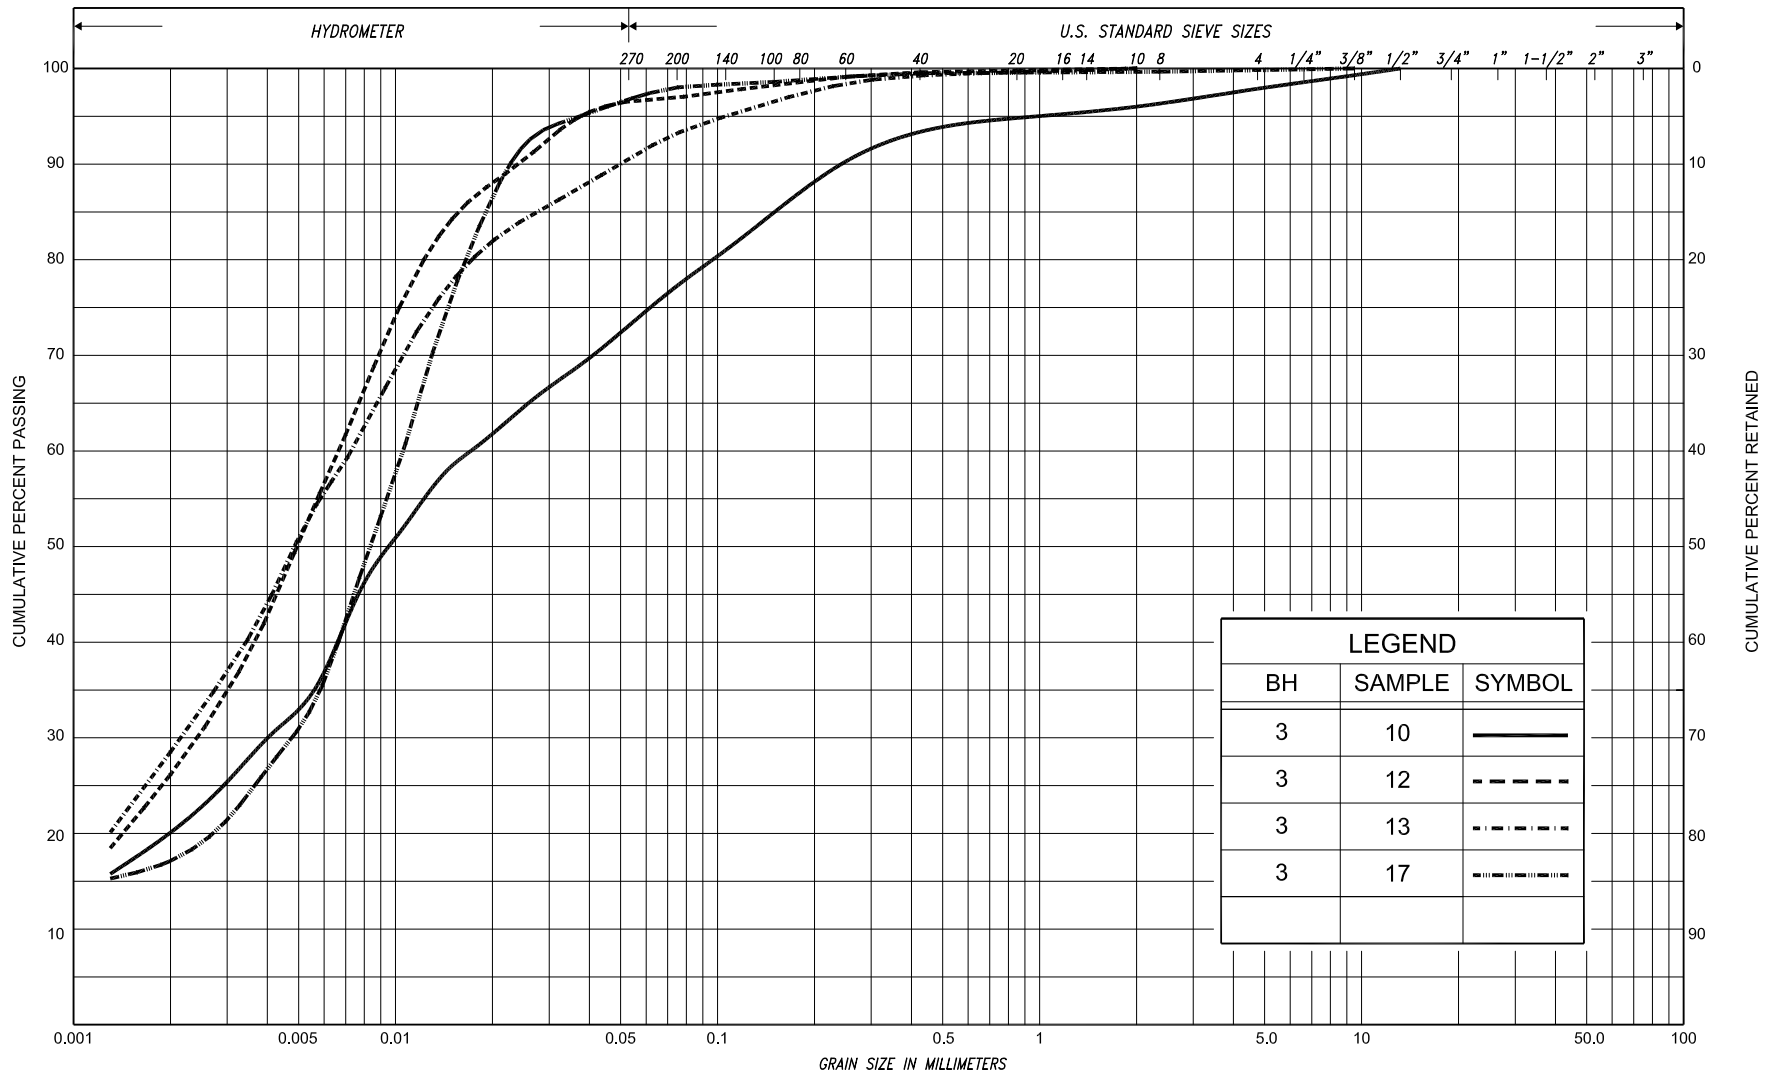
FIG No. DP-GS-2
 HWY: 401
 TASK No. 2013-E-0039-006

GRAIN SIZE DISTRIBUTION

CLAYEY SILT, trace to with sand, trace gravel
(FILL)

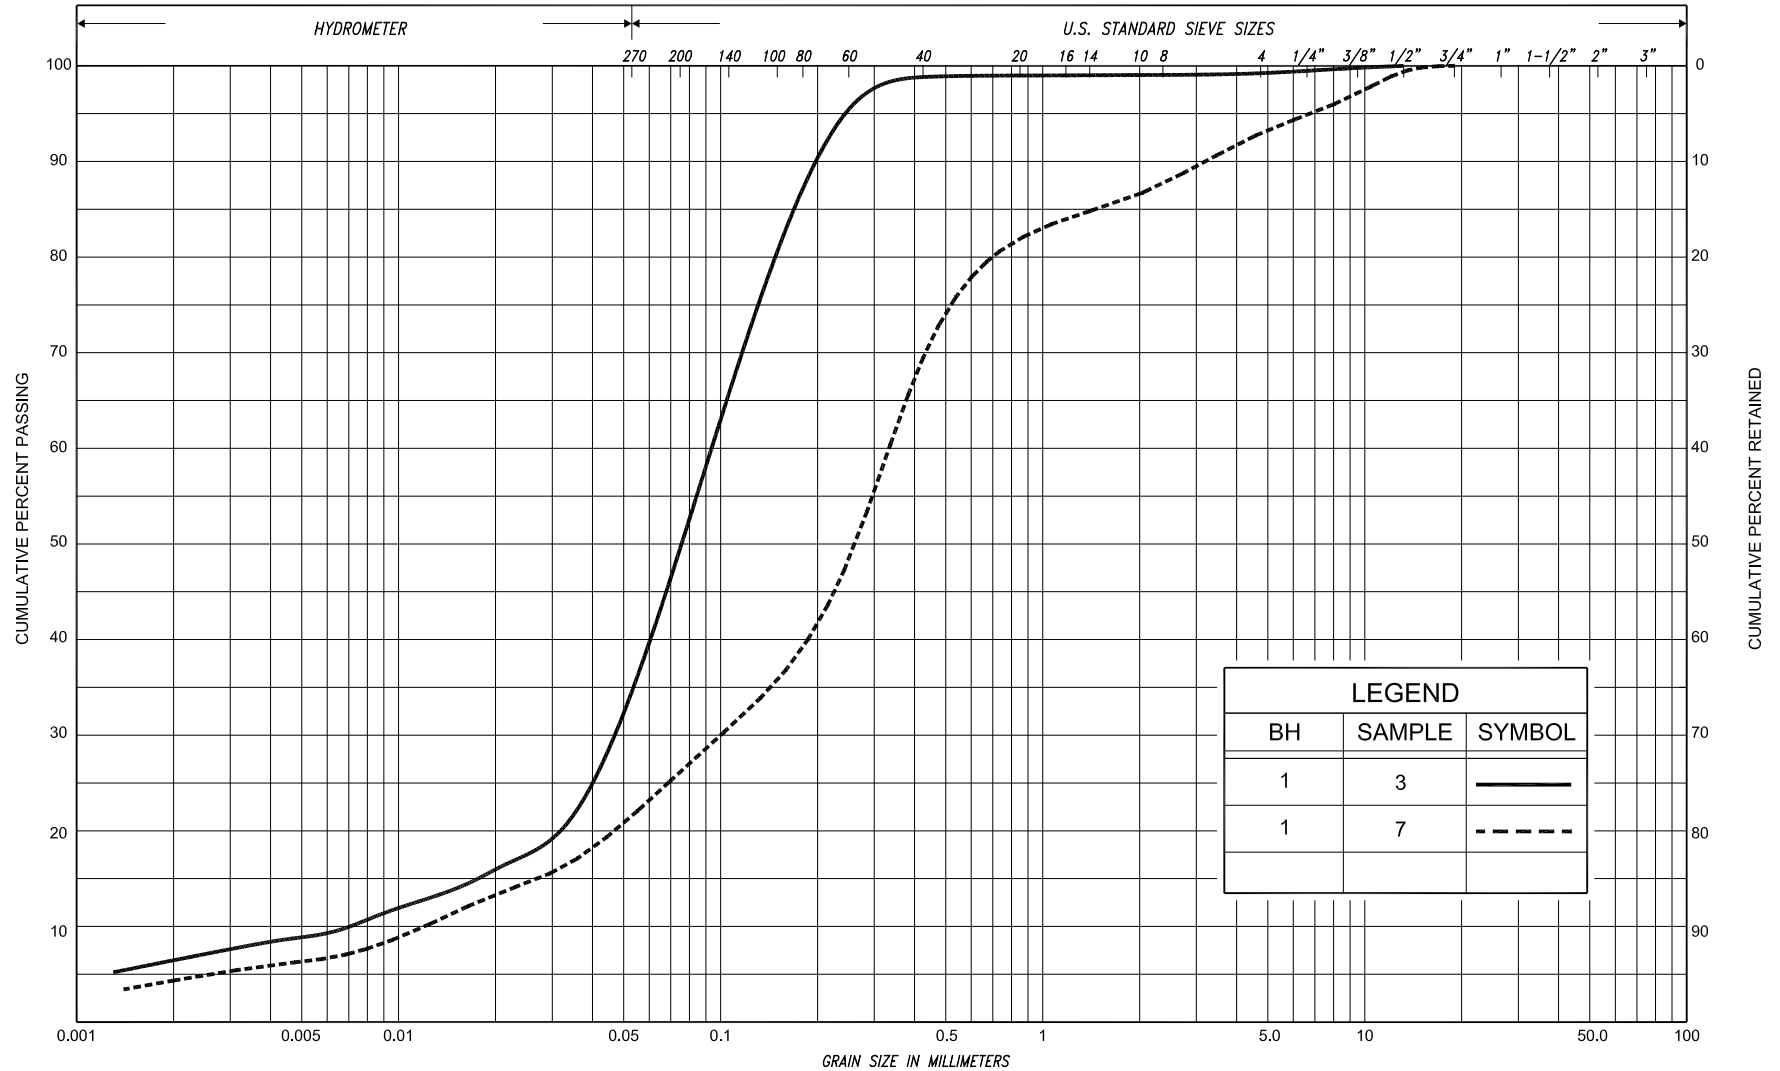
The results of grain size distribution analyses conducted on 4 samples of the deposit are shown in Figures DP-GS-3 and DP-GS-4. The moisture content of the deposit varied between 6 and 24%.

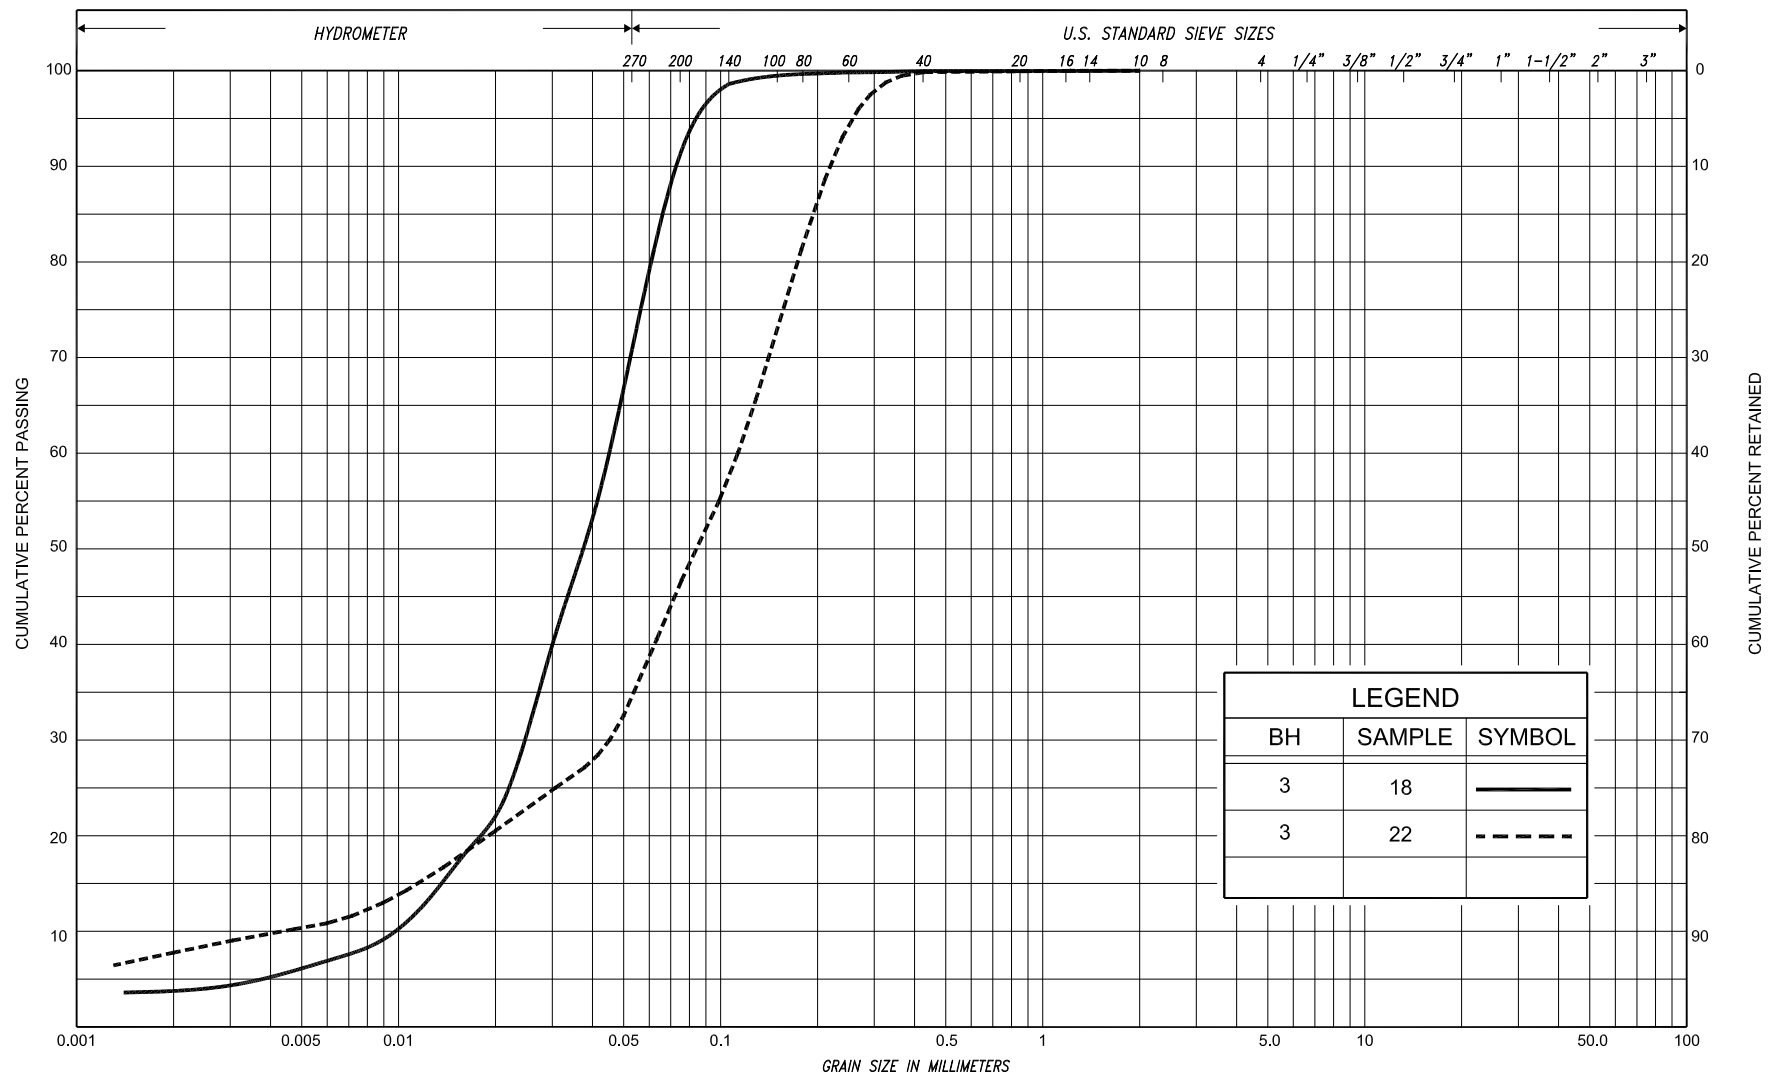
FIG No. DP-GS-4

GRAIN SIZE DISTRIBUTION

SILTY SAND TO SILT, trace sand, trace clay

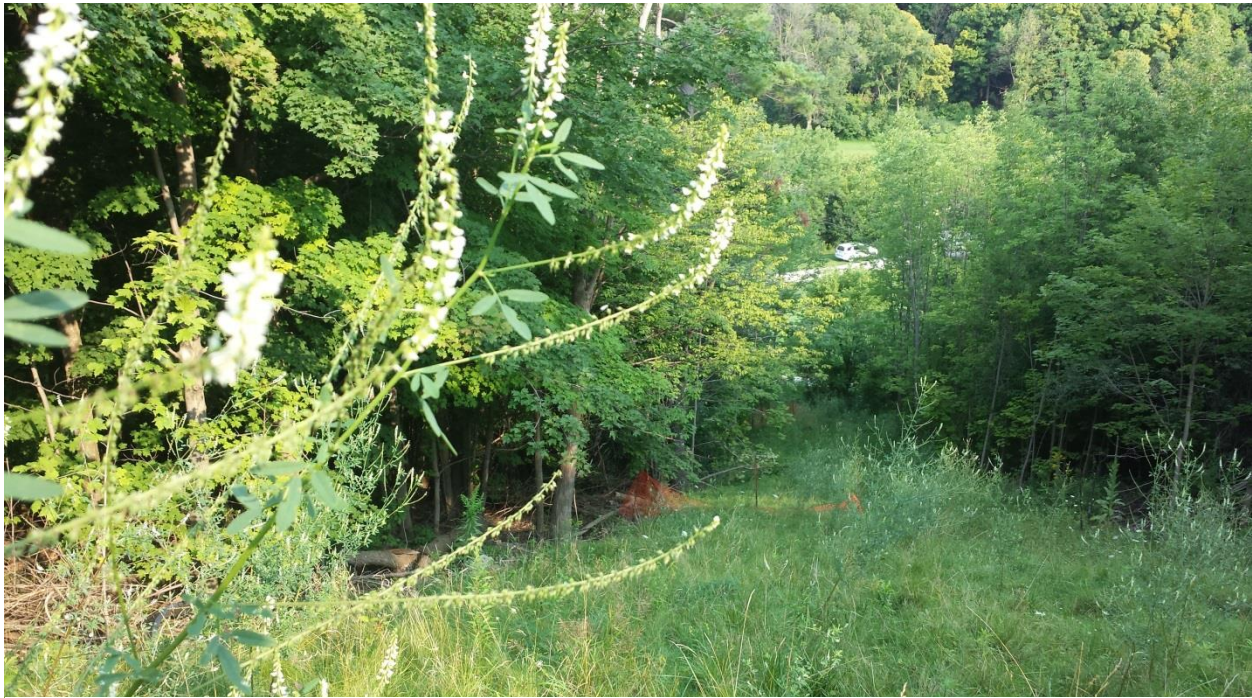
Photograph P1: Looking northwest from top of the slope. Light vegetation is visible along the embankment (August 8, 2014).

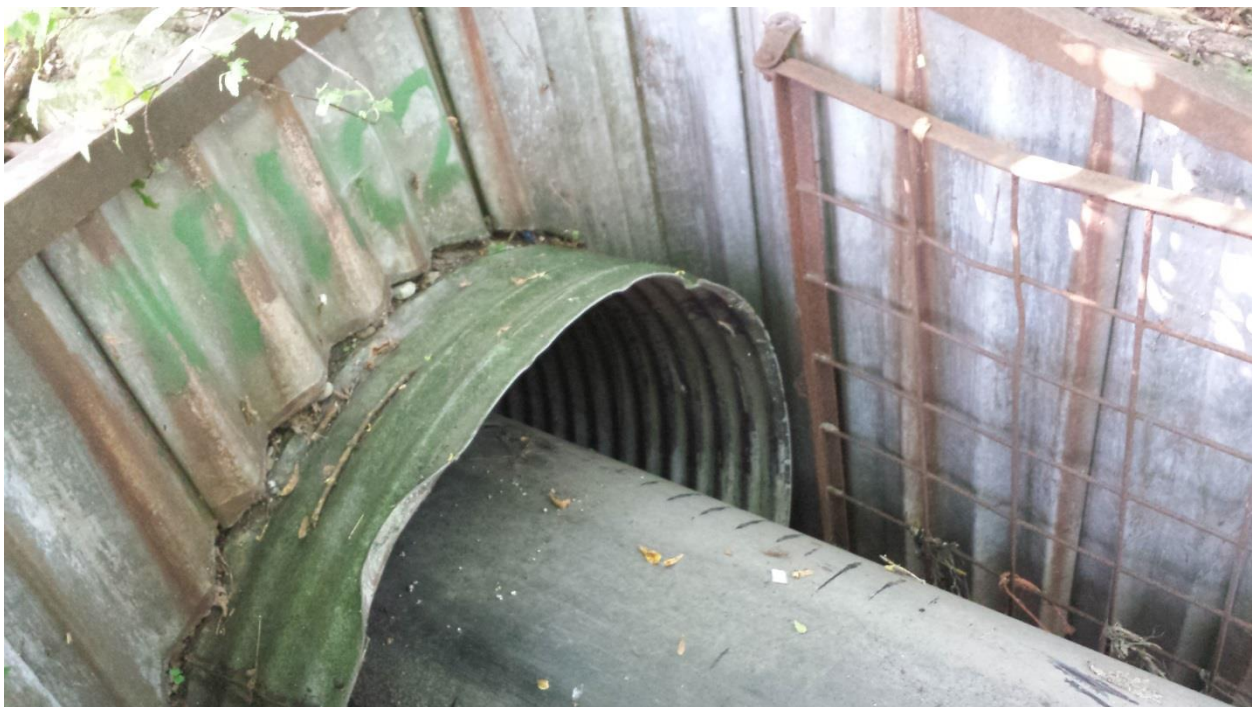
Photograph P2: Looking at the pipe outlet. The CSP pipe and HDPE liner are visible. The HDPE liner sheared off and slipped down the slope to the Don River (August 8, 2014).

The initial drainage pipe was a 1200 mm diameter corrugated steel pipe. In 2012, a pipe failure occurred near the top of the pipe that caused erosion and gully in the order of 1.2 m deep that extended from the pipe break to the bottom of the slope. As an interim remedial measure, a 900 mm diameter HDPE pipe was slip-lined inside the 1200 mm diameter CSP with the annular space partially grouted near the break point with unshrinkable fill. In 2014, the HDPE pipe sheared off at the previous pipe break location and slipped down the slope some 25 m. The HDPE liner was cut off and removed at the outlet of the CSP pipe and temporarily braced with blocks and bolts at the outlet.

Rehabilitation of the existing pipe is another alternative that could be considered for the drainage pipe remediation. In this method, thrust blocks or pipe anchors should be installed to improve the connection integrity of the pipe and liner. Video inspection of the pipe would be required to assess the extent of the damages on the pipe.

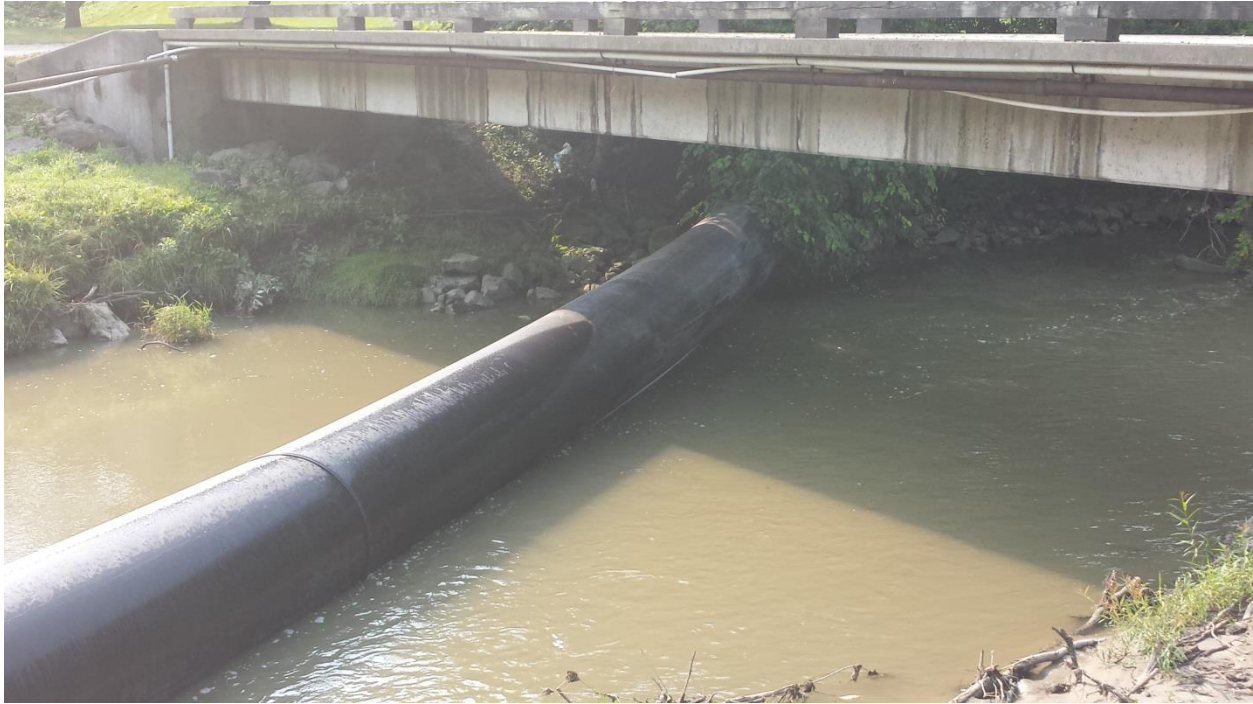
Photograph P3: Looking north at the location of the pipe outlet. The HDPE liner slipped down the slope to the Don River (August 8, 2014).

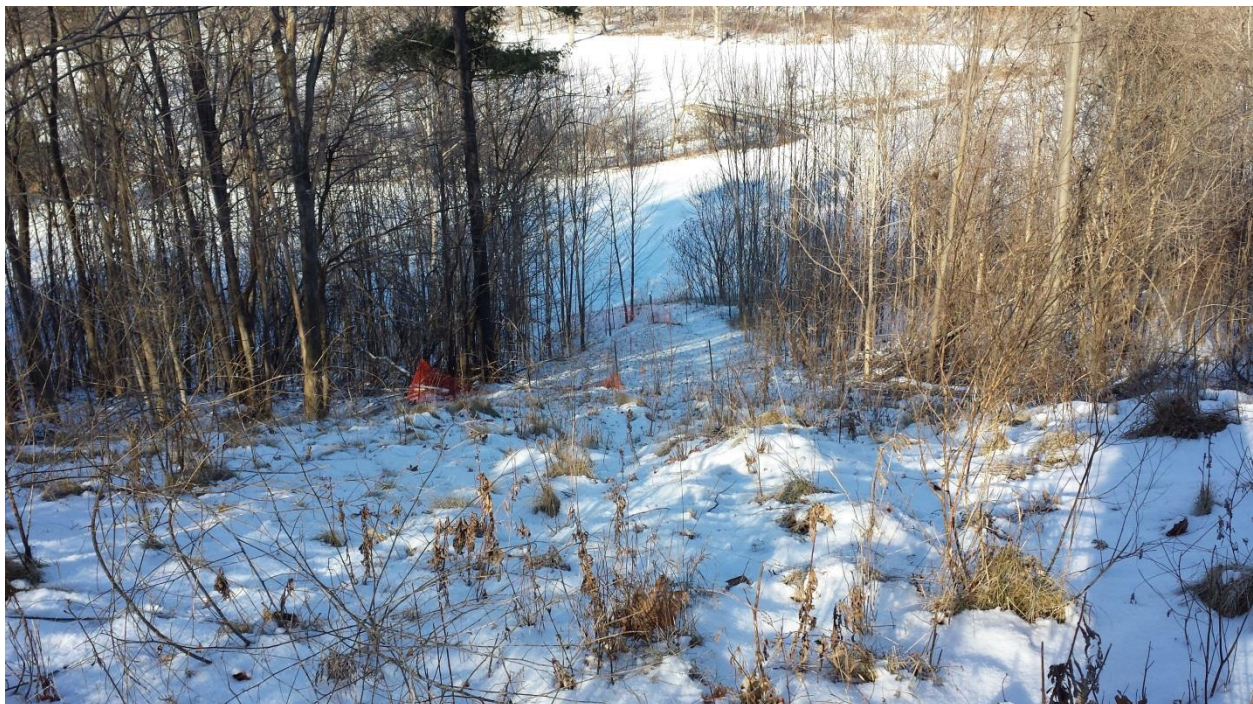
Photograph P4: Looking down from top of the slope. No significant surficial erosion is visible along the slope (January 14, 2015).

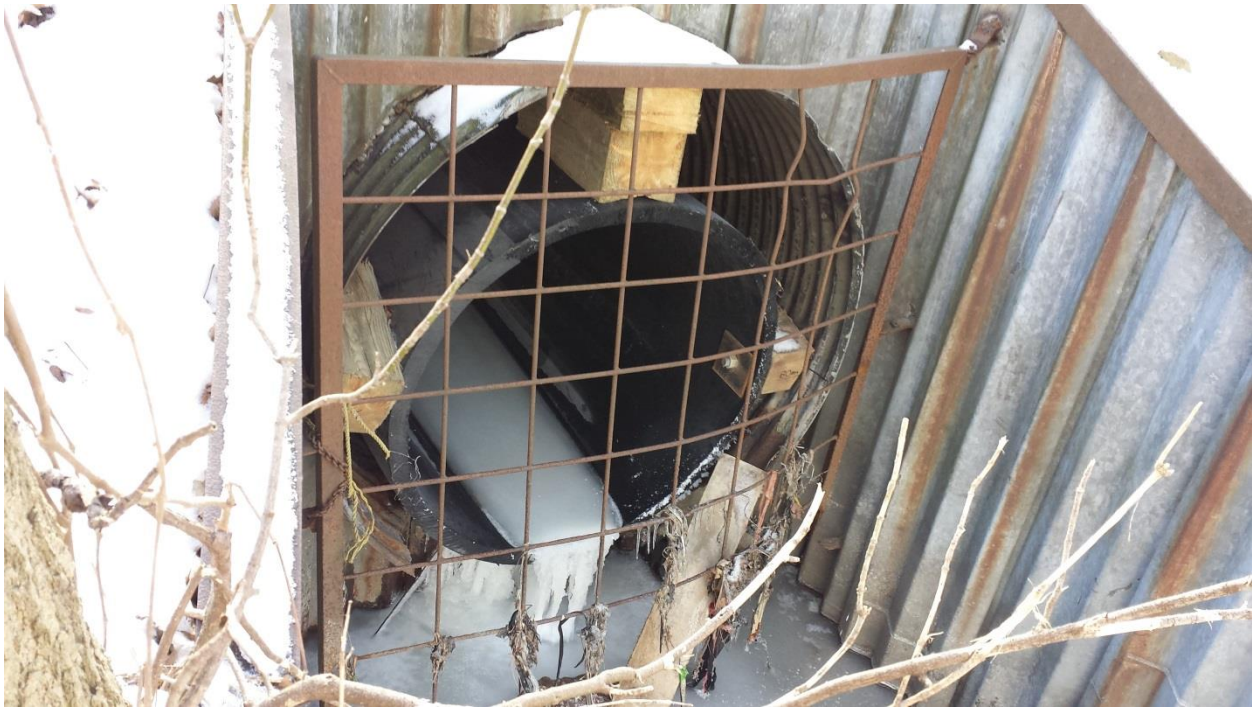
Photograph P5: Looking at the pipe outlet. The HDPE liner is cut off and temporary braced with blocks and bolts at the outlet (January 14, 2015).
