DESKTOP FOUNDATION INVESTIGATION AND DESIGN REPORT

**Teeswater River Bridge Rehabilitation
Site 2-256, Highway 9
Contract 5B Structure Replacements and Rehabilitation
GWP 3025-14-00
Ministry of Transportation, Ontario - West Region**

Report Number: 1534424-5002C-R01

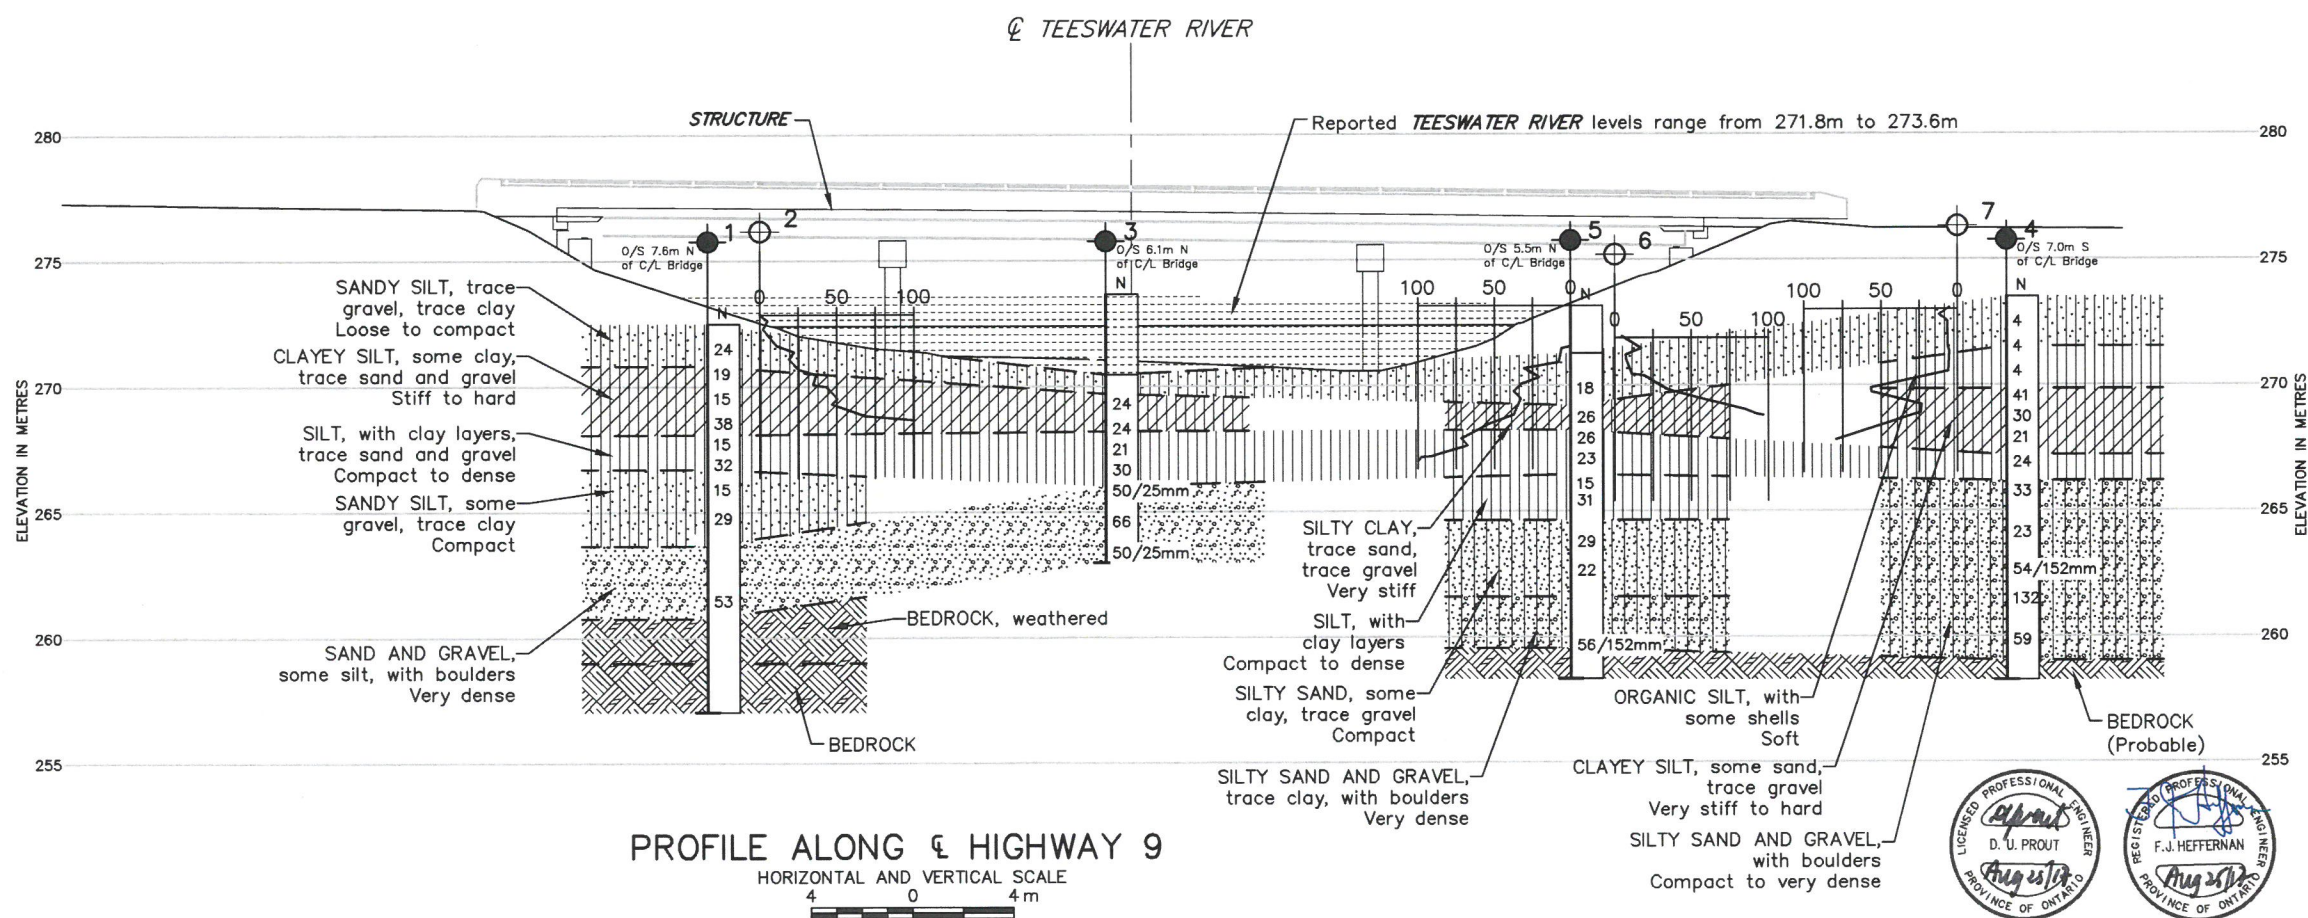
STRUCTURE REHABILITATION
BOREHOLE LOCATIONS AND SOIL STRATA

The boundaries between soil strata have been established only at borehole locations. Between boreholes the boundaries are assumed from geological evidence.

The borehole locations and ground surface elevations at the borehole locations are shown on the original Record of Borehole sheets in Appendix A and on Drawing 1, prepared by Golder. The table below summarizes the coordinates, ground surface elevations and depths of these previous boreholes.

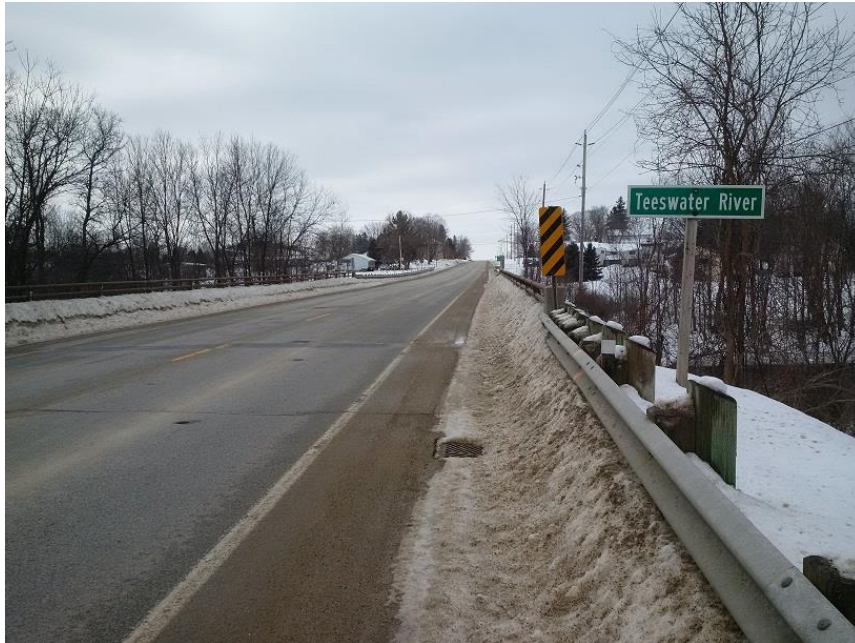
Photograph 1: East end of bridge, looking west.

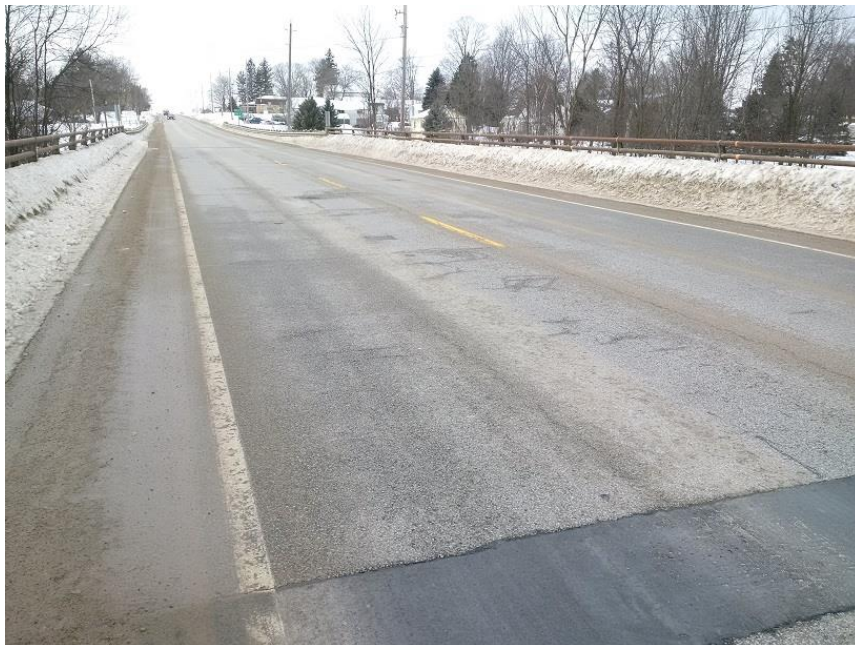
Photograph 2: East end of bridge, looking west.

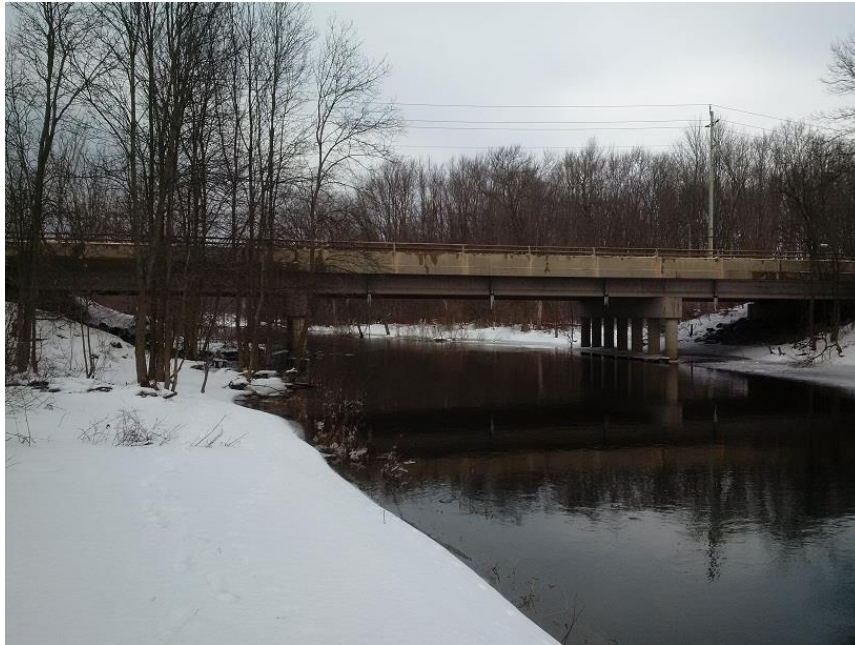
Photograph 3: South elevation.

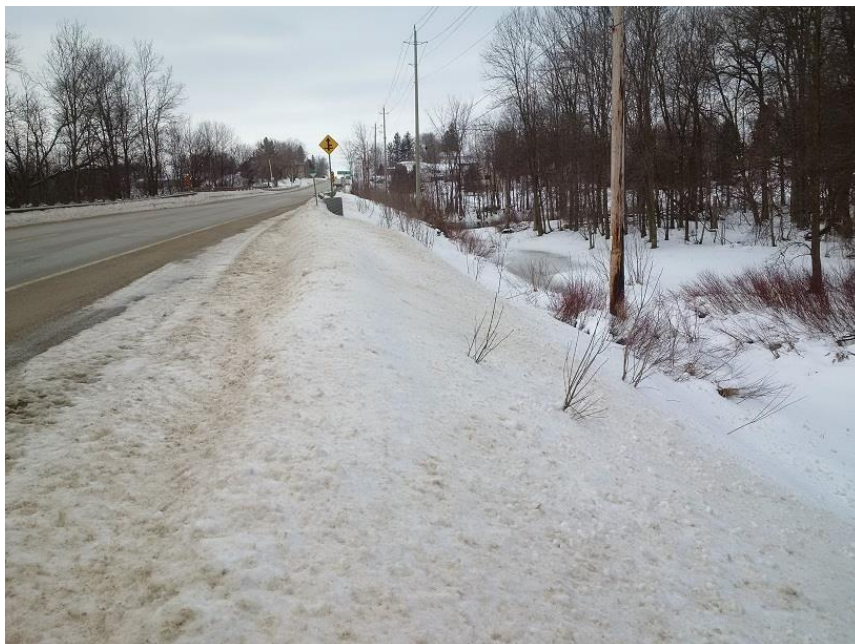
Photograph 4: Embankment sideslope in northeast quadrant.

A site reconnaissance was carried out at the site on February 14, 2017 by a member of our geotechnical engineering staff. In general, the approach embankments and abutment foreslopes appeared to be stable with no visible signs of movement. The foreslopes were covered with rip rap largely consisting of concrete pieces. The abutments appeared to be performing adequately with no observable movement(s) noted, although the east pile cap is partially exposed. Some concrete spalling and exposed rebar was noted at the abutment locations. The piers were in generally good condition although there appeared to be some exposed reinforcing steel in one of the columns at the east pier. Areas of delaminations and spalling were noted at the ends of some of the concrete girders. The bridge soffit is in generally good condition although some concrete spalling and exposed rebar was noted. The asphalt riding surface was in fair condition at the approaches, with some minor to moderate cracking, and in poor condition in the area of the bridge deck with more severe cracking. Photographs from the site reconnaissance are shown in Appendix B.

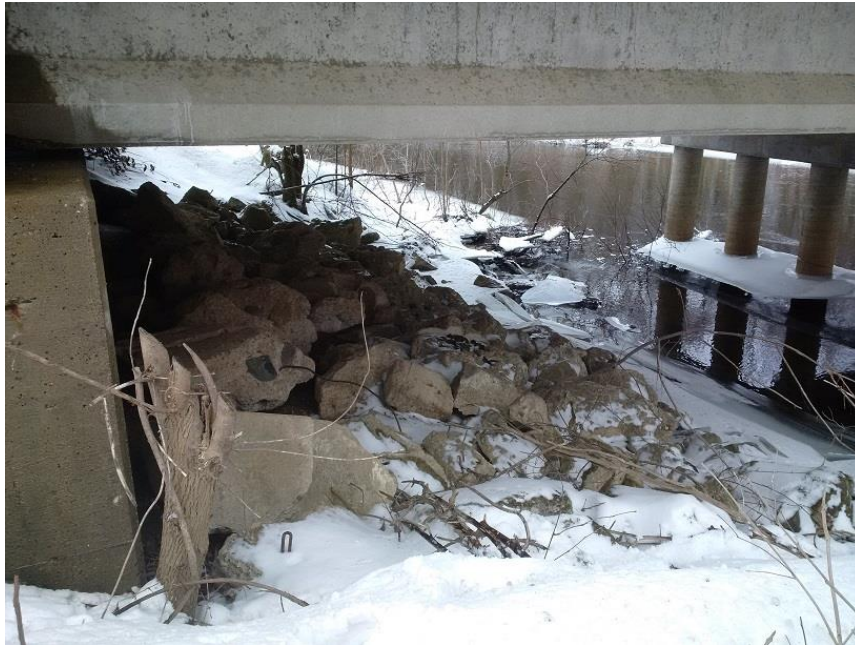
Photograph 5: West abutment, looking north.

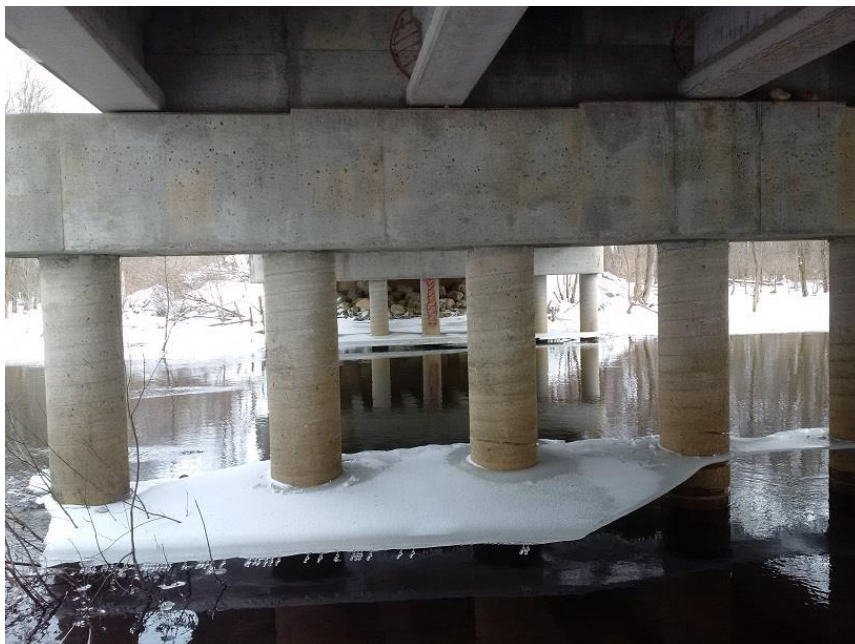
Photograph 6: Looking east under bridge.

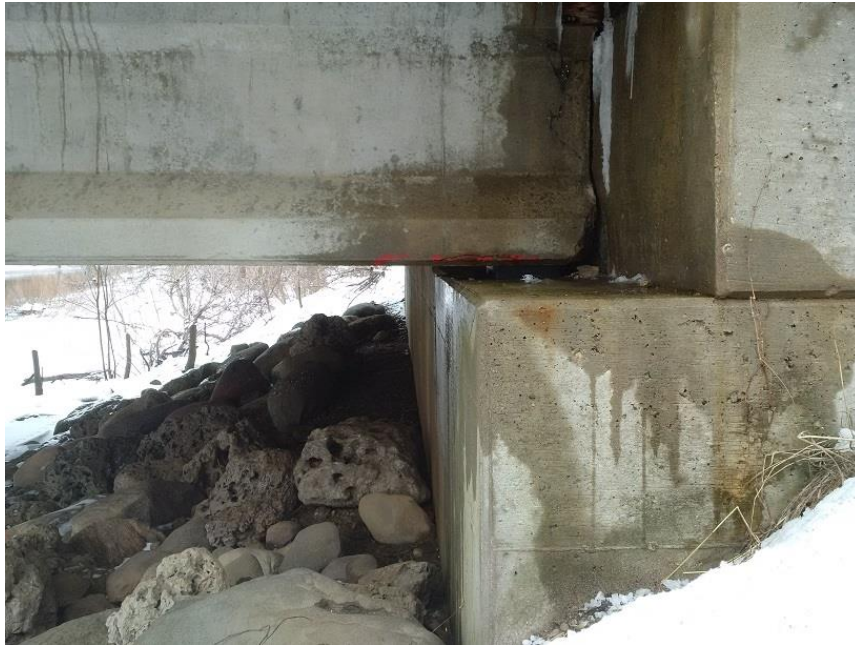
Photograph 7: East abutment, looking north.

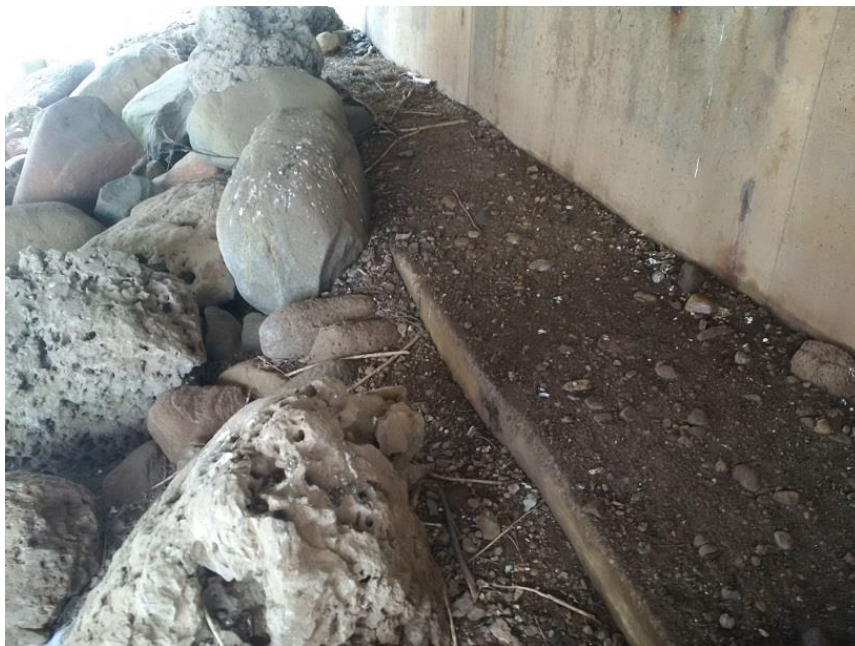
Photograph 8: Partially exposed pile cap at east abutment.
