**Preliminary Foundation Investigation
and Design Report
Ormond Street Overpass
Replacement - Site No. 16X-0123/B0**

Highway 401 Rehabilitation
Brockville, ON

G.W.P. 4003-19-00

Prepared for:
Ministry of Transportation Ontario

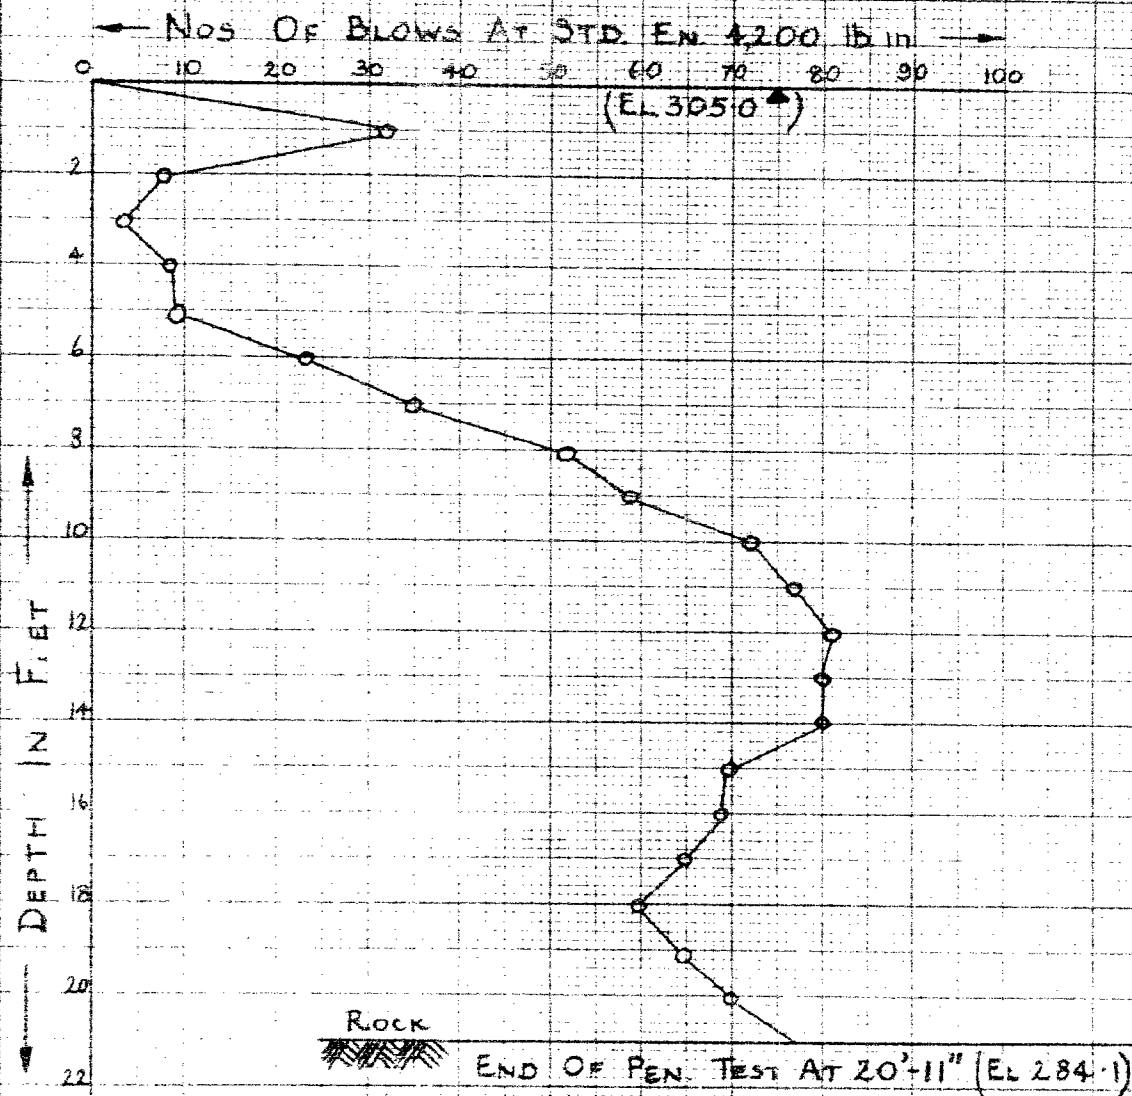
PEN. HOLE N°3 JOB F-55-9

LOCATION STA. 257+58.2; LT. 44' @ 76° 75'

GRAPH OF CONE PENETRATION TEST

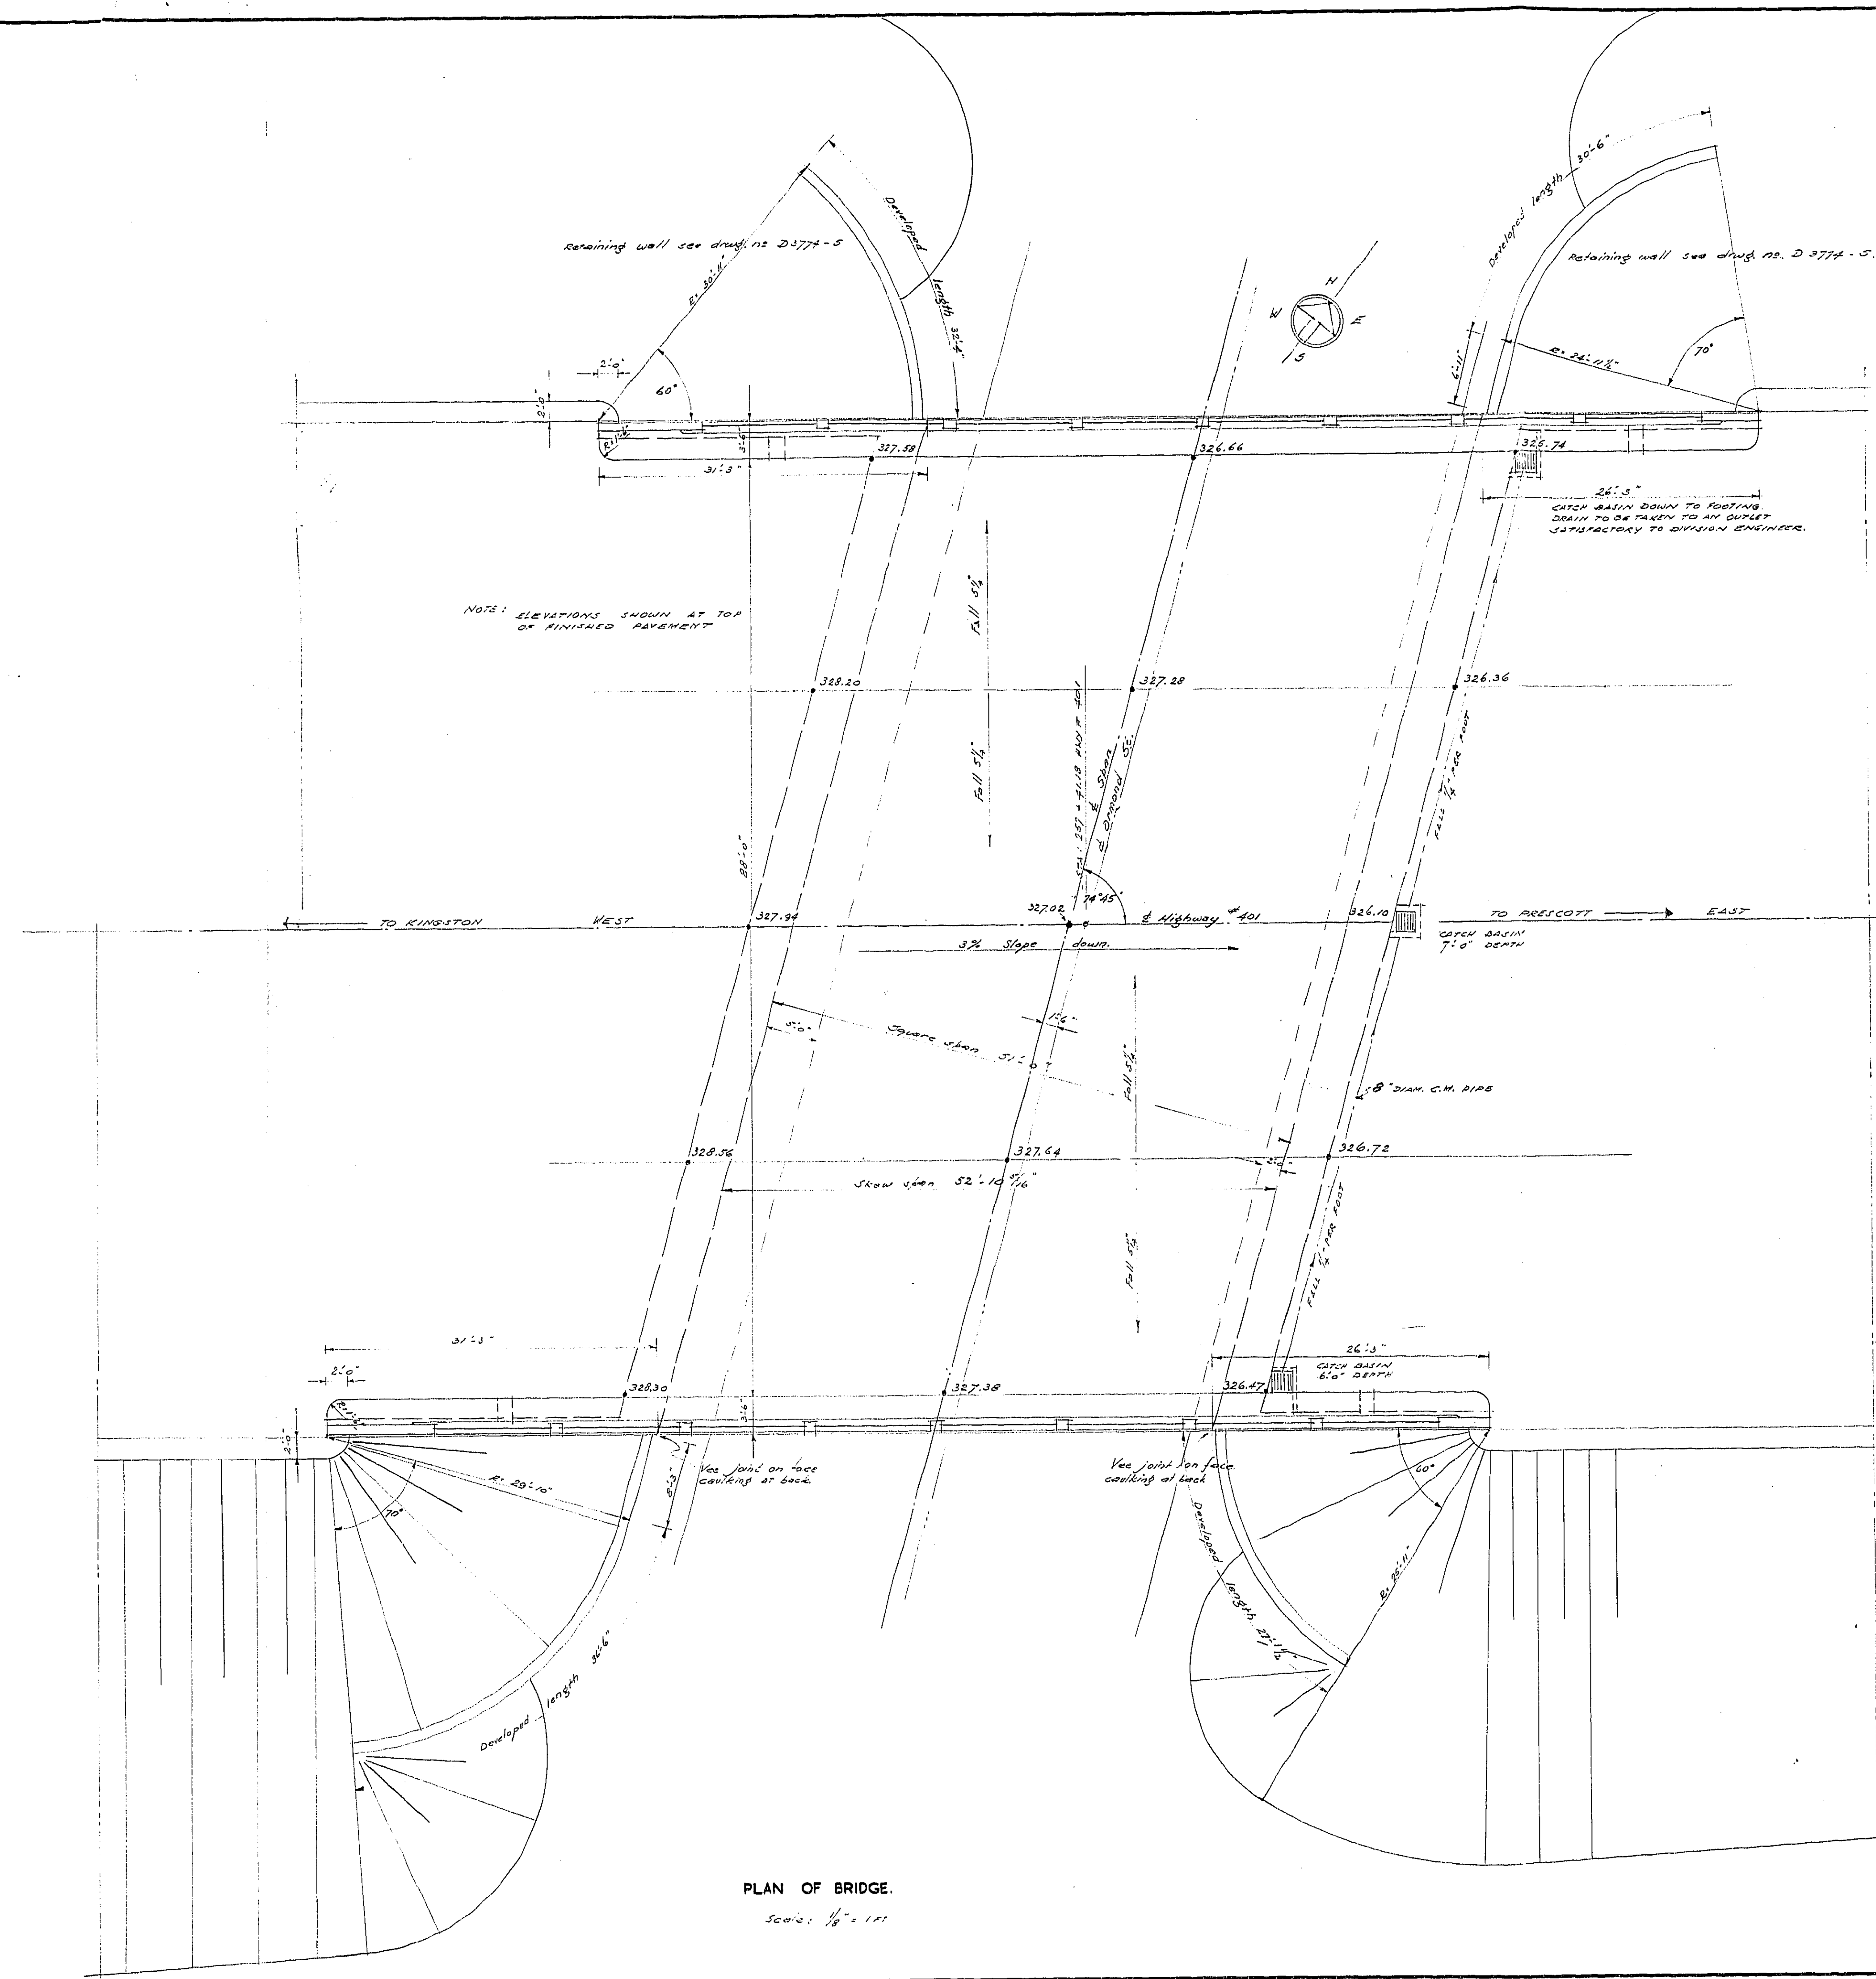
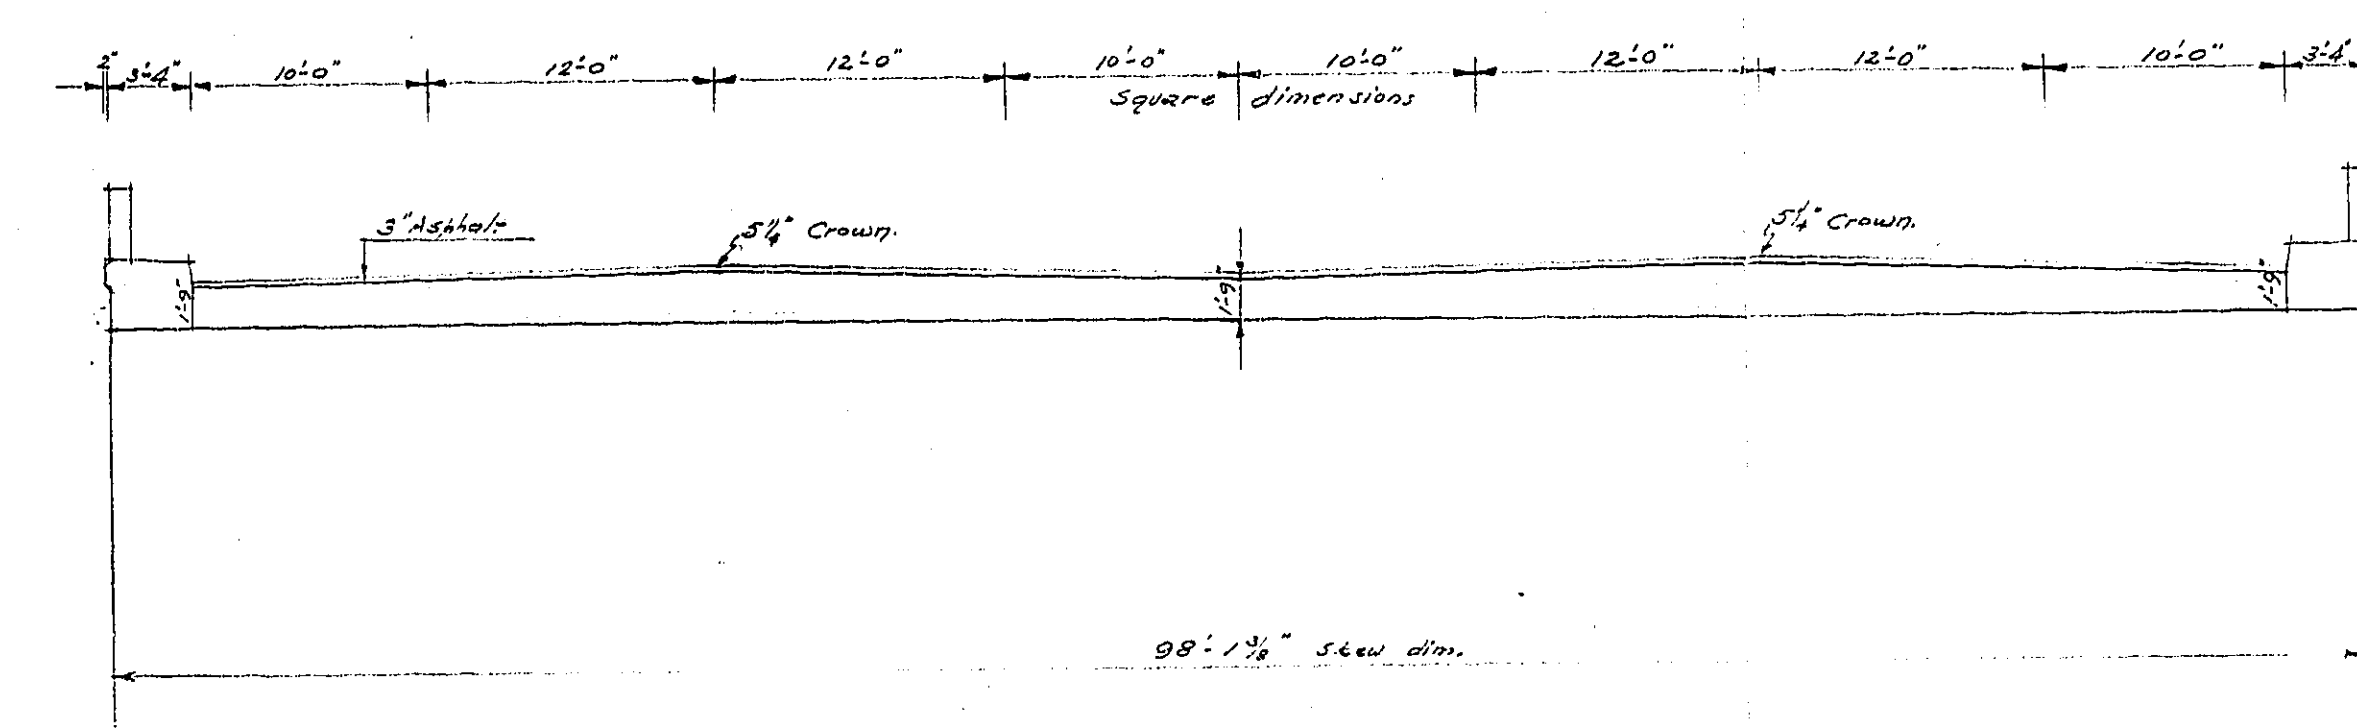
FOR CONTRACTOR:
STRUCTURE TO BE BUILT IN ACCORDANCE WITH FORM No. 9
REVISED MARCH 1957 AND THE SPECIAL PROVISIONS, EXTERA
COPIES OF WHICH MAY BE OBTAINED FROM THE DISTRICT
ENGINEER.
ALL CONSTRUCTION JOINTS TO BE STRAIGHT AND TRUE.
CONSTRUCTION JOINTS IN LOCATIONS NOT SHOWN ON THE PLANS ARE TO BE PROVIDED
BY THE SCOPE OF DESIGN.
ALL JOINTS FOR CURBS AND STRUCTURE TO BE 3000 P.S.I. @ 28 DAYS -
AND 1/4" AIR-LOCKING "S" PER GALS OF CEMENT, MAXIMUM AGRESTA SIZE TO BE 1/2"
ALL EXPOSED CORNERS TO BE CHAMFERED 1" UNLESS OTHERWISE NOTED.
REINFORCEMENT SHALL BE "41-BOND" MEDIUM HARD GRADE STEEL TO
CONFORM TO A.C.I. SPECIFICATIONS UNLESS OTHERWISE NOTED.
MINIMUM CLEAR COVER ON REINFORCEMENT TO BE 2" AT EXPOSED
CONCRETE SURFACES, OTHERWISE "3"

The General Arrangement drawing, and test hole records contained in the above noted report are included in Appendix B for reference.

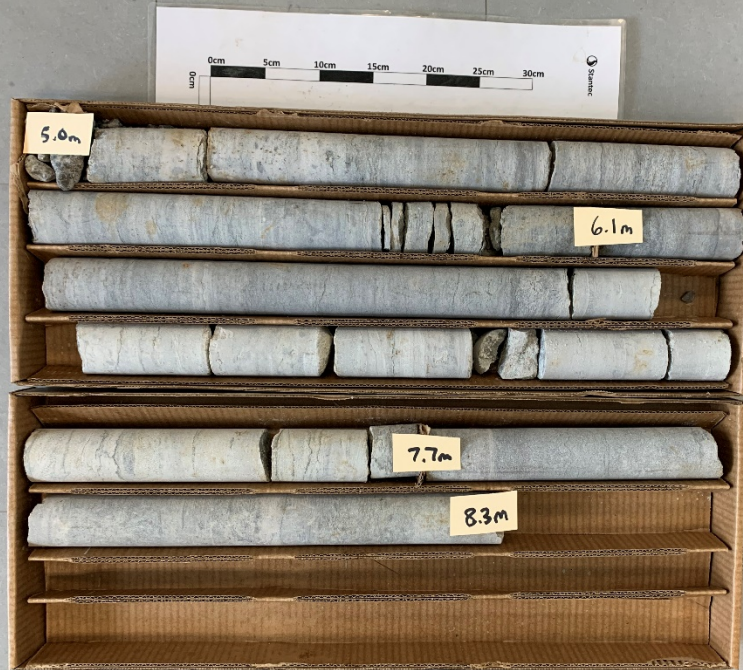
Rock Core Photo No.: 1

Borehole: BC21-1

Depth: 5.0 m to 8.3 m

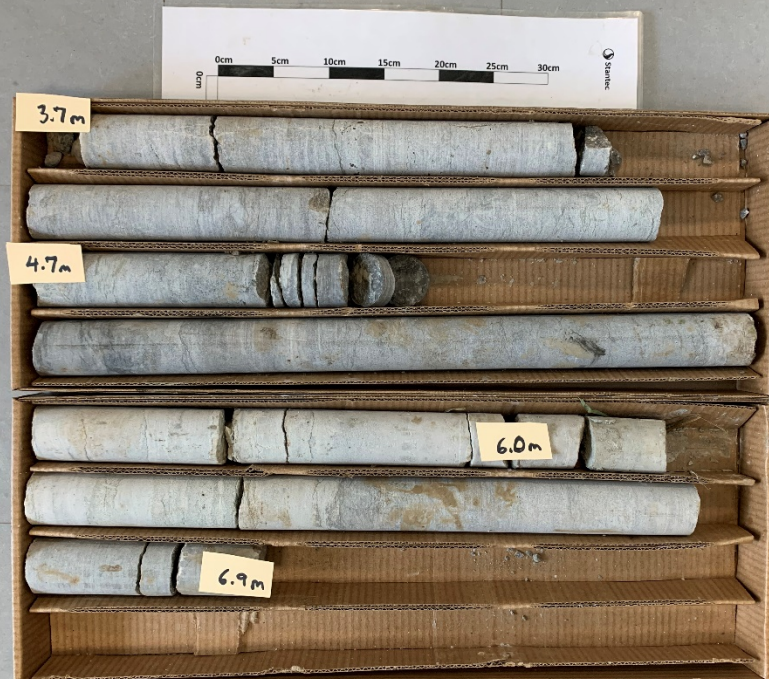
Rock Core Photo No.: 2

Borehole: BC21-2

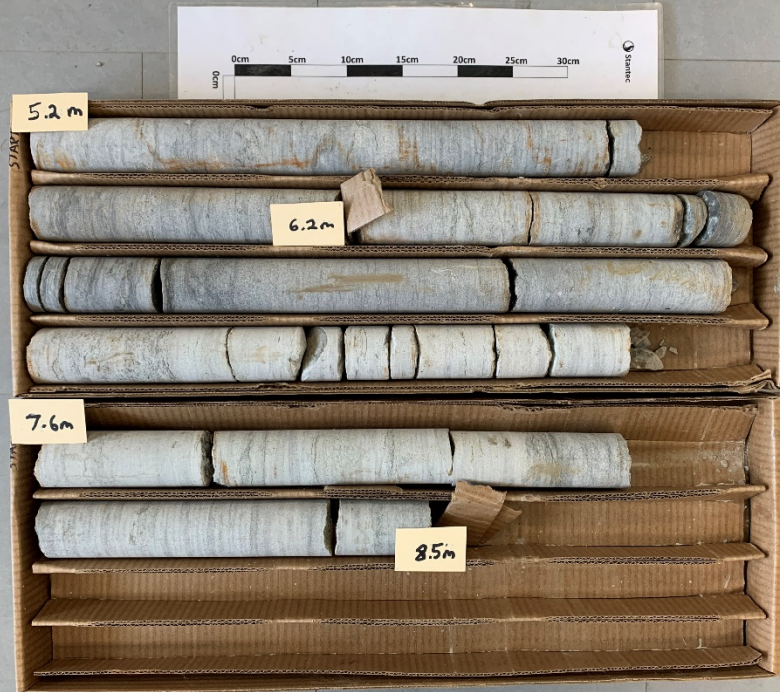
Rock Core Photo No.: 1

Borehole: OS21-1

Depth: 5.2 m to 8.5 m

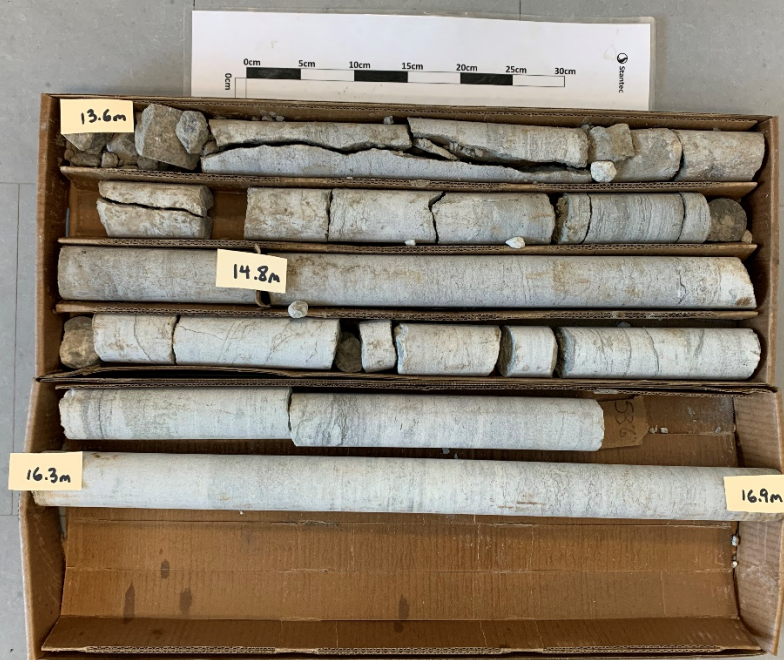
Rock Core Photo No.: 2

Borehole: OS21-2

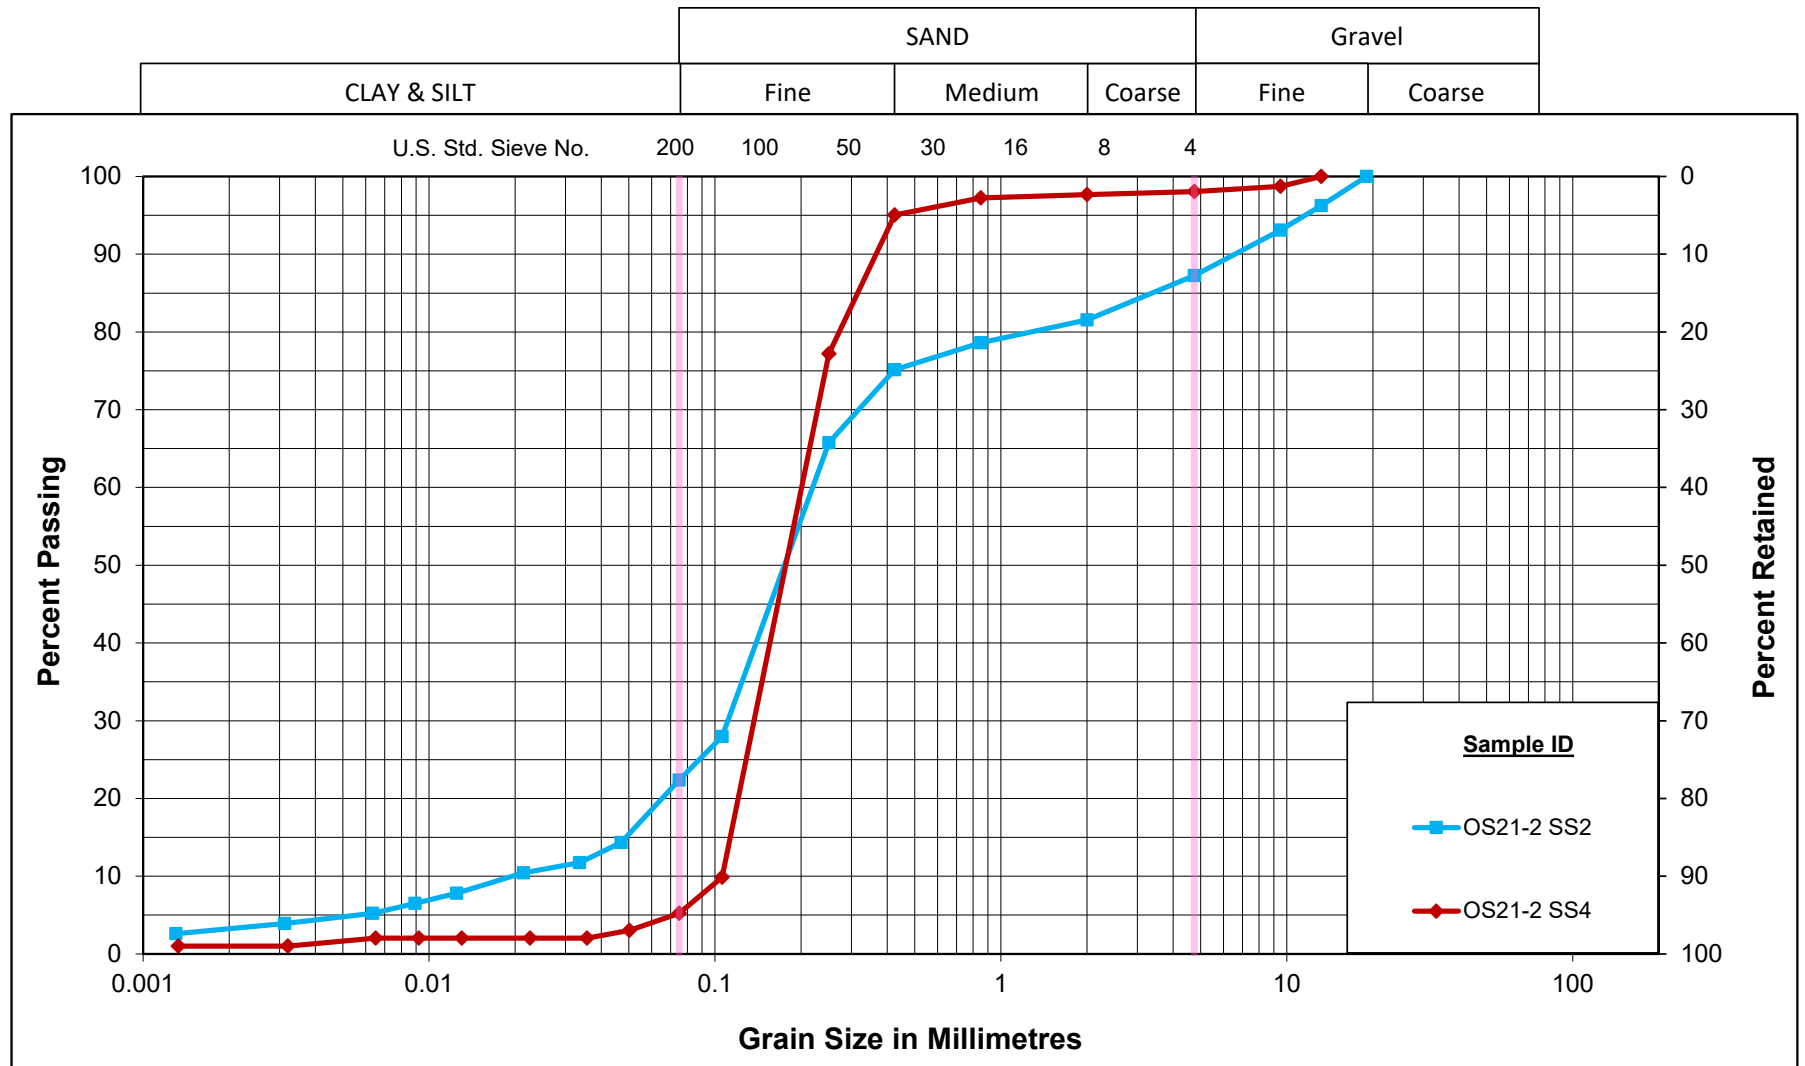
GRAIN SIZE DISTRIBUTION

FILL: SAND to Silty SAND (SP to SM)
Hwy 401 Brockville - Ormond Street Overpass

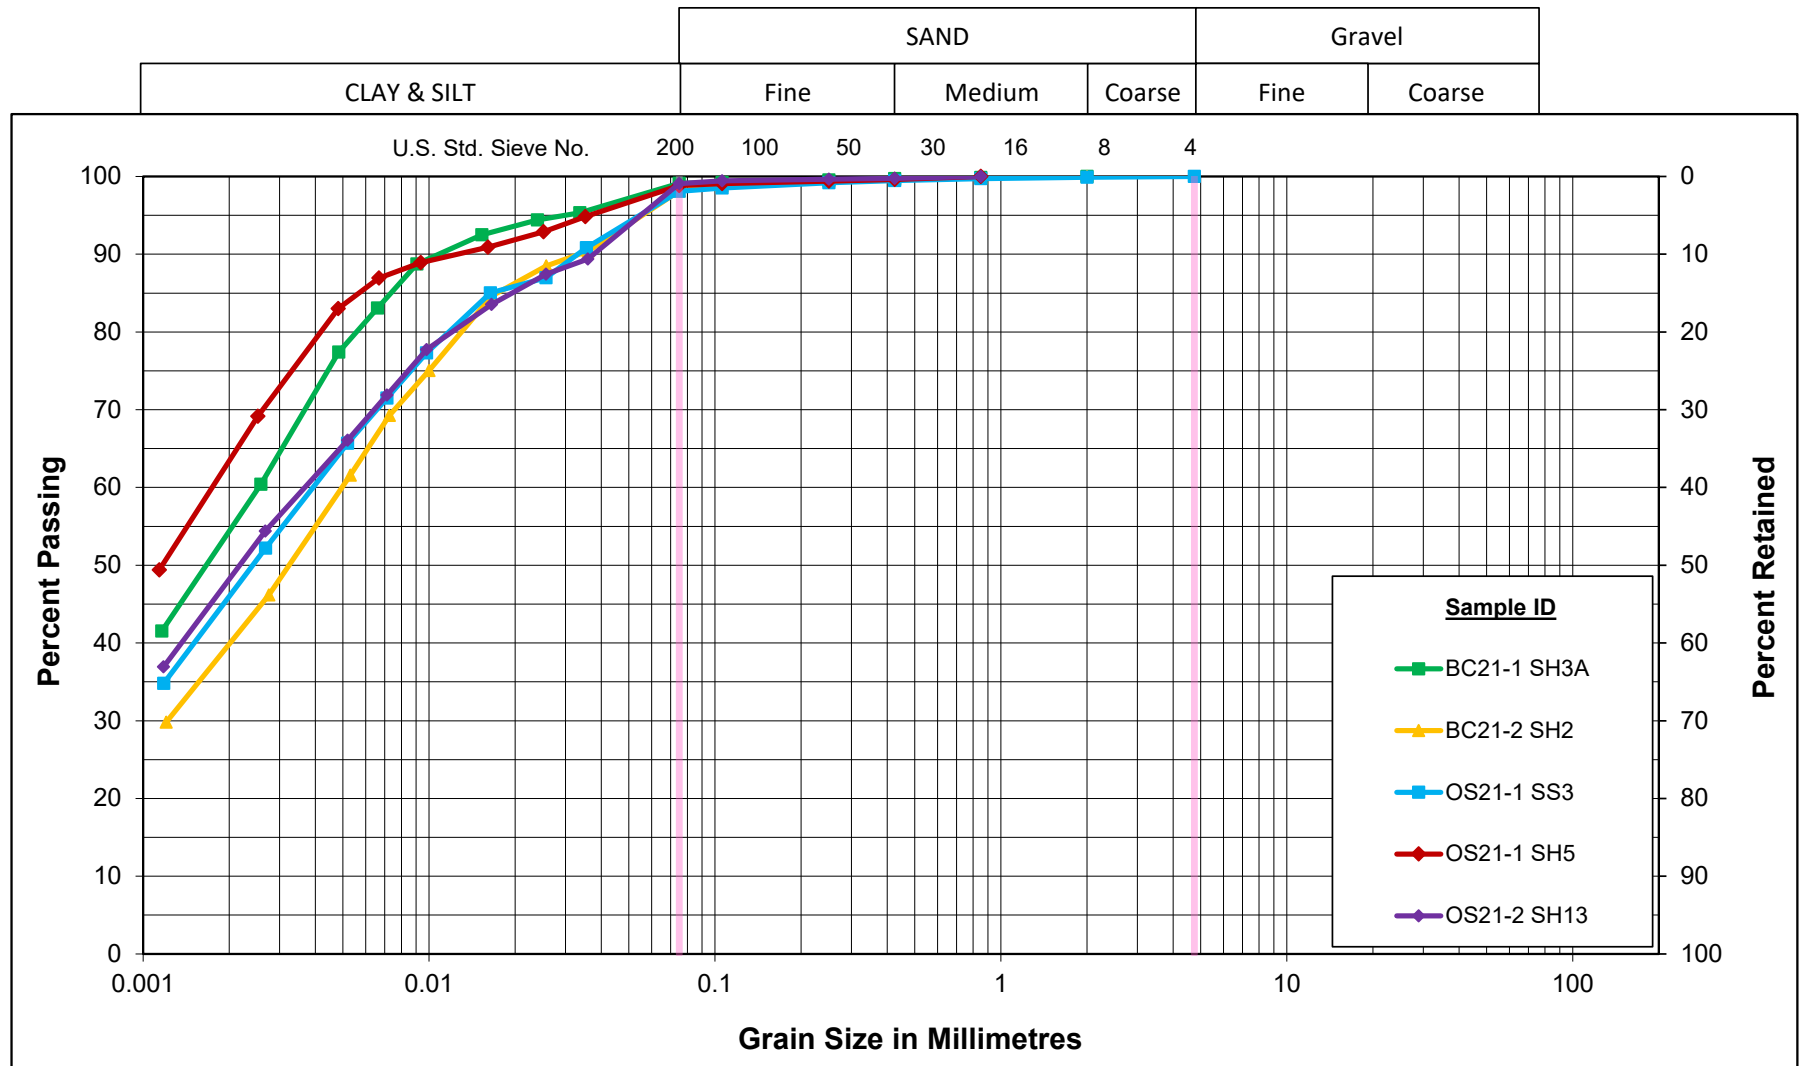
Figure No. D2

GRAIN SIZE DISTRIBUTION

SILTY CLAY (CI) to CLAY (CH)

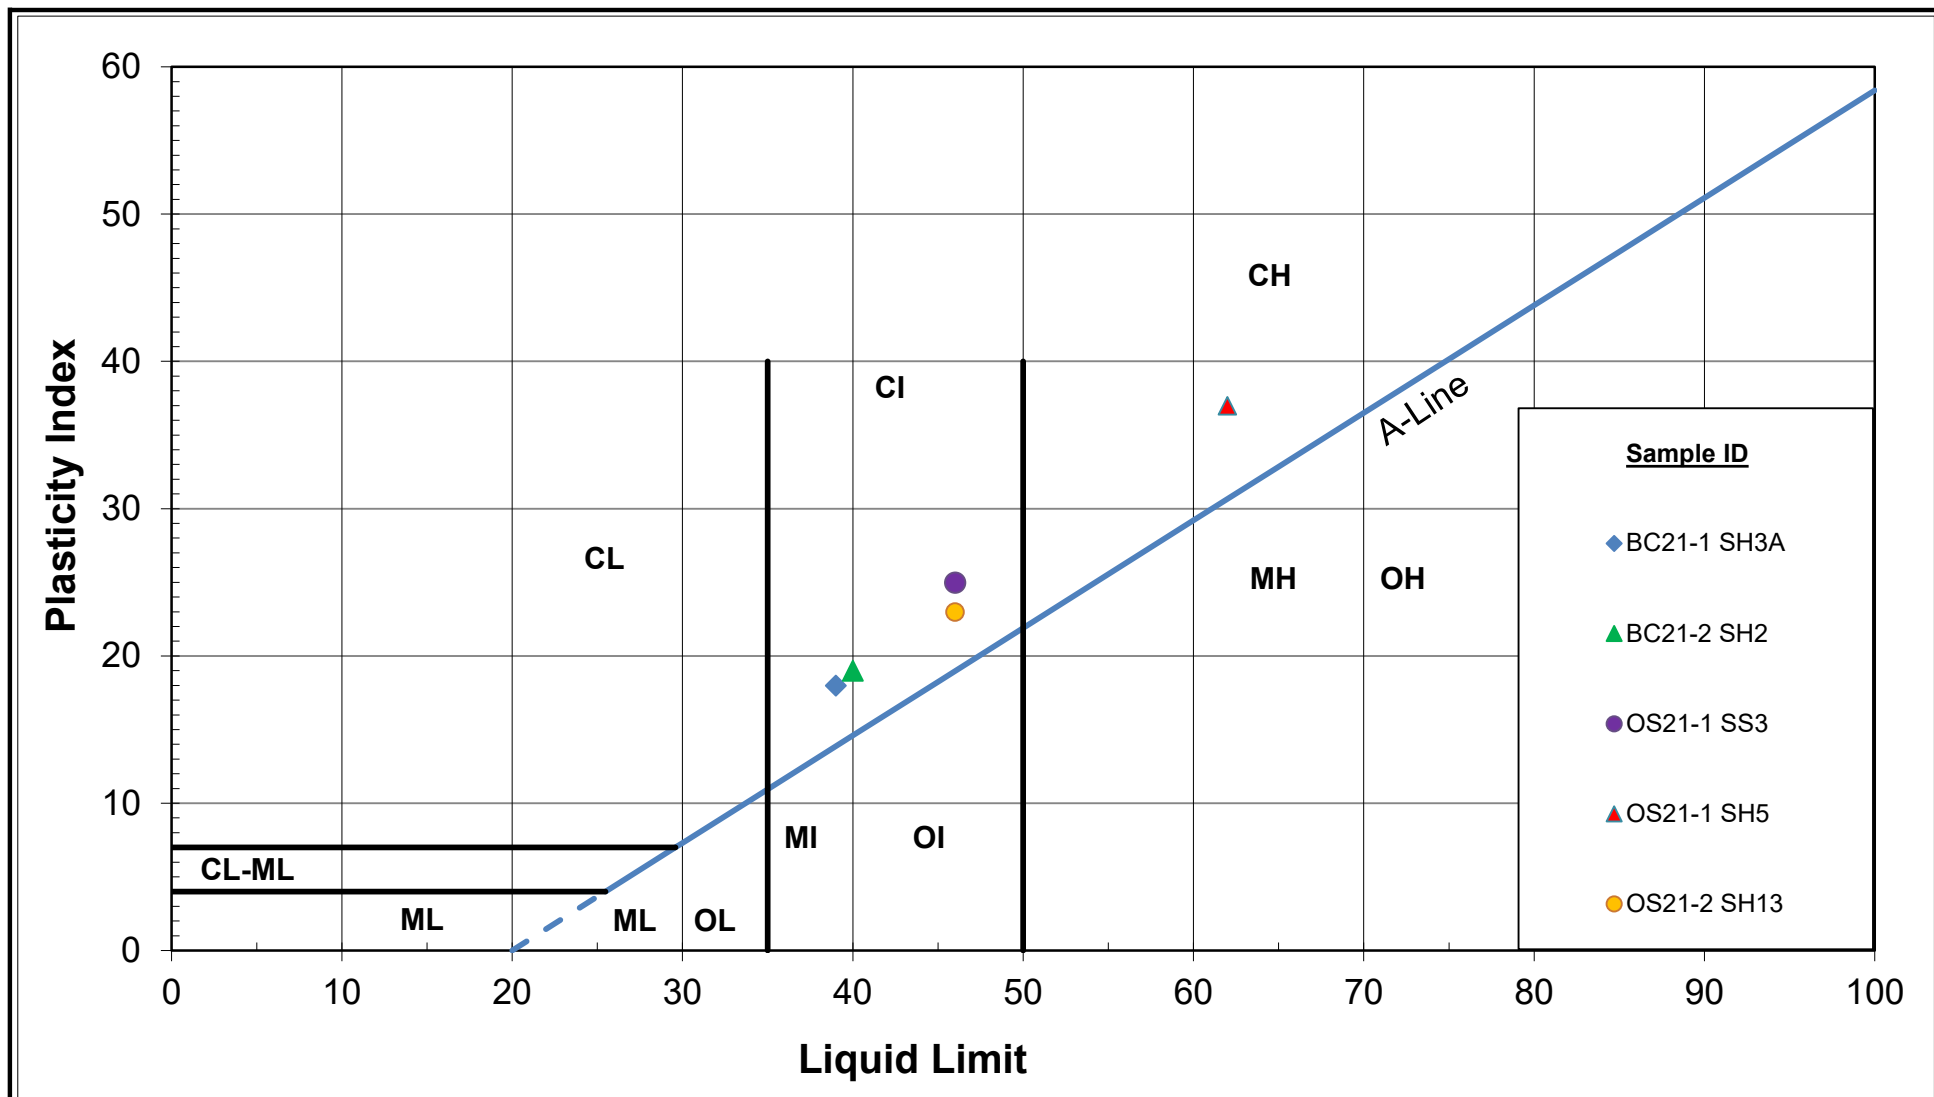
Figure No. D3

SILTY CLAY (CI) to CLAY (CH)
Hwy 401 Brockville - Ormond Street Overpass
PLASTICITY CHART

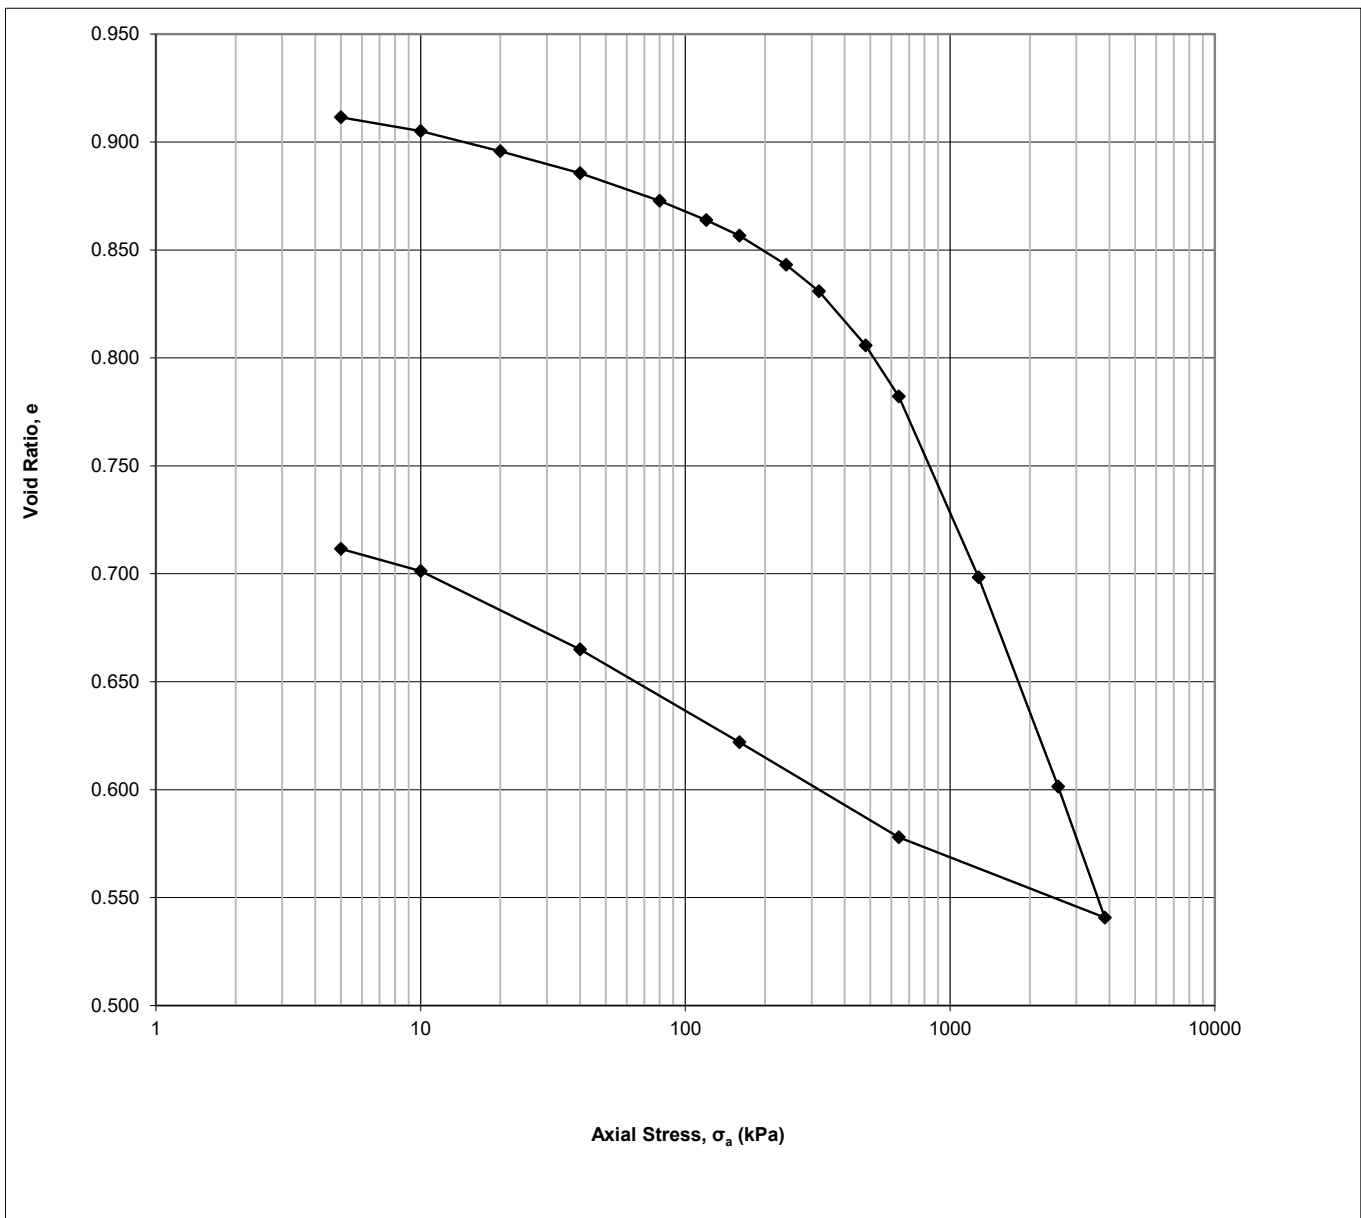
Figure D4A

Hwy 401 Brockville - Ormond Street Overpass
165001160(309)
BC 21-1
SH-3A
2.13 - 2.74 m.

Parameter	Sample ID		
	BC21-1, SH3A	OS21-1, SH5	OS21-2, SH13
Sample Depth (m below ground)	2.5	3.3	9.5
Sample Elevation (m)	89.8	90.0	90.9
Effective Vertical Stress (kPa)	25.8	32.0	171.8
Moisture Content	33%	40%	23%
Initial Void Ratio, e_0	0.960	1.127	0.698
Initial Unit Weight, γ	18.1 kN/m ³	17.8 kN/m ³	19.6 kN/m ³
Estimated Preconsolidation Stress, P'_c	580 kPa	900 kPa	650 kPa
Overconsolidation Ratio (OCR)	22.5	28.2	3.8
Recompression Index, C_r	0.06	0.02	0.02
Compression Index, C_c	0.33	0.49	0.23
Coefficient of Consolidation, C_v	0.3 mm ² /s	0.5 mm ² /s	0.5 mm ² /s

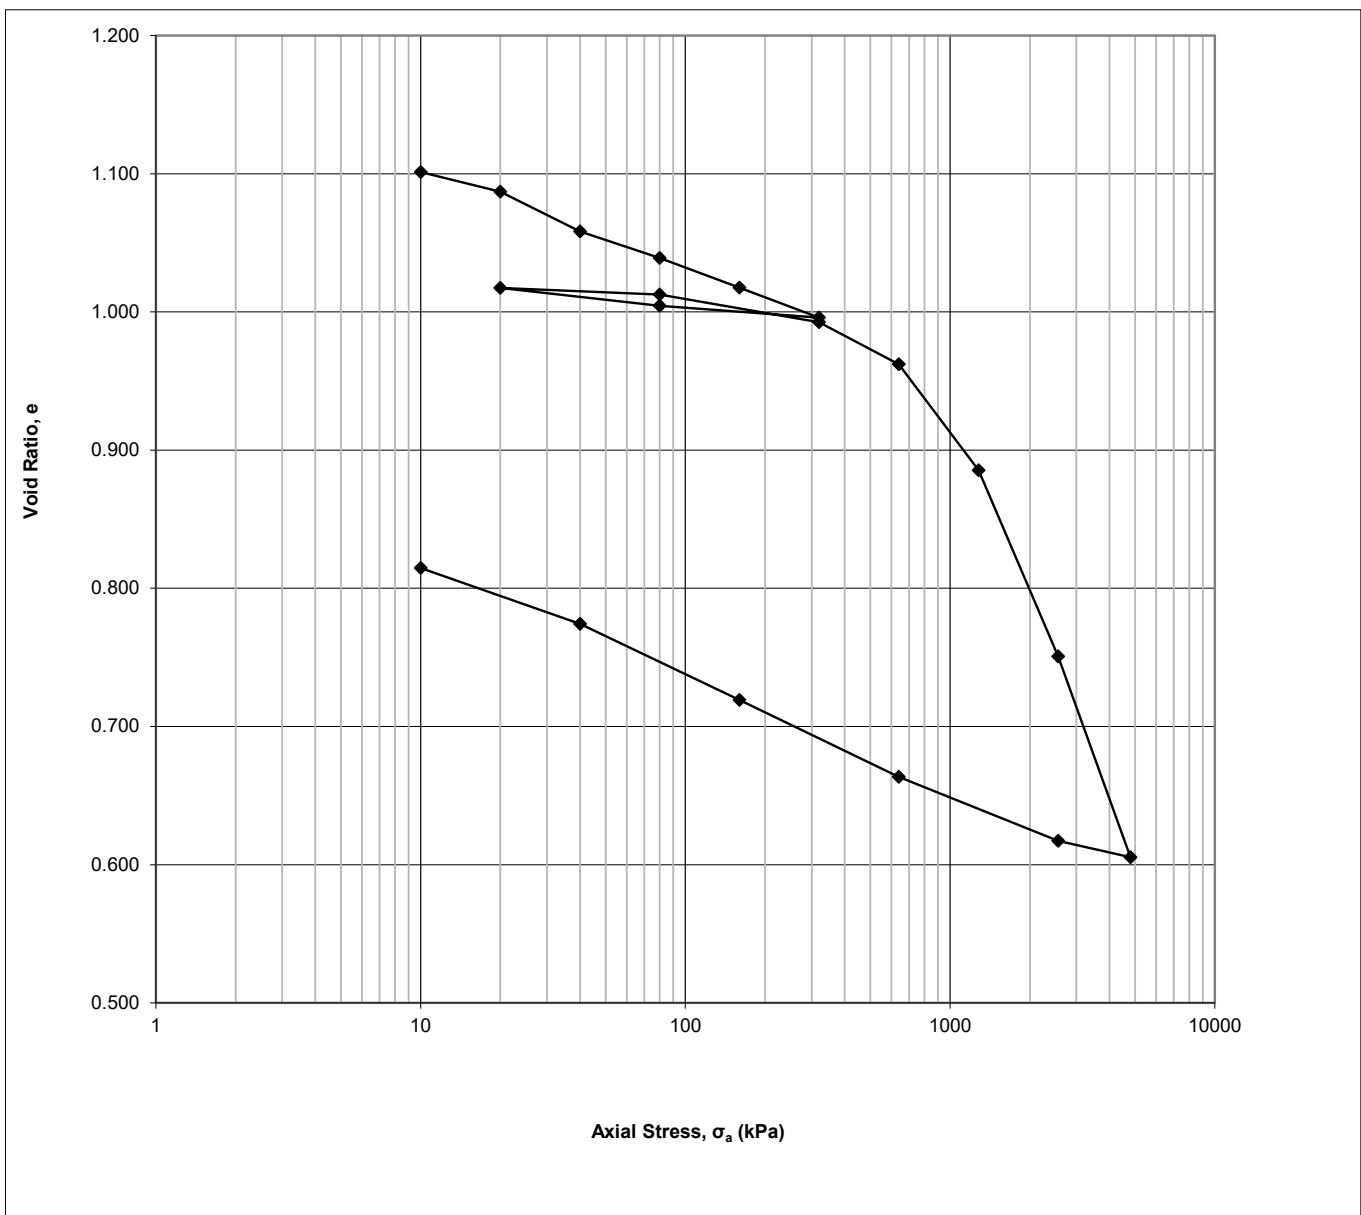
Figure D5A

Hwy 401 Brockville - Ormond Street Overpass
165001160(309)
OS 21-1
SH-5
3.05 - 3.66 m.

One-Dimensional Consolidation Test using Incremental Loading
ASTM D2435/D2435M - 11(2020)

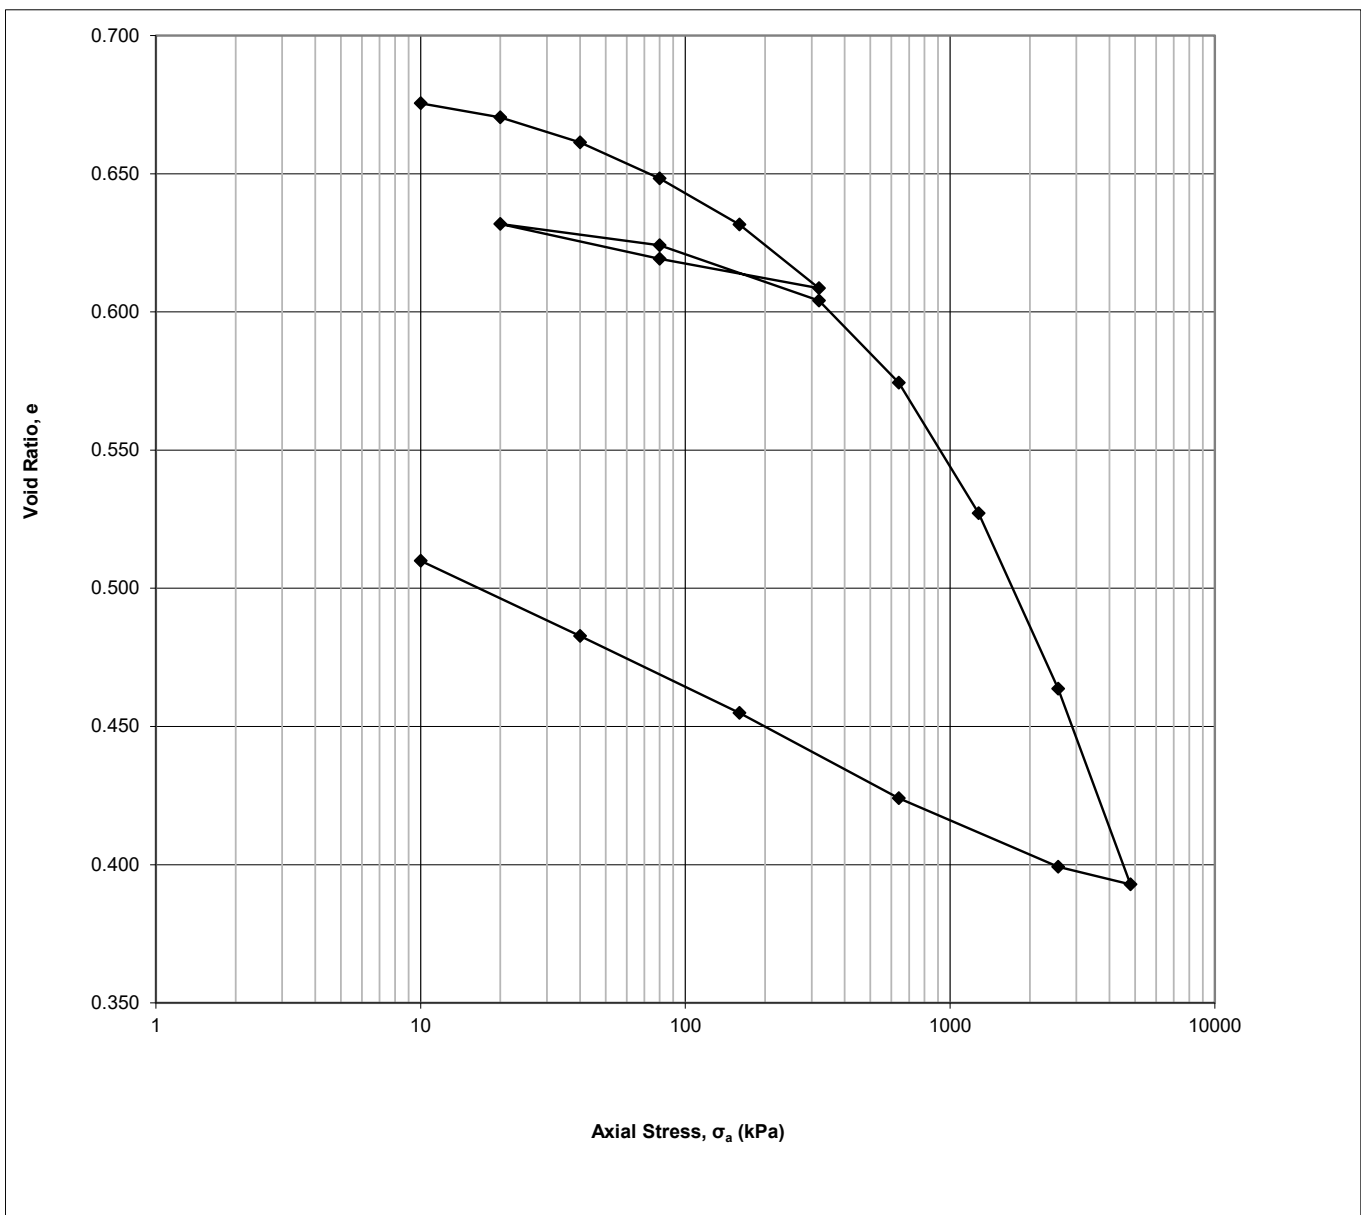
Figure D6A

Hwy 401 Brockville - Ormond Street Overpass
165001160(309)
OS 21-2
SH-13
9.91 - 10.52 m.

One-Dimensional Consolidation Test using Incremental Loading
ASTM D2435/D2435M - 11(2020)

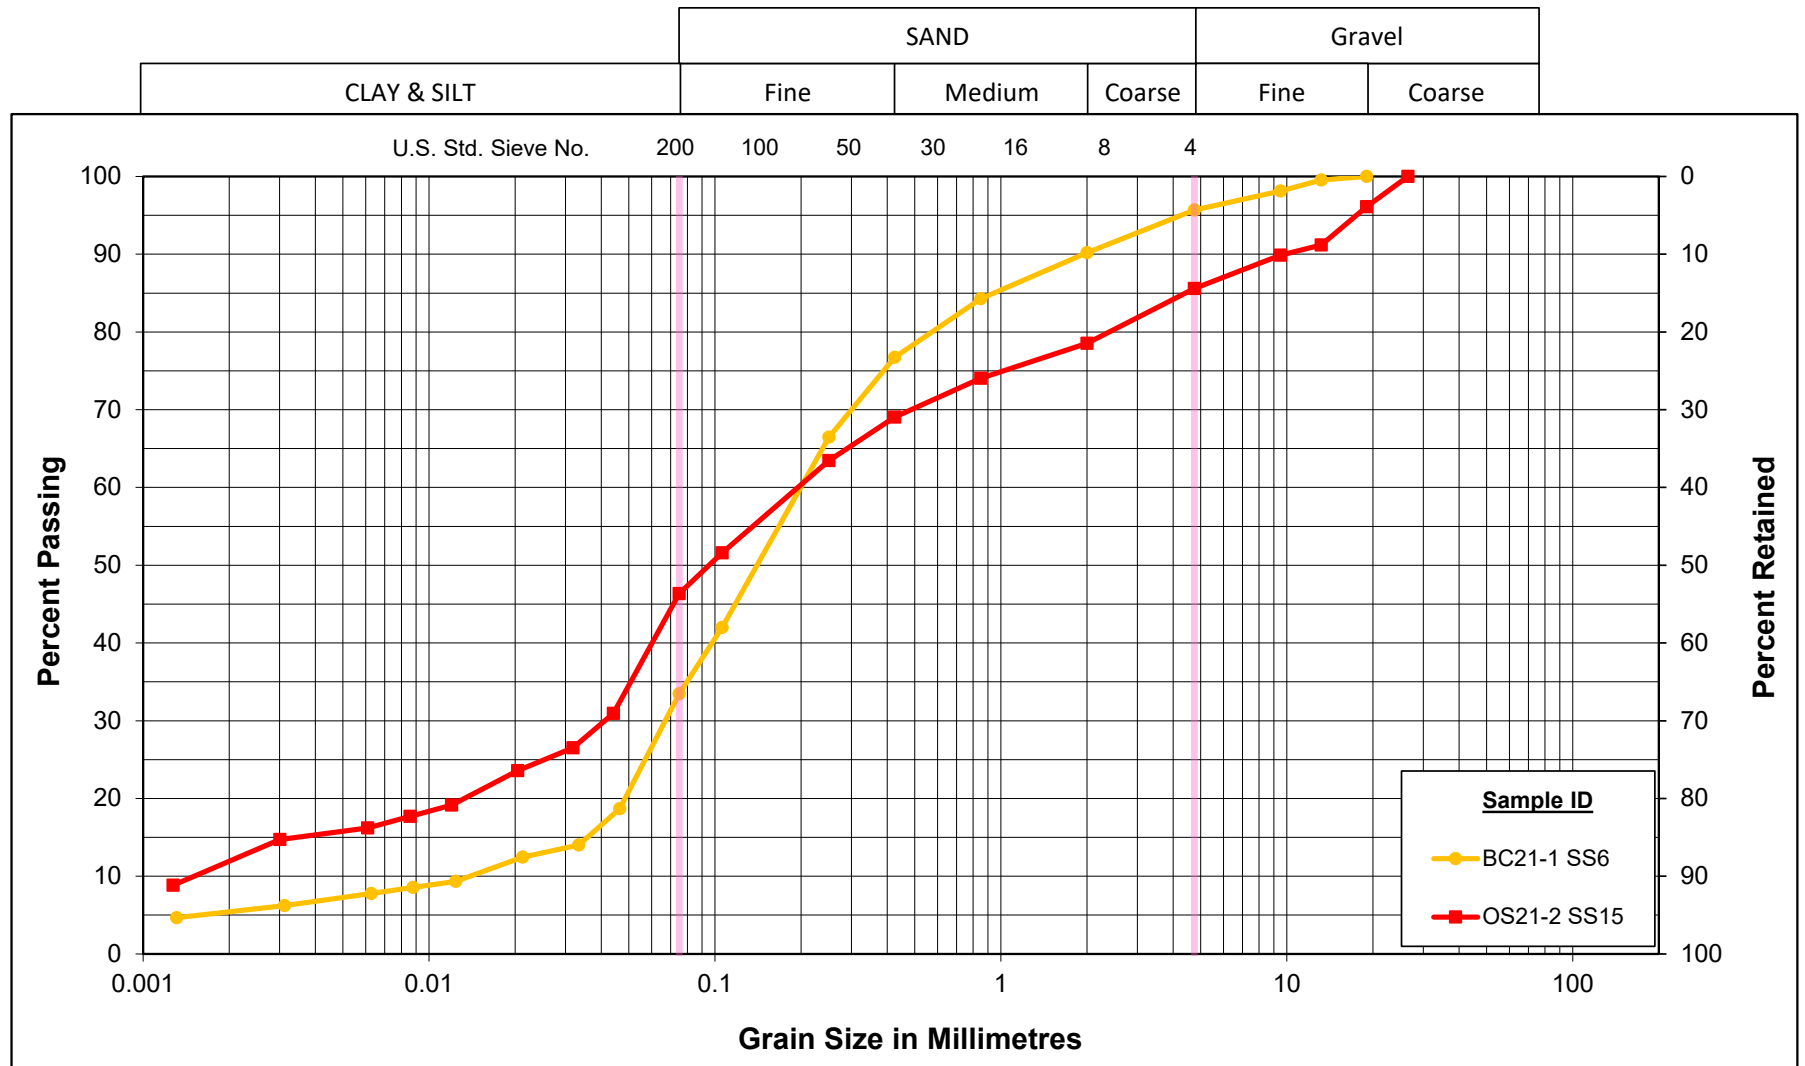
Figure No. D7

GRAIN SIZE DISTRIBUTION
 SILTY SAND to SILT and SAND (TILL) (SM to CL-ML)
 Hwy 401 Brockville - Ormond Street Overpass
