**Preliminary Foundation Investigation
and Design Report
Ormond Street Overpass
Replacement - Site No. 16X-0123/B0**

Highway 401 Rehabilitation
Brockville, ON

G.W.P. 4003-19-00

Prepared for:
Ministry of Transportation Ontario

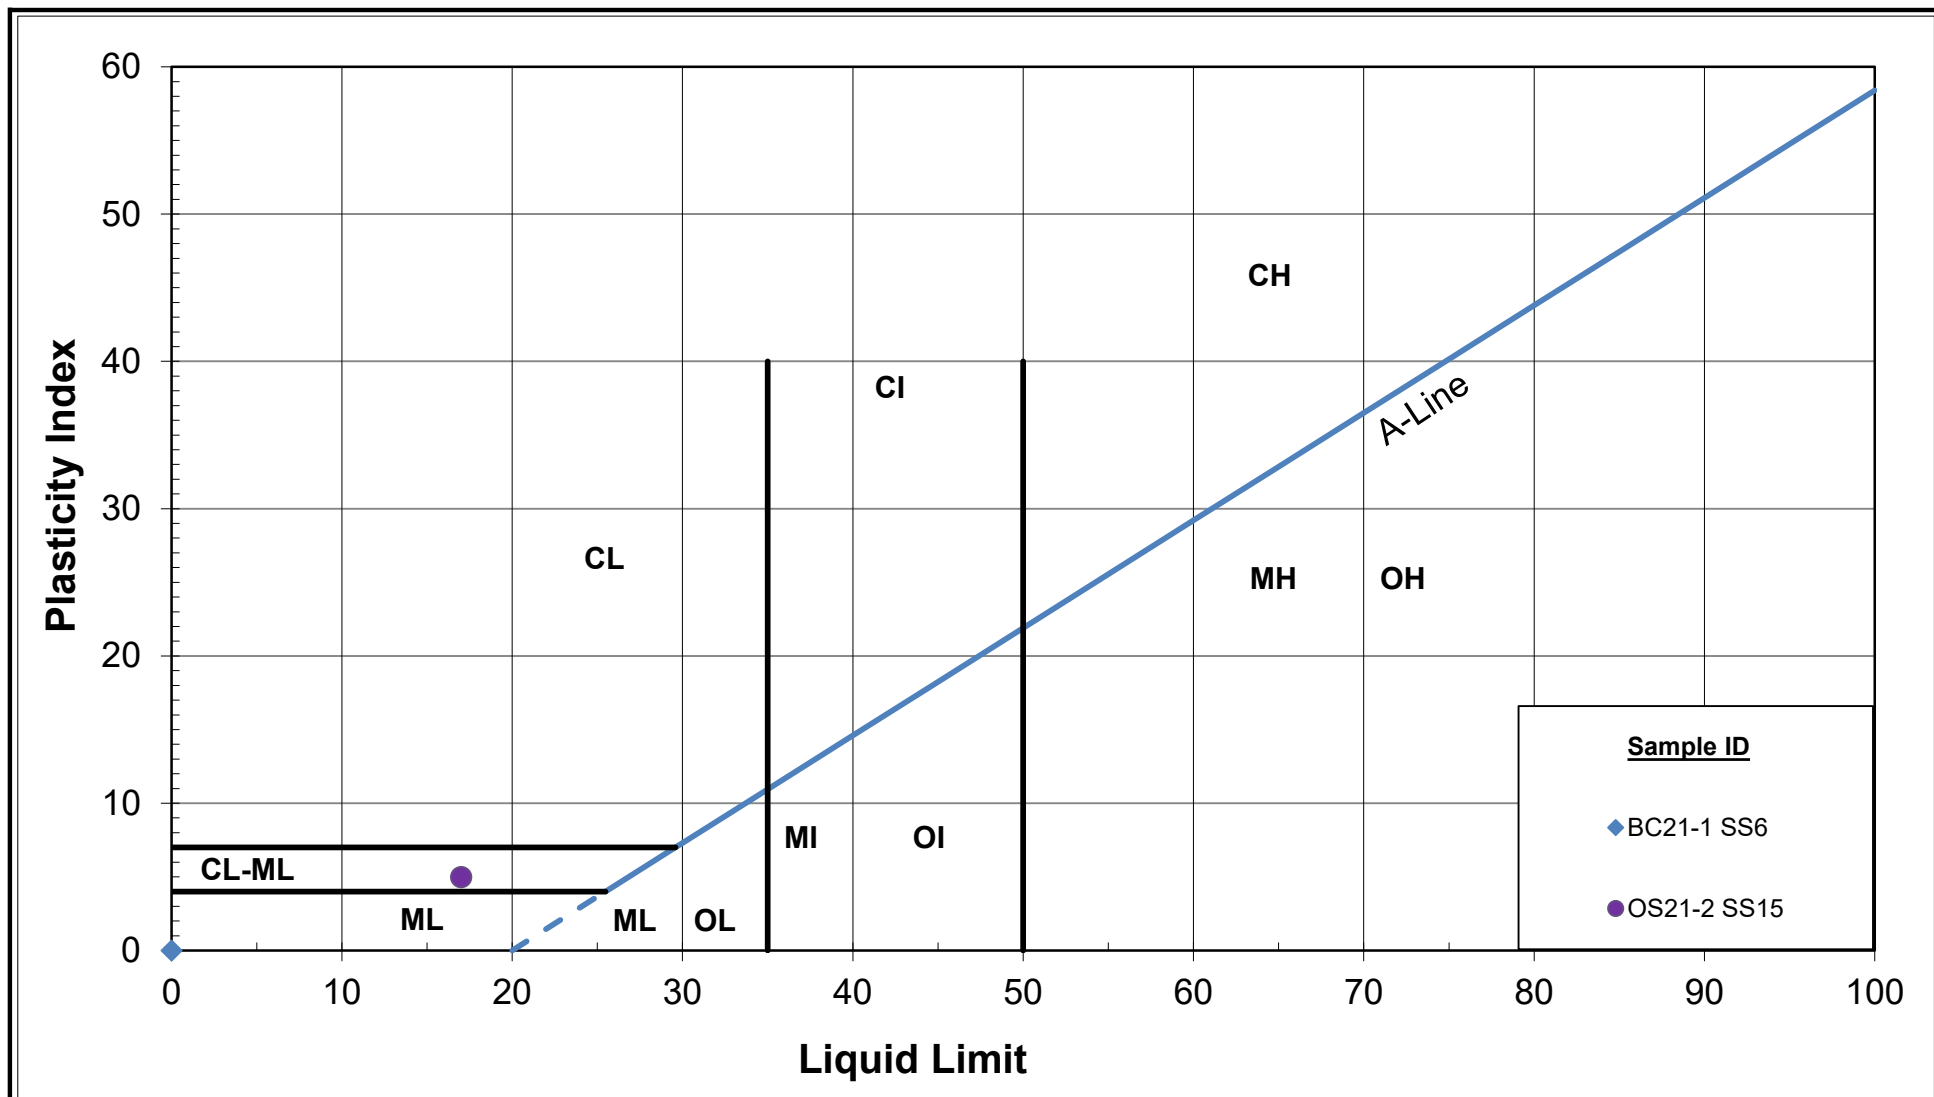
Figure No. D8

SILTY SAND (SM) tp SILT and SAND (CL-ML) (TILL)
 Hwy 401 Brockville - Ormond Street Overpass
PLASTICITY CHART

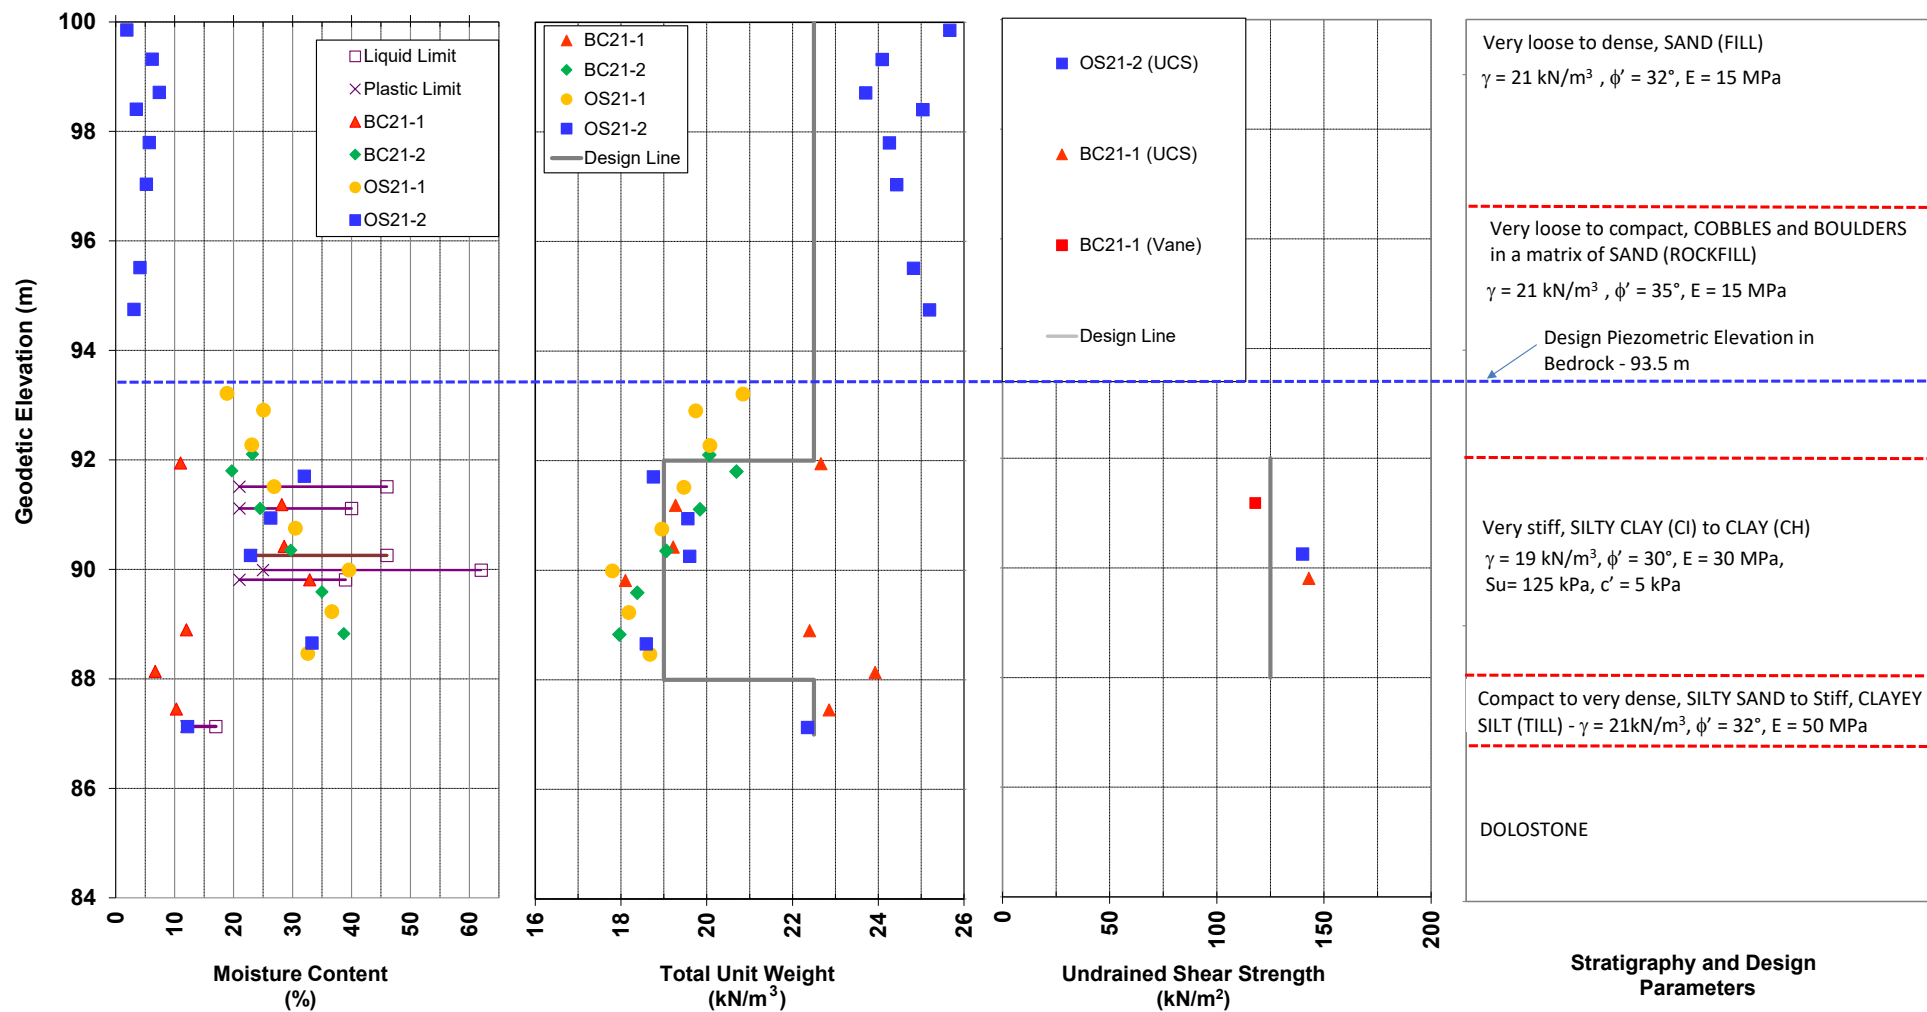
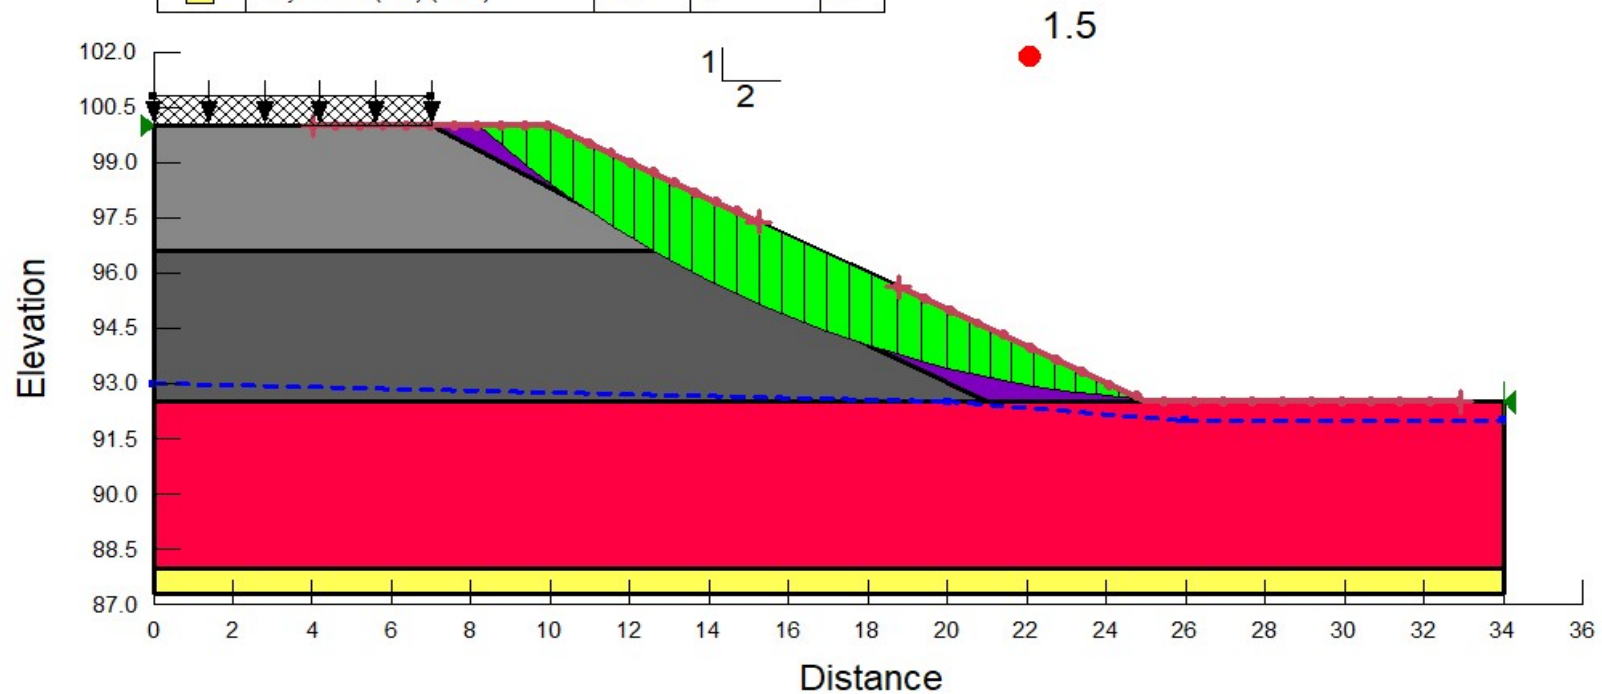
Color	Name	Unit Weight (kN/m³)	Cohesion' (kPa)	Phi' (°)
█	Existing ROCKFILL	21	0	35
█	Existing Sand FILL	21	0	32
█	Select Subgrade Material (SSM)	20	0	32
█	SILTY CLAY (CI) to CLAY (CH)	19	5	30
█	Silty SAND (SM) (TILL)	22.5	0	32

Slope Stability Analysis (Static)

E.2 DRAWINGS E2 TO E4 – SLOPE STABILITY ANALYSIS RESULTS

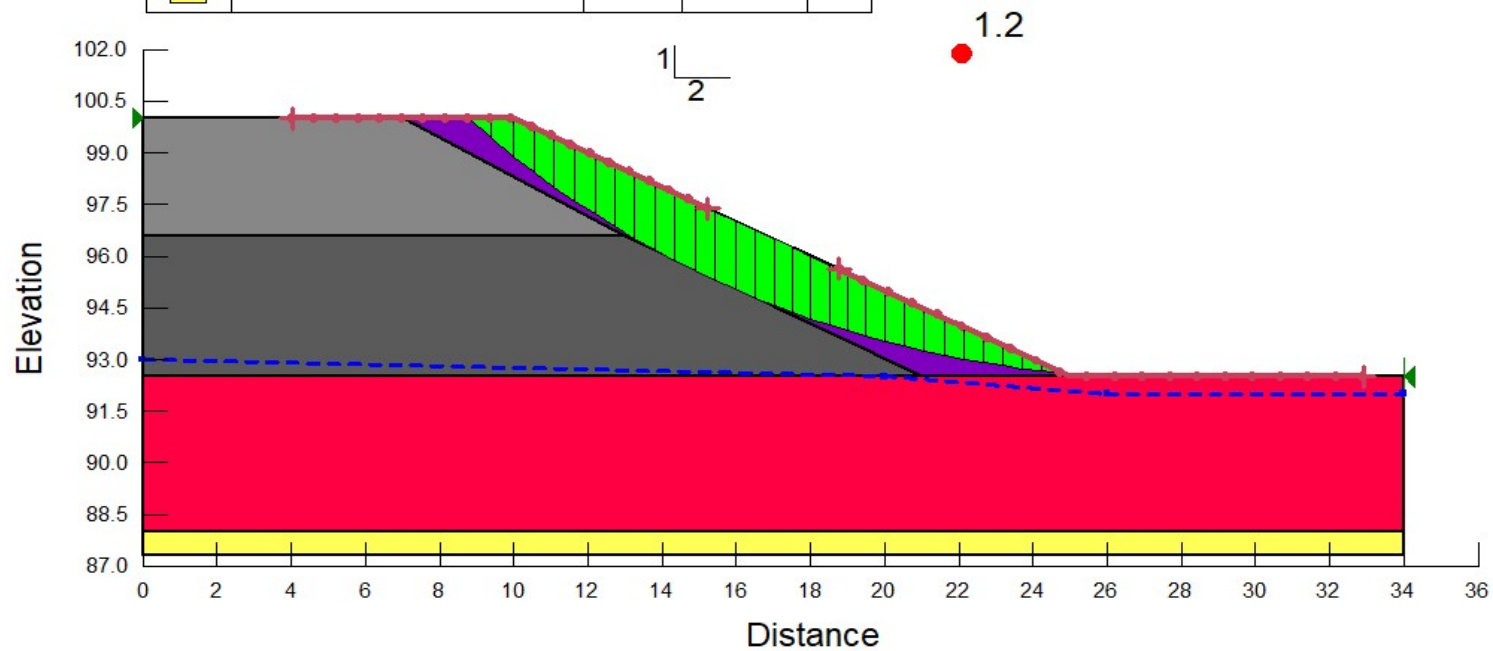
Slope Stability Analysis (Seismic)

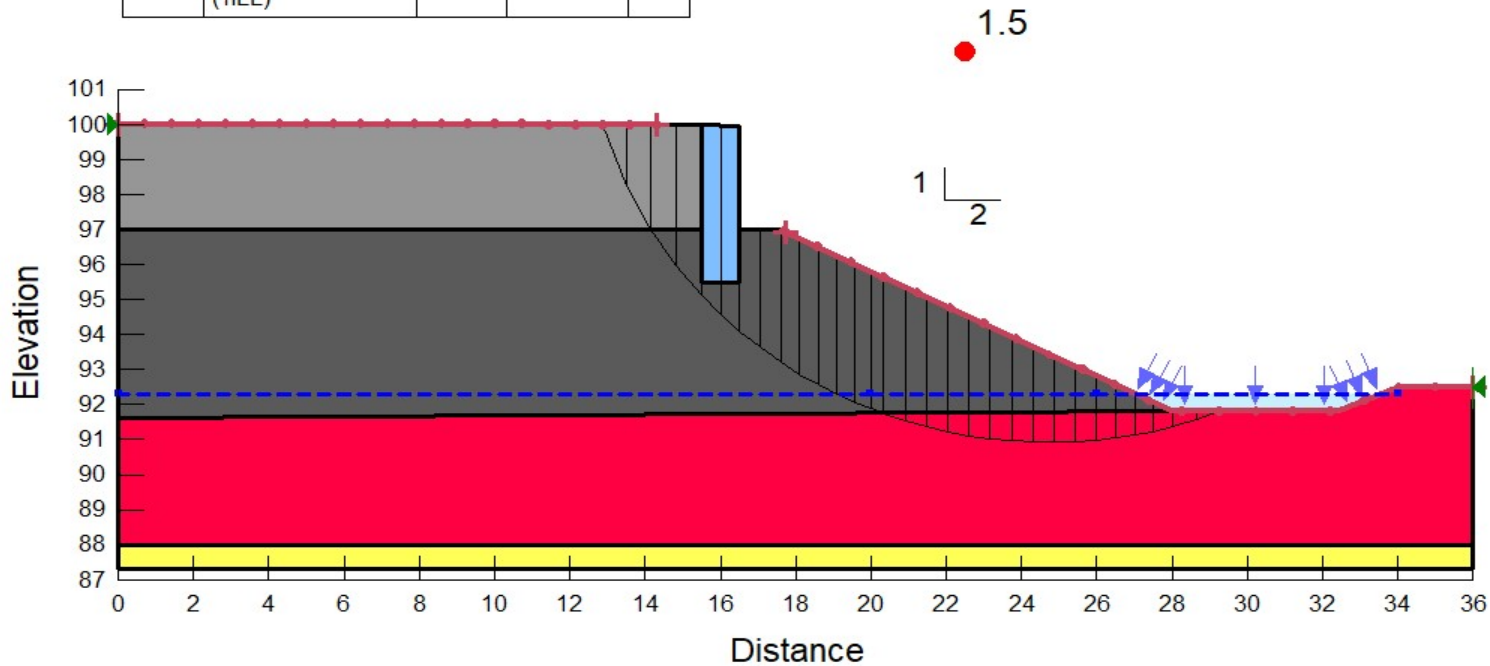
Slope Stability Analysis (Static with Open Channel)
